APPENDIX H

Environmental Mapping of the Conveyance Corridor and Scofield Island

ENVIRONMENTAL MAPPING OF THE CONVEYANCE CORRIDOR AND SCOFIELD ISLAND

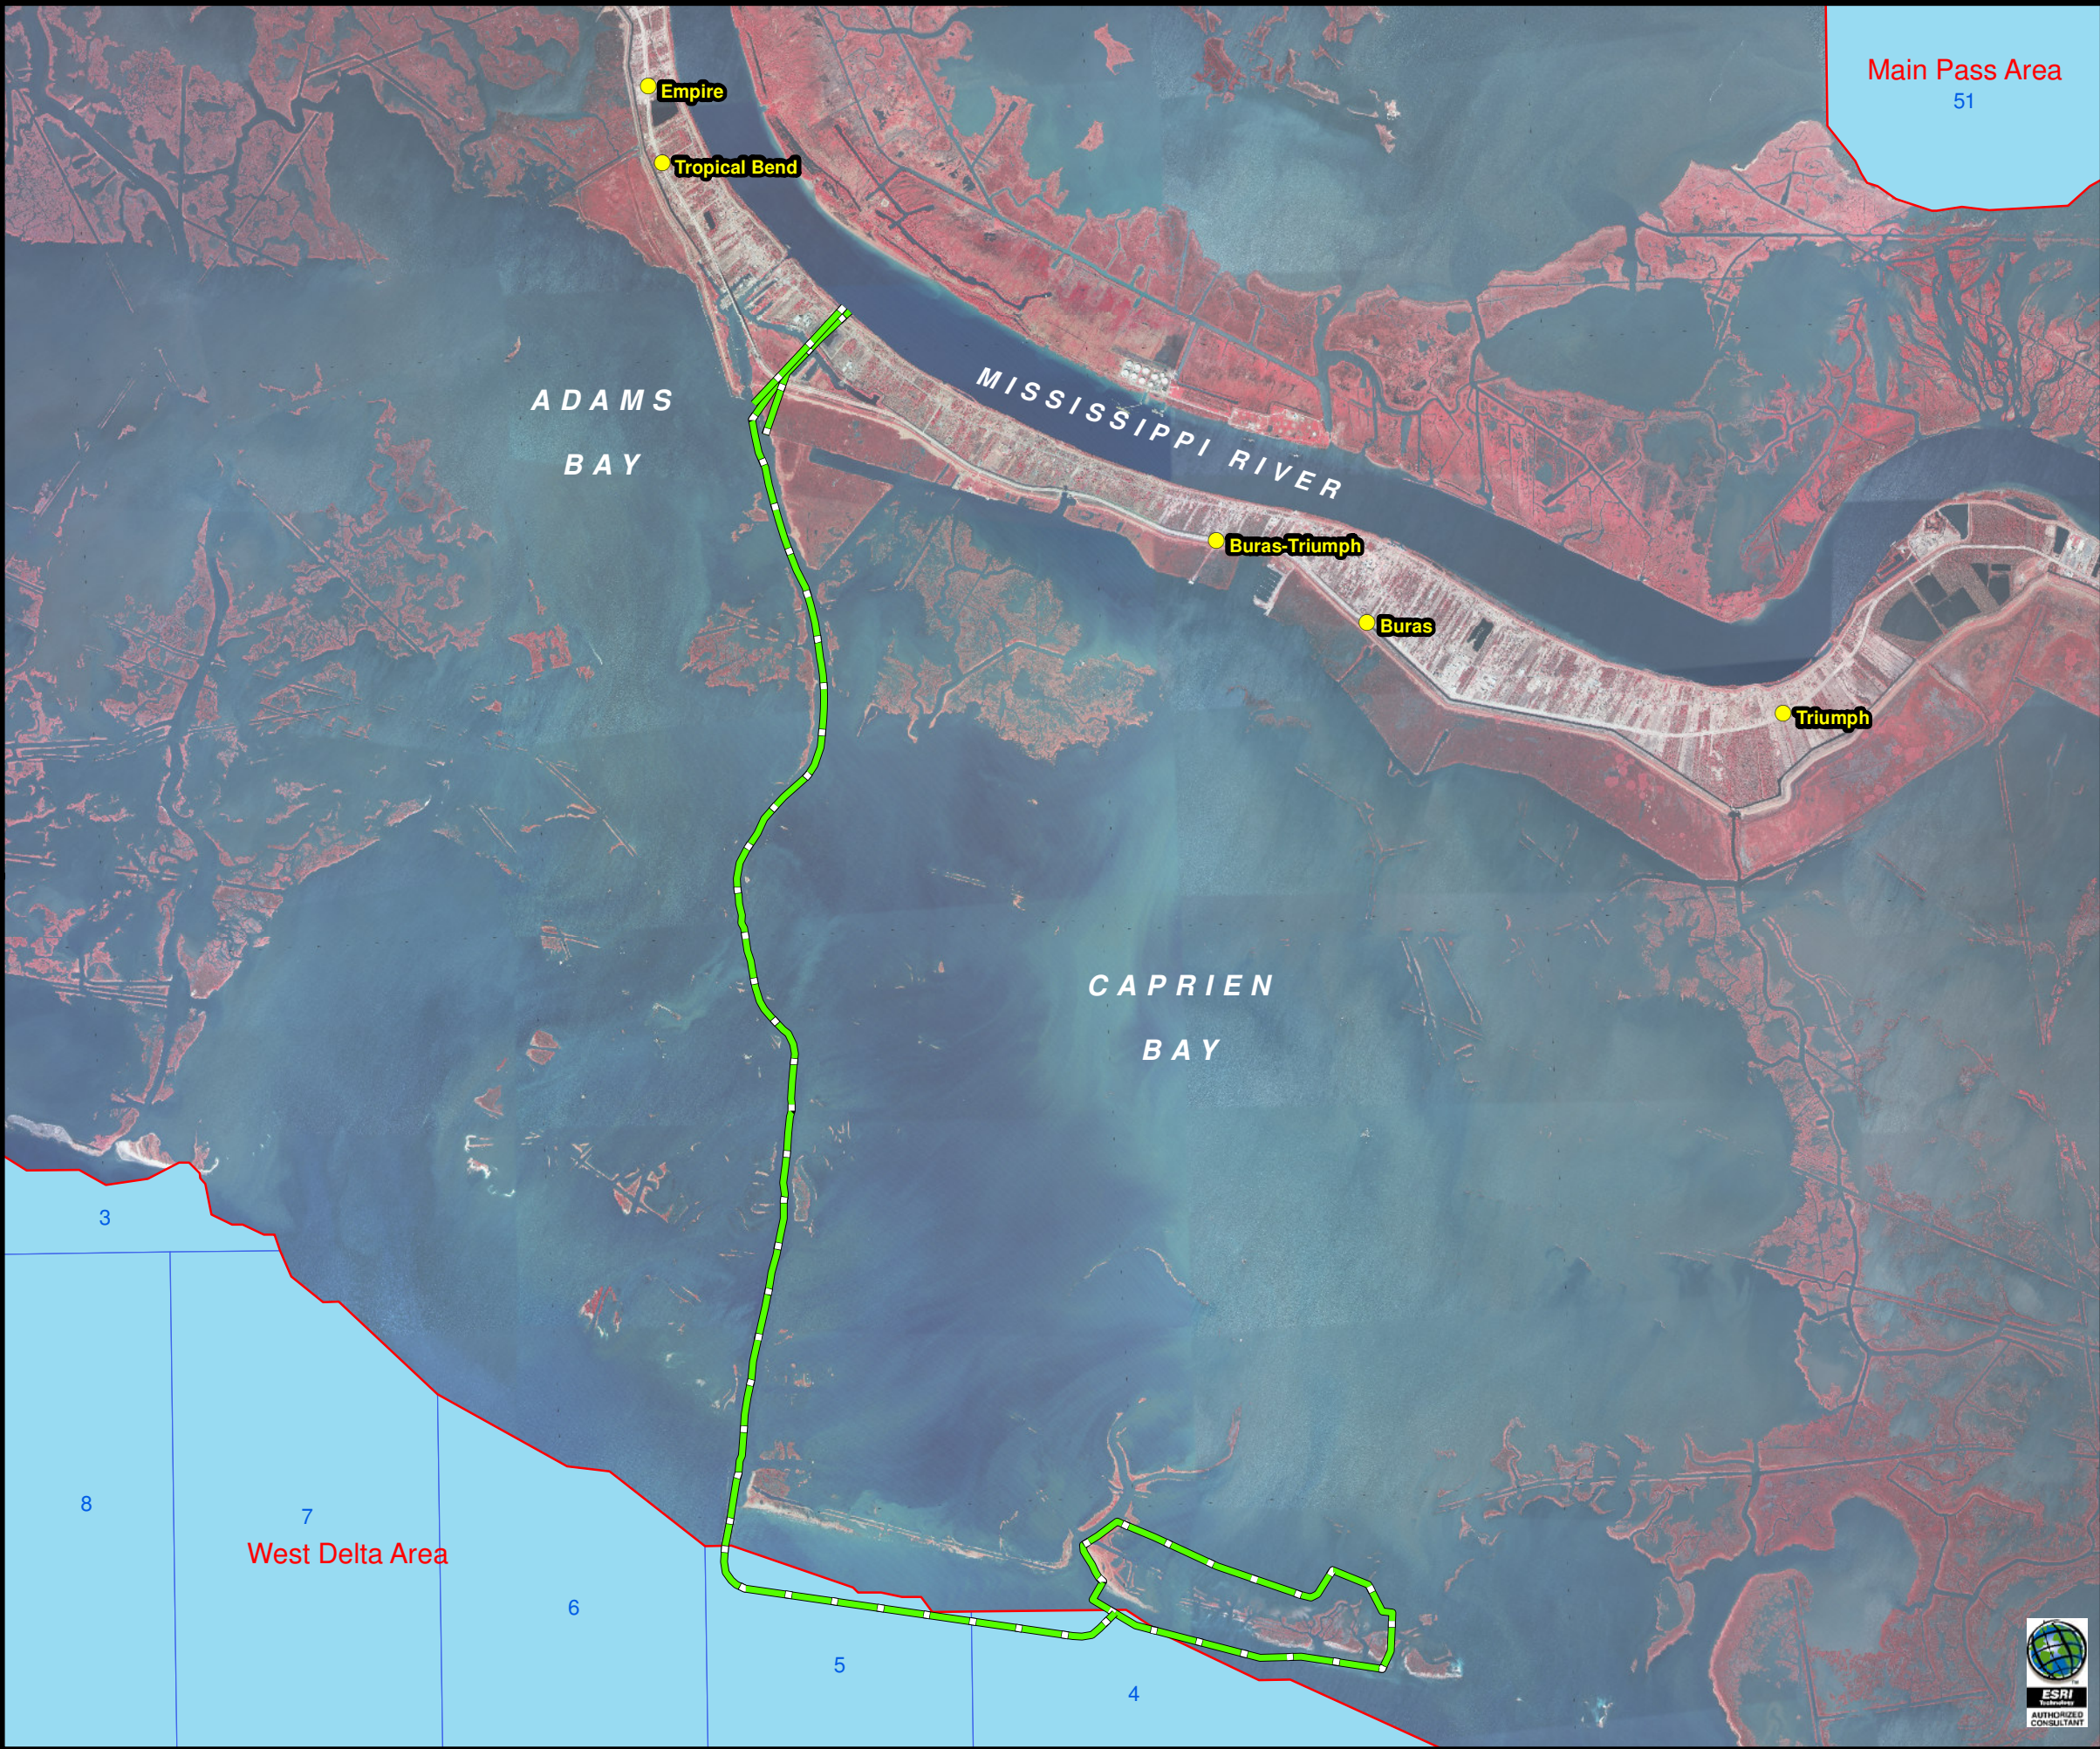
FIGURE 1

The Conveyance Corridor includes two segments. The Upland Segment is approximately 1,120 feet wide and extends approximately one mile from the western bank of the Mississippi River in Empire, Plaquemines Parish, southwest to the rock breakwater at the Empire Locks. The Over Water Segment is approximately 8.8 miles long, beginning at the Empire Locks and extending south through the Empire Waterway, crossing the eastern side of Caprien Bay, and entering the Gulf of Mexico through the jetties just west of Pelican Island. Scofield Island is a 2.4 mile long barrier island located east of Pelican Island between Scofield Bayou and the merger of Bay Coquette and the Gulf of Mexico. The Project area is shown in Figure 1.

**ENVIRONMENTAL MAPPING
SURVEY LOCATION MAP**

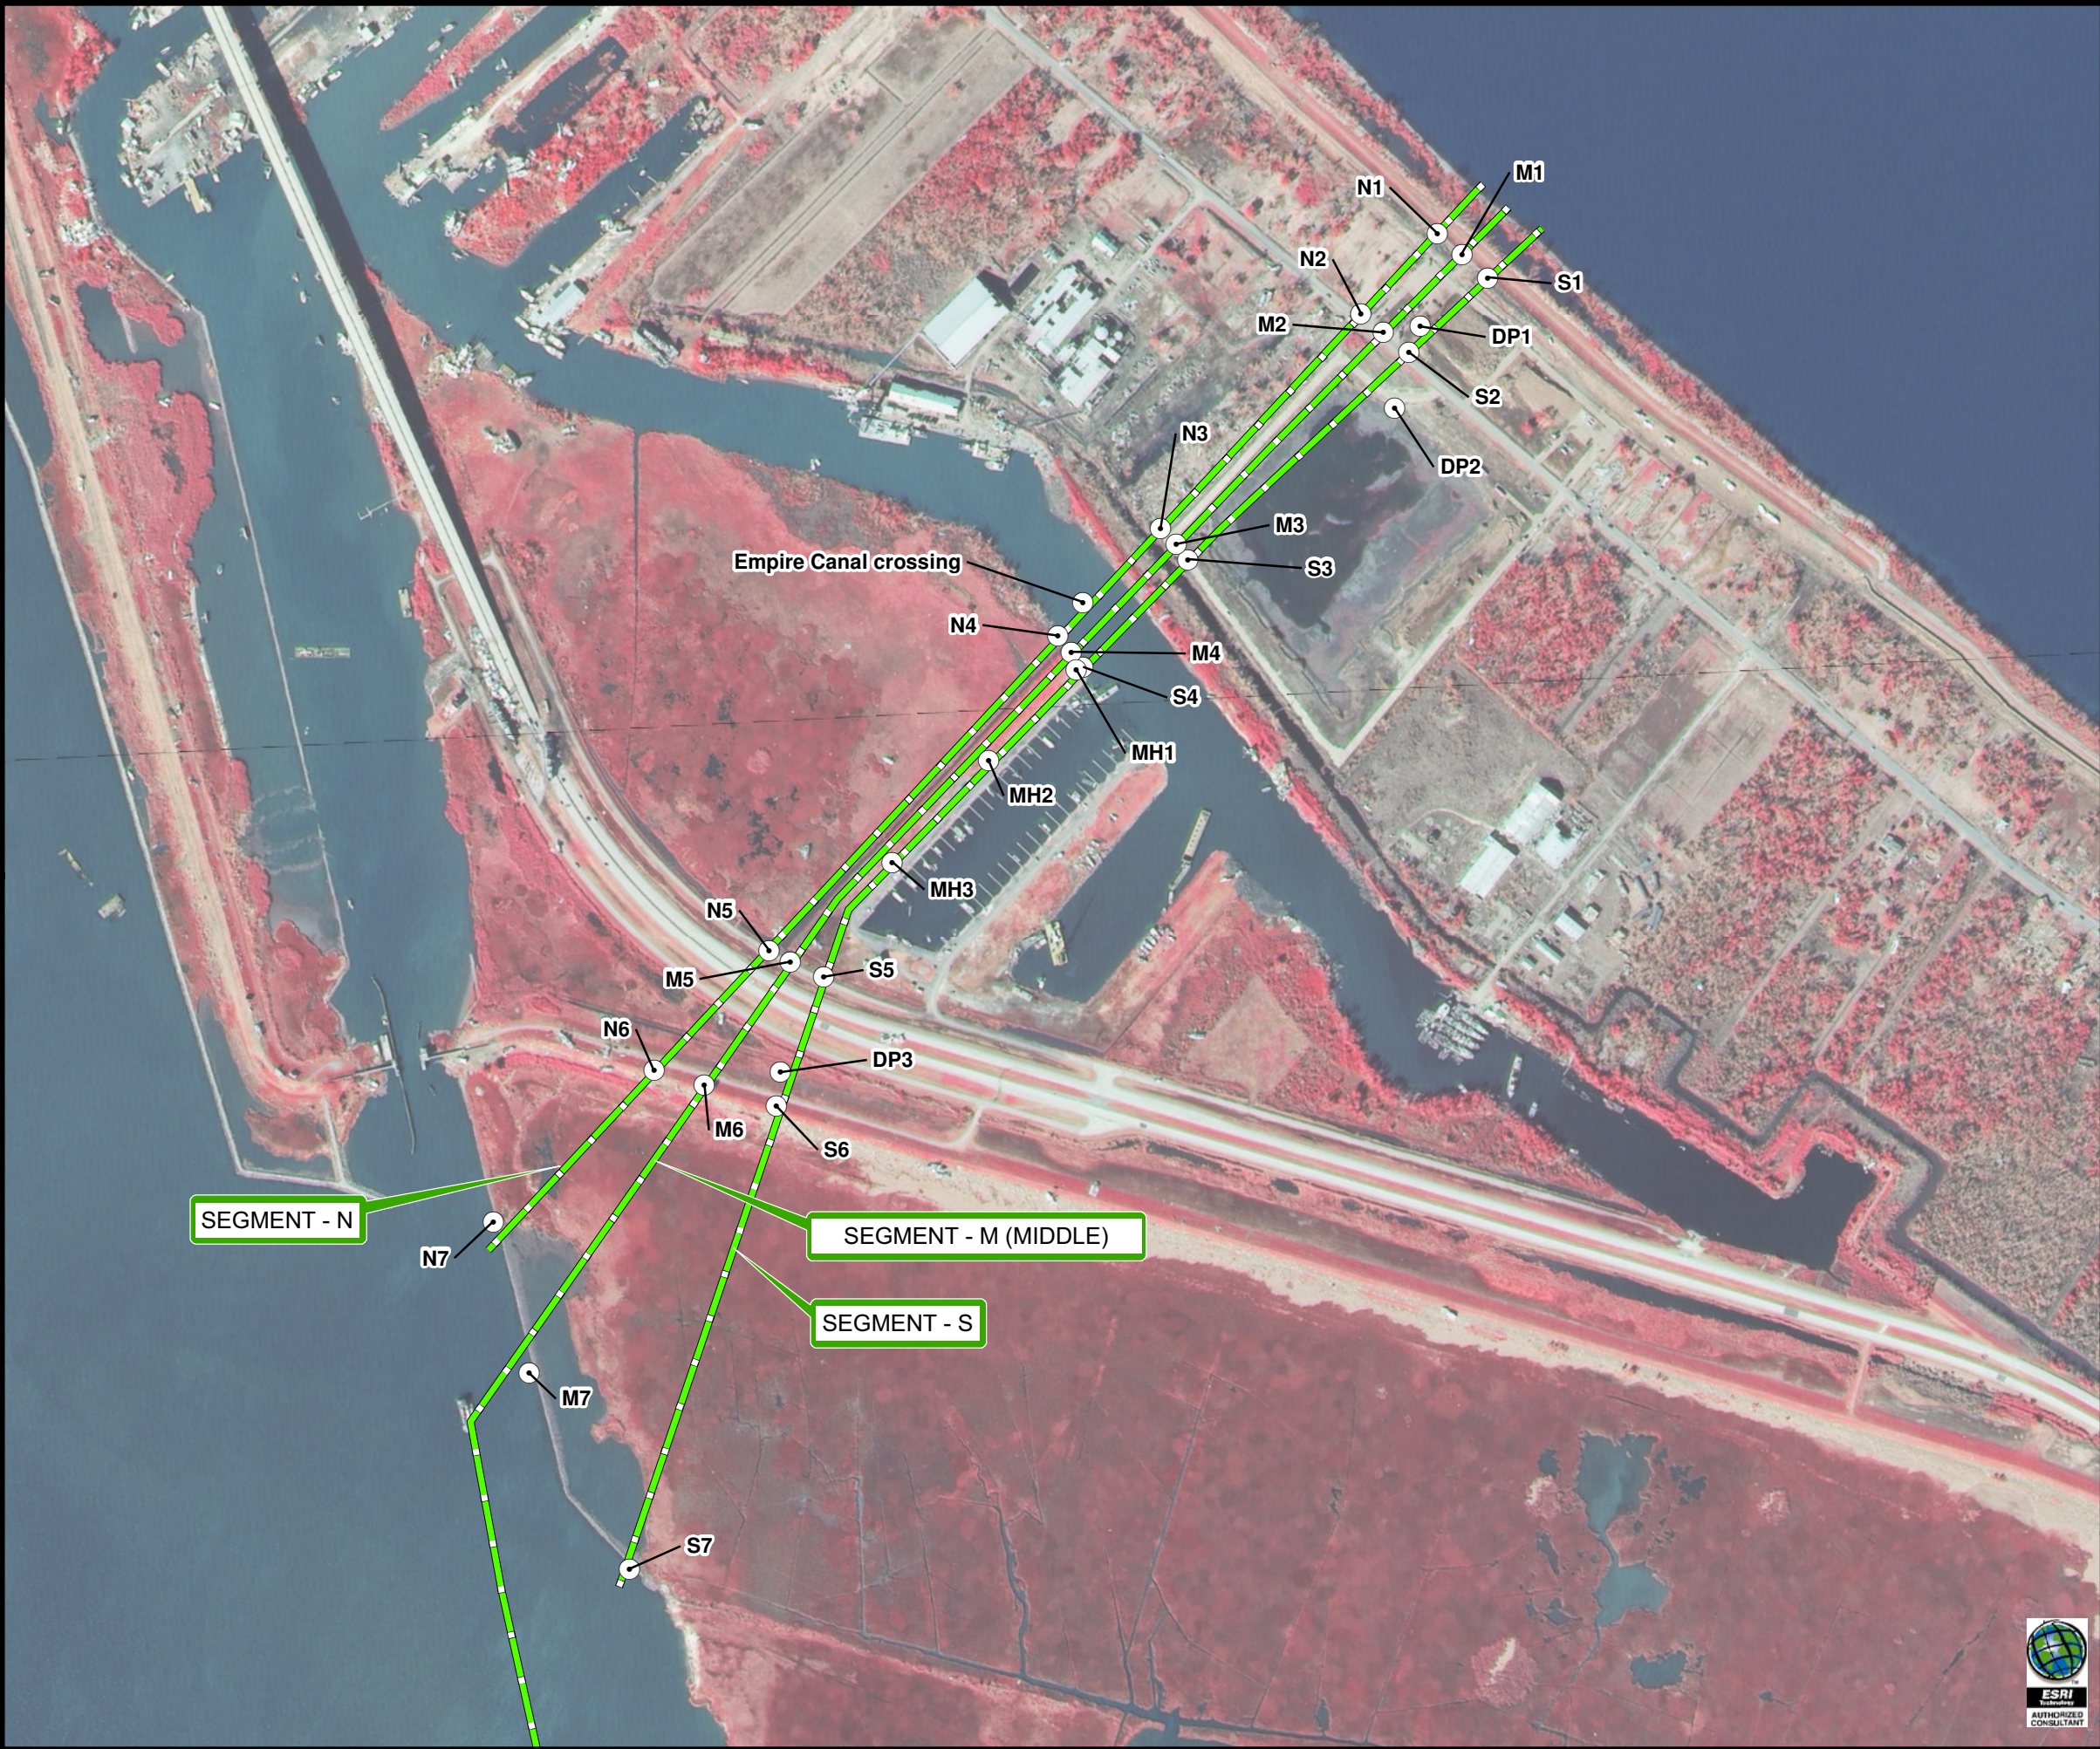
FIGURE 3

The Upland Segment of the Conveyance Corridor included three alternate land segments (Figure 3). The segments were mapped as Segment - N (N), Segment - M (M), and Segment - S (S) from the Mississippi River batture to the Empire Waterway Flood Control Structure.

RIVERINE SAND MINING/
SCOFIELD ISLAND RESTORATION (BA-40)
**SURVEY SEGMENTS FROM MISSISSIPPI
RIVER TO EMPIRE WATERWAY**
PLAQUEMINES PARISH, LOUISIANA

The batture in Region 1 was inundated and inaccessible to soil sampling. The observation points were mapped on the Mississippi River Levee (Figure 3: S1, M1, and N1). The batture plant community was scrub/shrub/herbaceous with no particular dominant species. The plant species were black willow (*Salix nigra*), sugarberry (*Celtis laevigata*), rattlebox (*Sesbania drummondii*), common reed (*Phragmites communis*), giant cutgrass (*Zizaniopsis miliacea*), cattail (*Typha* sp.),

Region 2 was accessible to soil sampling (Figure 3: DP1). Observation points were mapped between the Mississippi River Levee and Highway 11 (Figure 3: S2, M2, and N2). The plant community was dominated by coastal Bermudagrass (*Cynodon dactylon*), rattlebox, and common reed. One large live oak (*Quercus virginiana*) was centrally located on Segment N. Soil hydrology sampling indicated an absence of primary and secondary hydrologic indicators (>16 inches). Soil sampling for hydric soils was completed from 0.0 - 16.0 inches. From 0.0 to 10 inches, the soil chroma was non-hydric (10YR 5/3), and the soil texture was loamy. From 10.0 to 16.0 inches, the soil chroma was hydric (10YR 2/1), and the soil texture was clayey. Additionally, the degree of compaction and presence of oyster shell indicated that the materials overlaying the sampling point were potentially historic fill material. The mapped soil unit was Commerce (CM), which is hydric, level poorly drained, mineral soil in intermediate positions along the natural levees of the Mississippi River (NRCS, 2008)

Visible hazards were observed in Region 2. A natural gas line was parallel to the west side of Highway 11, which bisects Segments S, M, and N. A hurricane fence bisects Segments S2 and M2. Just east of Highway 11, a fire hydrant is located on Segment N. No ecologically sensitive sites were observed in Region 2 on Segments S, M, or N.

Region 3 was accessible to soil sampling (Figure 3: DP2). The observation points were mapped between Highway 11 and the Empire Canal Spoil Bank (Figure 3: S3, M3, and N3). The largest portion of Region 3 was a fenced landfill that was filled and capped. Located on the west side of the landfill was a shallow drainage canal, and on the north boundary of the landfill was a drainage ditch. The landfill plant community was dominated by coastal Bermudagrass (90%), and rattlebox (10%). Segments S and M were within the landfill. Segment N was within the east-west drainage ditch that bordered the landfill. Soil hydrology analysis indicated an absence of primary and secondary hydrologic indicators. Soil testing for hydric soils was completed. From 0.0 to 8 inches, the soil chroma was hydric (matrix 10YR 3/2; mottle 10YR 2/1) and the soil texture was loamy clay. From 8.0 to 16 inches, the soil chroma was hydric (matrix 10YR 3/2; mottle 7.5YR 4/6) and the soil texture was clayey. The mapped soil unit was Shriver (SK - Sharkey clay), which is hydric, level, poorly drained, mineral soil in low positions along the natural levees of the Mississippi River (NRCS, 2008).

Visible hazards were observed in Region 3. At the west end of the landfill on Segment M, there was exposed debris (outside of the fence) that was not covered by the landfill cap. Most of this debris consisted of household materials and commercial fishing net. Along Segment N, there appears to be an underground waterline, which services fire hydrants and an adjoining trailer park in Region 3. No ecologically sensitive areas were observed in Region 3 on Segments S, M, or N. However, the utilization of Segment S will minimize wetland and human impacts.

Region 4 was not soil sampled. The observation points were mapped between the Empire Canal spoil bank and Highway 23 (Figure 3: S4, M4, and N4). The marsh was identified as an undisturbed, inter-tidal saltwater marsh. The Empire Boat Harbor soil surface was compacted and improved with parking lots, boat docks, and municipal facilities (water and electricity). Segments S and M passed through the northern edge of the Empire Boat Harbor. Segment N passed through the inter-tidal saltwater marsh. The saltwater marsh plant community was dominated by smooth cordgrass (*Spartina alterniflora*), leafy three-square (*Scirpus robustus*), and black needle rush (*Juncus roemerianus*). The Empire Boat Harbor plant community was dominated by coastal Bermudagrass. Soil testing for hydric soils was not collected due to tidal inundation in the saltwater marsh and soil compaction in the Empire Boat harbor. The mapped soil unit was dredged Aquents (AN), which are hydric, hydraulically dredged; poorly drained soils (NRCS, 2008).

Visible hazards were observed in Region 4. Between Segments S and M, a waterline and fire

hydrant system are located. Three fire hydrants were observed on the Segment M (Figure 3: MH1, MH2, and MH3). The saltwater marsh was the ecologically sensitive area that was observed in Region 4 on Segment S.

Region 5 was accessible to soil sampling (Figure 3: DP3). The observation points were mapped between Highway 23 and the rock breakwater (Figure 3: S5, M5, and N5). The soil sample was collected in the high saltwater marsh between the Hurricane Protection Levee and the access road. The inter-tidal saltwater marsh was not soil sampled due to inundation at the time of sampling. The high saltwater marsh plant community was dominated by saltgrass (*Distichlis spicata*), annual glasswort (*Salicornia bigelovii*), sea-ox-eye daisy (*Borrchia frutescens*), marshhay cordgrass (*Spartina patens*), leafy three-square, black needle rush, and smooth cordgrass. The inter-tidal saltwater marsh plant community was dominated by smooth cordgrass, black needle rush, and leafy three-square. Soil water in the high saltwater marsh was at the soil surface level. The inter-tidal saltwater marsh soil hydrology was inundated and tidally dynamic. Soil testing for hydric soils was completed in the high saltwater marsh. From 0.0 to 6.0 inches, the soil chroma was hydric (matrix 10YR 4/2; mottle 10YR 3/6) and the soil texture was a sandy clay. From 6.0 to 16.0 inches; the soil chroma was hydric (matrix 10YR 5/1; mottle 10YR 4/4) and the soil texture was sandy. The high saltwater marsh soils were mapped as dredged Aquents, which was described in Section 4.4. The inter-tidal saltwater marsh soils were mapped as dredged, frequently flooded Aquent soils (AT), which are hydric, hydraulically dredged, poorly drained soils (NRCS, 2008).

Visible hazards were observed in Region 5. Segments S, M, and N cross the rock levee on the outside of the Empire Waterway Flood Control Structure. The high saltwater marsh and inter-tidal in saltwater marsh are ecologically sensitive areas that were observed in Region 5 on Segments S, M, and N. A more direct path (e.g. Segment M) would minimize wetland impacts.

From the Mississippi River to the Empire Waterway, the least invasive path is a combination of Routes S and M. The Conveyance Corridor should start at point S1 in the Mississippi River, be directed through the Empire Boat Harbor at point M4, and follow through points M5, M6, and M7. This Conveyance Corridor will reduce the interaction between the sediment pipeline, municipal appurtenances, and existing saltwater marshes. The open water segment of Conveyance Corridor did not appear to impinge upon any marsh islands. However, the corridor will traverse several oyster lease boundaries. In addition, there are physical hazards along the Empire Waterway (pipeline bulkheads, riprap, and channel markers). The open water segment of Conveyance Corridor should follow the east side of the Empire Waterway allowing for navigation access at pre-determined points along the access route.

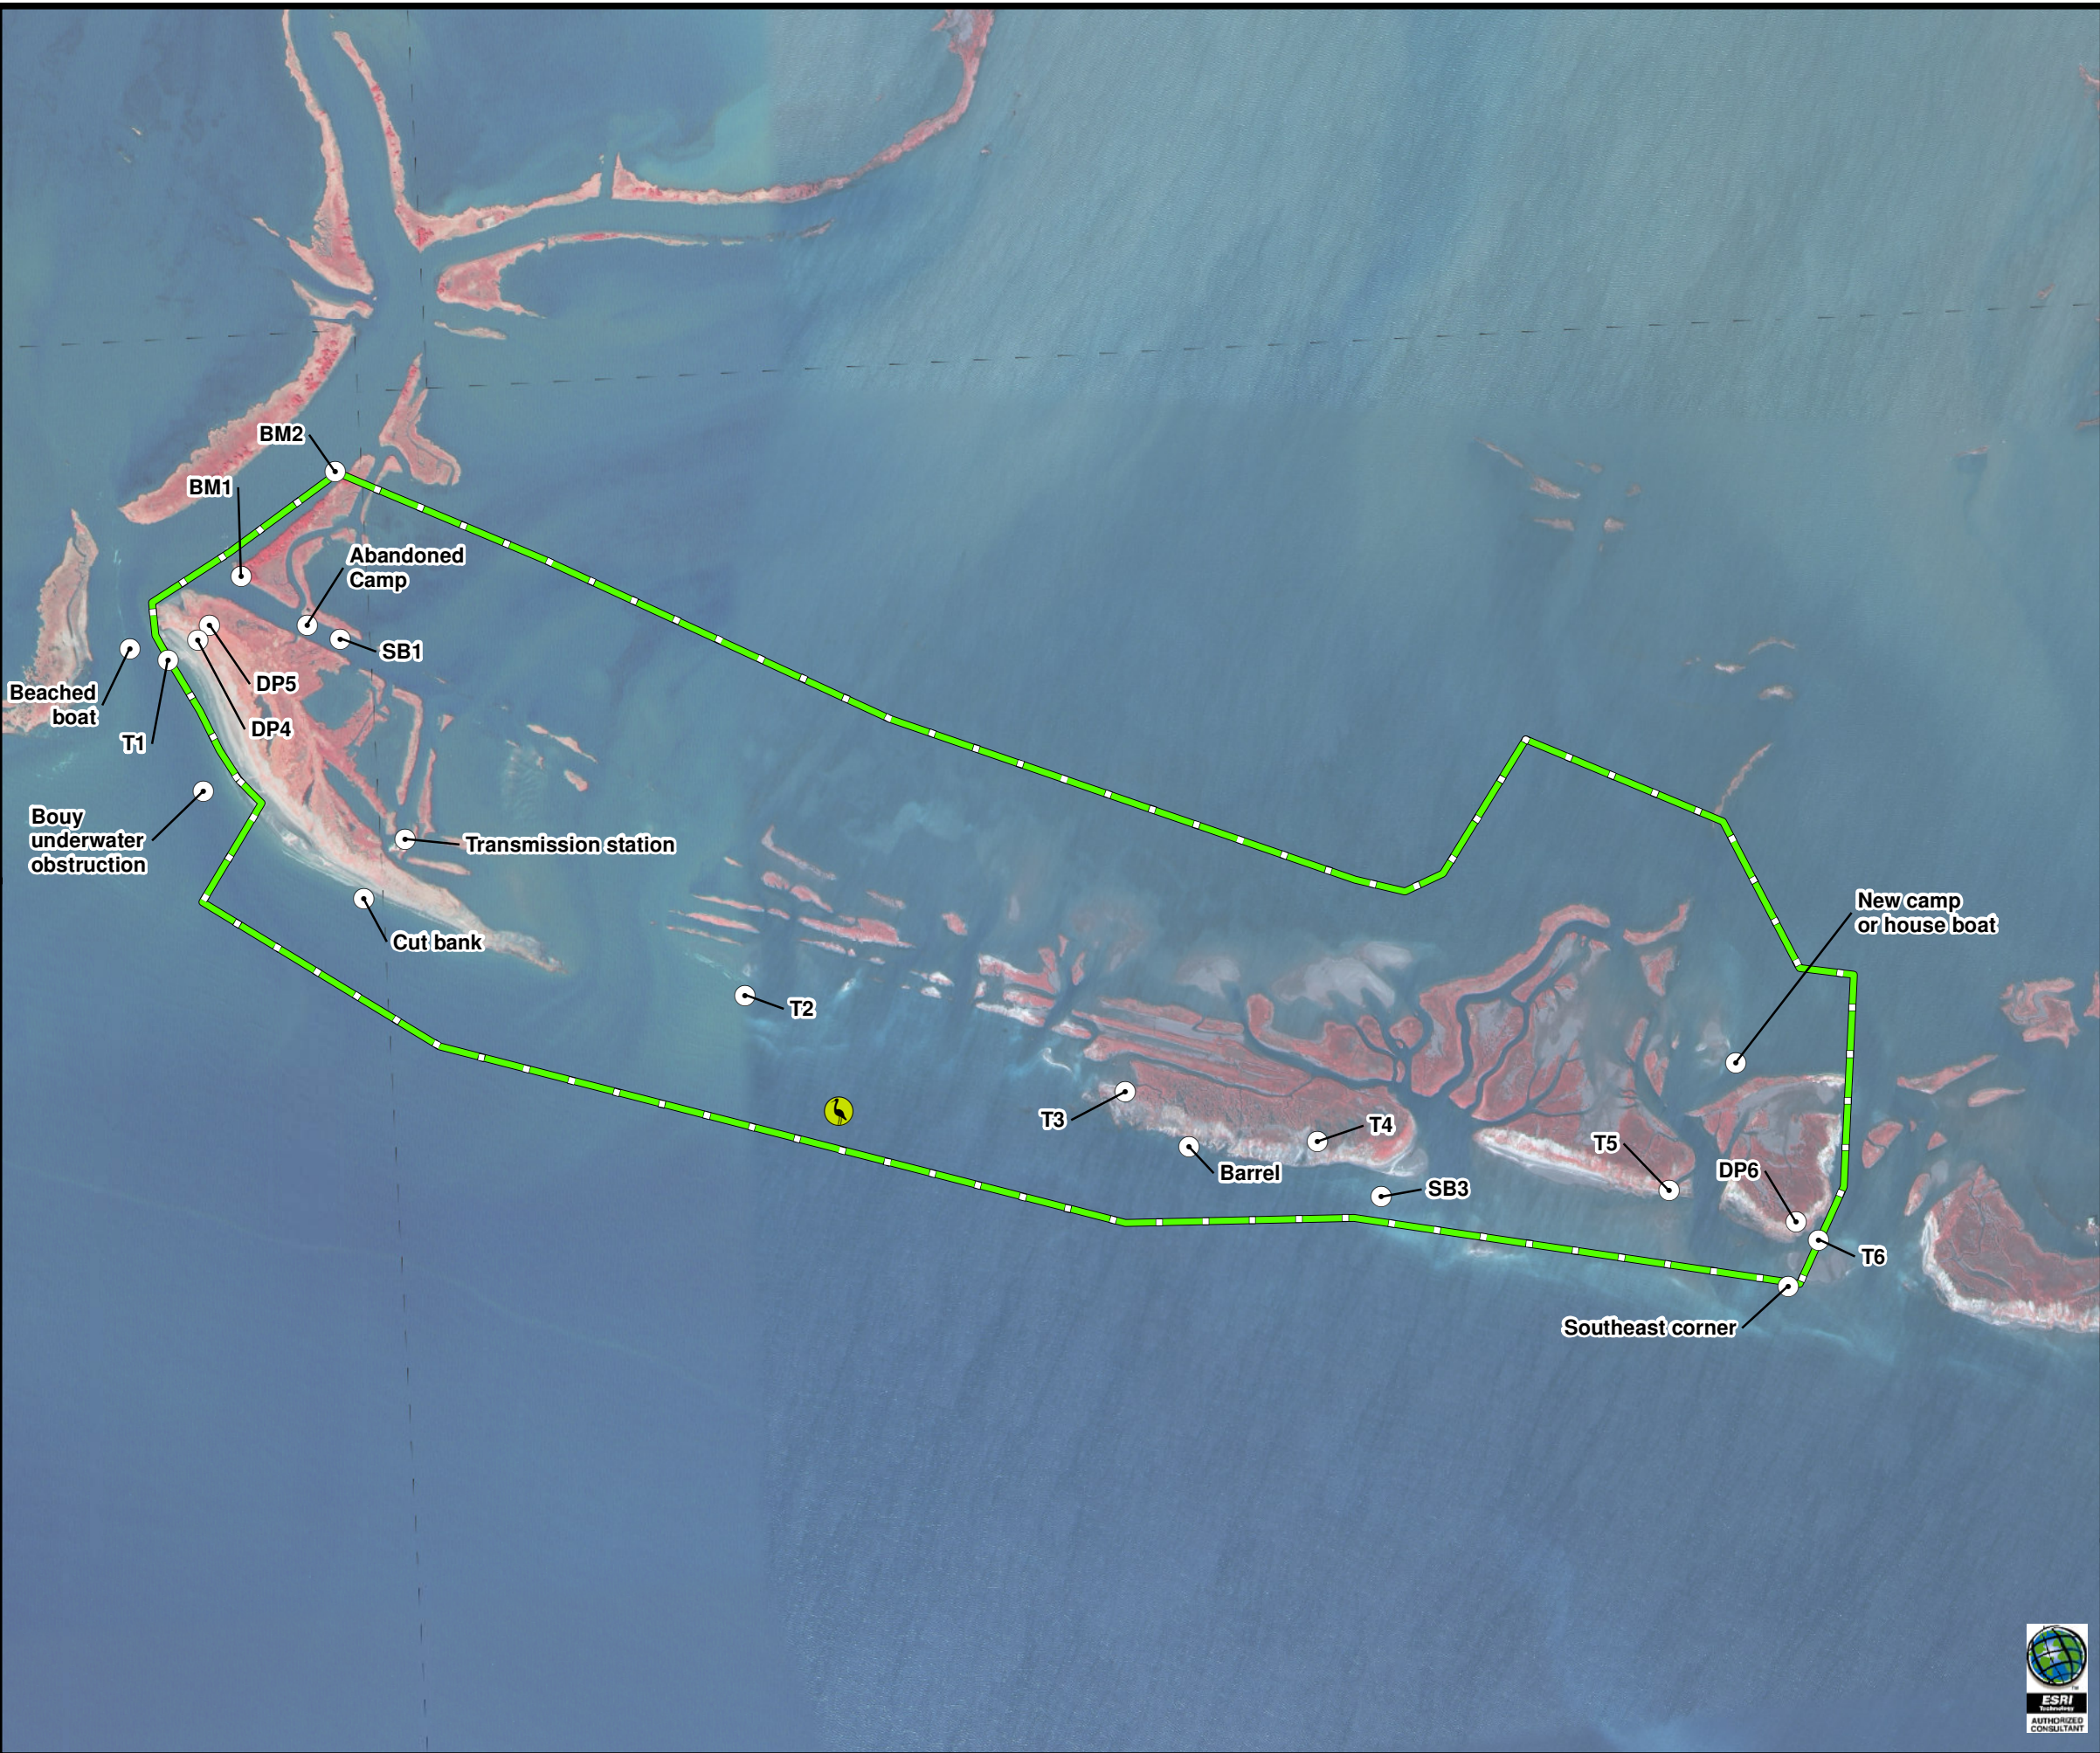
FIGURE 5

Region 7 is Scofield Island, which is a rapidly eroding barrier island (Figure 5). Six visual vegetative observation points (T1...T6) and three soil data points (DP4, DP5, and DP6) were established (Figure 5). Observation vegetative transects were established in a general north-south direction to bisect the island habitats. The soil data points were established at the southwest corner and southeast corner of Scofield Island.

Scofield Island soil hydrology was collected at three locations (Figure 5: DP4, DP5, and DP6). DP4 and DP5 were located on transect T1, and DP6 was located on transect T6. DP4 was located on a sand dune, DP5 was located in a smooth cordgrass saltwater marsh, and DP6 was located in a low lying/eroding sand dune/beach head. Data from DP4 indicated the absence of wetland hydrology features on the sand dune. Data from DP5 indicated wetland hydrology in the saltwater marsh (inundated, saturated, and raised water table at the soil surface). Data from DP6 (intermediate elevation between dune height and marsh level) indicated wetland hydrology (0.0 inundation, soil moisture \leq 6 inches below the soil surface, and water table \leq 2 inches).

SCOFIELD ISLAND

Visible hazards were observed in Region 7 (Figure 5). Marked, underground pipelines laterally bisect Scofield Island from southwest to northeast. For the following hazards, the UTM coordinates were plotted on Figure 5: three sunken boats (SB1, SB2, and SB3), one beached boat, one abandoned camp, one new camp, one transmission station, and one blue barrel on the beachhead.

The black mangrove colony was the only ecologically sensitive area observed in Region 7 (BMI and BM2). From shoreline and transect observations, ground nesting or scrub/shrub nesting bird species were not observed on Scofield Island at the time of the field reconnaissance. After reviewing the Louisiana Department of Wildlife and Fisheries Threatened and Endangered website, the only endangered species that may inhabit Scofield Island is the brown pelican (*Pelecanus occidentalis*). According to information posted on the website, the brown pelican nests from November to July. This survey was completed on July 15, 16, and 17, which is slightly outside of the nesting season. If fill material is to be placed on the Island during the brown pelican nesting season, then an over flight should be considered to investigate the potential of any nesting brown pelicans. Furthermore, the last active wading bird colony was mapped in 1990 at the following latitude and longitude +29.23861 -89.54917 (personal communications, Carolyn Michon, LDWF). The wading bird colony is indicated on Figure 5 by a wading bird symbol.

Scofield Island is visibly eroding, as indicated by Williams, *et al.* (1992), and is greatly in need of mineral sediment deposition and nourishment to restore the Island's historic boundaries. The ecologically significant habitats included a black mangrove colony that exists on the western edge of Scofield Island and a robust *Spartina alterniflora* marsh. As part of the restoration plan, consideration should be given to siting the western perimeter of the fill template along the eastern flank of the existing stable, black mangrove colony to protect this sensitive habitat and

minimize or avoid natural resource impacts. Furthermore, placing fill in Scofield Bayou will slough into the historic bayou channel. Consideration should also be given to avoiding direct placement of sediment on the existing *Spartina alterniflora* marsh. However, designing the restoration plan to take advantage of the existing island framework, thereby reducing the volume and corresponding cost required to construct the Project, along with creating and sustaining new marsh habitat in excess of the Project goal is a recommended alternative to avoidance. Further, this restoration plan is self mitigating by virtue of creating significantly more marsh habitat than what is being covered by the fill template.
