**Coastal Protection and Restoration
Authority of Louisiana**

2008 Annual Inspection Report

**NAOMI OUTFALL
MANAGEMENT**

State Project Number BA-3c
Priority Project List 5

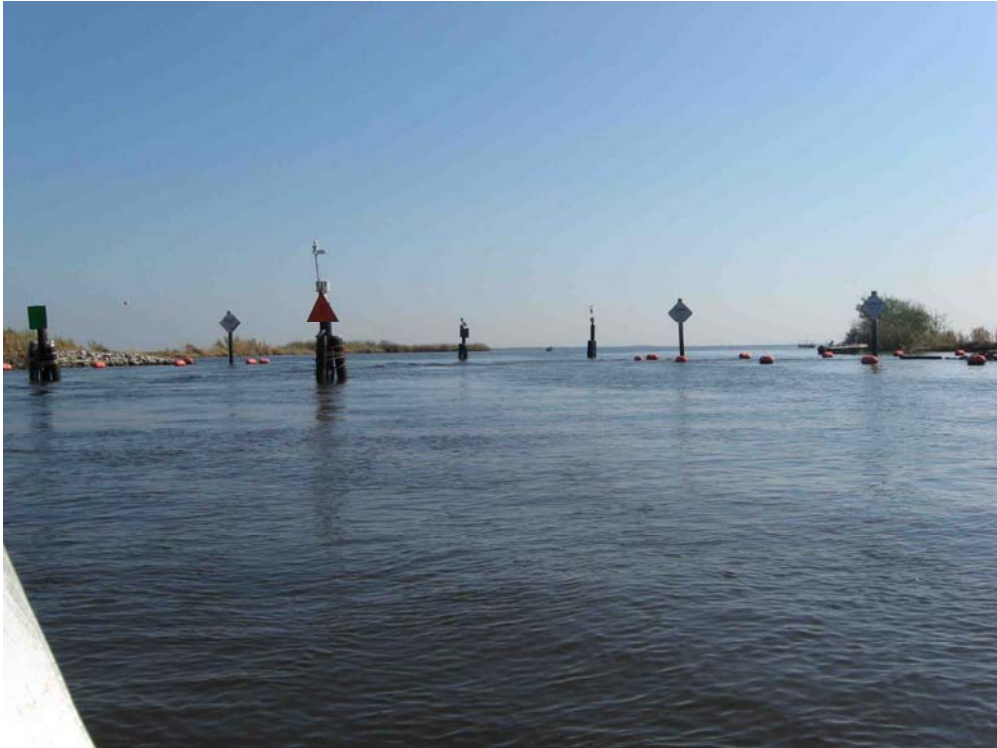
The two pilings on either side of the boat bay which were damaged at last year's inspection have been replaced with regulatory marker buoys. Both of these buoys are now missing. The damaged piling clusters supporting the navigation lights have been repaired and another cluster is now damaged.

Both buoys are missing.

Photo #1 – Bayou Dupont Canal Weir. Approaching the structure from the Barataria Waterway, looking toward the Pen.

Item	Condition	Physical Damage	Corrosion	Photo #	Observations and Remarks
Rock Riprap	Good	None	N/A	#1	
Creosote Piling	Fair	None	None	#1	Some damage to pile clusters
Warning Signs and Day Board Navigation Signs	Fair	None	None	#1	
Navigation Aid Lights	Fair	None	None	#1	
Warning Buoys	Poor	See observations	None	#1	Both Missing
Vandalism	N/A	N/A	N/A

- Access for BA-41 will require partial removal and replacement of Bayou Dupont Structure. All necessary maintenance needs for this structure will be included in the construction of BA-41.

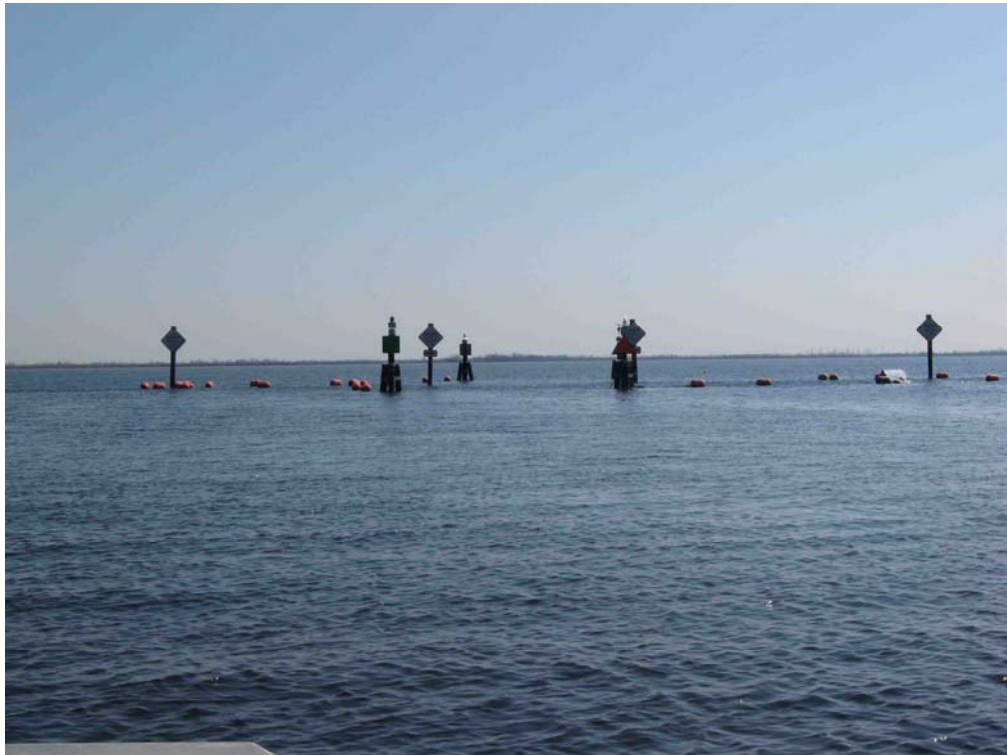
All pilings visually appeared to be damage-free and in good condition.

All signs appeared to be in satisfactory condition with no indication of significant damage.

Photo #2 – Goose Bayou Canal Weir. Looking East toward the Pen.

Item	Condition	Physical Damage	Corrosion	Photo #	Observations and Remarks
Rock Riprap	Good	None	N/A		
Creosote Piling	Good	None	None	#2	
Warning Signs and Day Board Navigation Signs	Good	None	None	#2	
Navigation Aid Lights	Good	None	None	#2	
Warning Buoys	Good	None	None	#2	
Vandalism	N/A	N/A	N/A
