2009 Annual Inspection Report

**NAOMI OUTFALL
MANAGEMENT**

State Project Number BA-3c
Priority Project List 5

March 20, 2009
Jefferson Parish

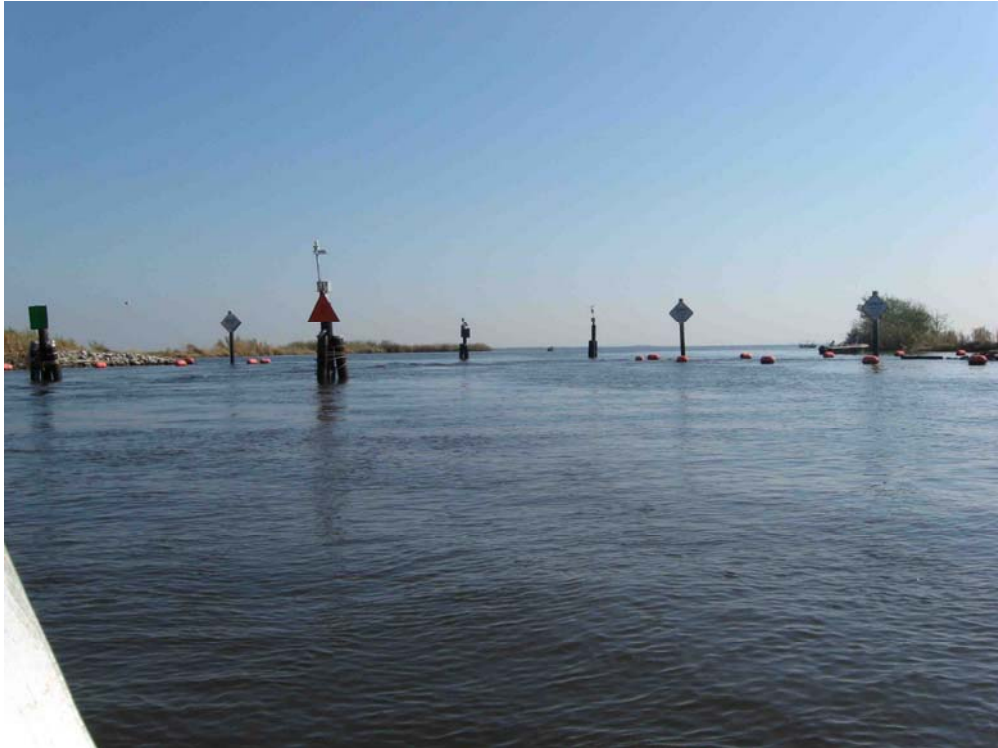
There were no notable changes in the rock rip rap during this inspection.

The two pilings on either side of the boat bay which were damaged at last year's inspection have been replaced with regulatory marker buoys. Both of these buoys are now missing. The damaged piling clusters supporting the navigation lights have been repaired and another cluster is now damaged.

Both buoys have gone missing.

Photo #1 – Bayou Dupont Canal Weir. Approaching the structure from the Barataria Waterway, looking toward the Pen.

Item	Condition	Physical Damage	Corrosion	Photo #	Observations and Remarks
Rock Riprap	Good	None	N/A	#1	
Creosote Piling	Fair	None	None	#1	Some damage to pile clusters
Warning Signs and Day Board Navigation Signs	Fair	None	None	#1	
Navigation Aid Lights	Fair	None	None	#1	
Warning Buoys	Poor	See observations	None	#1	Both Missing
Vandalism	N/A	N/A	N/A

Overall, the Naomi Outfall Management project is functioning properly and is in fair condition. Vandalism to the navigational aids continues to be a concern. The BA-41 South Shore of the Pen Shoreline Protection Project is anticipated to go into the construction phase this year and any repairs needed for the Bayou Dupont weir structure will be made at this time.

- Bayou Dupont repair needs listed in Section IV.

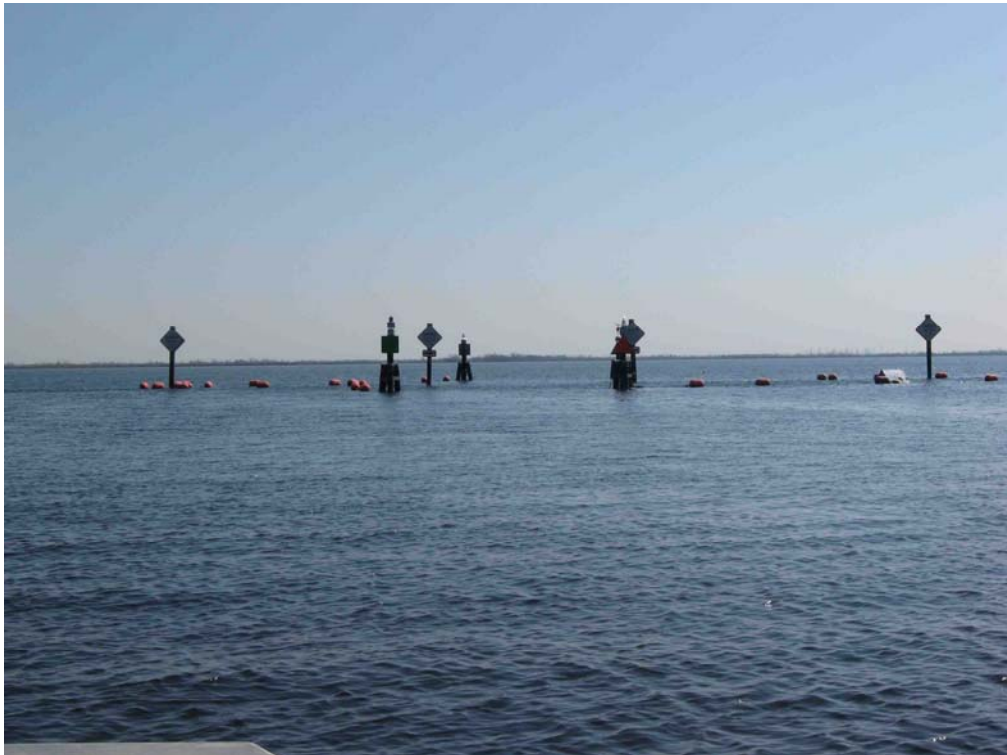
There were no notable changes in the rock rip rap during this inspection.

All pilings visually appeared to be damage-free and in good condition.

All signs appeared to be in satisfactory condition with no indication of significant damage.

Photo #2 – Goose Bayou Canal Weir. Looking East toward the Pen.

Item	Condition	Physical Damage	Corrosion	Photo #	Observations and Remarks
Rock Riprap	Good	None	N/A		
Creosote Piling	Good	None	None	#2	
Warning Signs and Day Board Navigation Signs	Good	None	None	#2	
Navigation Aid Lights	Good	None	None	#2	
Warning Buoys	Good	None	None	#2	
Vandalism	N/A	N/A	N/A
