## PROJECT COMPLETION REPORT

**PROJECT NAME:** GIWW to Clovelly Hydrologic Restoration Project (BA-02)  
Timber Pile Cluster and Navigational Aid Replacement

**REPORT DATE:** January 4, 2007

**PREPARED BY:** LDNR-TFO

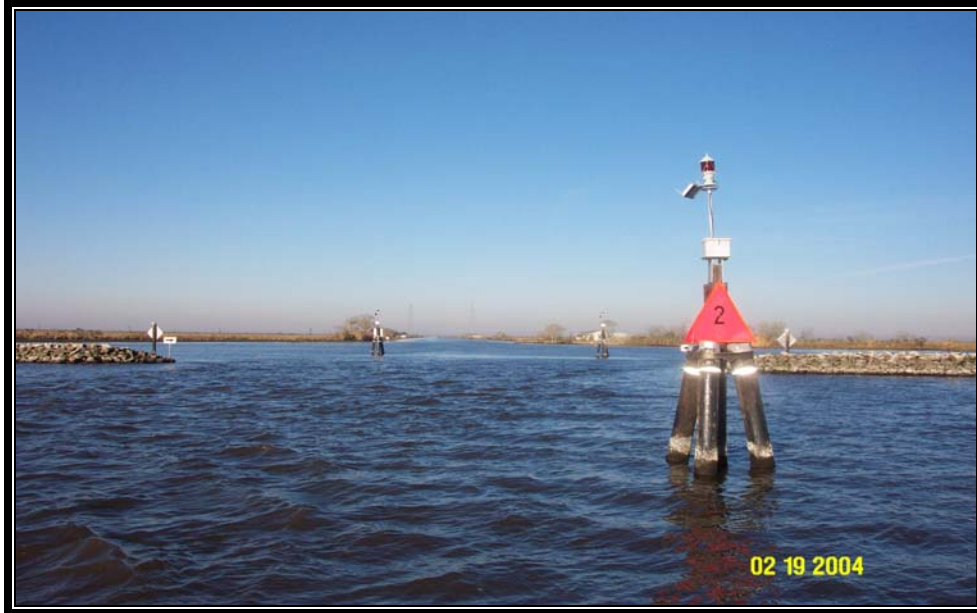
Photo of timber pile cluster and navigation light prior to being destroyed.

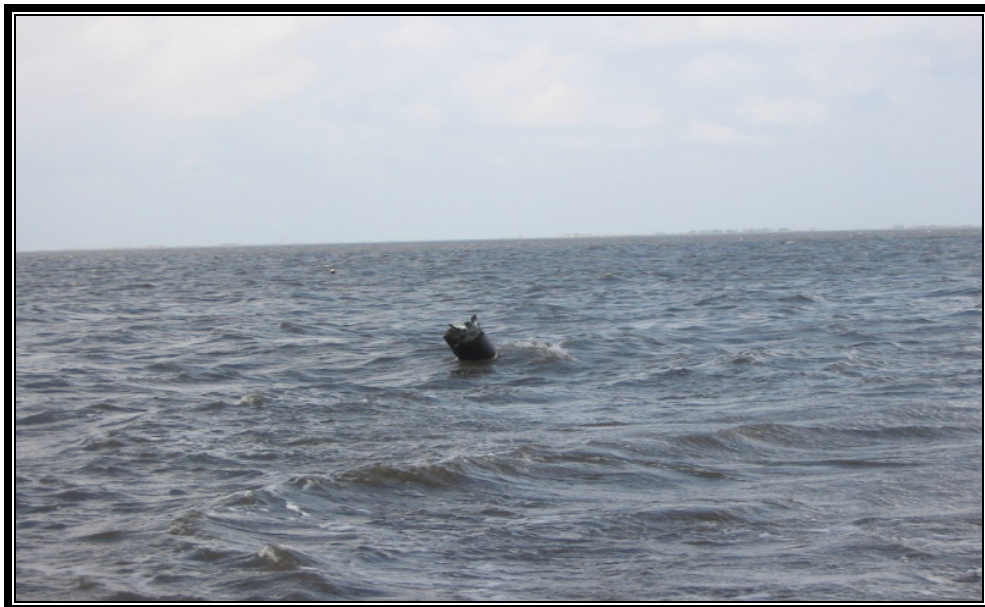
On September 25, 2006, LDNR was notified by Shaw Coastal, Inc., who is providing inspections services for the Little Lake Marsh Creation and Shoreline Protection Project (BA-37), that the timber pile cluster and navigation light located along Clovelly Canal at the mouth of Little Lake was destroyed. Apparently, a barge or large vessel accessing the barge bay at Structure 14A collided with the timber pile cluster on September 22, 2006. The initial report from Shaw Coastal was that the entire structure had been destroyed with only a 3' to 4' section of one batter pile was protruding from the water surface. (Below is a photo of the damage to the timber pile cluster)

Timber pile cluster after damage showing batter pile protruding from waters surface.

Since the exposed batter pile can be a navigation hazard, Shane Triche and Brian Babin visited the site on September 26, 2006 to mark the exposed batter pile with nail-on reflectors and reflective tape until arrangements are made for the replacement of the structure.

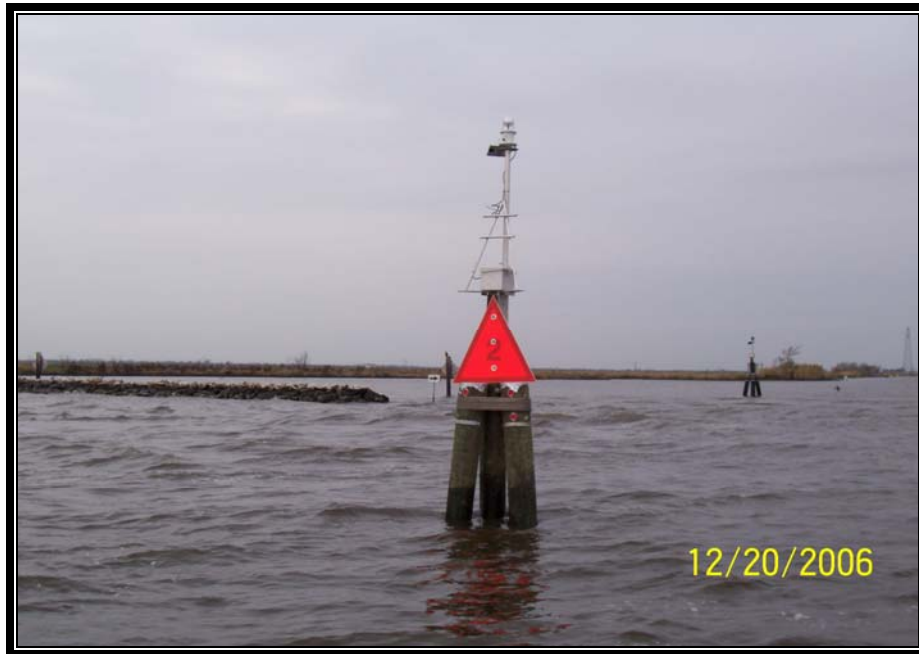
Replacement of timer pile cluster and navigational aid lights and signage.

The timber pile cluster replacement consist of the installation of 60' long 2.5 CCA treat timber piles with navigation light and signage, and the removal of existing structure below the mudline. (Below are photos of the completed structure)

The new navigation light assembly was supplied by Automatic Power, Inc. of Larose, La. and consisted of three leg adjustable stand constructed of aluminum with battery box, solar panel and red LED flashing bulb.
