# **2016 Operations, Maintenance, and Monitoring Report**

## Mississippi River Sediment Delivery System-Bayou Dupont (BA-0039)

State Project Number BA-0039 Priority Project List 12

December 2016
Jefferson and Plaquemines Parishes

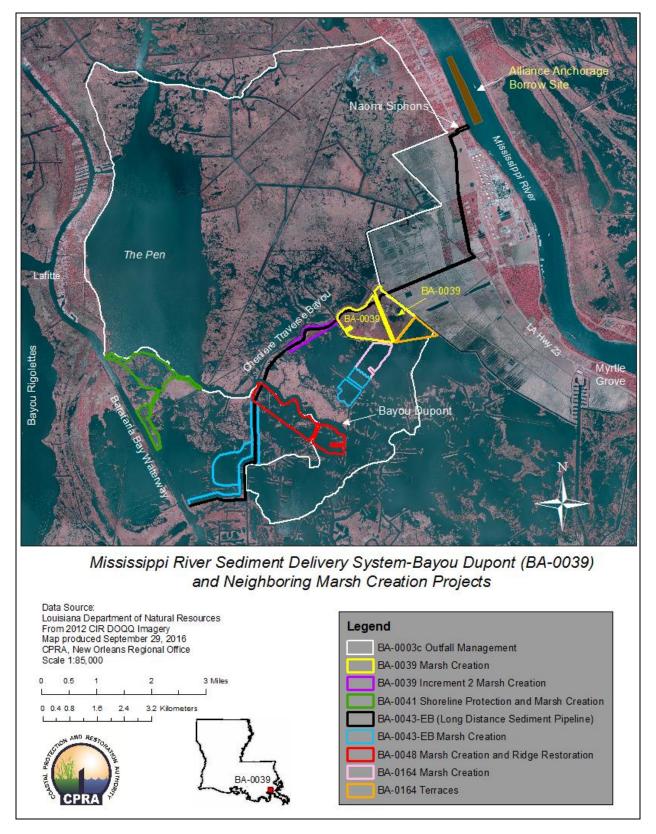
**Figure 1.** Location of the Mississippi River Sediment Delivery System–Bayou Dupont (BA-0039) project area and neighboring restoration projects.

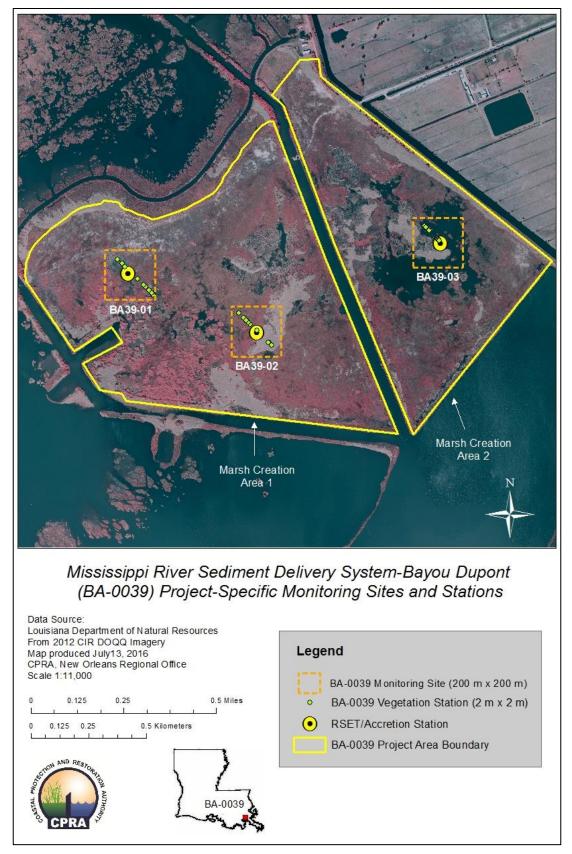
Figure 2. Location of BA-0039 project-specific monitoring sites and stations.

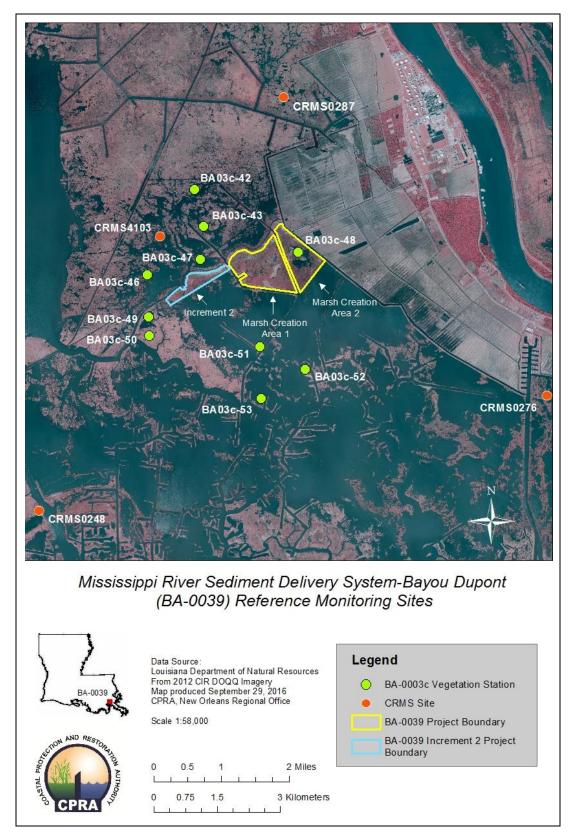
**Figure 3.** Location of neighboring CRMS sites and BA-0003c project-specific vegetation stations used as reference stations for BA-0039.

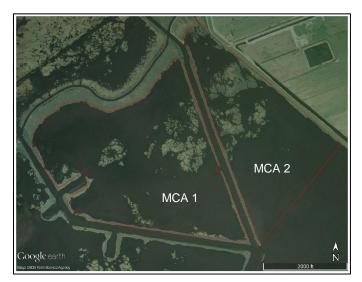
**Figure 4.** Google Earth aerial imagery of the BA-0039 project area acquired pre-construction on October 11, 2007, shows the majority of the project area as open water, with some remnant marsh.

Aerial imagery from October 11, 2007, shows the degraded condition of the project area prior to construction, with only a small amount of remnant marsh present in Marsh Creation Area (MCA) 1 and MCA 2 (Figure 4). Land-water analysis of post-construction aerial photography collected on November 14, 2012, indicates that the project area was predominantly land, with 458 acres of land and 37 acres of water (Figure 5). The project boundary used for land-water analysis contained an additional 24 acres than the 471 total acres listed in the project goals. These additional acres along the northeastern boundary of MCA2 appear to be land that was designated as "agricultural other" in the project area and were not used in the wetland value assessment or in the determination of project goals (USEPA, LDNR 2007).

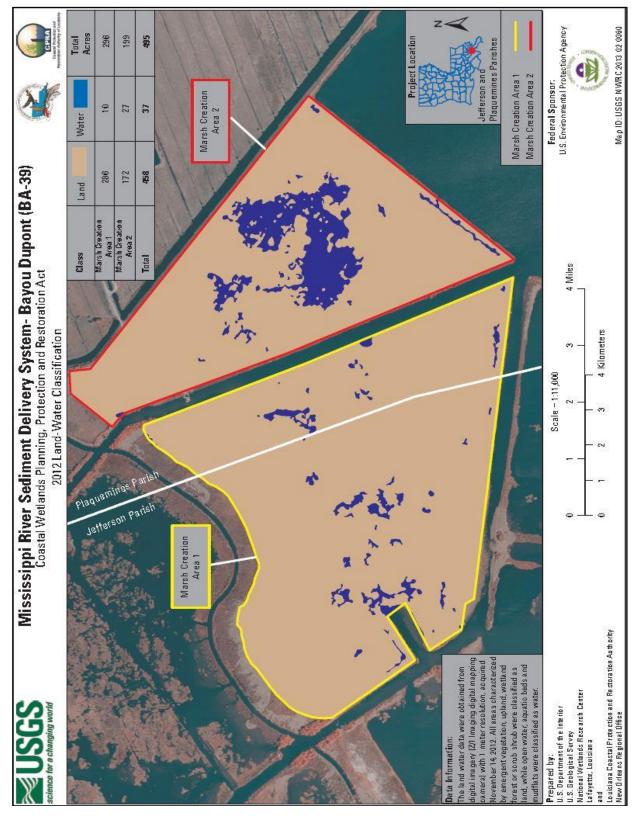
**Figure 5.** Land-water classification of the BA-0039 project area using CRMS aerial photography acquired on November 14, 2012.

The 37 acres of water are primarily due to ponding in areas of lower elevation. The area of shallow ponding in the center of MCA 2 has been a consistent feature of the project area since construction (Figure 5). Based on aerial imagery of the project area during and after construction, it appears as if sediment was not delivered as effectively to this area, which is located just south of remnant marsh. It is possible that this feature will prevent the attainment of 100% land classification in the project area; however, the shallow water area has provided increased habitat diversity. The area may also be providing habitat benefit for wildlife, as the landowner has reported that the shallow pond is utilized by waterfowl.

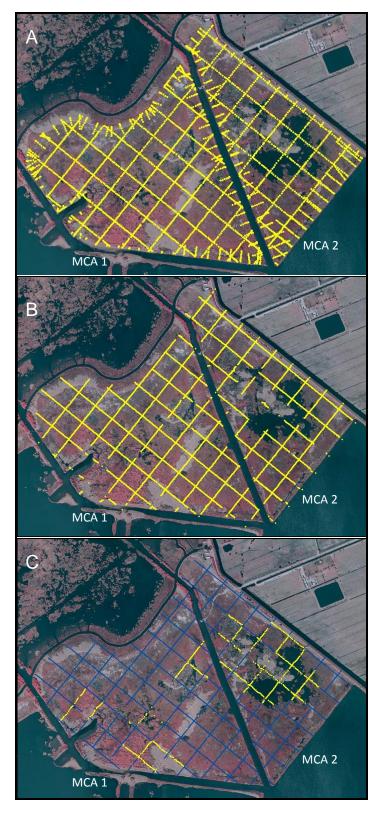
**Figure 6.** Completed transect lines for the **(A)** as-built, **(B)** year 2, and **(C)** year 5 BA-0039 elevation surveys. For the year 5 survey, the yellow lines represent the RTK data and the blue lines represent the LiDAR data used for analysis. MCA = Marsh Creation Area.

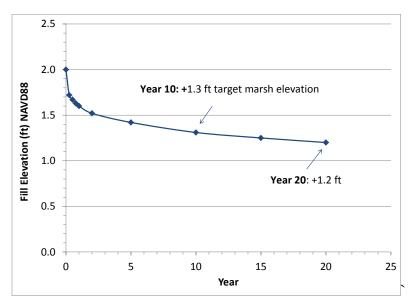
**Figure 7.** Predicted twenty-year settlement for BA-0039, based on a constructed marsh fill elevation of +2.0 ft NAVD88 (Geoid99).

Based on the predicted settlement for BA-0039, a target constructed elevation of  $+2.0 \pm 0.3$  ft NAVD88, Geoid99 was chosen to provide an initial marsh elevation that would settle into the intertidal zone and support emergent marsh vegetation through most of the project's 20-year CWPPRA life-span (Thompson 2007) (Figure 7). A target marsh elevation of +1.3 ft was chosen based on the average elevation of nearby *Spartina patens* (saltmeadow cordgrass) marsh. *Spartina patens* is found in intermediate to brackish marshes and has historically been the dominant local species. According to the predicted settlement for BA-0039, the target marsh elevation of +1.3 ft should be reached near year 10, with settlement to +1.2 ft near year 20 (Thompson 2007) (Figure 7).

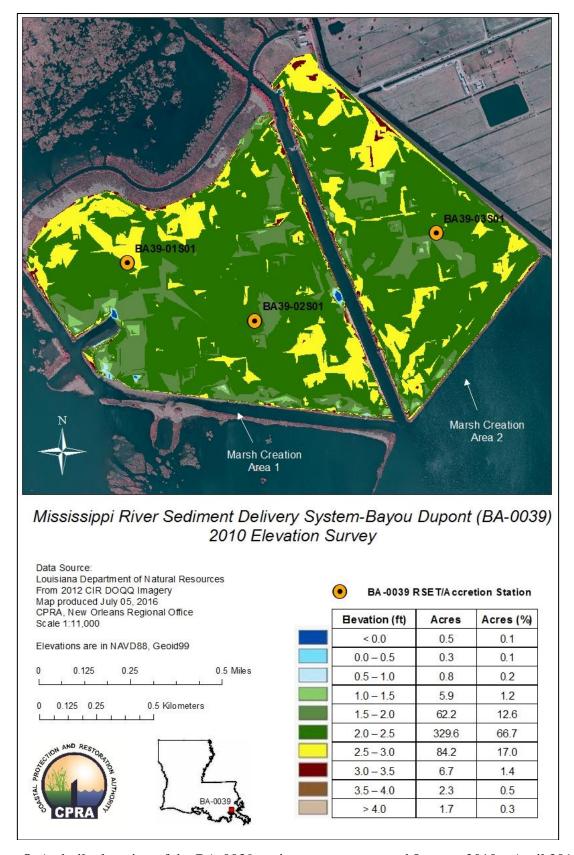
Figure 8. As-built elevation of the BA-0039 project area as surveyed January 2010 – April 2010.

The as-built (2010) survey data indicate that nearly half of the project area, 47.4%, was built within the targeted elevation of +2.0 ft  $\pm$  0.3 ft. That amount increases to 79.3% if the range is slightly expanded to include elevations between +1.5 ft and +2.5 ft, aligning with the 0.5 ft increments used for map generation (Figure 8). The majority of the project area (85.9%) was filled to an elevation greater than or equal to the +2.0 ft target, with the highest percentage of acres (66.7%) between +2.0 ft and +2.5 ft. Generally, the highest elevations were along the project's northern boundary and in the southern corners of each marsh creation area, adjacent to the canal that divides them. The lower elevations ran along a broad horizontal band through the center of the project area. Survey transects were established in the ponding area in MCA2, but due to their spacing and alignment, they failed to fully capture the extent of the lower elevations in the area (Figure 6A). The mean elevation of the project area as calculated from the marsh elevation survey points was +2.2 ft  $\pm$  0.0 SE (n = 2611).

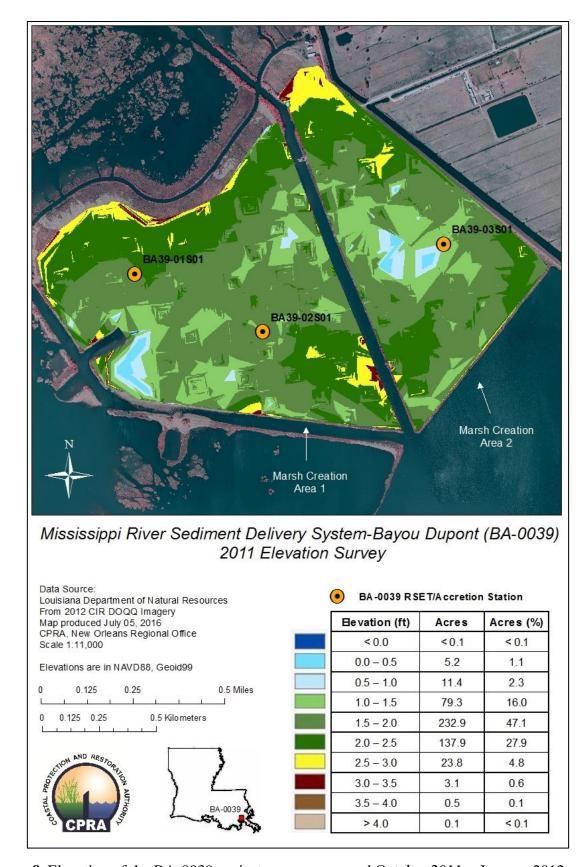
Figure 9. Elevation of the BA-0039 project area as surveyed October 2011 – January 2012.

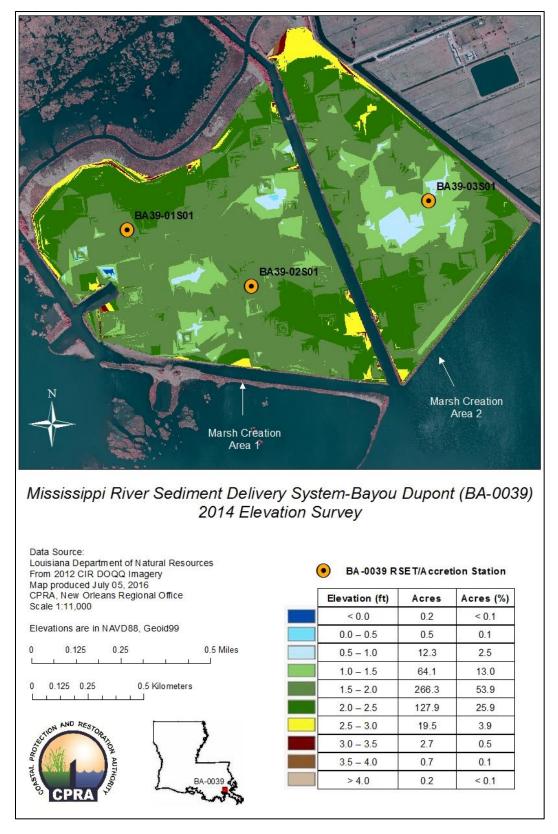
**Figure 10.** Elevation of the BA-0039 project area as surveyed in October 2014 (LiDAR and RTK) with additional RTK data collection along select transects in May 2015.

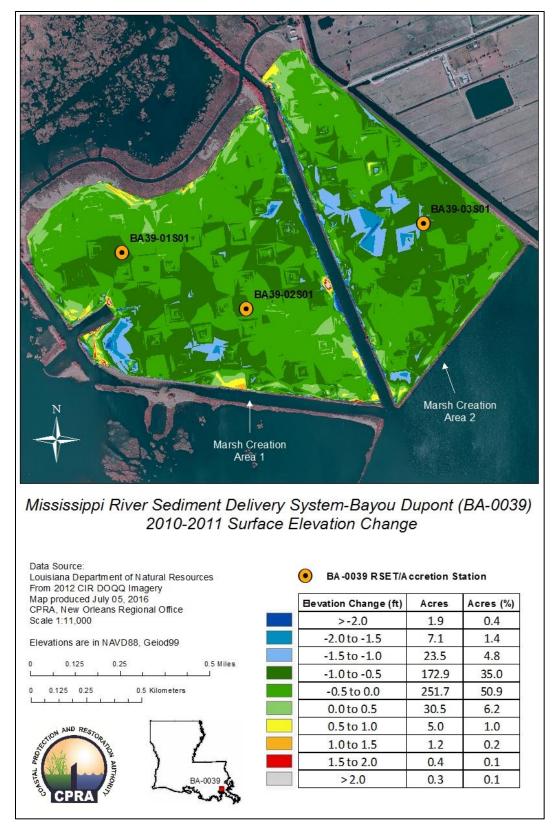
**Figure 11.** Surface elevation change of the BA-0039 project area between the as-built (2010) and year 2 (2011–2012) elevation surveys.

Contour maps were created to delineate the project area based on the elevation change that occurred between surveys. Between the as-built (2010) and year 2 (2011) surveys, the majority of the project area declined in elevation between 0.0 ft and -0.5 ft, with 50.9% of the project area settling within this range (Figure 11). The predicted amount of settlement by year 2 was -0.48 ft, which is just within the observed range (Figure 7). Areas of higher settlement in the center of MCA 2 and the along the western border of MCA 1 below the central cut are in areas where data were not collected during the 2011 survey; therefore, the calculation of settlement in these areas is based on highly-interpolated data. Average settlement in the project area calculated using the means of the 2010 and 2011 elevation survey points was -0.31 ft.

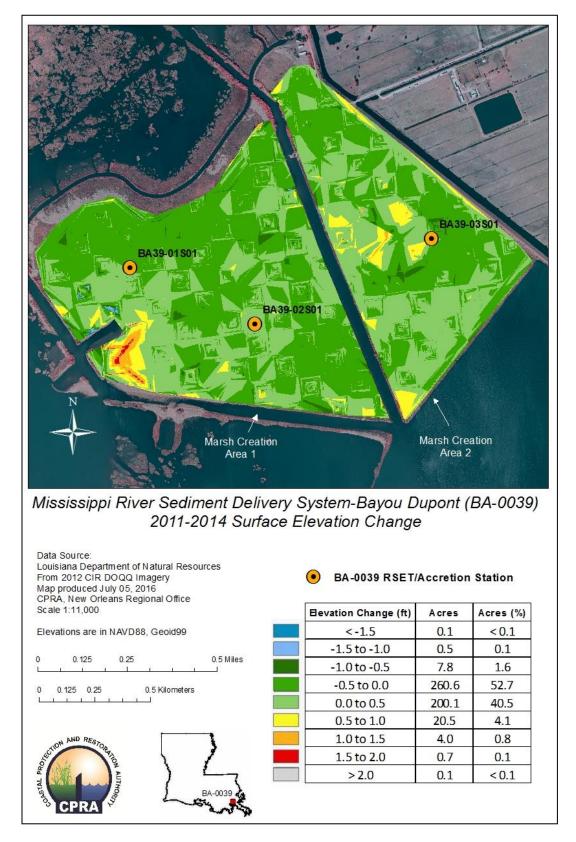
**Figure 12.** Surface elevation change of the BA-0039 project area between the year 2 (2011–2012) and year 5 elevation surveys.

Between the year 2 (2011) and year 5 (2014) surveys, the largest percent of the project area (52.7%) declined in elevation between 0.0 ft and -0.5 ft (Figure 12). Settlement during this time was predicted to be only an additional -0.1 ft, with most of the settlement expected to occur by year 2. The second highest category of elevation change (40.5%) was between 0.0 ft and +0.5 ft, indicating a stabilization or slight increase in elevation. It should be noted that the settlement curve is based on the consolidation of sediment and does not include a prediction of sediment accretion. The average elevation change calculated using the means of the 2011 and 2014 elevation survey points showed little difference in elevation between years, with an increase of +0.04 ft.

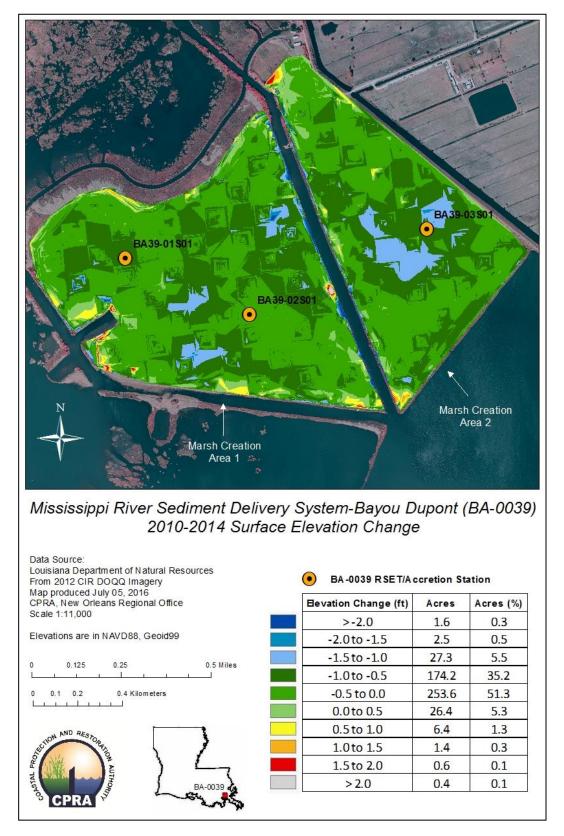
**Figure 13.** Surface elevation change of the BA-0039 project area between the as-built (2010) and year 5 (2014) elevation surveys.

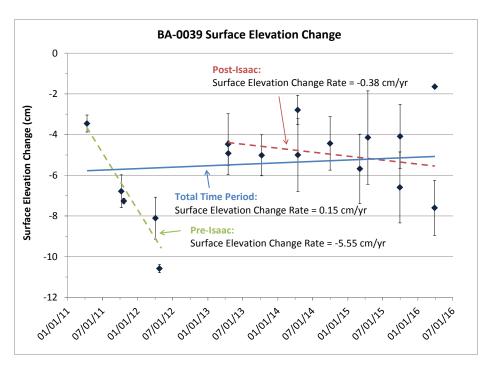
**Figure 14**. Mean surface elevation change (± SE) in the BA-0039 project area. Surface elevation change rates are calculated for the entire monitoring period, pre-Hurricane Isaac, and post-Hurricane Isaac. Graphs for each site are included in Appendix D.

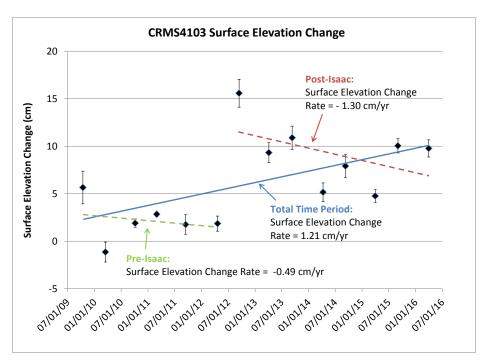
**Figure 15**. Surface elevation change (± SE) at CRMS4103. Surface elevation change rates are calculated for the entire monitoring period, pre-Hurricane Isaac, and post-Hurricane Isaac. The post-Isaac surface elevation change rate is -0.10 cm/yr if the data collected two weeks after the storm on 09/13/2012 are removed from the calculation.

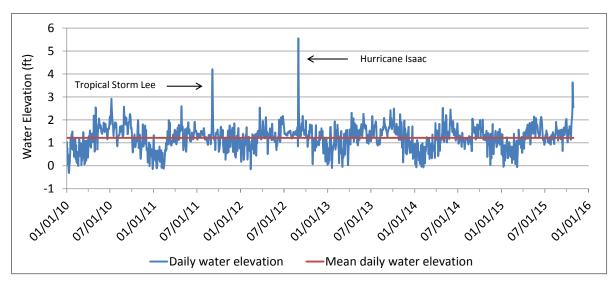
**Figure 16**. Daily water elevation and mean daily water elevation (NAVD88, Geoid99) recorded at CRMS4103 between 01/01/2010 and 10/30/2015.

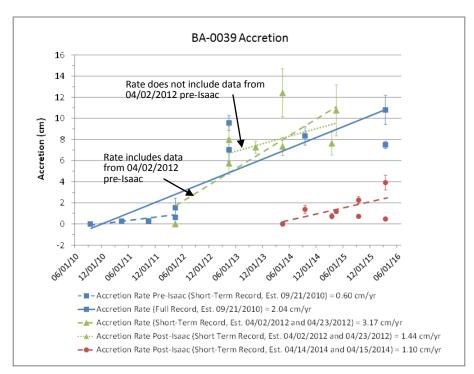
**Figure 17**. Mean accretion ( $\pm$  SE) in the BA-0039 project area. The accretion rate is graphed for monitoring periods pre- and post-Isaac, as well as for the full monitoring period. The two post-Isaac accretion rates are averaged in Table 1. Graphs for each site are included in Appendix D.

The mean rate of accretion in the project area since Hurricane Isaac has been 1.27 cm/yr  $\pm$  0.17 SE, an increase of 0.67 cm/yr over the pre-Isaac rate (Table 1, Figure 17). Since we are comparing short-term data sets, the difference may be due to inherent variability in data collection. But a higher accretion rate post-Isaac could be explained by an increase in root growth in the surface sediments, which has been documented on the accretion field data sheets. It could also be explained by soil expansion due to increasing water content (greater flooding). While field conditions at site BA39-01 and BA39-02 were noted as dry during the first two years of monitoring, after the storm, they were consistently recorded as wet or

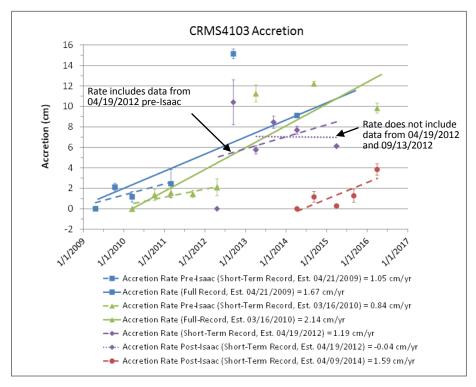
**Figure 18**. Accretion ( $\pm$  SE) at CRMS4103. The rate of accretion is graphed for monitoring periods pre- and post-Isaac, as well as for the full monitoring period. The two pre-, two post- and two full record accretion rates are averaged in Table 1.

flooded, and since the 04/23/2012 sampling, BA39-03 has been noted as flooded with water depth ranging from 1–10 cm. Other explanations could be sediment deposition or differences in the soil properties pre- and post-Isaac. The mean rate of accretion at CRMS4103 since Hurricane Isaac has been 0.77 cm/yr  $\pm$  0.82 SE, less than in the BA-0039 project area and slightly less than the pre-Isaac CRMS4103 rate (Table 1, Figure 18).

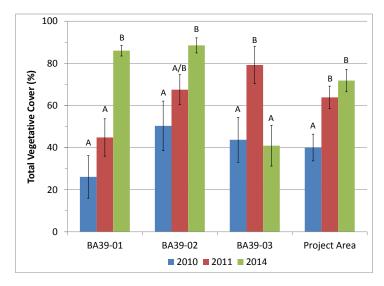
**Figure 19**. Mean total vegetative cover ( $\pm$  SE) at each BA-0039 monitoring site (10 stations/site) and in the project area in 2010, 2011, and 2014. Significant differences between years are indicated by different letters ( $\alpha$  = 0.05). BA39-01: p < 0.0001, F<sub>2,27</sub> = 15.05; BA39-02: p = 0.0104, F<sub>2,27</sub> = 5.44; BA39-03: p = 0.0169; F<sub>2,27</sub> = 4.76; project area: p = 0.0004; F<sub>2,87</sub> = 8.44.

Total percent cover is a visual estimation of vegetative cover that is assessed at each station and ranges from 0% –100%. Mean total percent cover for vegetation in the BA-0039 project area was compared between years at each of the three monitoring sites and in the project area (sites assessed collectively) using ANOVA in Proc GLM,  $\alpha = 0.05$ , followed by a Tukey's post-hoc test (SAS Institute Inc., Cary, NC, version 9.4). Total cover was significantly different over years at all sites and in the project area, with sites BA39-01 and BA39-02 and the project area showing a continuing upward trend in vegetative cover (Figure 19). Total cover increased at all sites between 2010 and 2011, but the increase was significant only at BA39-03, where cover increased from 44% to 79%. The increase in cover was also significant in the project area, with an increase from 40% in 2010 to 64% in 2011. Between 2011 and 2014, a significant increase occurred at BA39-01, where cover nearly doubled from 45% to 86%. Conversely, cover at BA39-03 declined significantly between these years from 79% in 2011 to 41% in 2014. Site BA39-03 is located in an area of lower elevation where some of the stations experience frequent to continual flooding. Between the 2010 and 2014 surveys, a significant increase in vegetative cover occurred at BA39-01, BA39-02 and in the project area.

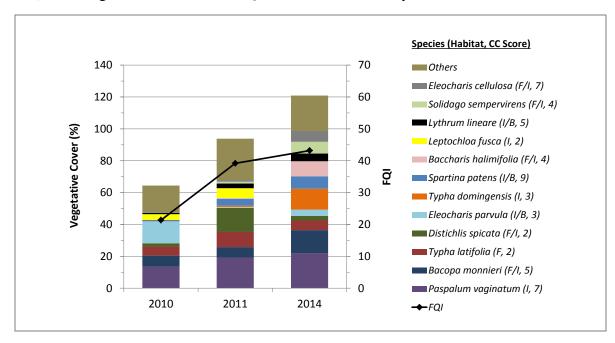
**Figure 20.** BA-0039 mean percent cover of vegetative species and FQI score. Species in the legend are ordered based on the highest mean percent cover over years, from bottom to top. The marsh habitat where the species typically grows and its CC score are listed after the species name. F: fresh, I: intermediate, B: brackish, S: salt.

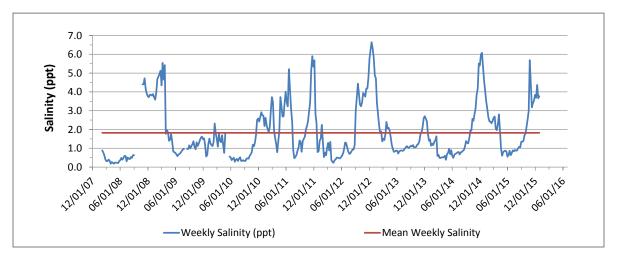
**Figure 21.** Weekly salinity at CRMS4103 between 02/01/2008 and 12/31/2015. Mean weekly salinity during the monitoring time frame was 1.82 ppt  $\pm$  0.07 SE, with weekly salinity ranging from 0.18 ppt - 6.64 ppt.

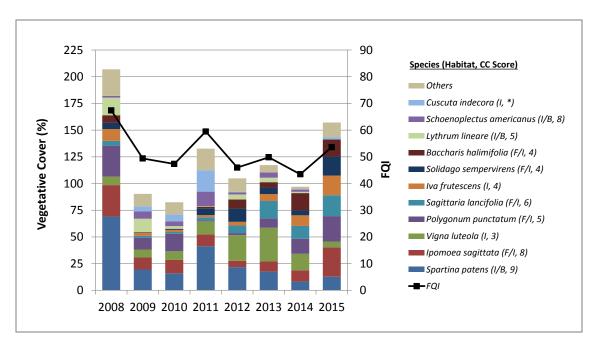
**Figure 22**. Mean cover (%) of species and FQI score for CRMS4103. The species in the legend are ordered based on the highest mean cover (%) over years, from bottom (S. patens—highest) to top (C. indecora—lowest). The marsh habitat where the species typically grows and its CC score are listed after the species name. F = fresh, I = intermediate, B = brackish, S = salt. \* C. indecora (bigseed alfalfa dodder) is a non-rooted parasitic plant and is not included in the FQI calculation.

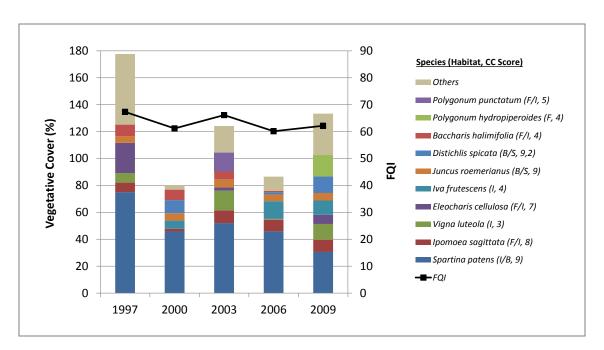
**Figure 23**. Mean cover (%) of species and FQI score for BA-0003c vegetation stations (n=10) located within 2 miles of the BA-0039 project area. The species in the legend are ordered based on the highest mean cover (%) over years, from bottom (S. patens—highest) to top (P. punctatum—lowest). The marsh habitat where the species typically grows and its CC score are listed after the species name. F = fresh, I = intermediate, B = brackish, S = salt.

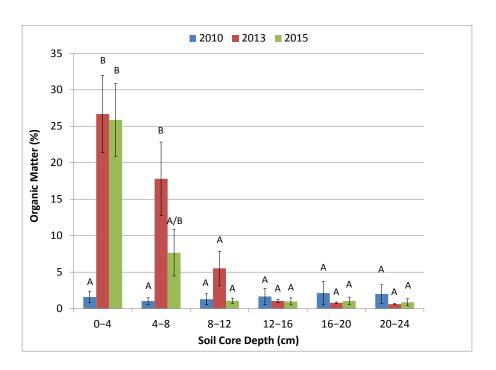
**Figure 24.** Mean organic matter ( $\pm$  SE) of soil cores collected in the BA-0039 project area. Significant differences between years at each depth are indicated by different letters ( $\alpha = 0.05$ , n = 9; 0 cm – 4 cm: p = 0.0003,  $F_{2,24} = 11.35$ ; 4 cm – 8 cm: p = 0.0078,  $F_{2,24} = 5.99$ ).

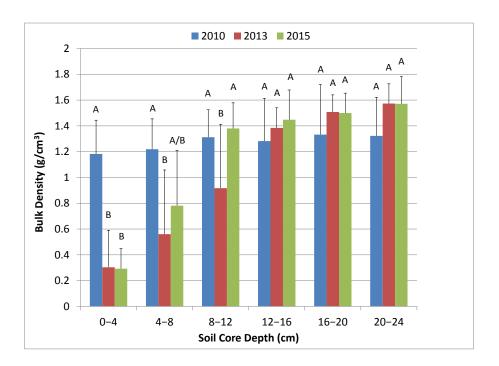
**Figure 25**. Mean bulk density ( $\pm$  SE) of soil cores collected in the BA-0039 project area Significant differences between years at each depth are indicated by different letters ( $\alpha$  = 0.05, n = 9; 0 cm – 4 cm: p < 0.0001,  $F_{2,24}$  = 40.33; 4 cm – 8 cm: p = 0.0065,  $F_{2,24}$  = 6.25; 8 cm – 12 cm: p = 0.0141,  $F_{2,24}$  = 5.12).

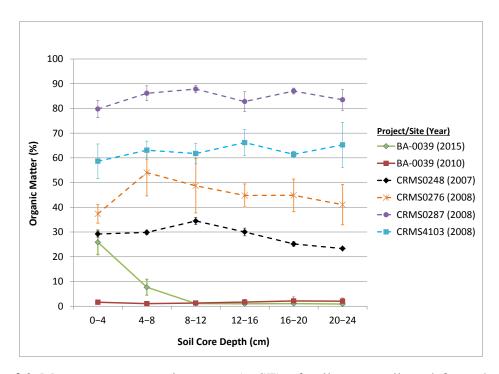
**Figure 26.** Mean percent organic matter ( $\pm$  SE) of soil cores collected from the BA-0039 project area and from surrounding CRMS sites. The year after the project/site name in the legend refers to the year of sample collection.

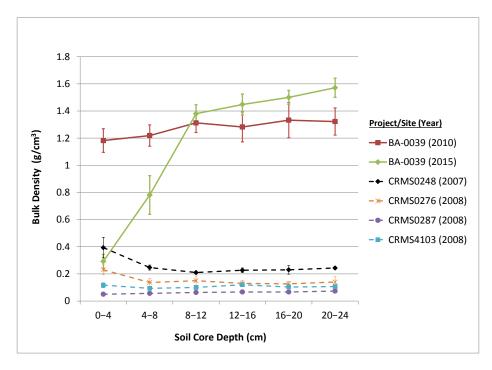
**Figure 27.** Mean bulk density ( $\pm$  SE) of soil cores collected from the BA-0039 project area and from surrounding CRMS sites. The year after the project/site name in the legend refers to the year of sample collection.

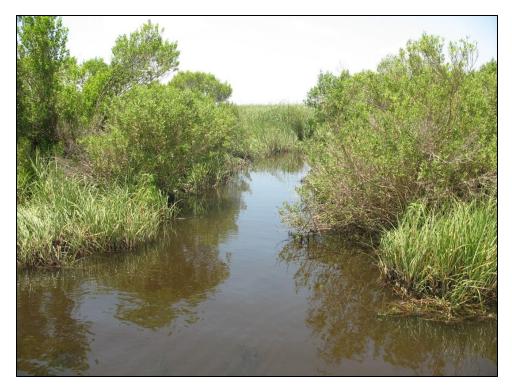
**Photo 1.** A gap in the spoil bank on the eastern boundary of Marsh Creation Area 1 enhances hydrologic exchange within the project area.

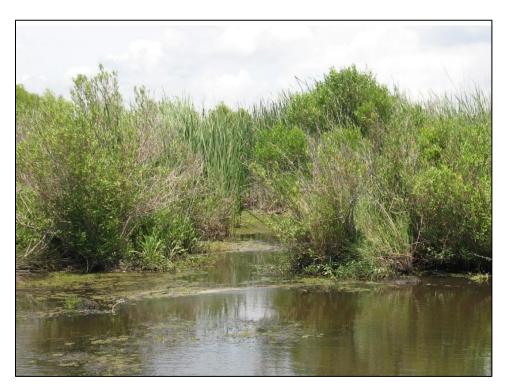
**Photo 2.** A gap in the spoil bank on the southern boundary of Marsh Creation Area 1 enhances hydrologic exchange within the project area.

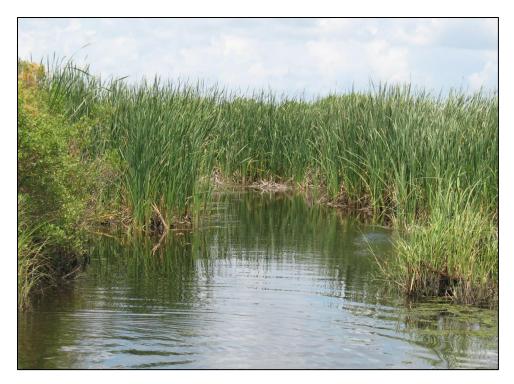
**Photo 3**. A gap was created in the southern containment dike of Marsh Creation Area 2 to enhance hydrologic exchange.

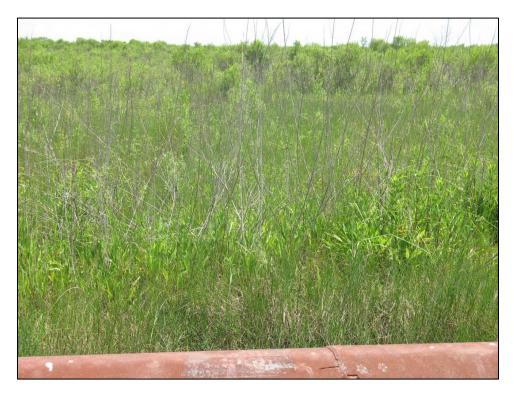
**Photo 4**. BA-0039 Marsh Creation Area 1, looking south from the BA-0043-EB sediment pipeline corridor. The pipeline is visible along the bottom of the photograph.

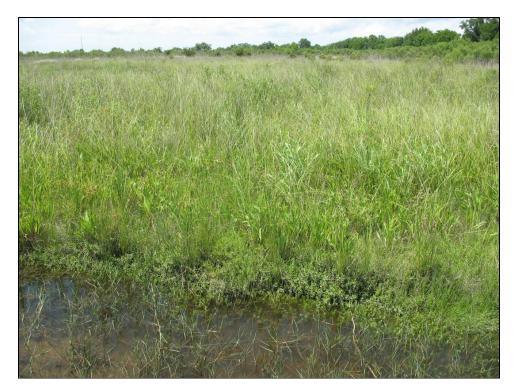
**Photo 5**. BA-0039 Marsh Creation Area 1, looking northwest from the BA-0043-EB sediment pipeline corridor.

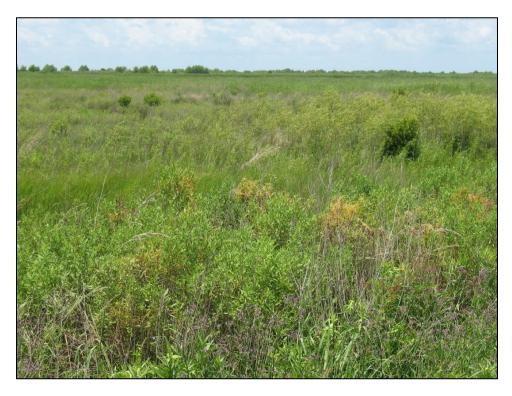
**Photo 6**. BA-0039 Marsh Creation Area 2, looking west from atop the Plaquemines Parish flood protection levee.

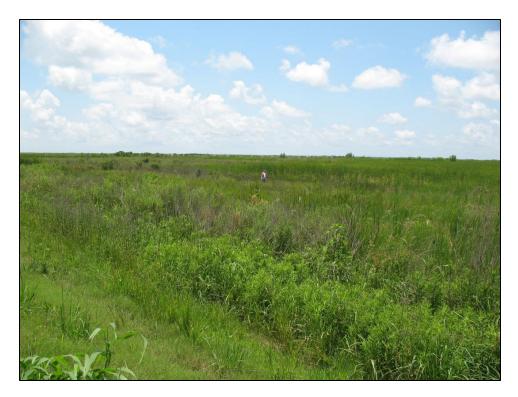
Photo 7. BA-0039 Marsh Creation Area 2, looking south from atop the Plaquemines Parish flood protection levee.

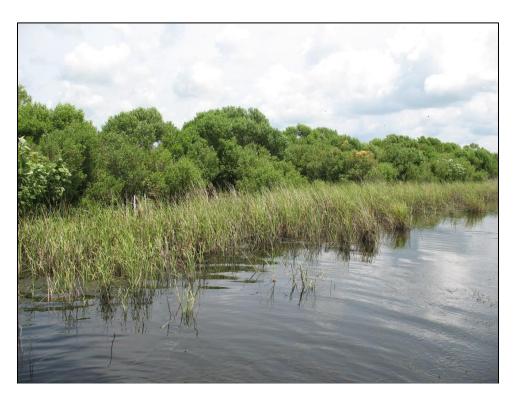
Photo 8. Spartina alterniflora planted along the southwestern edge of BA-0039 Marsh Creation Area 2 in 2010 continues to thrive.

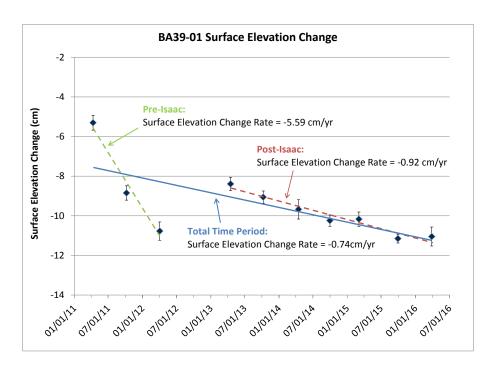
**Figure 1**. Surface elevation change (± SE) at RSET station BA39-01SO1. Surface elevation change rates are calculated for the entire monitoring period, pre-Hurricane Isaac, and post-Hurricane Isaac.

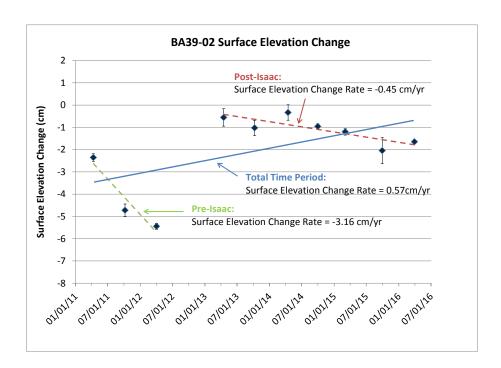
**Figure 2**. Surface elevation change (± SE) at RSET station BA39-02SO1. Surface elevation change rates are calculated for the entire monitoring period, pre-Hurricane Isaac, and post-Hurricane Isaac.

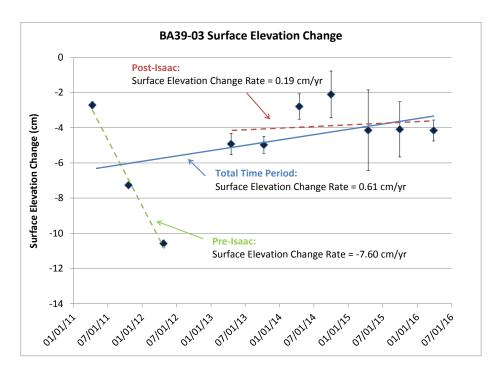
**Figure 3**. Surface elevation change (± SE) at RSET station BA39-03SO1. Surface elevation change rates are calculated for the entire monitoring period, pre-Hurricane Isaac, and post-Hurricane Isaac.

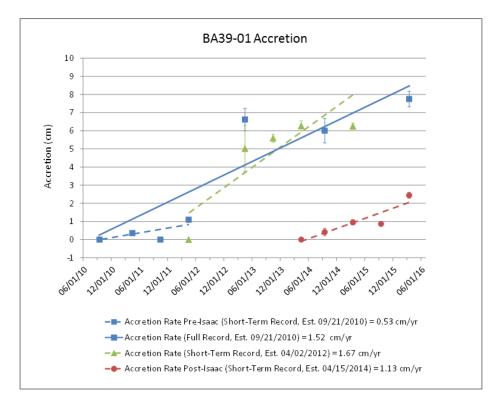
**Figure 4**. Accretion (± SE) at BA39-01. Accretion rates are calculated for the entire monitoring period, pre-Hurricane Isaac, and post-Hurricane Isaac.

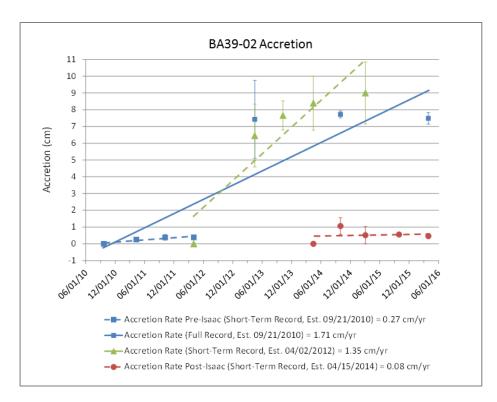
**Figure** 5. Accretion (± SE) at BA39-02. Accretion rates are calculated for the entire monitoring period, pre-Hurricane Isaac, and post-Hurricane Isaac.

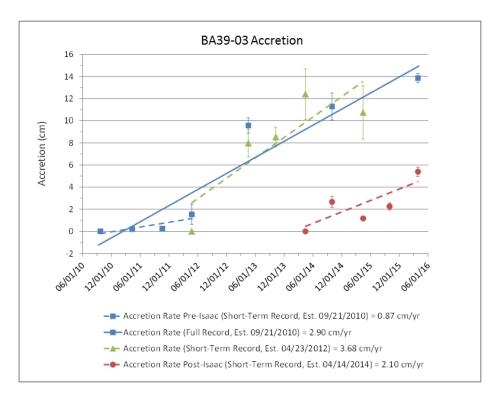
**Figure** 6. Accretion (± SE) at BA39-03. Accretion rates are calculated for the entire monitoring period, pre-Hurricane Isaac, and post-Hurricane Isaac.
