**State of Louisiana
Department of Natural Resources
Coastal Restoration Division**

**2006/2007 Annual Inspection
Report**

**NAOMI OUTFALL
MANAGEMENT
(BA-03c)**

State Project Number BA-3c
Priority Project List 5

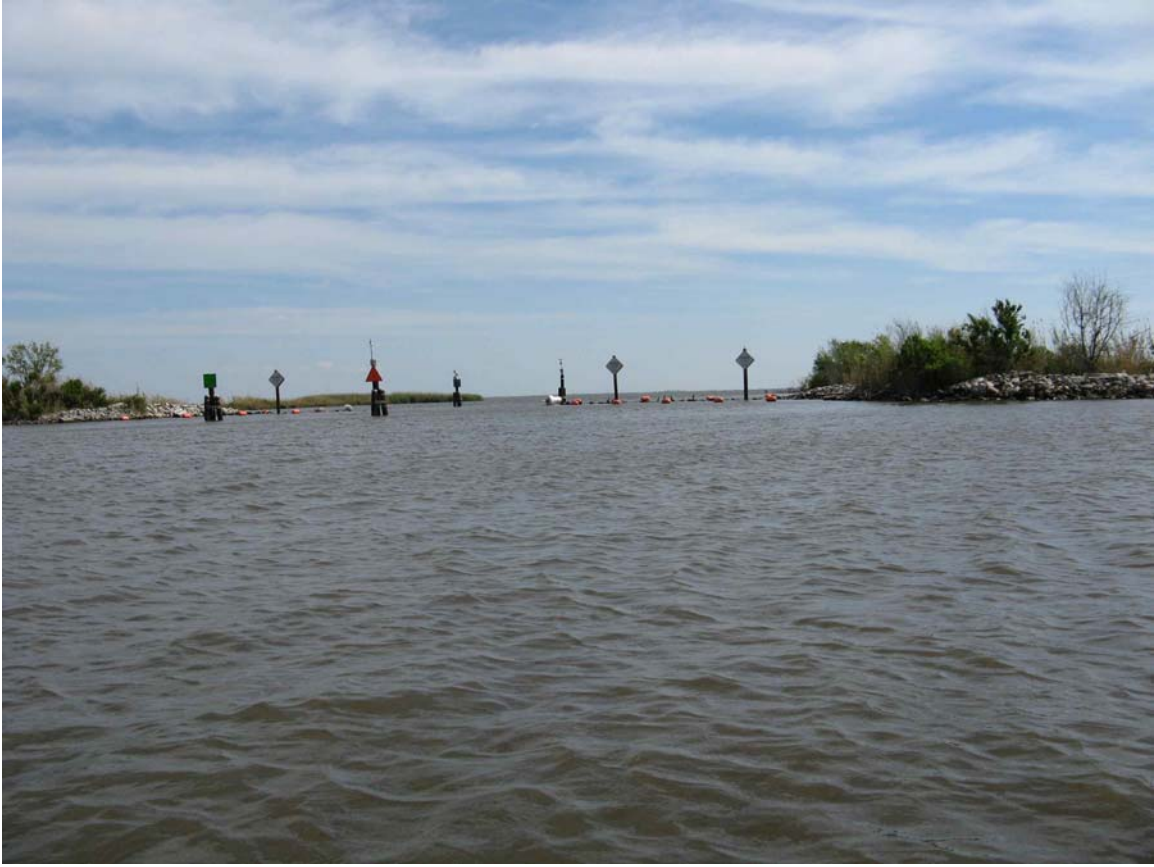
The two pilings on either side of the boat bay which were damaged at last year's inspection have been replaced with regulatory marker buoys (Photo #1). There was no damage to any others.

The two warning signs attached to the pilings which were noted as damaged in last year's inspection report have been replaced with regulatory marker buoys as mentioned above (Photo #1). There was no damage to any others.

The navigation lights which were noted as damaged in last year's inspection report have been replaced (Photo #1). There was no damage to any others.

The two new regulatory marker buoys on either side of the boat bay have washed up and are aground on the dikes and are lying on their sides (Photo #1).

Photo #1 – Bayou Dupont Canal Weir. Approaching the Bayou Dupont weir from the Barataria Waterway, looking across the weir boat bay toward the Pen. Warning signs and navigation aids have been restored. Note the grounded regulatory marker buoys.

Item	Condition	Physical Damage	Corrosion	Photo #	Observations and Remarks
Rock Riprap	Good	None	N/A		
Creosote Piling	Fair	None	None	#1	
Warning Signs and Day Board Navigation Signs	Poor	None	None	#1	
Navigation Aid Lights	Fair	None	None	#1	
Warning Buoys	Good	See observations	None	#1	The two (2) new regulatory marker buoys are aground on the rock dikes.
Vandalism	Good	None	-		Vandalism of the lights and batteries continue to be a concern although none was evident at the time of this inspection.

Overall, the Naomi Outfall Management project is functioning properly and is in fair condition. The new regulatory marker buoys at the Bayou Dupont structure have been washed up on the rock dikes. Possible solutions are being considered to keep the buoys off the dikes including relocating their anchors and/or modifying their ballast configuration. The contract cost of this work is preliminarily estimated to be \$25,000 plus \$5,000 Engineering and Design and Construction Oversight. Although none was evident at the time of this inspection, vandalism to the navigational aids continues to be a concern.

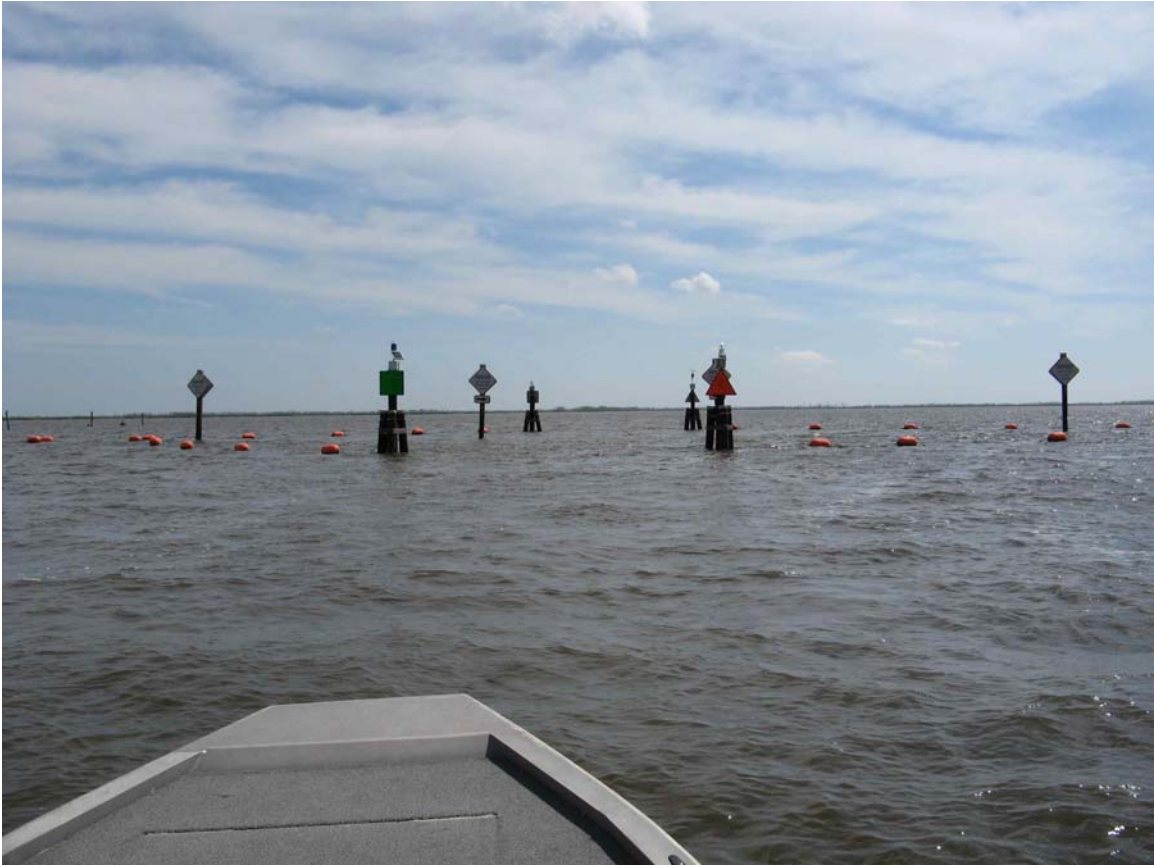
All pilings visually appeared to be damage-free and in good condition (Photo #2).

All signs appeared to be in satisfactory condition with no indication of significant damage (Photo #2).

Photo #2 – Goose Bayou Canal Weir. Approaching the Goose Bayou weir from the Barataria Waterway side, looking across the weir boat bay toward the Pen. Warning signs and navigation aids are shown on either side of channel through the boat bay.

Item	Condition	Physical Damage	Corrosion	Photo #	Observations and Remarks
Rock Riprap	Good	None	N/A		
Creosote Piling	Excellent	None	None	#2	
Warning Signs and Day Board Navigation Signs	Excellent	None	None	#2	
Navigation Aid Lights	Good	None	None	#2	
Warning Buoys	Good	None	None	#2	
Vandalism	-	None	-	-	Vandalism of the lights and batteries continue to be a concern although none was evident at the time of this inspection.
