State of Louisiana Coastal Protection and Restoration Authority

2016 Operations, Maintenance, and Monitoring Report

Pass Chaland to Grand Bayou Pass Barrier Shoreline Restoration (BA-35)

February 2017

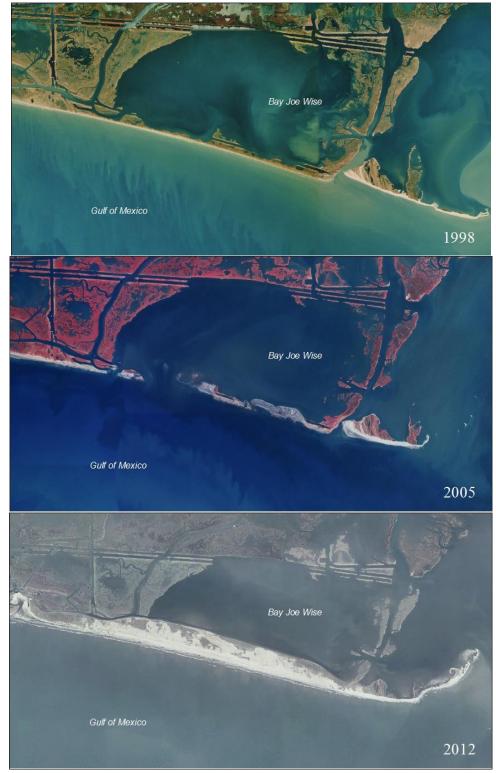
Figure 2. Aerial view of the Pass Chaland to Grand Bayou Pass barrier headland in 1998, 2005 (post-Hurricane Katrina), and 2012 (post-construction).

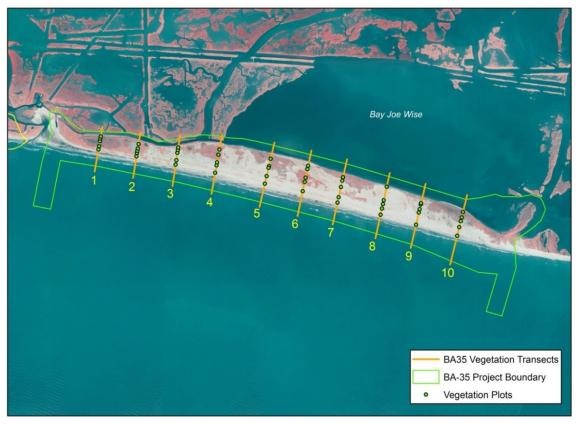
Figure 4. Vegetation plots established within the Pass Chaland to Grand Bayou Pass Barrier Restoration (BA-35) project area.

In October 2013, 50 vegetation sampling plots were established along 10 transects corresponding to the Barrier Island Comprehensive Monitoring (BICM) survey lines spaced approximately 1,500 ft apart (Figure 4). Using ESRI® ArcGIS 10.1, points were generated every 3 meters along each of the transect lines to generate a pool of prospective plots. In order to accurately characterize the vegetative composition of the different habitats of the island, plot selection was based on three habitat zones along each transect: 1) the upslope area, beginning at the backshore area and rising in elevation to the top of the dune (or highest elevation point) before sloping downward to a flat elevation, 2) the swale or platform which is relatively wide and uniform in elevation, and 3) the downslope or marsh zone often present along the back side of the Before going into the field, five potential plots were selected along each transect using 2012 post-Isaac imagery. The range of plot numbers falling into each habitat zone along each transect was determined, and random plot numbers were then selected from within each range. The number of plots randomly selected within each zone was dependent on the relative length of each zone. Coordinates for the 5 plots selected per transect, as well as the full set of potential plots, were then loaded onto a Trimble GeoXT unit to be used in the field.

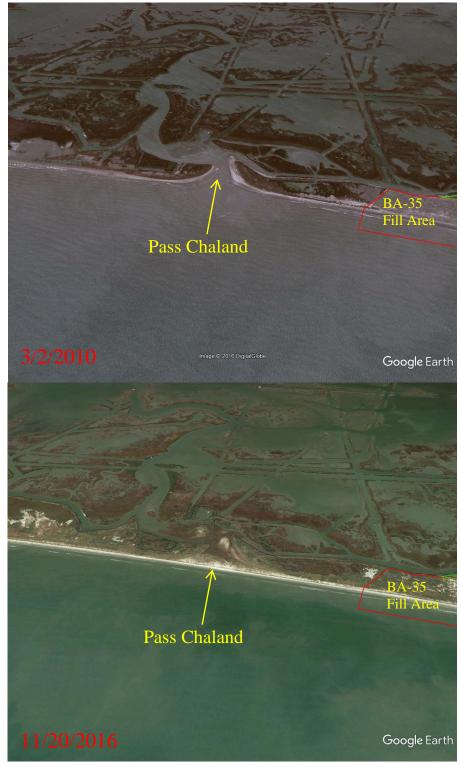
Figure 15. In-filling of Pass Chaland between 2010 and 2016.

Some eroded material from the beach face has likely contributed to the complete infilling of Pass Chaland through longshore transport (Figure 15), which is generally in the westward direction along this segment of Louisiana's coast (Georgiou et al. 2005). Much of this material was deposited during Hurricane Isaac in 2012. In addition, several other barrier restoration projects have recently been constructed to the east [Shell Island West (BA-0111), Shell Island East (BA-0110), Pelican Island (BA-0038), Scofield Island (BA-0040)], which have also introduced substantial amounts of sediment into the barrier system. The result of infilling of Pass Chaland is that the water exchange channel constructed for the BA-35 project to maintain the flow-way and circulation patterns between the Gulf of Mexico and Bay Joe Wise through Pass Chaland is no longer functioning as designed. It does appear that water exchange is still occurring between Bay Joe Wise and Bayou Chaland through the BA-35 water exchange channel. Water exchange between Bay Joe Wise and the Gulf of Mexico is now primarily occurring to the east through the remnants of Grand Bayou and Bastian Bay.

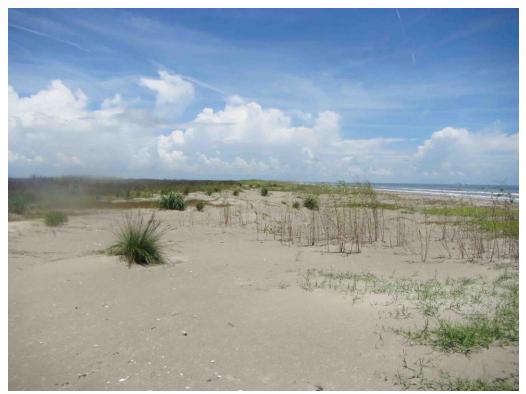
Photo #1 – West End Beach Looking East.

Item	Condition	Pysical Damage	Corrosion	Photo #	Observations and Remarks
Sand Fencing	Poor				No sign of any fencing remaining.
Containment Dike	Poor				No access, did not inspect.
Settlement Plates	Fair				Did not inspect on this visit.
Plantings	Good			1, 2, 3	Appear to be doing well.

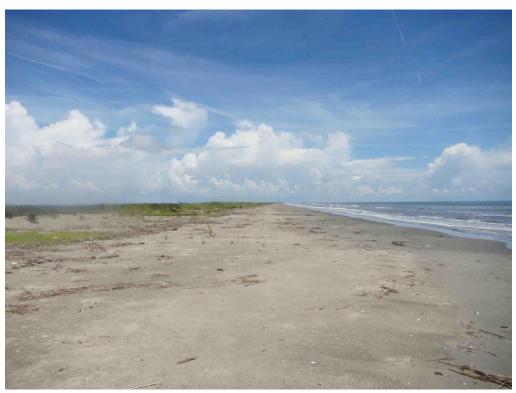
Photo #2 – West End Shoreline Looking East.

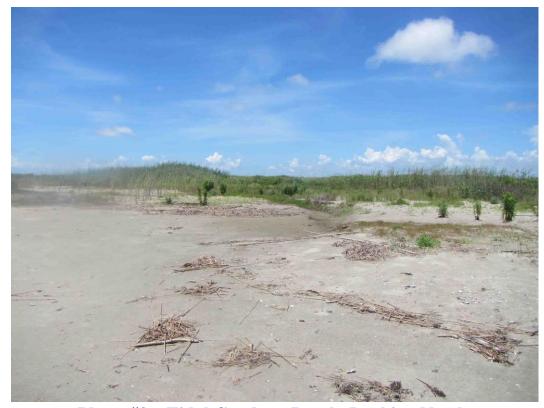
Photo #3 – Tidal Creek on Beach, Looking North.
