**State of Louisiana
Coastal Protection and Restoration Authority**

2024 Operations, Maintenance, and Monitoring Report

Naomi Outfall Management (BA-0003c) and Barataria Bay Waterway East Side Shoreline Protection (BA-0026)

State Project Numbers BA-0003c and BA-0026
Priority Project Lists 5 and 6

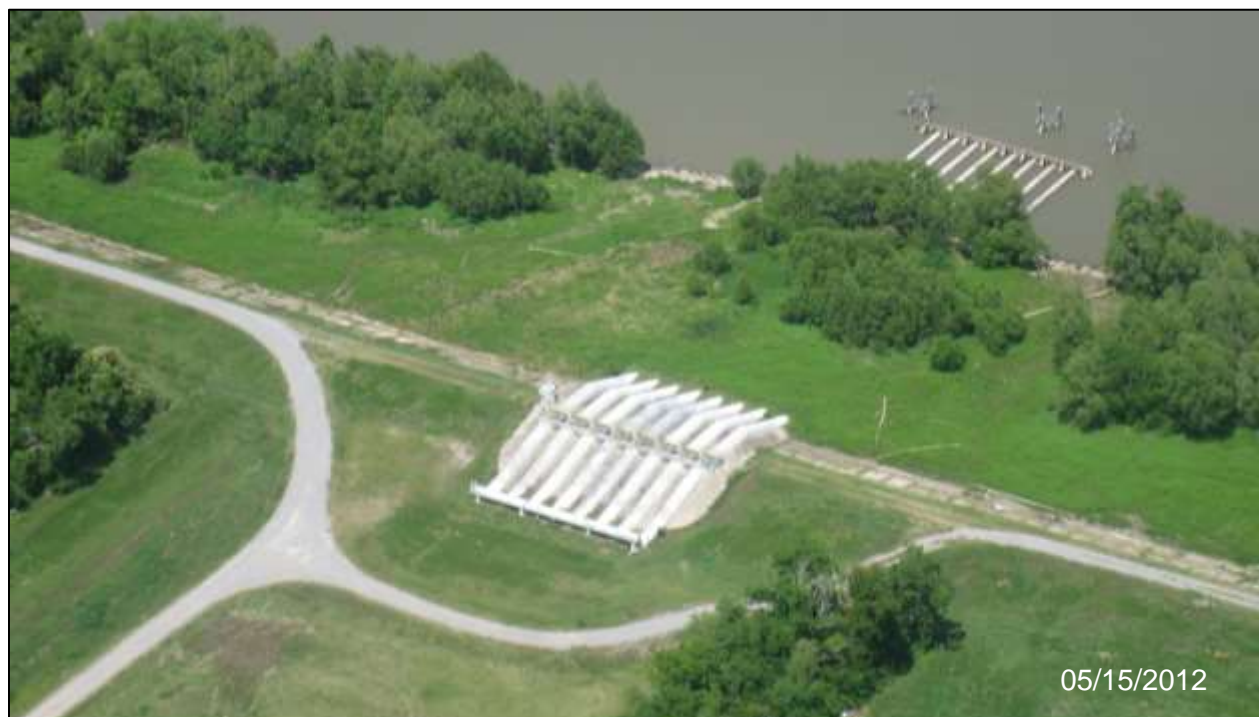
Figure 1. Naomi Siphon Diversion (BA-0003). Visible in the photograph is the location of the eight siphon intakes in the Mississippi River and the section of the siphons that was constructed over the top of the levee. The siphons discharge into an outfall pond just outside of the frame of the photograph.

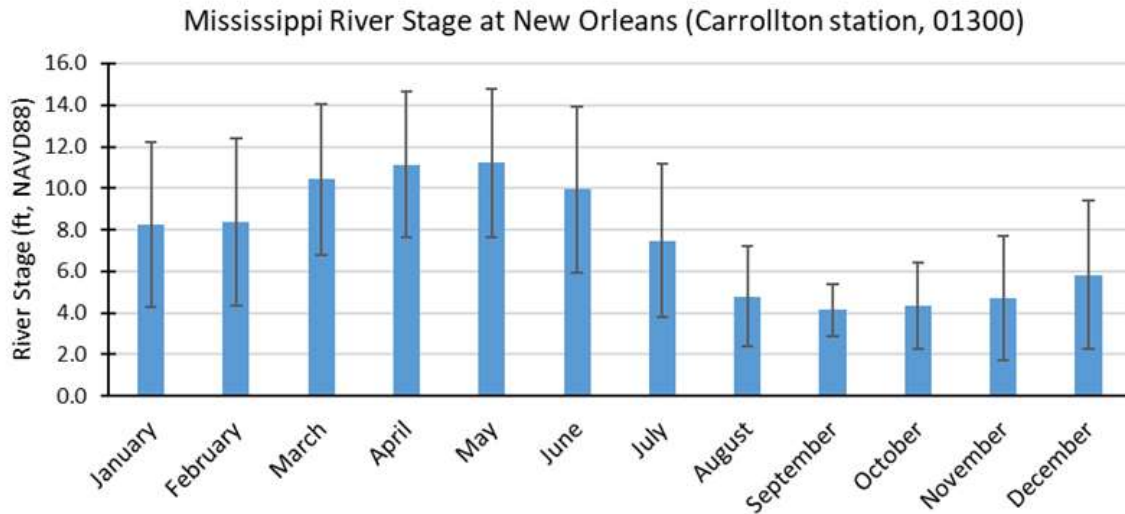
Figure 9. Mean monthly Mississippi River stage (\pm SD) between August 2002 and December 2022 at USACE gage 01300.

the post-construction period of analysis for the BA-0003c/BA-0026 projects, the mean monthly river stage at the USACE Mississippi River at New Orleans, Carrollton gage (01300) was lowest (< 5.0 ft NAVD88) between August and November and highest (> 10.0 ft NAVD88) between March and May (Figure 9).

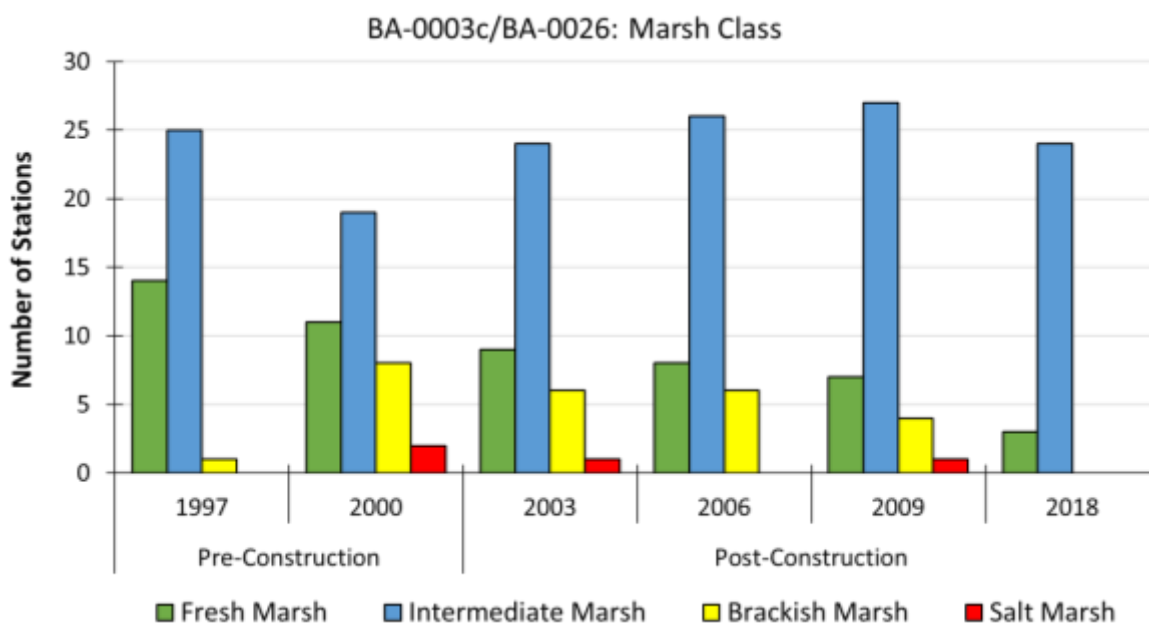
Figure 16. Number of BA-0003c/BA-0026 project-specific vegetation stations by marsh class by year.

The BA-0003c/BA-0026 project-specific stations were classified primarily as intermediate marsh over years (Figure 16). The percent of intermediate marsh stations ranged from a low of 48% in 2000 (drought), to a high of 89% in 2018, and increased consistently for surveys between these years. If the number of intermediate and fresh marsh stations are combined, the percent of stations ranges from 75% in 2000 to 100% in 2018. The number of fresh marsh stations has continually declined since 1997, with fresh marsh mainly transitioning to intermediate marsh. The number of brackish marsh stations has declined since 2000, with none recorded during the 2018 survey. Salt marsh has remained the least-represented marsh habitat in the project area, with a high of two stations recorded in 2000 (drought) and none recorded in 1997, 2006 and 2018. Of the 10 stations that were not surveyed in 2018, six had been classified consistently as intermediate or fresh marsh, and four had been classified as intermediate marsh for the previous two surveys (2006 and 2009). Conditions in the project area are supporting primarily intermediate marsh habitat and appear to be promoting its expansion.

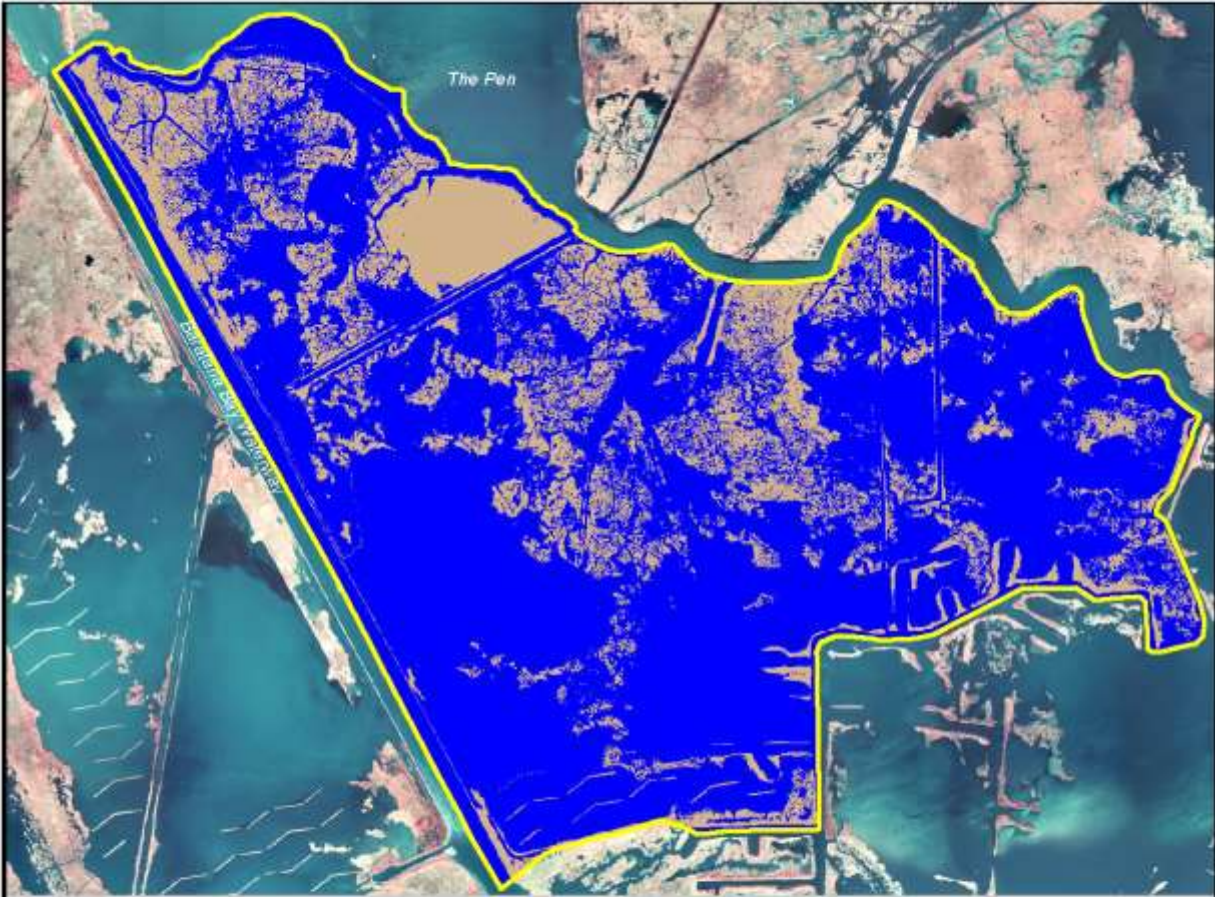
Barataria Bay Waterway East Side
Shoreline Protection (BA-26)
Coastal Wetlands Planning, Protection and Restoration Act
2011 Land-Water Classification

Data Information:
The land-water data were obtained from 1:12,000 scale, color-infrared aerial photography acquired November 11, 2011. All areas characterized by emergent vegetation, wetland forest, scrub-shrub, and upland were classified as land, while open water, mud flats, and aquatic beds were classified as water.

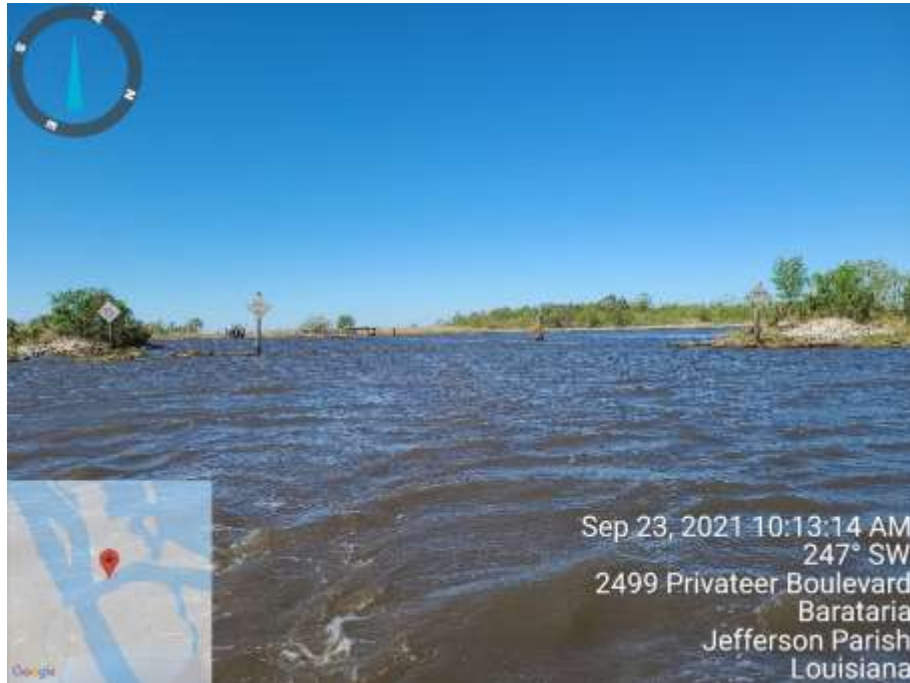
The structure was altered to facilitate construction of the BA-0207 project (completed). Rock was temporarily removed from the weir and stored within the footprint of the structure. The structure will be left altered through construction of the BA-0153 project and will be replaced as designed once construction is completed.

Photo 1. Bayou Dupont Canal weir, looking out from the Pen.

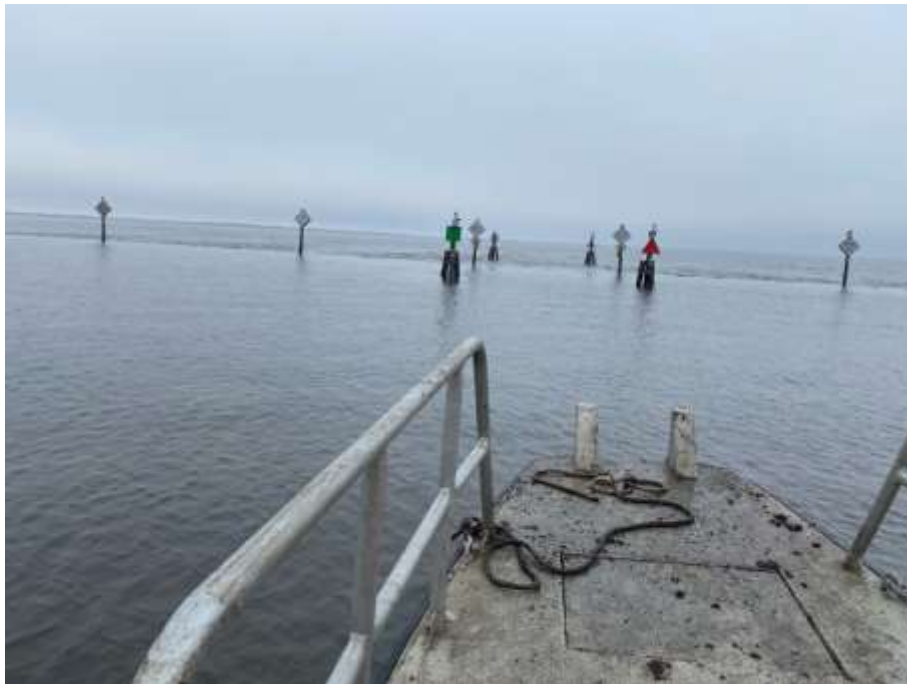
Based on a survey conducted in December 2010 by Pyburn and Odom, Inc., the structure settled an average of 2 feet since construction, resulting in most of the rock being submerged below the water surface. At this time, no rock maintenance is anticipated.

Photo 2. Goose Bayou Canal weir, looking east. The weir has settled below the waterline.

Since this project is being closed out it is recommended that the navigation aids be submitted to the CWPPRA Navigation Aids and Signage Program for all future programmed maintenance.

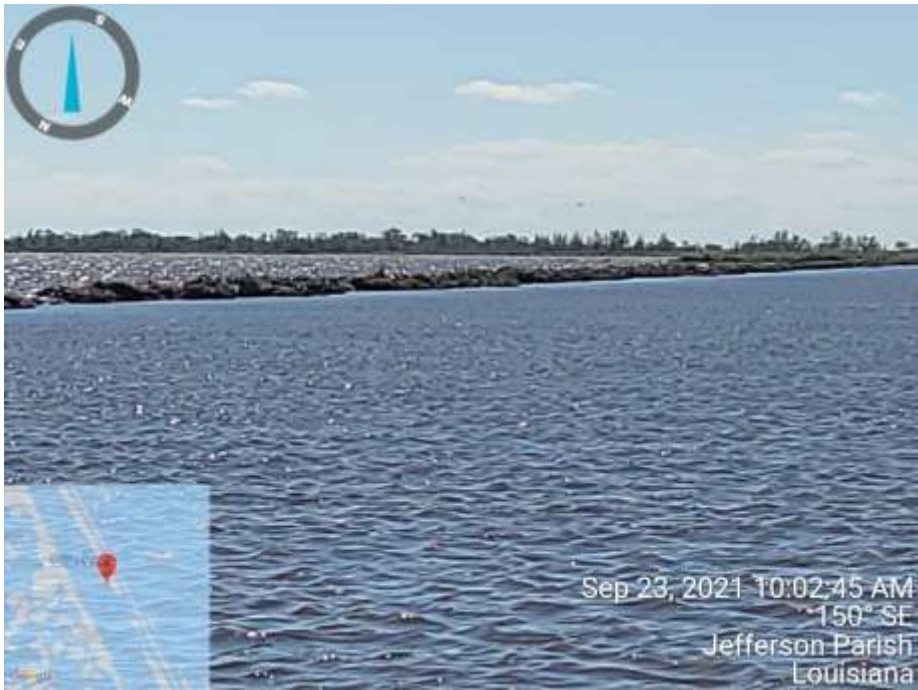
Most of the rock structure has settled, which was expected, and documented by the 2018 NRCS survey of the project that showed several areas approximately 1 to 2 feet below as-built elevations. During low water levels in the area, some sections of rock are just barely above the surface. Accretion and vegetation were observed behind the rock structure at the northern end of the project.

Photo 3. Barataria Bay Waterway East Side Shoreline Protection (BA-0026).

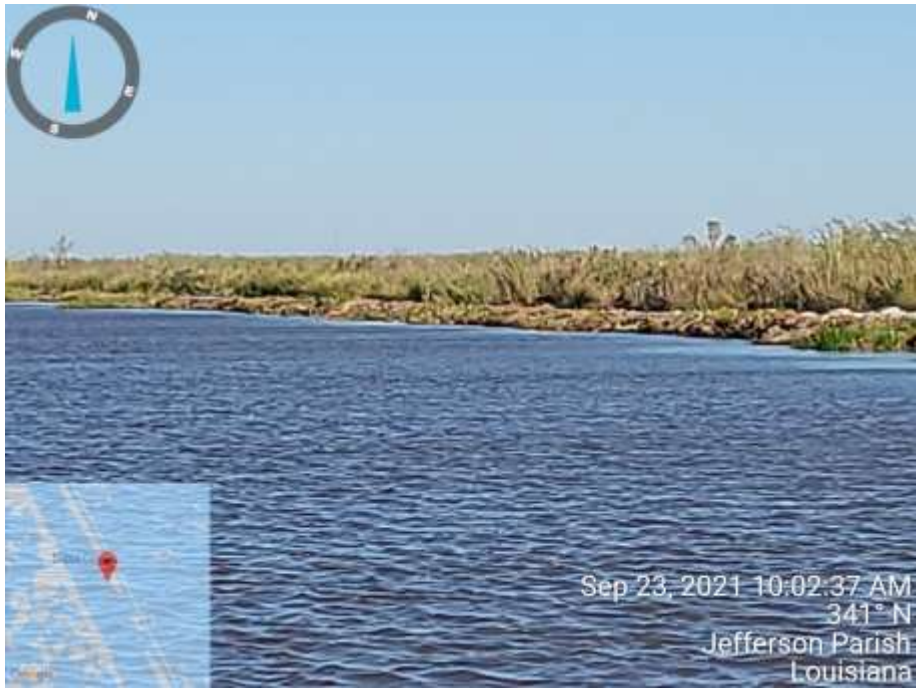
Photo 4. Evidence of accretion behind the rock wall for the BA-0026 project.
