2017 Operations, Maintenance, and Monitoring Report

Little Lake Shoreline Protection/Dedicated Dredging Near Round Lake (BA-37)

State Project Number BA-37
Priority Project List 11

September 2017
Lafourche Parish

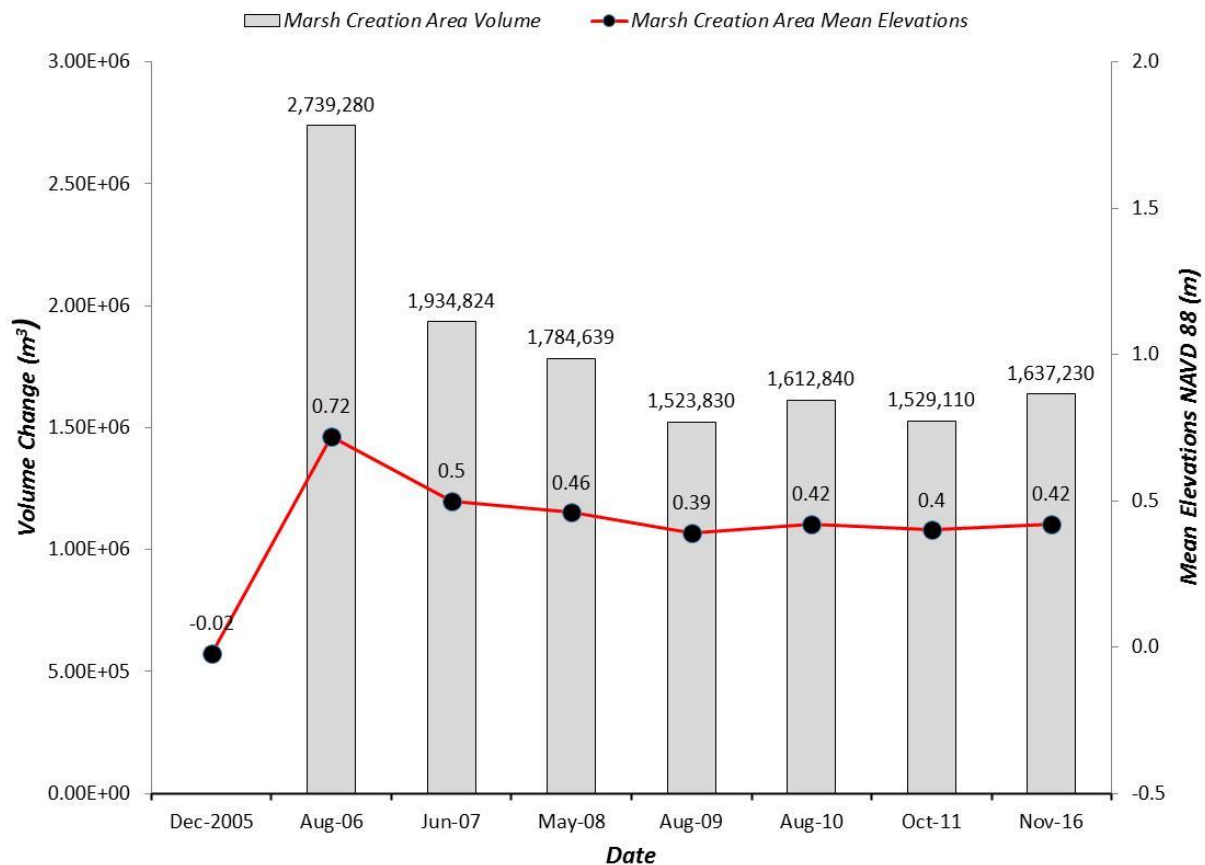
Figure 12. Sediment volumes and mean elevations over time inside the Little Lake Shoreline Protection/Dedicated Dredging Near Round Lake (BA-37) marsh creation and nourishment area.

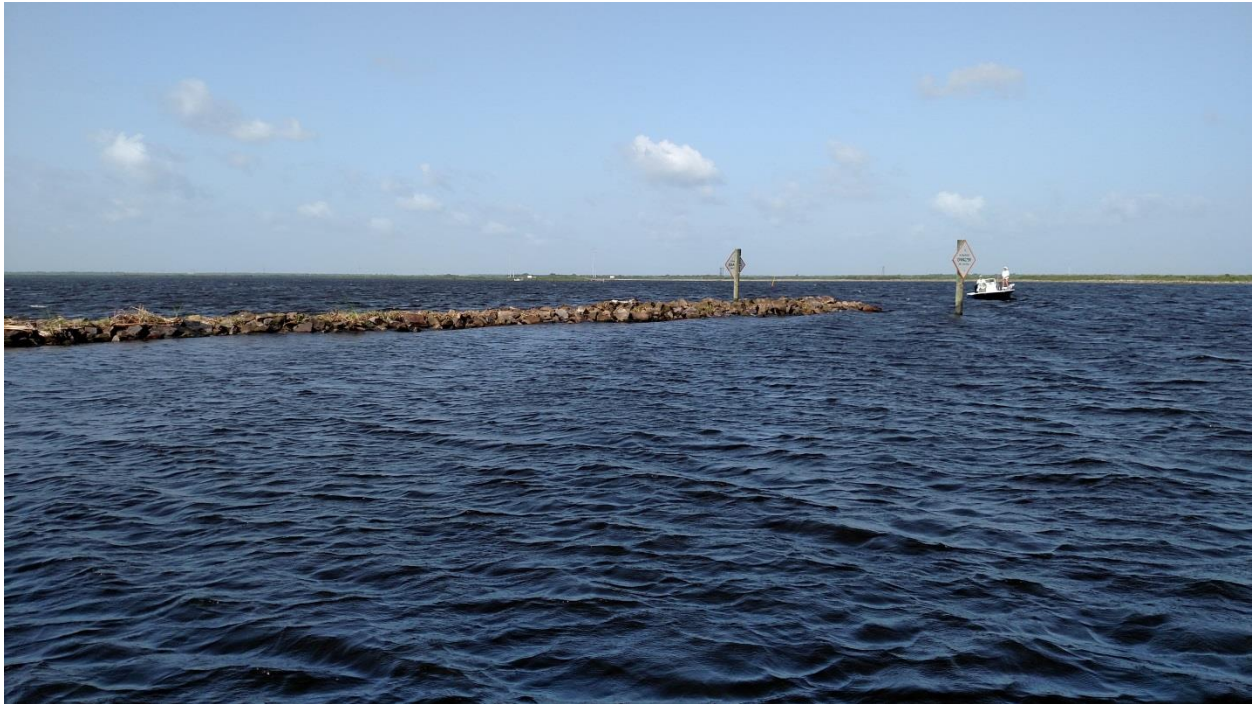
Currently, Rock Segments 1 and 2 have no marsh or vegetation along its southern edge, only open water. The fringe marsh that once separated Brusle Lake and Bay L'Ours, located just south of Segments 1 and 2 had eroded following Hurricane Katrina in 2005. This land loss occurred during construction of the project and the rock segments were installed as designed and contracted. Due to the liability associated with the rock dike being below the water surface during high tides and the lack of existing marsh behind the structure, NMFS and CPRA had decided to degrade Segment 1 and part of Segment 2, because the eastern edge of Segment 2 still protects the marsh behind Segment 3 from wave action. In the 2015 inspection report, CPRA had decided against recovering the rock riprap and installing at another location, instead electing to degrade the rock dike to a safe elevation along the lake bottom. This method was seen as more cost effective than recovering the rock riprap. However, 2016 discussions between the NOAA representative and CPRA rehashed the possibility of recovering the rock and building a Perpendicular Rock Dike branching off Segment 2 where the degrading terminates. The increased cost (although shared) of additional surveying and obvious alternative construction has been considered and deemed justifiable. The last survey of the entire rock shoreline was conducted in 2011. A complete Pre-Design survey of the rock on Segments 1 & 2 was concluded in February 2016 and additional surveying conducted in November 2016. The cost of construction of this project feature is reflected in the 3-year budget.

Photo 1: Beginning of the rock dike (Segment 1) near Sta. 10+00 at the entrance of Breton Canal.

Winter 2017 – As observed during post-construction surveys and visual inspections of the rock dike structure along the southern marsh of Little Lake and Round Lake, all of the rock dike segments have experienced some settlement. Over time, the settlement of the rock dike in the vicinity of Segments 1 and 2 has presented potential hazardous navigation conditions because the dike extends out into open water in an area without land behind it. A combination of high tides causing the rock dike to become submerged and the lack of a marsh shoreline behind both segments has resulted in a decision by NMFS and CPRA to degrade Segment 1 and part of Segment 2. Design surveys for degrading these segments were completed in February 2016. The current plan is to recover the rock rip rap for beneficial use in the construction of a “Perpendicular Rock Dike” near Segment 3 which will provide protection to adjacent land and reduce navigational hazards. The rock will be degraded to -2.0 ft NAVD88 (previous natural water bottom contour) on all of Rock Dike No. 1 and 870.00’ of Rock Dike No. 2. Additional surveys for the creation of the new feature were completed in November 2016. Construction is anticipated to start in December 2017. The staff gage will also be repaired during this winter 2017-2018 maintenance event.

Maintenance Event No.1 - to degrade approximately 1,900 linear (Segment No.1 and 2) of existing rock dike from Breton Canal southward.

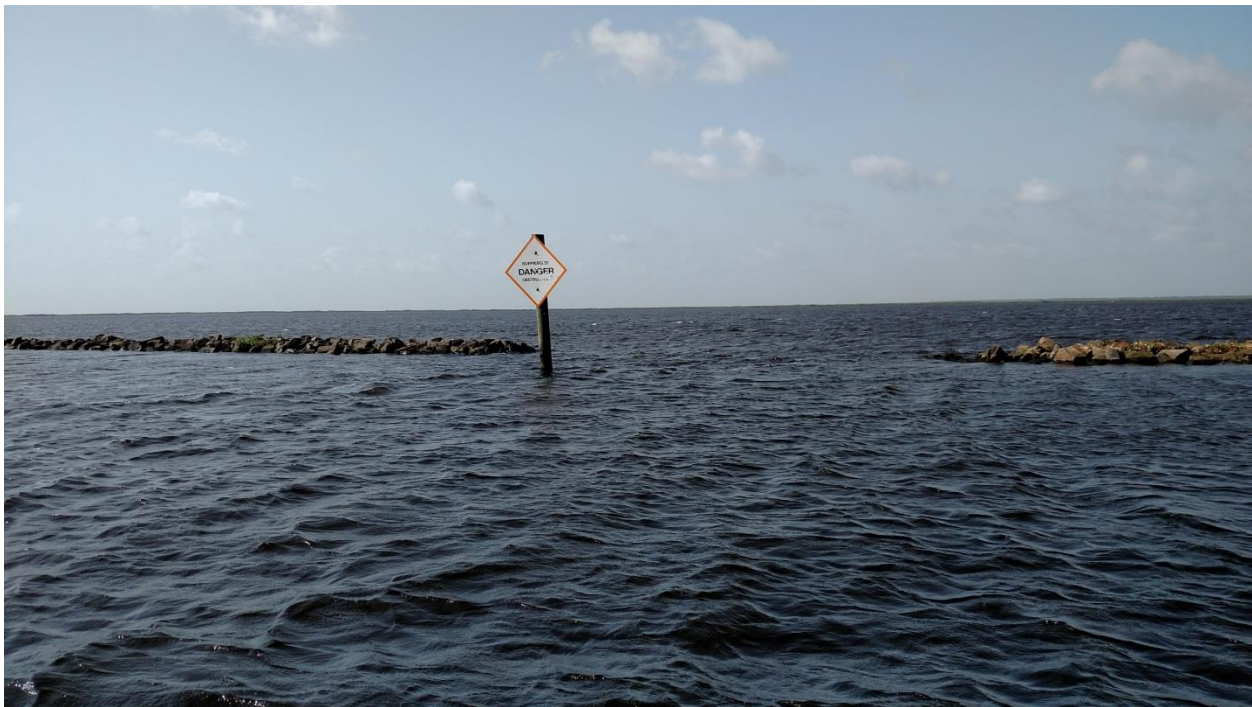
Photo 2: Beginning of rock dike (Segment No.2) looking southward.

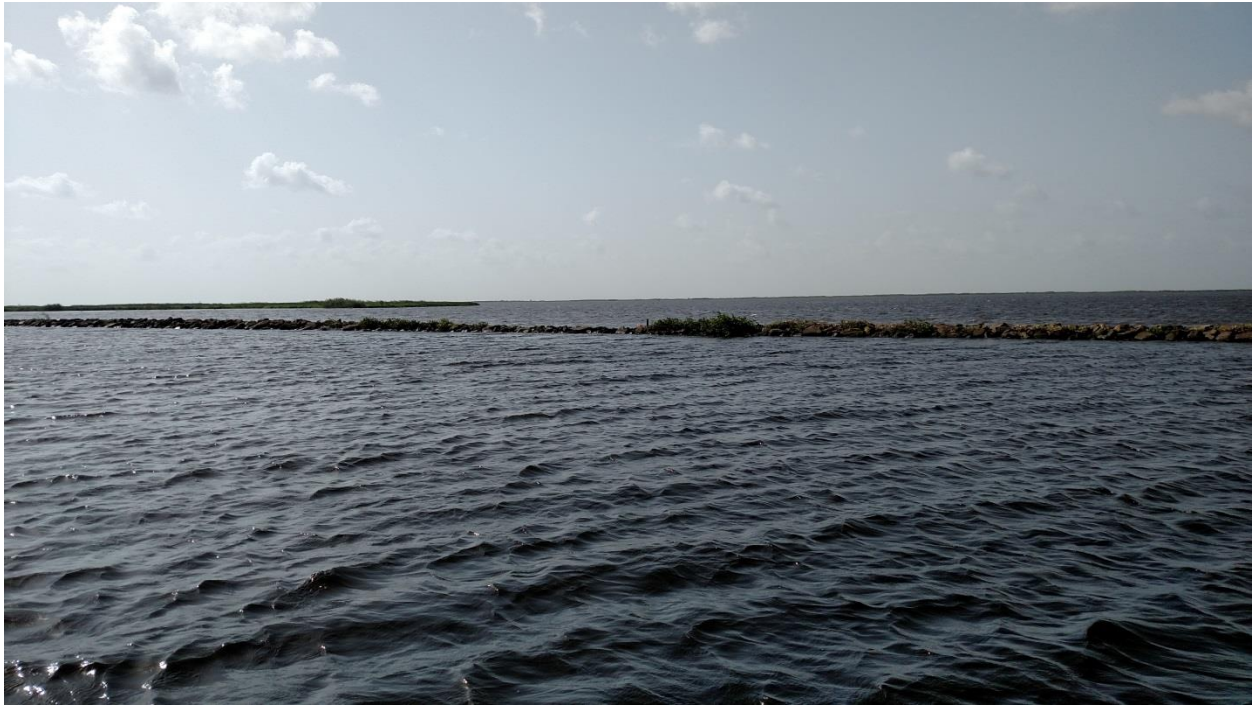
All rock segments were visually inspected by boat. It appears that all rock segments have experienced some degree of settlement with the most obvious settlement on the western end of the project (Segments 1 through 8), where only two (2) rock lifts were made during construction. Segments 10 through 24 received a third lift during construction and appear to be in good to fair condition.

Photo 3: Low area along the rock dike (Segment No.2) near Sta. 23+93.

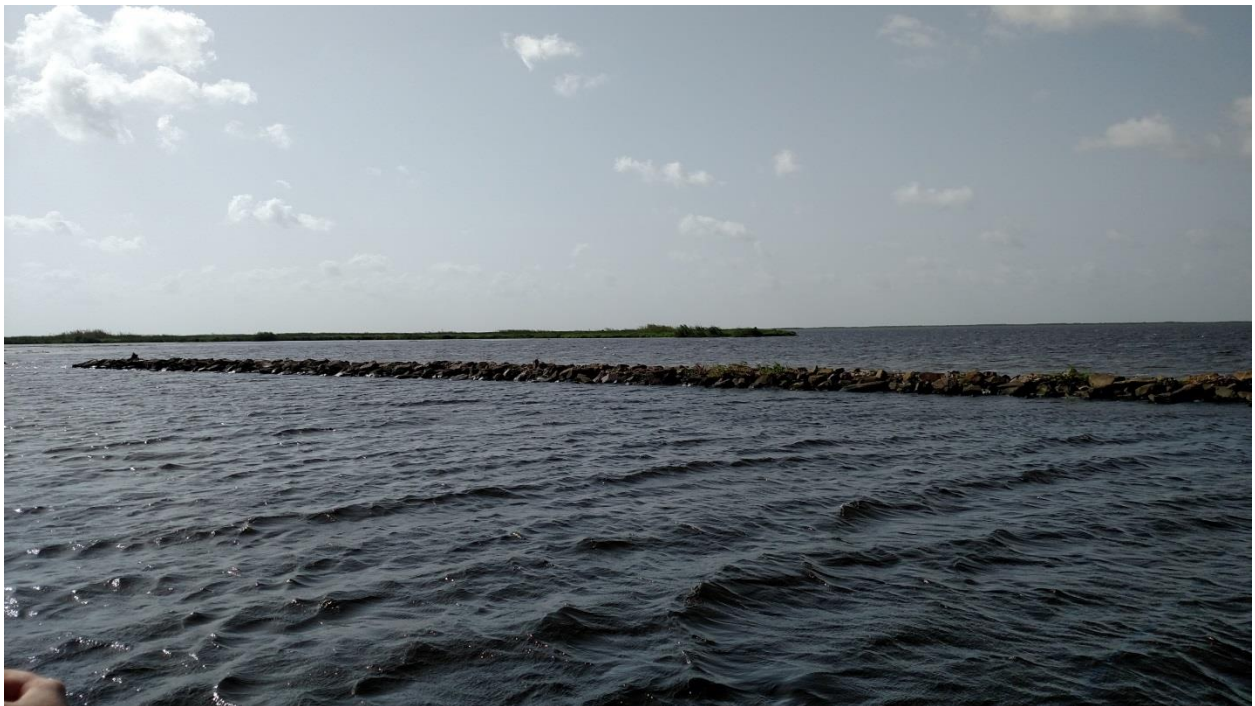
Photo 4: View of the end of rock dike (Segment No.2)

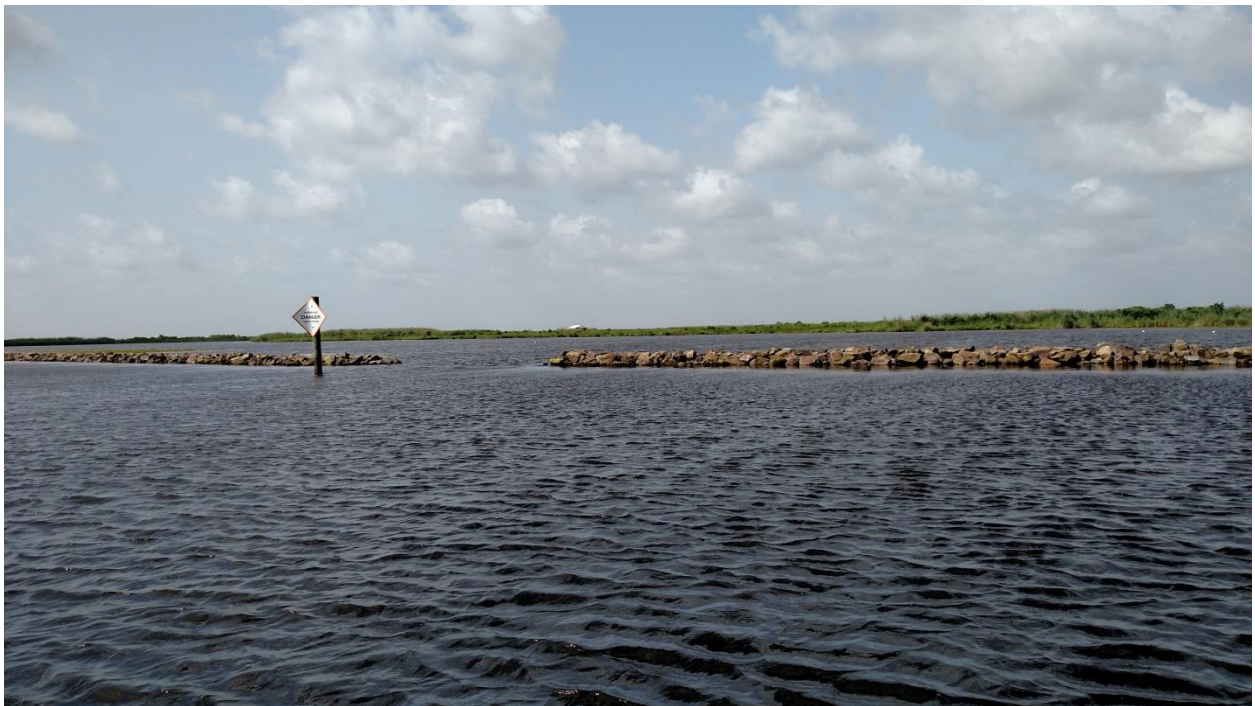
Photo 14: View of the rock dike and bent warning sign (Segment No. 10 & No. 11) looking southwest.

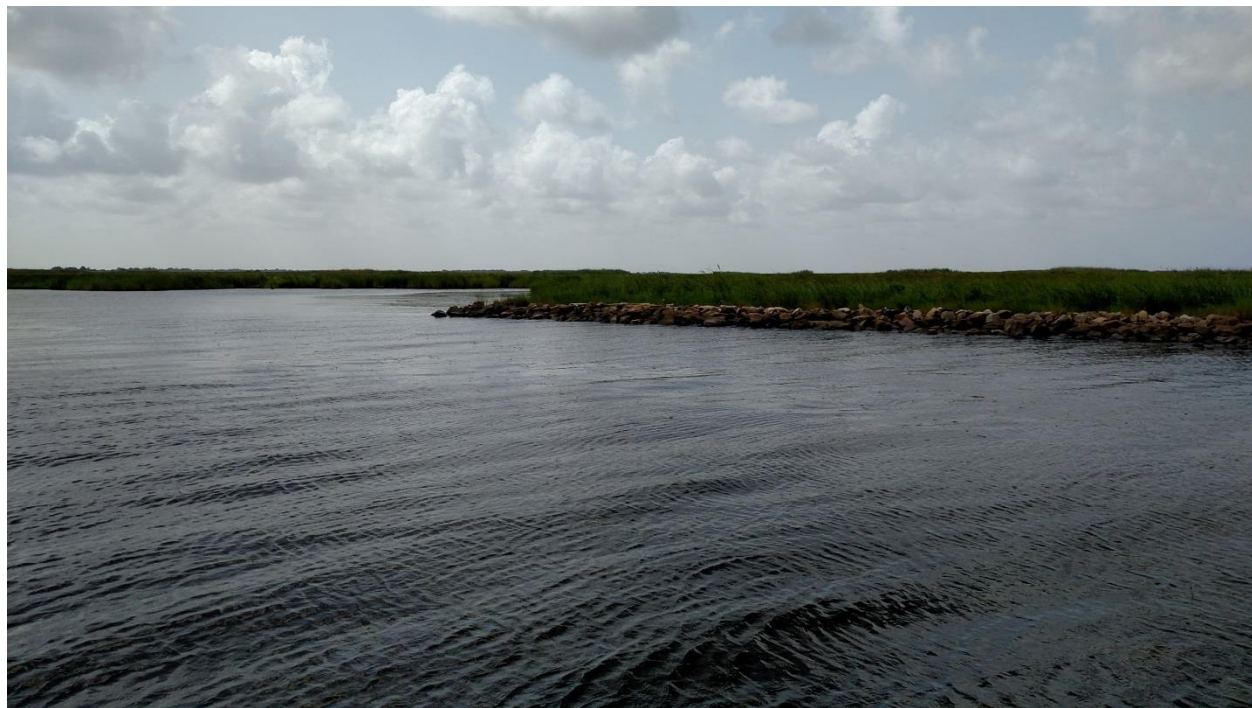
We were only able to visually inspect the marsh creation area from the perimeter of the project and marsh fringe along Round Lake and the southern containment dike. The fill material in the marsh creation area appeared to be in very good condition and fully vegetated. The latest post-construction survey of the fill area was completed in 2016. Below is a table showing the average grid elevations from 2006, the year construction was completed, through 2016. The final post-construction survey of the marsh fill area was conducted in 2016 and is shown in Figure 1. In 2016, CPRA conducted design surveys for degrading Segment 1 and 2

Photo 30: View of the rock dike, marsh, and open water just inside the opening of the southern containment dike (Segment No. 24) looking southward.
