**Coastal Protection and Restoration Authority of
Louisiana**

2023 Operations, Maintenance, and Monitoring Report

Bayou Dupont Sediment Delivery Marsh Creation #3 and Terracing (BA-0164)

State Project Number BA-0164
Priority Project List 22

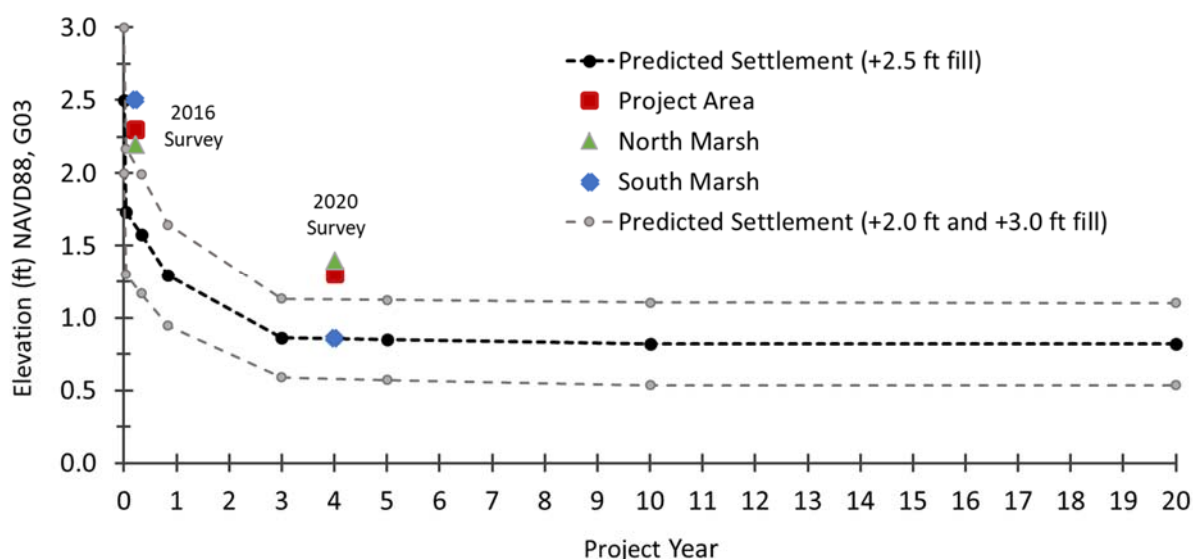
Figure 13. BA-0164 marsh settlement curve for a constructed elevation of $+2.5 \pm 0.5$ feet. The curves for a $+3.0$ ft and $+2.0$ ft constructed elevation are included to show the construction tolerance (± 0.5 feet). The as-built and year 4 mean marsh surveyed elevations are included on the graph.

By 2020, the mean surveyed marsh elevation had declined by one foot to $+1.3 \pm 0.5$ ft, which was 0.4 ft higher than the $+0.9$ ft predicted elevation (Figure 13). The settlement rate was different between cells, with the northern cell declining 0.8 ft since 2016, and the southern cell declining 1.7 ft, over twice the amount, during the same time period. The 2020 mean elevation of the northern cell was $+1.4 \pm 0.5$ ft, approximately 0.5 feet higher than predicted, while the southern cell was at the predicted elevation of $+0.9 \pm 0.4$ feet. It is early in the 20-year project life; however, on the current trajectory, the northern cell is settling slower than predicted and the southern cell is settling as expected. As previously discussed, the extent of the containment berms and the characteristics of the soils may have contributed to the differences in elevation between the cells.

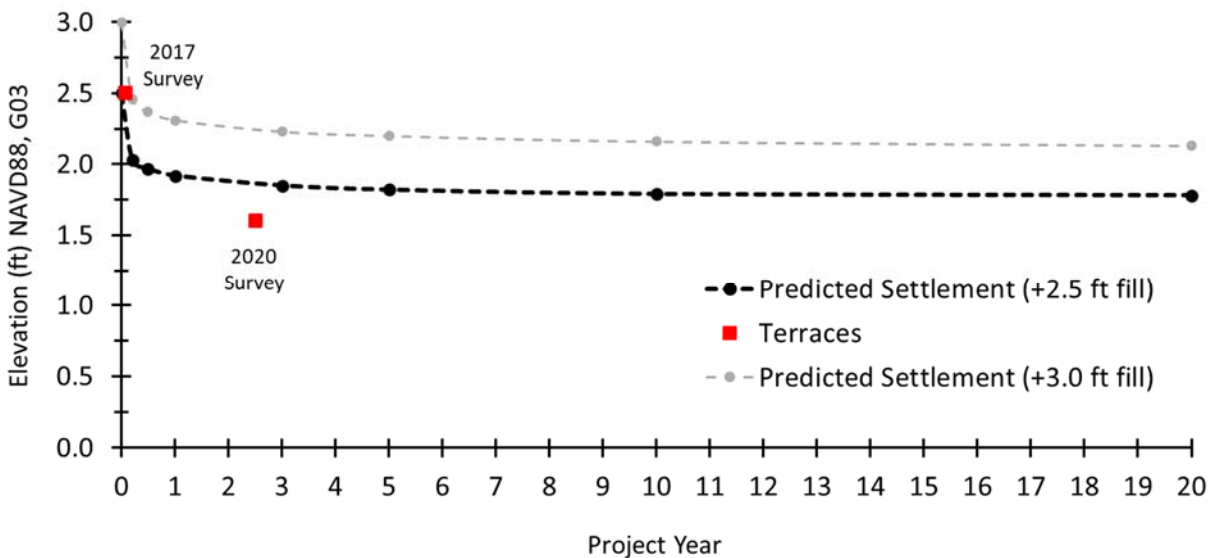
Figure 14. BA-0164 terraces settlement curve for a constructed elevation of $+2.5 \pm 0.5$ feet. The predicted elevations for a $+3.0$ ft constructed elevation is included to represent the construction tolerance (± 0.5 feet). The as-built (2017) and year 2.5 (2020) mean surveyed elevations of the terrace crowns are included on the graph.

Elevation data points collected only on the terrace crowns were used to compare mean terrace elevation to the predicted settlement curve. The settlement curve was developed considering compaction of the soils, but did not factor in shrinkage of fill due to drying of the sediments as they were placed above water (GeoEngineers 2014a). The 2017 as-built survey was conducted approximately 1 month after the end of construction. The mean as-built elevation of the terraces was $+2.5 \pm 0.3$ feet, which was approximately 0.2 ft higher than the predicted elevation for that time. Between the 2017 and 2020 surveys, the mean elevation of the terraces declined 0.9 ft to an elevation of $+1.6 \pm 0.3$ ft, slightly lower than the $+1.9$ ft predicted by the settlement curve (Figure 14). The difference between the predicted and measured settlement may be partially attributed to the shrinkage of soils, which was expected to occur between three and six months after construction. Based on a similar terrace design, but with a wider 15 ft crown, additional settlement from shrinkage during the 20-year project life was estimated to be an additional 0.3 feet (GeoEngineers 2014a). Future settlement of the terrace crowns is expected to be minimal through the remainder of the monitoring period, as the predicted settlement is < 0.1 foot between year 3 and year 20.

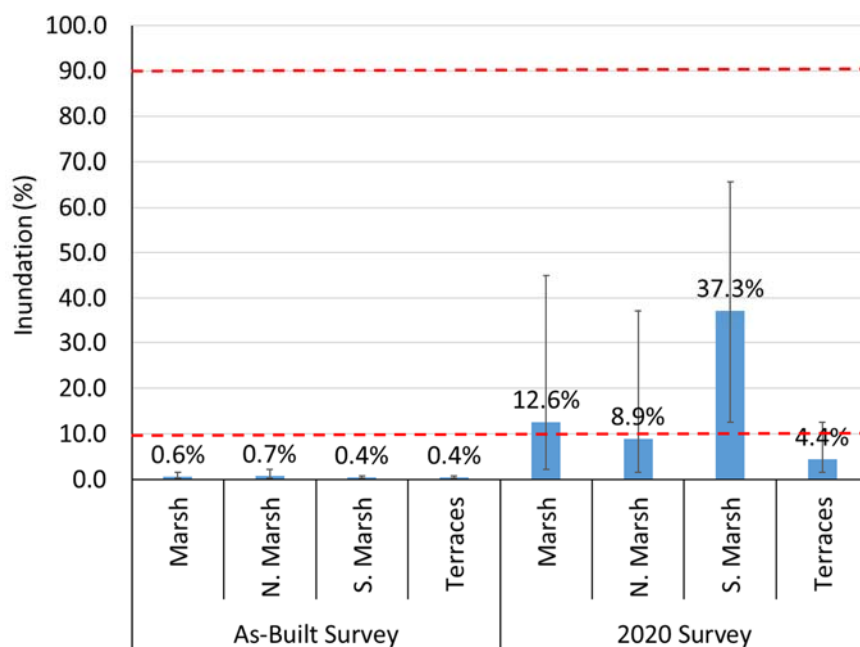
Figure 15. Calculated inundation (%) of the marsh and terraces for the as-built and 2020 elevation surveys. The dashed lines at 10% and 90% inundation represent the optimal inundation range for marsh. Inundation (%) is calculated based on the mean elevation of each feature, with the \pm bars representing the inundation range calculated for the \pm SD of the mean feature elevation.

The terrace crowns settled to a mean elevation of $+1.6 \pm 0.3$ ft by the 2020 survey, and at that elevation, were inundated only 4% of the time (Figure 15). If the inundation range is calculated for the mean terrace elevation \pm SD, inundation ranged between 13% and 2%. By remaining at a higher elevation in the landscape, the terraces are serving as speed bumps to reduce localized tidal energy. Figure 16 provides a visual representation of where the terraces and marsh cells lie in regards to CRMS4103 daily mean water elevation and the mean elevation of each feature.

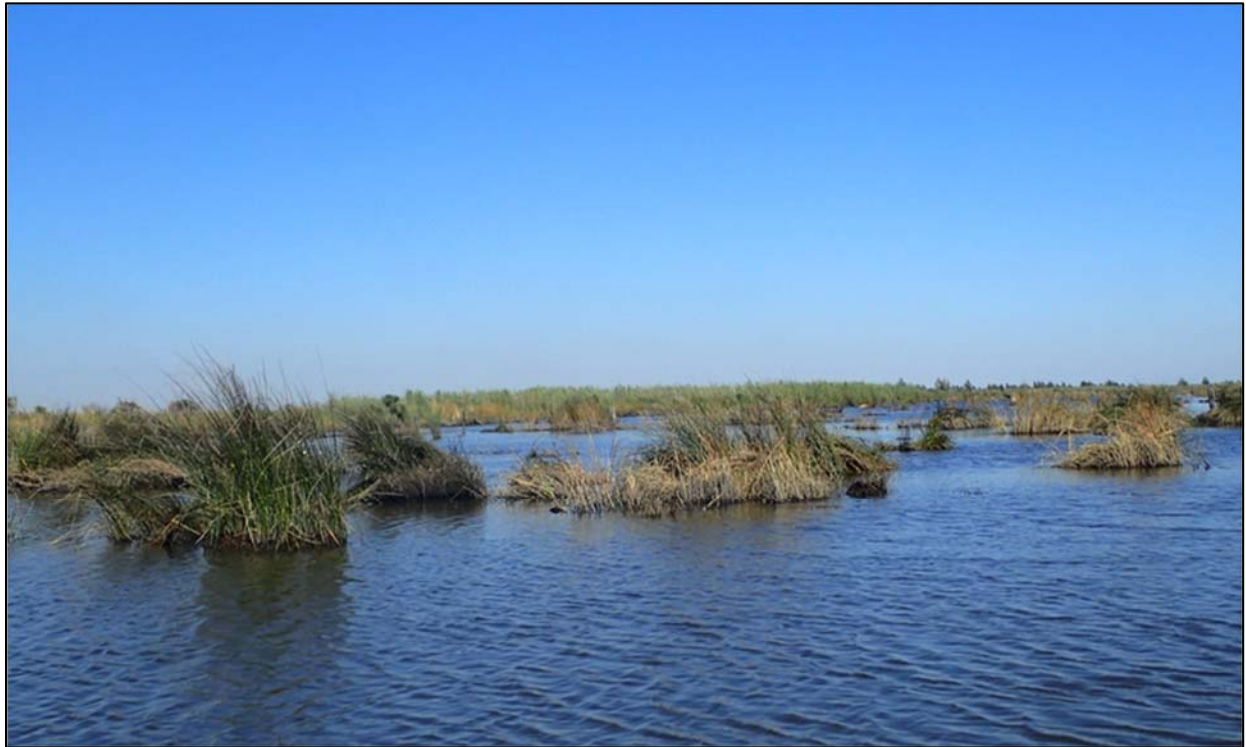
Photo 1. Broken up marsh deposited by Hurricane Ida southeast of the BA-0164 marsh creation area. Despite significant damage to natural marsh in the area, the BA-0164 marsh appeared to weather the storm with little damage.

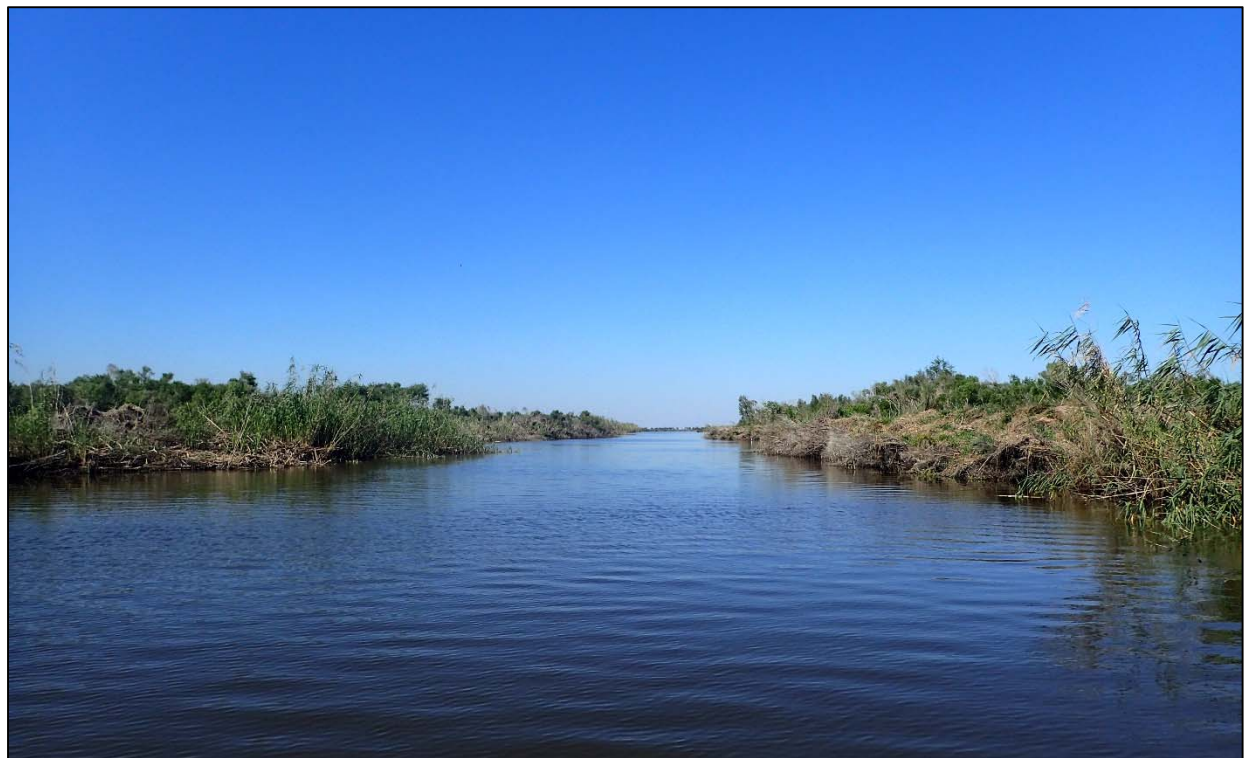
Photo 2. Looking northwest along the canal that divides the northern and southern BA-0164 marsh creation cells.

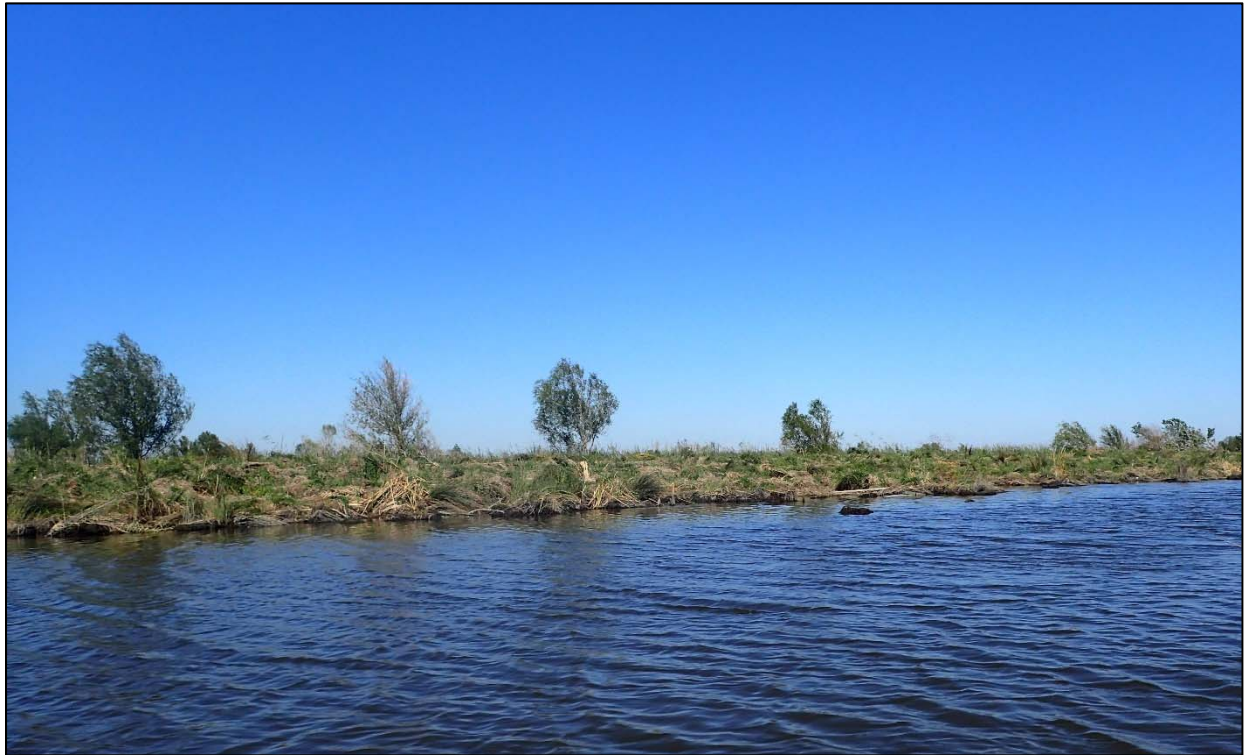
Photo 3. Eastern shoreline of the BA-0164 northern marsh creation cell. Some wrack deposited during Hurricane Ida is visible along the shoreline.

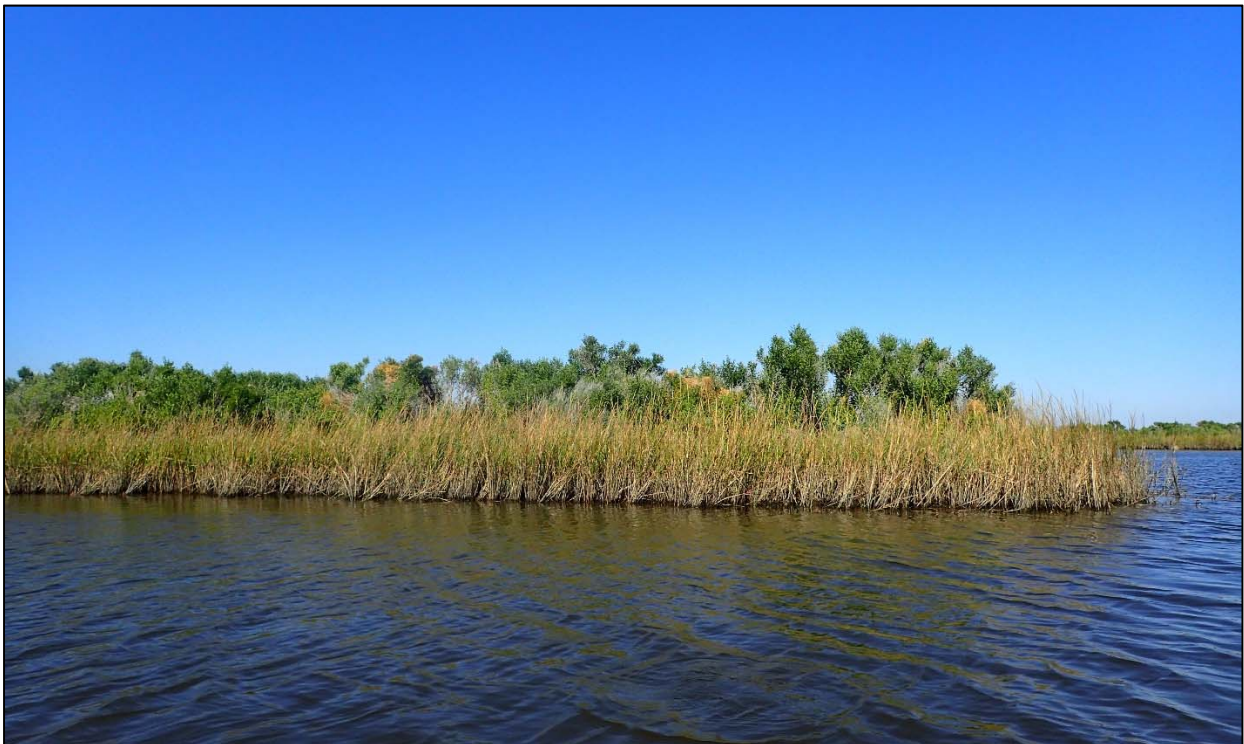
Photo 4. Terrace 8, showing shrubs growing on the crown and expanding, planted *Spartina alterniflora* growing along the base of the slope.

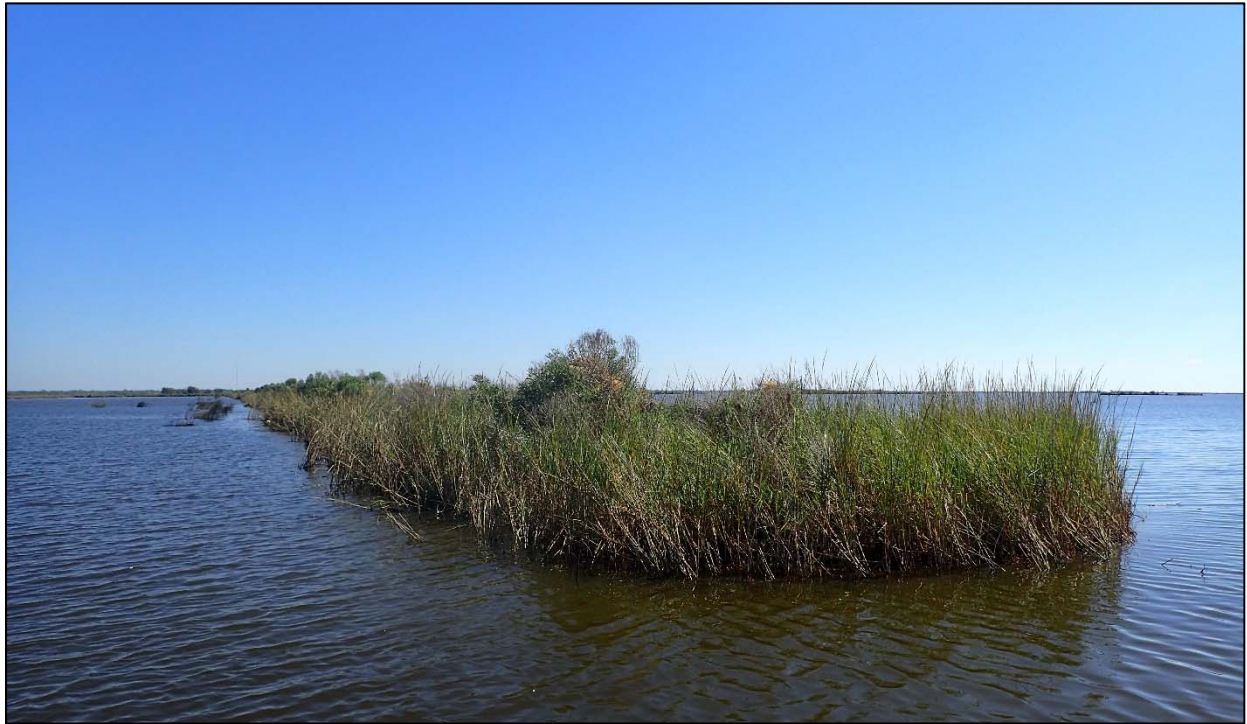
Photo 5. Terrace 12 is on the outermost terrace row, which is most exposed to wave energy. This photograph is taken from the southeastern side of the terrace, looking outwards and northwest from the terrace field.

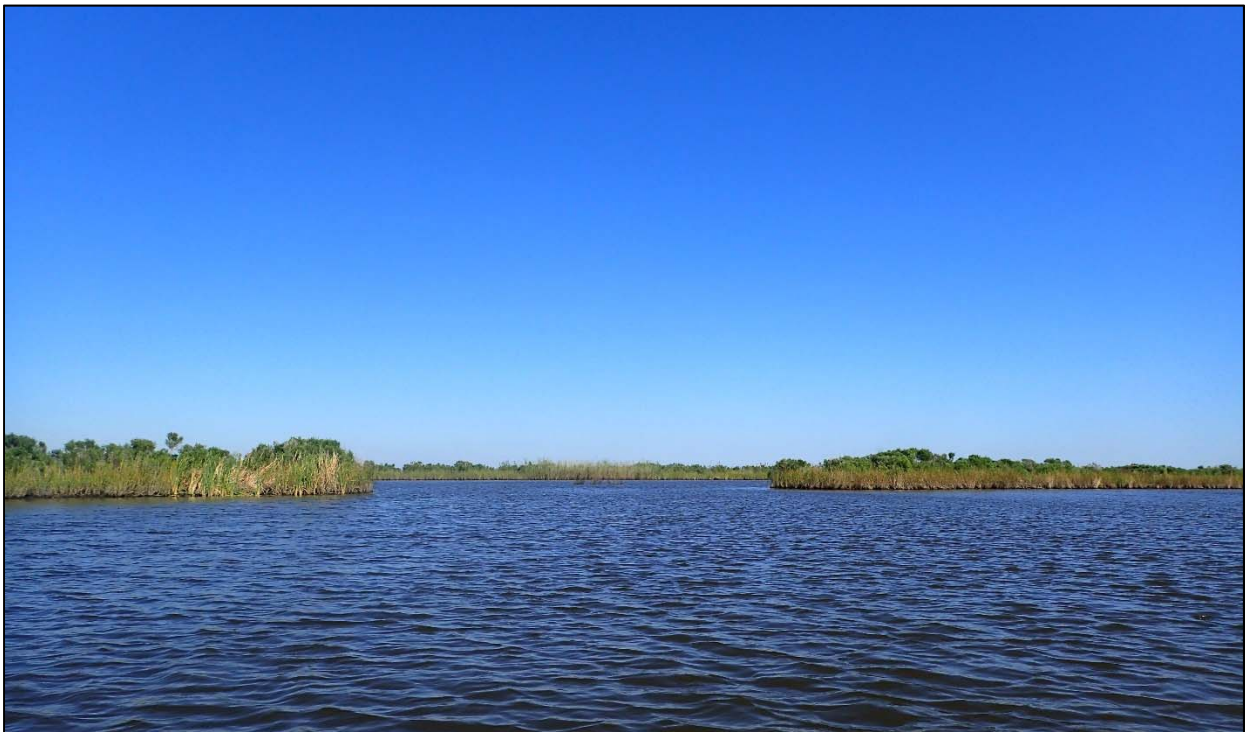
Photo 6. Looking north between Terraces 3 and 4, with Terrace 2 in the background.

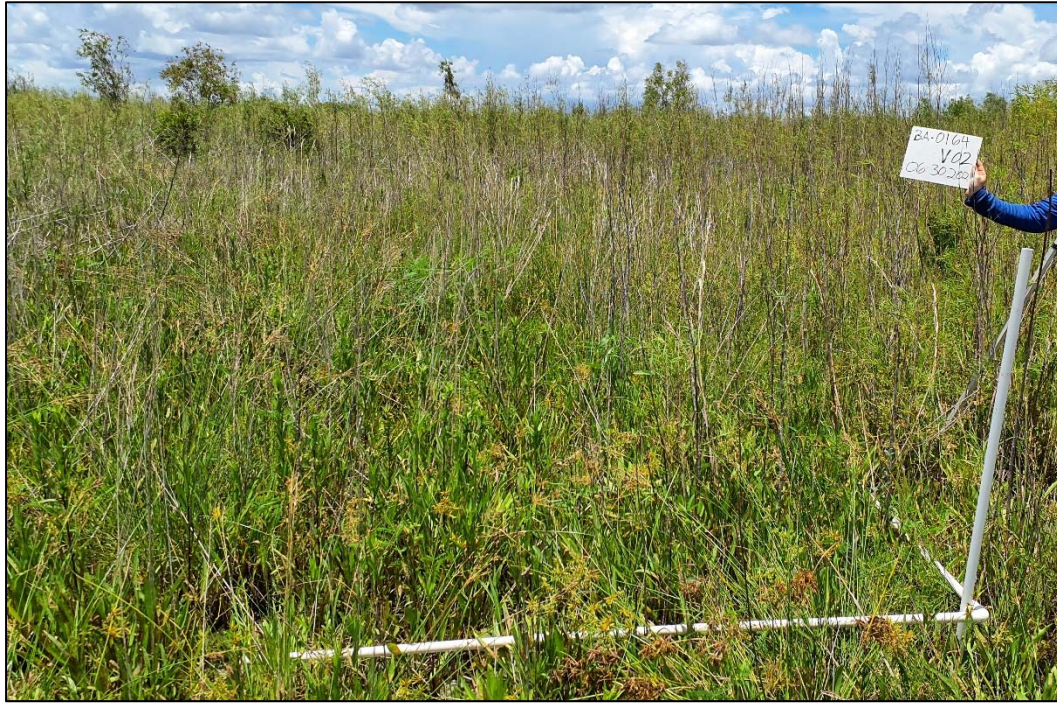
Photo 1. Marsh community at vegetation monitoring station V02 in the northern BA-0164 project area during the 2021 survey. *Solidago sempervirens* (seaside goldenrod) had the greatest cover (60%) and the marsh was flooded at a depth of < 0.1 feet.

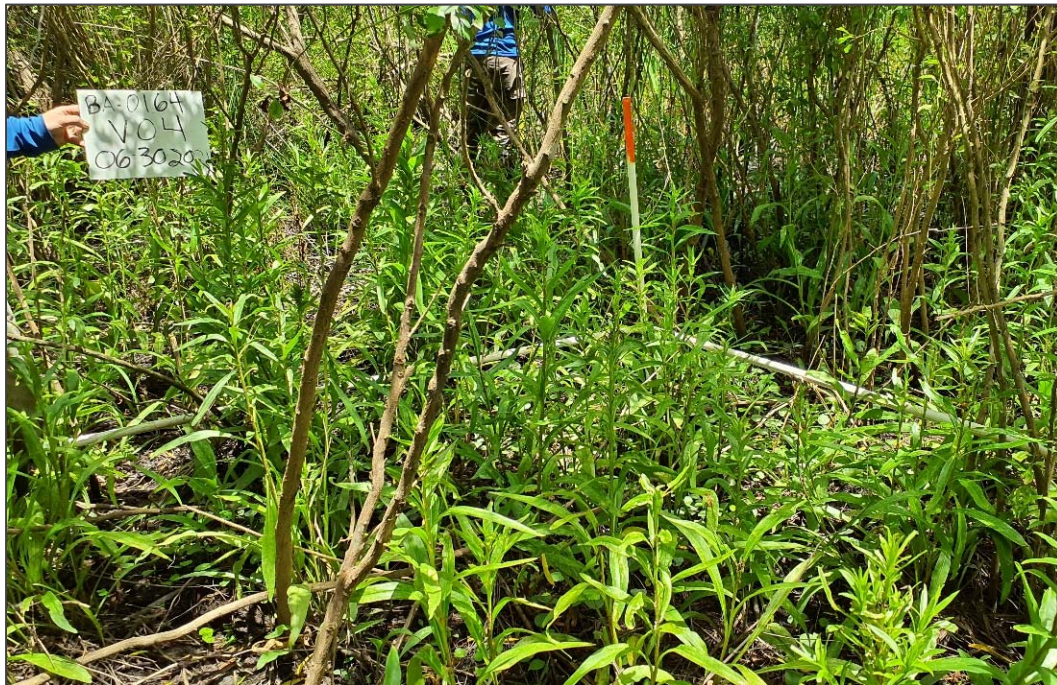
Photo 2. The vegetation community at monitoring station V04 had a high shrub cover during the 2021 survey, with *Baccharis halimifolia* (eastern baccharis) providing 65% cover. The tree *Salix nigra* (black willow) was also present and provided 35% cover. The marsh was not flooded at this station.

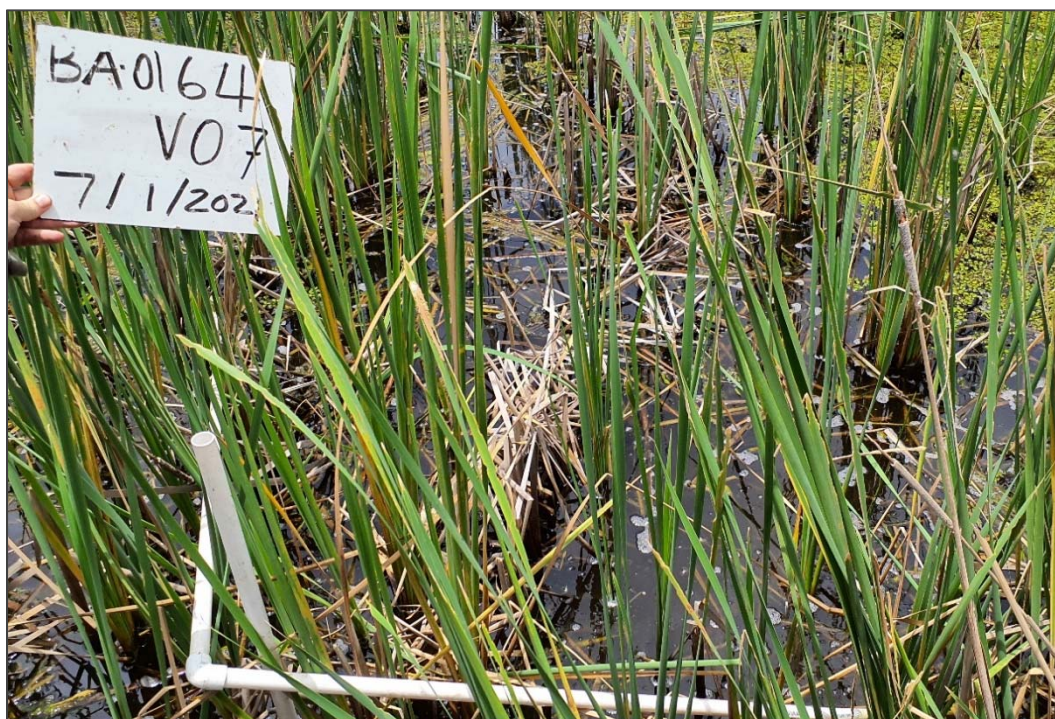
Photo 3. Vegetation monitoring station V07 is located in the southern area of the northern cell. For the 2021 survey, *Typha domingensis* (southern cattail) was the only species rooted in the plot. Water depth was 0.7 feet.

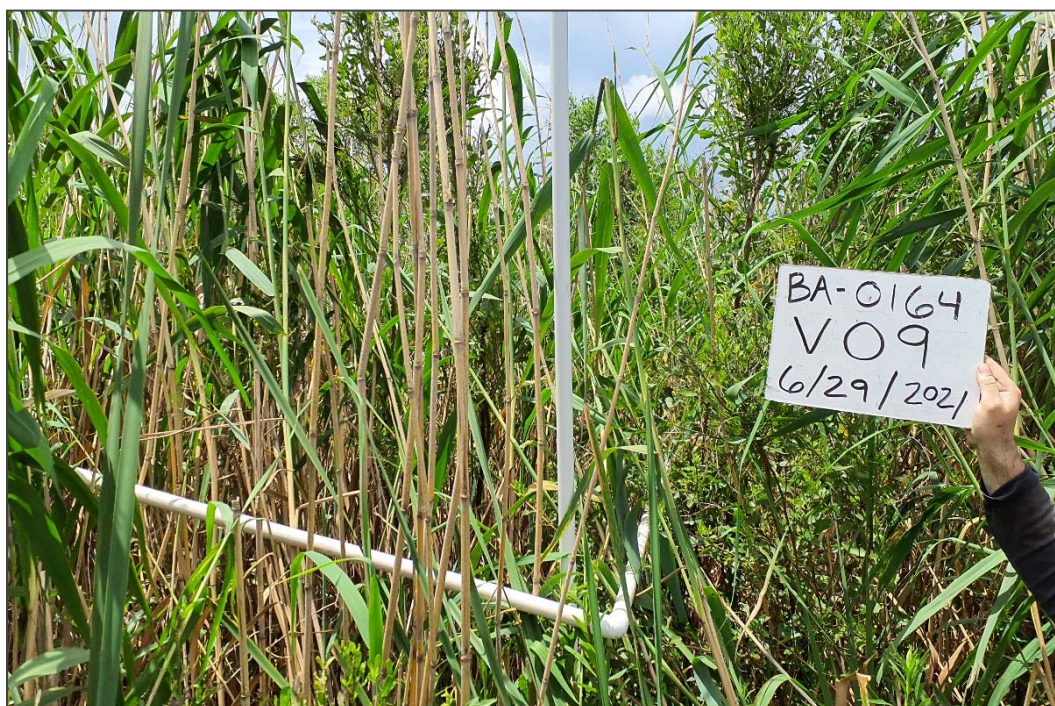
Photo 4. Vegetation monitoring station V09 was the only marsh station that had a high cover of *Phragmites australis* (common reed, 85%). This station is located in the southern cell and was not flooded during the 2021 survey.

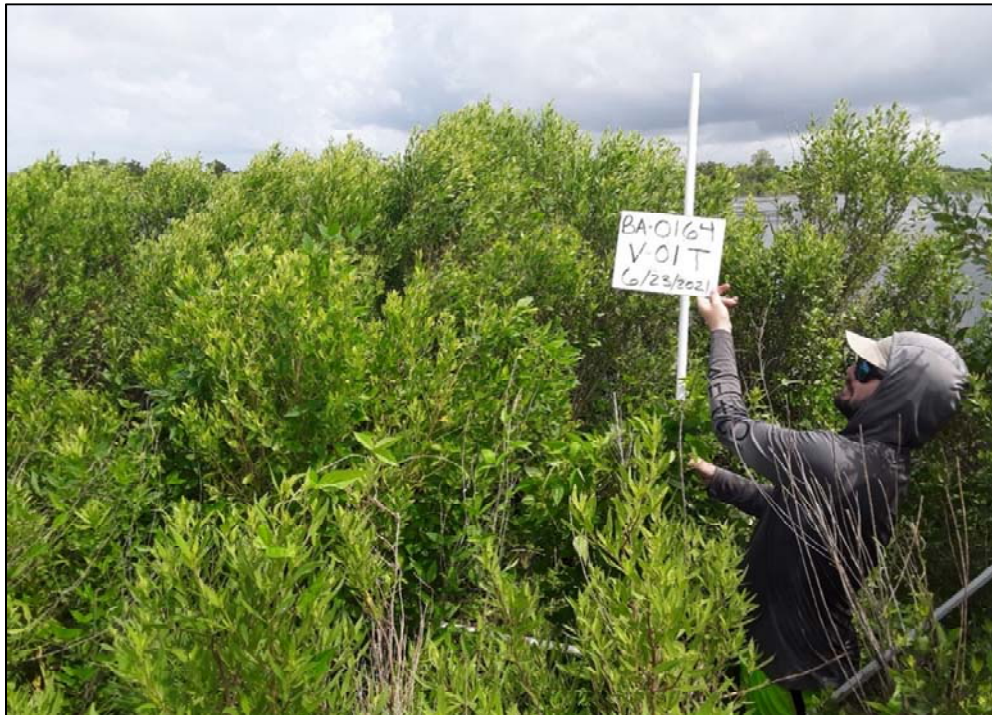
Photo 5. *Baccharis halimifolia* (eastern Baccharis) grows along the crown of Terrace 1 during the 2021 survey. This dense coverage is representative of the shrub growth that was encountered at most of the terrace vegetation monitoring stations during the 2021 survey.
