# 2020 Operations, Maintenance, and Monitoring Report

## Jonathan Davis Wetland Restoration (BA-20)

State Project Number BA-20  
Priority Project List 2

September 2020  
Jefferson Parish

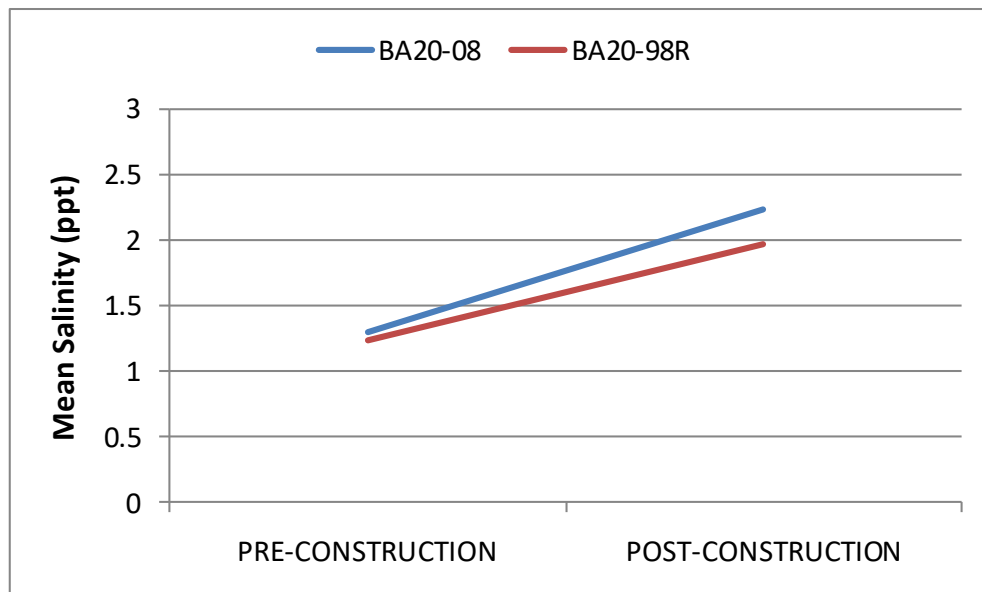
**Figure 11:** Comparison of mean weekly salinity of western sondes (BA20-08 and BA20-98R) during the pre- and post-CU1 periods.

The western project area also experienced a slightly significant impact ( $p=.0355$ ) of the project on mean weekly salinity levels at BA20-08. This shows up graphically as lines out of parallel in Figure 11, which shows that salinity increased slightly more in the project area in the post-CU1 period. Salinity increased by 71% and 60% in the project and reference areas, respectively. Again, the statistical significance corresponds to an impact with only modest biological significance, a departure of less than one part per thousand from what would be expected had there been no impact. It should be noted that the drought occurred during the pre-construction period for the eastern analysis and during the post-construction for the

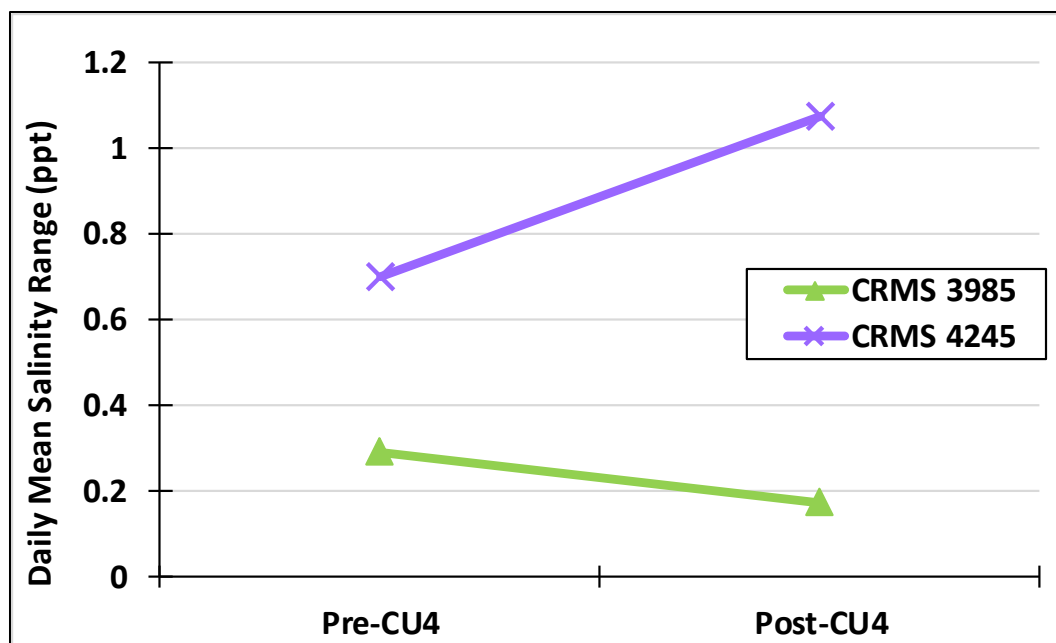
**Figure 15:** Daily mean salinity range pre- (2008-2011) and post - (2012-2019) construction of CU4 at CRMS3985 and CRMS4245.

15). Mean daily salinity range at CRMS4245 was significantly higher in the post-CU4 period at 1.07 ppt ( $F=116.1$ ,  $p<0.001$ ) than in the pre-CU4 period (0.7 ppt). At CRMS3985, salinity range was significantly lower post-CU4 construction (0.17 ppt) than pre-CU4 construction (0.29 ppt) ( $F=90.2$ ,  $p<0.001$ ). However, as indicated above, there appears to be a regional freshening in the post-construction period that could also decrease salinity variability. Additionally, CRMS3985 is located at the northern end of the Jonathan Davis Wetland, where it is far from project features and closer to the Davis Pond Diversion. While this diversion was constructed in 2002, consistent operation did not begin until 2006 and higher discharges didn't occur until 2008. Therefore, the decreased in salinity variability at CRMS3985 in the post-construction period could be due to the operation of Davis Pond decreasing salinity overall, as well as salinity variability at the northern end of the Jonathan Davis Wetland.

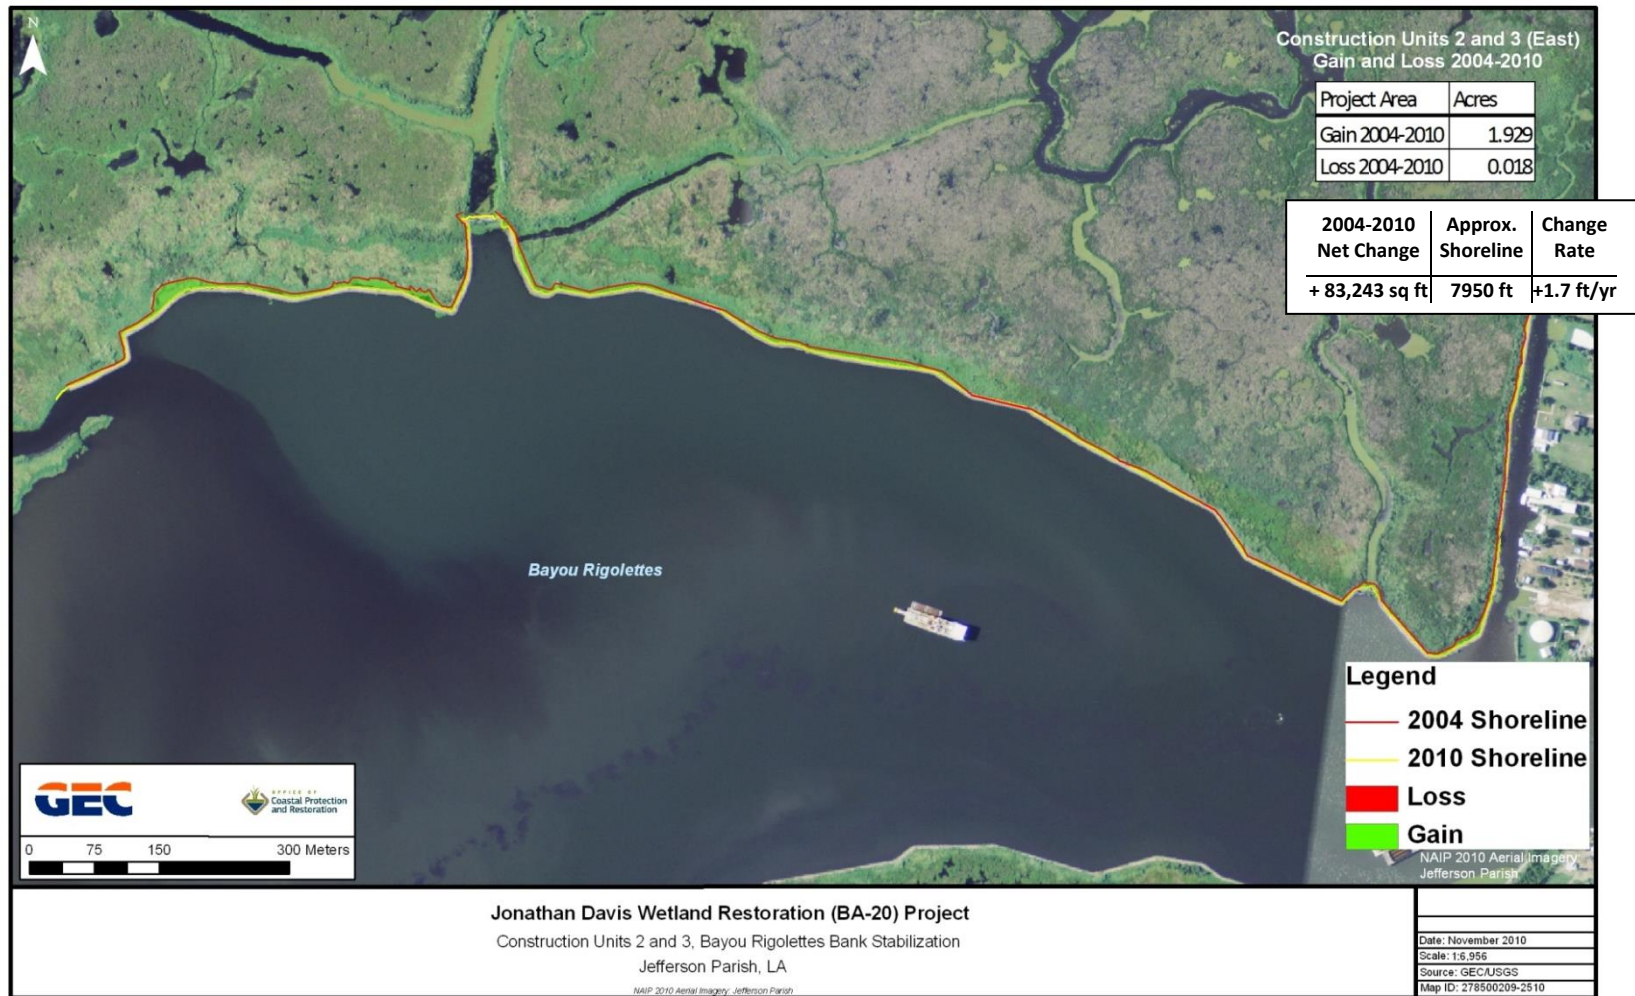
**Figure 25:** Shoreline change within Construction Unit 2 and the eastern portion of Construction Unit 3 of the Jonathan Davis Wetland Restoration (BA-20) project from 2004 to 2010.

A combined shoreline analysis of CU2 and the eastern portion of CU3 from 2004 to 2010 showed a net gain of 1.9 acres (+1.7 ft/yr) with negligible loss occurring (Figure 25). This increase in land occurred mostly in the CU3 area which had been constructed not long before the 2004 survey. As observed in the 2001-2004 analysis, the area between the rock structure and the original shoreline became vegetated, thereby causing an increase in shoreline acreage. The shoreline analysis of the western portion of CU3 exhibited a net land loss of 4.6 acres (+3.8 acres, -8.4 acres) for the period of 2004-2010 (Figure 26). However, the major extent of the land loss occurred along a large section of interior marsh located within the central portion of the project area. Therefore, separate land area calculations were made to determine the land changes to the 'shoreline' and 'interior marsh' independently. The 'shoreline' component exhibited a net gain of 3.34 acres (+3.51 acres, -0.17 acres), and the 'interior marsh' exhibited a net loss of 8 acres (+0.29 acres, -8.25 acres). The gain of land along the 'shoreline' component was again due to the vegetating of areas between the rock structure and the original shoreline between the first and second surveys. The shoreline gain rate (with the interior marsh area excluded) was determined to be +2.2 ft/yr.

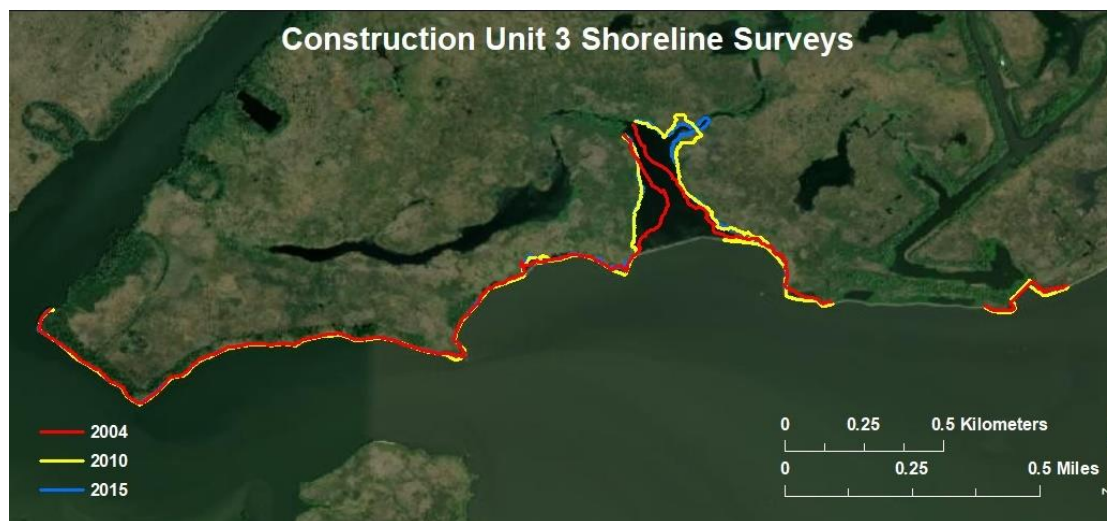
**Figure 27:** Three shoreline surveys associated with Construction Unit 3.

A third data collection event for CU3 occurred in October 2015, and was compared to data collected in 2004 and 2010 (Figure 27). As in the previous analysis, CU3 was analyzed as a whole, but also by separate ‘Interior’ and ‘Shoreline’ regions, because these two sections of shoreline were shown to differ in shoreline change patterns.

As mentioned above, the DSAS analysis draws transects to determine shoreline change rates at a user defined spacing. For the 2004 to 2015 comparison of CU3, there was a total of 151 transects drawn. Between 2004 and 2015, the average shoreline change along the entire length of CU3 was  $-0.57 \pm 1.26$  ft/yr (Figure 28). In this analysis, 37% of the transects were erosional and 63% were accretional. The analysis determined that 20% of the transects had shoreline change that was statistically significant, with 18% erosional and only 2% accretional. Therefore, most of the accretion during 2004-2015 was not statistically significant. When the interior marsh shoreline and exterior shoreline data were analyzed separately for 2004-2015, results showed that the interior change was mainly erosional or demonstrating shoreline retreat, while the shoreline change (directly behind the protection structure) was accretional. Average shoreline change rate of the interior shoreline was  $-9.5 \pm 4.1$  ft/yr. In the interior, there was a total of 37 transects with 92% erosional and 8% accretional. Approximately 70% of the transects had statistically significant erosion and none had significant accretion. Average change along the exterior shoreline sections was  $0.7 \pm 4.1$  ft/yr. Along the exterior shoreline, there were 117 transects, 18% erosional and 82% accretional. Only 6% of the exterior shoreline transects had change that was statistically significant, 2.6% erosional and 3.4% accretional, indicating that most of the change detected along the shoreline was not statistically significant. A summary of shoreline change rates can be found in Table 5.

In summary, there was little change along the CU3 shoreline between 2004 and 2015 and 2010 and 2015. The majority of the change took place in the interior marsh with substantial loss between 2004 and 2010 and then stabilization or gain between 2010 and 2015. In the northeast corner of the interior marsh, at the opening to a small bayou, there was a gain of 26 to 29 ft/year from 2010 to 2015, where it appears that the mouth of the small bayou is narrowing.

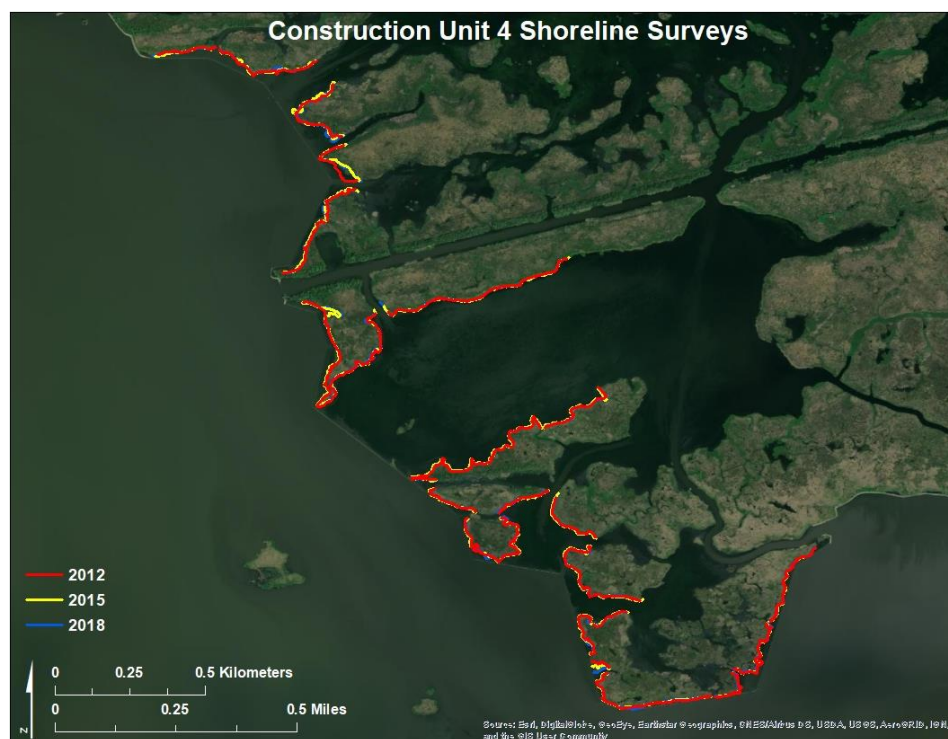
**Figure 30:** Three shoreline surveys associated with Construction Unit 4.

The CU4 shoreline was analyzed as a whole unit and not split up into smaller units. Shoreline location data was collected along CU4 in 2012, 2015, and 2018 (Figure 30). For the 2012 to 2018 shoreline comparison, there was a total of 303 transects drawn. Between 2012 and 2018, the average shoreline change along CU4 was  $-0.03 \pm 1.6$  ft/yr (Figure 31). In this analysis, 50% of the transects were erosional and 50% were accretional. The analysis determined that only 2% of the transects had shoreline change that was statistically significant, with 1.3% erosional and 0.7% accretional transects; therefore, most of the shoreline during this time period was not statistically significant. A summary of shoreline change rates can be found in Table 5. For the 2015 to 2018 shoreline comparison, there was a total of 307 transects drawn. Between 2015 and 2018, the average shoreline change along CU4 was  $-0.75 \pm 3.4$  ft/yr (Figure 32). In this analysis, 78% of the transects were erosional and 22% were accretional. The analysis determined that less than 1% of the transects had shoreline change that was statistically significant. Overall, it appears that the CU4 shoreline is relatively stable, not exhibiting substantial gain or loss along most of its length.

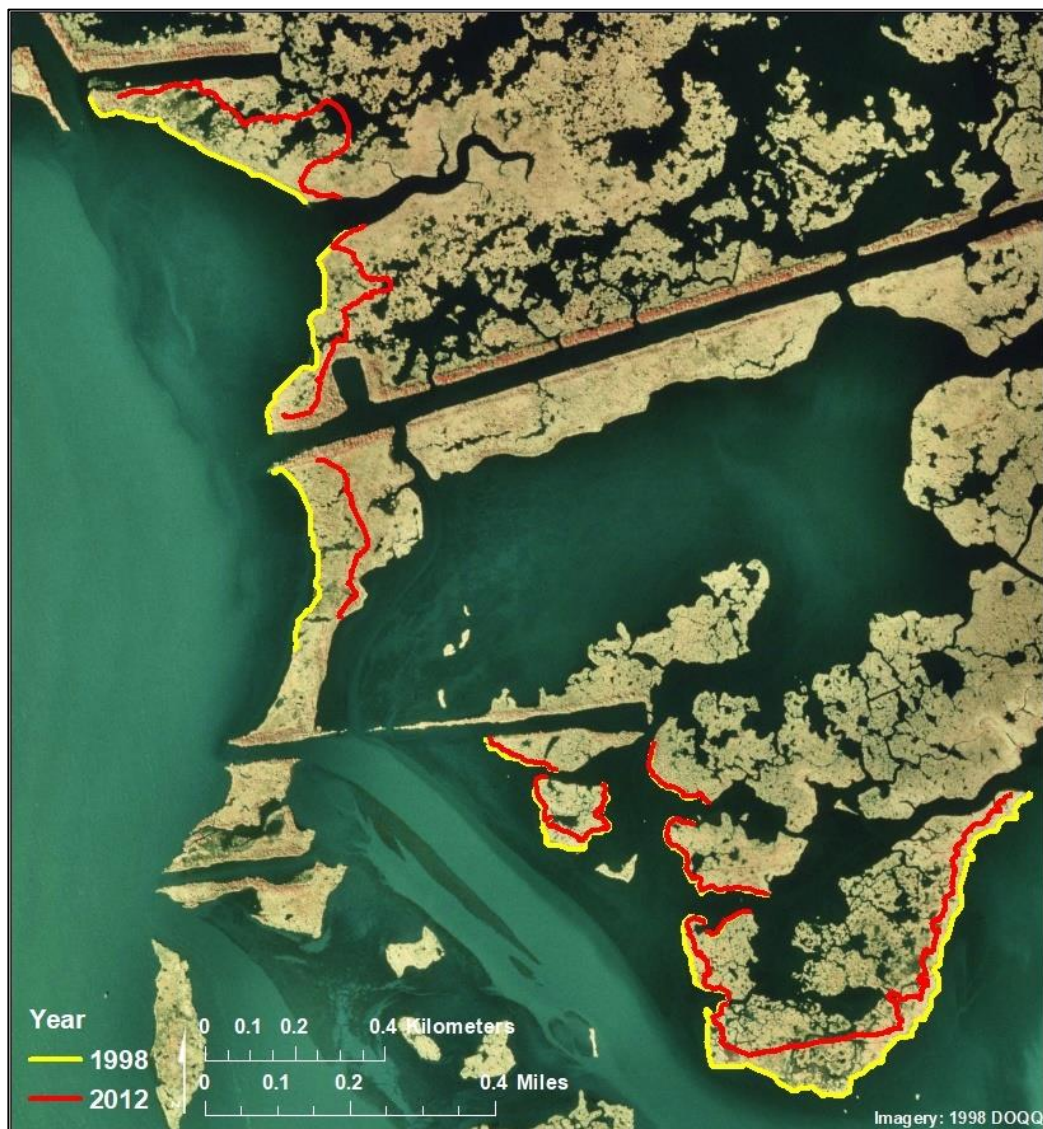
The land acreage that was potentially saved by having the shoreline protection project in place was estimated by applying the pre-construction land loss rate along the CU4 shoreline from 1998 to 2012 to the length of the protected shoreline. To obtain an estimate of the loss rate, the 1998 shoreline was digitized from DOQQ imagery and compared to the 2012 CU4 shoreline survey conducted immediately after construction (Figure 36). The same methodology used for Reference Area 1 above was used for this analysis and the same caveats about water level apply for the 1998 digitized shoreline. The results of the DSAS analysis revealed an average shoreline retreat rate of -9.88 ft/yr. along the CU4 shoreline. This average rate was then subtracted from the shoreline change rate post-construction (described above) to determine a net shoreline change rate. This net rate was then multiplied by the shoreline length for CU2, CU3, and CU4 to determine the net acres per year that were saved and multiplied by the number of years the structure has been in place to estimate the acres saved through 2020 (CU2 and CU3 have been in place for 16 years, and CU4 for 8 years). The same rate of acres per year was also multiplied by the number of years that project features will be in place at the end of the project life (2032) to predict the net acres to be saved throughout the whole project. Using this method, the net acres saved thus far (through 2020) is estimated to be 118 acres and the net acres to be saved over the life of the project is estimated to be 241 acres. The methodology used here makes some assumptions that

must be considered: 1) the shoreline delineated from the 1998 imagery did not account for water level at the time of photo acquisition, and therefore could be over- or underestimating the shoreline location, 2) the loss rate from CU4 was applied to all construction units when rates could vary depending on fetch, shoreline orientation, prevailing wind directions, and soil types, 3) a steady rate is used to project forward in time when future rates could speed up or slow down, or there could be large weather events that impact the area, and 4) this methodology does not account for subsidence and interior marsh loss that may accelerate shoreline loss. Project features can protect the shoreline but do not address other processes that cause land loss beside shoreline erosion.

**Figure 36:** The 1998 and 2012 shoreline used to determine shoreline erosion rates prior to the construction of CU4. The 1998 shoreline was drawn from imagery and adjustments for water levels were not conducted.

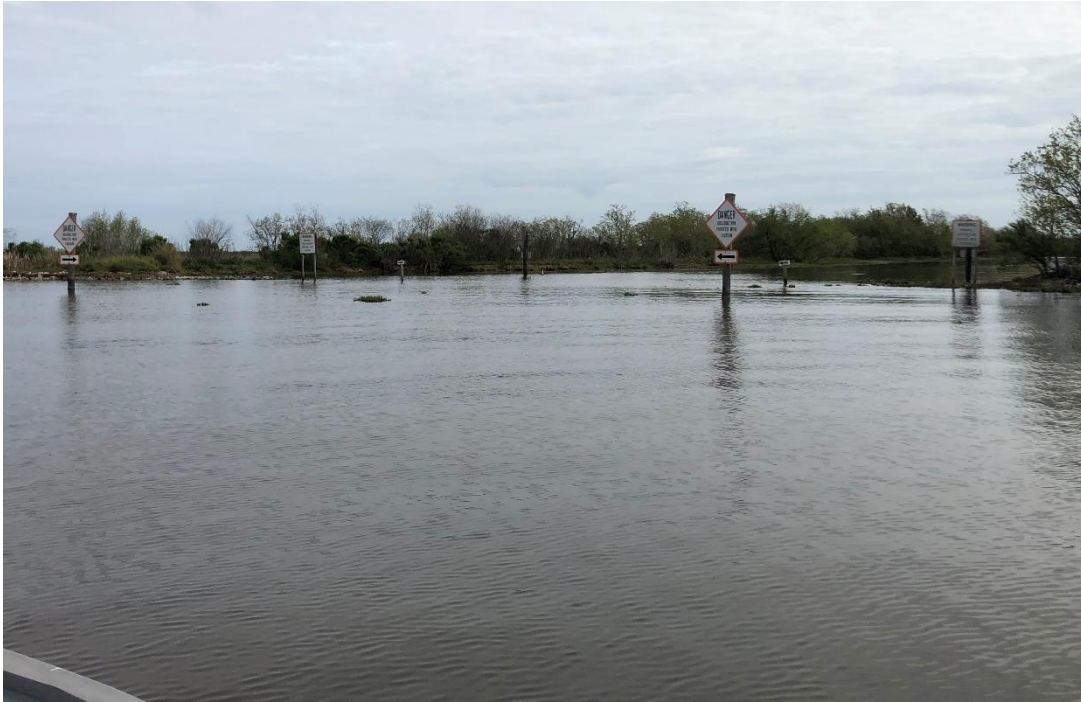
**Photo #1 – Structure #13**

Due to the water level and structure settlement, the structure was not visible, preventing a detailed inspection. Signs and timber supports were generally in good condition. No maintenance will be required at this time. (Photo #1)

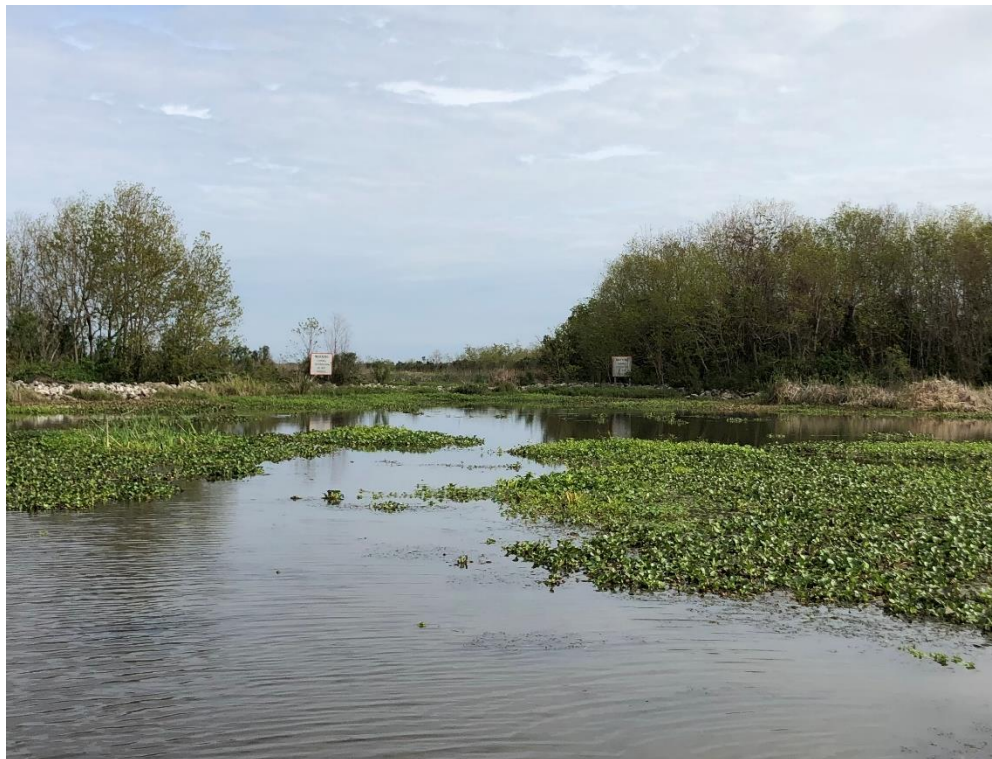
**Photo #2 – Structure #15**

The original weir was converted to a rock plug structure as part of the work effort for Construction Unit 4. No defects were noted during the inspection. (Photo #2)

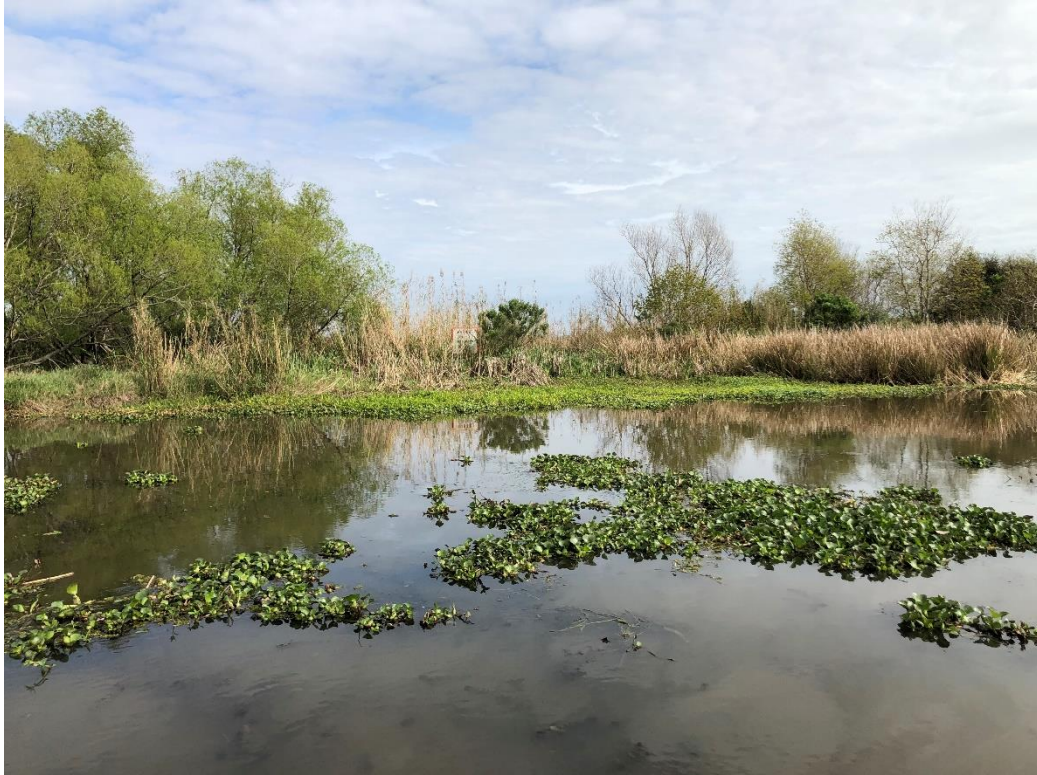
**Photo #3 – Structure #16**

Rip-rap and warning signs appeared to be in good condition. No maintenance work is recommended at this time. (Photo #3)

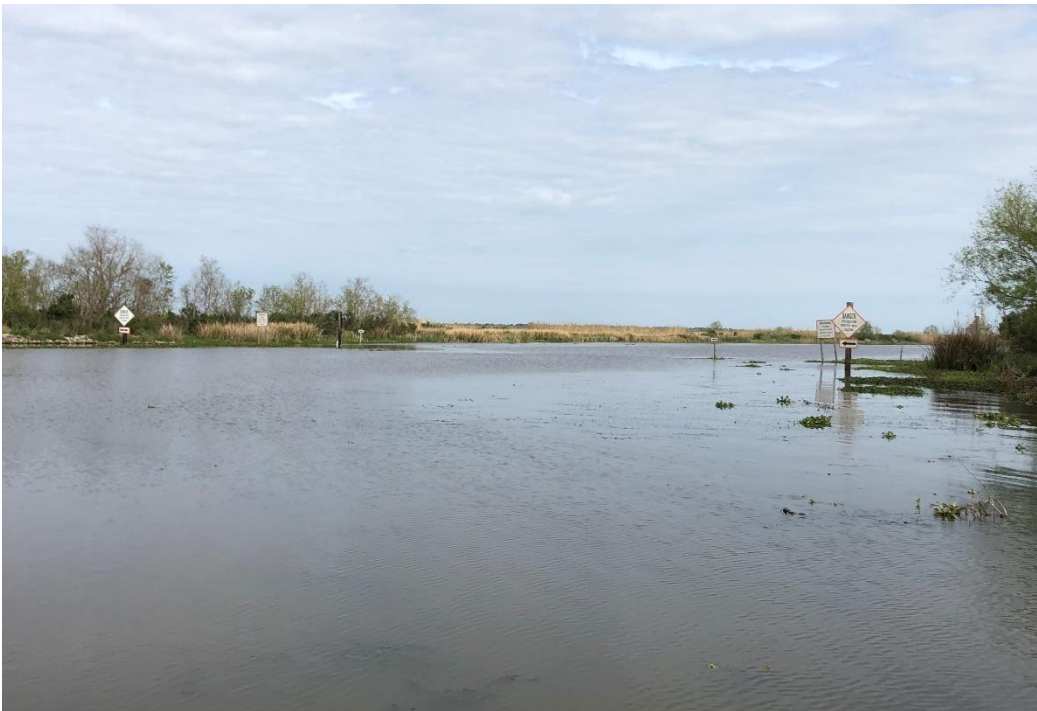
**Photo #4 – Structure #19**

The weir has experienced some settlement, but is performing as designed. Signs and timber supports were generally in good condition. No maintenance will be required at this time. (Photo #4)

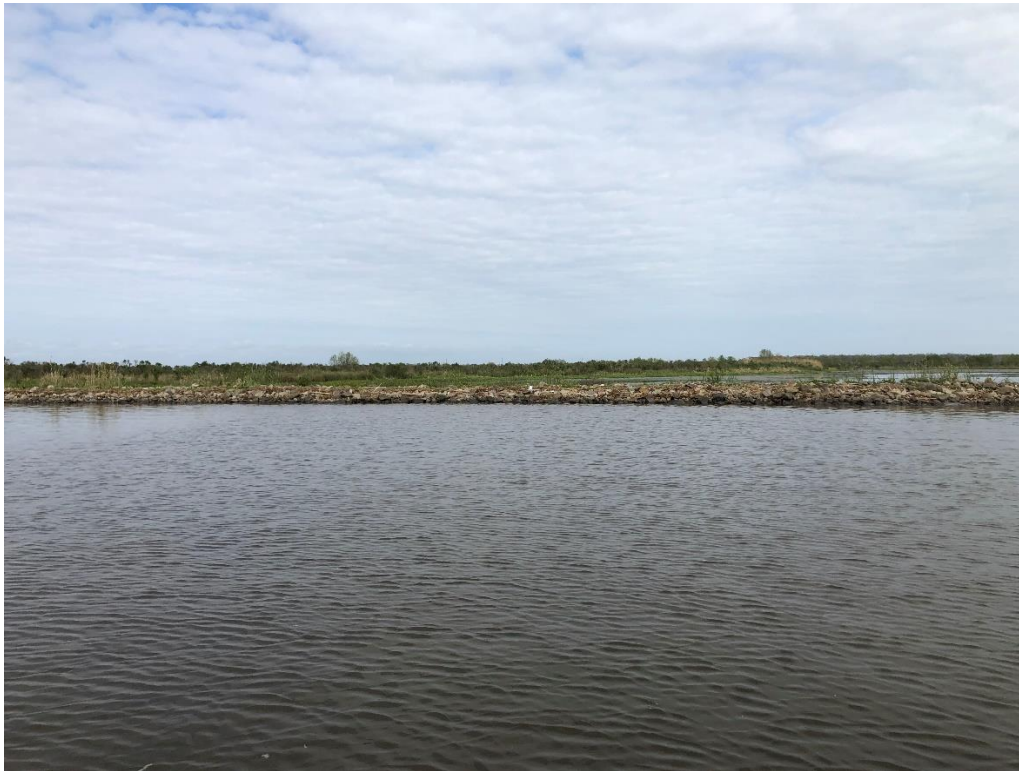
**Photo #5 – Bayou Perot Shoreline Protection (CU3)**

No significant changes were noted since the last inspection. The rock shoreline protection appeared to be in good condition, with minor settlement in some areas. The areas of lower elevation requires continued observation on future inspections, but no maintenance needs were identified at this time. (Photo #5)

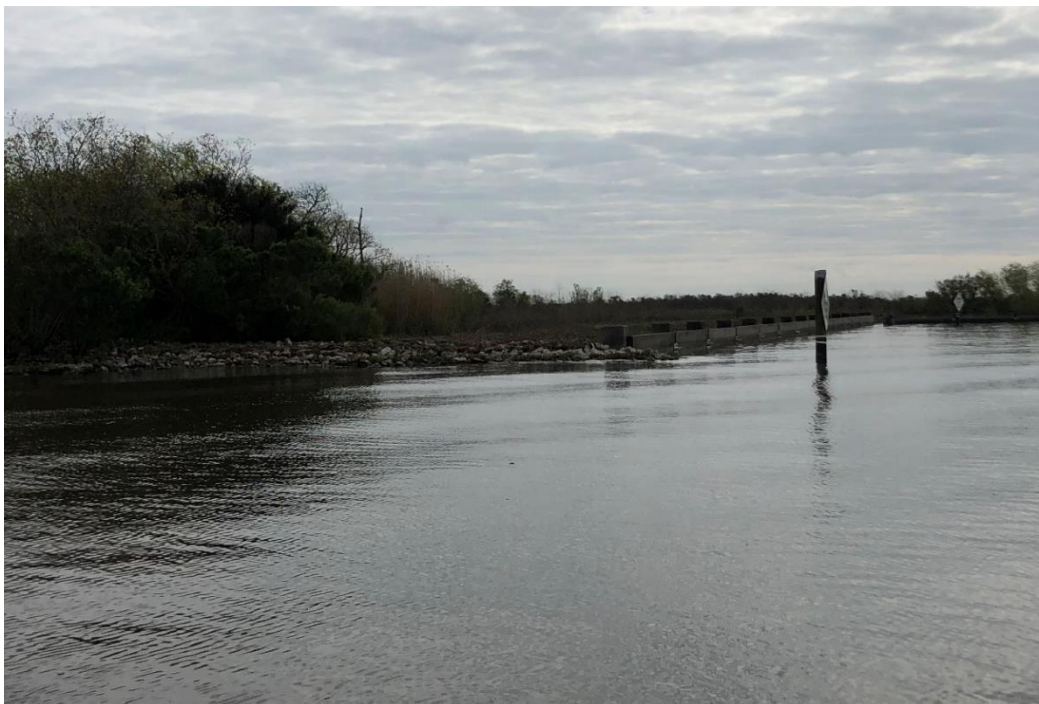
**Photo #6 – Panel Wall Shoreline Protection (CU4)**

No defects in the concrete panel wall sections were noted; the structure appeared to be in good condition. Minor damage/vandalism to some warning signs are noted, as in previous inspections, and one sign was missing, but all other signs and timber supports are in place and performing as designed. No immediate maintenance needs were identified at this construction unit. (Photo #6)

All project features were serving their intended purpose. Continued monitoring of signs along the concrete panel wall for any additional vandalism or missing signs is needed. Continue to inspect and assess project conditions annually.
