## **2022 Operations, Maintenance, and Monitoring Report**

### **Bayou Dupont Marsh and Ridge Creation (BA-0048)**

State Project Number BA-0048  
Priority Project List 17

December 2022

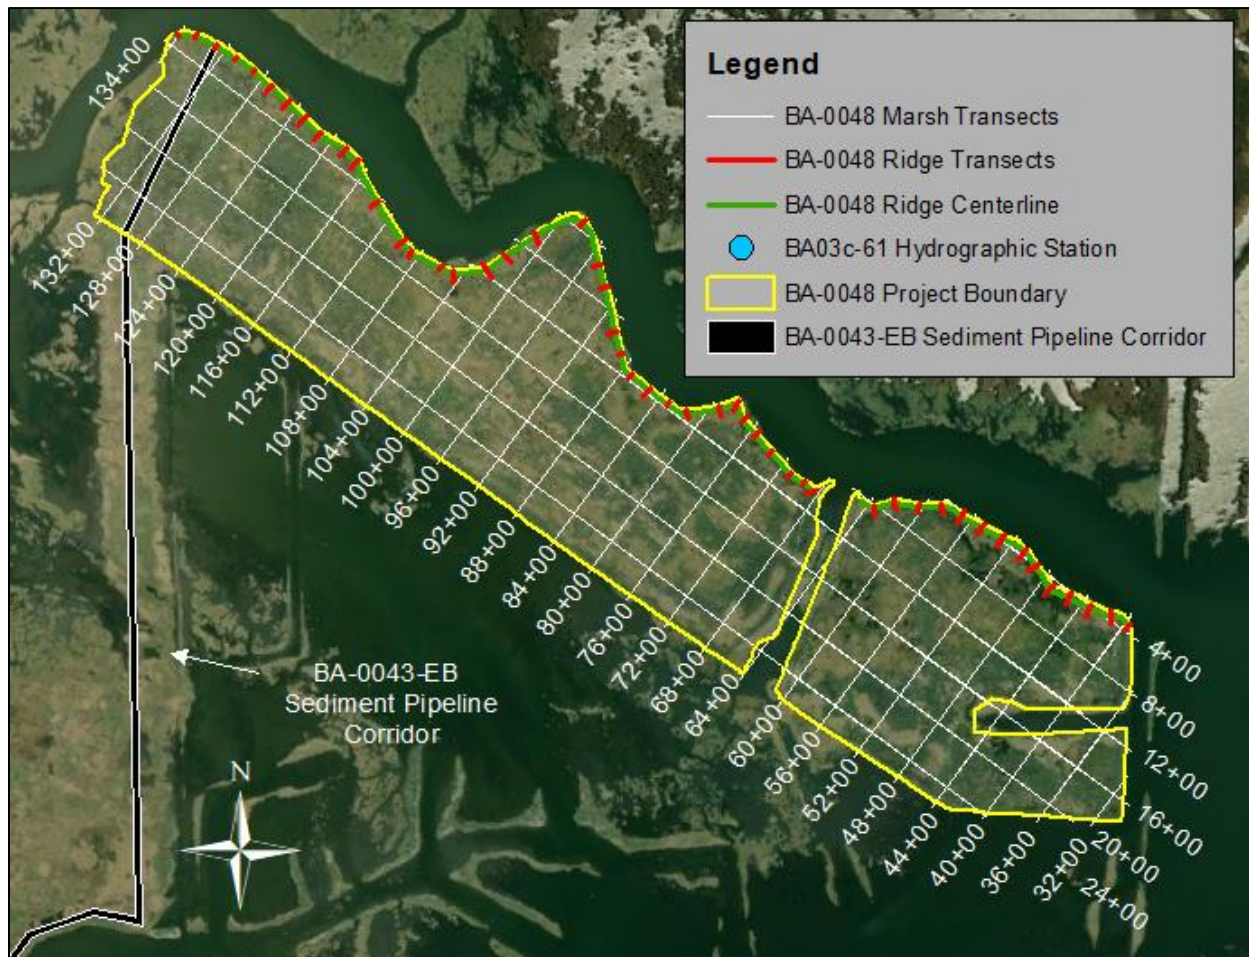
**Figure 2.** BA-0048 marsh and ridge established elevation survey transects.

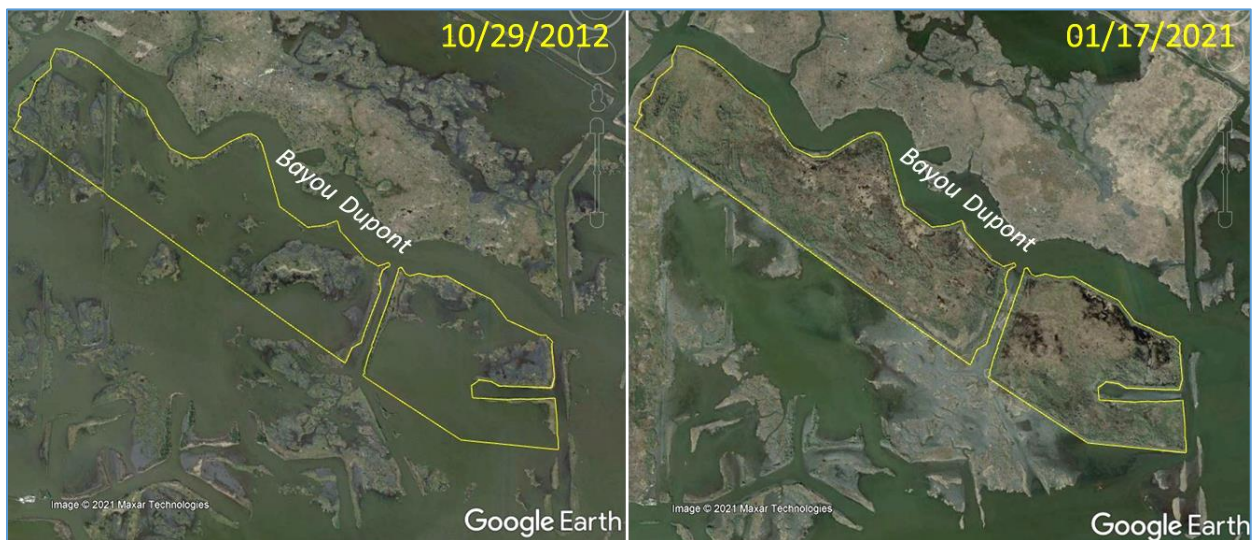
**Figure 4.** GoogleEarth imagery of the BA-0048 project area in 2012 (before construction) and in 2021 (after construction).

As of 2009, the western ridge of Bayou Dupont within the BA-0048 project boundary had largely eroded, with only two acres of land remaining in the 24-acre assessed ridge footprint. Likewise, the marsh within the project boundary had eroded significantly, with a reduction to 94 acres of land within the assessed 285-acre footprint (NMFS 2010). GoogleEarth satellite imagery from October 2012 shows the vast extent of open water that existed within the project footprint prior to project construction (Figure 4). Subsequent GoogleEarth imagery from January 2021, over five years after construction was completed, shows those acres of previously open water largely replaced by vegetated land.

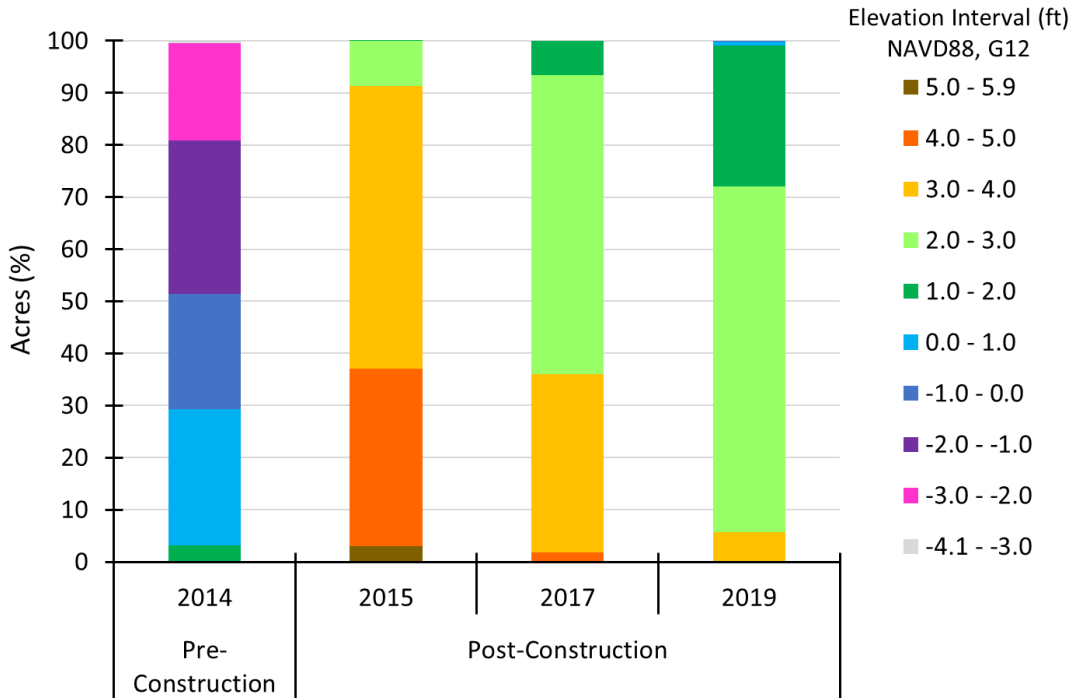
**Figure 18.** Percent of ridge acres within each one-foot elevation interval in the BA-0048 project area for the pre- and post-construction surveys.

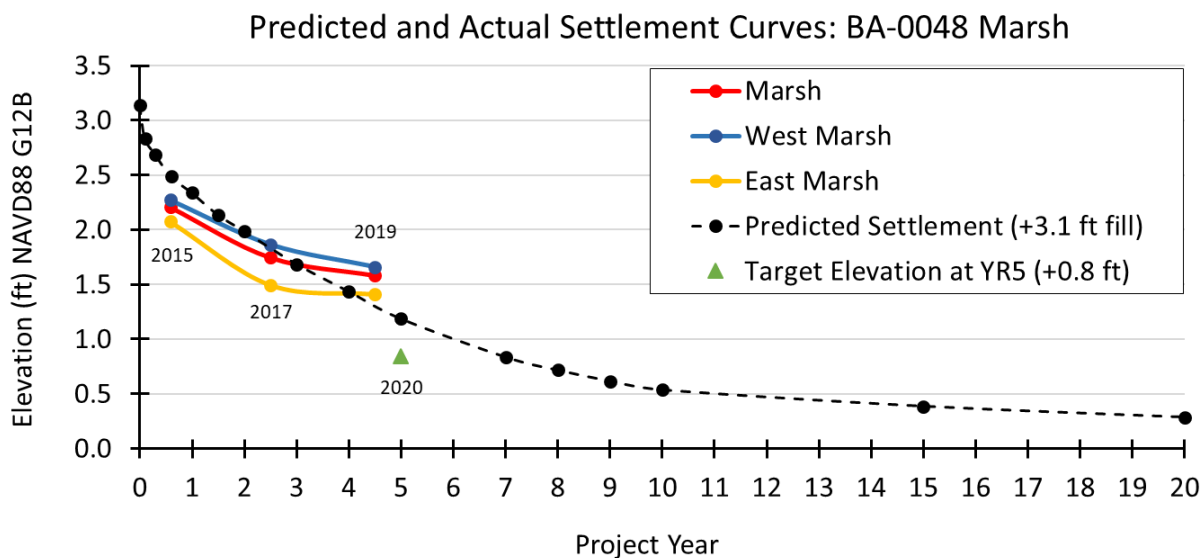
**Figure 19.** Predicted and actual marsh settlement for BA-0048. The target marsh elevation at year five is included for reference.

The marsh was expected to settle into the intertidal zone by approximately year five (2020), with a target elevation of +0.8 ft NAVD88 (Coco 2010), but based on the 2019 elevation survey, the mean marsh elevation was likely > 0.5 ft higher at that time (Figure 19). When plotted with the daily mean water elevation from station BA03c-61 (see Figure 2 for location), the 2019 mean marsh elevation is at the higher range of the hydrograph, while the target elevation is near the middle (Figure 20). However, habitat analysis of BA-0048 aerial imagery (Figure 6) indicates that 80% of the project area was already classified as emergent marsh habitat by 2016. Therefore, despite the higher-than-expected marsh elevation in 2019, the marsh creation platform had already vegetated with primarily marsh habitat only 1.5 years after construction completion. However, the occurrence of woody vegetation species increased between the 2016 and 2019 vegetation surveys, as is discussed in detail in the Vegetation section (p. 29).

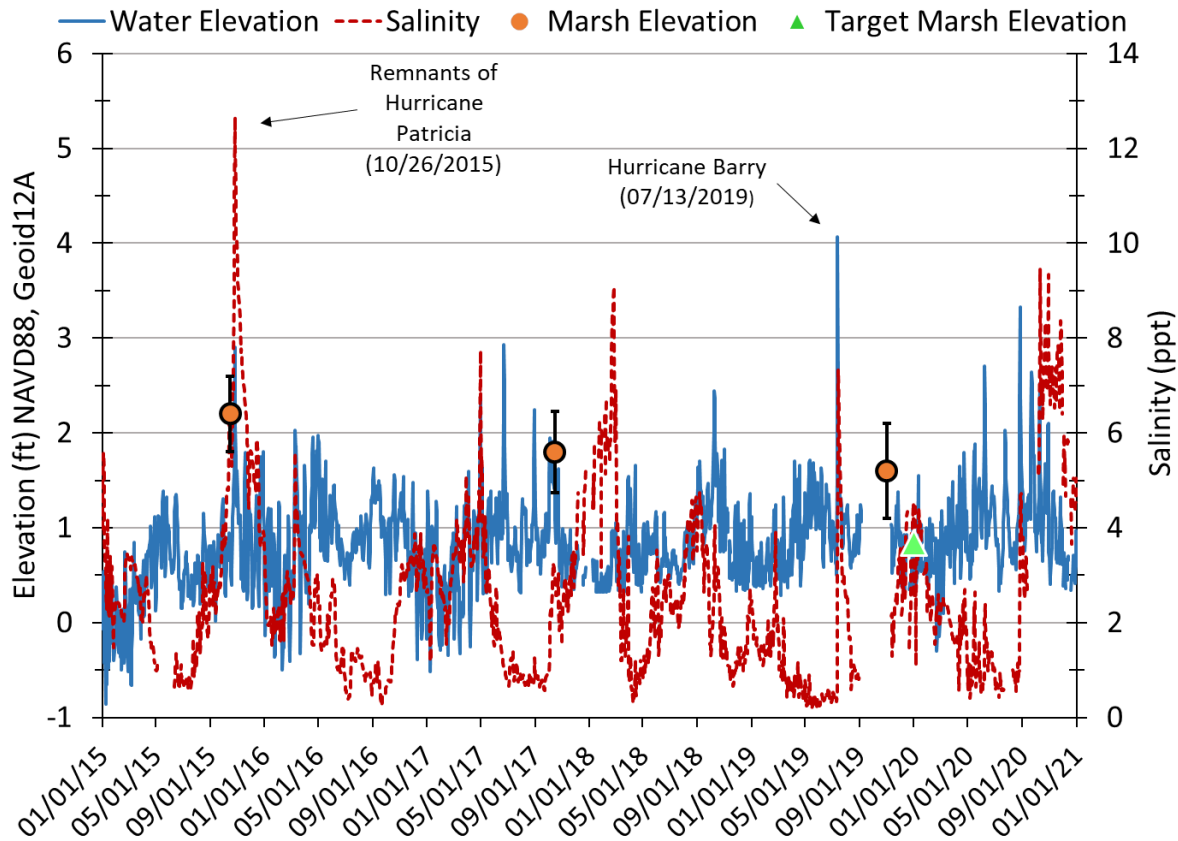
**Figure 20.** Mean daily water elevation and salinity at hydrographic station BA03c-61, with the mean marsh elevation ( $\pm$  SD) for each survey, and the target marsh elevation at year five.

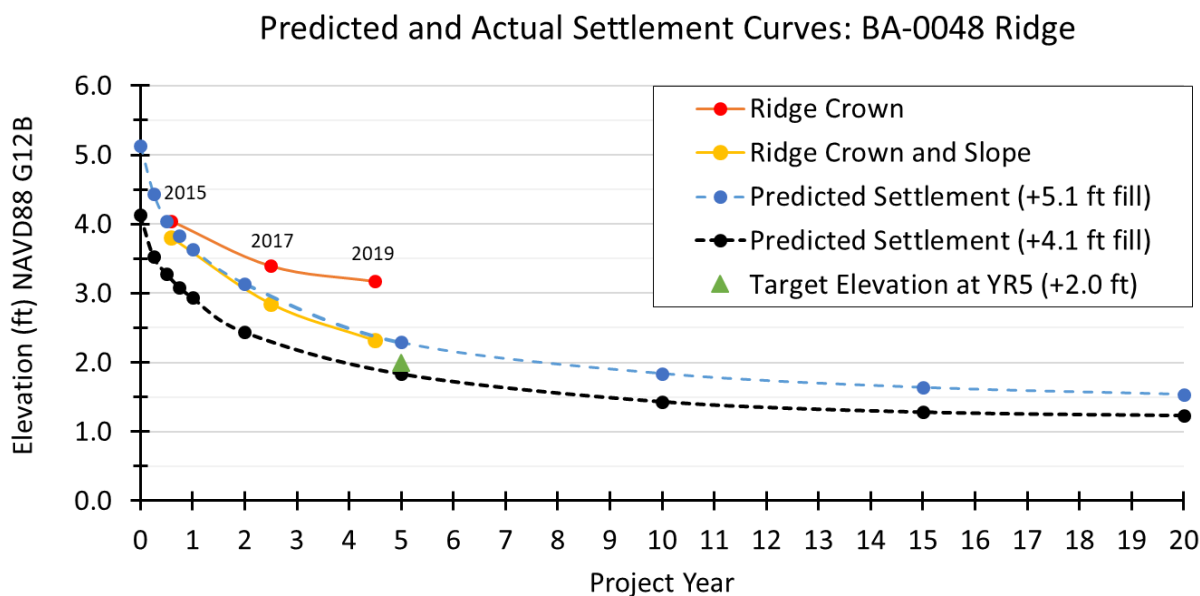
**Figure 21.** Predicted and actual settlement of the BA-0048 ridge.

For comparison, the mean ridge elevation that included the entire ridge feature (including the slope), was also plotted on the settlement curve (Figure 21). The mean survey elevations for the entire ridge feature follow the projected curve for a +5.1 ft fill elevation. This curve has a higher rate of settlement than the crown, which may be an indication of erosion along the ridge slopes.

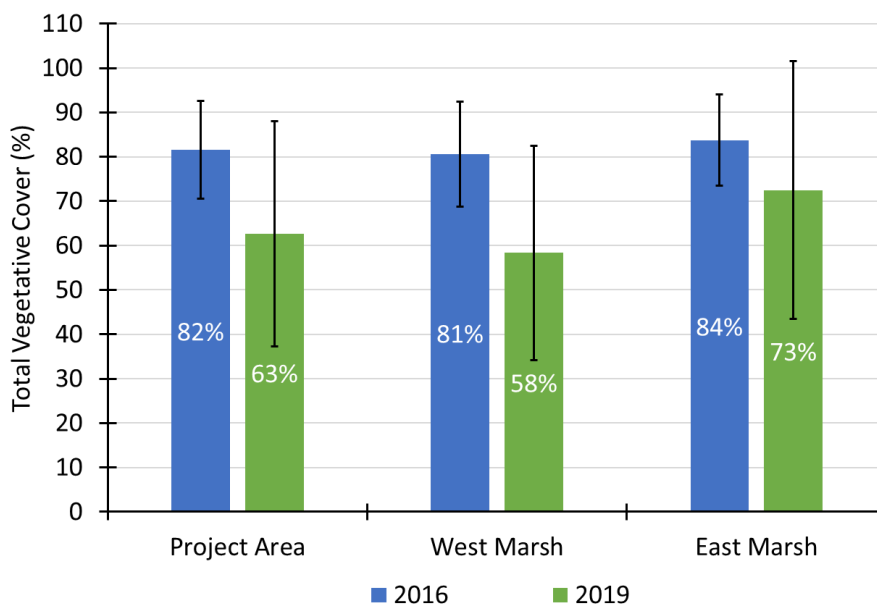
**Figure 22.** Comparison of total percent vegetative cover ( $\pm$  SD) in the BA-0048 marsh for the 2016 and 2019 vegetation surveys.

separate analysis of each marsh creation cell found this decline significant only in the western marsh ( $p = 0.0246$ ,  $F = 6.16$ ) (Figure 22). One explanation for the decrease in cover could be the timing of Hurricane Barry, a Category 1 storm that made landfall on July 13, 2019, in Vermilion Parish, LA, just west of Vermilion Bay. The vegetation survey was conducted less than two months after the hurricane, which caused a spike in water level and salinity in the project area (Figure 21). While hurricane-related stressors could have resulted in a reduction of live vegetative cover for the 2019 survey, especially herbaceous cover, the early successional vegetative community was also undergoing a change in species composition and structure (layer) that may have contributed to the overall decline. These changes will be discussed in the following sections on Layer Percent Cover and Species Cover and Distribution.

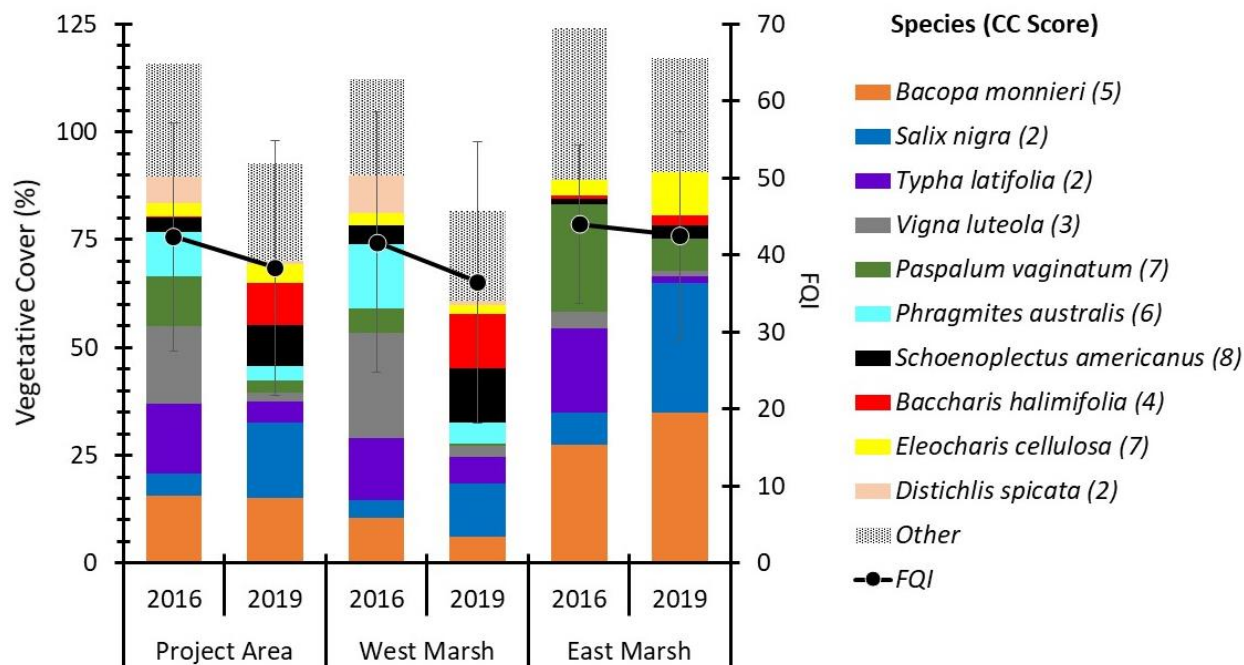
**Figure 23.** Mean species percent covers and mean FQI score ( $\pm$  SD) by year and area for the BA-0048 marsh. The graph shows the sum of the mean covers for each species. Due to the physical overlap of individual species at stations, this sum can be greater than 100%.

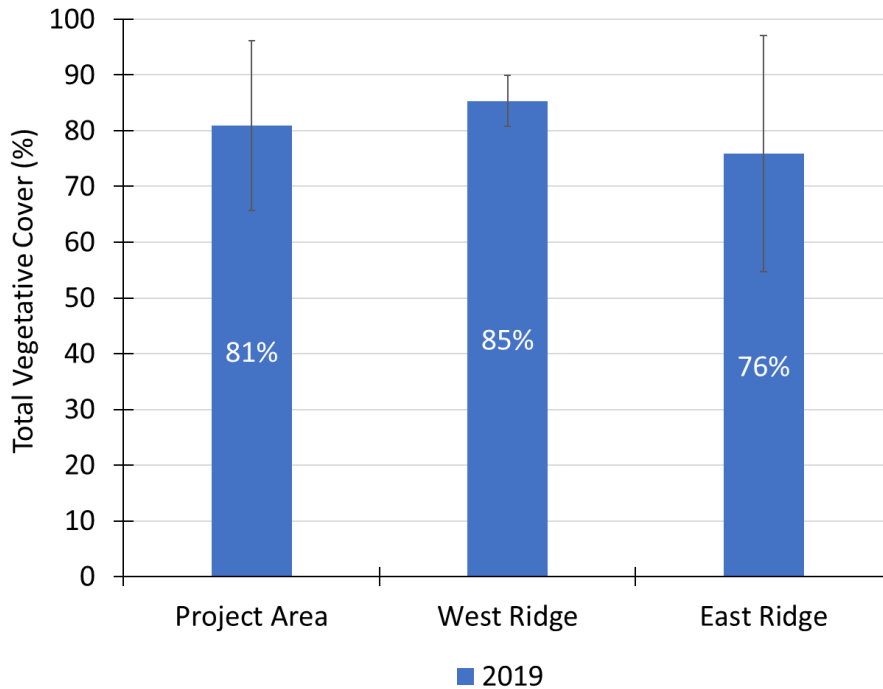
**Figure 24.** Total percent vegetative cover ( $\pm$  SD) on the BA-0048 ridge for the 2019 vegetation survey.

Total percent cover for the 2019 survey was high, at  $81 \pm 15\%$ , with no significant difference in cover between the western and eastern ridge (Figure 24). The variability in cover between stations on the eastern ridge was greater than on the western ridge due to the location of monitoring stations both in locations that quickly vegetated, and locations where natural establishment was slow to occur. Total percent cover was higher on the ridge than in the marsh (marsh:  $63 \pm 25\%$ ) for the 2019 survey.

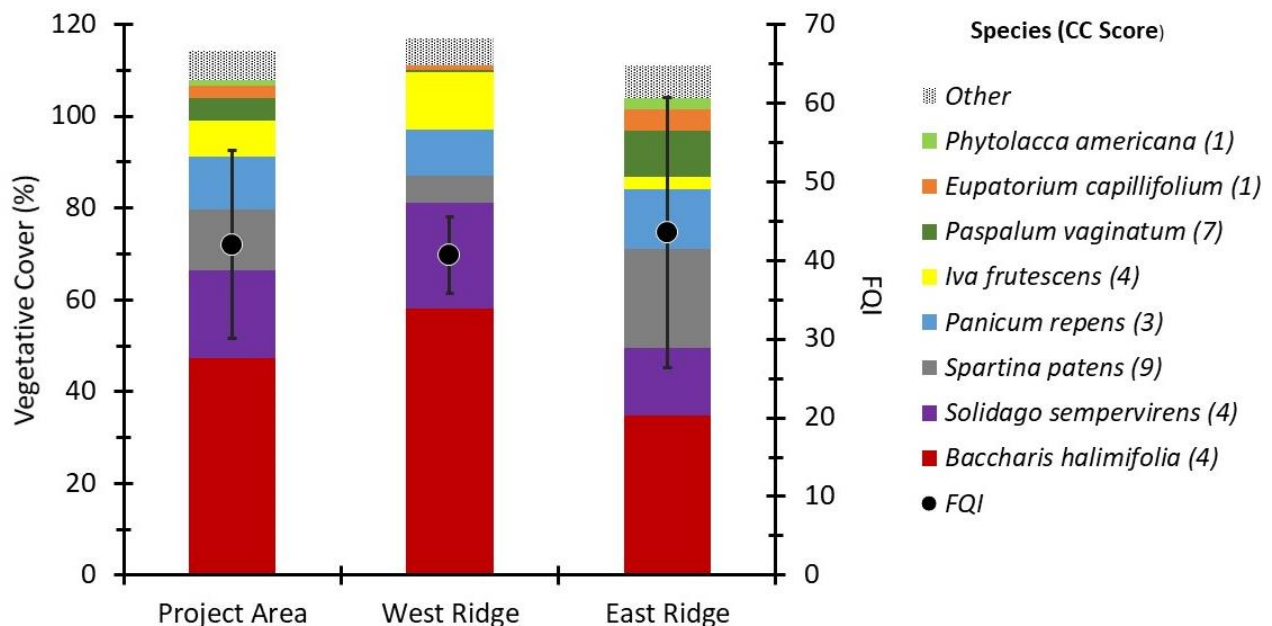
**Figure 25.** Mean species percent covers and mean FQI scores ( $\pm$  SD) by area for the 2019 BA-0048 ridge survey. The graph shows the sum of the mean covers for each species. Due to the physical overlap of individual species at stations, this sum can be greater than 100%.

The FQI value for the BA-0048 ridge for the 2019 vegetation survey was  $42 \pm 12\%$  and it was similar between the western and eastern ridges (Figure 25). The variability (standard deviation) was larger between stations on the eastern ridge due to greater differences in species composition and cover. It should be noted that the FQI is targeted for marsh habitat, and species with high CC scores are assigned those scores due to their significance of being species that represent stable marsh environments. For example, 100% cover of *S. patens* (C = 9) would be favorable in the marsh, but the prevalence of this species is not indicative of a thriving ridge environment. Therefore, the application of this index to the BA-0048 ridge is helpful in assessing the presence of native versus invasive species, but it is not entirely effective at gauging the quality of the ridge vegetative community. The forested floristic quality index (FFQI) uses tree basal area and CC score values of trees and may be useful for future ridge assessments (Wood et al. 2017).

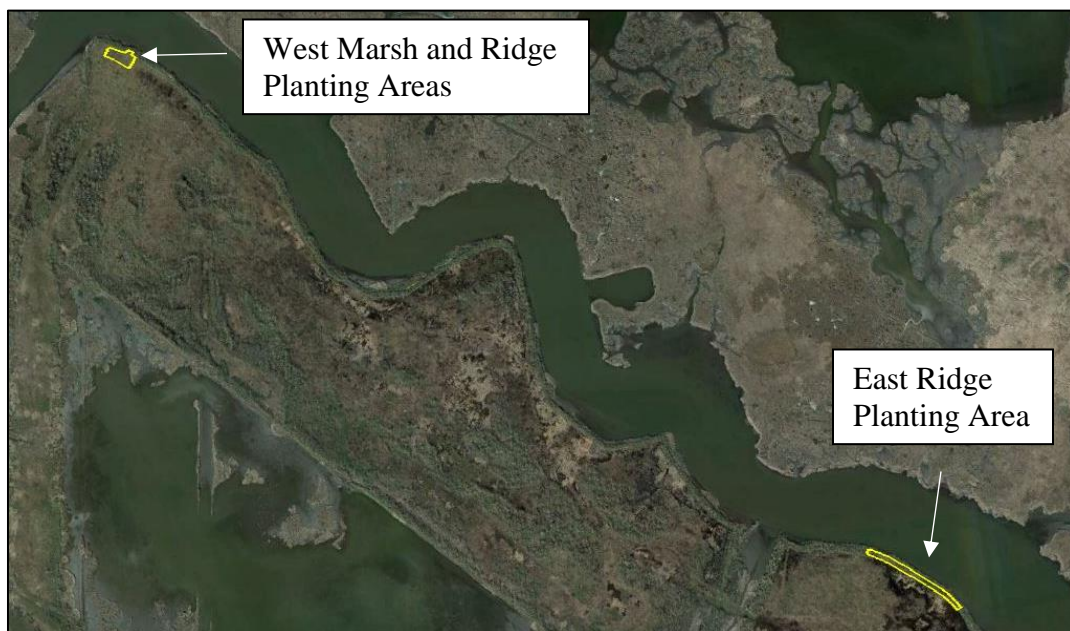
**Figure 26.** Location of the BA-0048 planting areas. Imagery from GoogleEarth, 01/17/2021.

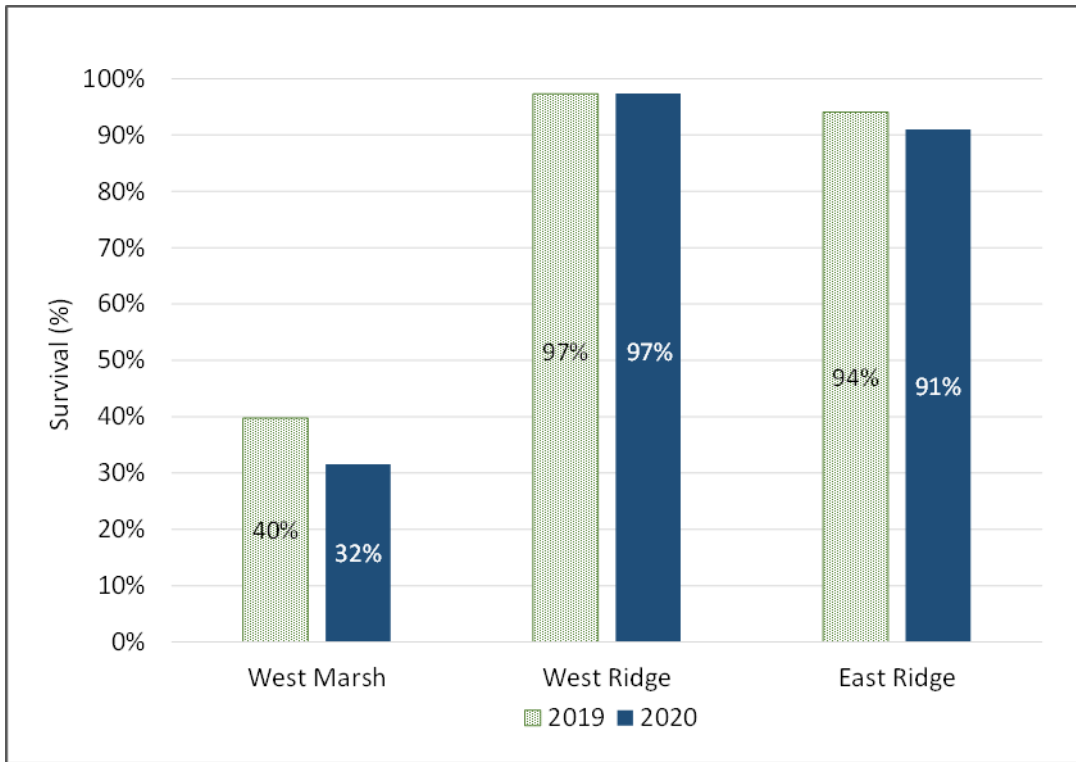
**Figure 27.** BA-0048 tree planting survival in the marsh and on the ridge.

Survivorship of the trees planted in the marsh was lower than on the ridge for the 2019 survey, with an overall survival of 40% and a species survival range from a high of 79% for *C. laevigata* to a low of 15% for *C. americana* (Figures 27, 28). Overall survivorship further declined between the 2019 and 2020 surveys, dropping to 32% in 2020. *Celtis laevigata* maintained the highest survival in the marsh at 60%, while *C. americana* had the lowest survival at 12%. Despite the relatively higher survival of *C. laevigata* in the marsh, 93% of the living trees were noted as stressed during the 2020 survey. This observation, coupled with the highest continuing mortality of any species between the 2019 and 2020 surveys in the marsh and on the ridge, may indicate that survivorship of this species for the 2022 survey will be low. In comparison, none of the 11 surviving *M. cerifera* were noted as stressed and this species experienced no additional mortality in the marsh between the 2019 and 2020 surveys, potentially indicating a greater chance of longer-term survivability.

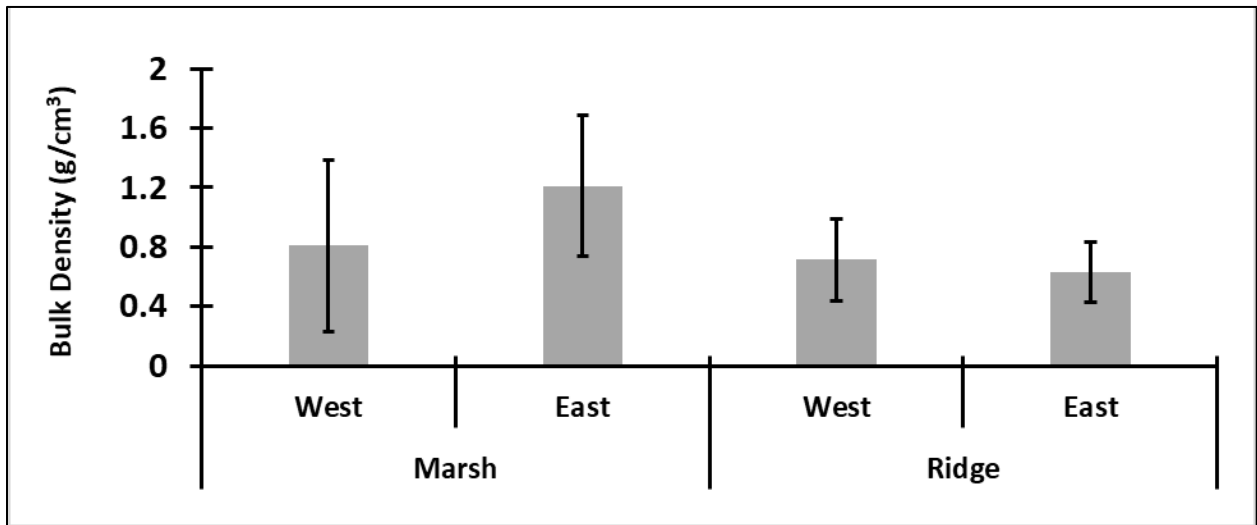
**Figure 29.** Mean bulk density ( $\pm$  SD) of the marsh and ridge soils for the western and eastern cells.

The BD of individual marsh sediment cores ranged from values common in a highly-organic marsh environment, including Louisiana marshes, to values indicative of highly mineral soils (Mitsch and Gosselink 2015, Wang et al. 2016). When analyzed by coring station, it is clear that the wide range in BD is due to non-uniform soils throughout the project area (Figure 30). Specifically, stations 8 and 9 in the western marsh have a low BD and are highly organic (BD: station 8 =  $0.49 \pm 0.36 \text{ g/cm}^3$ , station 9 =  $0.29 \pm 0.09 \text{ g/cm}^3$ ) and the remaining stations have high BD and are highly mineral (mean BD of remaining stations =  $1.28 \pm 0.42 \text{ g/cm}^3$ ). The difference in BD between soils is explained by the development of localized “mud waves” during construction. The two stations with organic soils are in an area where the underlying organic soils were displaced and brought to the surface in a “wave” during construction by the deposition of heavy river sediment. Because the cores sampled from stations 8 and 9 are from a different sediment source than the rest of the marsh cores (*in situ* organic sediment vs. riverine mineral sediment), sediment properties were different at these stations for all analyzed parameters.

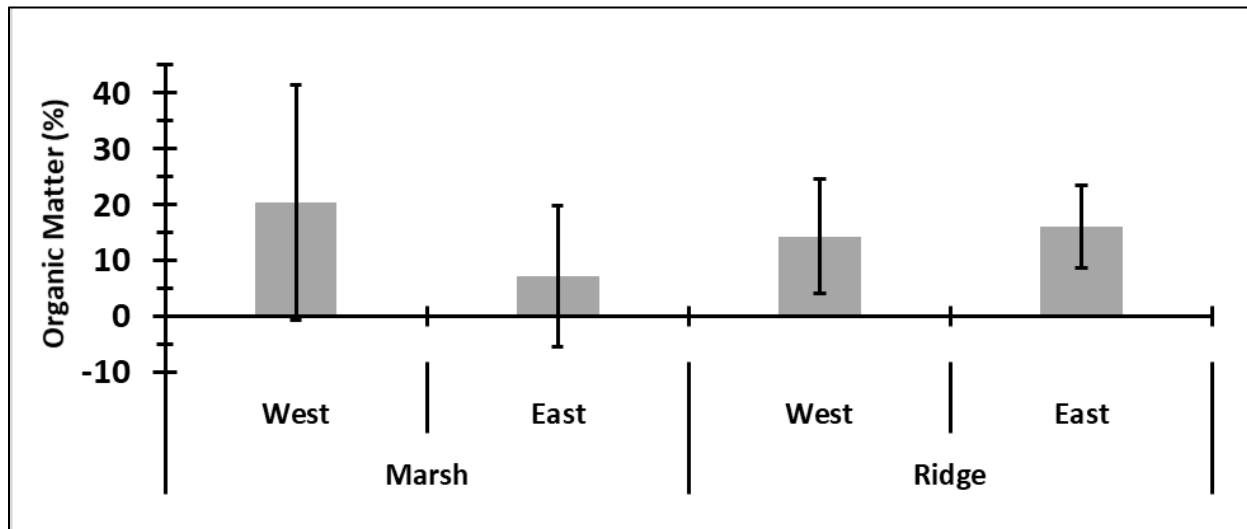
**Figure 31.** Mean percent organic matter ( $\pm$  SD) of the marsh and ridge soils for the western and eastern fill cells.

The mean percent OM of the ridge soils was similar between the western and eastern cells; however, there were significant differences over years ( $p = 0.0186$ ,  $F = 4.12$ ). The mean OM of the ridge increased from  $15.9 \pm 9.5\%$  in 2016 to  $17.9 \pm 10.6\%$  in 2017, and then decreased to  $12.4 \pm 7.7\%$  in 2019. There are multiple possible explanations for the variance in OM between years, with differences in sampling location and the depth of the *in situ* surface sediment being two of the more likely causes. The continuing expansion of the scrub-shrub habitat on the ridge indicates that the organic content has been sufficient to support woody vegetation.

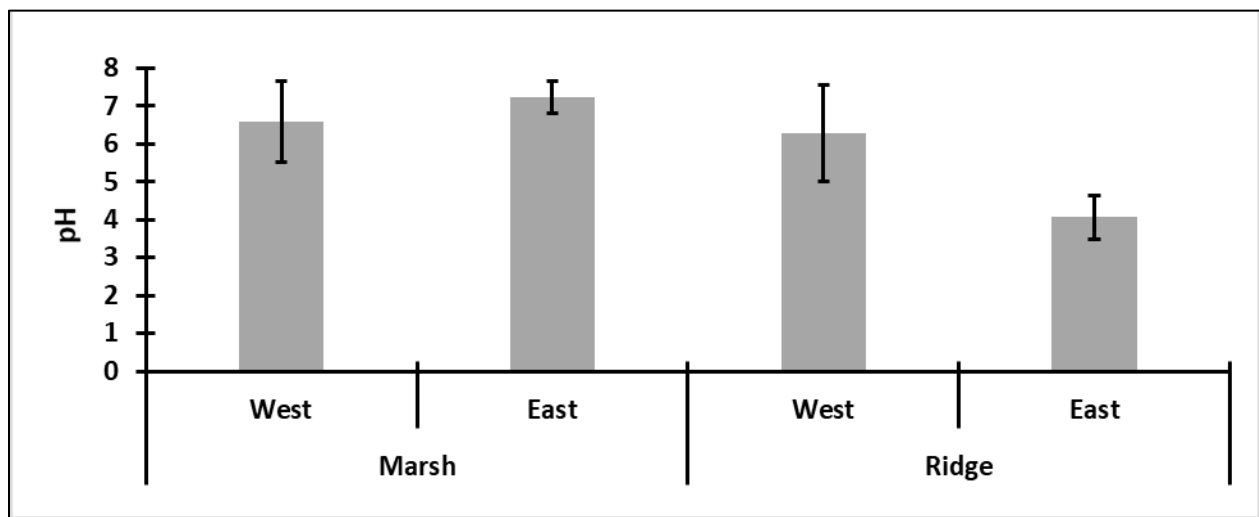
**Figure 32.** Mean pH ( $\pm$  SD) of the marsh and ridge soils for the western and eastern cells.

The pH of the marsh soils was significantly different only by cell ( $p = 0.0103$ ,  $F = 7.01$ ) with a mean pH of  $6.6 \pm 1.1$  in the western marsh and  $7.2 \pm 0.1$  in the eastern marsh. The pH of the western marsh was lower than the eastern marsh due to the lower pH of the organic soils at stations 8 and 9 (Figure 30). However, mean pH in both cells was in the neutral range and did not appear to hinder the natural colonization of plants.

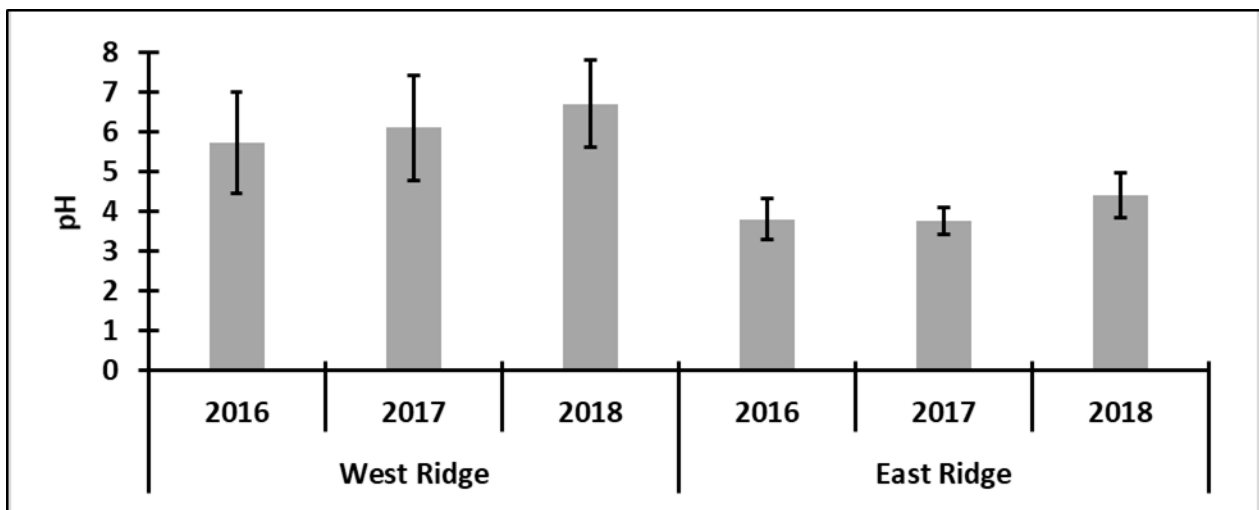
**Figure 33.** Mean soil pH ( $\pm$  SD) by year for the western and eastern ridge.

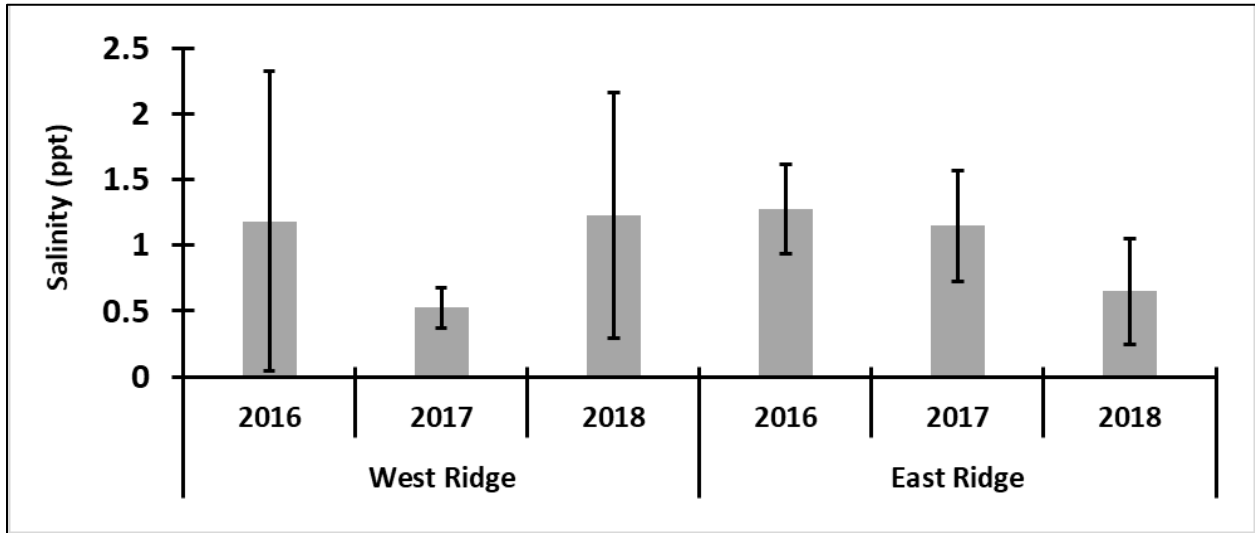
**Figure 35.** Mean soil salinity ( $\pm$  SD) over time for the western and eastern ridge.

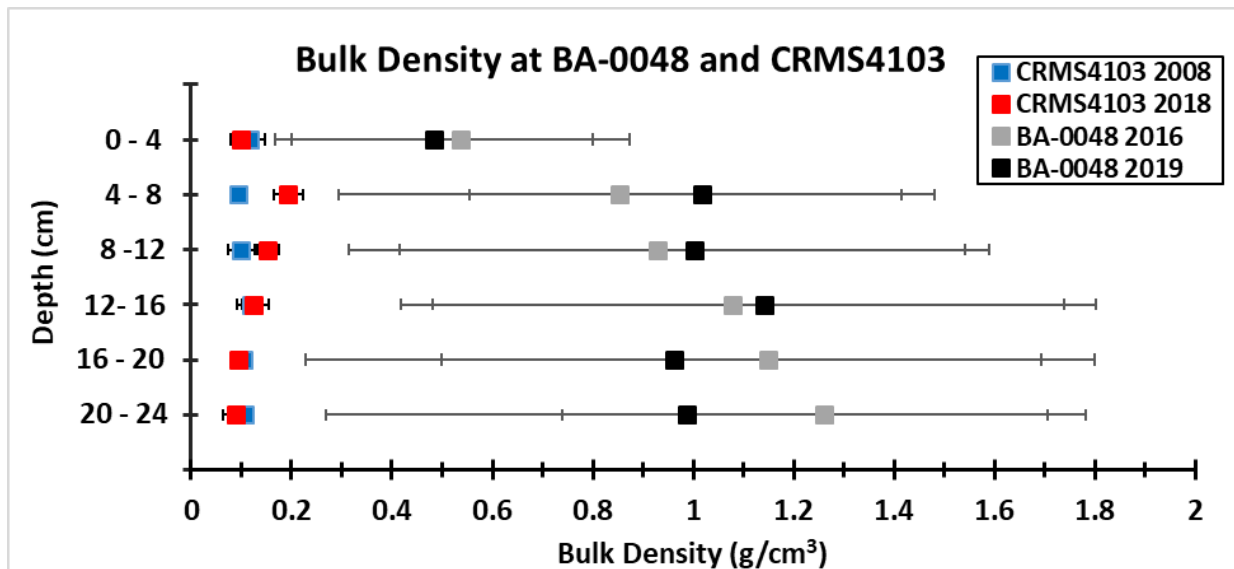
**Figure 37.** Mean soil bulk density ( $\pm$  SD) at BA-0048 (constructed marsh) and CRMS4103 (natural marsh) by depth.

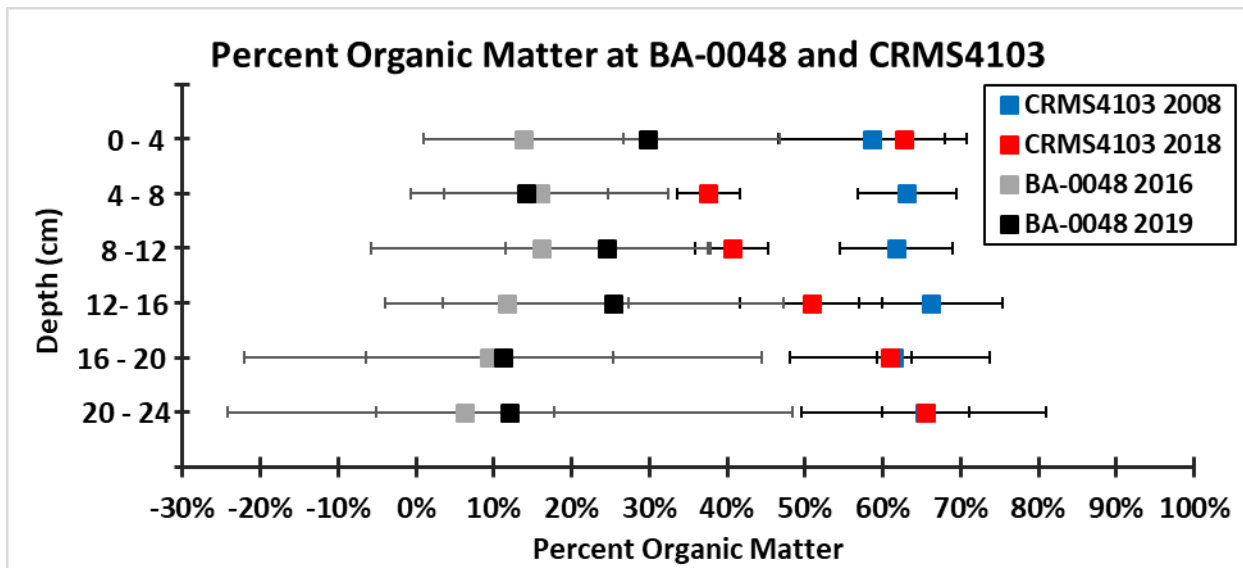
**Figure 38.** Mean soil organic matter content ( $\pm$  SD) at BA-0048 (constructed marsh) and CRMS4103 (natural marsh) by depth.

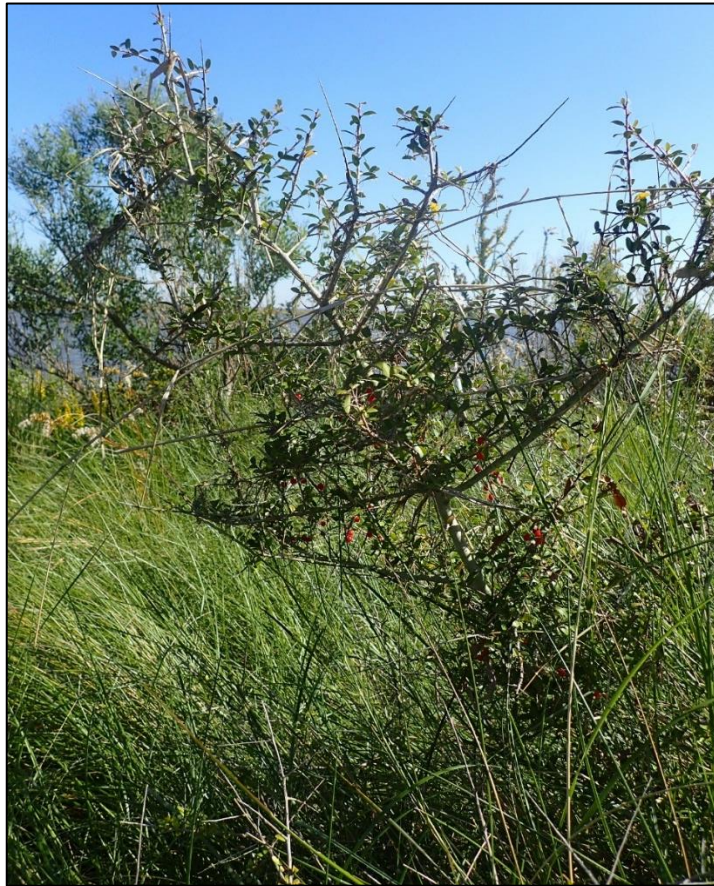
**Photo 1.** Planted *Ilex vomitoria* (yaupon) with berries on the eastern ridge.

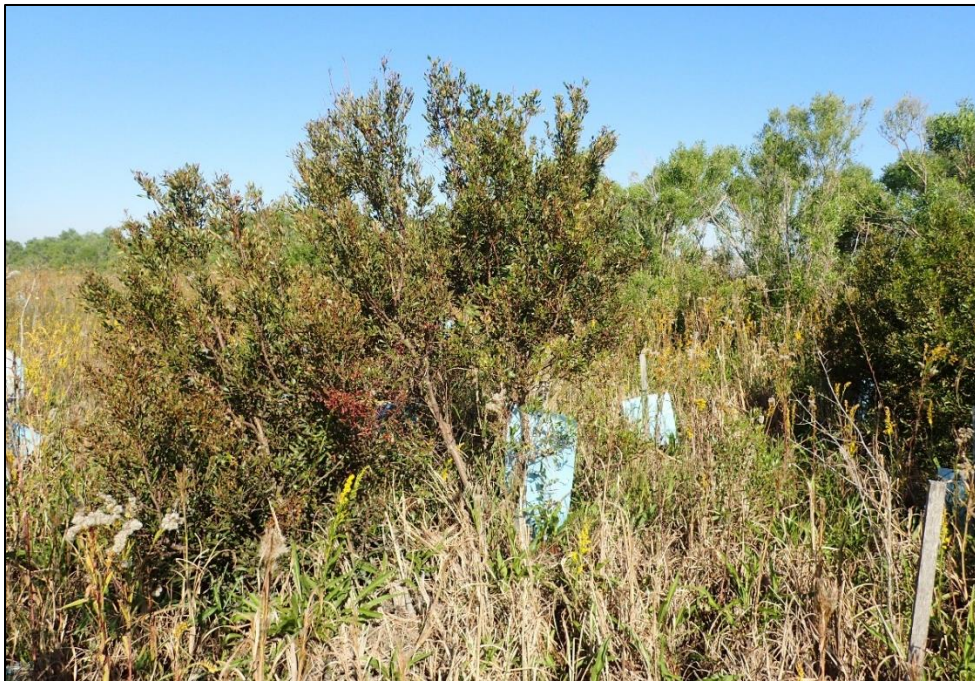
**Photo 2.** Trees and shrubs planted on the eastern ridge.

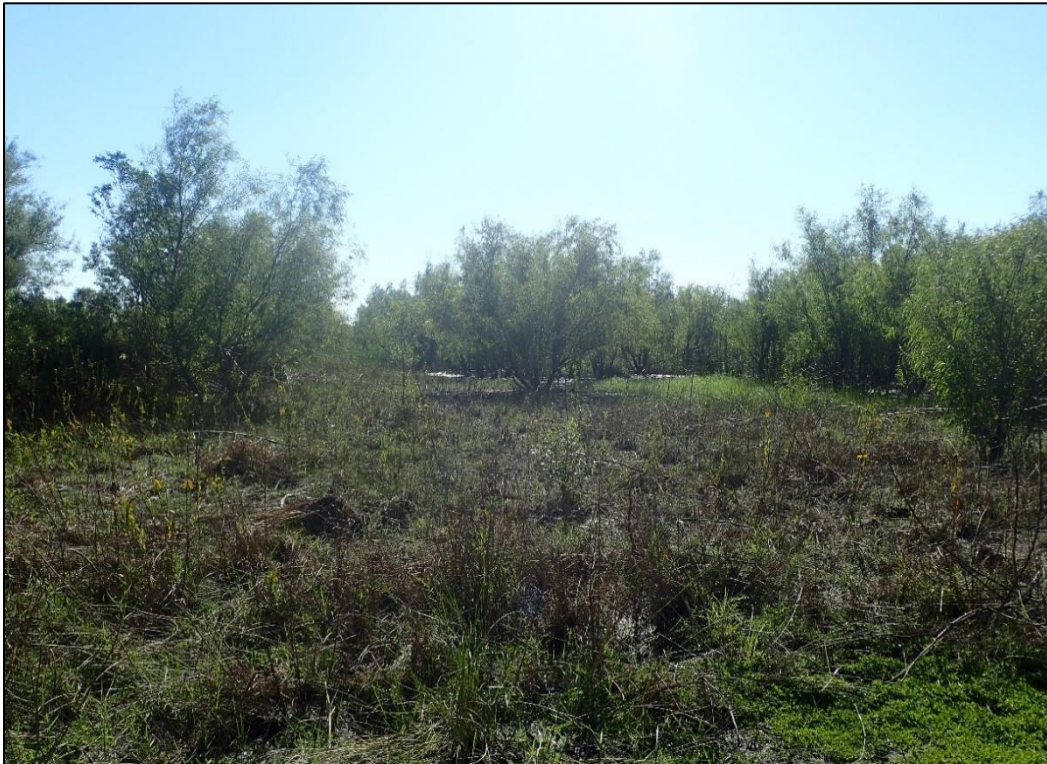
**Photo 3.** Western marsh creation area with *Salix nigra* (black willow) trees.

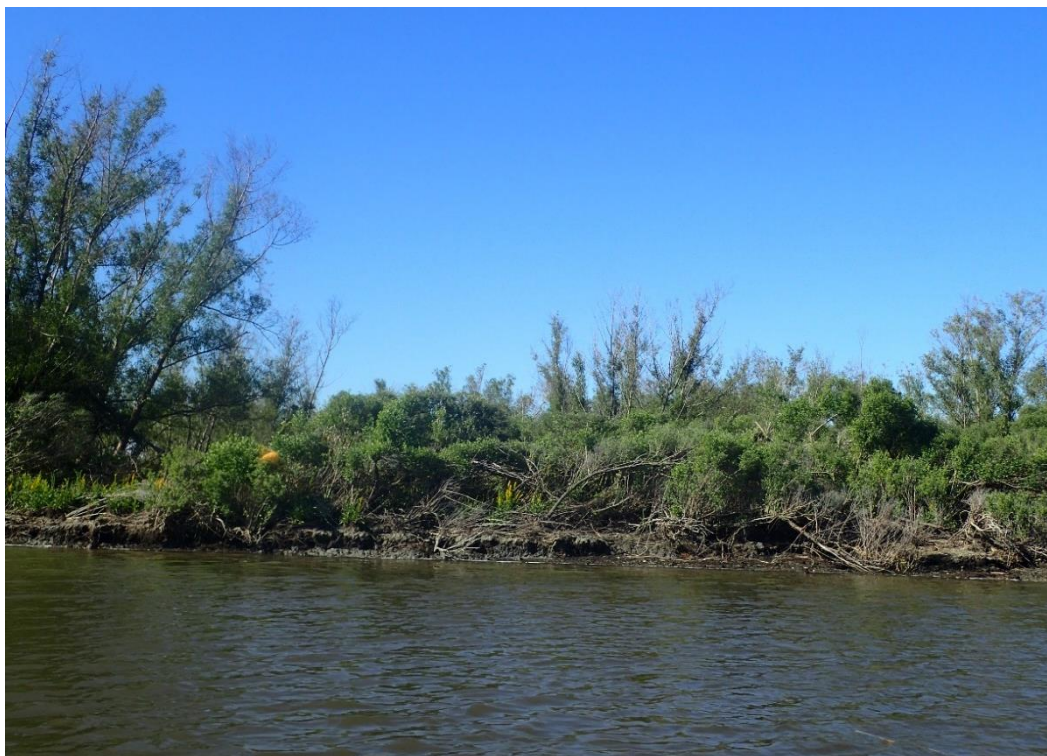
The ridge restoration area visually appears to be settling faster in some areas than others. Wind damage from Hurricane Ida was evident on the ridge, with some naturally-recruited and planted shrubs and trees leaning over. However, most of the observed planted trees were still alive, and many were still standing upright. Some erosion is occurring along the base of the ridge along Bayou Dupont.

**Photo 4.** Ridge habitat with noticeable erosion at the edge of Bayou Dupont.

2. The monitoring plan for BA-0048 is robust, but the addition of a ridge shoreline analysis for this project and all created ridges is recommended. More intensive surveying of the ridge could be added to the already scheduled elevation surveys to more precisely monitor edge erosion or accretion, and to identify the need for adaptive management.

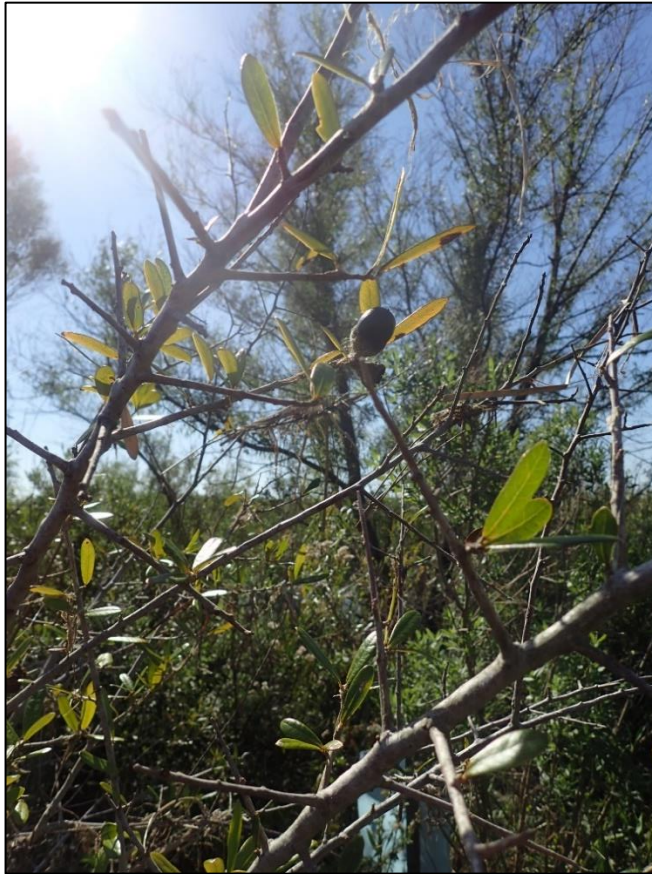
**Photo 5.** Planted *Quercus virginiana* (live oak) with acorn on the eastern ridge.

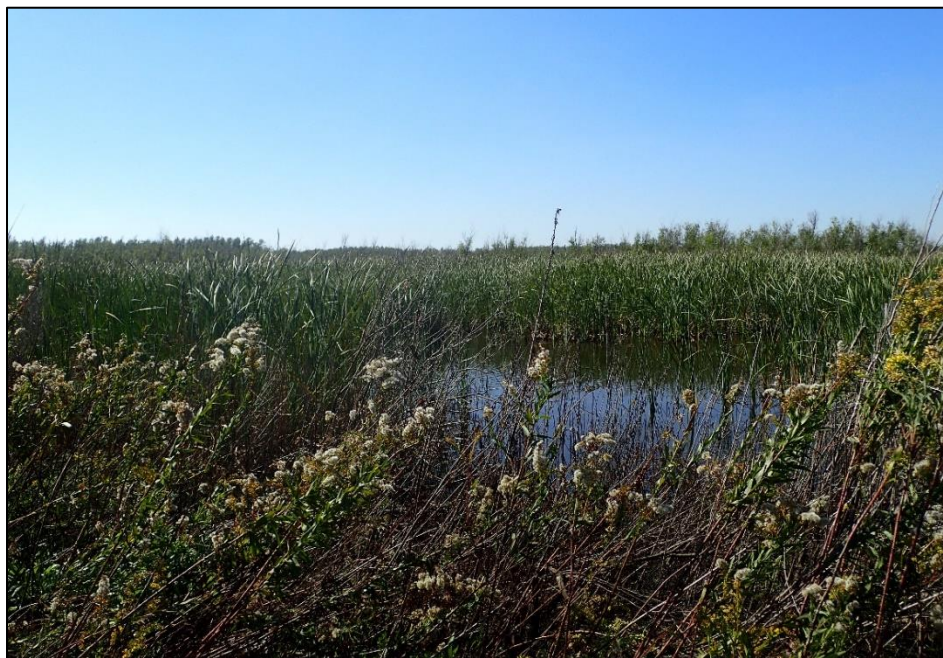
**Photo 6.** Ponding water in an area of lower elevation in the eastern marsh. Note the growth of flood-tolerant cattails along the far edge of the pond.

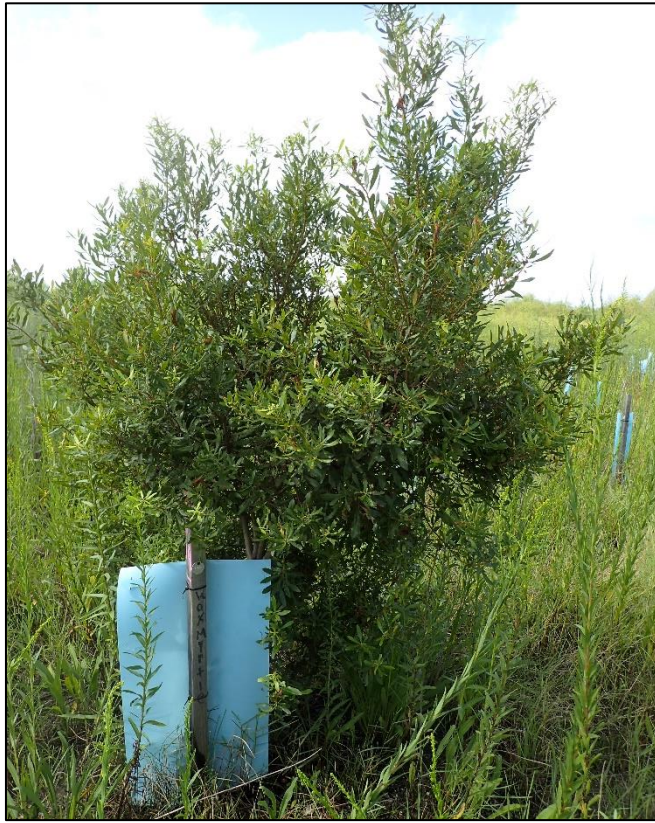
**Photo 1.** Thriving *Morella cerifera* (wax myrtle) in the marsh planting area (09/25/2020).

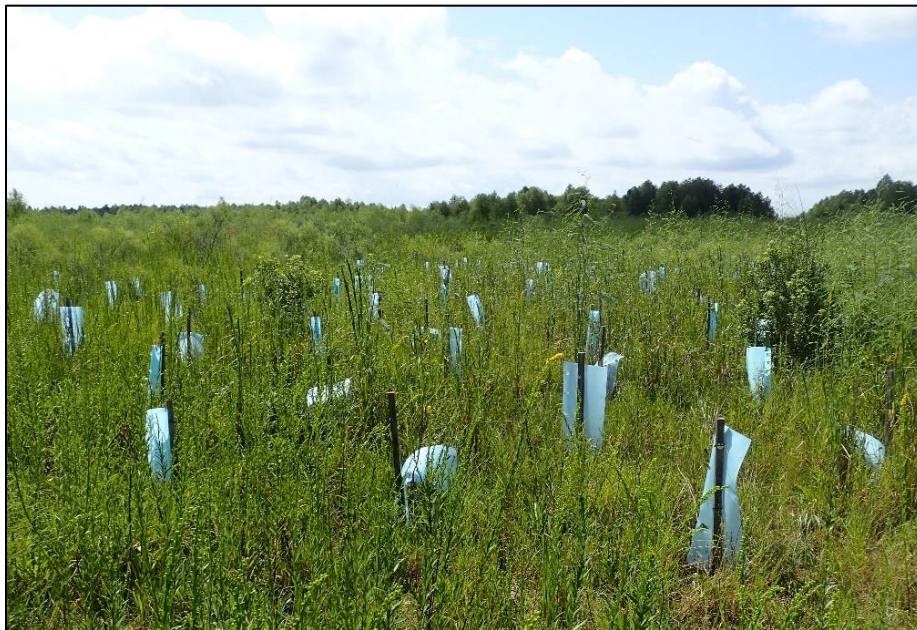
**Photo 2.** Marsh planting area (09/25/2020). The blue plastic sleeves are nutria exclusion devices (NEDs) meant to protect seedlings and saplings from predators.
