## **2022 Operations, Maintenance, and Monitoring Report**

### **Bayou Dupont Marsh and Ridge Creation (BA-0048)**

State Project Number BA-0048  
Priority Project List 17

December 2022

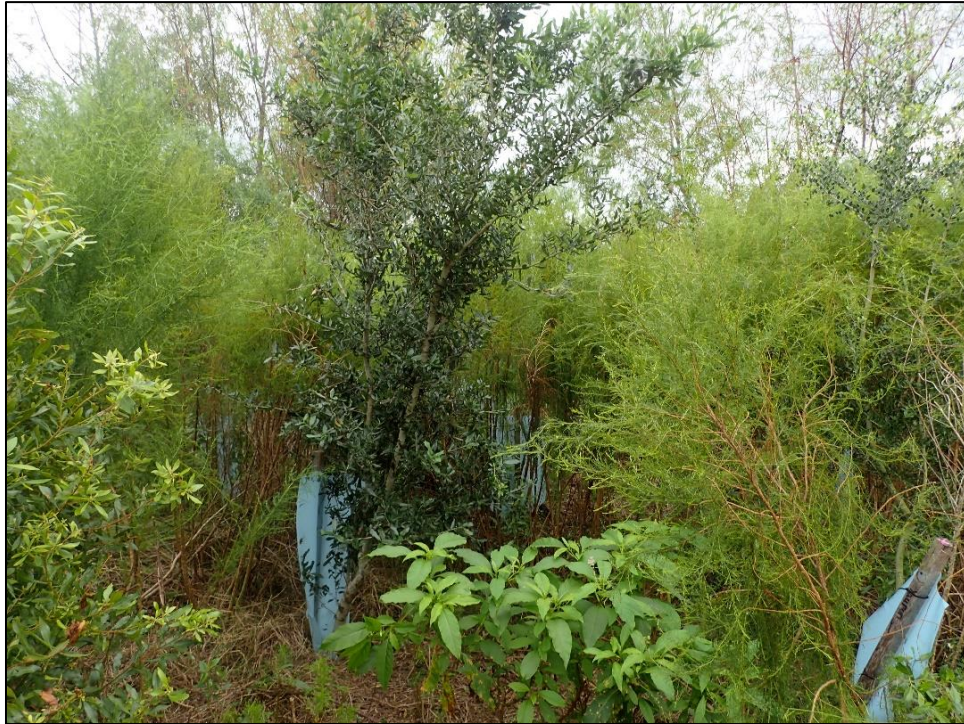
**Photo 3.** *Quercus virginiana* (live oak) planted along the eastern ridge (09/25/2020).

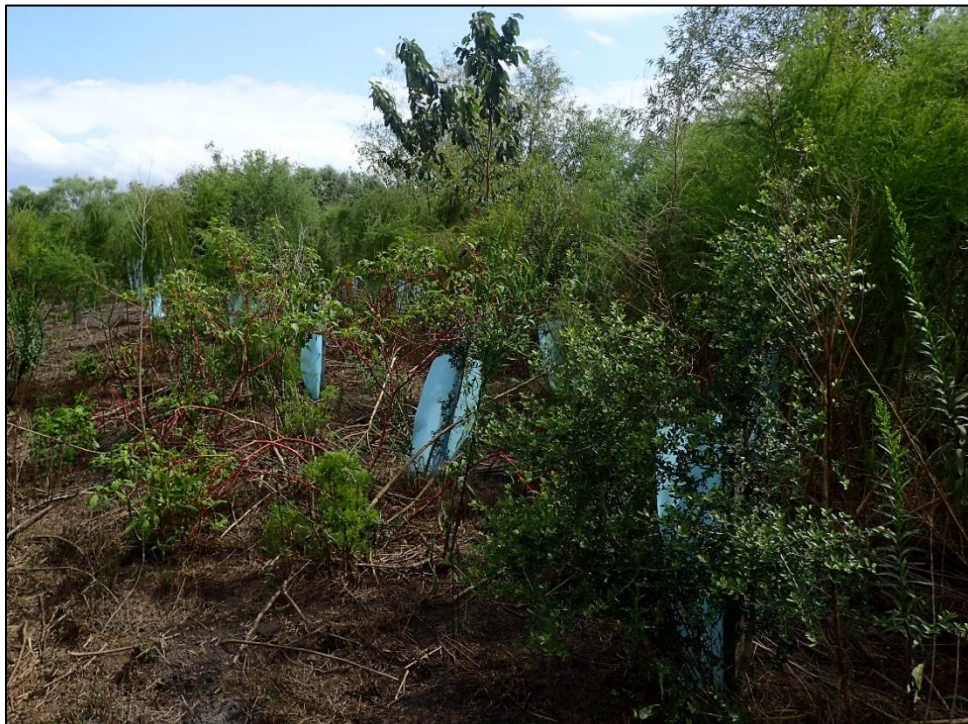
**Photo 4.** *Ilex vomitoria* (yaupon), right foreground, and *Diospyros virginiana* (persimmon), tall tree in center background, planted along the eastern ridge (09/25/2020).

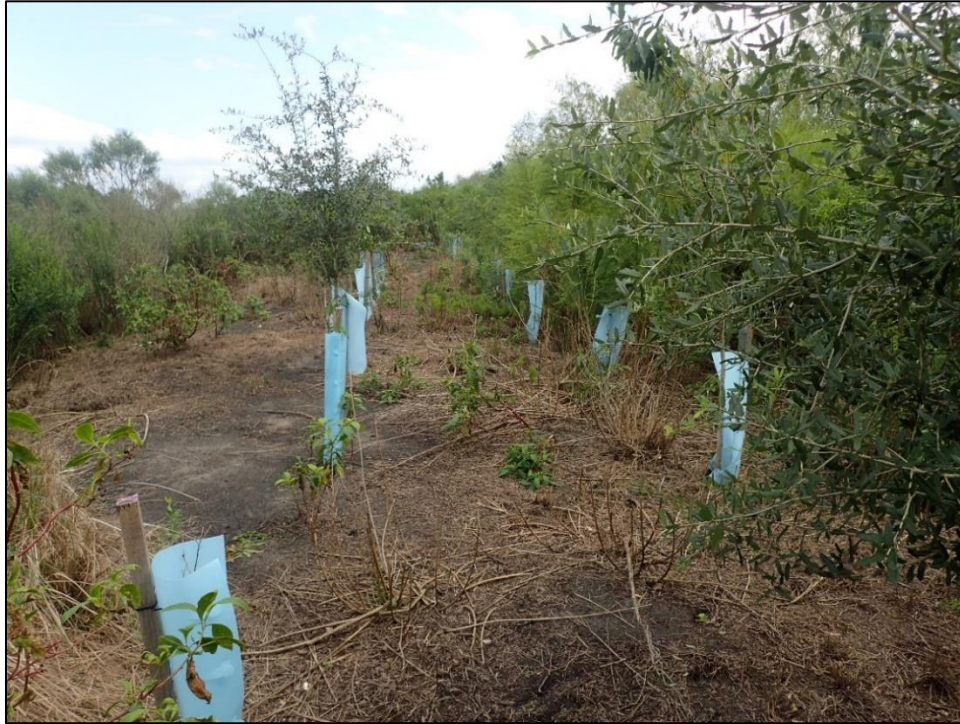
**Photo 5.** Eastern ridge planting along an expanse of the ridge crown where vegetation remains sparse, yet tree survival was still strong at the time of this survey (09/25/2020).

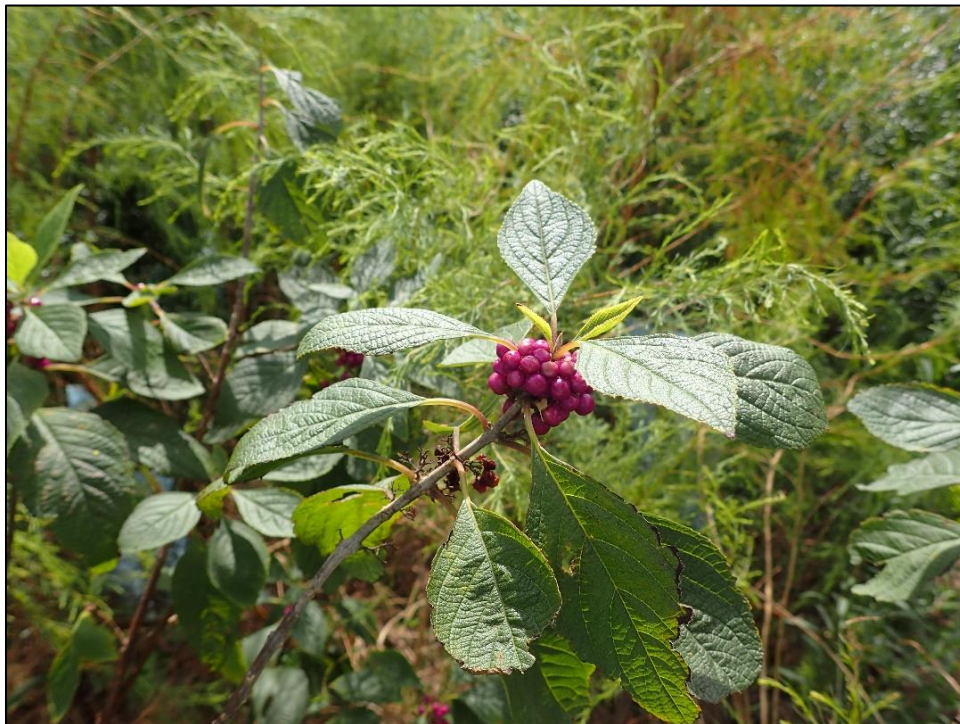
**Photo 6.** Fruiting planted *Callicarpa americana* (beautyberry) along the eastern ridge (09/25/2020).

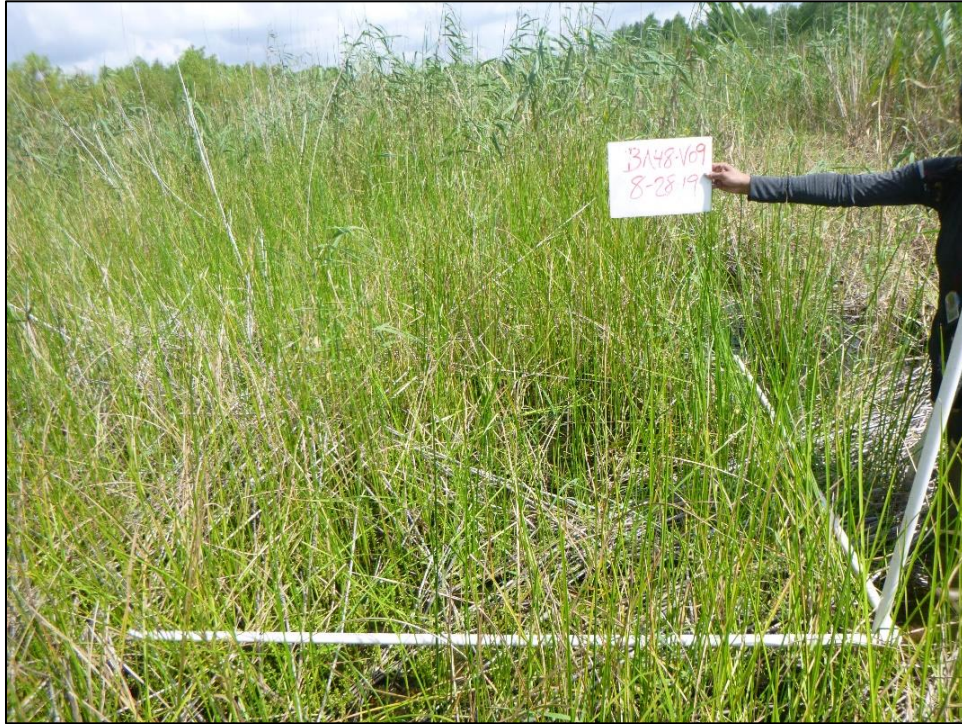
**Photo 7.** *Schoenoplectus americanus* (chairmaker's bulrush) at a marsh vegetation monitoring station (08/28/19).

As expected in newly-created marsh, the cover and distribution of vegetative species is still greatly in transition; however, the number of species has not changed significantly between years. In 2016 there were 30 species documented at stations, while in 2019 there were 27. The complete list of all species both years, along with their mean covers, distributions, and associated marsh habitats, is included in Appendix E. Photographs from the marsh vegetation monitoring stations are included in Appendix D (photos 7–9).

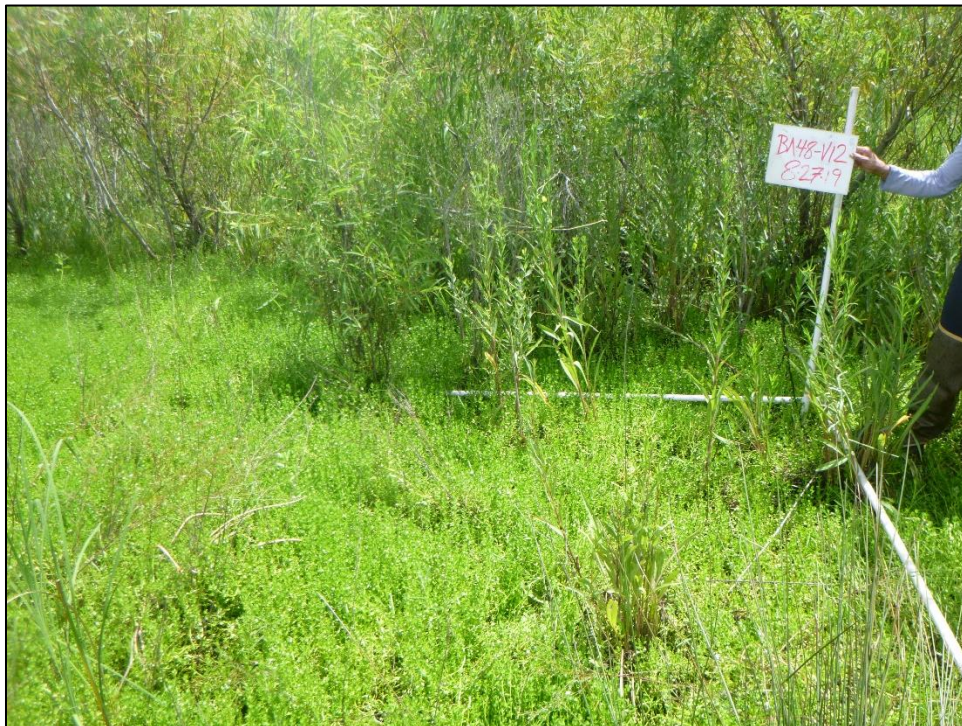
**Photo 8.** Marsh vegetation monitoring station with dense *Bacopa monnieri* (herb of grace) growing in the foreground and *Salix nigra* (black willow) in the background (08/28/19).

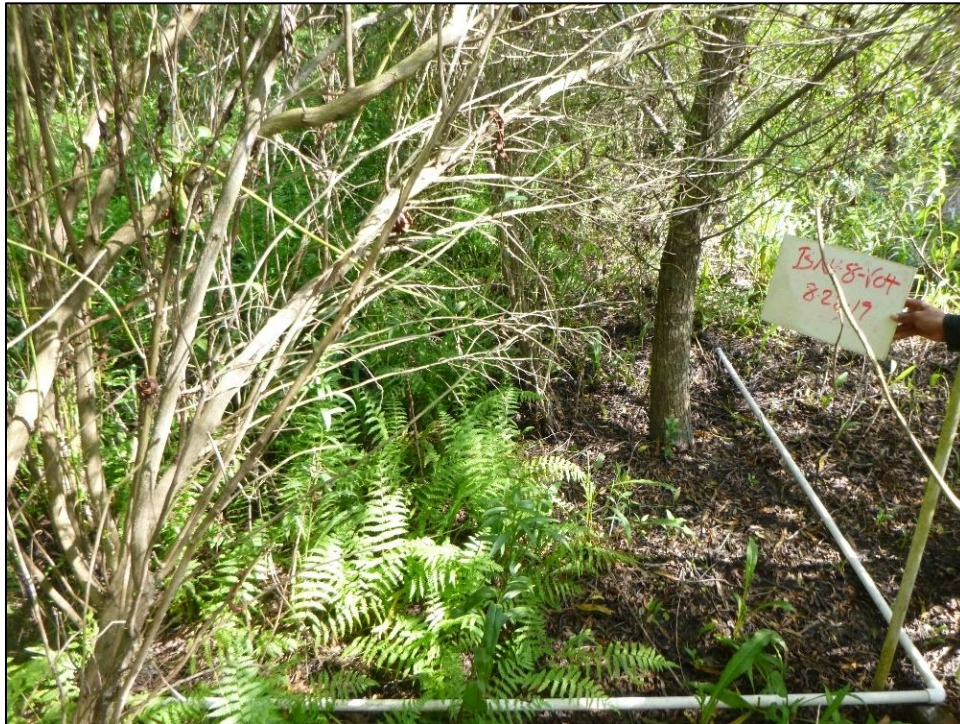
**Photo 9.** Forested community with *Salix nigra* (black willow) and *Thelypteris palustris* (eastern marsh fern) at a marsh vegetation monitoring station (08/28/19).

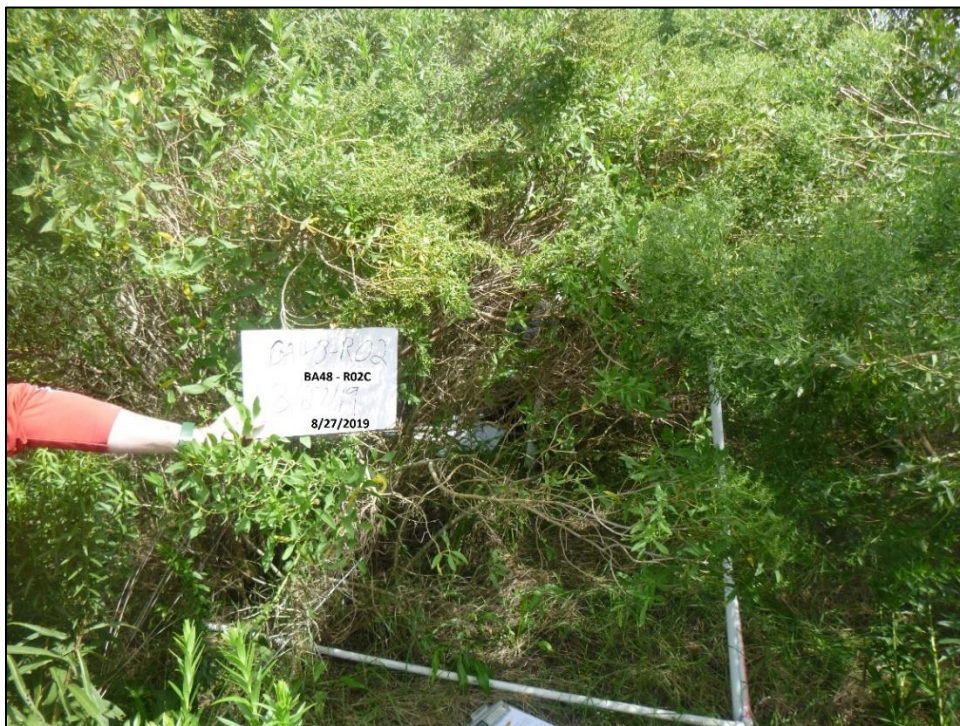
**Photo 10.** Dense *Baccharis halimifolia* (eastern baccharis) and *Iva frutescens* (Jesuit's bark) scrub-shrub community at a ridge vegetation monitoring station on the western ridge (08/27/2019).

*Solidago sempervirens*, *B. halimifolia*, and *Panicum repens* (torpedo grass) were the most widely distributed species at ridge vegetation stations, occurring at 96%, 85%, and 65% of sites, respectively. These three species had the widest distribution on both the western and eastern ridges. Of the three species, *B. halimifolia* had the largest difference in distribution between ridges with an occurrence at 93% of stations on the western ridge, but only 75% of stations on the eastern ridge. There was a total of 30 species recorded on the ridge. The complete list of these species, along with their mean covers, distributions, and associated marsh habitats, is included in Appendix E. Photographs from the ridge vegetation monitoring stations are included in Appendix D (photos 10–12).

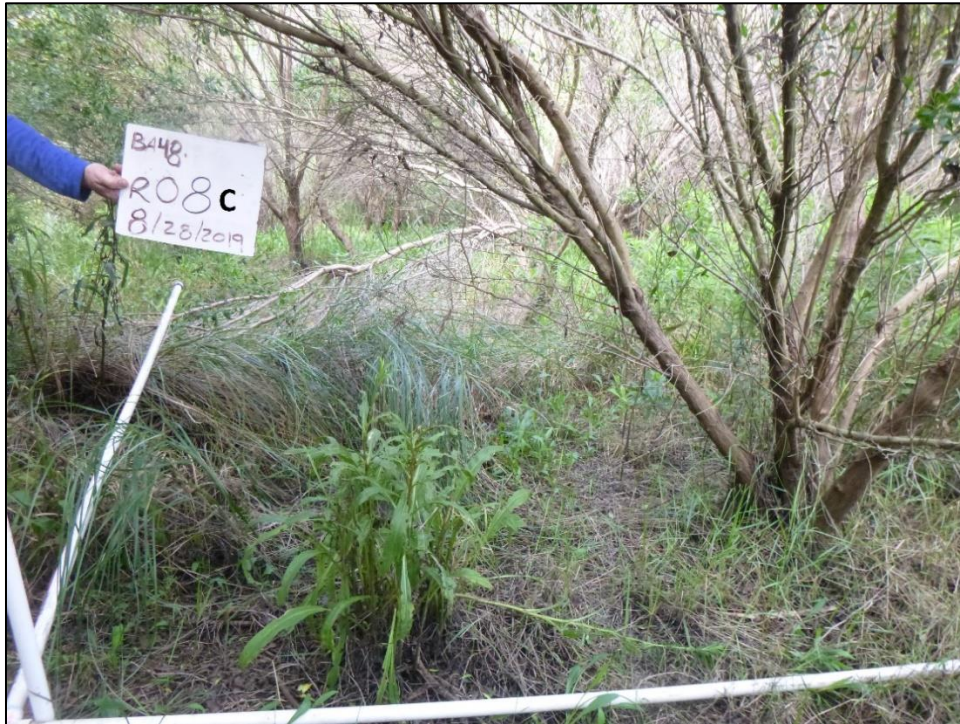
**Photo 11.** Ridge vegetation monitoring station on the western ridge with a mixture of scrub-shrub and herbaceous species (08/28/2019).

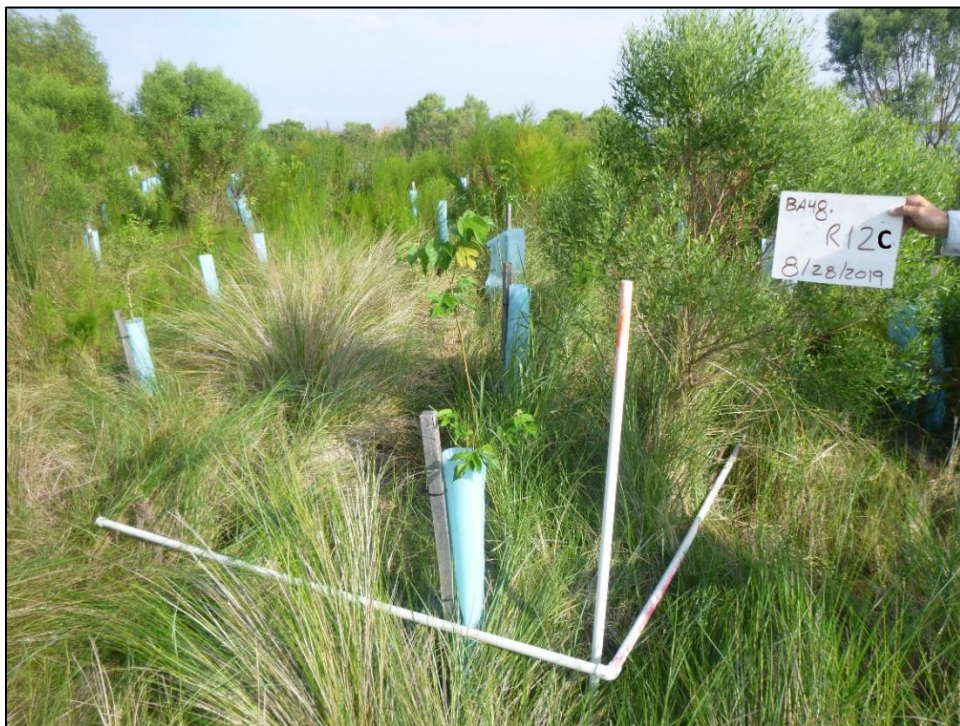
**Photo 12.** Ridge vegetation monitoring station on the eastern ridge, with dense *Spartina patens* (saltmeadow cordgrass). The tree planted in the plot is *Morus rubra* (red mulberry) (08/28/2019).
