2019 Operations, Maintenance, and Monitoring Report

Delta Management at Fort St. Philip (BS-11)

State Project Number BS-11
Priority Project List 10

October 7, 2019
Plaquemines Parish

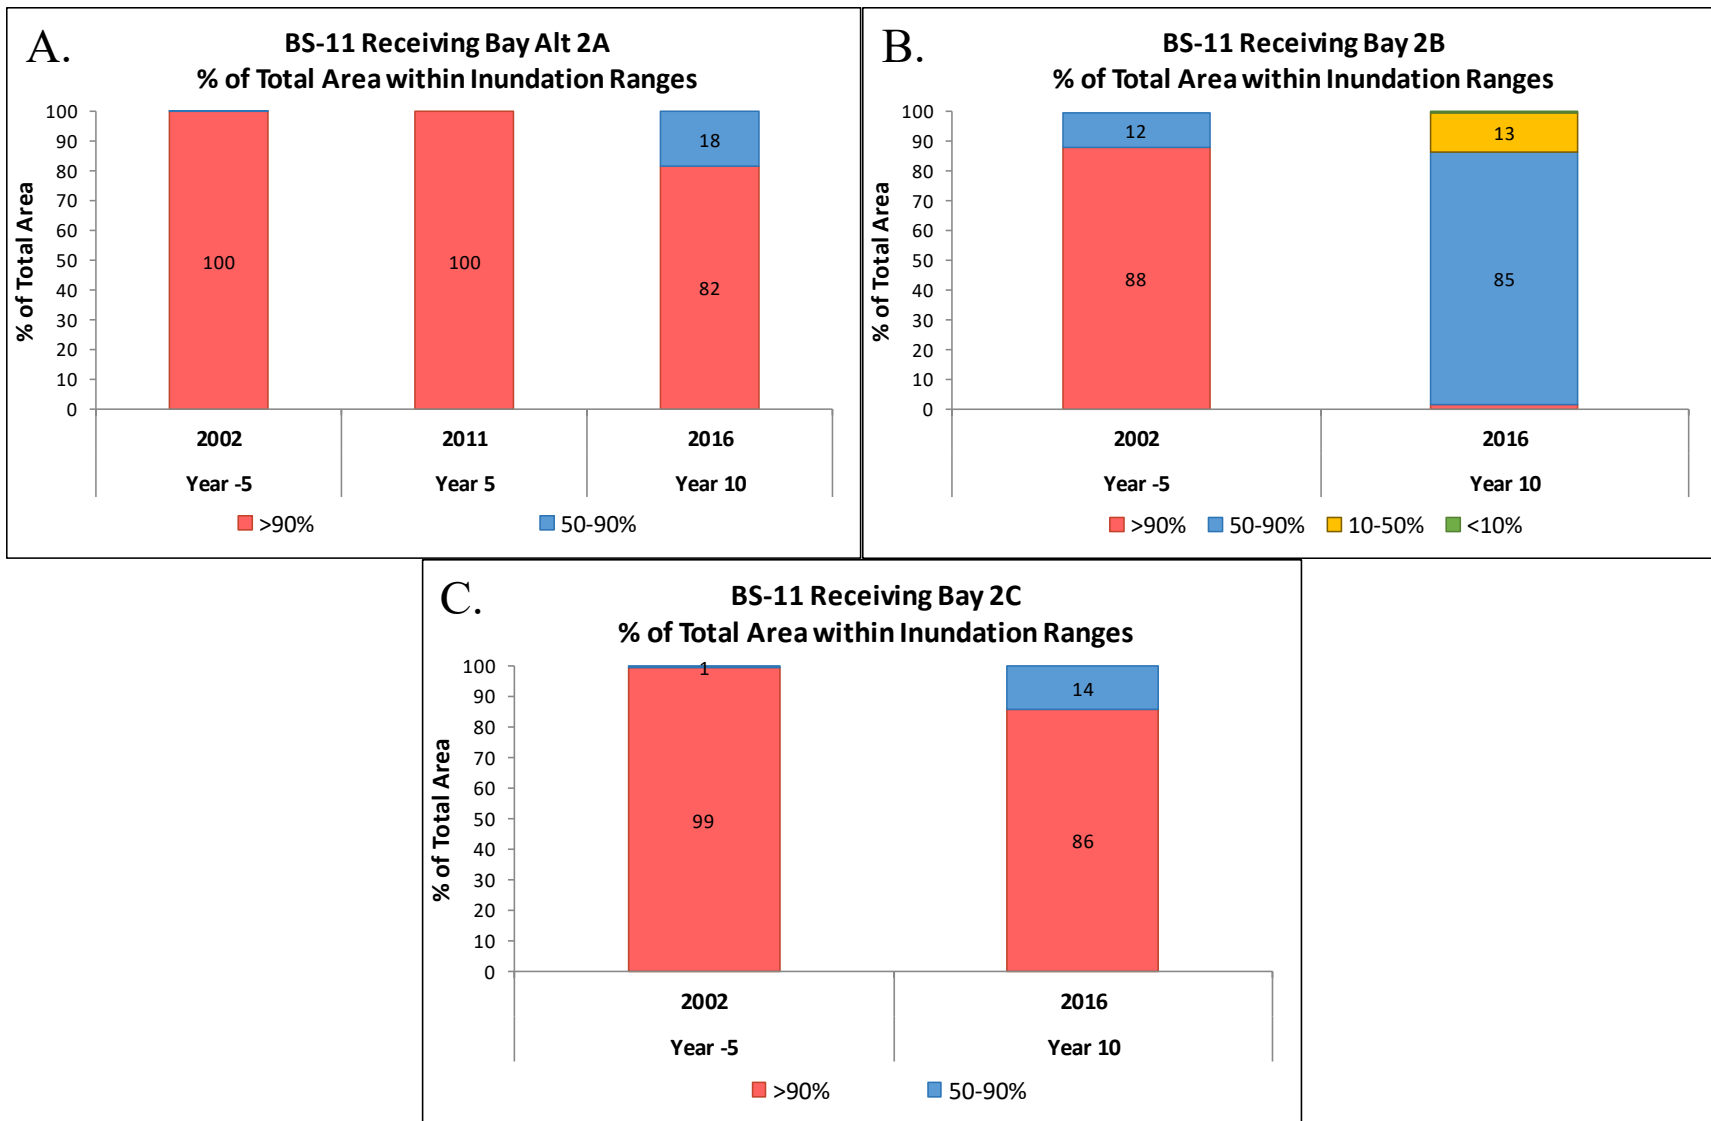
Figure 14. Percent of total area within defined inundation classes within BS-11 Receiving Bay Alt 2A in 2002, 2011, and 2016 (A), within Receiving Bay 2B in 2002 and 2016 (B), and within Receiving Bay 2C in 2002 and 2016 (C).

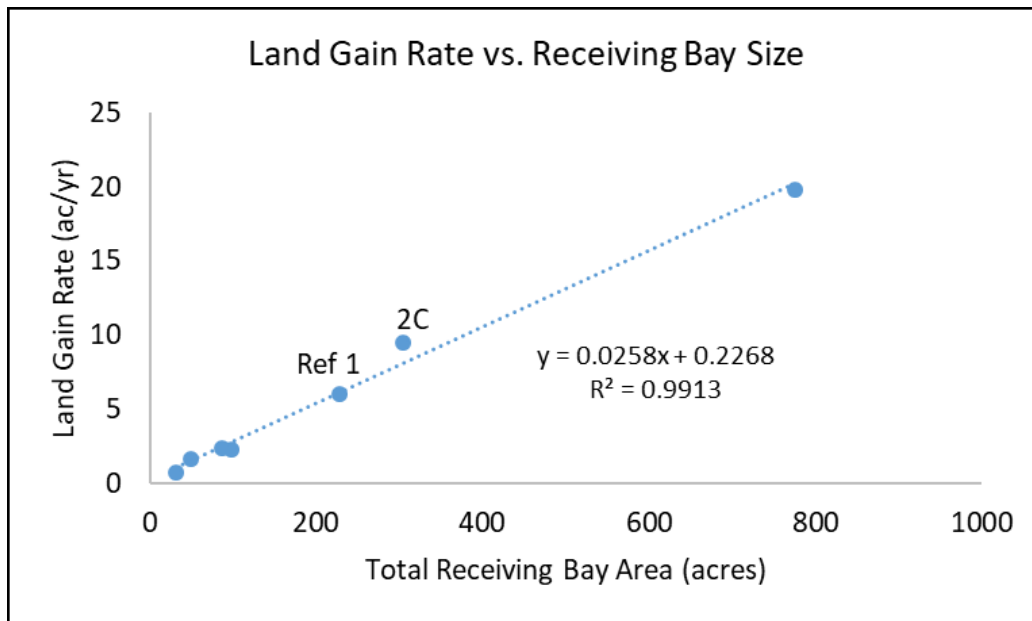
Figure 18. Observed rate of land gain (acres/year) from 2002 to 2017 vs. total receiving bay area (acres) for the crevasses within the BS-11 project and reference areas.

The rate of land gain for all crevasses combined from 2011-2013 was 63 ac/yr and increased to 82 ac/yr from 2013-2017. While Crevasse 1A showed the same gain rate for both of these periods (~40 ac/yr), all three of the Subarea 2 crevasses showed an increase in the land gain rate from 2013-2017. Reference Area 1, which receives significant riverine input, showed proportional land gains to the project areas with a gain of 92 acres (+40%) from 2002-2017. Overall rate of land gain for each crevasse was highly correlated ($r^2=0.9913$) with the size of its receiving basin and the land gain observed within Reference Area 1 was proportional to the other BS-11 crevasses (Figure 18).
