Coastal Protection and Restoration Authority of Louisiana

2022 Operations, Maintenance, and Monitoring Report

South Lake Lery Shoreline and Marsh Restoration (BS-0016)

State Project Number BS-0016
Priority Project List 17

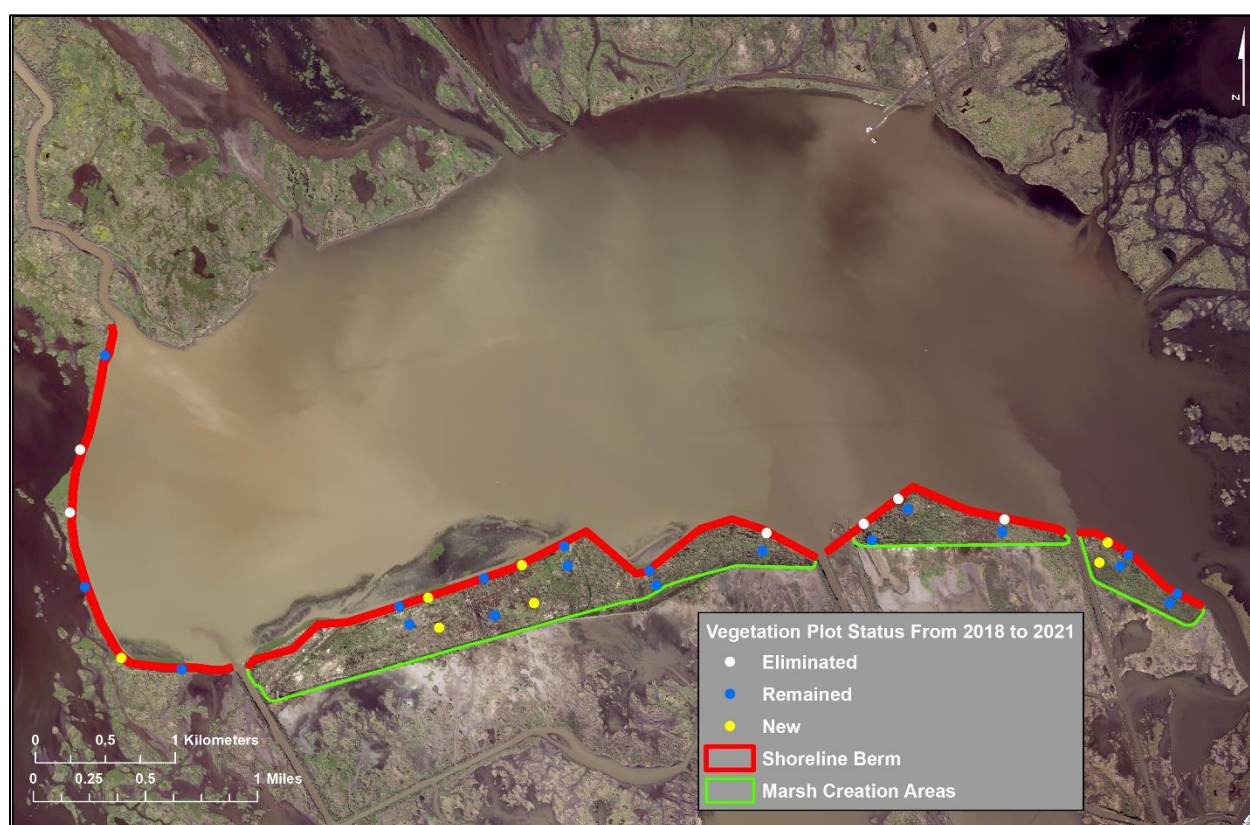
Figure 4: Location of the vegetation survey stations in the South Lake Lery Shoreline and Marsh Restoration (BS-0016) project area for 2018 and 2021. Some stations were eliminated when the shoreline berm eroded away in some locations. Stations were added in 2021 to replace the stations that were eliminated.

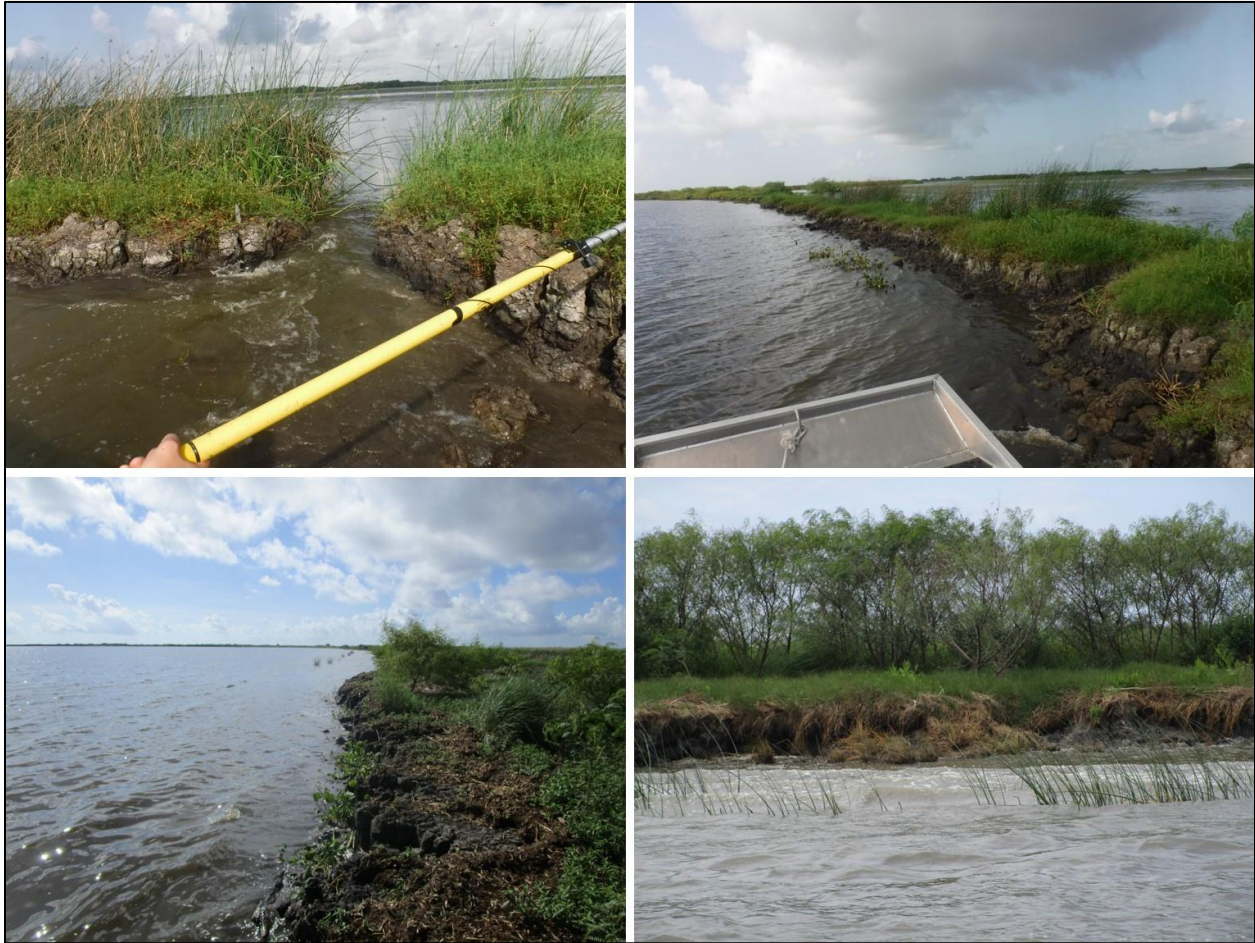
The shoreline at the South Lake Lery Shoreline and Marsh Creation project is an overall erosional environment (**Figure 15**). There are some small areas with low rates of accretion (mostly less than 5 ft/yr), with areas of erosion surpassing 30 ft/yr early on in the project and averaging 20 to 30 ft/yr of erosion over the five years since project construction. Erosion rates were highest along the western shoreline where there was no marsh creation behind the constructed shoreline feature and along the southern shore where project polygons juttied out into the lake (rather than a straighter lined shore). Erosion rates were highest between 2017 and 2019, and decreased during the 2019 – 2022 period. However, during the later increment, erosion rates still surpassed 30 ft/yr in some locations. Areas of accretion were concentrated in the southwest corner, extending along the western end of the south shore. In front of this area of shoreline there appears to be a shallow area where submerged aquatic vegetation grows (perhaps ephemerally throughout the year), which may provide some wave energy dampening, allowing for expansion of the bulrush that was planted in front of the lake rim to help protect the lake berm feature. These shallows can be seen in figures 2, 13, and 14. Along the shoreline that is erosive, the bulrush is mostly not present. There is also a small length of low rate shoreline accretion at the far eastern end of the project shoreline. This stretch of shoreline is facing northeast and may be protected by land just to the north as the lake narrows on the eastern end. This decreases the fetch of direct wind driven wave action from northeastern winds. Shoreline erosion rates for the 2019 to 2022 and 2017 to 2022 periods represent a conservative shoreline rate because of the missing shoreline along the western edge. These areas would have a higher rate of erosion similar to the rest of this shoreline, if analysis was able to be conducted on these stretches. The western shoreline was especially vulnerable, both because no marsh creation was conducted behind this shoreline to help stabilize and slow erosion, and because the lake fetch is longest along this shoreline and would be impacted during east winds. The east/west fetch of Lake Lery is approximately 6 miles while the north/south fetch is approximately 2 miles. Strong northerly and easterly winds would affect the project area the most. The next shoreline survey is scheduled for 2026, which will be year 9 of the project.

Figure 15: Pictures of the erosional environment as the BS-0016 project: Clockwise from top right: Erosional western shoreline with gap developing; Long-view of the erosional western shoreline; erosional southern shoreline with planted *Schoenoplectus californicus* in front, which was originally planted right on the shoreline; Long-view of the erosional southern shoreline with planted species off of the shoreline.

A repair of the western shoreline feature is recommend. The repair should be constructed in conjunction with marsh creation behind the shoreline as outlined in the 95% design for this project, or the repair

should incorporate some harder material such rock, or another strategy such as articulated concrete mats, if they can be proven to be effective in a high energy environment. The entire western shoreline should be fortified, not only the areas where breaches have occurred. If shoreline erosion rates remain similar on the southern shore in future surveys, a fortification of the southern shoreline with harder material is also recommended.
