Coastal Protection & Restoration Authority of Louisiana Operations, Maintenance and Monitoring (OM&M) Workshop

Tuesday December 6, 2011 State Library Conference Center, Baton Rouge 9:00 a.m.-4:00 p.m.

Each year, the CPRA field offices in New Orleans, Lafayette, and Thibodaux prepare Operations, Maintenance & Monitoring (OM&M) reports for completed restoration projects. These reports are produced on a rotating schedule of every three years, and thus, reports on different projects are completed every year.

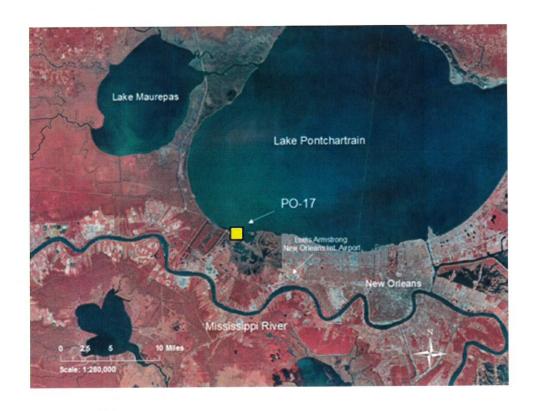
Project Description

- Wetland creation from sediment dredged from Lake Pontchartrain
 - Well-suited for project area due to close proximity to borrow site, small, shallow project area (average depth of 1 ft.)
- 2.7 million yds³ of sediment dredged from the lake bottom and pumped into the northern project area (completed in 1 month)
 - Sediment could not be discharged within 1000 feet of I-10
 - Resulted in an elevation gradient: highest N, lowest S

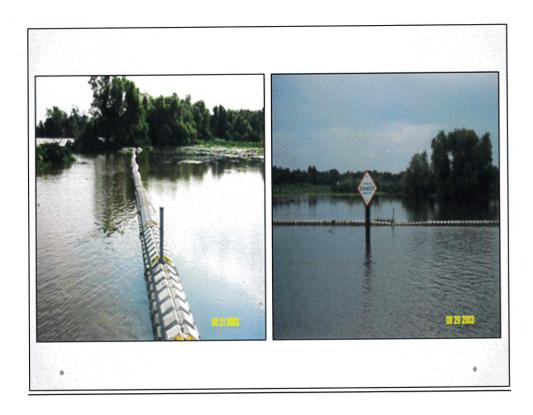
Approximately 1,857 ft (566 m) of parallel straight-walled fiberglass sheet pile divided among three replicate treatment blowouts (V1, V2, V3).

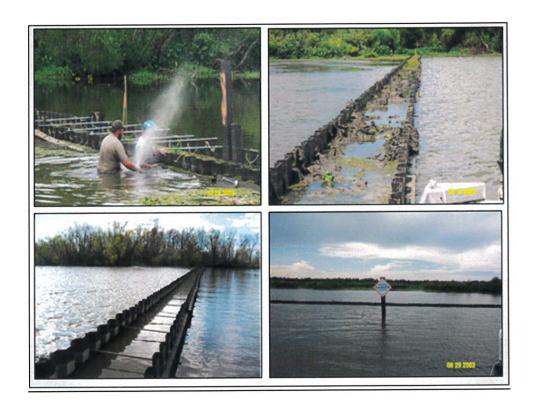
Approximately 1,283 ft (391 m) of 24 inch (0.61 m) high A-Jacks concrete blocks in an interlocking double row with two staggered rows of Zizaniopsis miliacea (Michx.) Doell & Aschers. planted on five foot centers between it and the shoreline divided among three replicate off-bank treatments (J1, J2, J3).

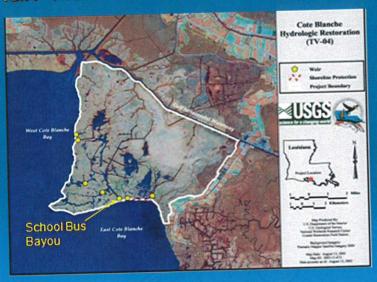
Plan View of TV-04 Cote Blanche

- The Cote Blanche Hydrologic Restoration project area consists of 31,637 acres of freshwater marsh in the Teche/Vermilion Basin in St. Mary Parish. The project boundaries include the GIWW to the north, Hwy 317 to the east, East Cote Blanche Bay to the south, and West Cote Blanche Bay to the west.
- Land loss in the area has been caused by several factors including subsidence, shoreline erosion, and rapid tidal fluctuations.
- Project goals were to create a lower energy environment by reducing the larger openings that penetrate fragile interior marsh and act as direct conduits for increased tidal influences and provide shoreline protection in the most critical areas.
- Initial construction was completed in 1999. Maintenance events were completed in 2001, 2005, & 2007 with another one to be completed in early 2012.

- The project was completed in January 1999 at a constructed cost of \$3,875,018.
- The project consisted of low level weirs at Mud Bayou, Humble-F Canal, Bayou Long, Bayou Carlin, Humble Canal, Jackson Bayou and British American Canal. Approximately 3,500 L.F. of PVC shoreline protection was constructed along the southern boundary.
- Problems with the design of the PVC wall became apparent early on during construction. A change order was issued correcting the issues.

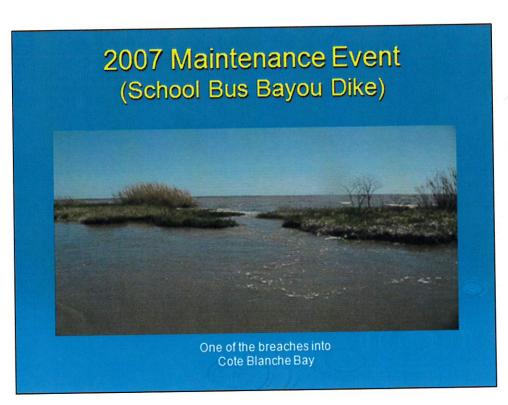
2007 Maintenance Event Details (For School Bus Bayou Dike)

- Work consisted of installing a foreshore dike approximately 3,300 LF in length along the northern shore of Cote Blanche Bay in front of School Bus Bayou.
- Construction of two low level rock weirs at the intersection of School Bus Bayou and Humble Canal.
- Installation of warning signs.
- Work was completed in Sep. 2007.

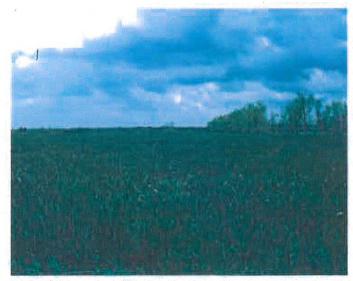
Fragile, highly organic marsh is vulnerable to increased erosive energy caused by tidal fluctuation. Structural measures associated with the project will improve hydrologic conditions by decreasing the amplitude of tidal events.

This hydrologic restoration project contains structural measures that were designed to improve hydrologic conditions and provide shoreline protection along the southern project boundary. A series of water control structures (shown on map) reduce rapid water exchange and tidal energies, and the shoreline protection provides a stable buffer for the interior marsh from the wave action along Bayou Perot and Bayou Rigolettes. The project will be constructed in four units. The first unit will install the majority of the water control structures. The second unit will install the remaining structures and a segment of shoreline protection. The remaining units will install the bank protection along the southern boundary.

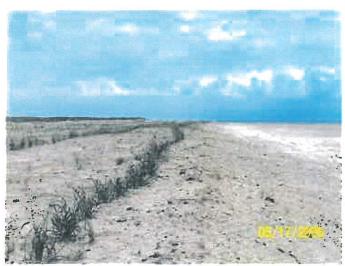
The plants and sand fencing shown above will help to maintain the integrity of Timbalier Island by capturing and retaining wind-blown sand.

Specifically, the project introduced sediment from the Gulf of Mexico to restore 2.2 miles of the beach rim and dune system and create a marsh platform on the bay side of the island. The marsh platform was built around existing marsh with minimal impact. Approximately 4.6 million cubic yards of material was dredged from the Little Pass borrow area about 14,000 feet away from the project and 22,750 linear feet of sand fencing was placed. Over 110,000 container grown plants consisting of eight species were initially planted. This is the most diverse plantings to date for a CWPPRA barrier island project. The sand fencing and vegetative plants help capture and retain wind-blown sand.

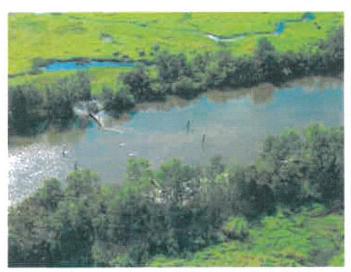
A low-level weir constructed across the British American Canal within the project area.

The most notable effect of the project was a reduction in the range of water level fluctuation. Since the project was completed, preliminarily analysis of monitoring data indicates the range in water level fluctuation increased or showed no change in the reference area, but decreased in the project area. This project is on Priority Project List 3.
