COASTWIDE REFERENCE MONITORING SYSTEM (CRMS)

# CRMS SITES THAT HIGHLIGHT COASTAL PROCESSES

APPENDIX C

REPORT: VERSION 01

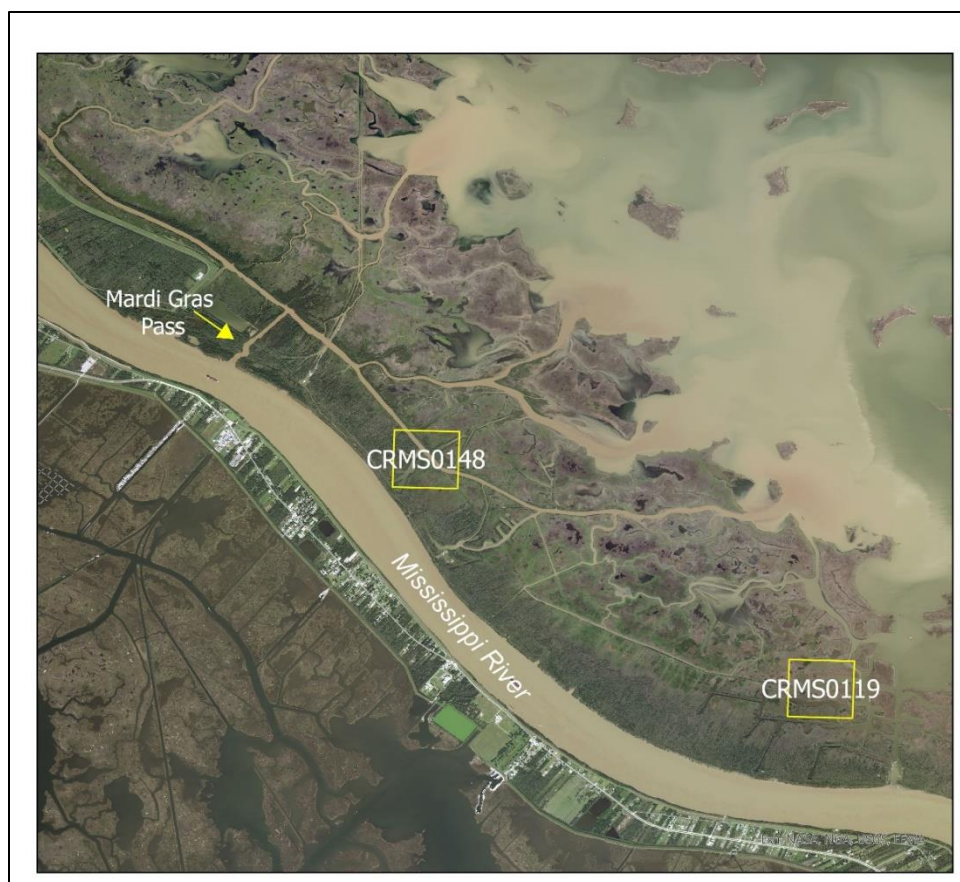
Figure 1. Location of CRMS0148 and CRMS0119 in relation to Mardi Gras Pass

Mardi Gras Pass is a free-flowing channel located on the east bank of the Mississippi River at mile 43.5 above Head of Passes and is the northernmost distributary along a stretch of the river where levees on the east bank are not maintained. Formation of Mardi Gras Pass began during a 2011 Mississippi River flood event, which caused an area of scour along the natural levee. By February 2012, the channel had breached into a free-flowing distributary into Breton Sound. Since that time, several high river years (2018–2020) have caused further enlargement of the pass to a maximum discharge capacity of approximately 800 m<sup>3</sup>/s (~28,000 cufs) at river flood stage (Henkel et al. 2023). Two CRMS sites, CRMS0148 and CRMS0119, have captured effects of Mardi Gras Pass since its formation (Figure 1). CRMS0148 is located about three miles from the pass along the Back Levee Canal, which receives outflow directly from Mardi Gras Pass. CRMS0119 is located about 6.5 miles further south from the pass and is not on the direct flow path.

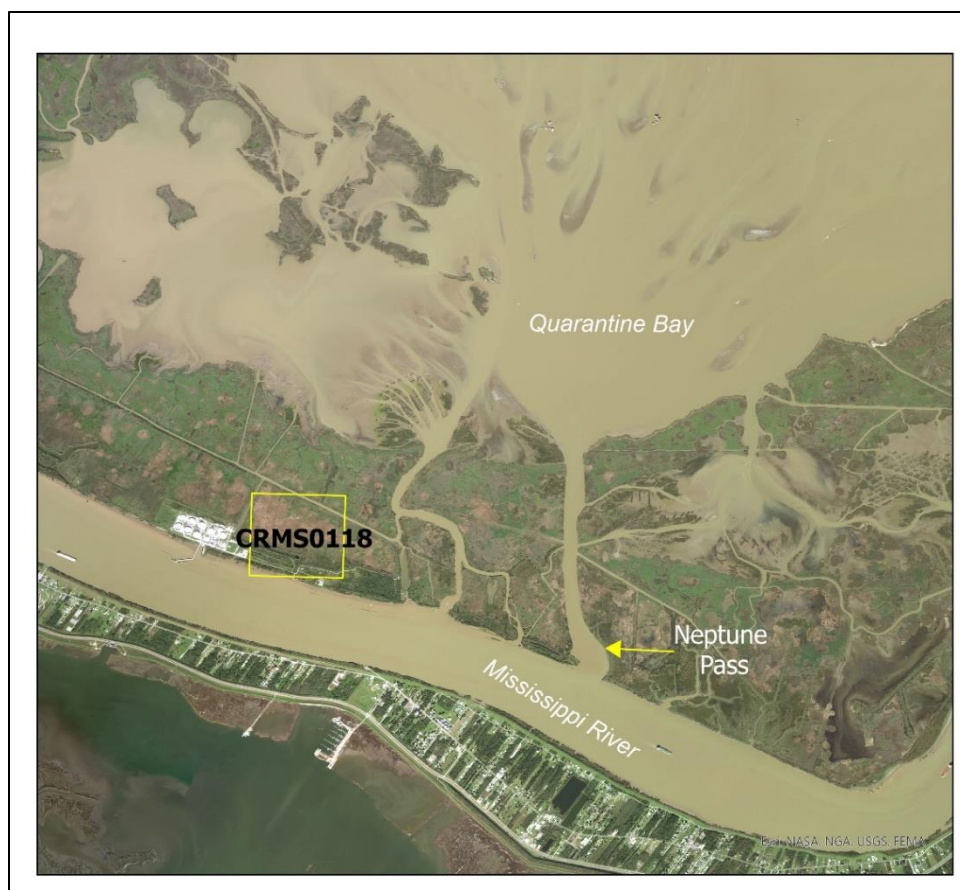
Figure 9. Location of CRMS0118 in relation to Neptune Pass

CRMS0118 is located approximately two miles upriver from the main channel of the pass (Figure 9). While the site has historically received riverine influence through several small crevasses in the Ostrica region, this was significantly increased with the formation of Neptune Pass. An increase in water level in 2019 was observed at the site following the enlargement of the pass (Figure 10). Surface elevation change has been positive at the site since data collection began in 2008, but deposition due to the enlarged Neptune Pass diversion was reflected as a significant increase in the surface elevation since 2021 (Figure 11).

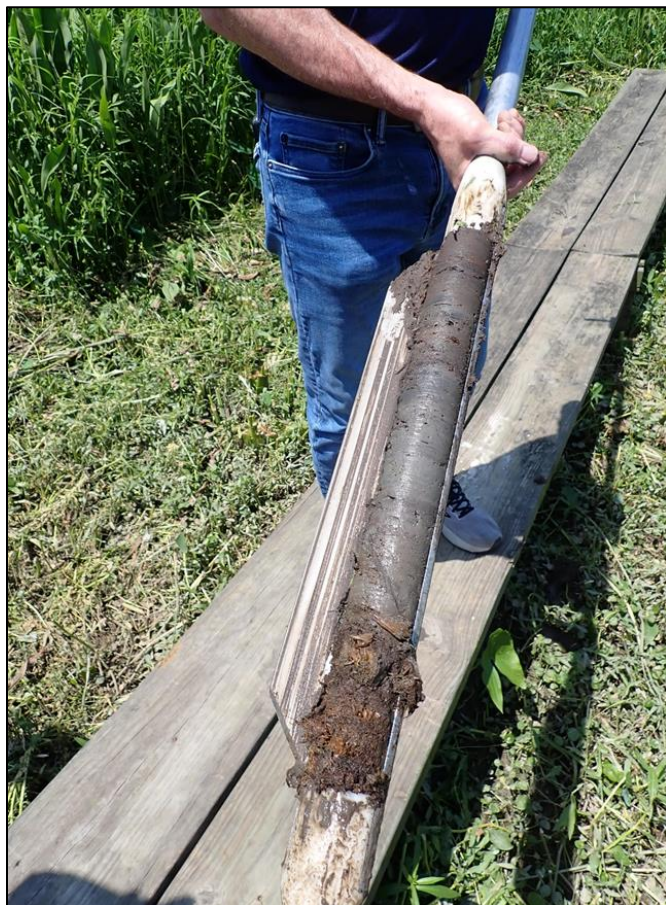
Figure 26. Soil core taken at CRMS3169 in 2024 shows the grey, fine mineral sediment that has accumulated on the marsh above the highly organic sediment below

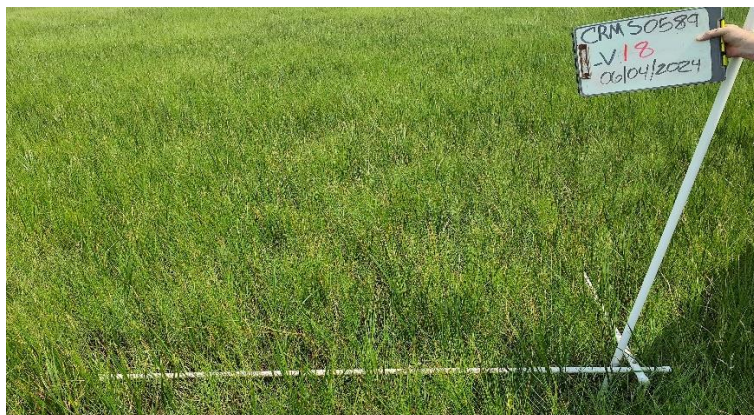
Figure 37b. Photograph of CRMS0589 vegetation station in 2024 after very high salinity in the 2023 drought. Note monoculture of *Distichlis spicata*.

CRMS0589 is located within a borrow canal on Rockefeller Refuge that sees occasional overwash of the beach rim. Drought conditions in the summer of 2023 caused extremely low water levels and hypersaline conditions at this location due to evaporation. Salinity readings in the small ponds that remained reached the highest salinities ever measured at CRMS sites, over 100 ppt (Figure 36). Handheld salinity meters only measure up to 70 ppt so water samples were sent to an LSU laboratory to confirm the >100 ppt values. Salinities remained elevated through the end of the year. The drought event caused a shift in species assemblage without land loss. In the first year post drought, only *Distichlis spicata* emerged (Figures 37a and 37b).

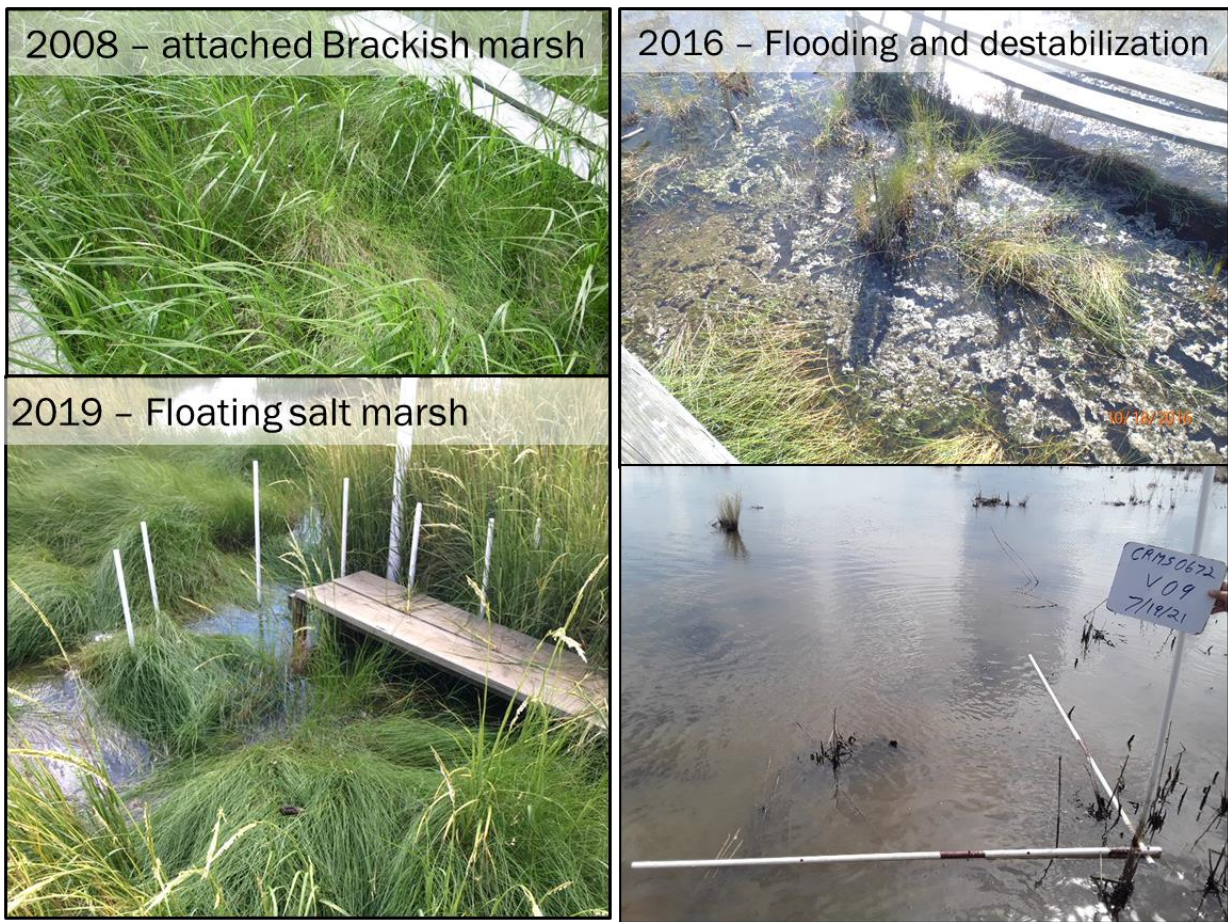
Figure 40. Images of CRMS0672 from 2008 through 2021 showing destabilization and eventual marsh collapse

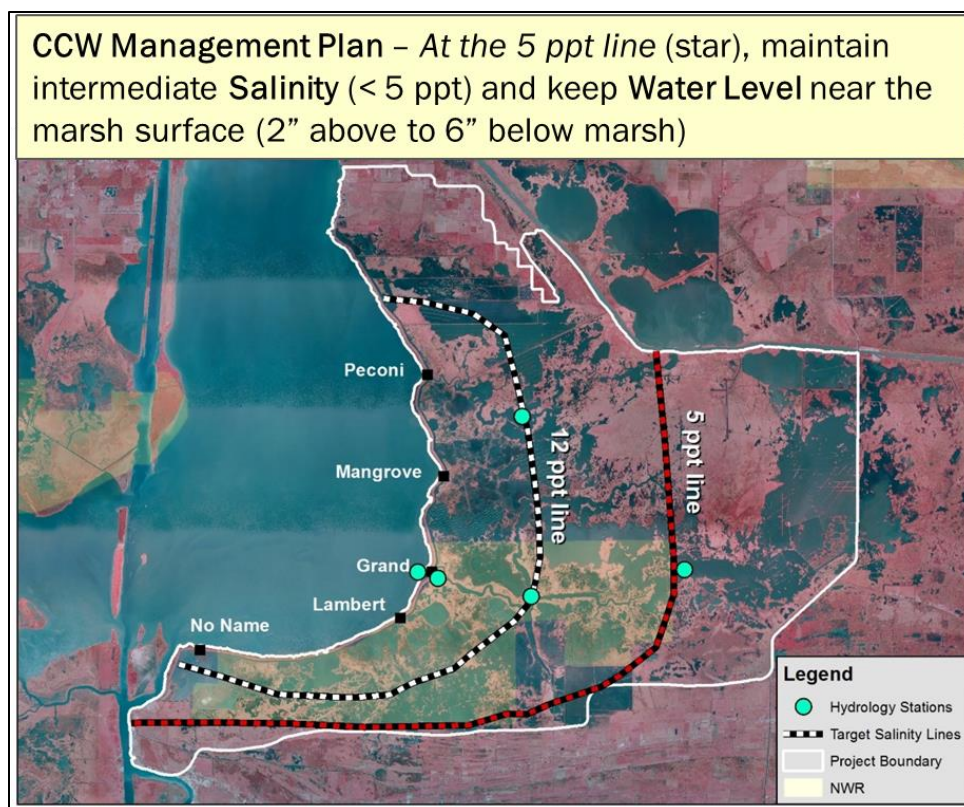
Figure 41. The CCW Management Plan that guides operations

Sea level rise has made management challenging in recent years. Limited drainage opportunities have trapped water on the landscape and led to chronic flooding making it difficult to impossible at times to achieve water level goals. The resulting persistent inundation has weakened marsh vegetation and contributed to land loss. The Calcasieu-Sabine Large-Scale Marsh and Hydrologic Restoration Project (CS-87) seeks to reduce marsh stress from inundation within the CCW by improving marsh drainage and increasing elevation capital with dredged sediment (Figure 45). The project will construct seven new drainage structures and improve existing conveyance channels with the aim to increasing drainage when lower tides and low lake levels seen with frontal passages result in a favorable head differential. One benefit of this increased drainage is it will allow for more frequent and longer openings of the five existing manual water control structures.

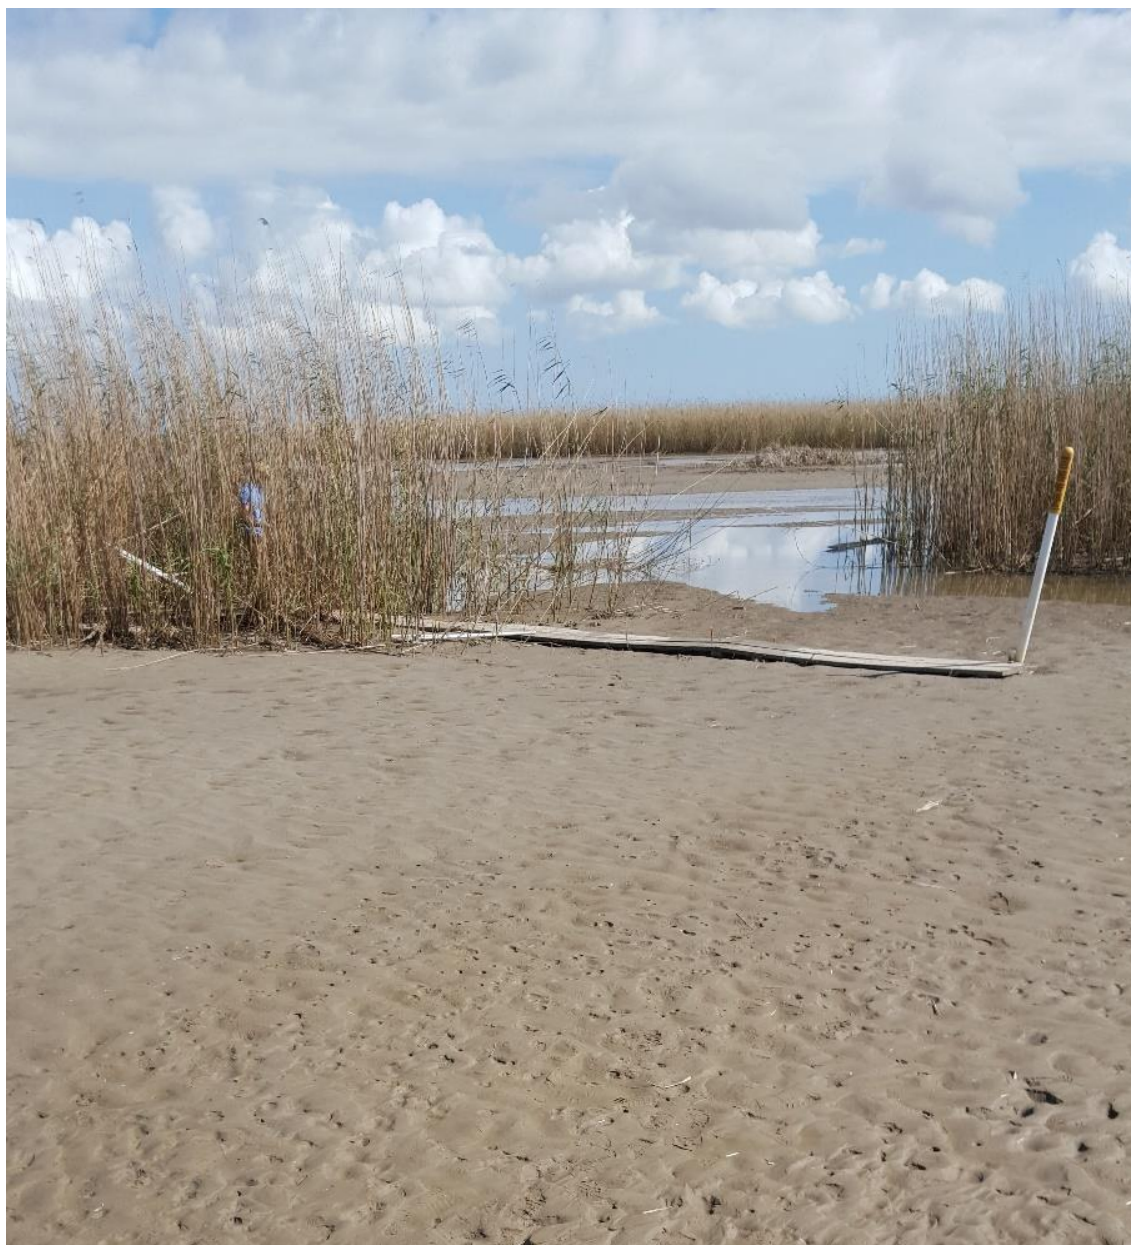
Figure 51b. Photograph of the boardwalk at CRMS2627 buried in sediment in September, 2016. Boardwalk was constructed 1.5' above the marsh surface in 2008.

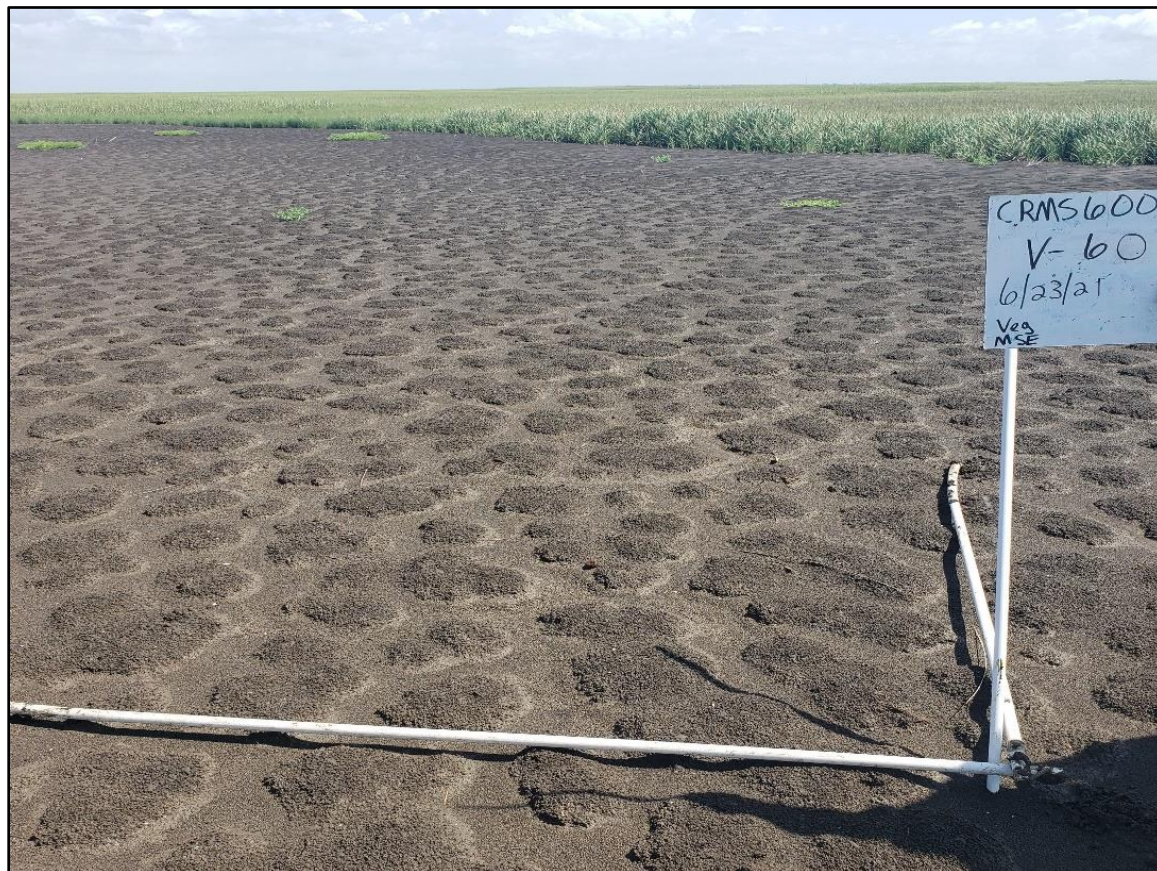
Figure 54. Sediment deposition from Hurricane Laura at CRMS0600. Photo taken during June 2021 Vegetation survey

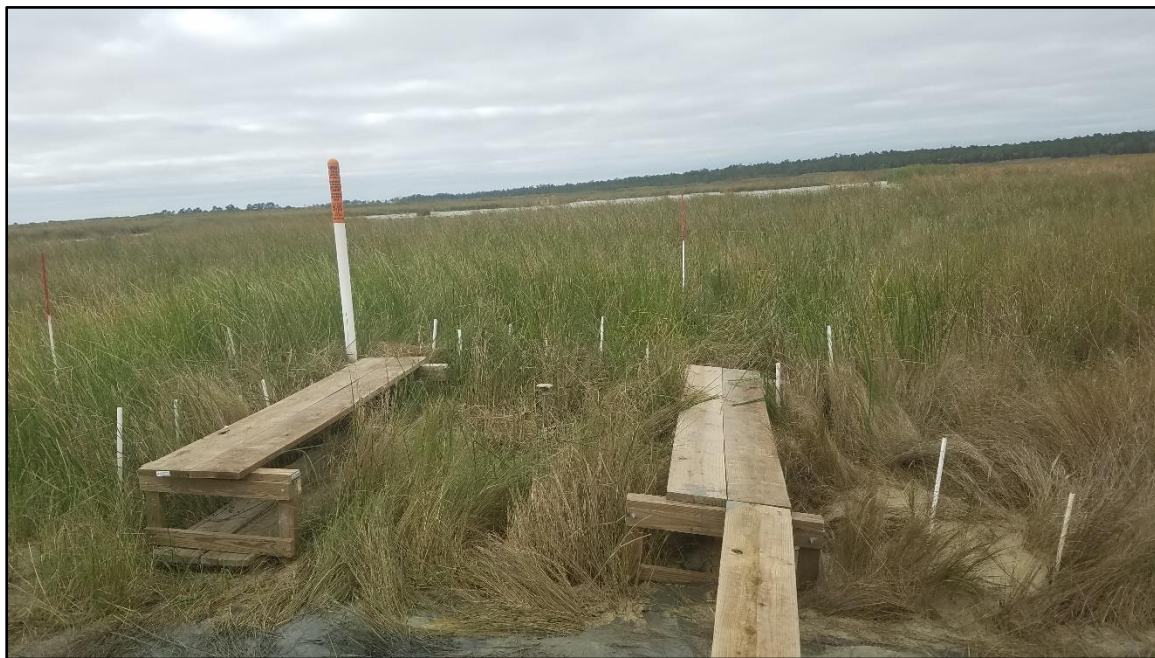
Figure 56a. Photograph of the boardwalk at CRMS3667 after marsh nourishment in 2017. Note new boardwalk constructed on top of old boardwalk due to very high sedimentation.

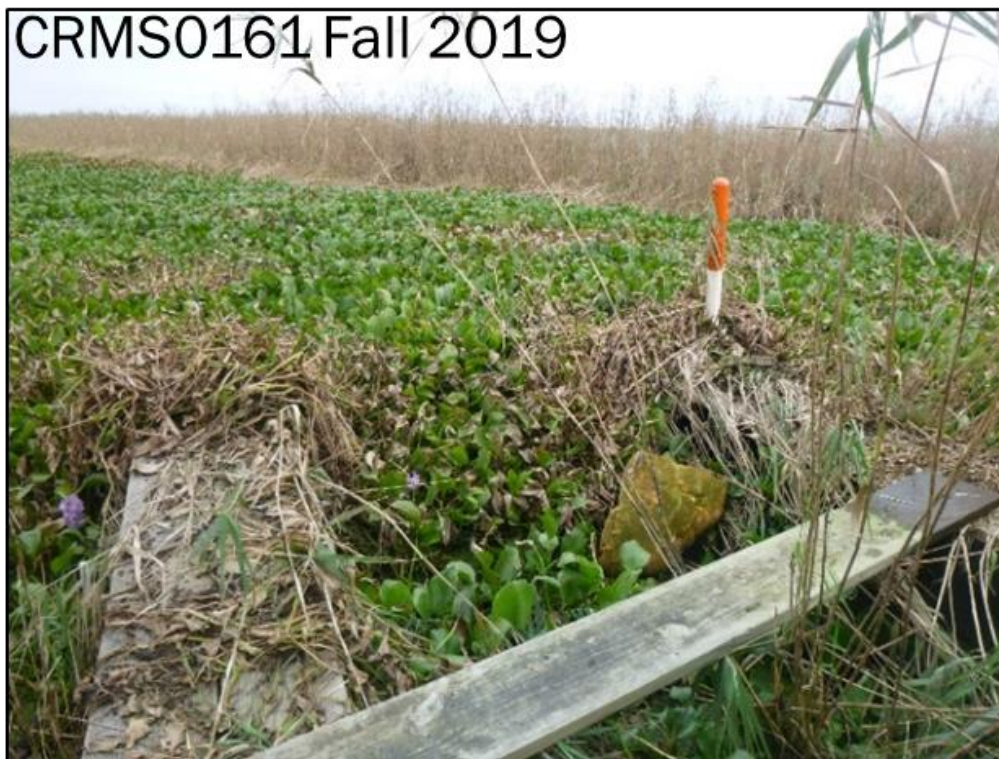
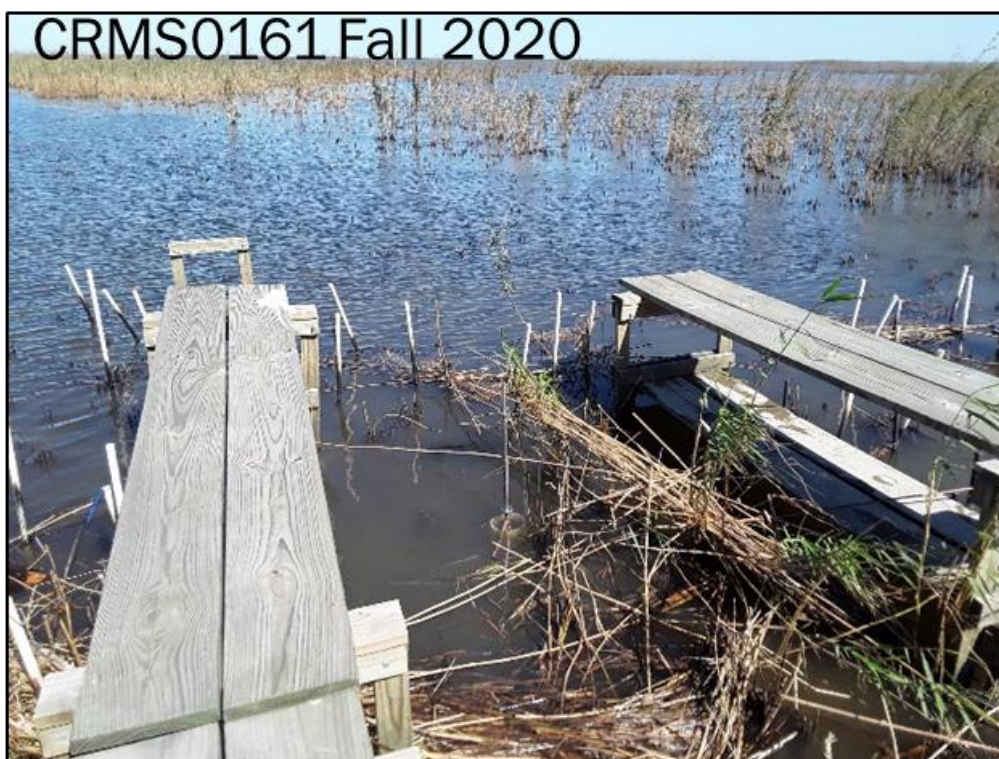
Figure 58. Photos taken at CRMS0161 showing water hyacinth raft at the boardwalk in 2019 (above) and after it washed away in 2020 (right)

At CRMS0161, a steep increase in surface elevation was recorded (Figure 57) which coincided with the presence of a large floating raft of water hyacinth (*Pontederia crassipes*) observed at the site. The raft sat on top of the existing marsh platform, smothering vegetation, and trapping deposited sediment (Figure 58). When the water hyacinth raft was later removed by natural processes, previous elevation gains were lost and elevation dropped lower than what they were prior to hyacinth raft presence. Persistent elevation and vegetation loss has been observed at this site since that event.

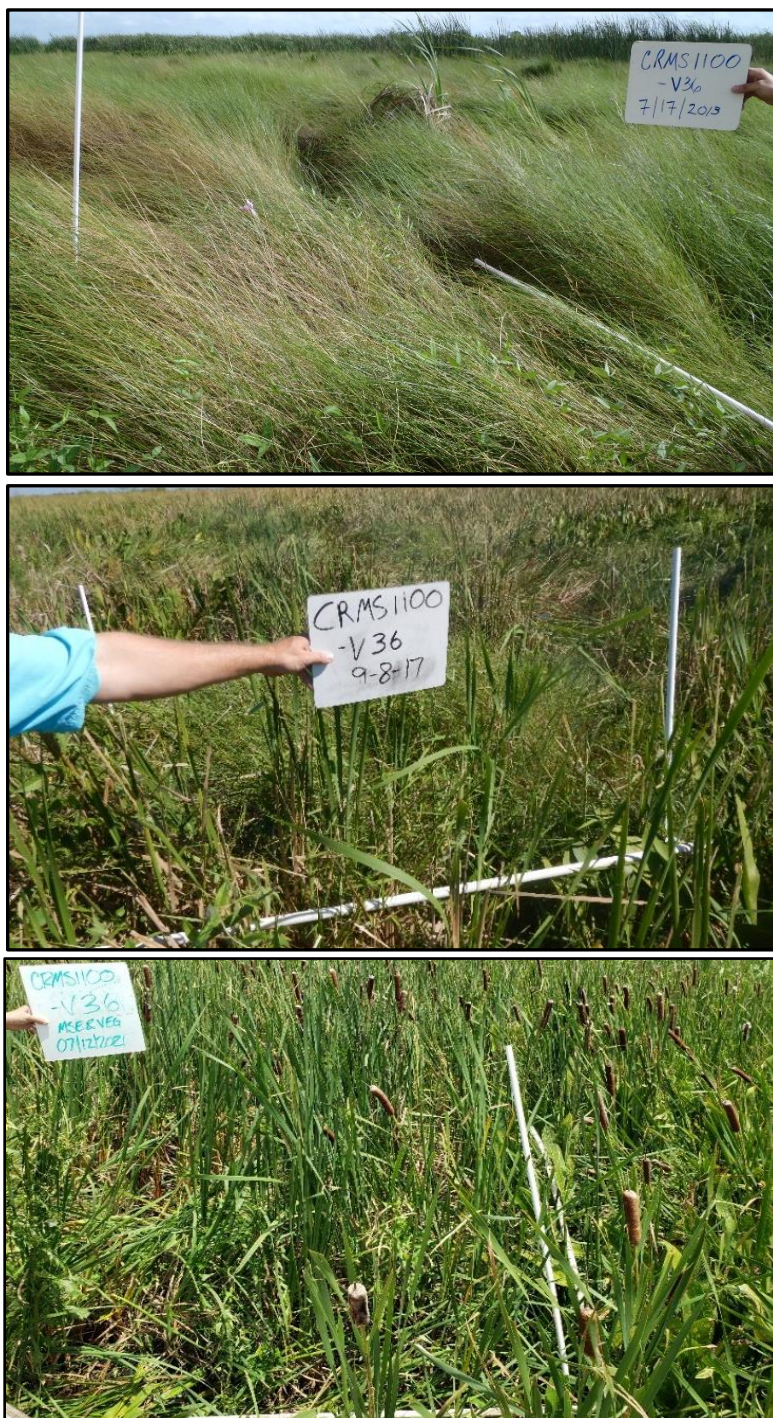
Figure 61. Photos taken at vegetation plot V36 at CRMS1100 in 2013, 2017 and 2021 showing species composition shift over time

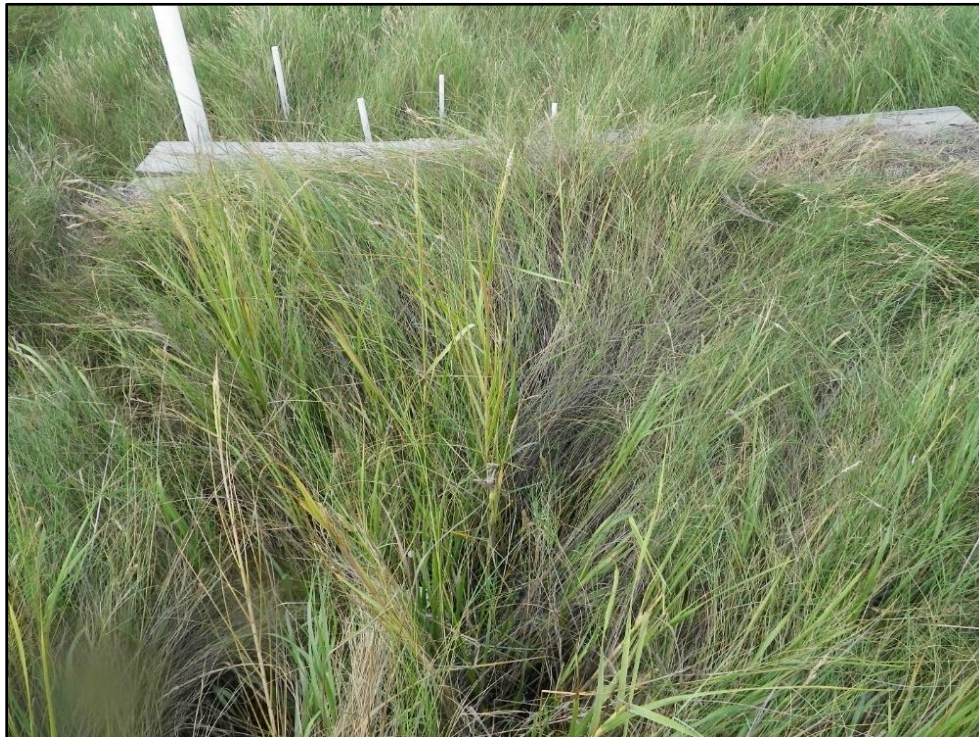
Figure 64. CRMS0258 RSET station in the fall of 2011 pre Hurricane Isaac with robust above ground vegetation present

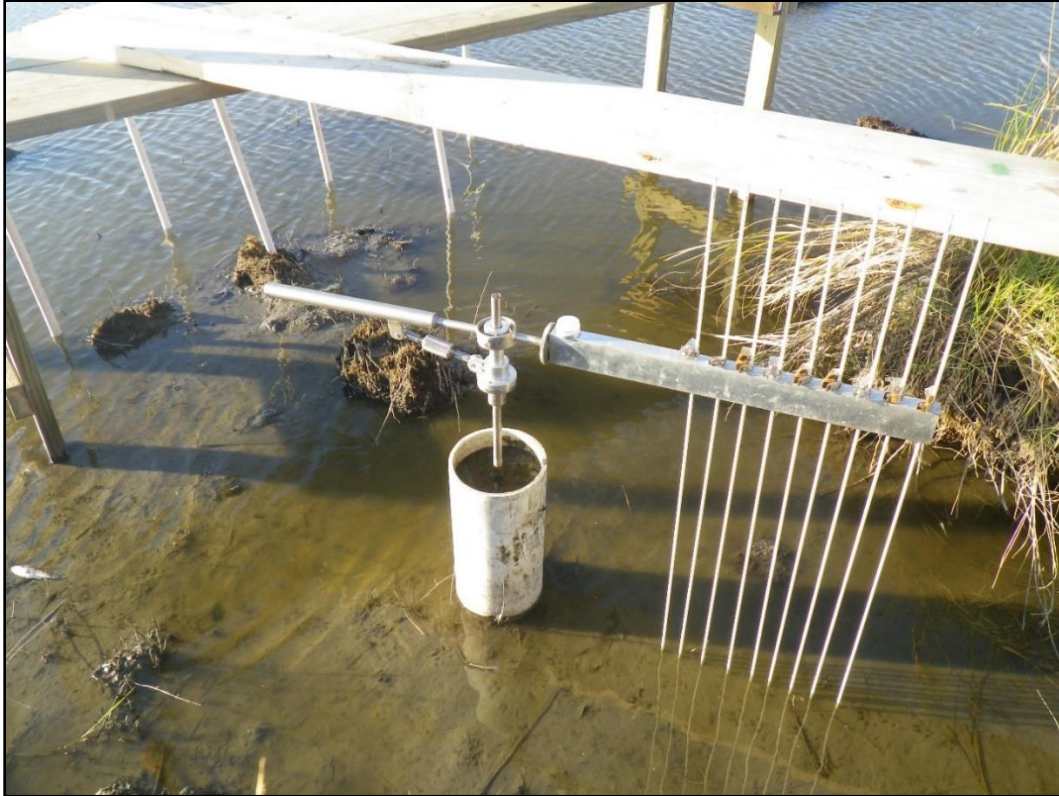
Figure 65. CRMS0258 RSET station in the fall of 2012 post Hurricane Isaac with minimal above ground vegetation present, mostly containing shallow open water

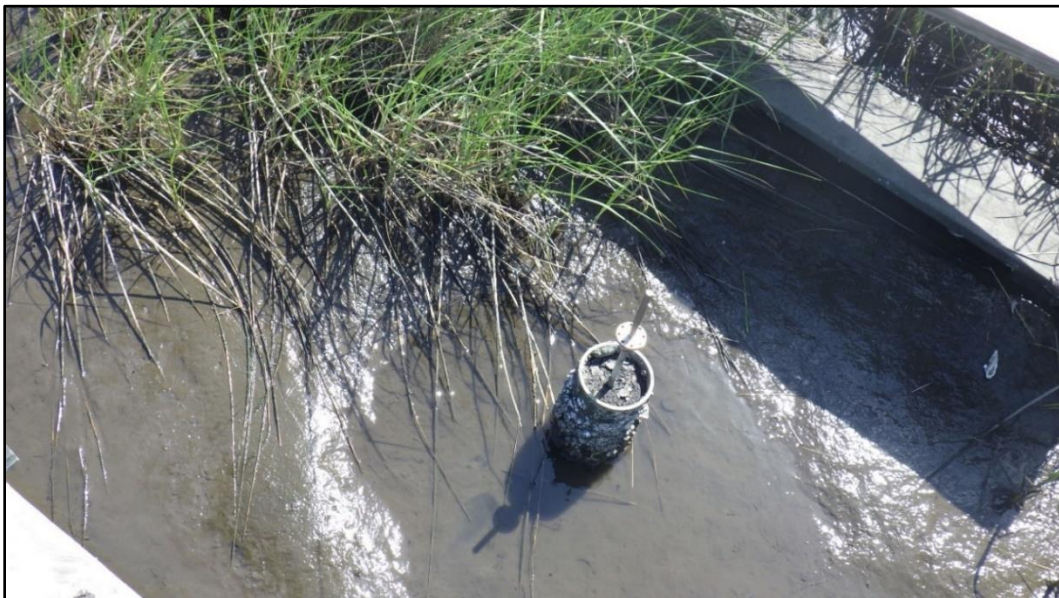
Figure 66. CRMS0258 RSET station in the fall of 2025, 13 years after the top 30 cm of soil was removed containing mostly shallow open water, mudflats, and minimal vegetation

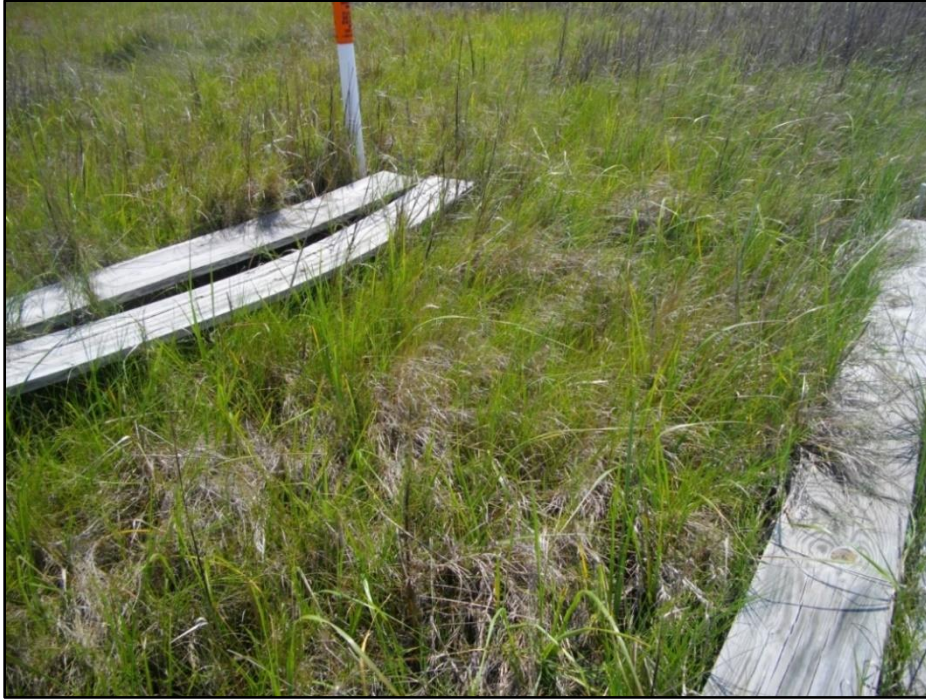
Figure 68. CRMS0260 RSET station in the spring of 2013, post Hurricane Isaac with healthy above ground biomass present

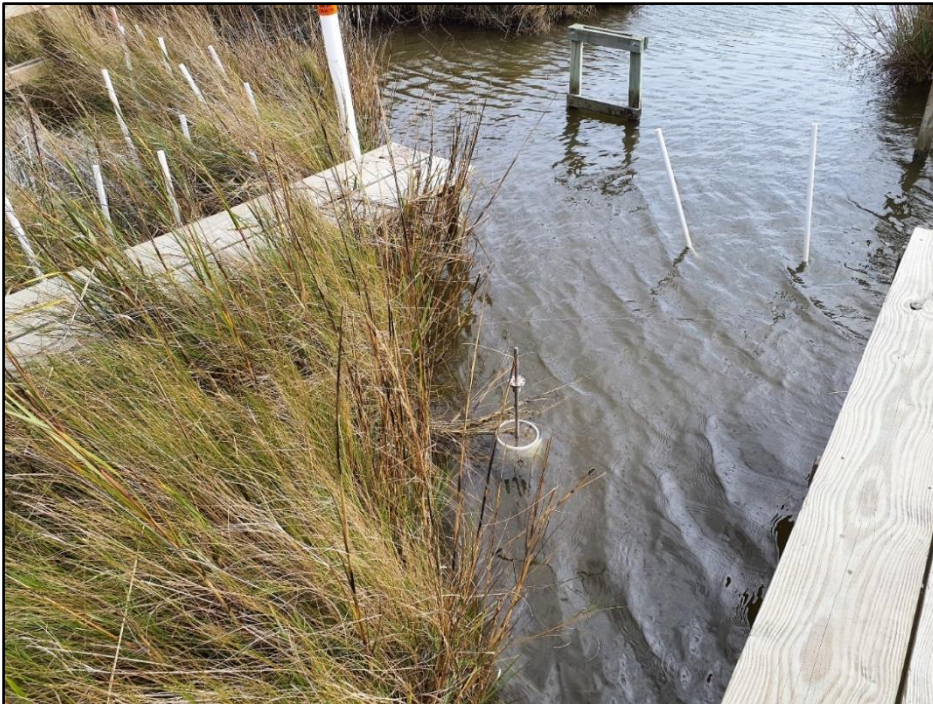
Figure 69. CRMS0260 RSET station in the spring of 2023, post Hurricane Ida after the wrack deposited from the storm washed away leaving half of the station in shallow open water

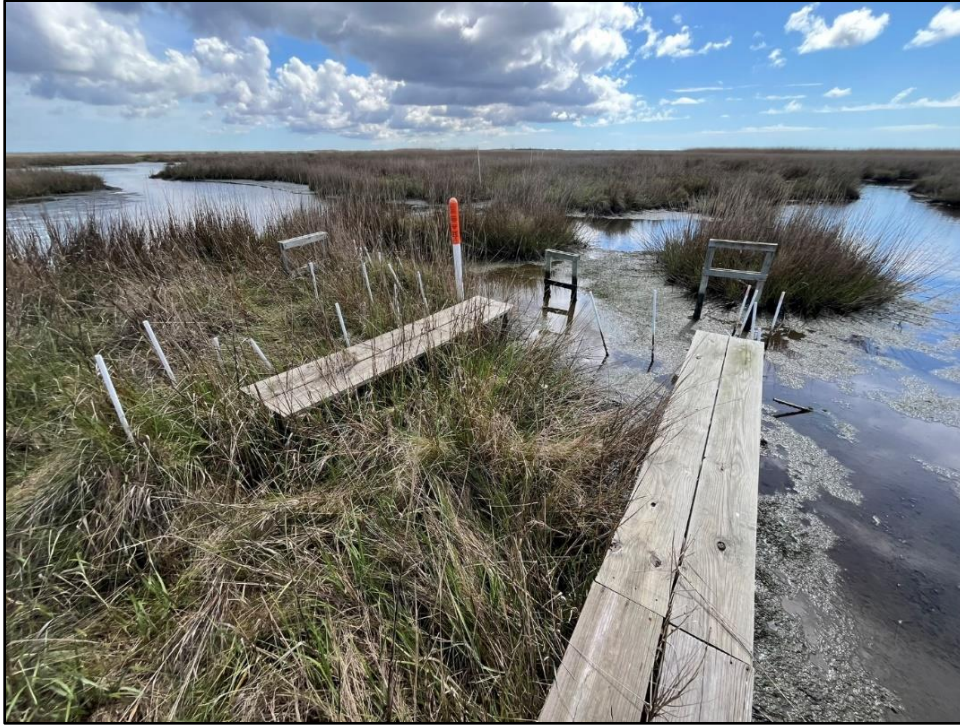
Figure 70. CRMS0260 RSET station in the spring of 2025 with broken marsh interspersed with lower elevation open water. The station is recovering elevation with the vegetated side gaining more rapidly due to sedimentation in the vegetative growth

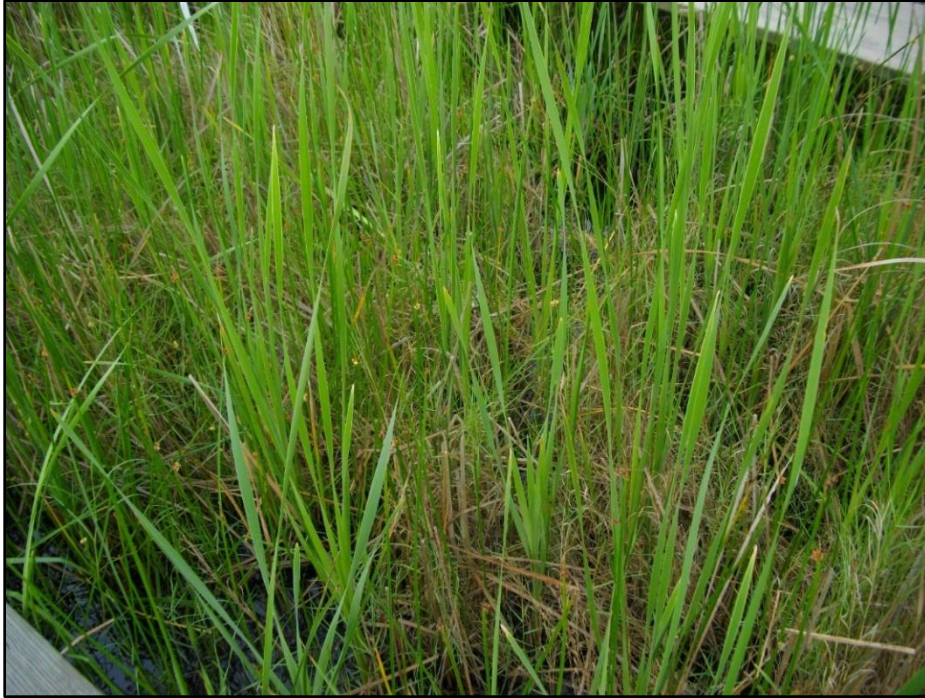
Figure 74. CRMS0635 RSET station in the spring of 2015; this shows a response to freshwater flooding, which is causing the vegetation to transition from *Spartina patens* dominated vegetation to *Typha* dominated. This is a more preferable food source for nutria and muskrats

During the CRMS monitoring timeframe, there have been periods of intense drought, flooding, and storms. These are powerful effects independently but when transitioning between extremes rapidly it intensifies the stress to the vegetated marsh surface causing species switching and destabilization. One of these events was captured at CRMS0635 in Sabine National Wildlife Refuge during a period of sea level acceleration and localized flooding. From spring 2016 to fall 2016 the RSET elevation loss was nearly 18 cm caused by herbivory during a freshwater flood resulting in vegetation removal (Figure 73). As the vegetation was completely destroyed in a previously health marsh platform, this caused the soil surface to destabilize and liquefy. Through herbivore management and continued flooded fresh conditions, the vegetation returned and the soil surface stabilized regaining pre disruption elevations (Figures 74-76).

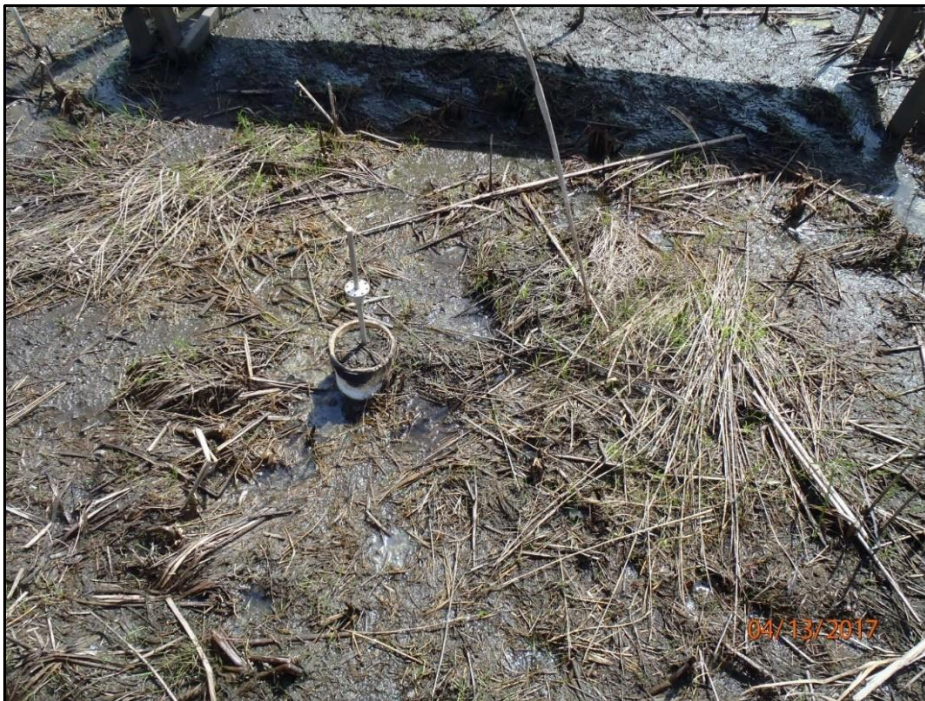
Figure 75. CRMS0635 RSET station in the spring of 2017 after a winter herbivory event at the site denuded the vegetation and destabilized the soil

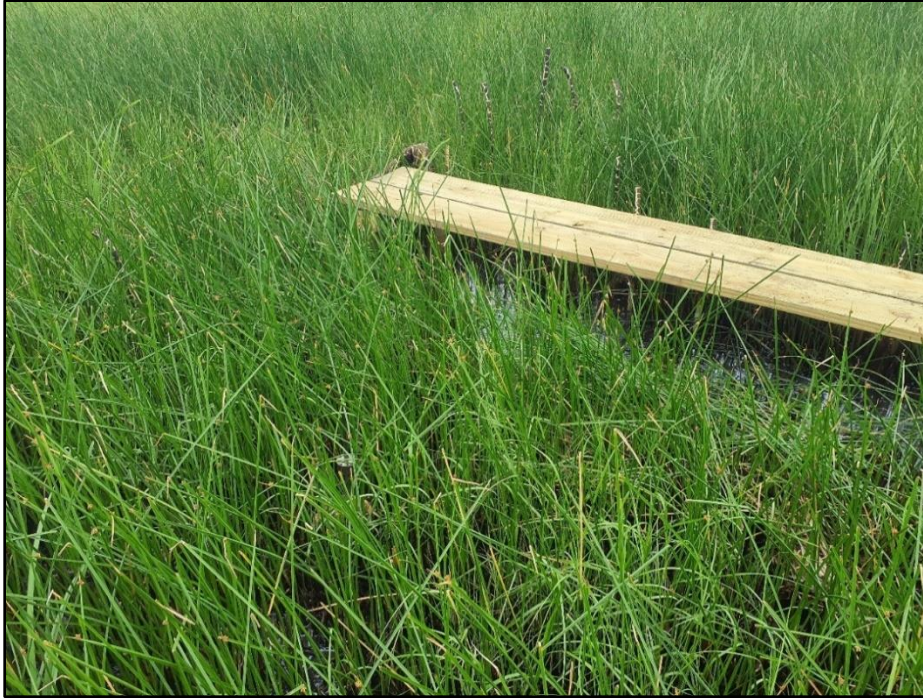
Figure 76. CRMS0635 RSET station in the spring of 2025, post winter fire showing full recovery of both the marsh vegetation and the elevation of the marsh platform

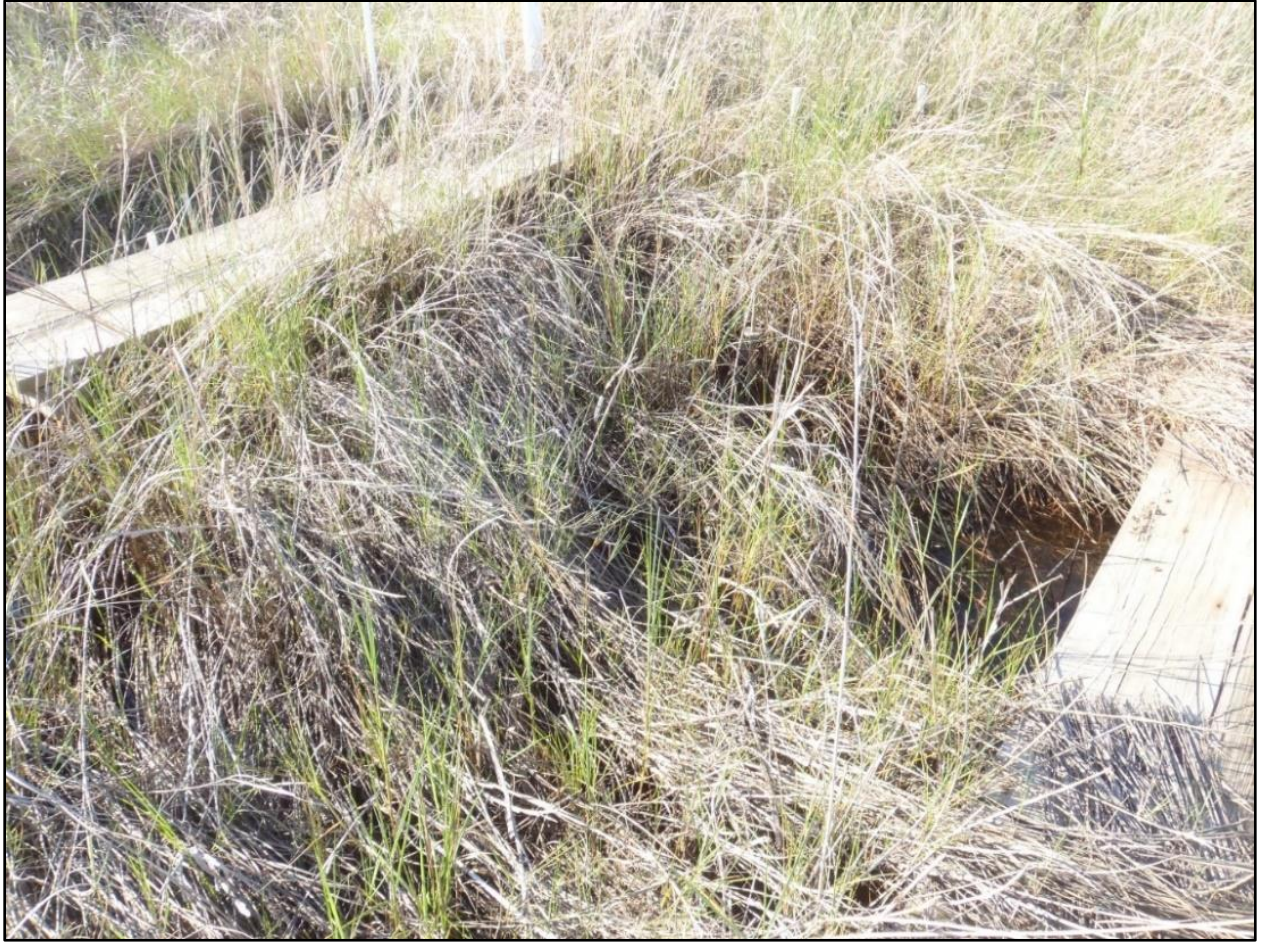
Figure 78. CRMS0553 RSET station in the spring of 2013 dominated by *Spartina patens*

CRMS0553 north of Little Cheniere in the Mermentau basin also experienced a vegetation switching from intermediate to fresh along with an herbivory event (Figures 77-80). But this site recovered almost 30 cm of elevation facilitated by the marsh platform floating and further stabilized by organic deposition from hurricanes in 2020 and herbaceous growth. That elevation was maintained even as drought and low water dominated the hydrologic conditions from 2023-2025. This dramatic elevation gain if maintained moving forward is a relatively understudied mechanism for impounded marshes to maintain elevation with a lack of mineral deposition.

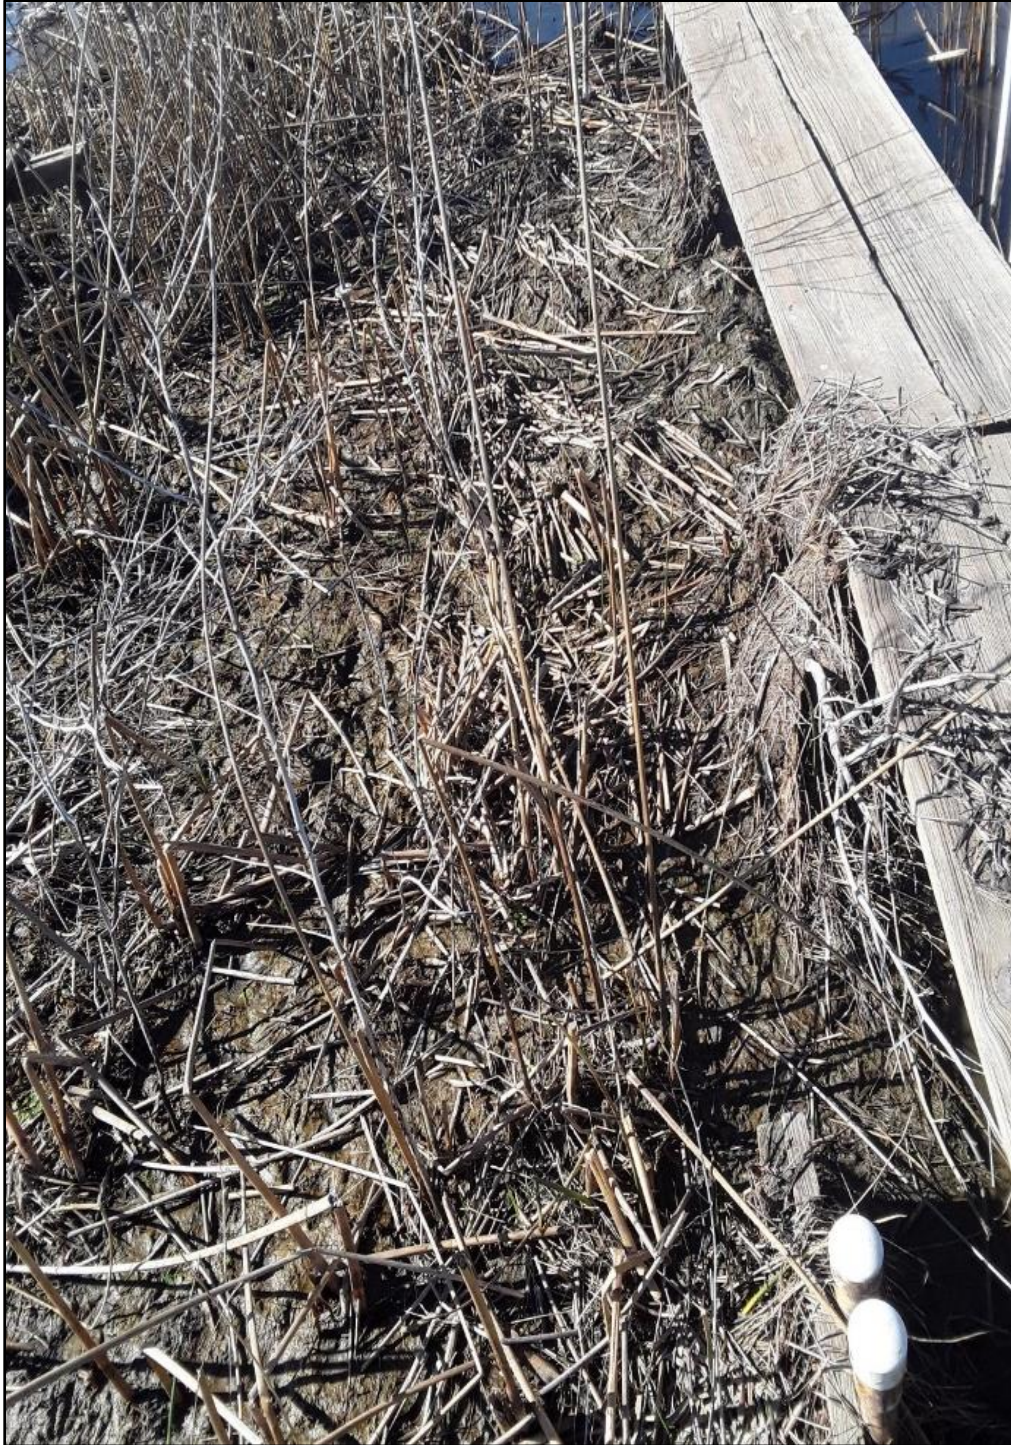
Figure 79. CRMS0553 RSET station in the spring of 2021 showing a floating marsh platform of dead above ground vegetation and live root mass
