COASTWIDE REFERENCE MONITORING SYSTEM (CRMS)

# CRMS SITES THAT HIGHLIGHT COASTAL PROCESSES

APPENDIX C

REPORT: VERSION 01

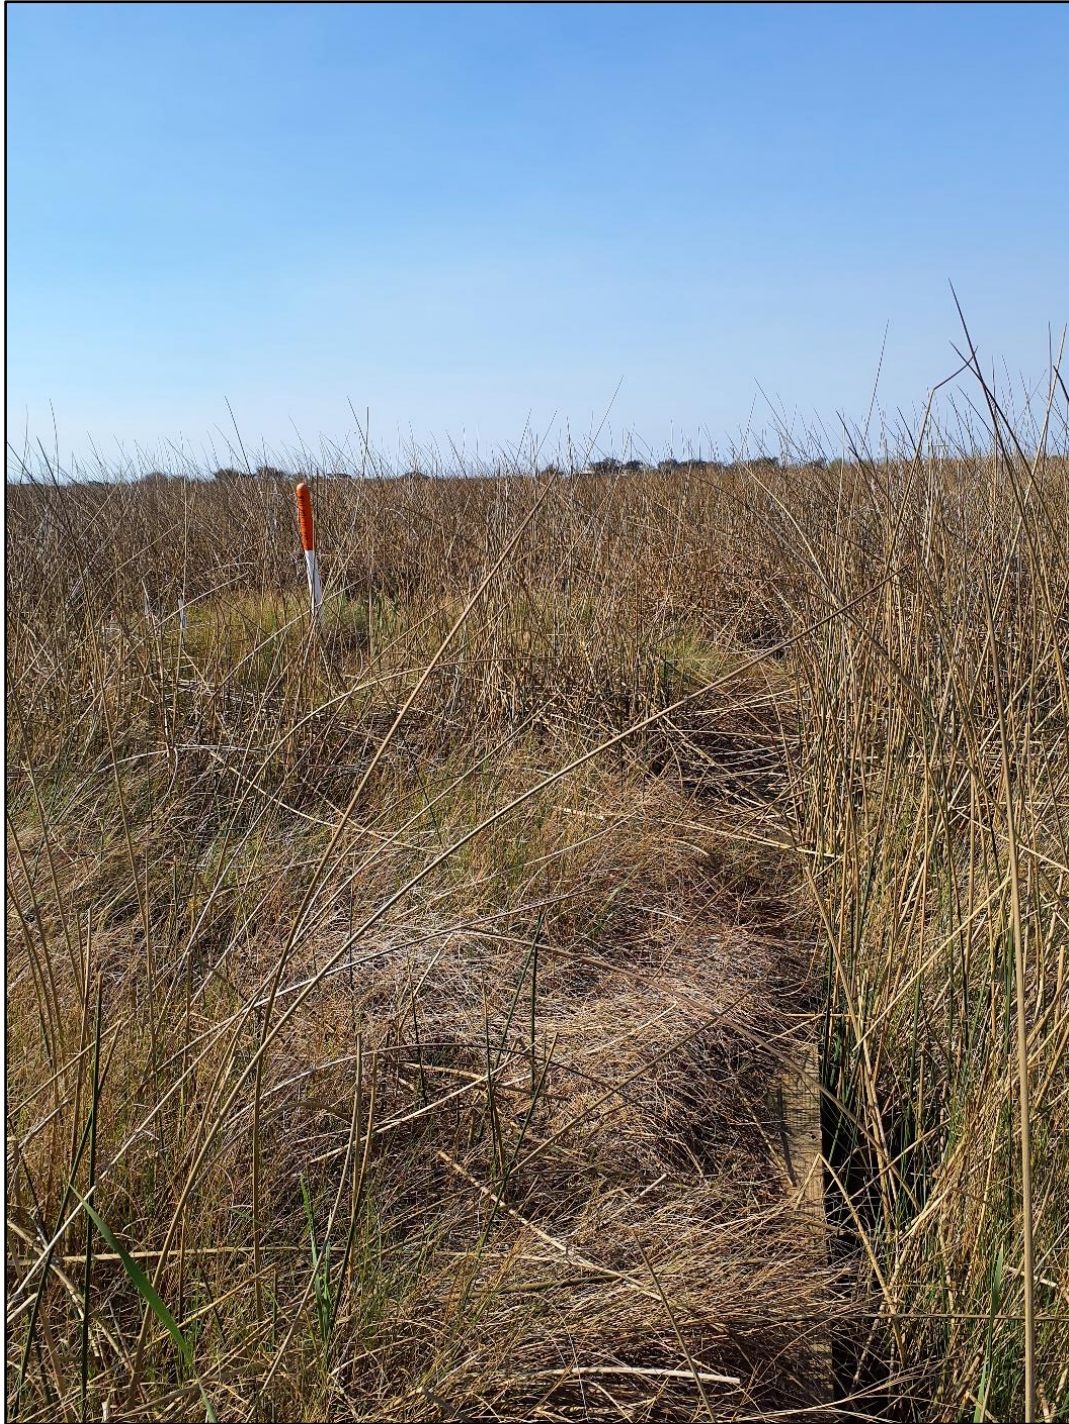
Figure 80. CRMS0553 RSET station in the spring of 2025 displaying a thriving marsh, while maintaining the elevation gained through floating and hurricane deposition

CRMS0553 north of Little Cheniere in the Mermentau basin also experienced a vegetation switching from intermediate to fresh along with an herbivory event (Figures 77-80). But this site recovered almost 30 cm of elevation facilitated by the marsh platform floating and further stabilized by organic deposition from hurricanes in 2020 and herbaceous growth. That elevation was maintained even as drought and low water dominated the hydrologic conditions from 2023-2025. This dramatic elevation gain if maintained moving forward is a relatively understudied mechanism for impounded marshes to maintain elevation with a lack of mineral deposition.
