**Coastal Protection and Restoration Authority  
of Louisiana (CPRA)**

## **2015 Short Summary Report**

## **Highway 384 Hydrologic Restoration (CS-21)**

State Project Number CS-21  
Priority Project List 2

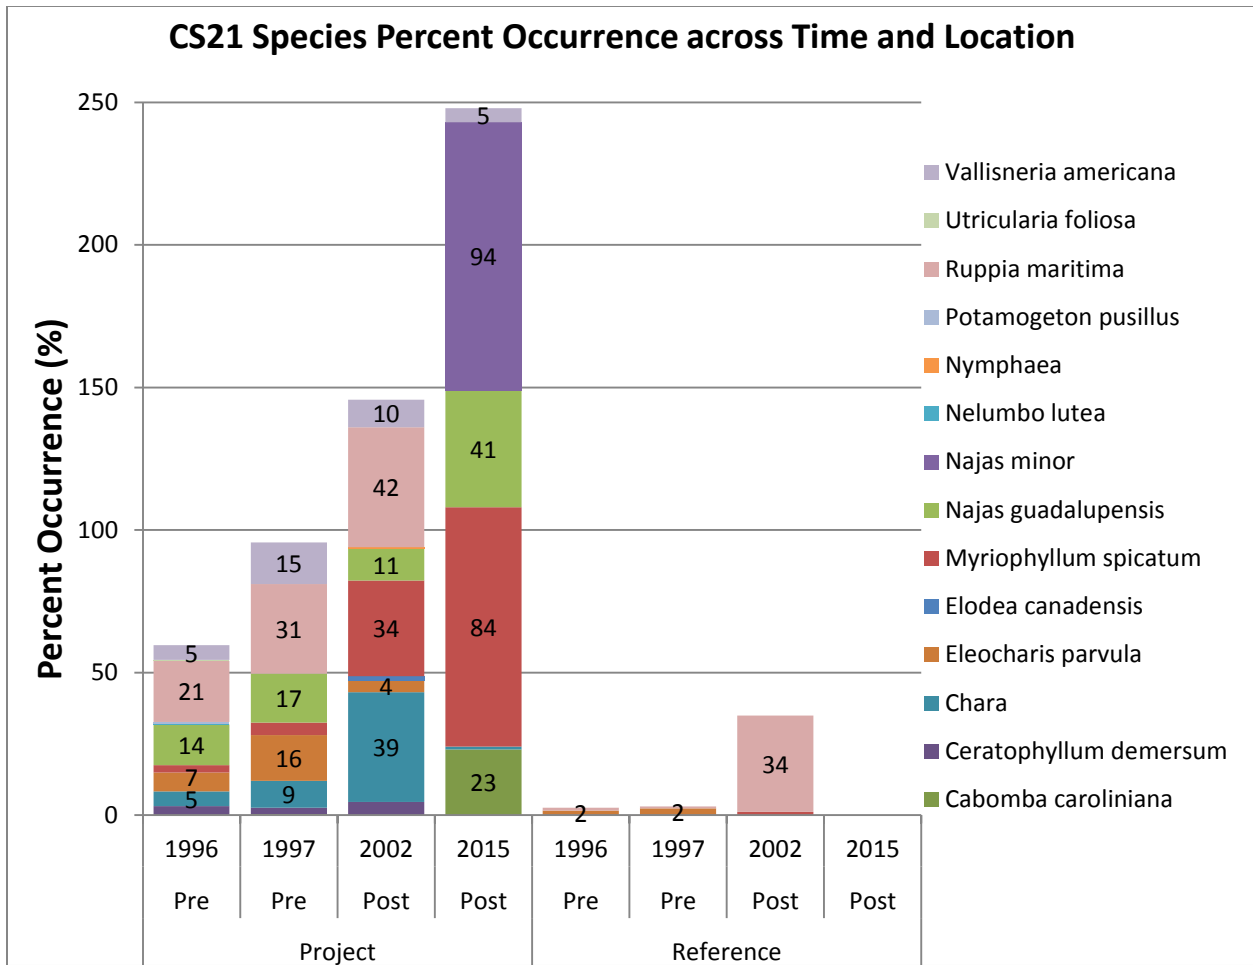
**Figure 2.** Percent occurrence of SAV species within the project and reference area pre-and post-construction.

The project goal for SAV was to increase cover or frequency of occurrence. SAV was measured pre-construction in 1996 and 1997 and post-construction in 2002 and 2015 (Figure 2). SAV cover increased every year measured in the project area while it was rarely present in the reference area (Figure 3).

In 1996, 1997, and 2002 the project area was dominated by *Ruppia maritima* with some *Najas guadalupensis*, *Myriophyllum spicatum*, and a few other SAV species (Figure 2). In the reference area a very small amount of *R. maritima* was found in 1996 and 1997, some in 2002.

In 2015, the project area was still covered in SAV, but the dominant species had shifted from the more salt tolerant *R. maritima* to fresher species like *M. spicatum* and *Najas minor*. No SAV was found in the reference area in 2015. Salinities during sampling in 2015 were <1 ppt in the project area and over 16 ppt in the reference area. Water levels were so low that several ponds in the project area were dry in 2015.

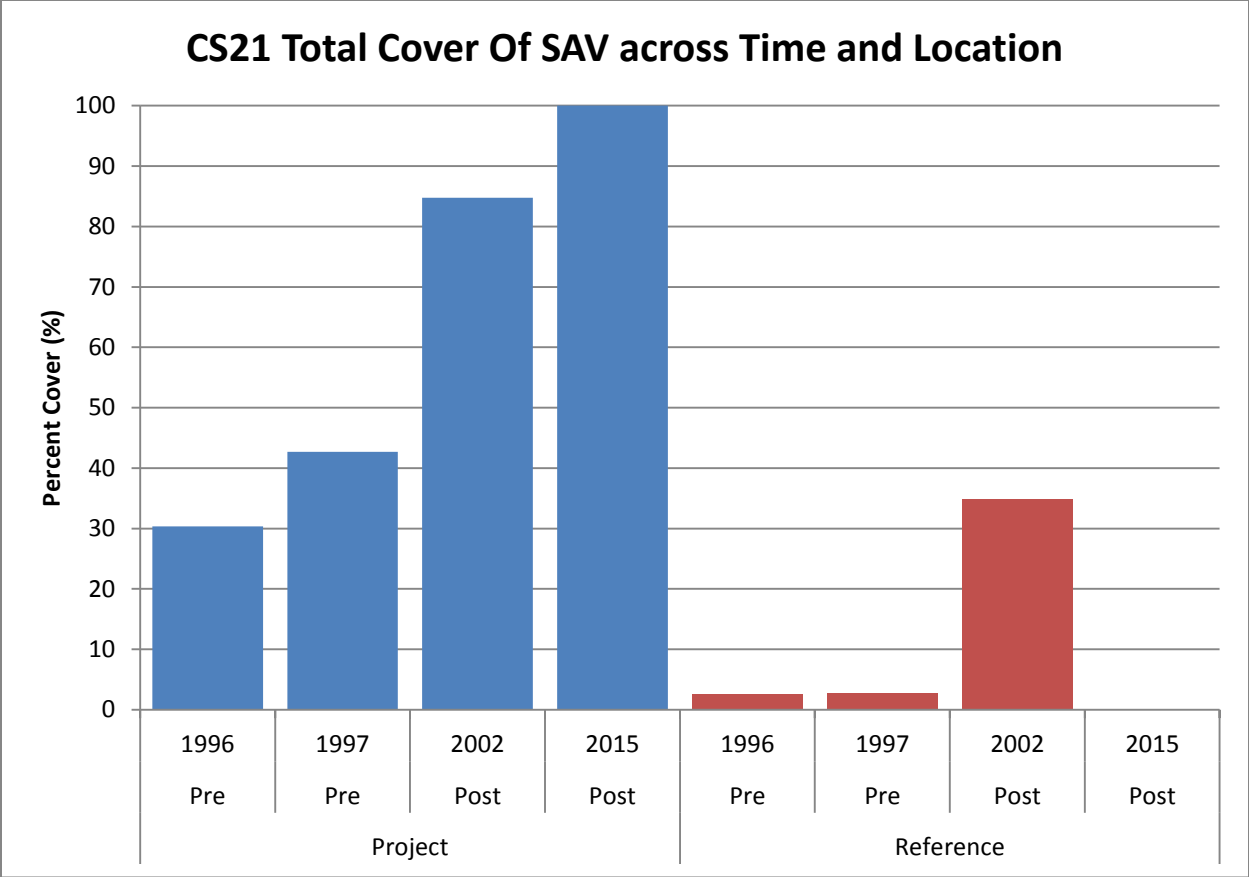
**Figure 3.** Total percent cover of SAV within the project and reference area for pre-construction in 1996 and 1997 and post-construction in 2002 and 2015.

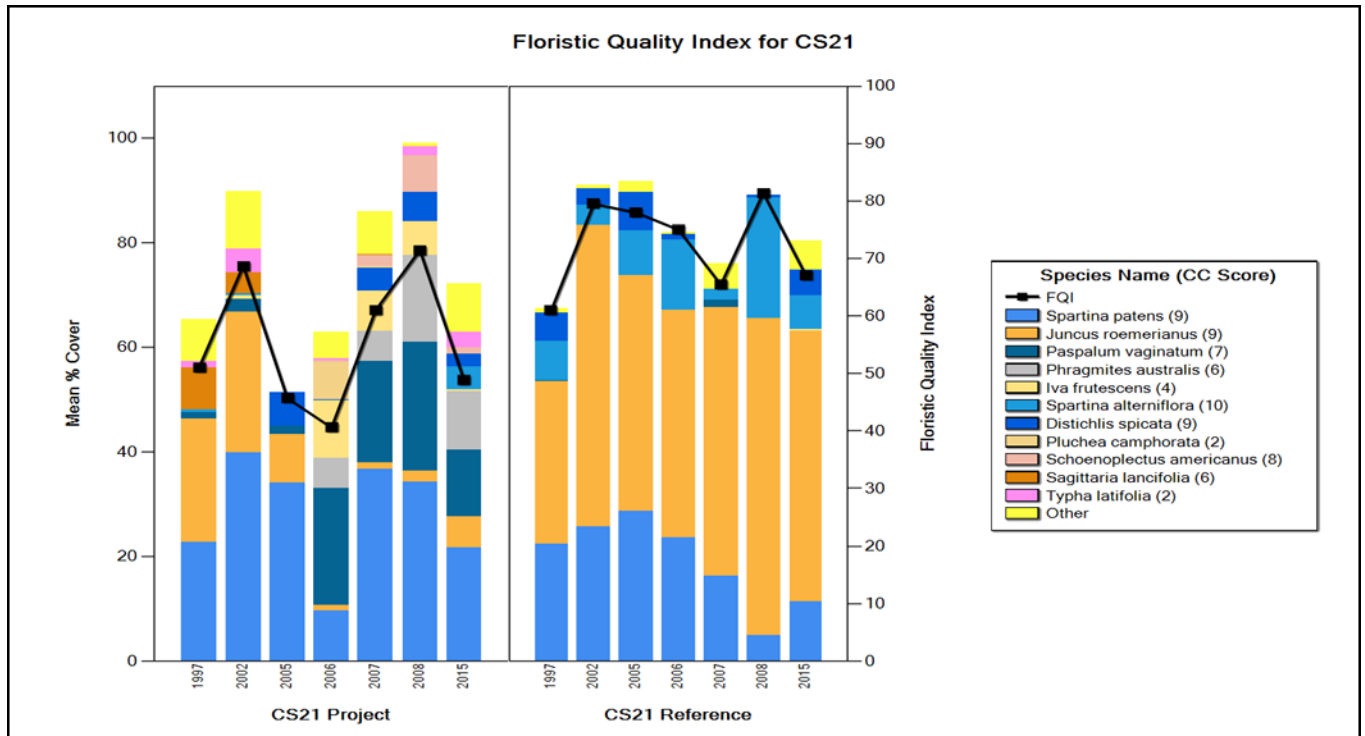
**Figure 4.** Floristic Quality Index (FQI) and mean % cover of emergent vegetation species within the project and the reference area from 1997 to 2015.

The project goal for emergent vegetation was to increase cover in the project area. Vegetation recovered from Hurricane Rita from 2006 to 2008 but had decreased overall by 2015, most likely due to very dry conditions (Figure 4). Vegetation in the project area has shifted from Saline species to Intermediate species over time and is now dominated by *Spartina patens* and *Paspalum vaginatum* along with several other species including *Phragmites australis*, *Distichlis spicata*, *Juncus roemerianus* and *Pluchea camphorata*. Cover of saline vegetation in the reference area has remained high throughout the project.
