2014/2015 Annual Inspection Report

Replace Sabine Refuge Water Control Structures at Headquarters Canal, West Cove Canal, and Hog Island Gully (CS-23)

State Project Number CS-23 Priority Project List 3

November 12, 2014 Cameron Parish

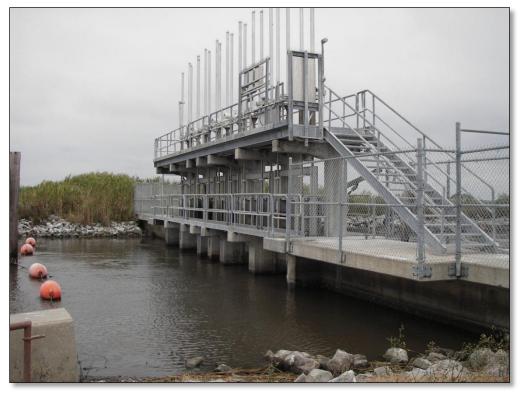
The structure is in fully operational condition as a result of the 2011 maintenance event. The conversion from single to dual stems appears to have helped with the operation of the gates. (Photos: Appendix B, Photos 1 - 2)

Photo No. 1, Hog Island Gully Structure looking from the Hwy 27 side

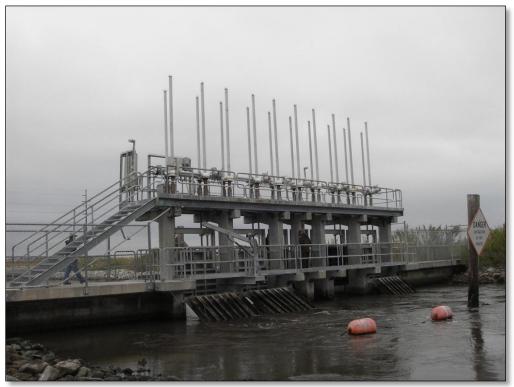
Photo No. 2, Hog Island Gully Structure from the Calcasieu Lake side– gates being exercised and in open position

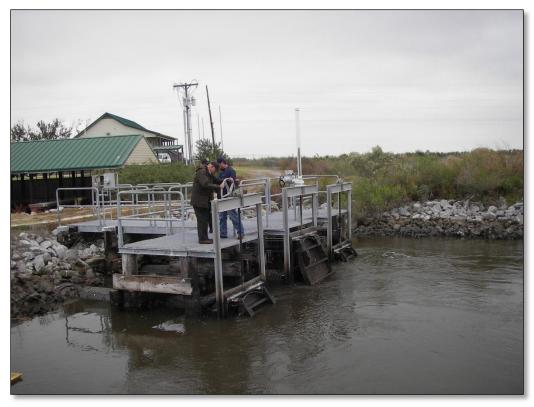
The structure is in fully operational condition as a result of the 2011 maintenance event. (Photos: Appendix B, Photos 3-4).

Photo No. 3, Headquarters Structure with outside flapgates flapping

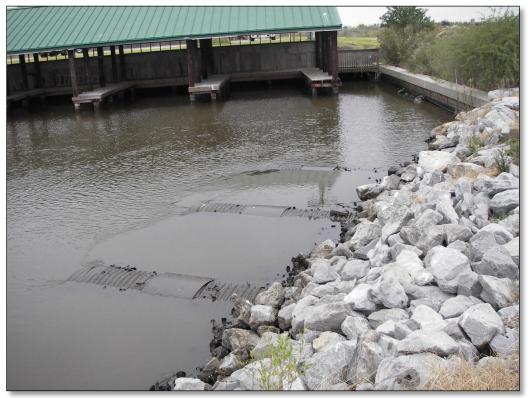
Photo No. 4, Headquarters Structure marsh side culverts with riprap

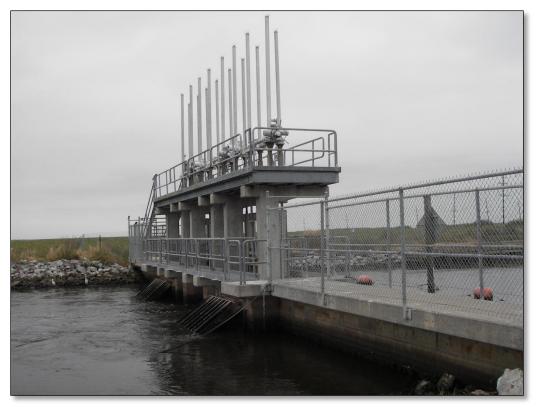
Gate 2A is not working due to a problem with the actuator motor. A quote was obtained from Custom Actuation and CPRA is in the process of developing a purchase order for repair. (Photos: Appendix B, Photos 5-6).

Photo No. 5, West Cove Canal Calcasieu Lake side of structure with flapgate flapping

The Gate 2A actuator (motor) at West Cove will be replaced upon the issuance of a purchase order. The Sabine Refuge Structure replacement project structures are operating well with occasional minor repair issues on a few gates needing periodic maintenance.

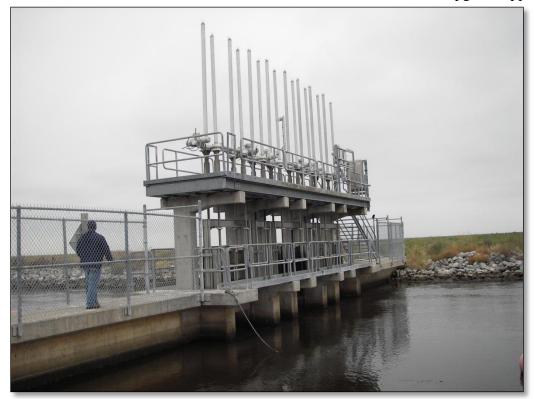
Photo No. 6, West Cove Canal from Hwy 27 side – gates being exercised and in open position
