Monitoring Series No. CS-19-MSTY-1200-3

CLOSEOUT MONITORING REPORT  
For the period April 01, 1994 to December 31, 2000

**WEST HACKBERY PLANTINGS AND SEDIMENT  
ENHANCEMENT  
CS-19**

**First Priority List Vegetative Planting Project  
of the Coastal Wetlands Planning, Protection, and Restoration Act  
(Public Law 101-646)**

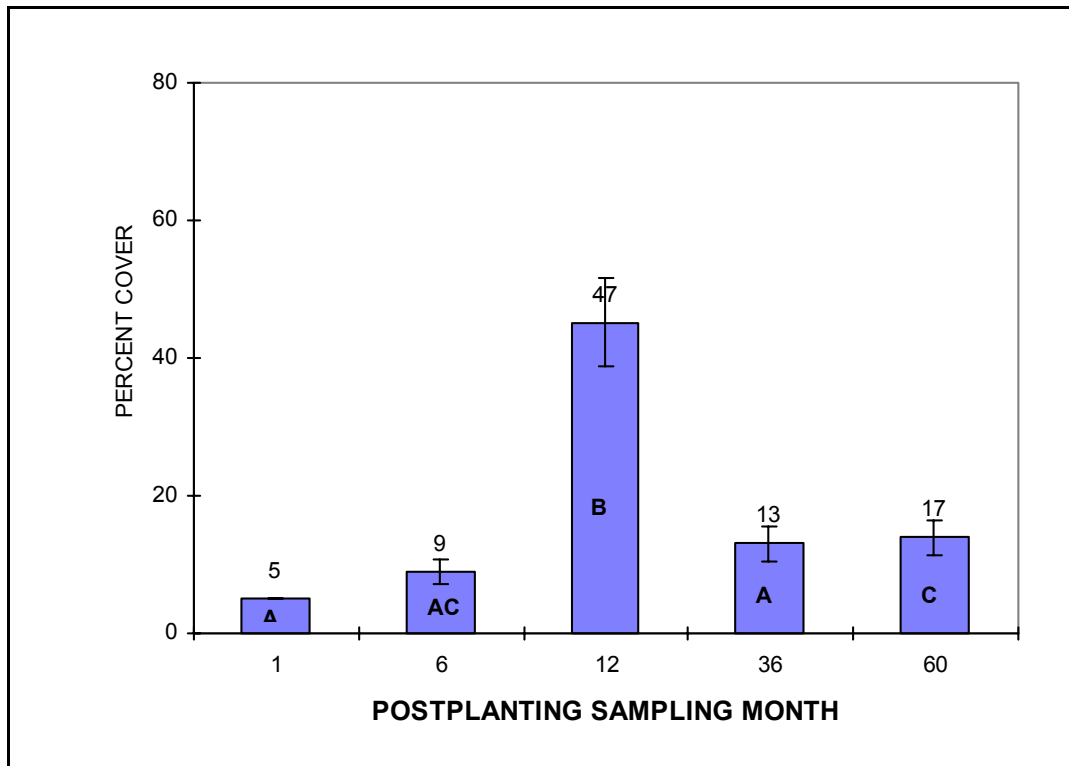
The mean percent cover at 1, 6, 12, 36 and 60 mo postplanting was 5.0%, 9.0%, 47.0%, 13.0% and 17.0%, respectively (figure 5). The results of the ANOVA indicate a significant difference ( $p \leq 0.05$ ) in percent cover over time (table 1). Significant differences ( $p < 0.05$ ) in percent cover occurred between 1 - 12 mo ( $p = 0.028$ ), 6 - 12 mo ( $p = 0.005$ ), 12 - 36 mo ( $p = 0.003$ ) and 12 - 60 mo ( $p = 0.005$ ), respectively. The largest decrease in vegetative cover was noticed after month 12 when high salinity water entered into the project area during the drought of 1996 (figure 5).

**Figure 5.** Mean percent cover of *S. californicus* plantings in 16 random sampling plots from August 1994 to August 2000. Plantings observed at 1, 6, 12, 36, and 60 mo postplanting. Similar letters on histogram columns indicate no significant differences among time periods

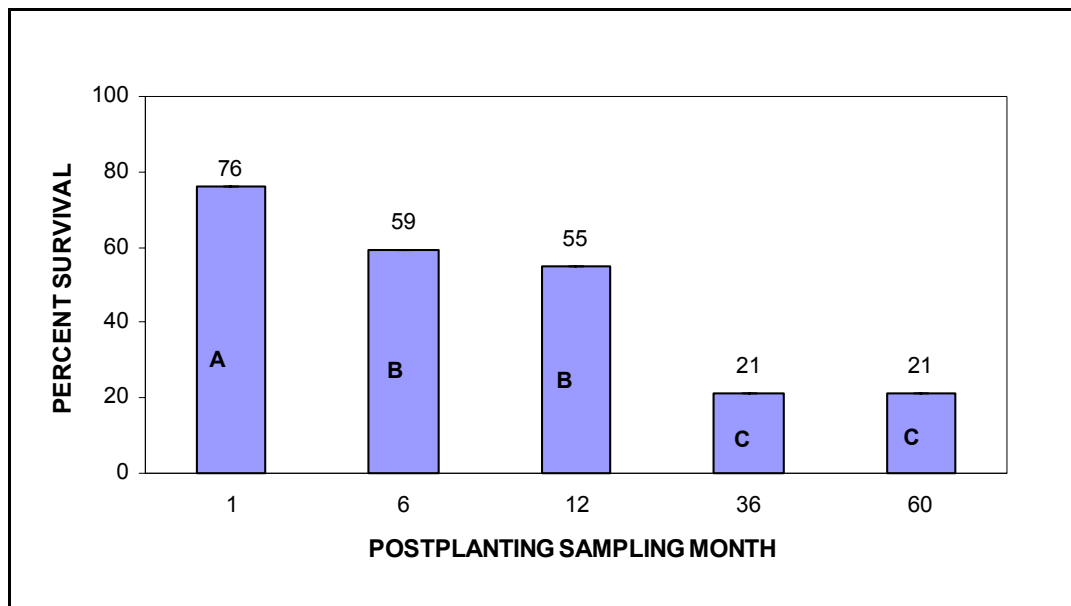
**Vegetation Plantings Survival:** Survivorship (percent survival) decreased during the first 36 mo postplanting, averaging 76.0%, 59.0%, 55.0% and 21.0% at 1, 6, 12 and 36 mo postplanting, respectively (figure 6). Survivorship remained at 21.0% through month 60. The results of the ANOVA indicate a significant difference in the survivorship of the planting groups over time (table 2). Least square means multiple comparisons of the survivorship values indicate that there were significant differences between 1 - 6 mo, 1 - 12 mo, 1 - 36 mo, 1 - 60 mo, 6 - 36 mo, 6 - 60 mo, 12 - 36 mo and 12 - 60 mo postplanting (figure 6).

**Figure 6.** Mean survivorship of *S. californicus* plantings in 16 random sampling plots from August 1994 to August 2000. Plantings observed at 1, 6, 12, 36, and 60 mo postplanting. Similar letters on histogram columns indicate no significant difference among time periods.

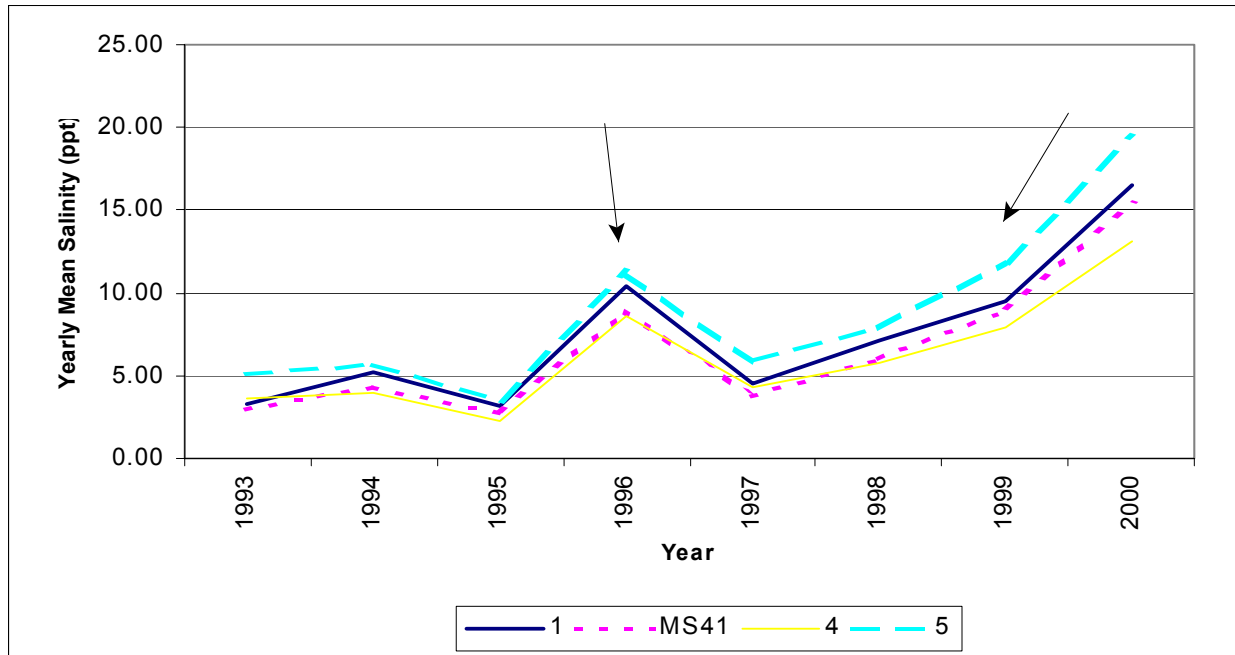
Analysis of pre- (September 1993 to June 1994) and postconstruction (July 1994 to August 2000) water salinity data from the Rycade Canal (CS-02) project, which influences salinity in the West Hackberry Plantings project area, indicates that salinity averaged 4.0 ppt in the vicinity of the West Hackberry plantings during that period of record (Weifenbach 1996). *Scirpus californicus* is described as common to intermediate marshes (Chabreck 1972), but the salinity tolerance for *S. californicus* is not documented. Data collected for this project indicate that *S. californicus* plantings can easily tolerate salinity of up to 6.0 ppt for short periods after initially planted, and can tolerate salinity of up to 10.0 ppt after plantings become established. Plantings that survived appear to have been those that were the most vigorous before the 1996 drought, which suggests that larger stands may tolerate higher salinity better than smaller stands. In addition, salinity averaged slightly higher on the eastern half than on the western half of the West Hackberry plantings area for each year, further suggesting that die-back of the plantings was associated with high salinity.

**Figure 7.** Yearly mean discrete salinity averages in the West Hackberry Planting project area at stations 1, MS41, 4 and 5 depicting salinity ranges for years 1993 to 2000. (Based on monthly and bimonthly discrete data collected by LDNR/CRD personnel for the Rycade Canal [CS-02] project.)

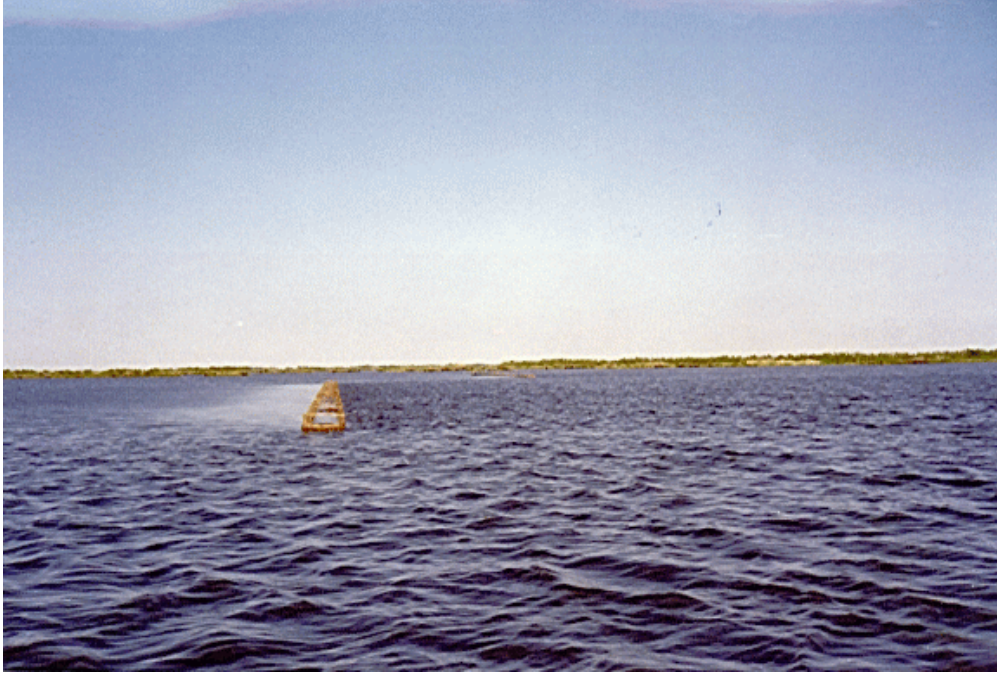
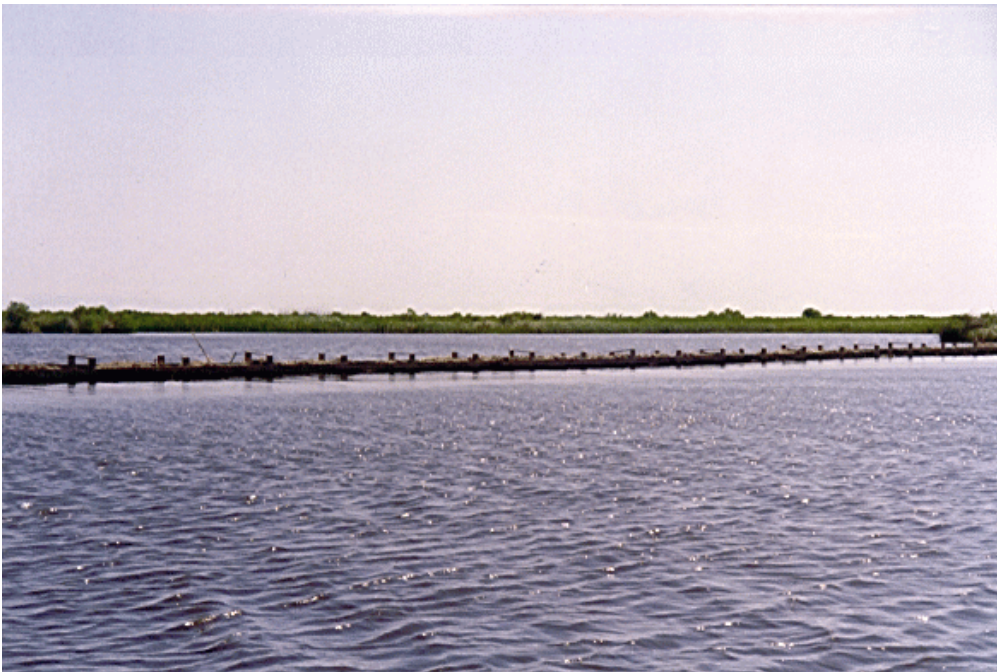
The results demonstrated that hay-bale fences are ineffective at abating wave energy as designed and deployed in this environment due to the hay deteriorating rapidly after exposure to water. Once this happened, even minimal wave action caused the hay bales to break apart. However, the treated lumber fences have remained intact. The fences may serve somewhat as wave damping devices, since they do apparently diminish some of the wind generated wave energy adjacent to the structures (figures A1 and A2).

While the hay bales proved to be unsuitable, the fences used to accommodate the hay bales remained intact and are still unaltered. Due to large spaces between the boards parallel to the water line and the fences being placed up to 100 ft (30.5 m) from the shoreline, wave erosion still occurs but possibly at a slower rate. No data have been collected to determine shoreline erosion rates behind the fences. Minimal calming has been observed periodically.

**Figure A1.** Group C hay-bale fence within the CS-19 project area showing wave damping as a secondary benefit once the hay bales deteriorated.

**Figure A2.** Group B hay bale fencing within the CS-19 project area showing wave damping ability and distance from shoreline the fences were constructed.

The results presented in this report have shown that hay bales cannot be used in a high wave energy system as the bales deteriorate rapidly and wash out of the fence enclosures. Future use of hay bales to control shoreline erosion is not recommended. The fences, constructed of treated lumber, have remained intact and secondarily may serve somewhat as wave damping devices when the fences are within near proximity of the shoreline.

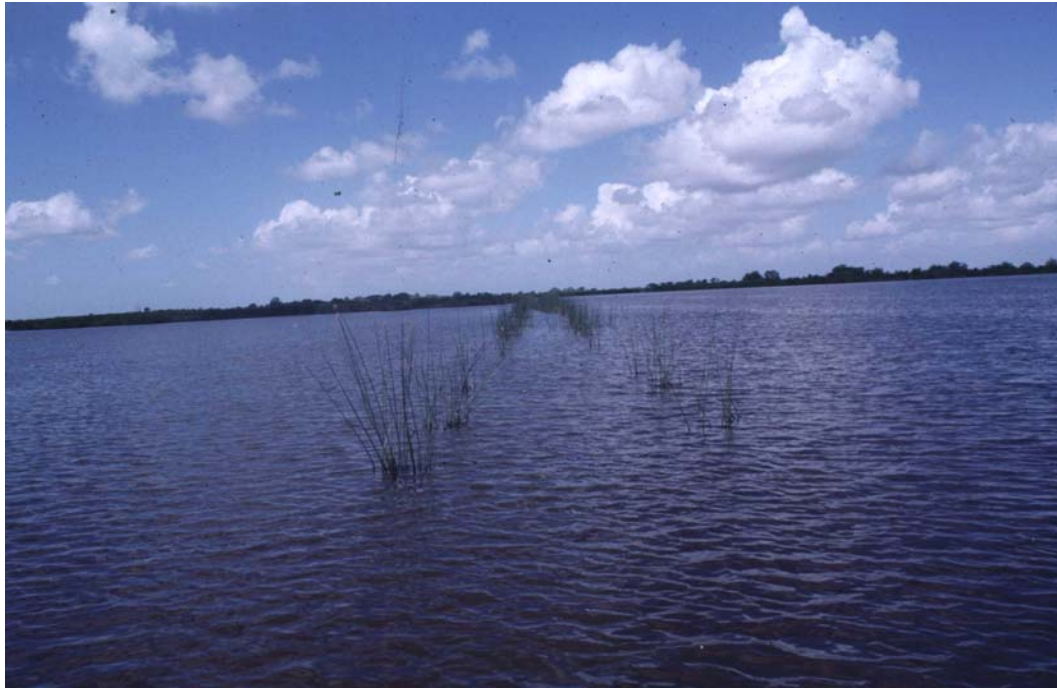
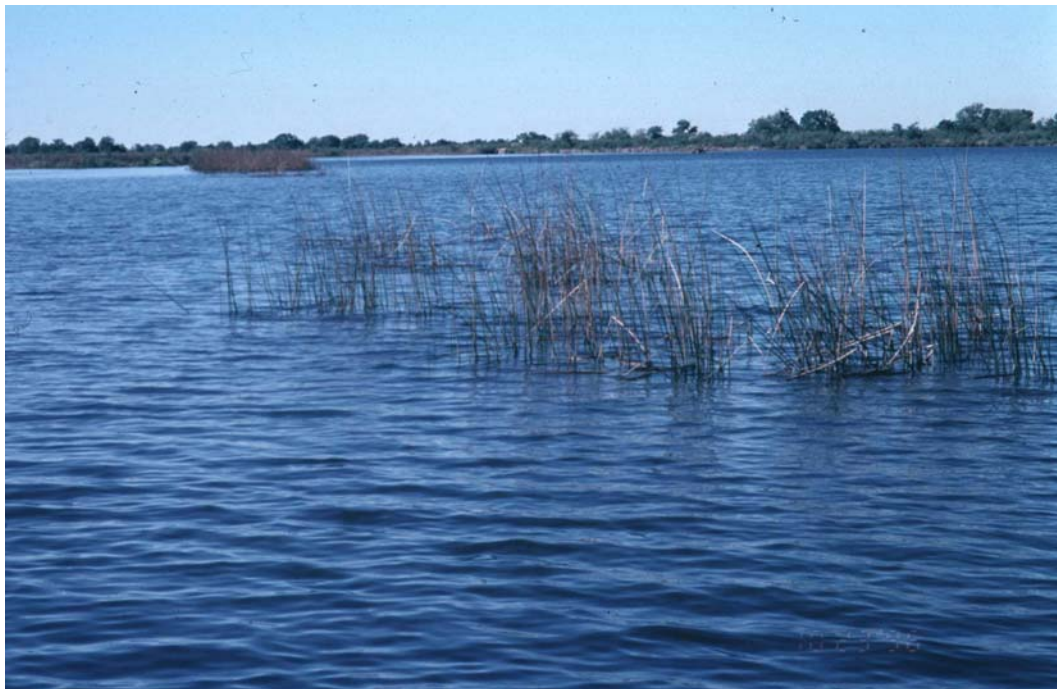
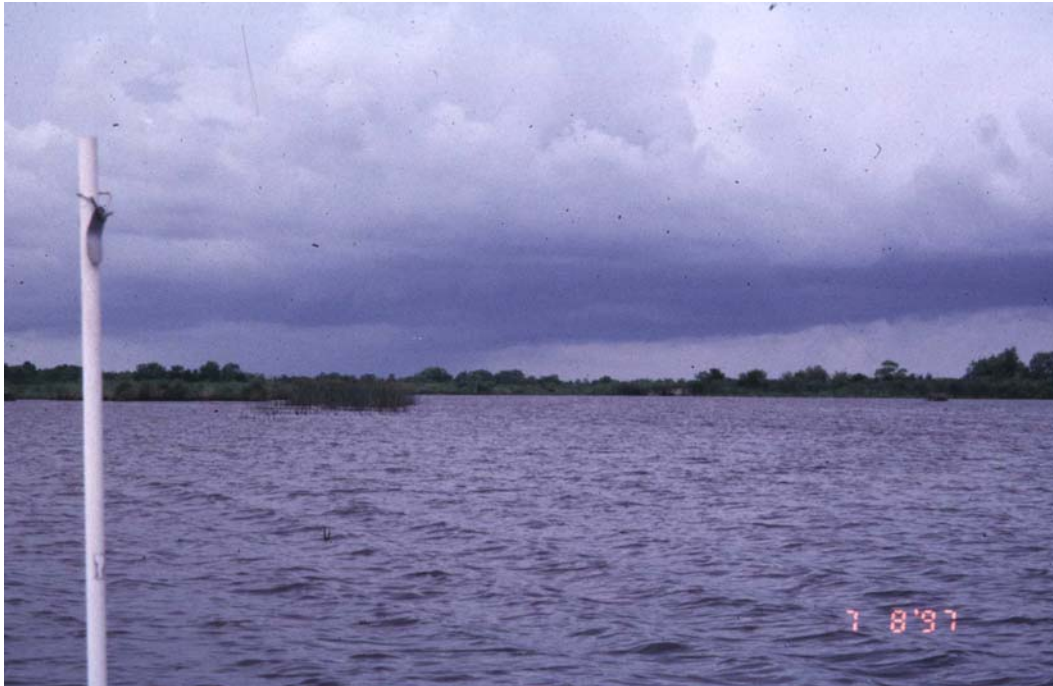
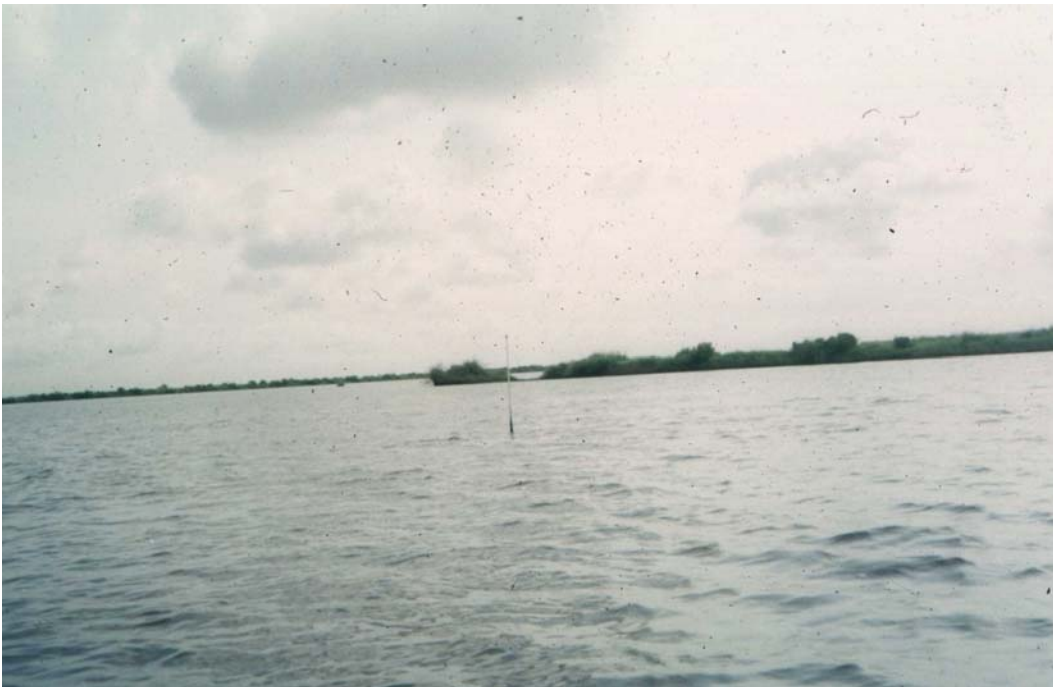
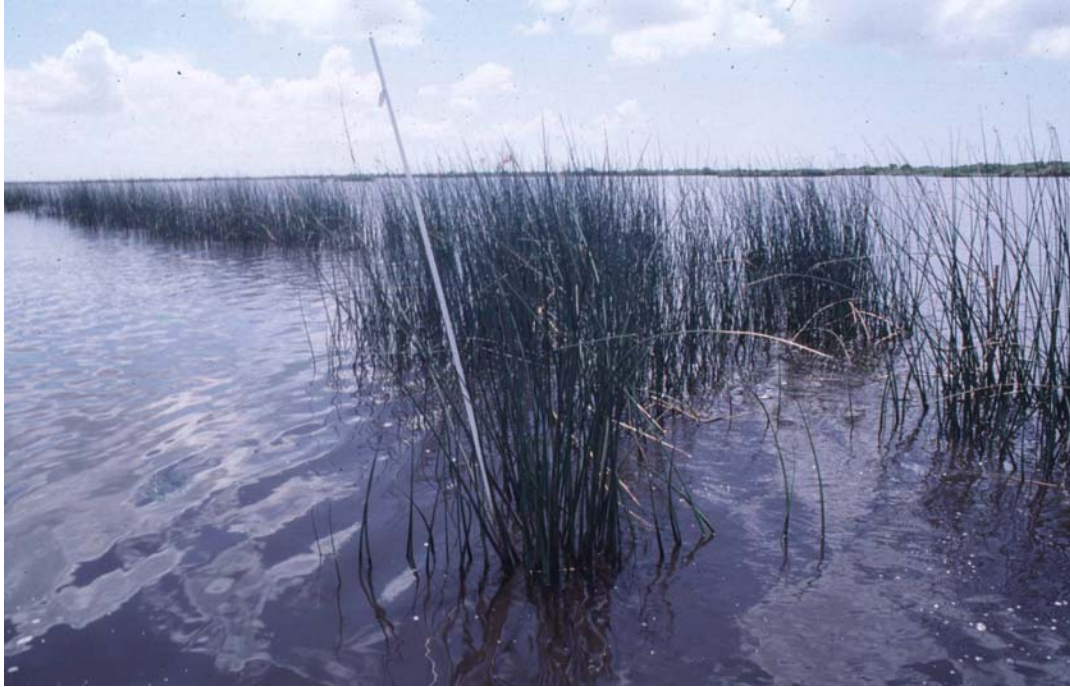
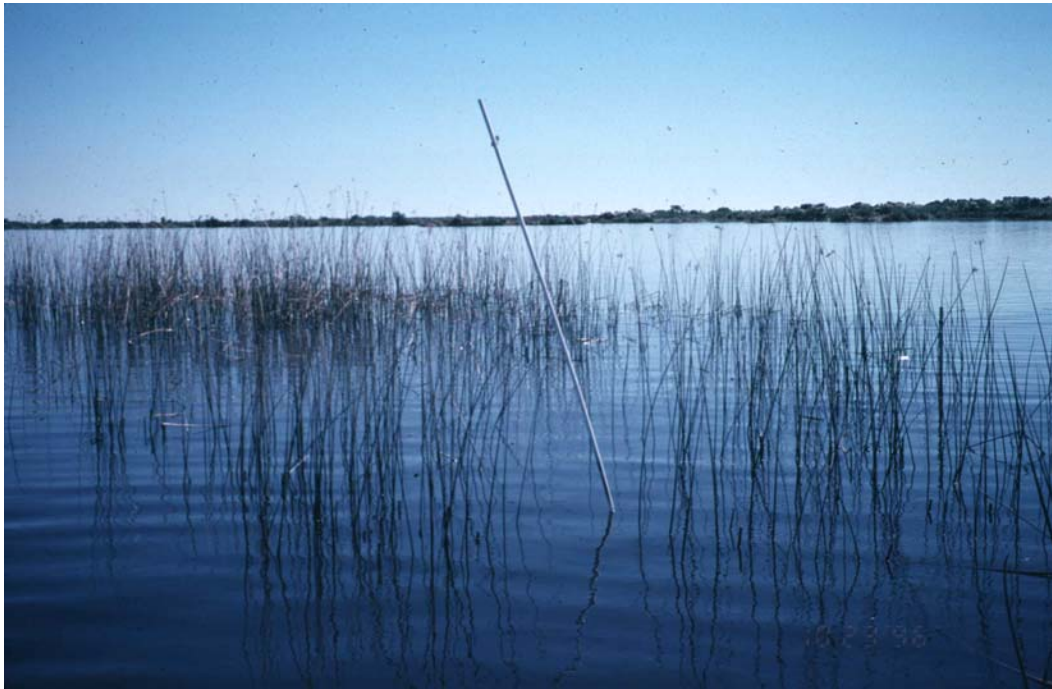
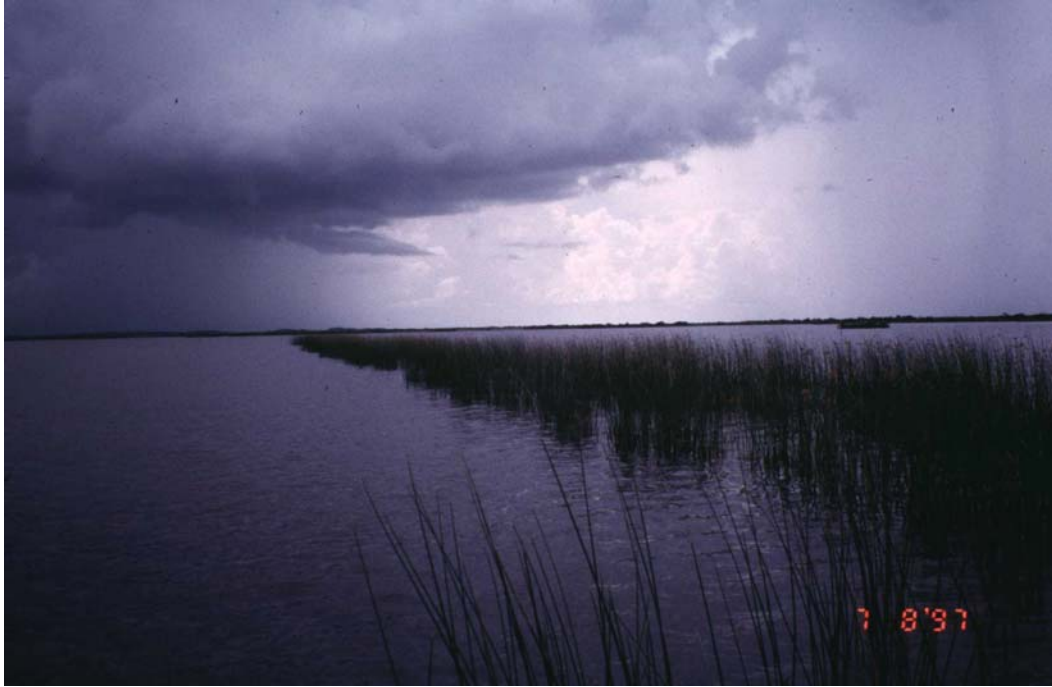
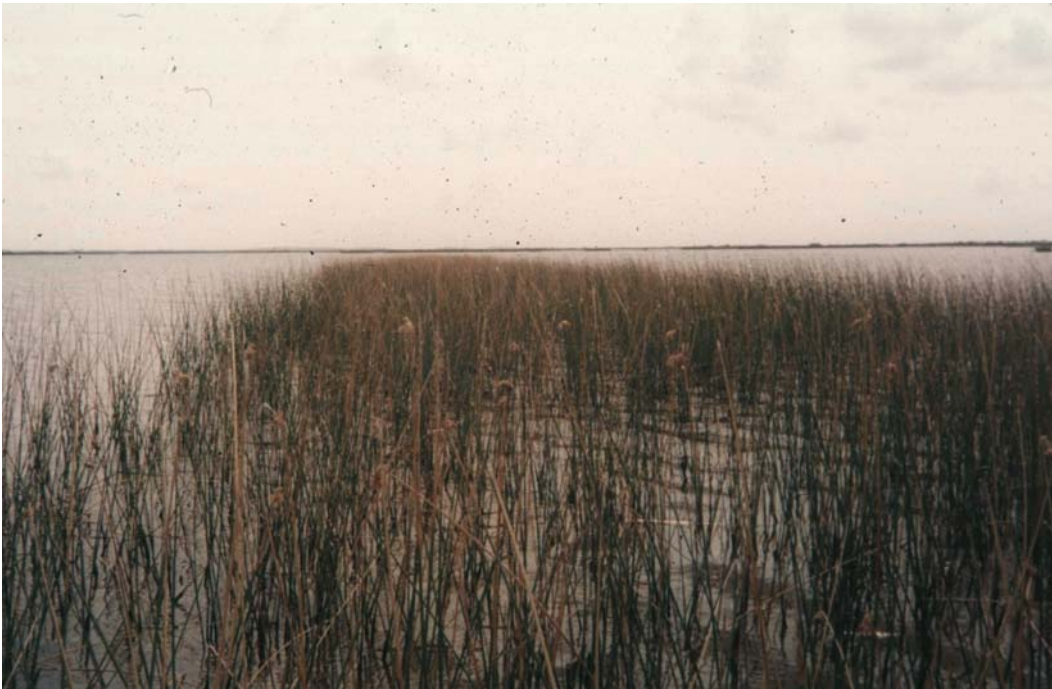
Before the 1996 drought, all mature stems on the plantings were noticed to be dark green in appearance and the greatest percent cover was recorded. After the drought, nearly all of the mature stems on the plantings were brown and appeared to be dead, and most of the remaining transplants did not bear obvious young, green shoots. However, the plantings were growing in approximately 2 ft (0.6 m) of turbid water, and it is likely that any additional new growth was submerged and was not apparent. The planting rows on the east side of the planting area showed the greatest impact. Vigorous growth of the transplants has developed only on the south end of planting row A1, and on rows B1 and B2 (figures A3 to A10).

**Figure A3.** Row A1 vegetative plantings within the CS-19 project area for the 1995 monitoring period.

**Figure A4.** Row A1 vegetative plantings within the CS-19 project area for the 1996 monitoring period.

**Figure A5.** Row A1 vegetative plantings within the CS-19 project area for the 1997 monitoring period.

**Figure A6.** Row A1 vegetative plantings within the CS-19 project area for the 1999 monitoring period.

**Figure A7.** Row B2 vegetative plantings within the CS-19 project area for the 1995 monitoring period.

**Figure A8.** Row B2 vegetative plantings within the CS-19 project area for the 1996 monitoring period.

**Figure A9.** Row B2 vegetative plantings within the CS-19 project area for the 1997 monitoring period.

**Figure A10.** Row B2 vegetative plantings within the CS-19 project area for the 1999 monitoring period.

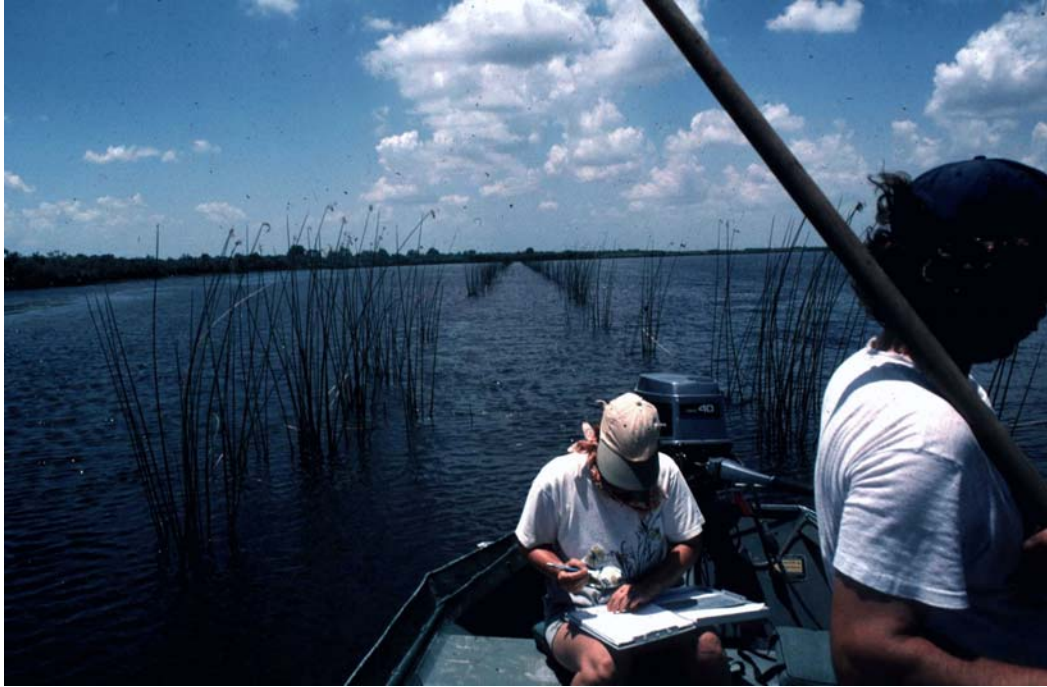
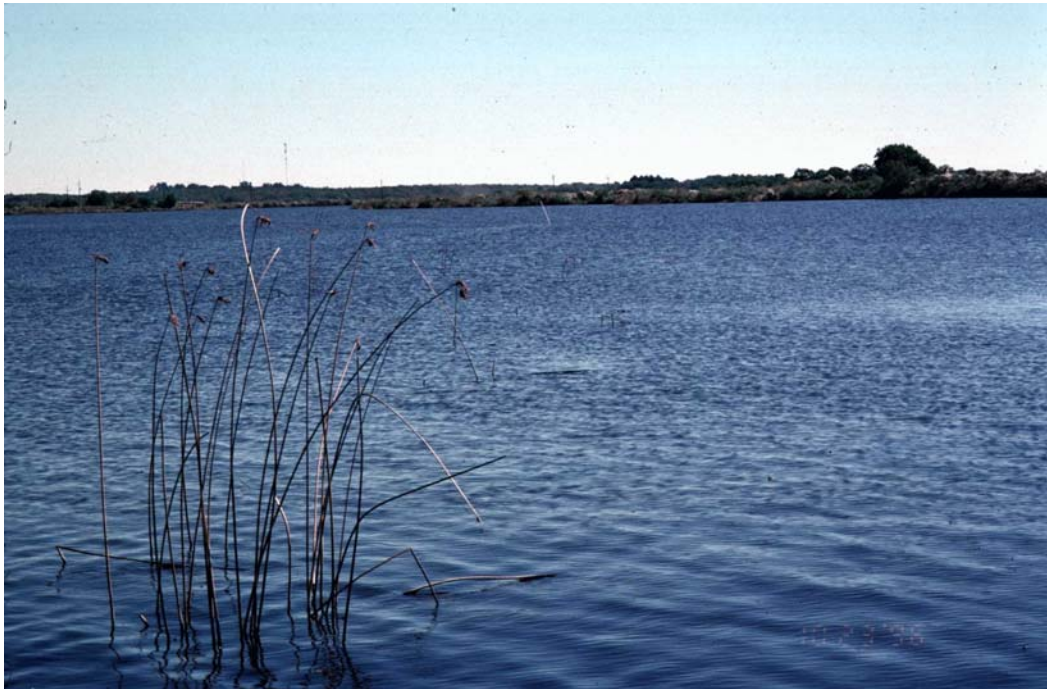
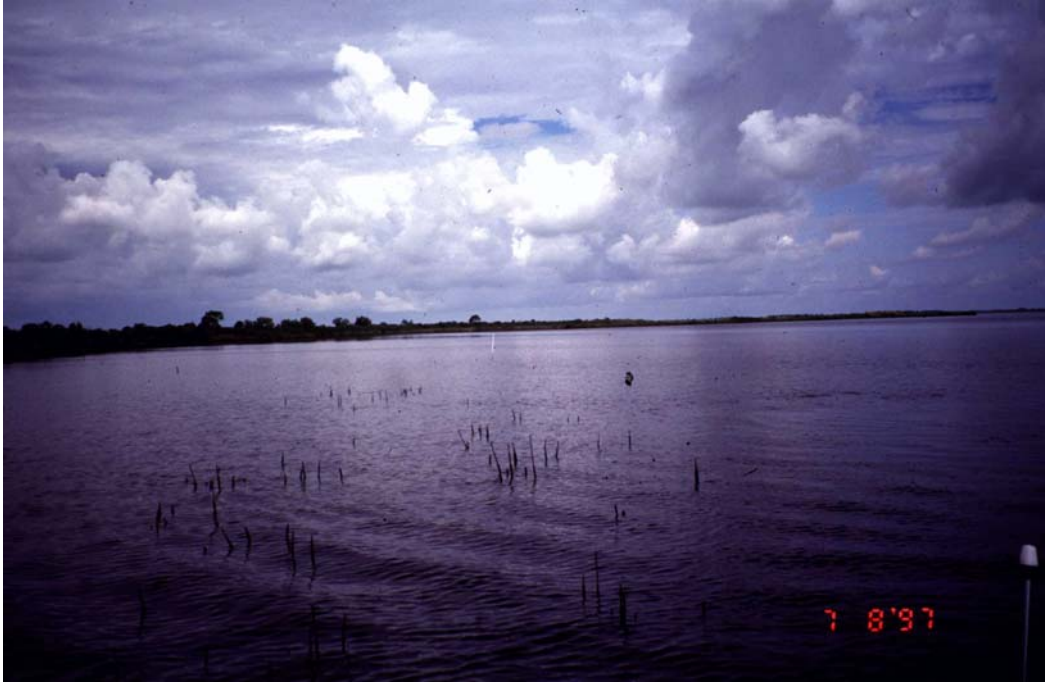
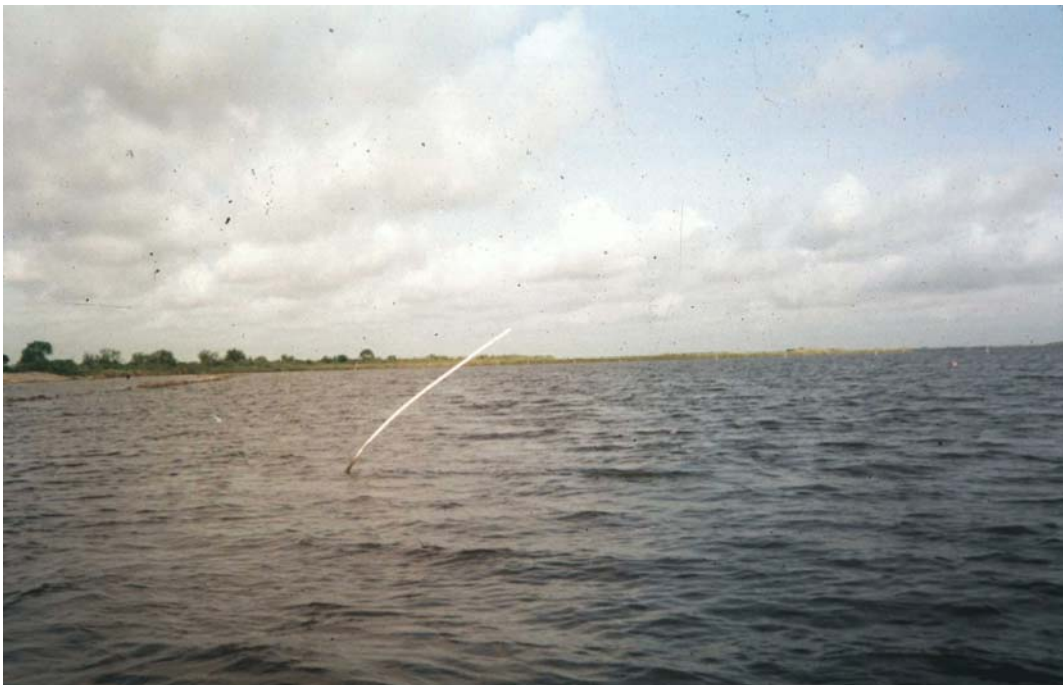
**Figure A11.** Row C3 vegetative plantings within the CS-19 project area for the 1995 monitoring period.

**Figure A12.** Row C3 vegetative plantings within the CS-19 project area for the 1996 monitoring period.

**Figure A13.** Row C3 vegetative plantings within the CS-19 project area for the 1997 monitoring period.

**Figure A14.** Row C3 vegetative plantings within the CS-19 project area for the 1999 monitoring period.
