**Coastal Protection and Restoration
Authority of Louisiana (CPRA)**

2018 Operations, Maintenance, and Monitoring Report: Final Closeout Report

Non-rock Alternatives to Shoreline Protection Demonstration Project (LA-0016)

State Project Number LA-0016
Priority Project List 18

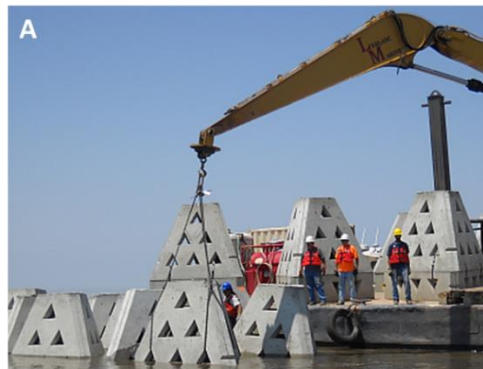
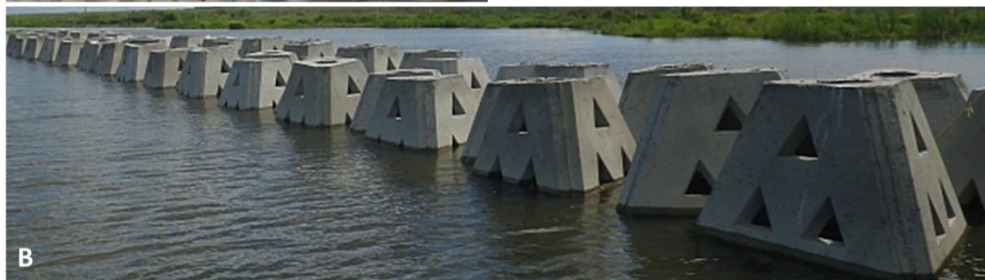
Figure 6. (A) Installation of Wave Attenuation Devices (WADs). Note metal bands attaching the base to the bottom of the WAD. (B) The initial alignment of WADs at Shark Island along the northeastern shore of Vermilion Bay for LA-0016 Non-rock Alternatives to Shoreline Protection Demonstration Project.

The alignment of the product was shifted during installation, because a tugboat scoured a hole on the south end of the project and made the water bottom too deep and irregular. WADs #1 and 3 were moved from the bay side of the structure to the shore side, and the hole was backfilled with seven, smaller WADs (Fig. 7A).

- The bands that connected the top and base pieces of the WADs were primarily designed to assist in installation (Fig. 6A); however, they did not hold up through the monitoring period, and contributed to WAD shifting and toppling.
 - Consider manufacturing each WAD and base as a single piece. If multiple components are needed, then a better connection method should be considered to ensure stability over a longer duration.
- The concrete on one WAD came completely apart and the concrete was broken into many large pieces. It appeared that the reinforcement fibers used in the concrete mix design were poorly distributed.
 - Consider increasing quality control observations during concrete mixing to ensure even distribution of reinforcement fibers.

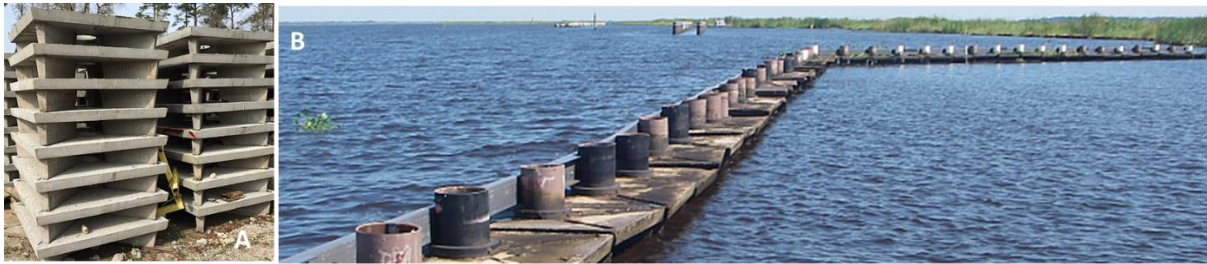
The ESUs were installed half way through the LA-0016 project life in November 2015; monitoring resumed on the schedule of the other products and lasted for one and one-half years. They are designed to convert wave energy to calm water. The ESUs structure consists of pile-supported concrete units; the pile is 12 inch fiberglass tubing driven down to about 60 ft. Each unit is comprised of 1 ft tall × 4.9 ft wide plates stacked to a desired elevation (Fig. 16A). Each plate was constructed with fiberglass reinforced concrete weighing approximately 1100 lbs (Fig. 16A). An average of seven (7) plates per pile were installed in approximately 4' of water to an average crest elevation of 3.0 ft NAVD88, Geoid03. The piles were driven at 5 ft. on-center allowing for a gap of 0.2 ft between units. The final constructed feature spanned ~500 linear feet of shoreline as the ends flared toward the marsh (Figs. 1 and 16B); it consisted of 545 linear feet of ESUs with 787 plates installed on 105 piles (Fig. 16).

Figure 16. (A) Stacks of EcoSystem Units (ESUs) plates prior to installation. Note hole in the middle of plates for placement around a piling. (B) The northern end of the ESUs after removal of top plate and added brace to stabilize the pilings at Shark Island along the northeastern shore of Vermilion Bay for LA-0016 Non-rock Alternatives to Shoreline Protection Demonstration Project.

The flexibility of the fiberglass pilings and wave action caused the upper plates of adjacent units to contact each other and ultimately caused several of the upper concrete plates to break. Walter Marine removed the upper plate of each unit and connected each unit together by bolting a fiberglass C-channel brace across the top of the fiberglass pilings to prevent contact between units. After the modification, there were 675 plates remaining on the 105 piles.

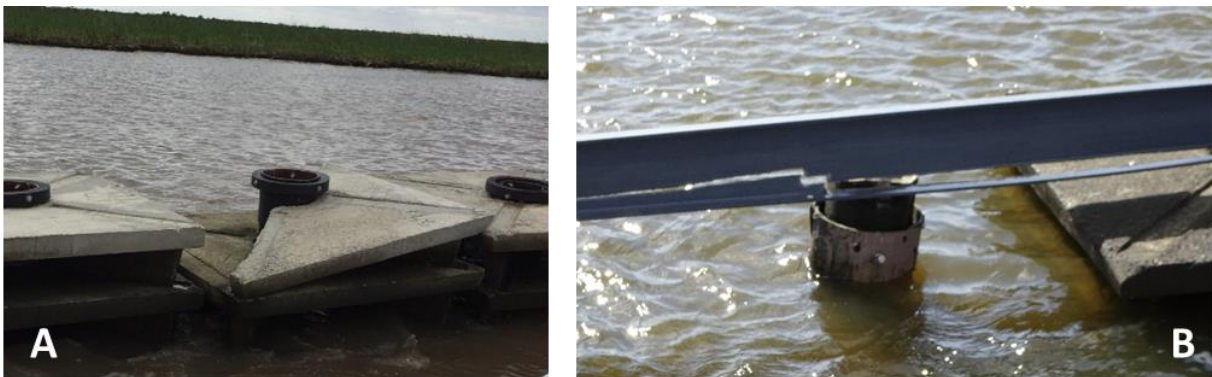
- Several of the upper concrete plates broke during the early monitoring period (Fig. 17A).
 - Consider modifying the fiberglass pile installed through the center of each unit to reduce the flexibility. Or, consider an alternate pile material.
- The fiberglass C-channel added to prevent contact between each unit was splitting in several locations (Fig. 17B).
 - Consider thicker fiberglass or using a different material for the C-channel. Or, design another method to keep units from coming into contact with one another.

Figure 17. (A) Breakage of upper plates was caused by flexibility of the fiberglass pile. (B) The C-channel used for bracing the piles cracked and split by the end of the one and one-half year monitoring period.

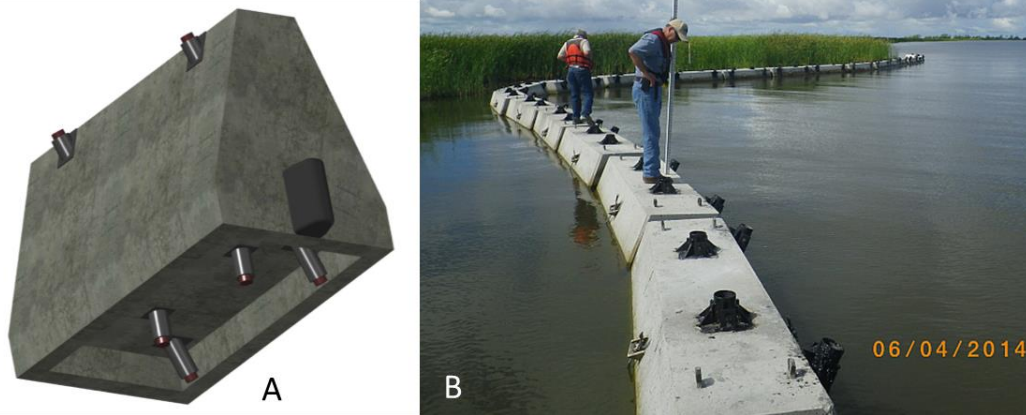
Jansen, Inc. was the contracted designer and builder of the BCECMS for the LA-0016 project, and Louisiana Shoreline Solutions, LLC owned the rights. The BCECMS was designed to provide a wave barrier throughout the water column while allowing water to pass between the individual modules to equalize hydrostatic pressure on either side of the structure. The 10 ft long by 7 ft tall trapezoidal modules have a base width of 6 ft and a crest width of 2 ft. The modules are composed of a polystyrene foam core encased in concrete. Each module settled about one foot into the bay bottom and was stabilized with two vertical and two diagonal 60 ft pin piles (Fig. 22A). The final constructed BCECMS was ~515 linear ft articulating with the shoreline consisting of 48 modules and 192 pin piles. The straight-line linear distance between terminal points was 460 feet. Each module was installed on the bay bottom in approximately 2-3 ft of water and within 5-30 ft from the existing shoreline. The average crest elevation was 3.5 ft NAVD88, Geoid03 (Fig. 22B).

Figure 22. (A) A bottom-view, isometric drawing of a Buoyancy Compensated Erosion Control Modular System (BCECMS) module displays position of pin pilings. (B) The southern half of the BCECMS at Shark Island along the northeastern shore of Vermilion Bay for LA-0016 Non-rock Alternatives to Shoreline Protection Demonstration Project.
