Coastal Protection and Restoration Authority of Louisiana

2017 Operations, Maintenance, and Monitoring Report

Coastwide Vegetative Planting Project (LA-0039)

September 2017

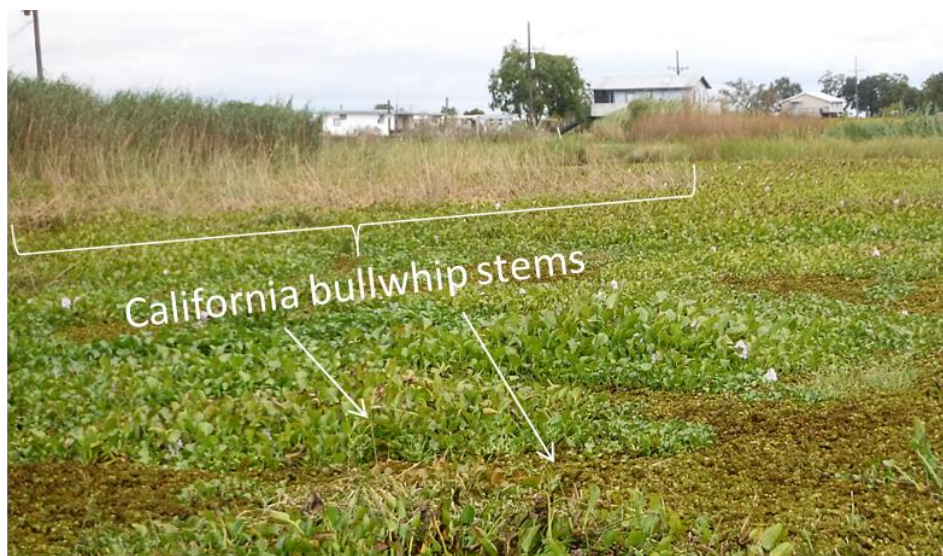
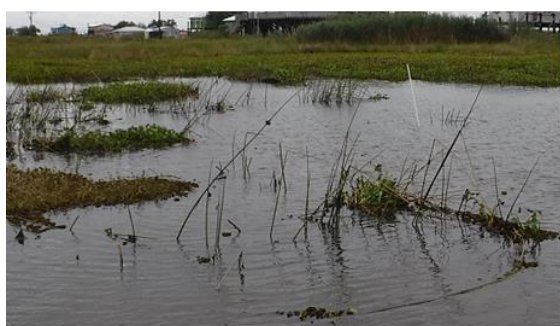
Figure III-4. Expansive mats of floating vegetation impacted the Area 2 by pushing over and covering California bullwhips (A). Sparse and damaged plants, if any, typically remain when the mats dissipate (B). Pictures were taken during the Oct 2015 monitoring.

Water depths were typically greater than the optimum range of 1 - 18 inches for smooth cordgrass 'Vermilion' strain establishment (Fine and Thomassie. 2000); and, the plants were constantly flooded (Fig. III-8) which causes anaerobic soil conditions that can be toxic to plant roots. Isolated plants, as planted along rows with five feet spacing between plants, are especially vulnerable to anaerobic soil conditions. Submerged and floating aquatic vegetation (SAV and FAV) rafting over the plants is another significant contributor to planting failure (Fig. III-2). Water salinity averaged around 2 ppt which is within the tolerance range of smooth cordgrass 'Vermilion' strain (8–30 ppt) and should not have been a stress factor (Fine and Thomassie. 2000). The California bulrush plantings were not stressed by the water levels or salinity. Sometime between January 2015 (Fig. III-3) and field sampling in October 2015 established stands of California bulrush were smothered out by large mats of floating invasive species, giant Salvinia and water hyacinth (Fig. III-4).

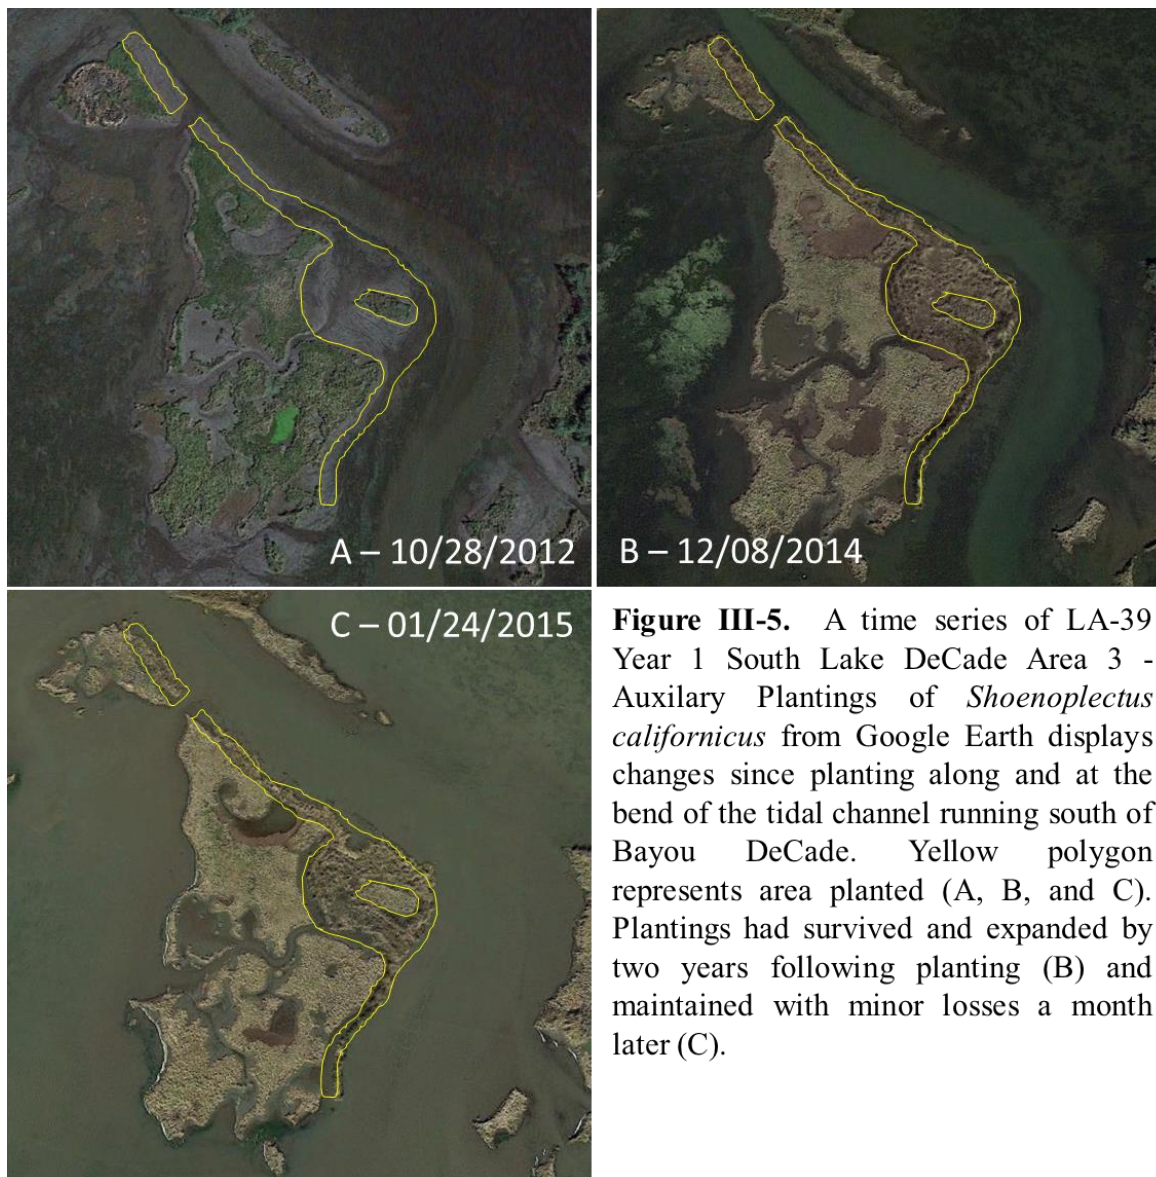
Figure III-5. A time series of LA-39 Year 1 South Lake DeCade Area 3 - Auxiliary Plantings of *Shoenoplectus californicus* from Google Earth displays changes since planting along and at the bend of the tidal channel running south of Bayou DeCade. Yellow polygon represents area planted (A, B, and C). Plantings had survived and expanded by two years following planting (B) and maintained with minor losses a month later (C).

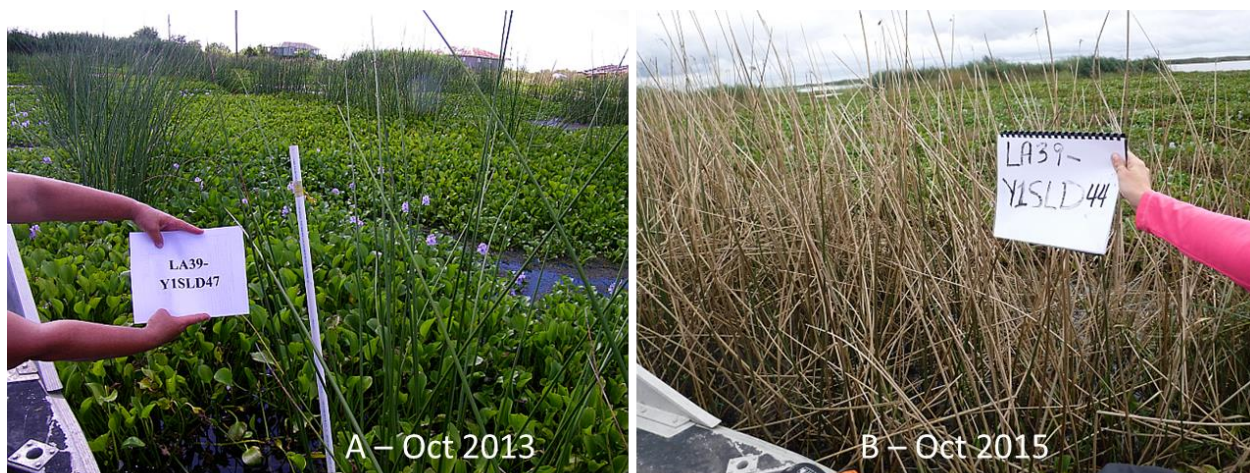
Figure III-7. Pictures of LA-39 Year 1 South Lake DeCade Area 2 - Double Row *Shoenoplectus californicus* (California bulrush) plantings were taken during 1 (A) and 3 (B) years after planting. Losses from the rafting of floating aquatic vegetation began prior to the 2013 sampling (A) and expanded by the 2015 sampling (B). The dead stems in B are from seasonal senescence's.

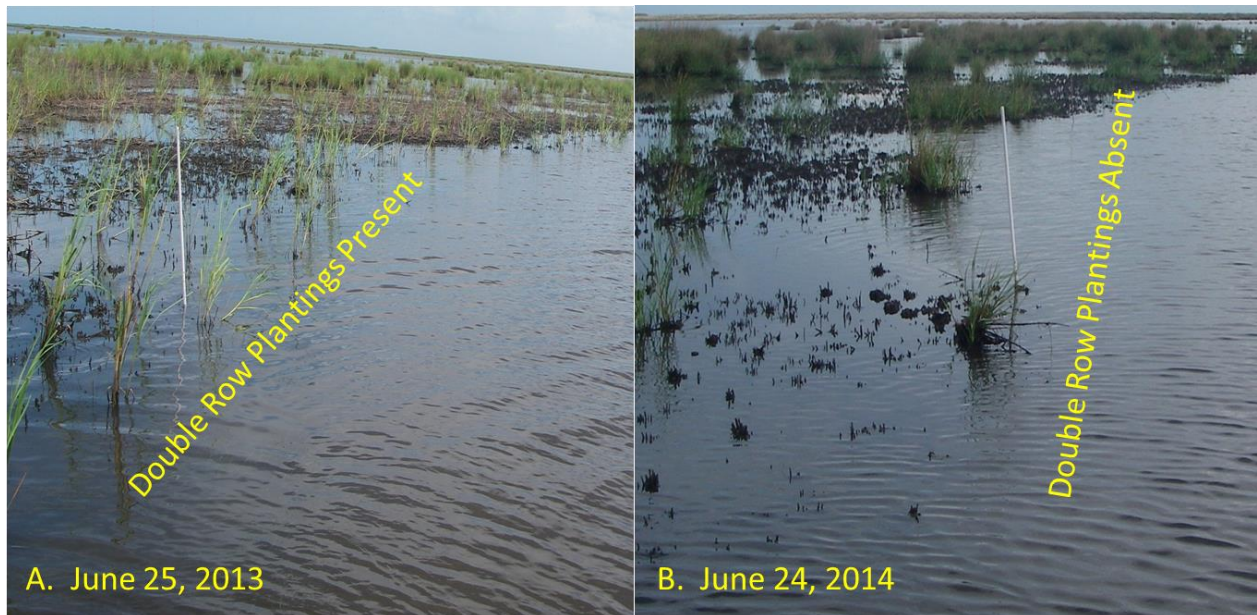
Figure IV- 3. A double row of *Spartina alterniflora* Vermilion was planted to stabilize the Lambert Bayou shoreline in the Northwest Area of the LA-39 Year 1 Cameron Creole site in June 2013 (A). Most of the plantings were absent a year later in June 2014 (B).

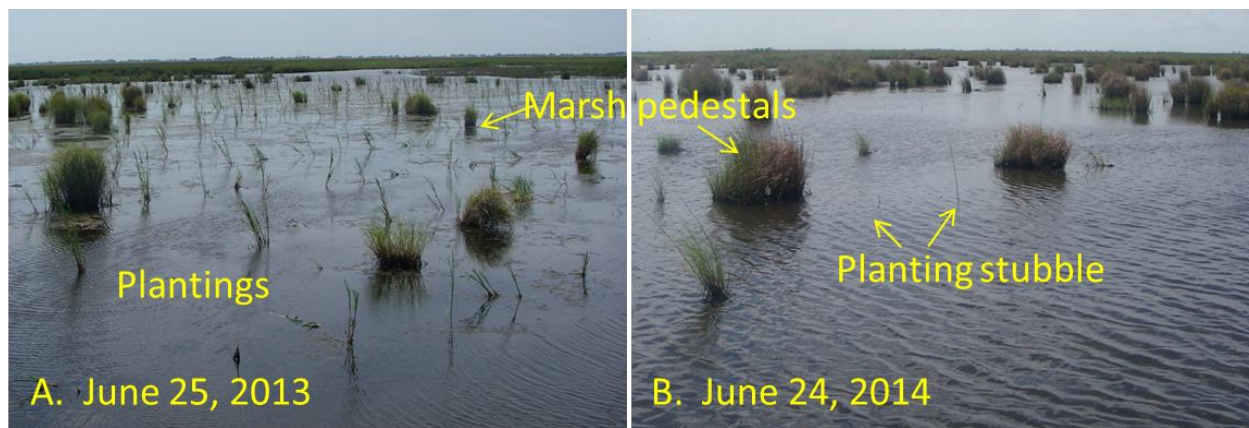
Figure IV- 4. *Spartina alterniflora* Vermilion was planted on a broken marsh platform in the Northwest Area of the LA-39 Year 1 Cameron Creole site in June 2013 (A). Most of the plantings were absent a year later in June 2014 (B).

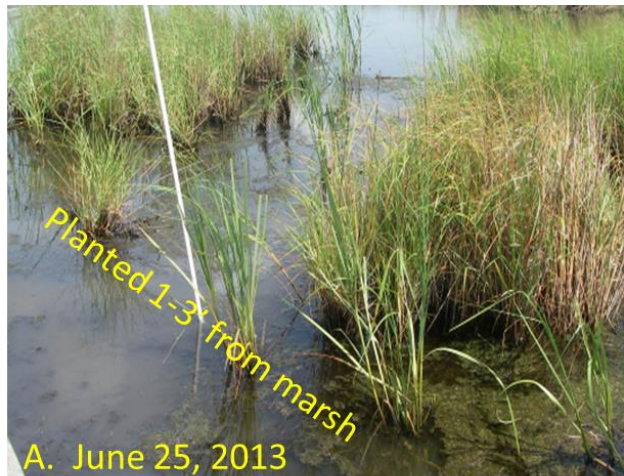
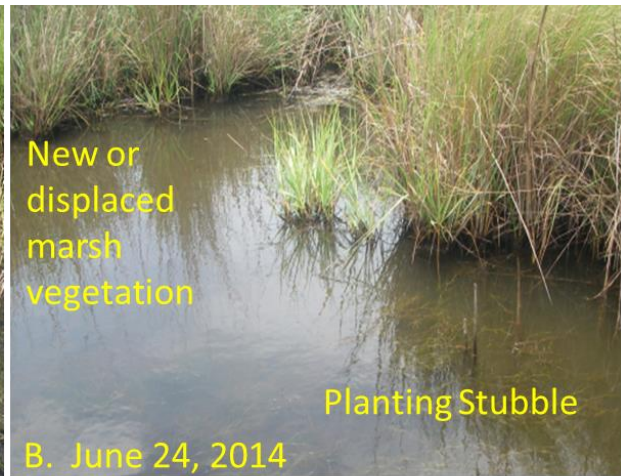
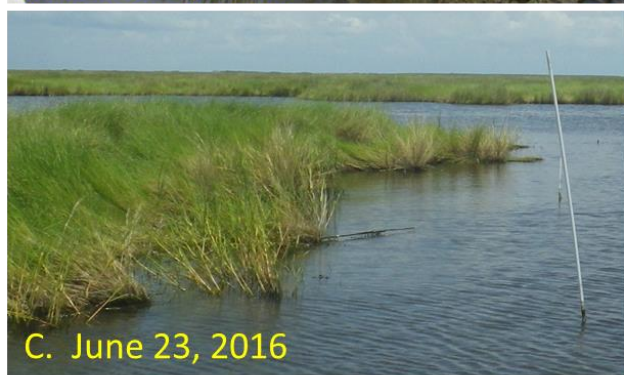
Fig 1V- 5. *Spartina alterniflora* 'Vermilion' strain was planted around patches of existing marsh in the Central Area of the LA-39 Year 1 Cameron Creole site in June 2013 (A). Most of the plantings were absent a year later in June 2014 (B). The marsh edge eroded 3-9 ft by June 2016 (C); the poles represent the original planting position.

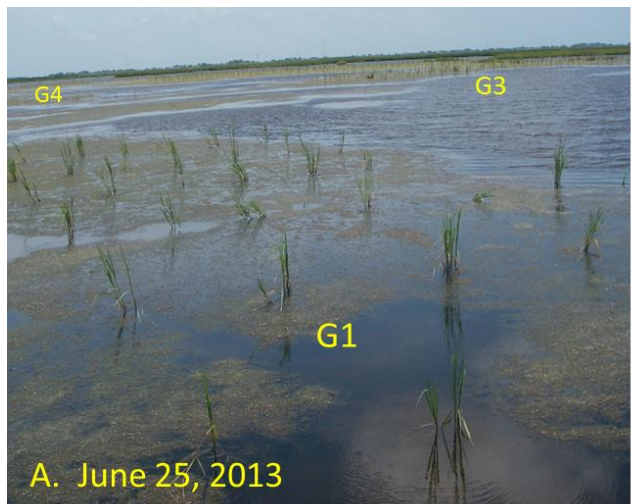
Figure IV- 6. *Spartina alterniflora* Vermilion was planted in shallow open water/former mudflats between patches of marsh in the Central Area of the LA-39 Year 1 Cameron Creole site in June 2013 (A). Note algae rafts on SAV in A. All of the plantings were absent a year later in June 2014 (B); SAV was still present although algae were reduced. G# represents different planting grids.

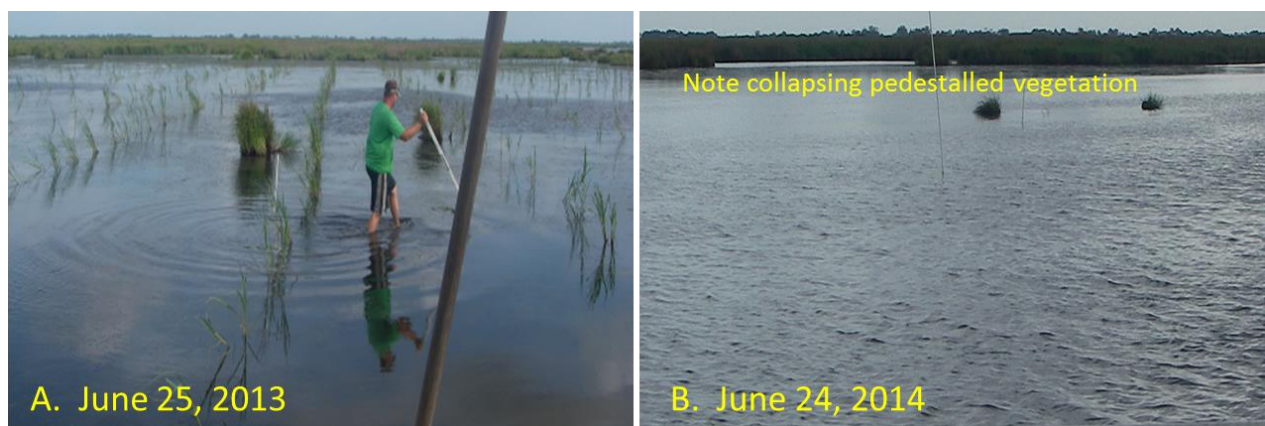
Figure IV- 8. Rows of *Spartina alterniflora* Vermilion were planted in shallow open water/former mudflats near marsh in parallel to the South Prong of Grand Bayou in the Northeast Area (A). Most of the plantings were absent and most pedestals of marsh vegetation were collapsing a year later in June 2014 (B). Note 6’4” Bernard Wood (CPRA) for scale (A). SAV was present in both years.

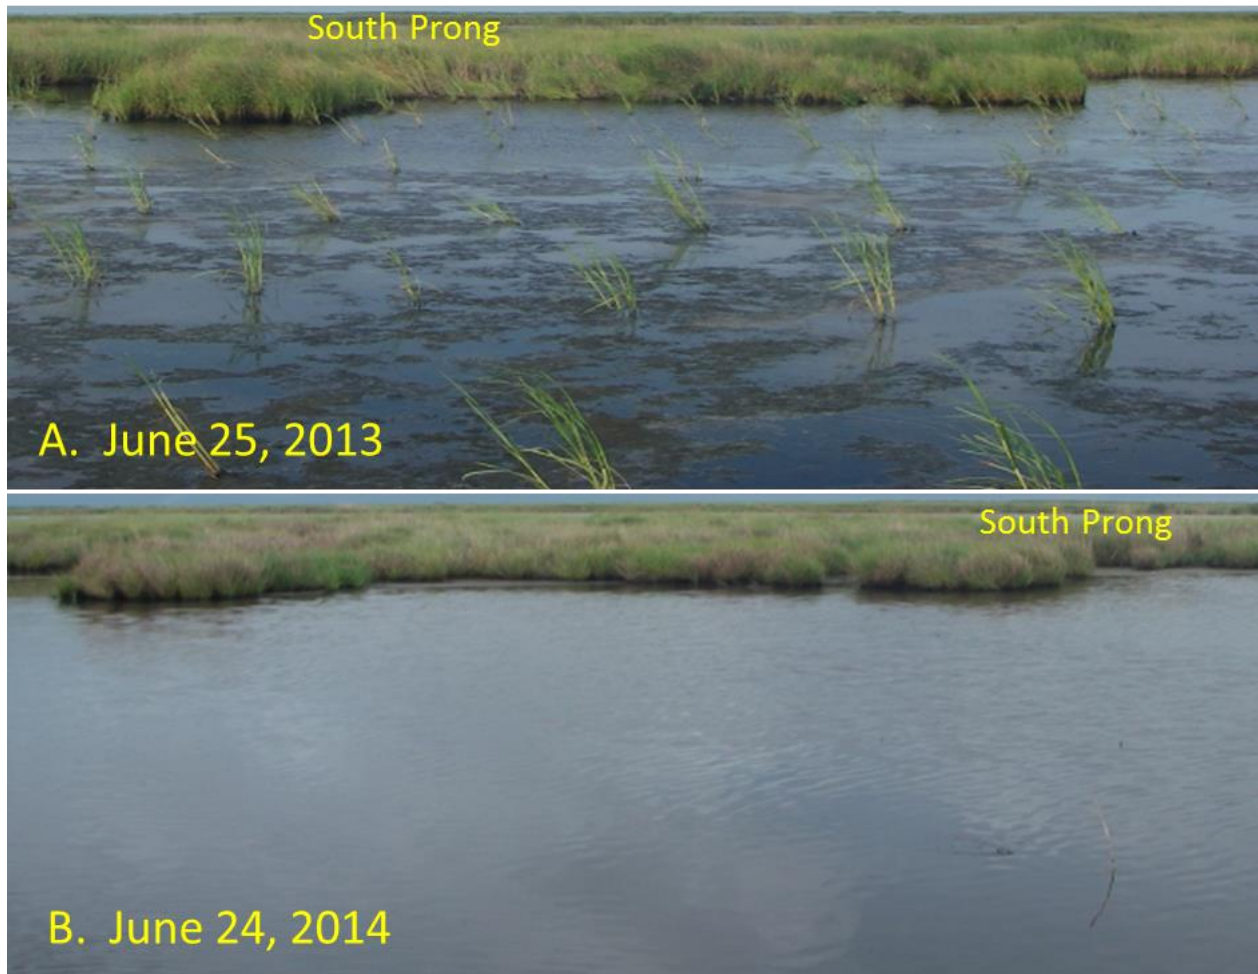
Figure IV- 9. Rows of *Spartina alterniflora* Vermilion were planted in shallow open water/former mudflats near marsh in parallel to the South Prong of Grand Bayou in the Northeast Area (A). Note some algae rafts on SAV in A. Most of the plantings were absent a year later in June 2014 (B); SAV was still present although algae were reduced.

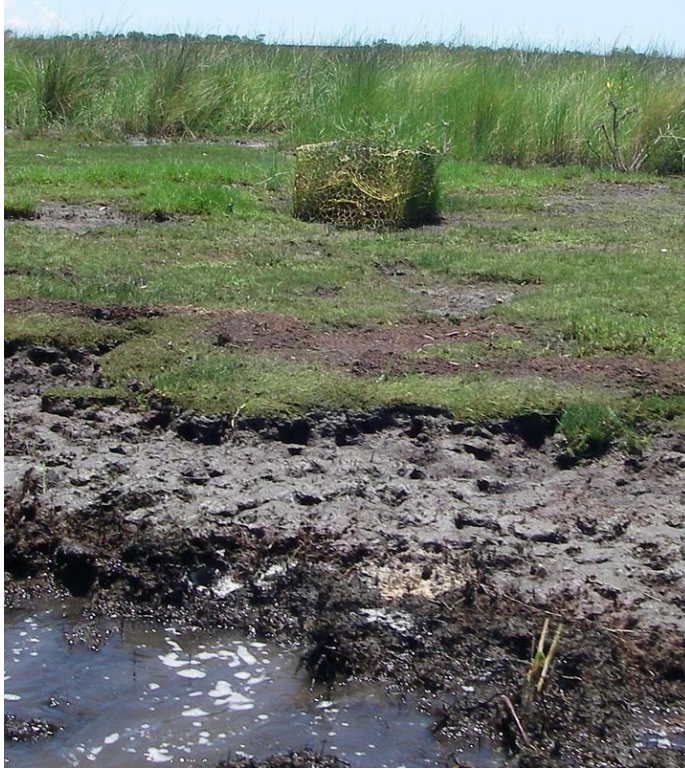
Figure V-3. The Northern Shoreline on 06/03/2013 during typical water levels. Note the taller, interior marsh vegetation in the background, the reduced vegetation height in the nearshore marsh platform impacted by herbivory (note taller vegetation in the crab cage), and the unvegetated shoreline eroded by surf conditions with a surviving plant to the bottom right side.

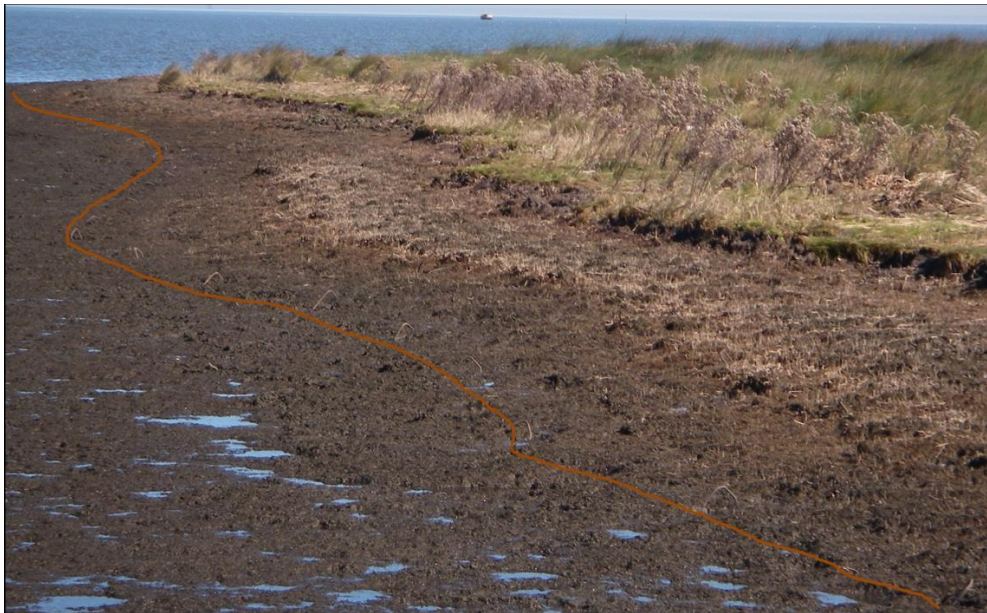
Figure V-4. The Northern Shoreline had low water levels on 12/18/2013. Empty anchors along the brown line indicate the planting alignment. The shoreline eroded back about 15-20 ft in the 8 months since the plantings installation.

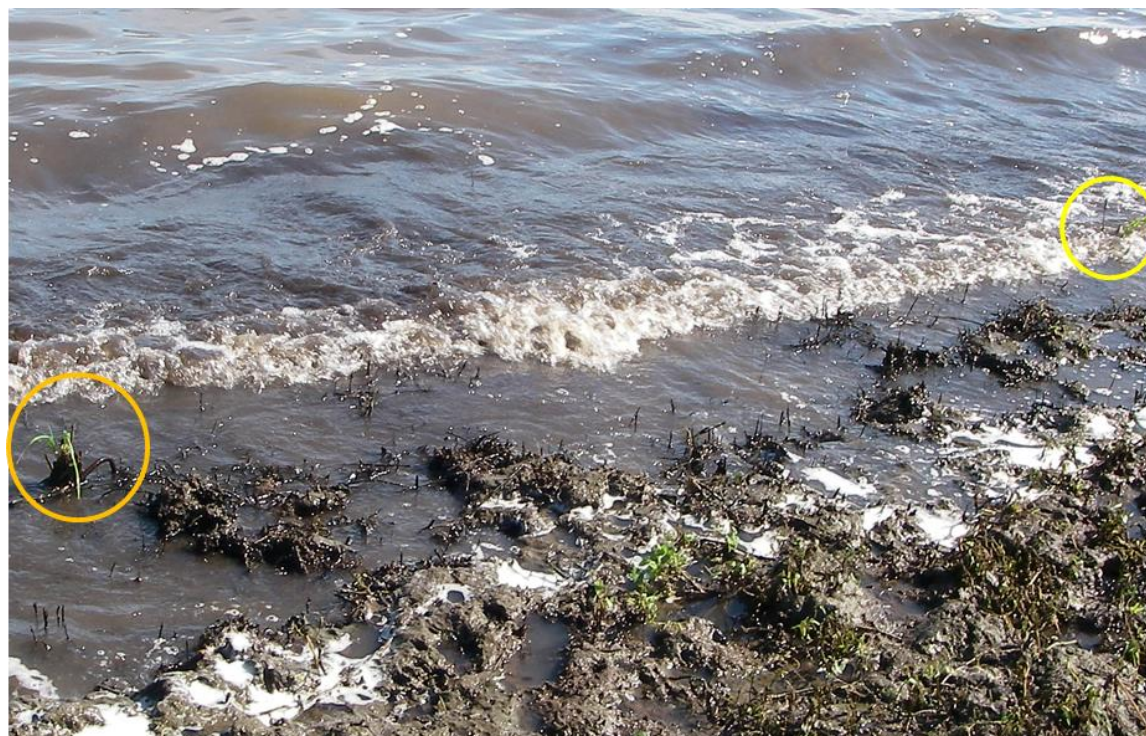
Figure V-7. Two surviving plants along a typical Northern Shoreline planting alignment were photographed on 06/03/2013 during typical water levels and calm wave conditions. Surviving plants were impacted by wave action. Note the anchored plant on the left and the non-anchored

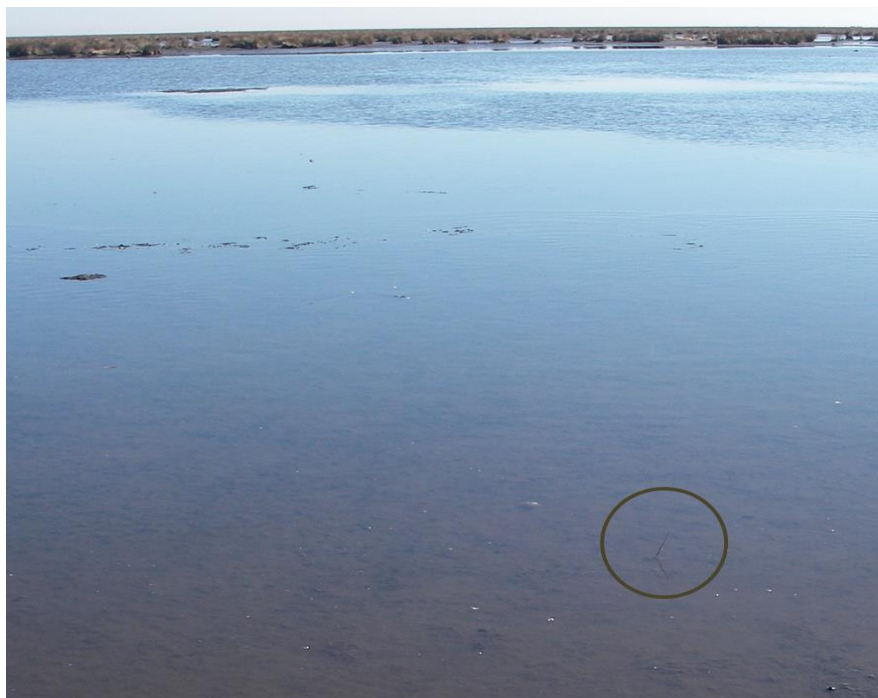
Figure V-11. The Oyster Bayou planting area was photographed on 12/18/2013 during very low water level; however, the area was still inundated with a couple inches of water. Note the potential remnant of a planting in the circle.

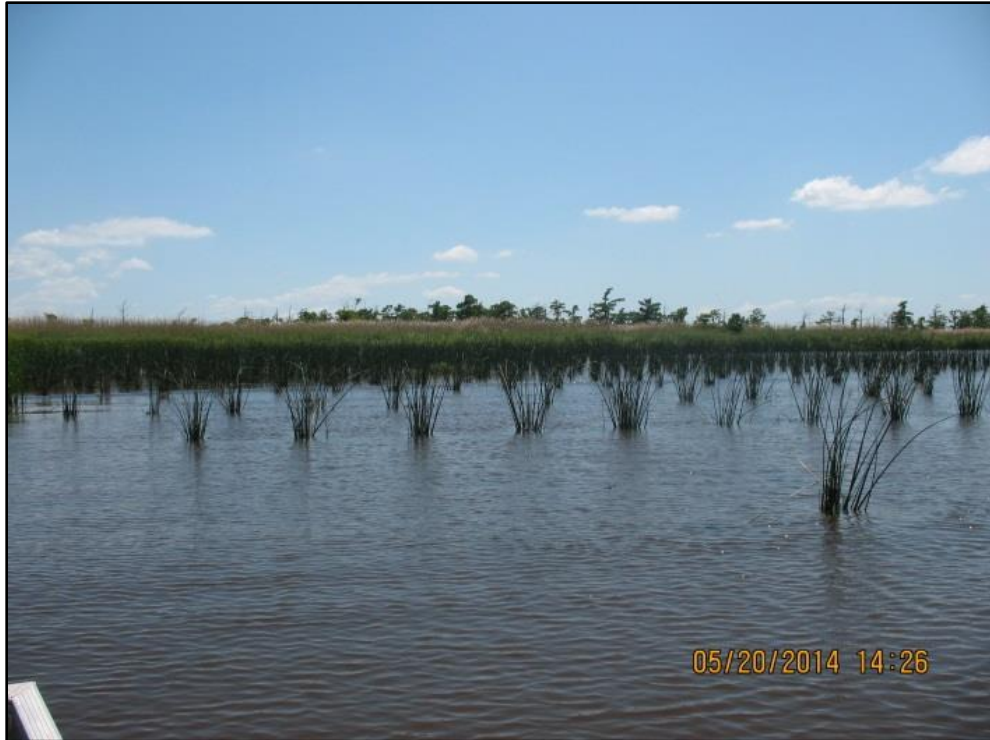
Figure VI-2. Double row planting area 3A, photographed during the 2014 vegetation survey.

Planting survival of *Schoenoplectus californicus* was 100% at each of the 17 vegetation stations for the 2014 initial vegetation survey. By the 2015 survey, *S. californicus* had vegetated prolifically along and between the planted rows and individual plants were indistinguishable within the stations. Survival at all stations is assumed to be 100% or nearly 100% (Figures VI-2–5). This level of survival was representative of all of the area and double row plantings.

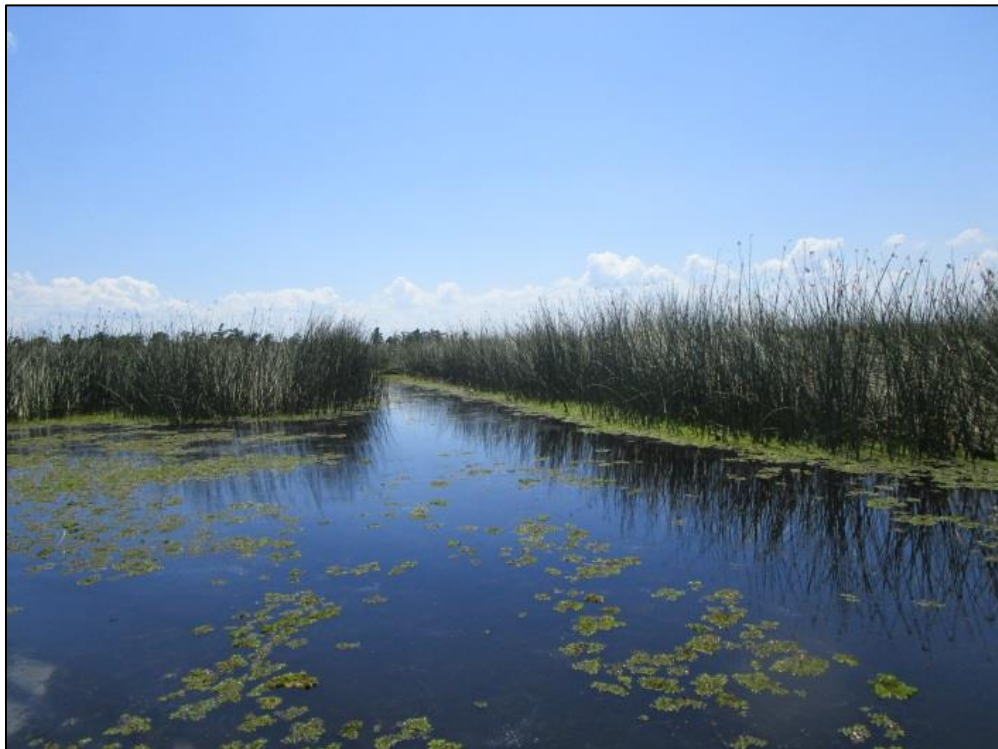
Figure VI-3. Double row planting area 3A, photographed during the 2015 vegetation survey.

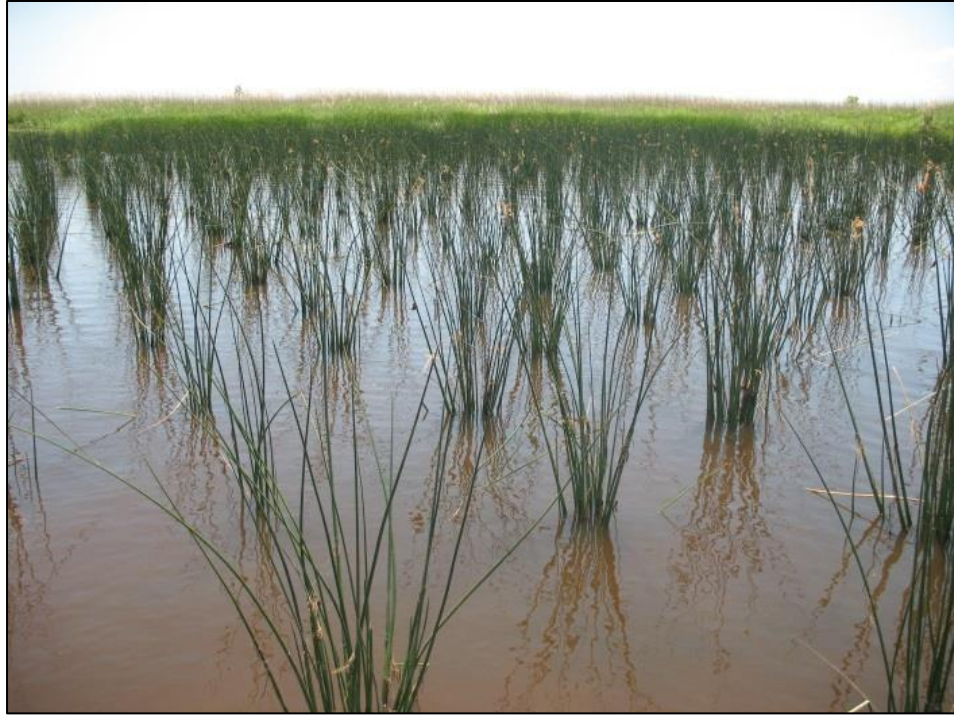
Figure VI-4. Area planting 2A, photographed during the 2014 vegetation survey.

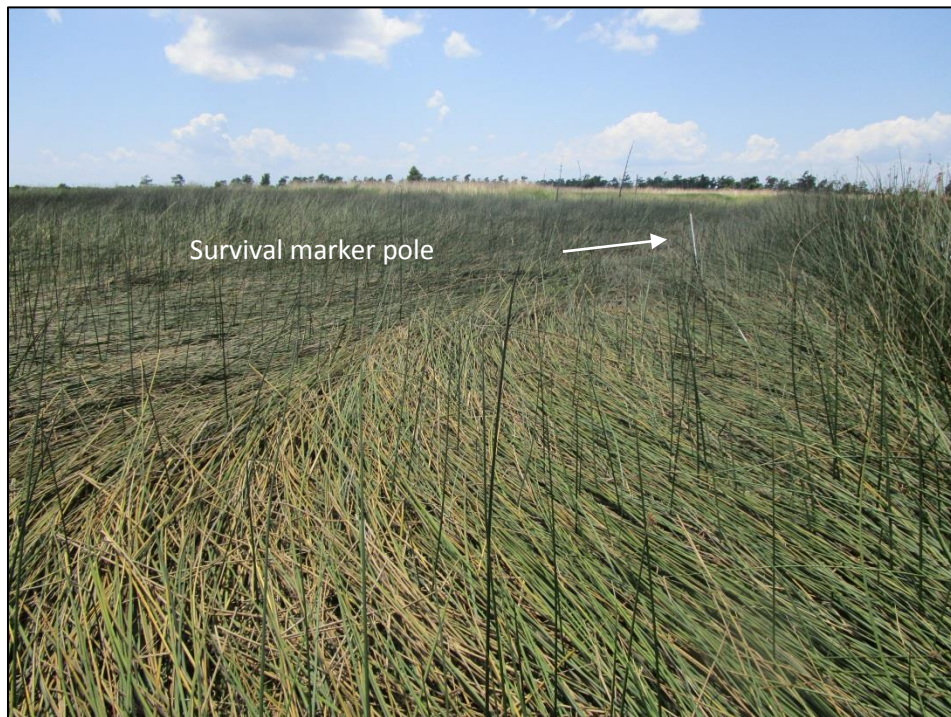
Figure VI-5. Area planting 2A, photographed during the 2015 vegetation survey. The SW marker pole for the survival plantings for station P08 is visible in the photograph. Note the laid over *S. californicus* stems.

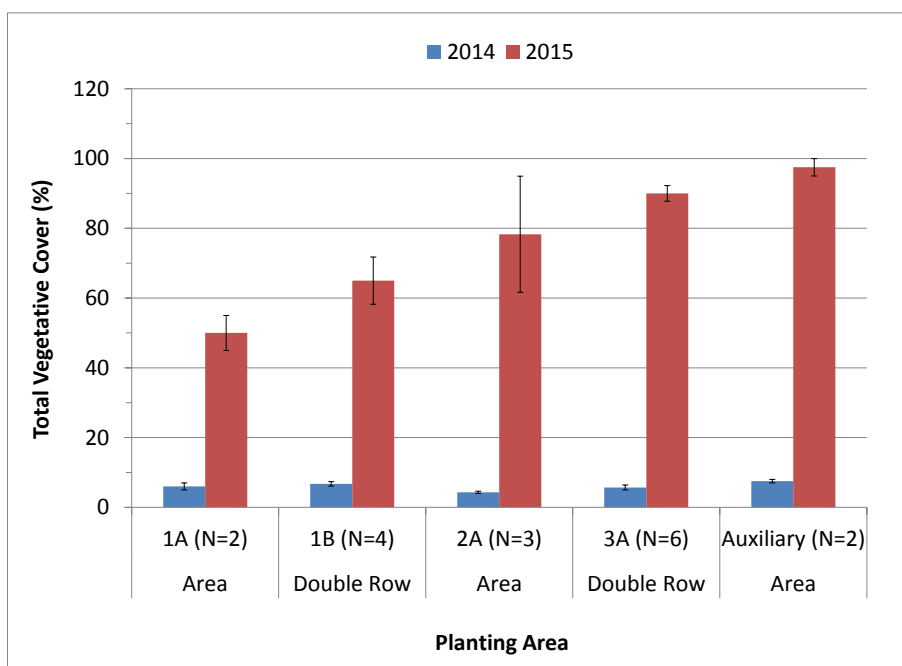
Figure VI-6. Mean total cover (\pm SE) of vegetation at stations in each planting area as measured during the 2014 and 2015 vegetation surveys. Area and Double Row refer to the type of planting. N refers to the number of stations surveyed.

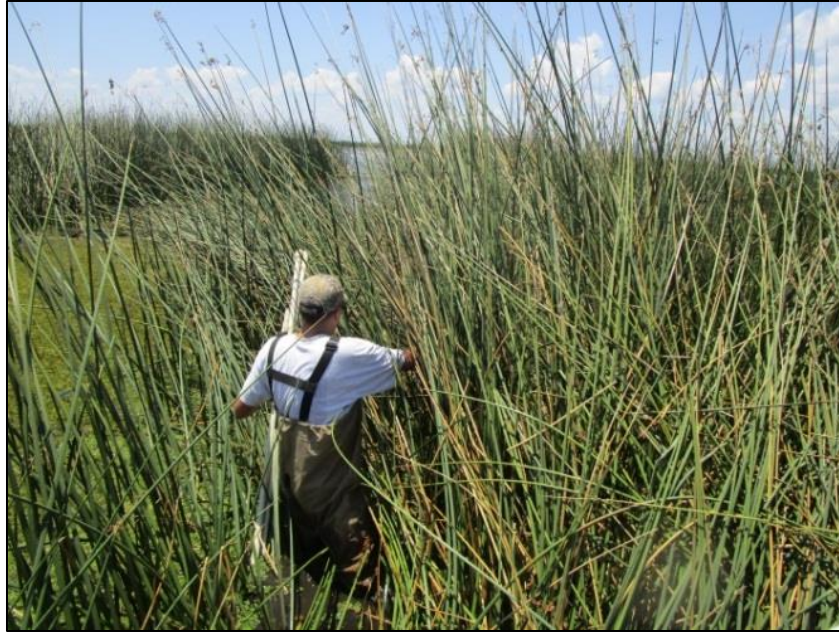
Figure VI-8. Ten-foot tall *S. californicus* photographed during the 2015 vegetation survey in double row planting area 3A.

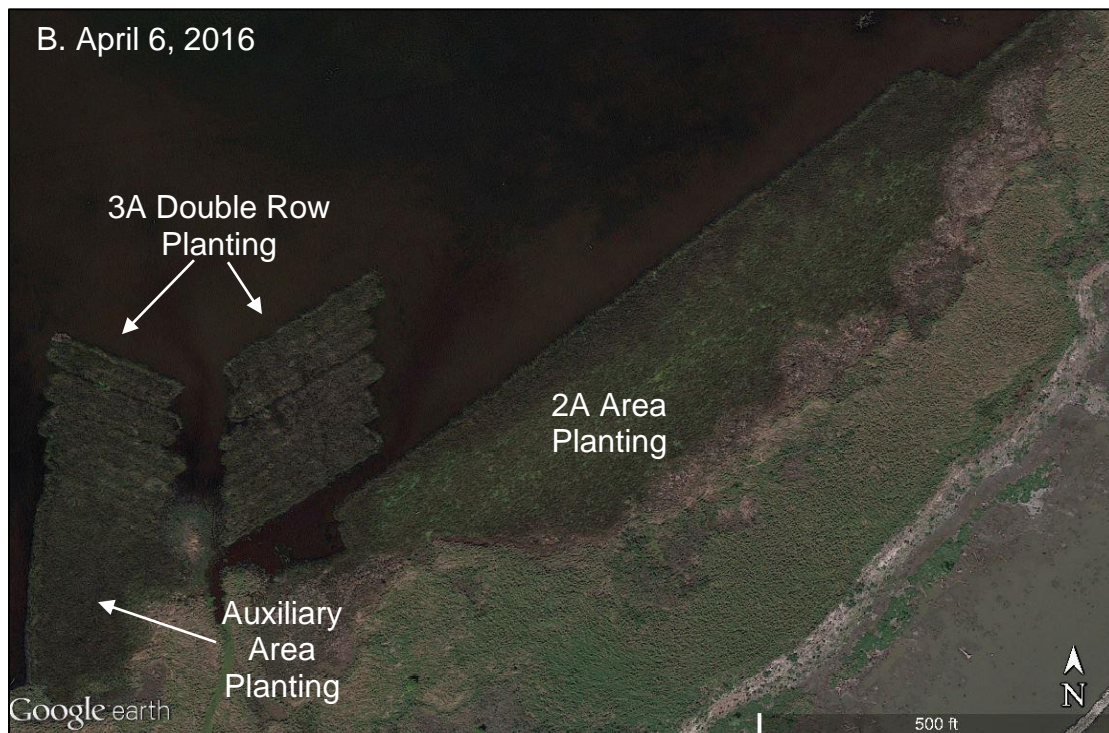
Figure VI-10. Google earth imagery taken October 31, 2014 (A) and April 6, 2016 (B) of planting areas 2, 3, and the Auxiliary planting area. The 2B single row of *S. alterniflora* appears visible in 2014 (A) but not 2016 (B). The 3A double rows of *S. californicus* appear to have grown together (B).

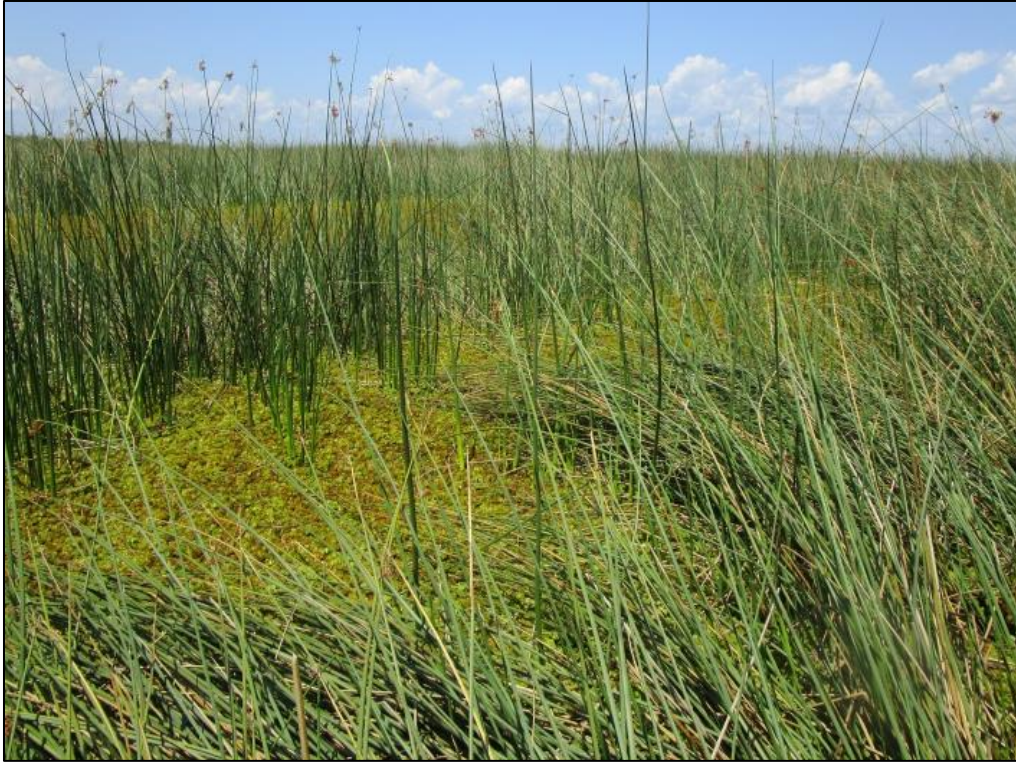
Figure VI-11. New *S. californicus* stems are visible growing between a double row during the 2015 vegetation survey in area 1B. *Salvinia molesta* covers the surface of the water.

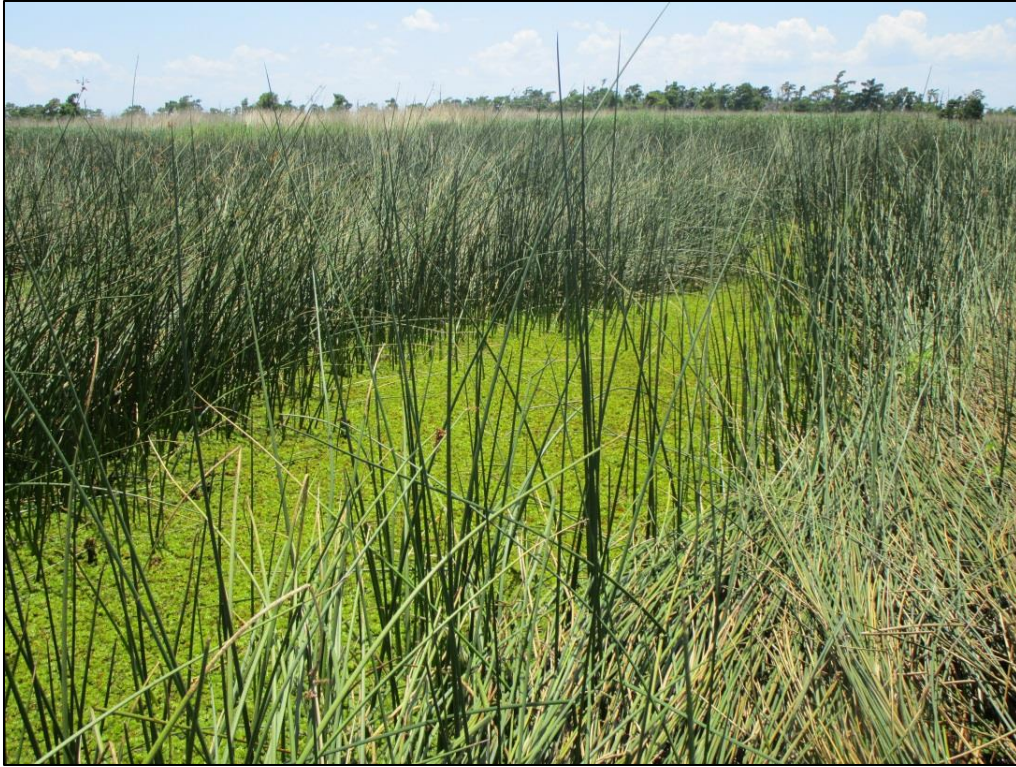
Figure VI-12. Approximately 5 ft remained between the double row of *S. californicus* during the 2015 vegetation survey in area 3A. *Salvinia minima* covers the surface of the water.

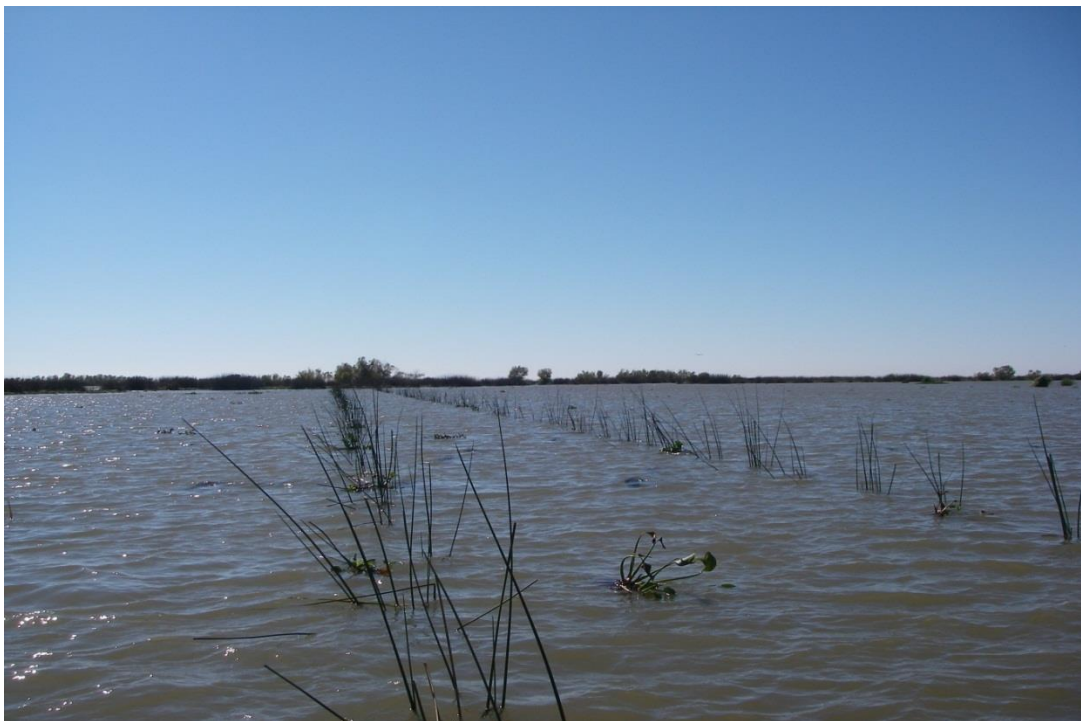
Figure VIII-3. Typical view of a double row planting at LA-39 Year 3 The Jaws in Nov 2014.

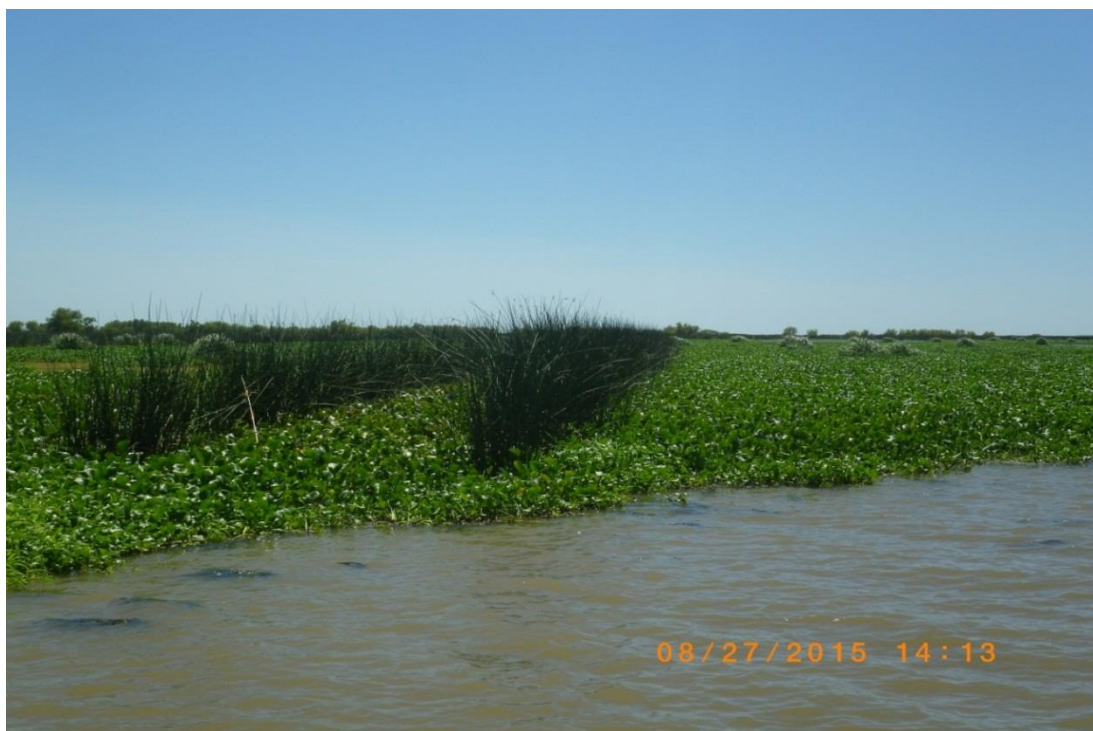
Figure VIII-4. Typical view of a double row plantings at The Jaws LA-39 just prior to the Sept 2015 sampling.

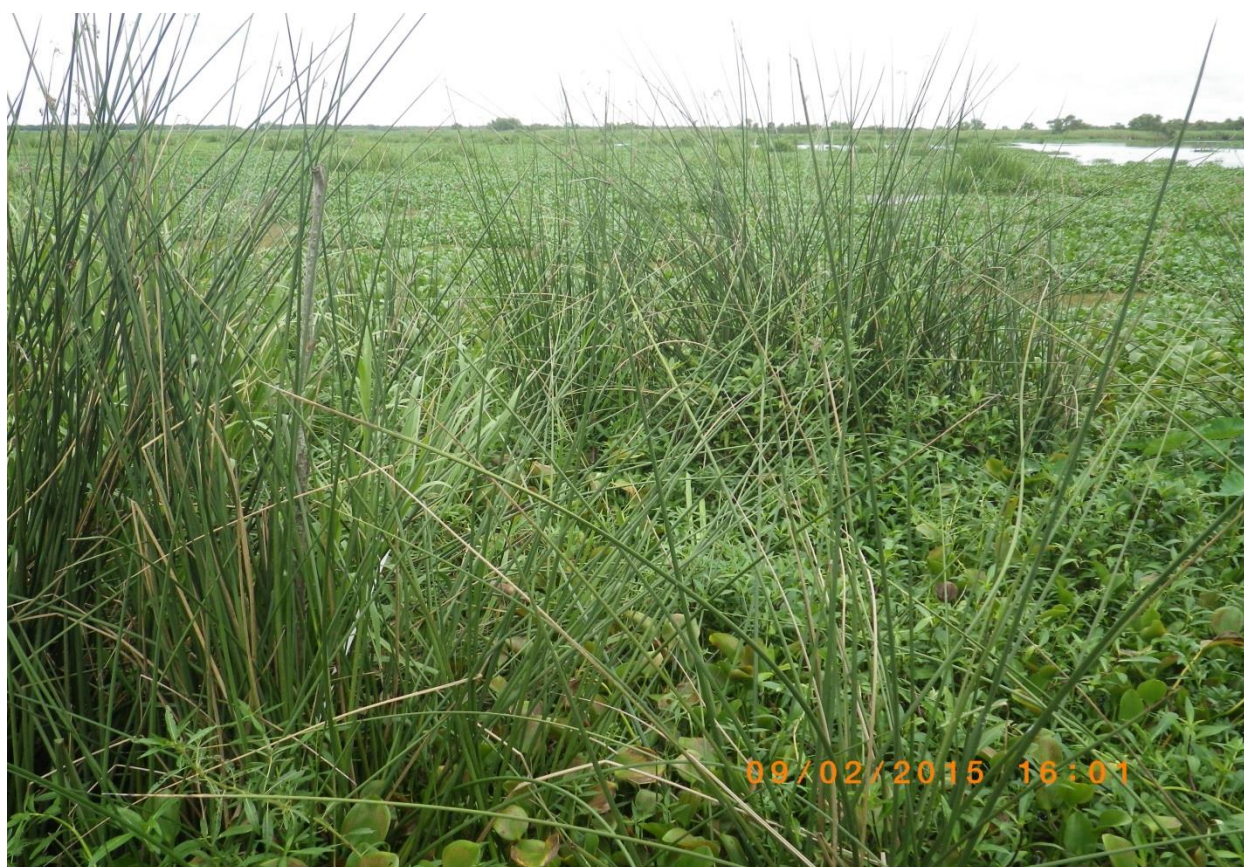
Figure VIII-6. Recruited species growing in and among the double row plantings during 2015 sampling including *Alternanthera philoxeroides* and *Zizaniopsis miliacea*.

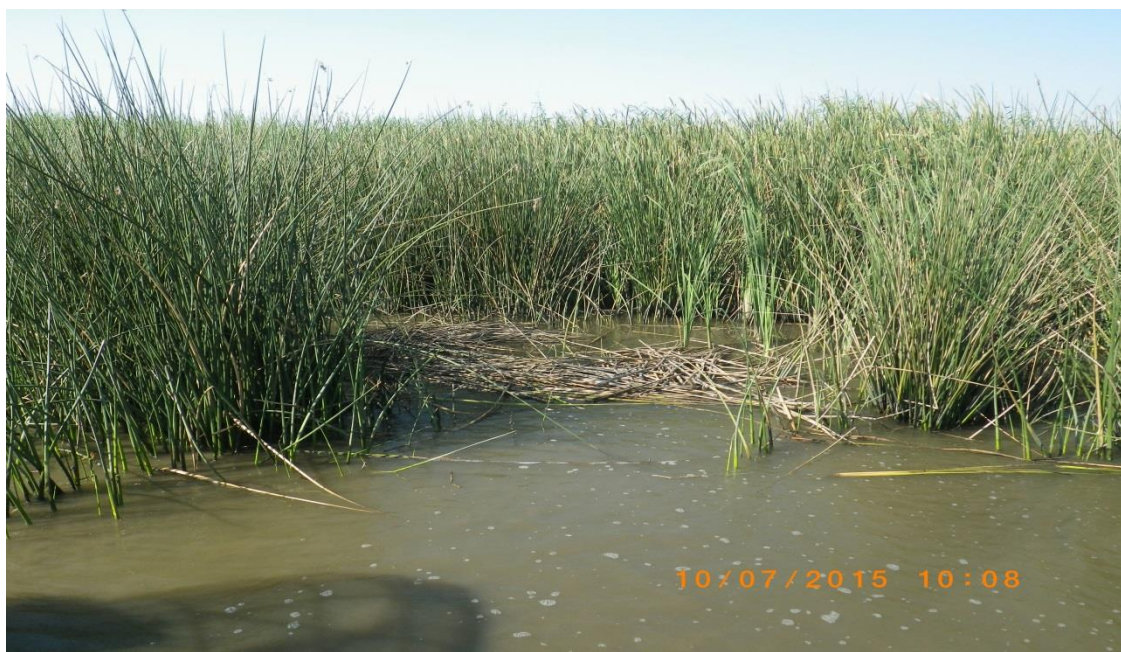
Figure IX-3. View of minor herbivory damage in the LVB east LA-39 area at T₂.

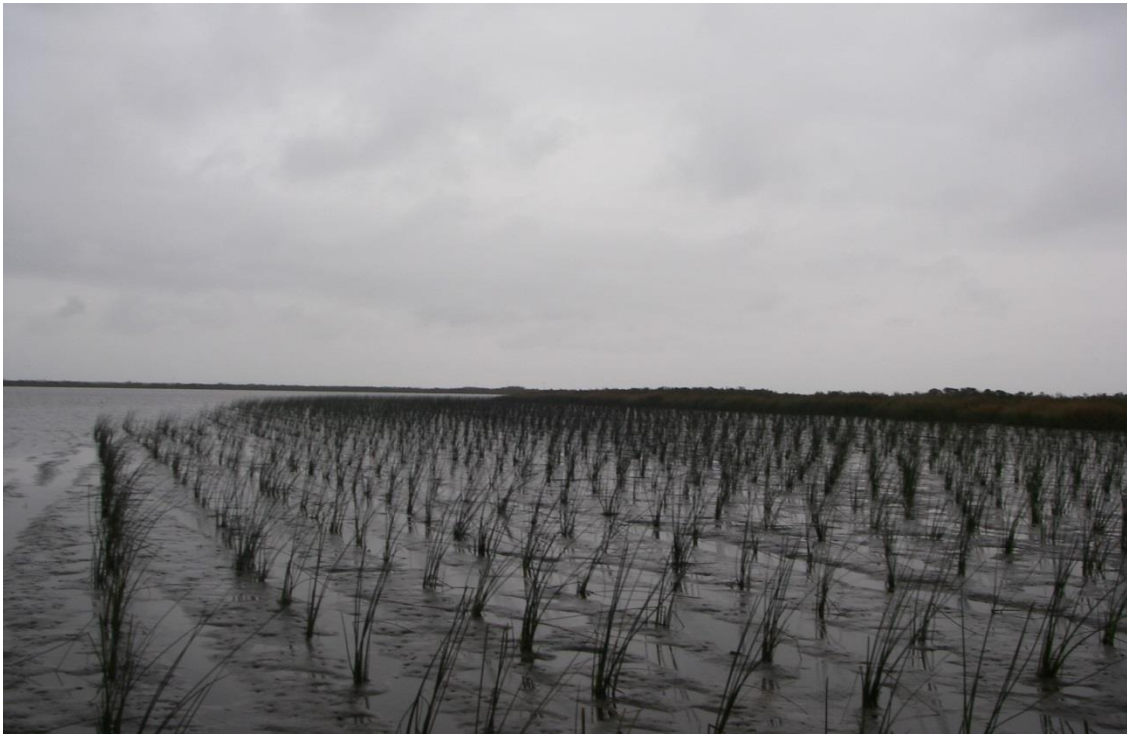
Figure IX-6. Typical veiw of a LA-39 LVB west area planting at low tide during Nov 2014.
