Coastal Protection and Restoration Authority of Louisiana

2017 Operations, Maintenance, and Monitoring Report

Coastwide Vegetative Planting Project (LA-0039)

September 2017

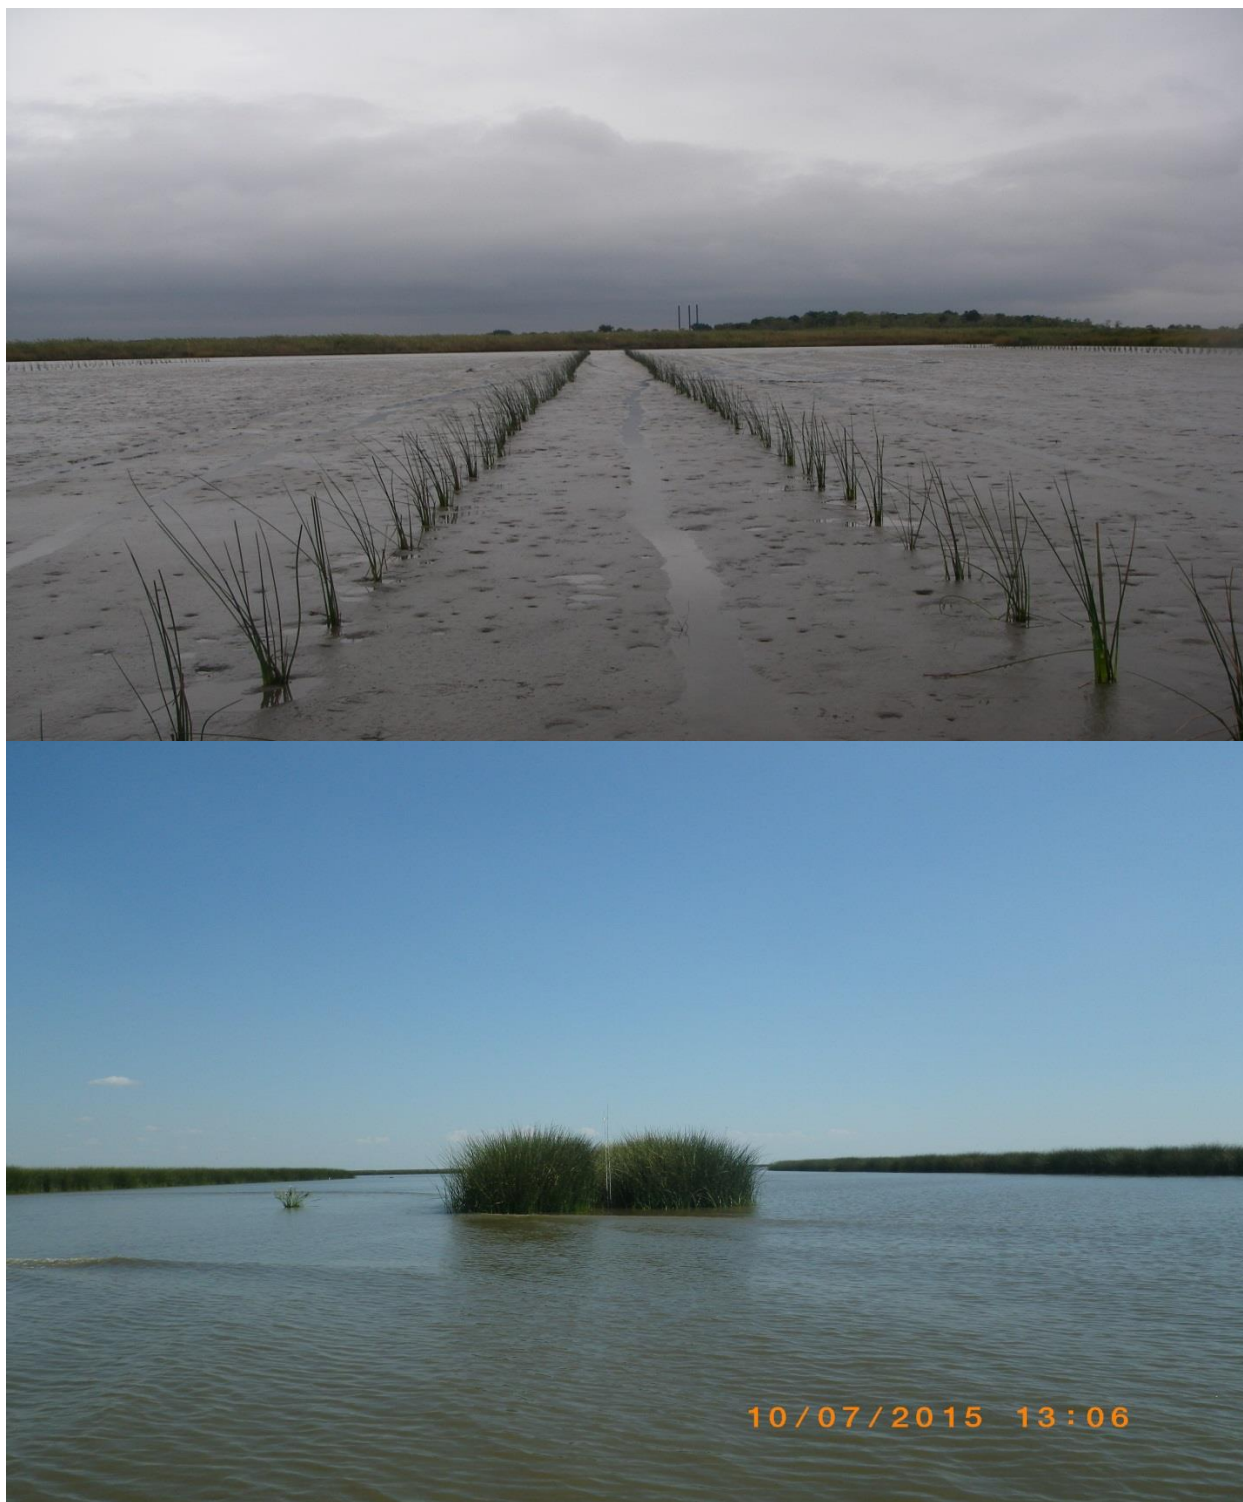
Figure IX-8. The growth over one year (Nov 2015 – Oct 2014) of a typical double row in the Little Vermilion Bay west plantings.

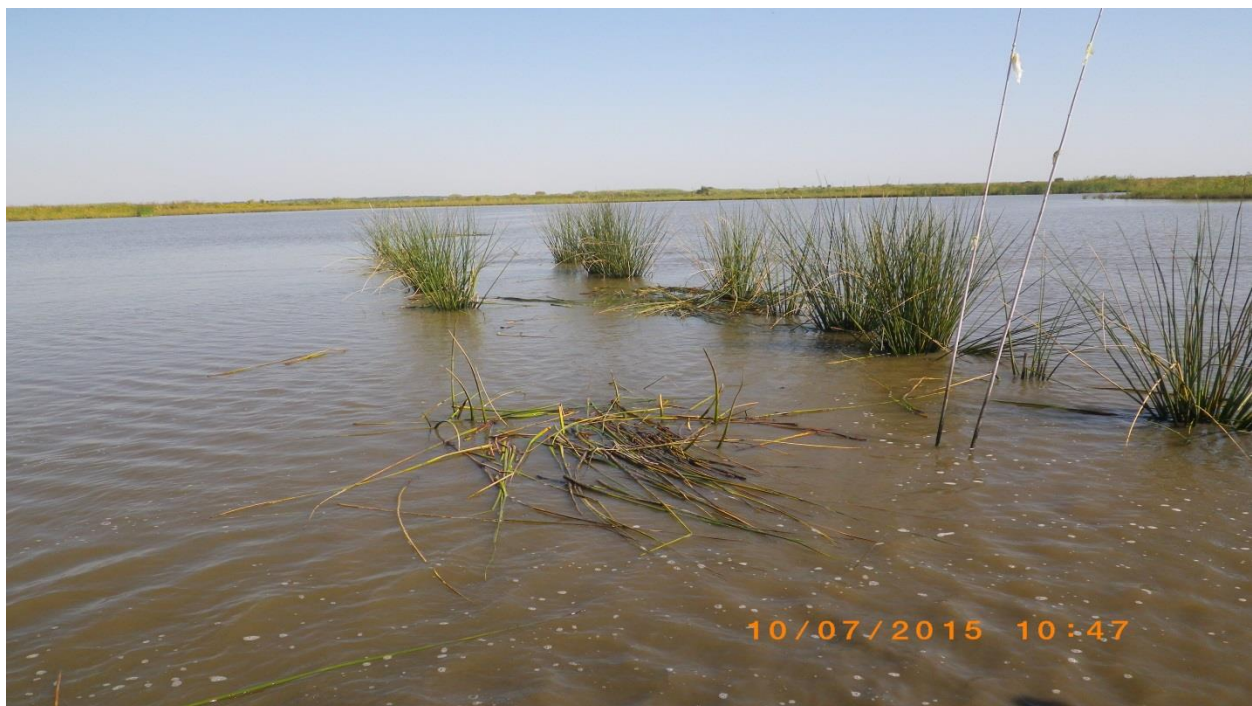
Figure IX-10. Active herbivory damage to the planted double rows in the LVB east location during the October 2015 sampling. The double row had extended to the terrace to the north in the background prior to herbivory.

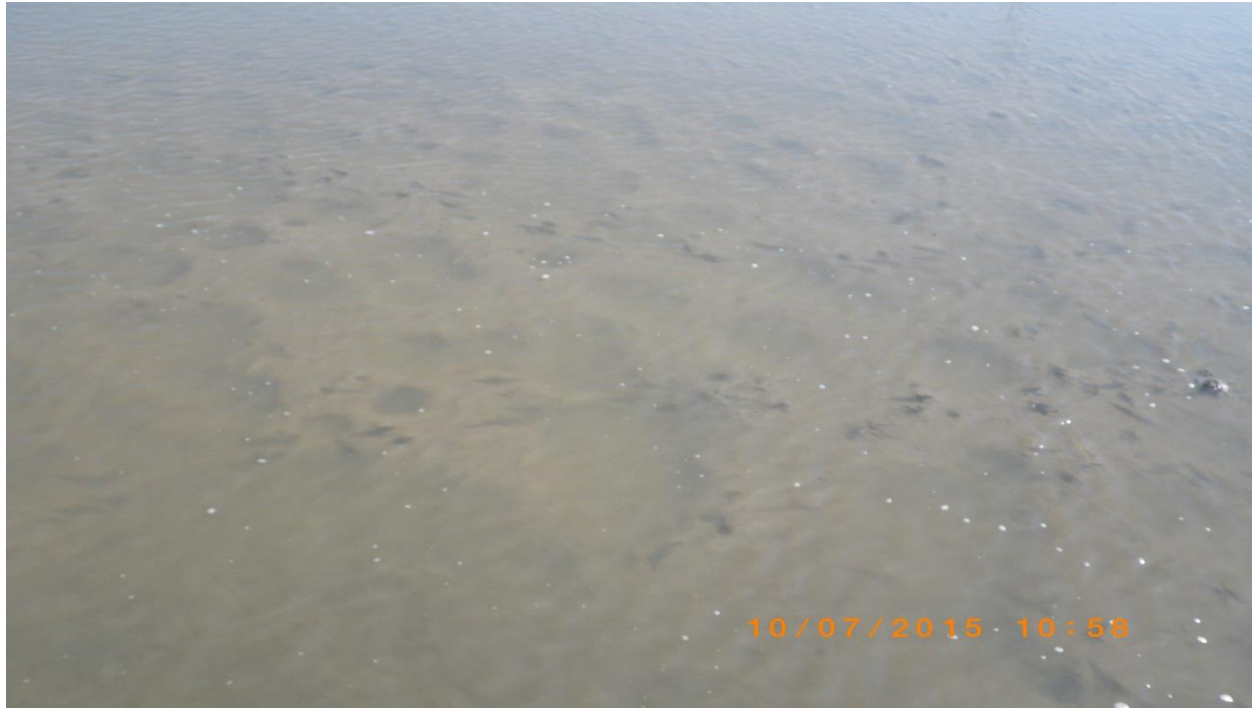
Figure IX-11. Herbivore tracks in and among the planted double rows in the LVB east location.

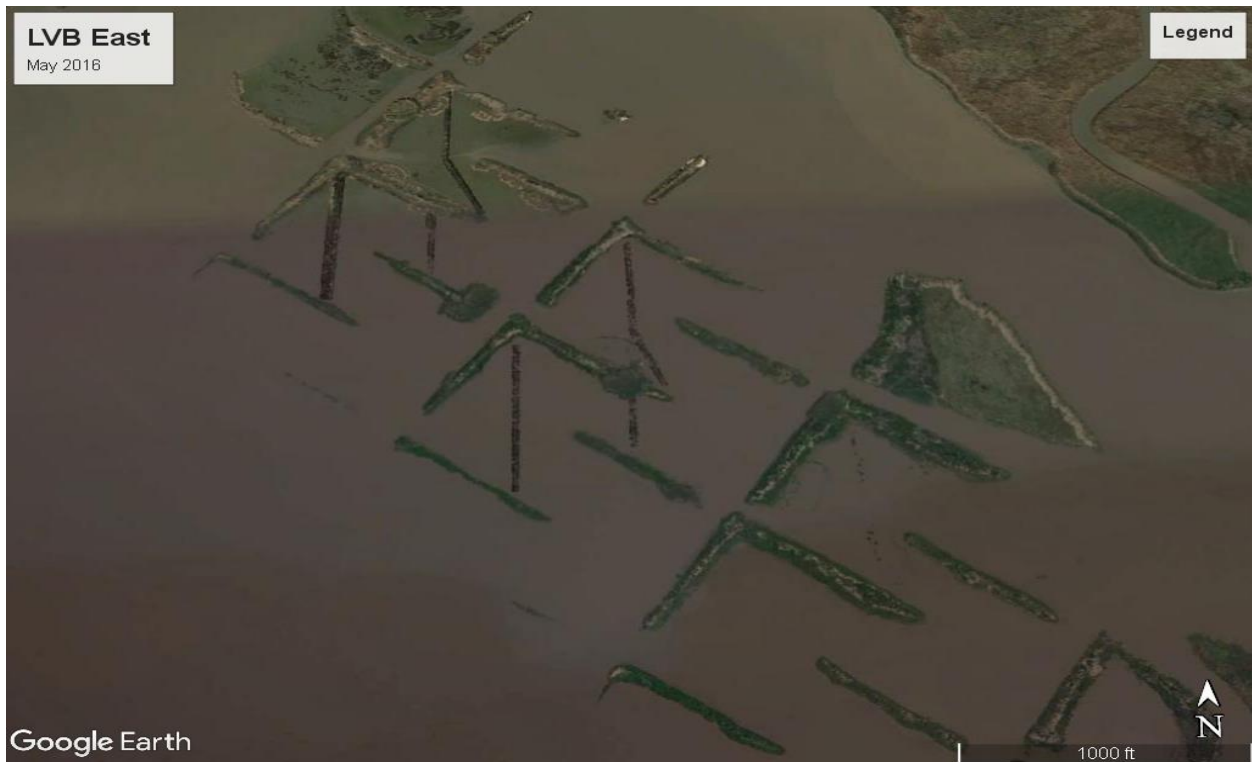
Figure IX-12. Google Earth imagery of the LVB East plantings taken on 5/6/2016. The northeastern and middle sets of double rows expanded, whereas, the southeastern set of double rows were mostly removed by herbivory.

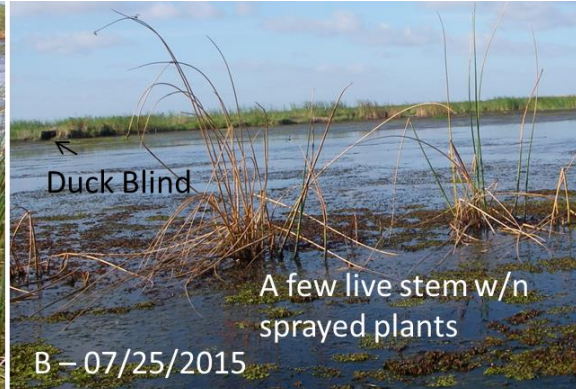
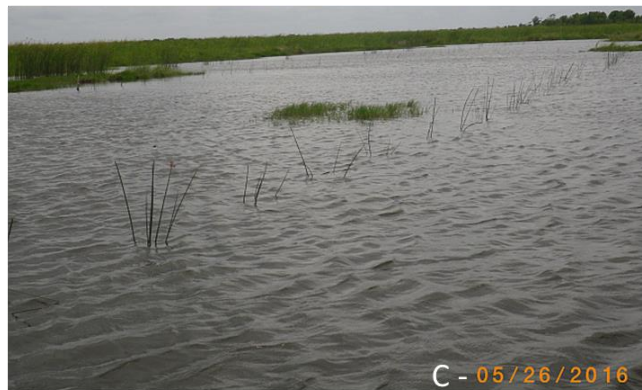
Figure X-3. Two sections of double row plantings in the eastern pond of the LA-39 Year 3 Willow Lake - South area were poisoned by a lessee for duck hunting (A and B). The plants were subsequently replaced by the lessee in other parts of the pond to help secure against breaching from Willow Lake (C). See site map for locations (Fig. X-1).

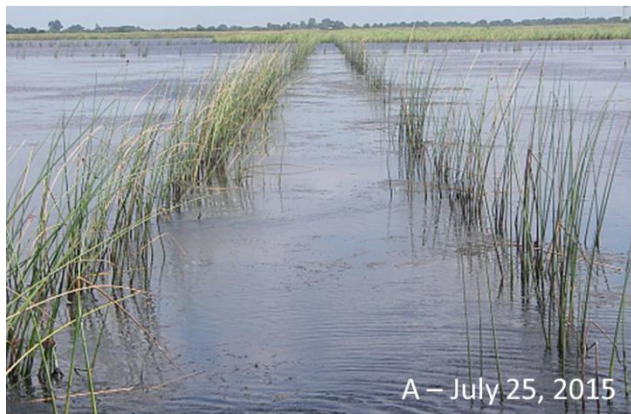
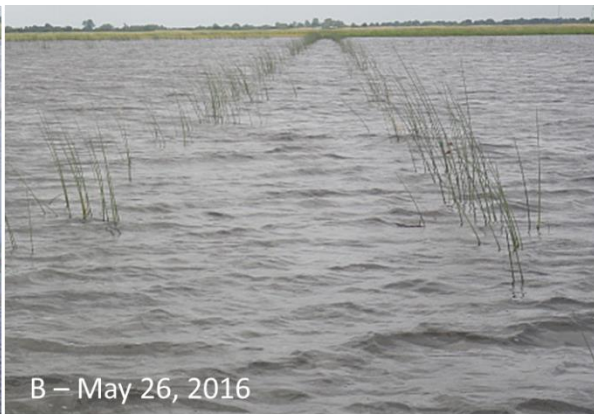
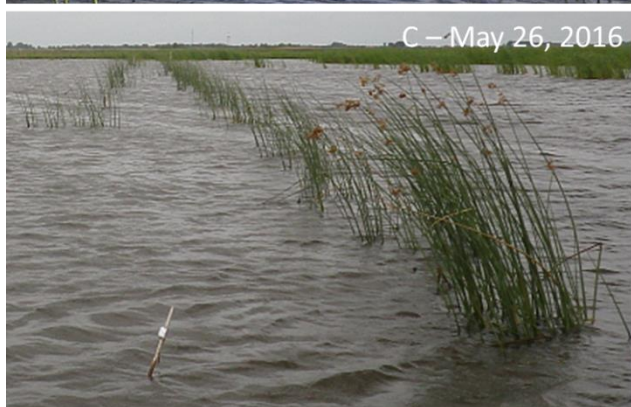
Figure X-4. Pictures were taken about 9 months (A) and 19 months (B and C) after planting in the western pond of the LA-39 Year 3 Willow Lake - South area. The foreground is between rows of a south to north double row; (A) shows expansion towards the middle despite plants not being as big as in other areas, and (B and C) show a lack of expansion yet still healthy plants. Note the larger flowering plants in (C) which are typical of plants in other areas. West to east double rows are in the background. Water levels were about 1' higher in (B and C) than (A), so less of the plants are showing.

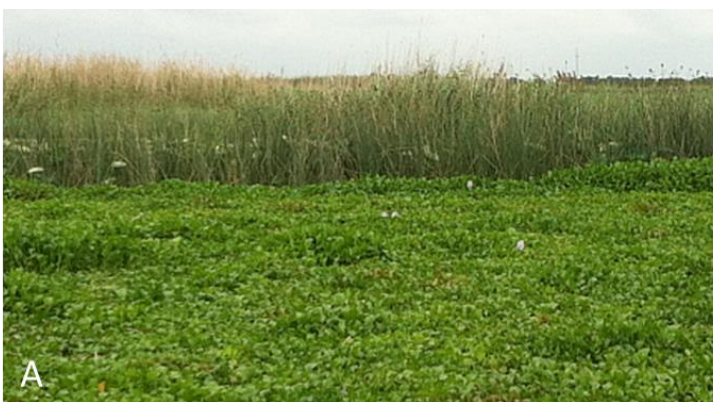
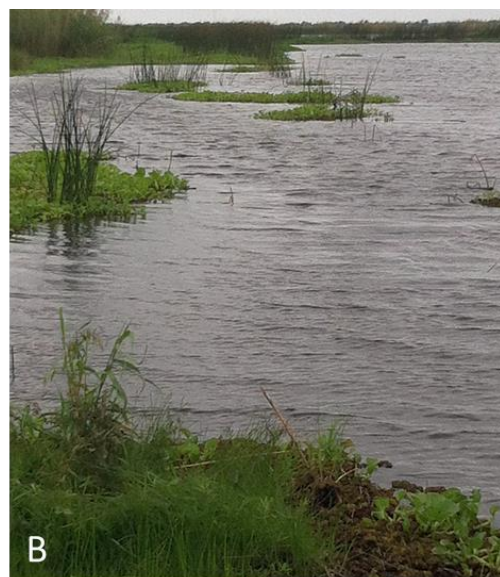
Figure X-6. Large floating vegetation mats lead to planting loss even among the more robust plantings in the LA-39 Year 3 Willow Lake - East area. Floating mats consisted of water hyacinth (A) and combinations of water hyacinth, giant Salvinia, and otherwise emergent vegetation (B).

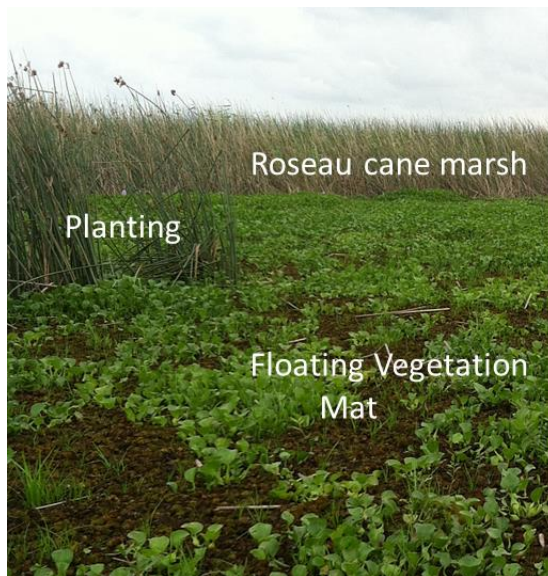
Figure X-7. Damage from floating vegetation mats was noted to be more severe where the plantings were closer to the existing marsh within the LA-39 Year 3 Willow Lake site, especially along the northern portion of the West and East areas.

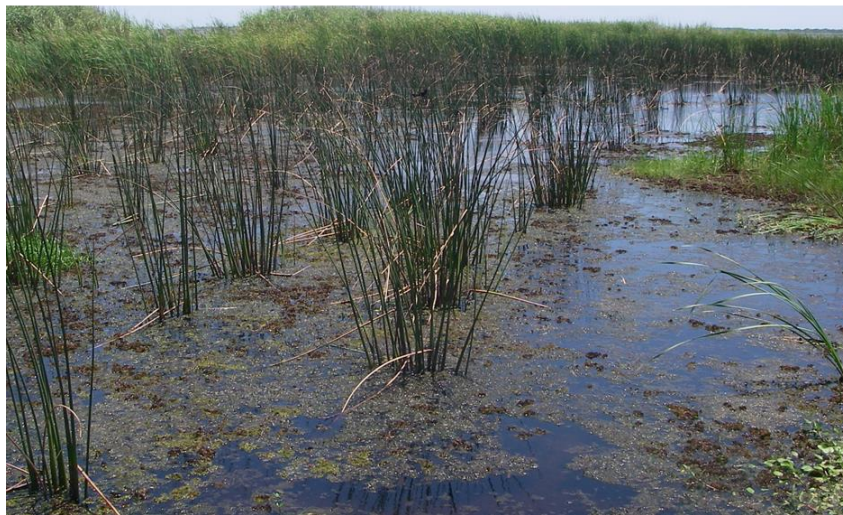
Figure X-8. Auxiliary plants were used for area plantings to help vegetate areas susceptible to breaching from Willow Lake. Pictured is the East Area Auxiliary planting on July 25, 2015.

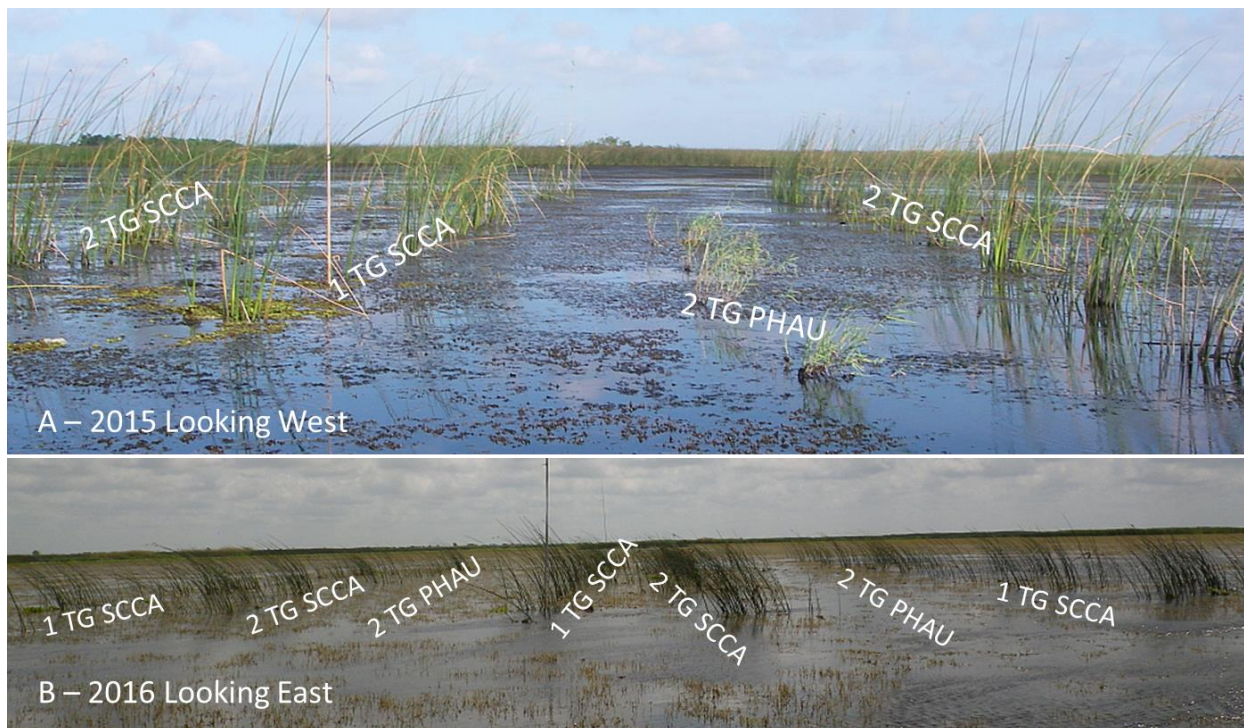
Figure X-11. The deeper test plots from LA-39 Year 3 Willow Lake were observed on 07/25/2015 (A) and 05/26/2016 (B). The test plots consisted of rows of 1 and 2 Trade Gallon sized (1 and 2 TG) *Schoenoplectus californicus* (SCCA, California bulrush) and 2 TG *Phragmites australis* (PHAU, Roseau cane). The submerged aquatic vegetation in both pictures is *Cabomba caroliniana*. Note the absence of visible PHAU in 2016 (B, see Fig. X-12). Water was about one foot deeper in 2016 than 2015.

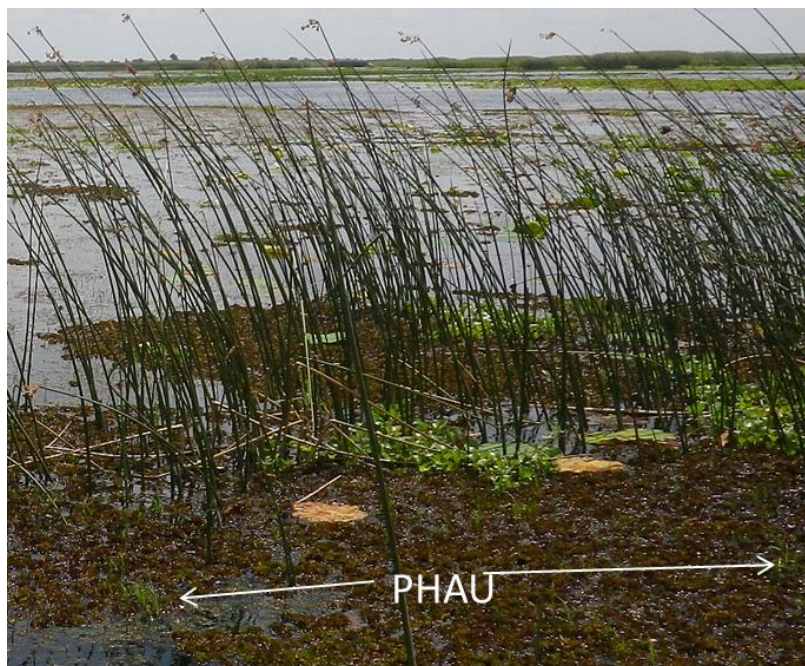
Figure X-12. Growth of *Phragmites australis* (PHAU, Roseau cane) from two trade-gallon sized containers was limited by competition from submerged and floating aquatic vegetation. California bullwhip was also susceptible to floating vegetation during higher water.

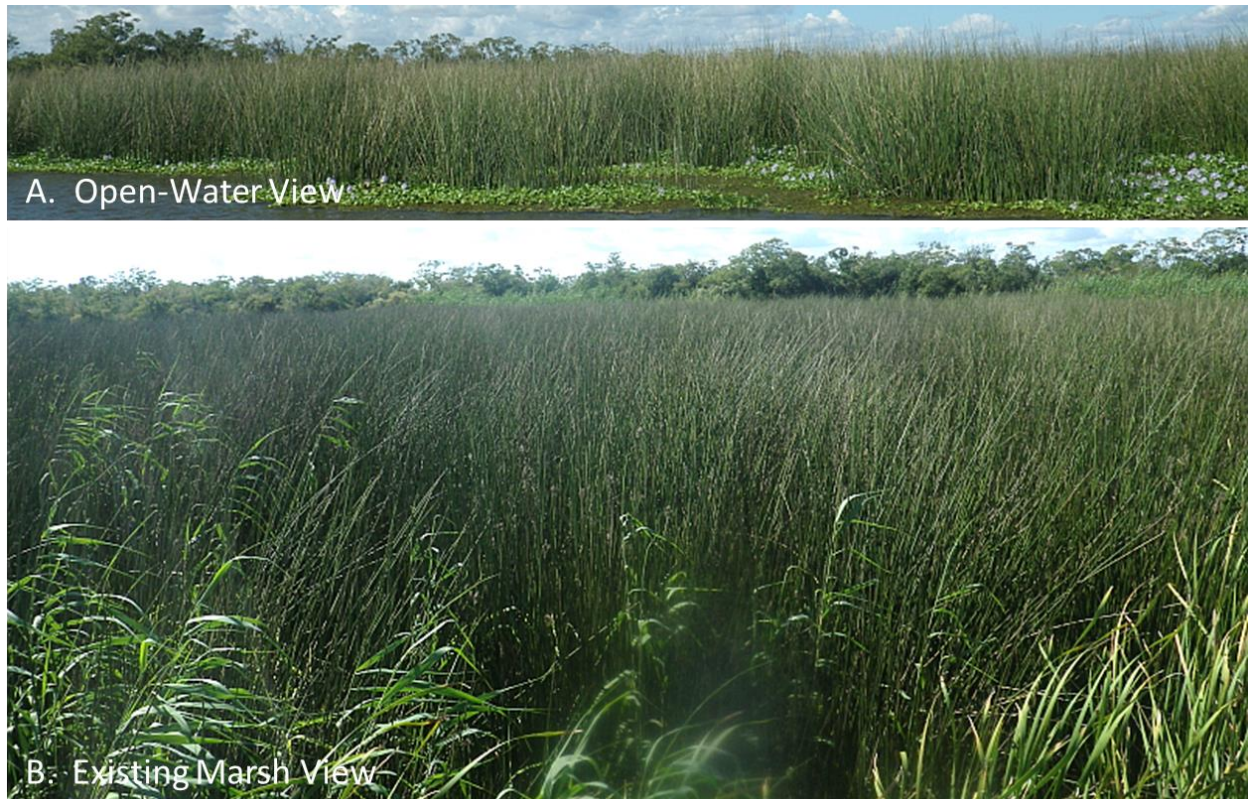
Figure XI-3. Plantings in the North area (Ponds 1 and 2) experienced the best survival and growth (12+ ft stems) of the Green Island Bayou plantings. Marsh vegetation (Roseau cane and cattails) are creeping into the area planting (B). Water depth is the same as the other plantings, but the water bottom is firmer here; the soil contains a clay/silt mix in the top 5 inches, then a silt/organic mix down to a clay lens at about 12 inches, then peat below.

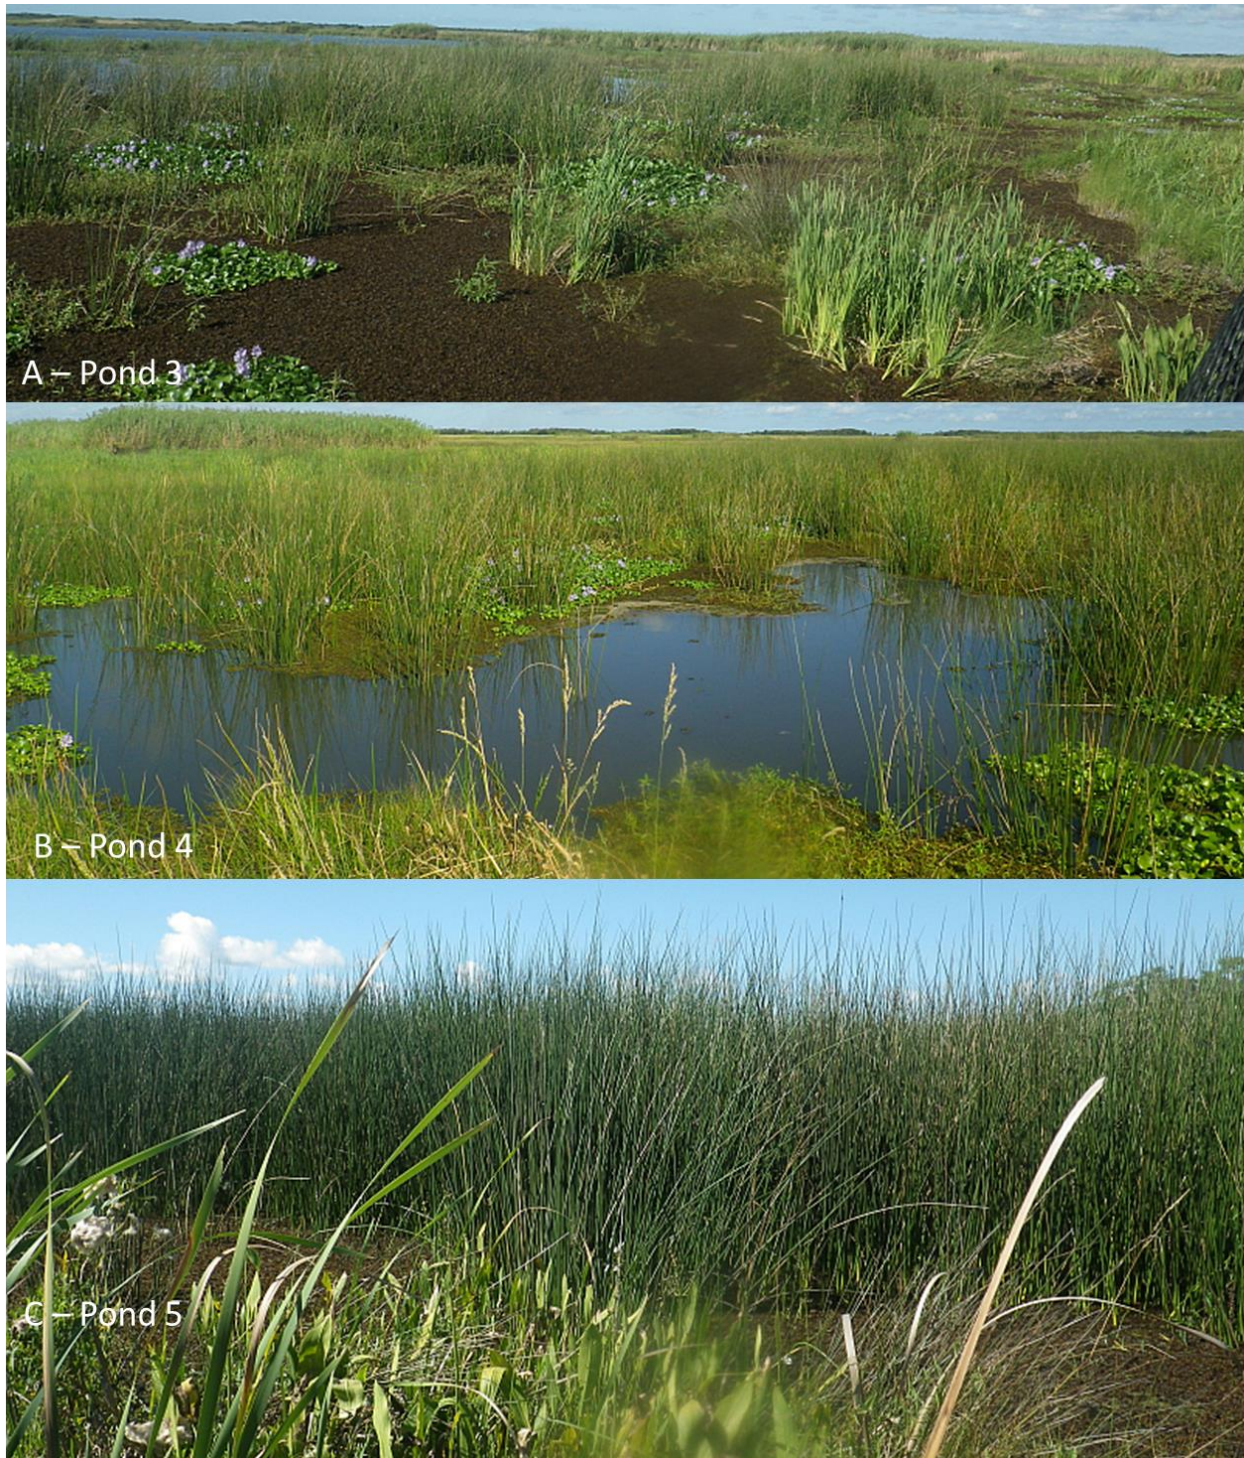
Figure XI-4. Area Plantings – The northern half of the West area experienced varying degrees of success. (A) Pond 3 had the least survival and growth (stems 6-7 ft tall) which was limited to the middle of the pond while survival and stature of plant decreases towards the edges. (B) Pond 4 also had a similar pattern as Pond 3 but with greater survivorship and growth (stems 7-8 ft tall). (C) Pond 5 had excellent survivorship and growth (stems 8-10 ft tall); individual plantings are

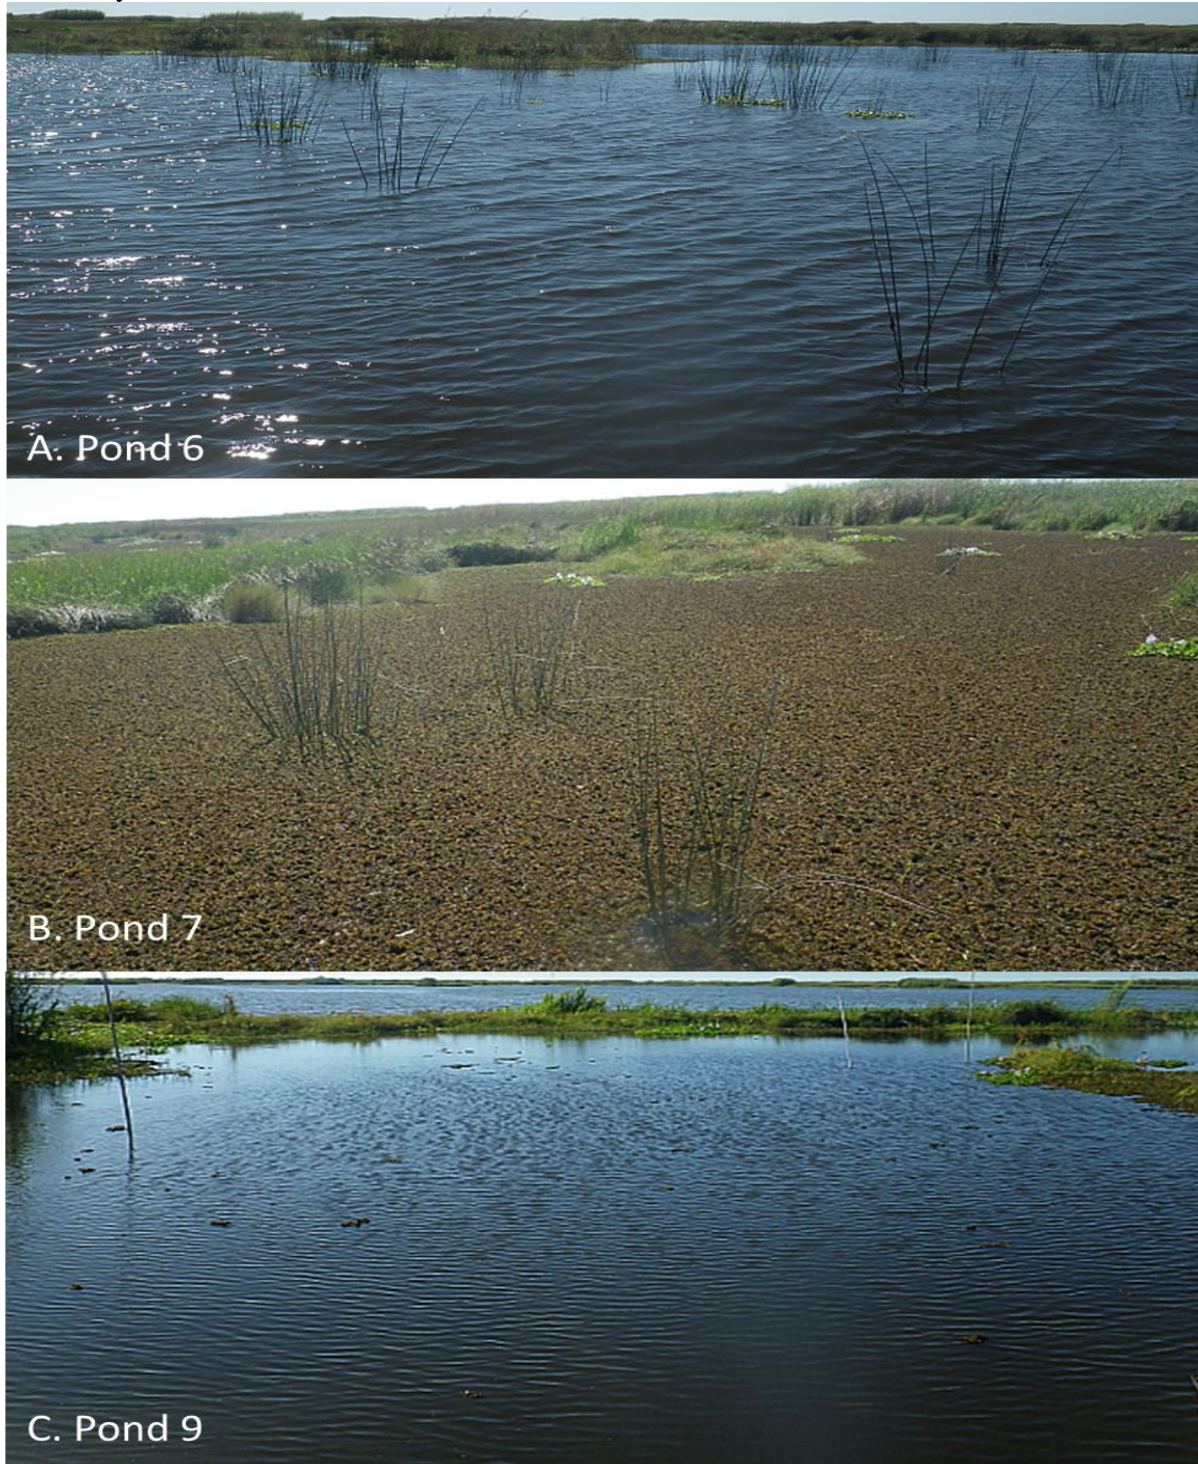
Figure XI-5. The southern portions of the west and southwest areas had very low success. Survival was limited to the middle of Southwest Area Ponds 6 (A) and 7 (B). Surviving plants were dark green but had not grown much; individual plants were ~6ft tall and highly distinguishable. Survival was sparser in Pond 7, possible because of the high occurrence of giant

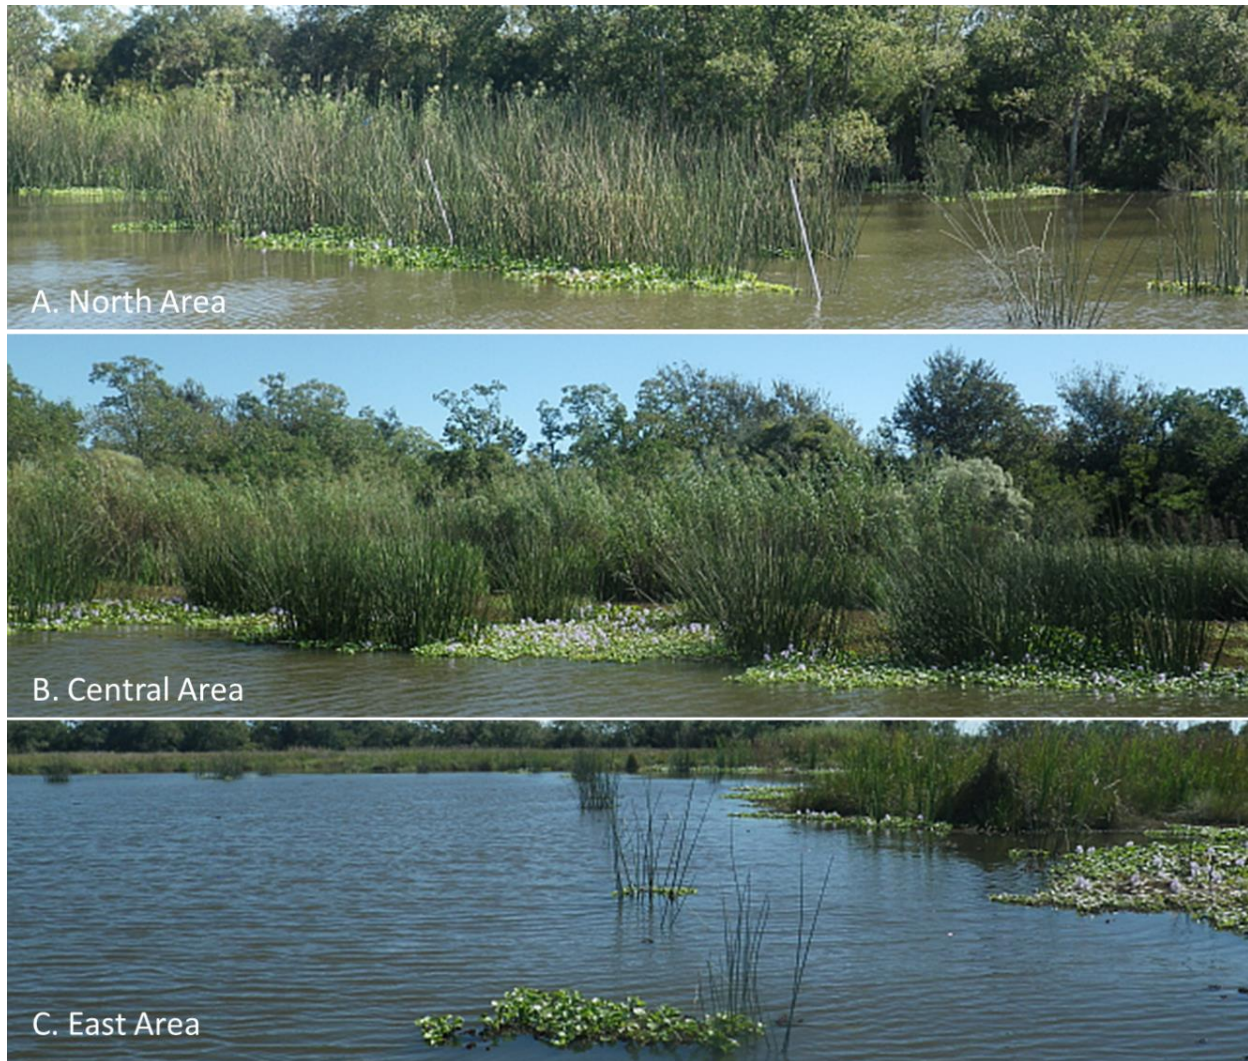
Figure XI-6. Double rows were planted in the North, Central, and East areas. (A) The North had 40-70% survival; plants are growing well (8-10 ft stems) and expanding. (B) The Central had highly variable survival (0-70%) among reaches; plants are growing well (stems ~8 ft) and expanding. The marshside row is performing better than the pondside row. (C) The East had ~40% survival but not much growth (stems 5-6 ft tall) or expansion of surviving plants.

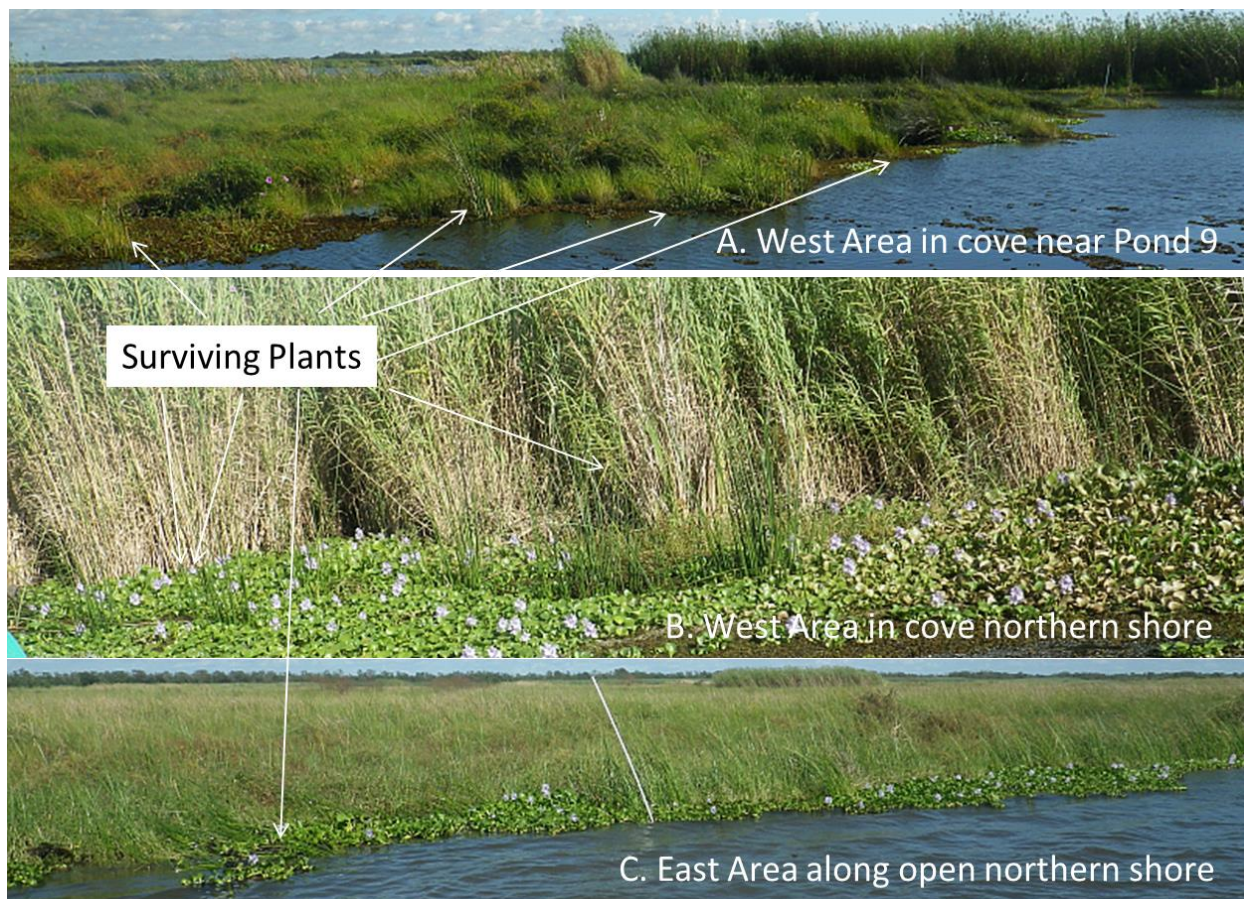
Figure X1-7. The Shoreline Planting pictures taken on October 16, 2016 targeted remaining plants. (A) The southwestern shoreline plantings of the West Area were in a cove off of the main open-water body; survival was sparse, but this stretch of shoreline plantings had the highest survival of all the shoreline plantings. (B) Much of the northern and western shorelines of the West site survivors were limited to protected areas and stems were only 3-4 ft tall. (C) Shoreline plantings north and south of the double row cover had <1% survival. Isolated, surviving plants in the NW corner were very small (~3 ft).

The shoreline plantings were not successful (Fig. XI-2 and 7). Surviving plants were targeted for vegetation station locations. After a sharp initial loss of 57 percent of survival over the first two months after planting, the shoreline plantings lost another 37 percent over the next year. By one year after planting, vegetative cover, which also includes existing marsh along the shoreline, decreased by ~27% and stem heights grew a modest 0.6 ft.

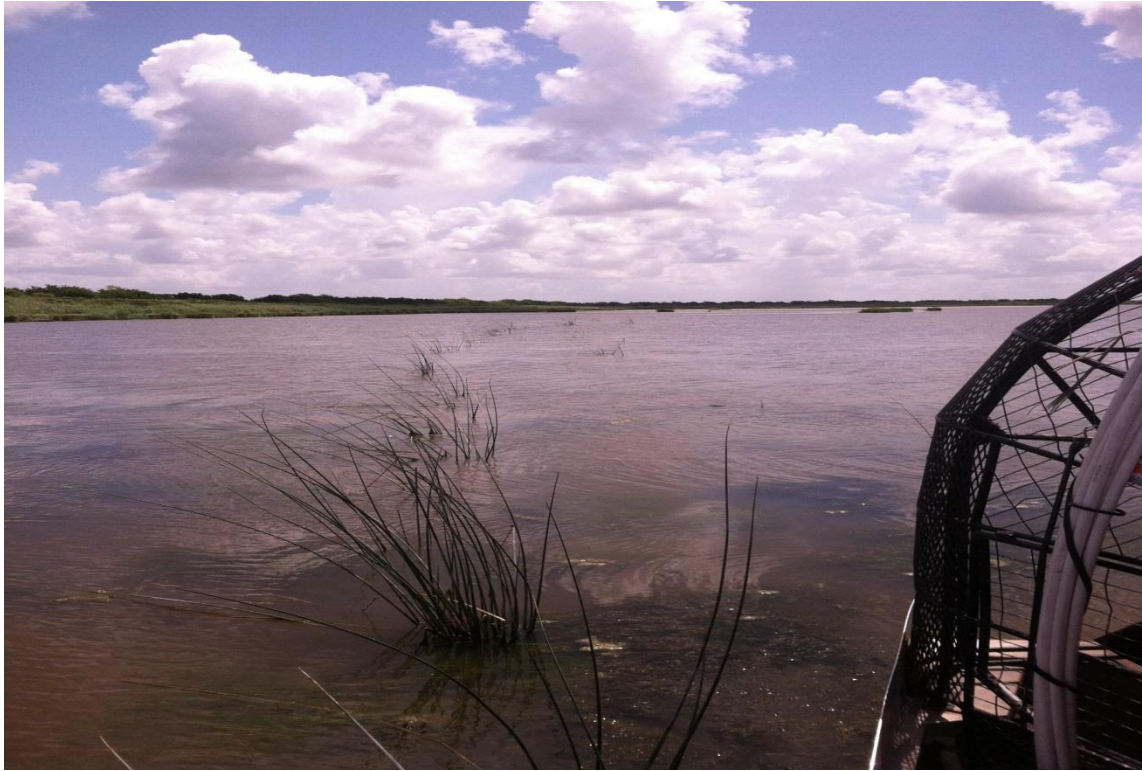
Figure XII-3. View of surviving *S. californicus* plantings on end of row across northern open water area in August 2015.

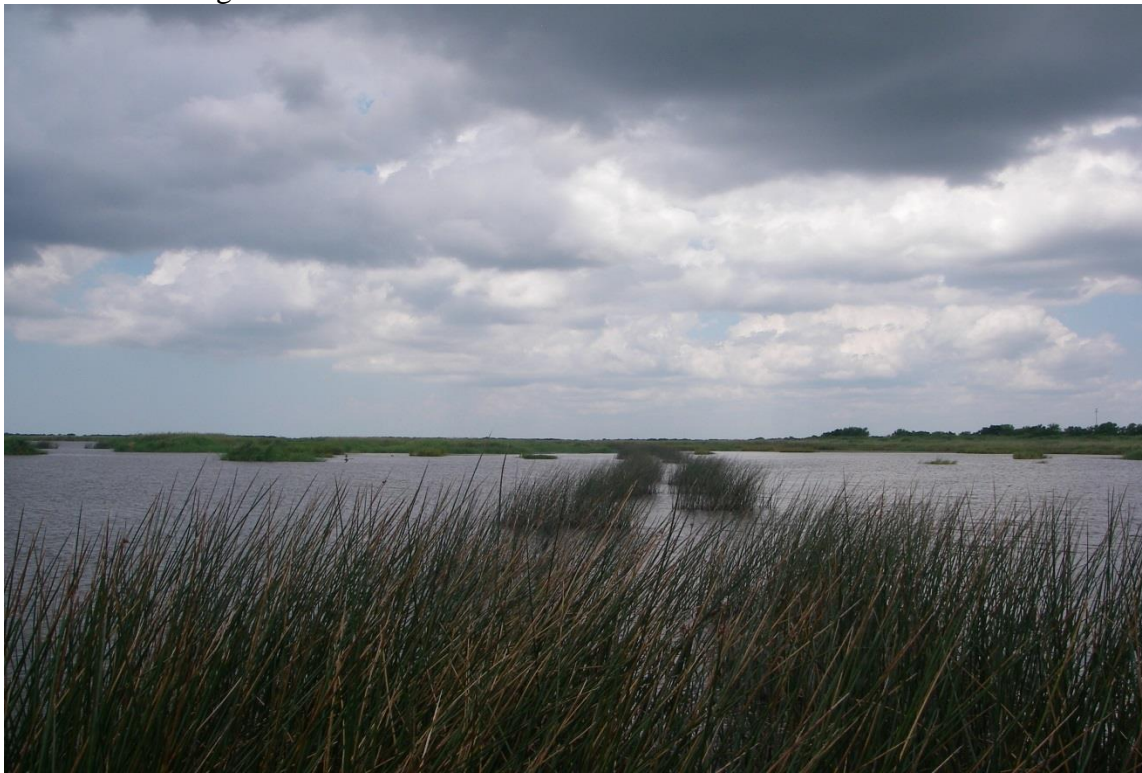
Figure XII-4. View of healthy *S. californicus* forming clumps in the protected, northeast double row in August 2016.

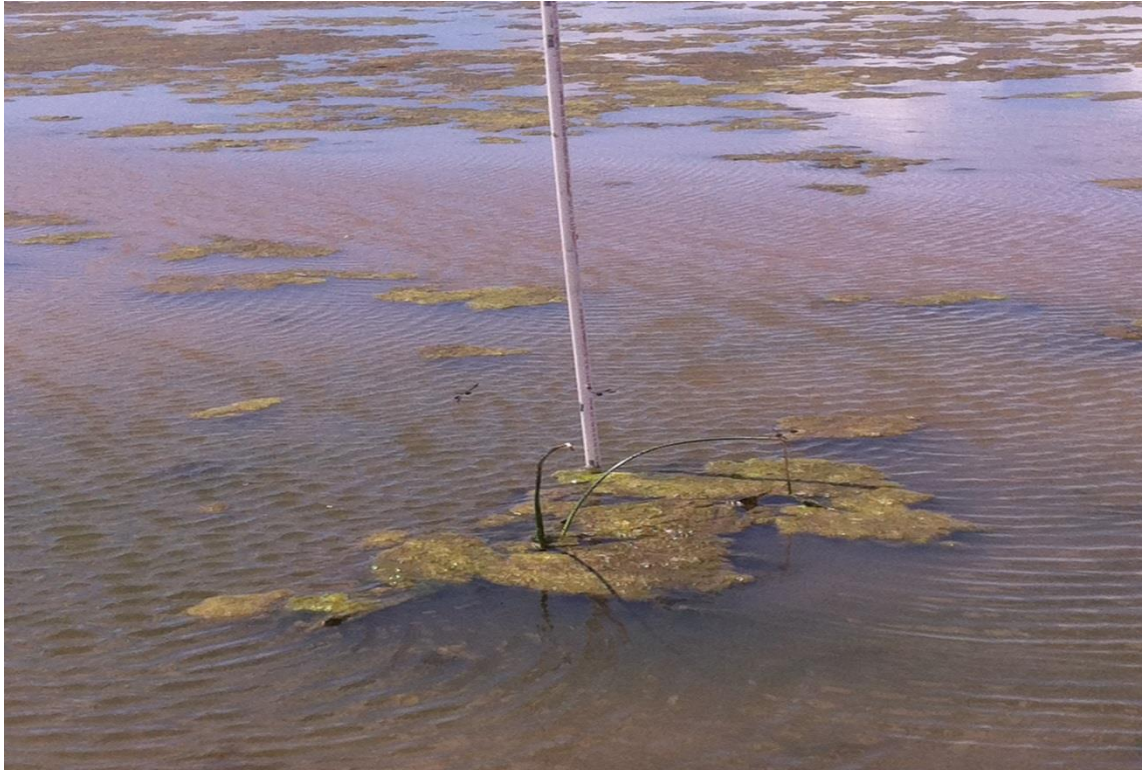
Figure XII-6. Example of algal rafts collecting on stressed *S. californicus* plantings in August 2015.
