2021 Operations, Maintenance, and Monitoring Report

Coastwide Vegetative Planting Project (LA-0039)

State Project Number LA-0039
Priority Project List 20

September 2021

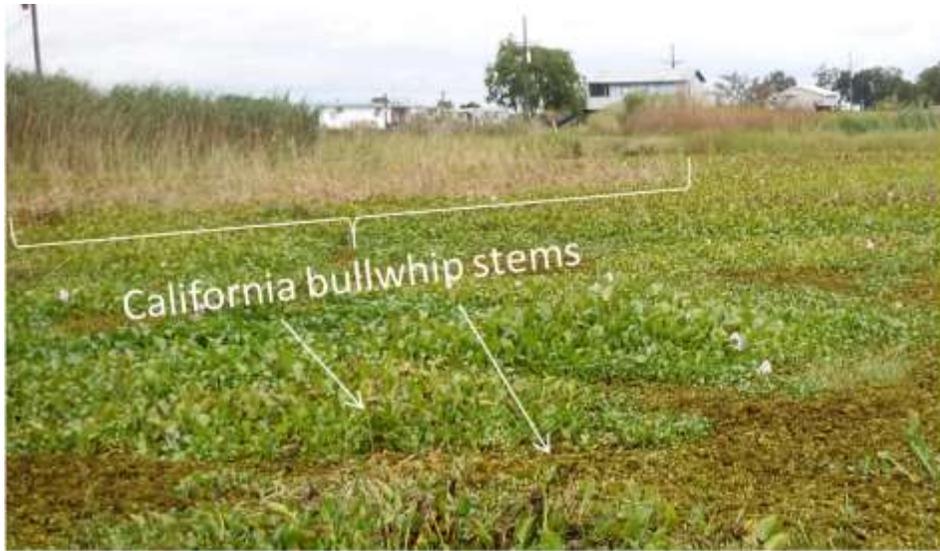
Figure III-4. Expansive mats of floating vegetation impacted the Area 2 by pushing over and covering California bullwhips (A). Sparse and damaged plants, if any, typically remain when the mats dissipate (B). Pictures were taken during the Oct 2015 monitoring.

Water depths were typically greater than the optimum range of 1 - 18 inches for smooth cordgrass ‘Vermilion’ strain establishment (Fine and Thomassie. 2000); and, the plants were constantly flooded (Fig. III-9) which causes anaerobic soil conditions that can be toxic to plant roots. Isolated plants, as planted along rows with five feet spacing between plants, are especially vulnerable to anaerobic soil conditions. Submerged and floating aquatic vegetation (SAV and FAV) rafting over the plants is another significant contributor to planting failure (Fig. III-2). Water salinity averaged around 2 ppt which is within the tolerance range of smooth cordgrass ‘Vermilion’ strain (8–30 ppt) and should not have been a stress factor (Fine and Thomassie. 2000). The California bulrush plantings were not stressed by the water levels or salinity. Sometime between January 2015 (Fig. III-3) and field sampling in October 2015 established stands of California bulrush were smothered out by large mats of floating invasive species, giant Salvinia and water hyacinth (Fig. III-4).

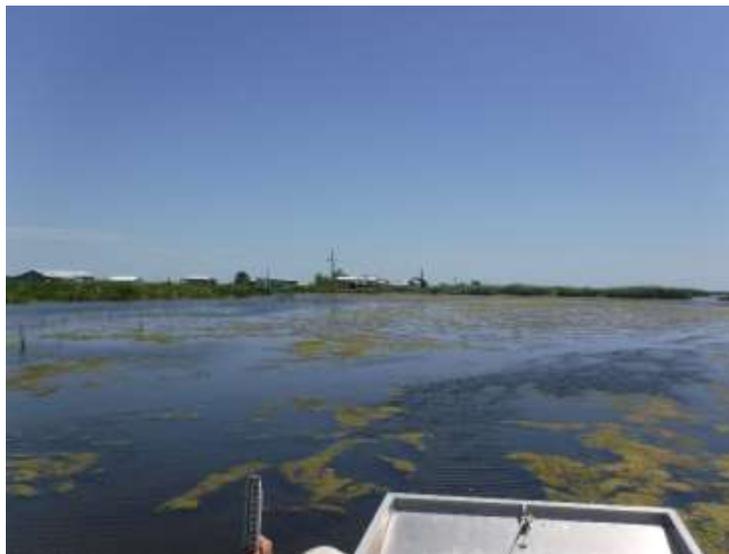
Figure III-5: Photo taken during the October 2018 data collection trip indicates the loss of the initial plantings installed in Area 2. The plantings in the background of the photograph are newly installed LA-0039 Year 6 DeCade Vicinity plantings.

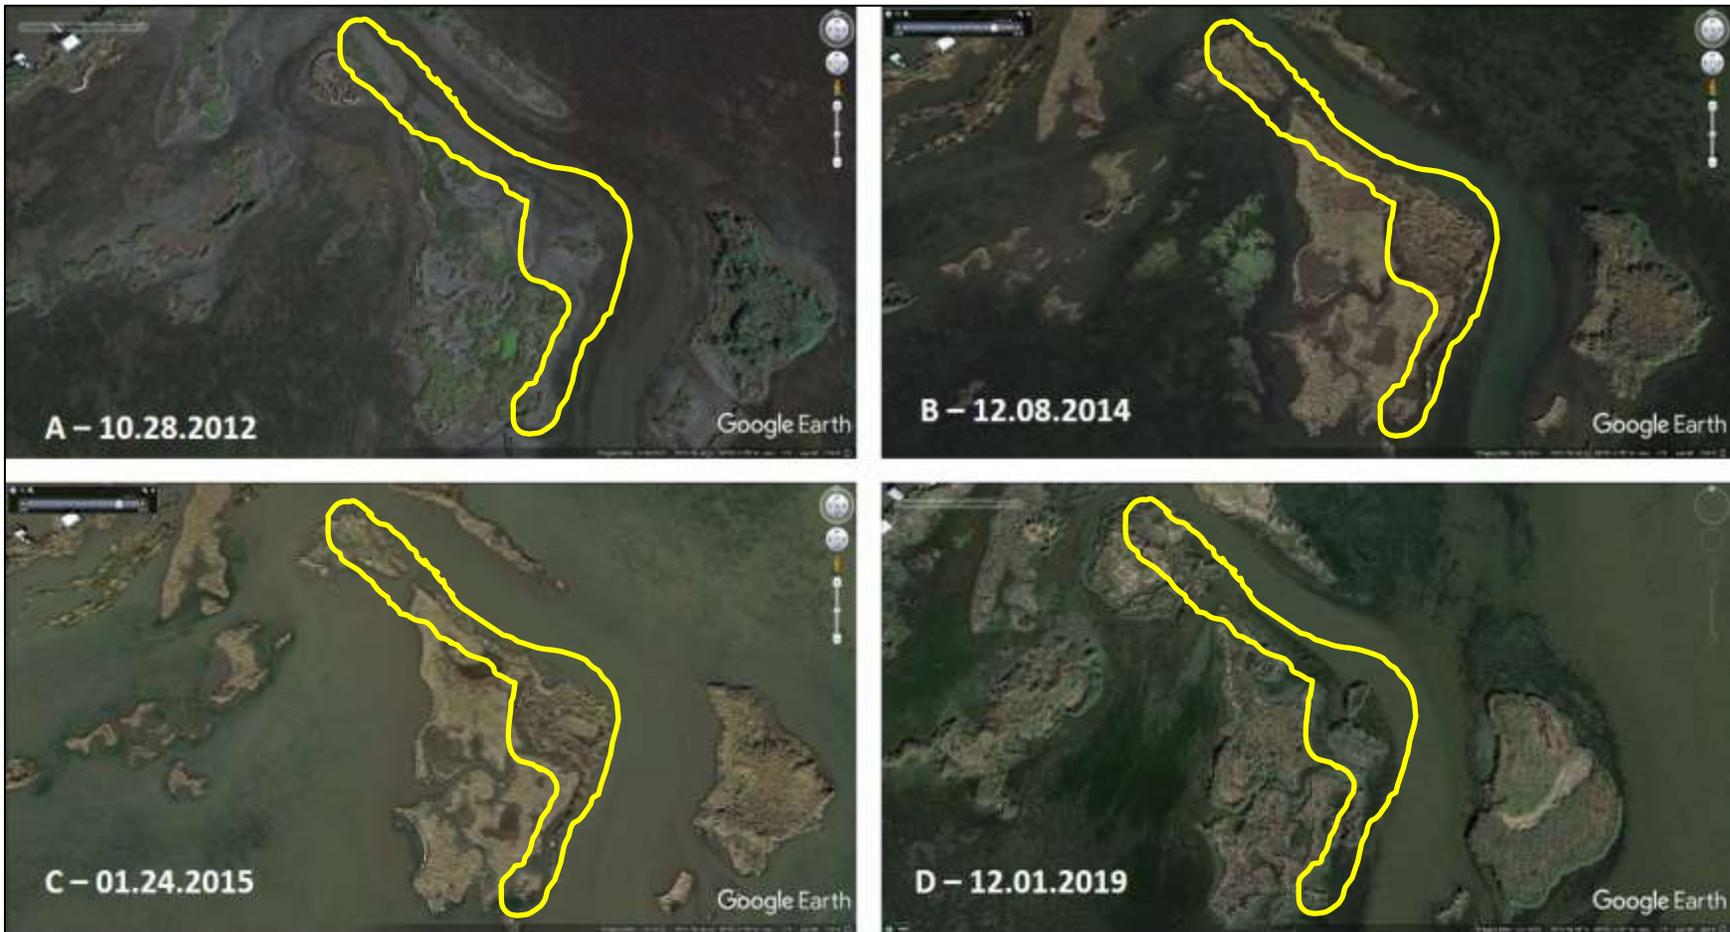
Figure III-6: A time series of LA-39 Year 1 South Lake DeCade Area 3 – Auxiliary Plantings of *S. Californicus* from Google Earth displays changes since planting along and at the bend of the tidal channel running south of Bayou DeCade. Image A indicates pre-installment time frame while images B, C, and D indicate 2 years, 3 years, and 7 years post-installment time frames respectively. Plantings expanded and survived through 2015, however by 2019 the auxiliary area shoreline eroded back leaving few survivors.

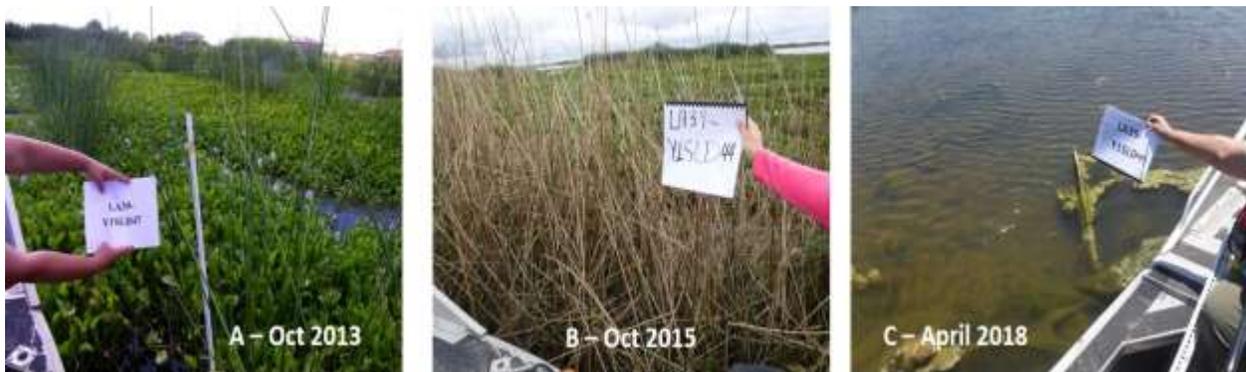
Figure III-8. Pictures of LA-0039 Year 1 South Lake DeCade Area 2 - Double Row *Shoenoplectus californicus* (California bulrush) plantings were taken during 1 (A), 3 (B), and 5.5 (C) years after planting. Losses from the rafting of floating aquatic vegetation began prior to the 2013 sampling (A) and expanded by the 2015 sampling (B). The dead stems in B are from seasonal senescence.

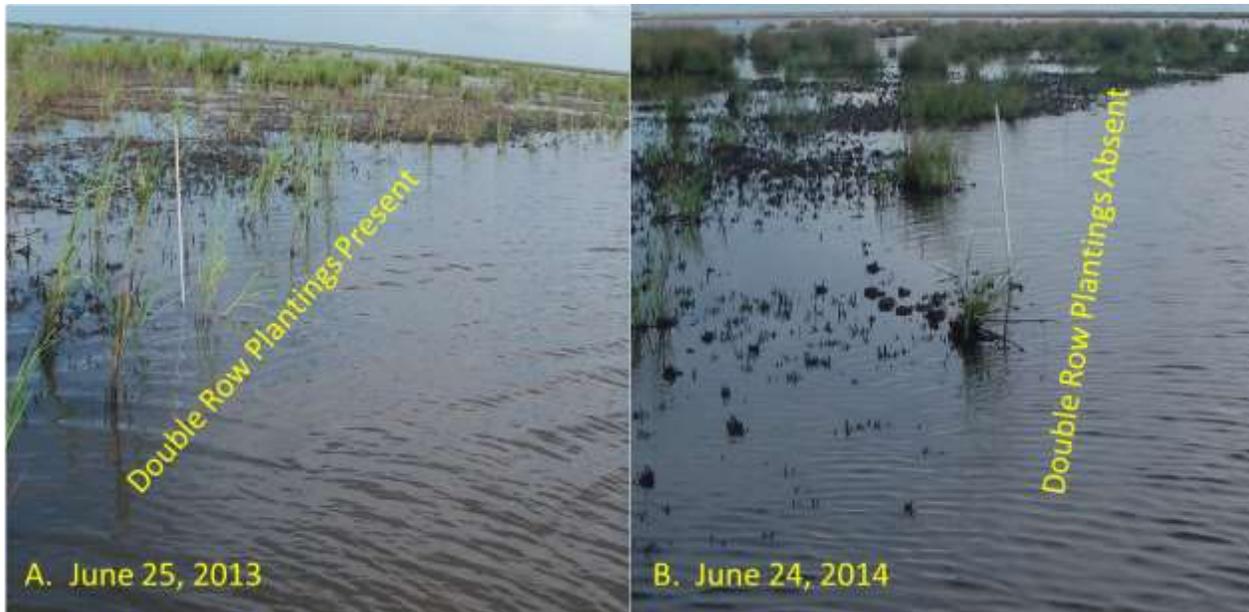
Figure IV- 3. A double row of *Spartina alterniflora* Vermilion was planted to stabilize the Lambert Bayou shoreline in the Northwest Area of the LA-0039 Year 1 Cameron Creole site in June 2013 (A). Most of the plantings were absent a year later in June 2014 (B).

Failure of the Cameron Creole plantings was caused by chronic flooding of mostly stagnant water (Fig. IV-10). Chronic flooding causes anaerobic soil conditions that can be toxic to plant roots. Isolated plants, planted along rows with five ft spacing between plants, are especially vulnerable to anaerobic soil conditions. Of the existing marsh, higher elevation vegetation within larger patches was healthy throughout the monitoring period whereas isolated pedestals of vegetation and plantings diminished (Fig. IV-11). Rafting by algae and SAV physically damaging the plants is another contributor to planting failure; however, algal rafting was not as widespread throughout the site as the planting failure. Water salinity averaged 7.9 ± 5.2 ppt within a range of 0.4 – 22.5 ppt which is within the tolerance range of smooth cordgrass (Vermilion) and should not have been a stress factor (Fine and Thomassie 2000).

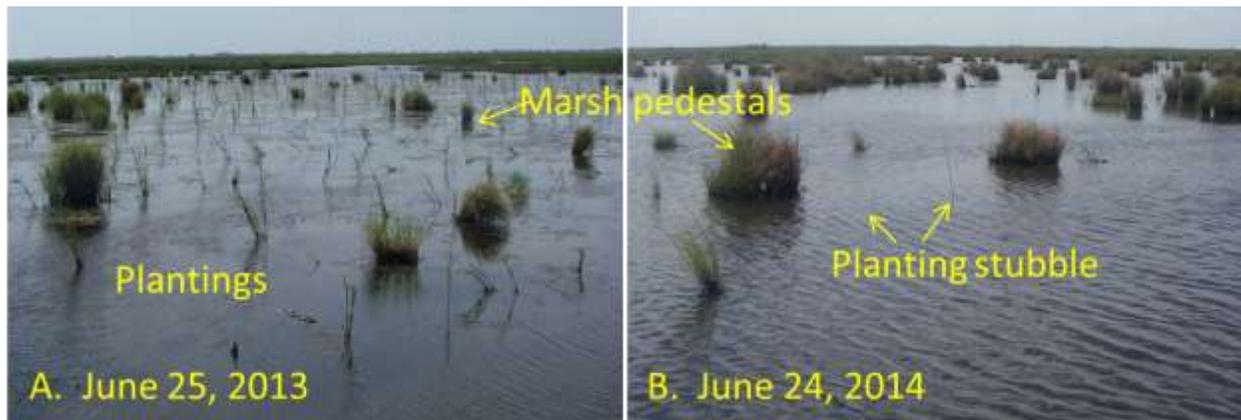
Figure IV- 4. *Spartina alterniflora* Vermilion was planted on a broken marsh platform in the Northwest Area of the LA-0039 Year 1 Cameron Creole site in June 2013 (A). Most of the plantings were absent a year later in June 2014 (B).

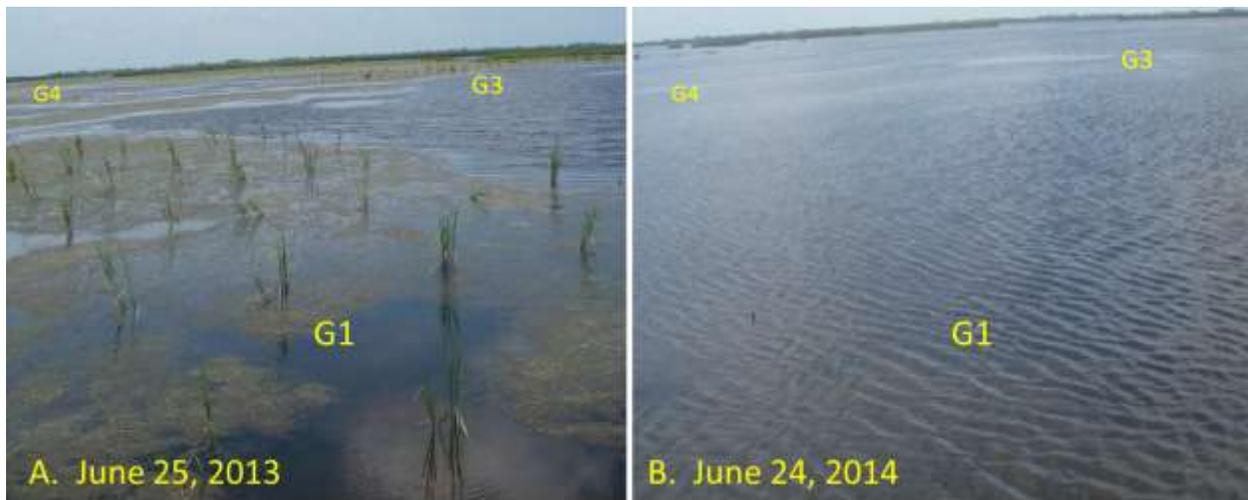
Figure IV- 6. *Spartina alterniflora* Vermilion was planted in shallow open water/former mudflats between patches of marsh in the Central Area of the LA-0039 Year 1 Cameron Creole site in June 2013 (A). Note algae rafts on SAV in A. All of the plantings were absent a year later in June 2014 (B); SAV was still present although algae were reduced. G# represents different planting grids.

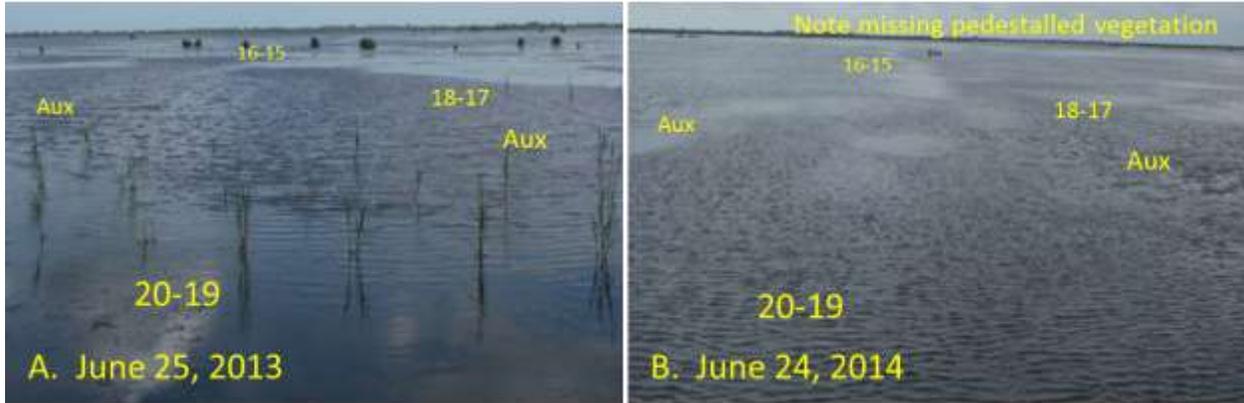
Figure IV- 7. Triple rows of *Spartina alterniflora* Vermilion was planted in shallow open water/former mudflats in the Northeast Area of the LA-0039 Year 1 Cameron Creole site in June 2013 (A). Note some algae rafts on SAV in A. All of the plantings and most pedestals of marsh vegetation were absent a year later in June 2014 (B); SAV was still present although algae were reduced. Paired numbers and “Aux” represent sets of triple rows.

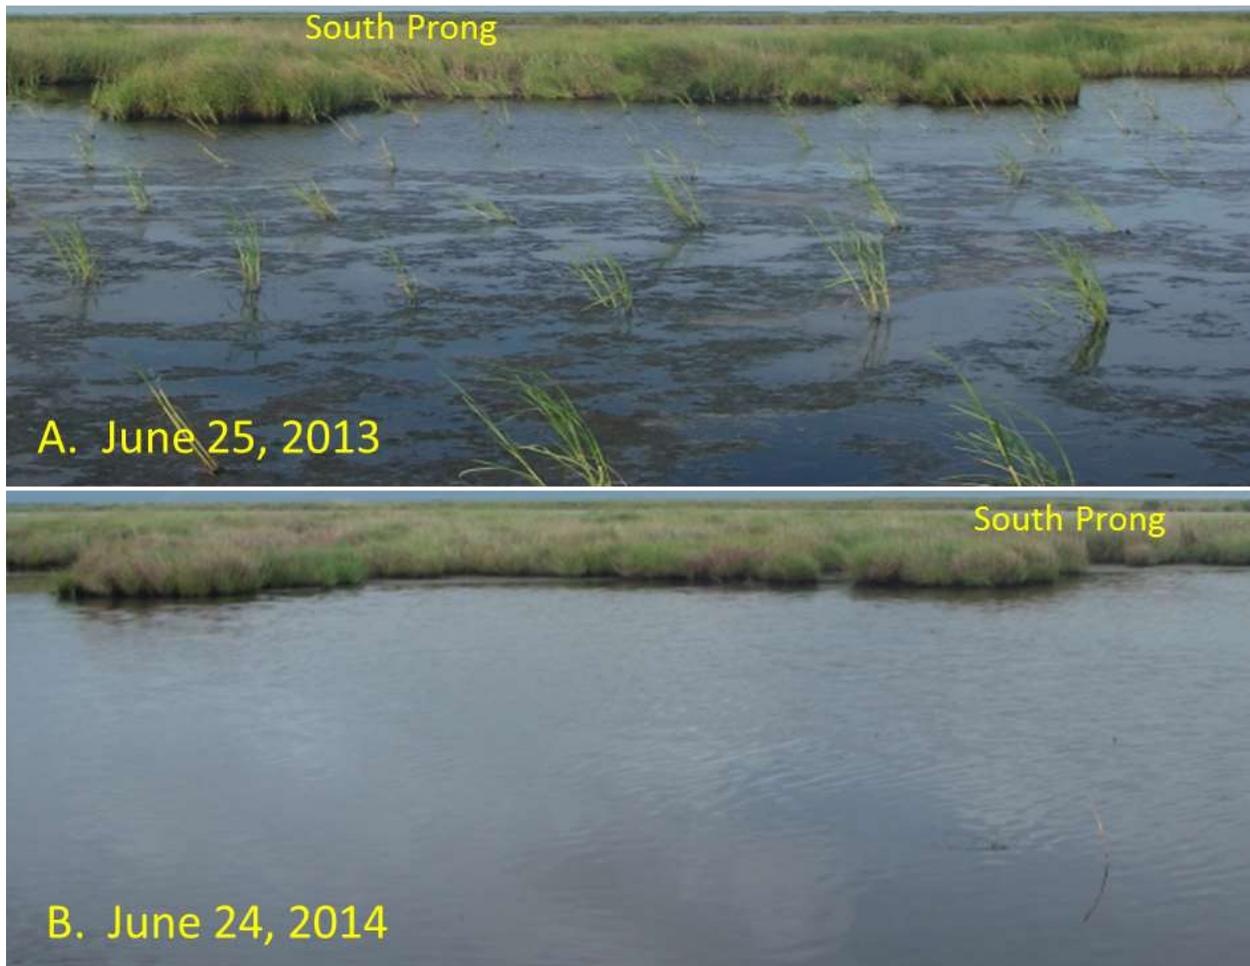
Figure IV- 9. Rows of *Spartina alterniflora* Vermilion were planted in shallow open water/former mudflats near marsh in parallel to the South Prong of Grand Bayou in the Northeast Area (A). Note some algae rafts on SAV in A. Most of the plantings were absent a year later in June 2014 (B); SAV was still present although algae were reduced.

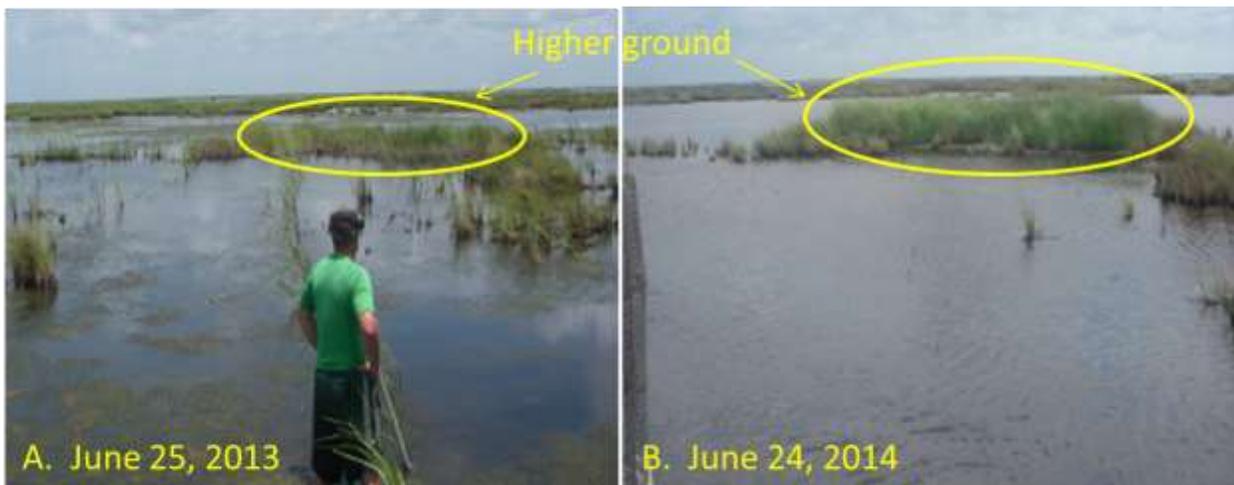
Figure IV-11. Higher elevation vegetation in larger patches fared better than lower elevation vegetation such as the individual plantings and pre-existing pedestalled vegetation.

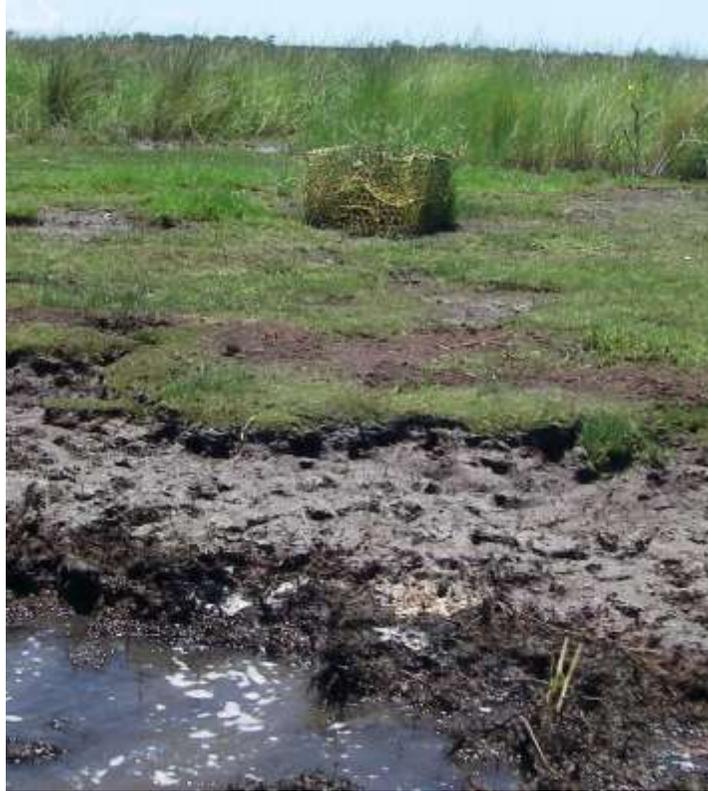
Figure V-3. The Northern Shoreline on 06/03/2013 during typical water levels. Note the taller, interior marsh vegetation in the background, the reduced vegetation height in the nearshore marsh platform impacted by herbivory (note taller vegetation in the crab cage), and the unvegetated shoreline eroded by surf conditions with a surviving plant to the bottom right side.

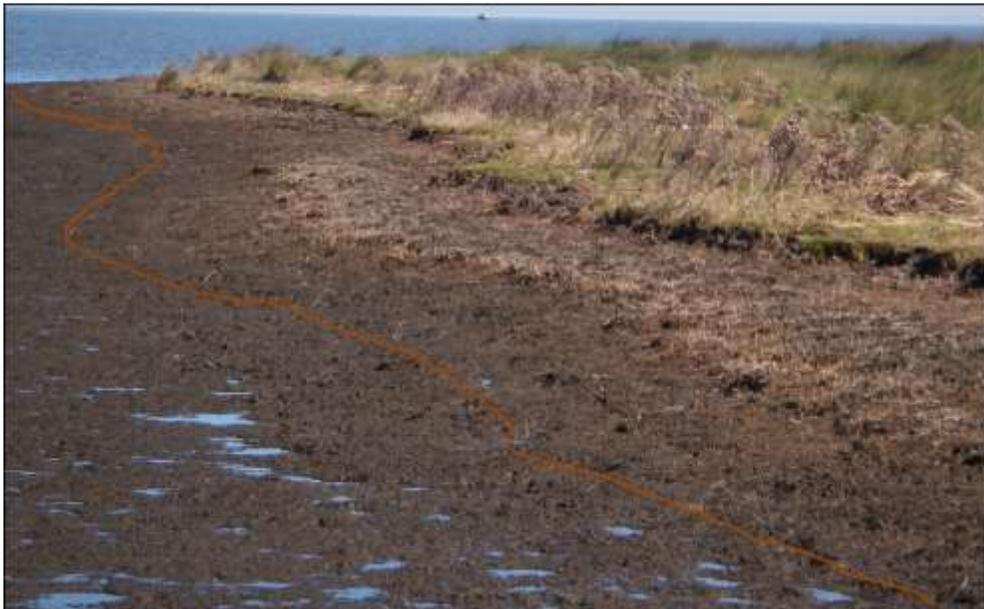
Figure V-4. The Northern Shoreline had low water levels on 12/18/2013. Empty anchors along the brown line indicate the planting alignment. The shoreline eroded back about 15-20 ft in the 8 months since the plantings installation.

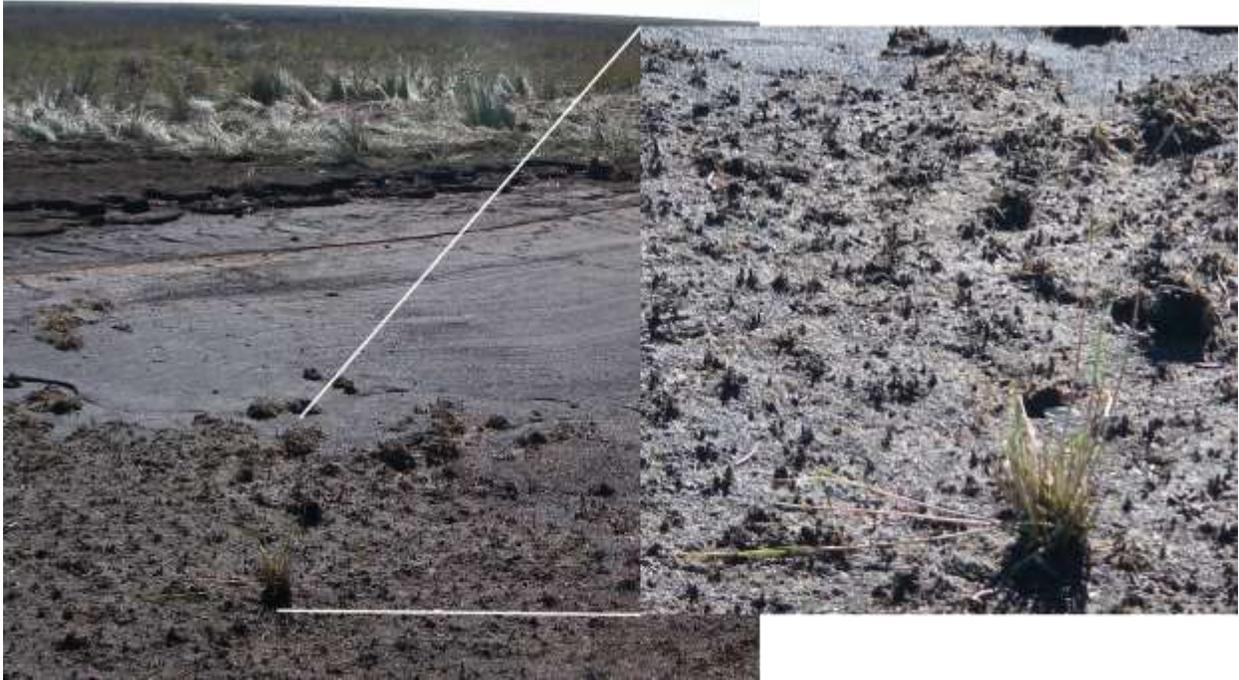
Figure V-5. The loan surviving plant was in Bayou Michael Pond area planting along the northern shoreline of Marsh Island; it was photographed on 12/18/2013 during very low water levels.

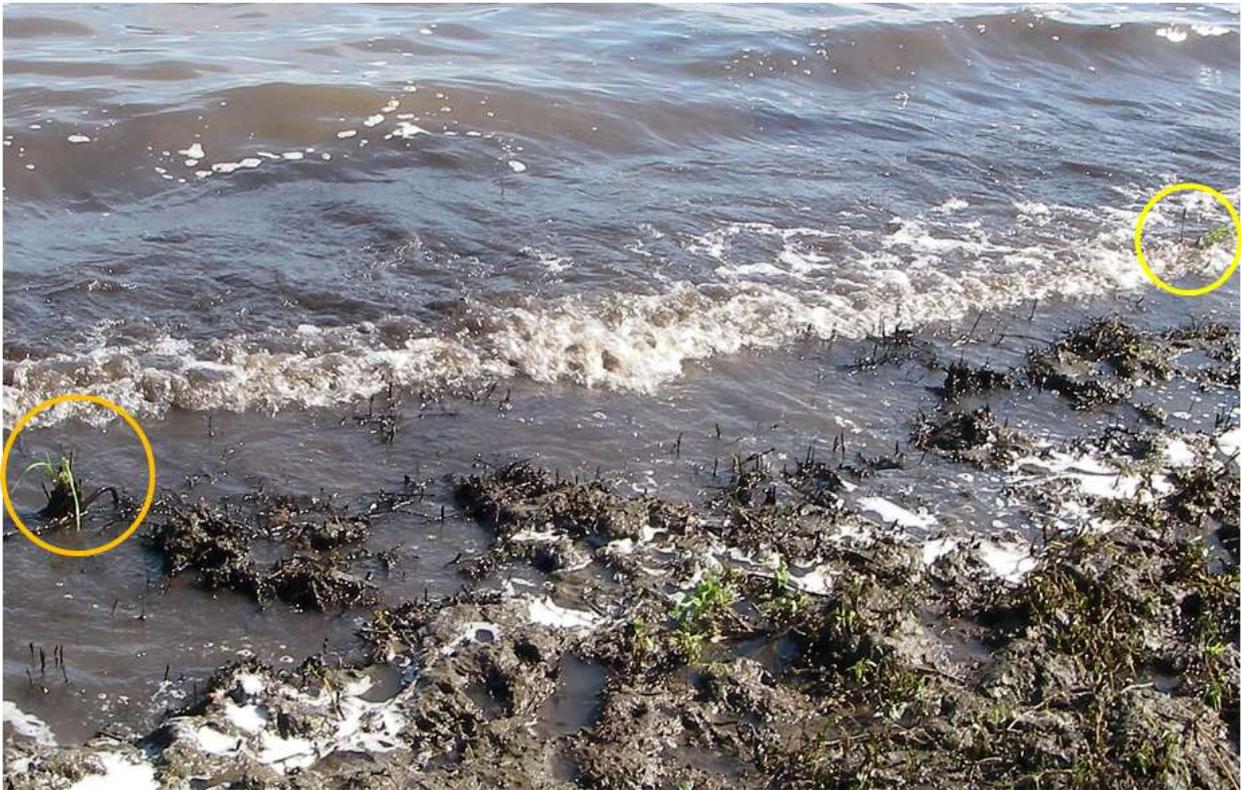
Figure V-7. Two surviving plants along a typical Northern Shoreline planting alignment were photographed on 06/03/2013 during typical water levels and calm wave conditions. Surviving plants were impacted by wave action. Note the anchored plant on the left and the non-anchored plant on the right. Two plants, one non-anchored and one anchored (anchor is missing), are absent between the surviving plants based on the planting specifications.

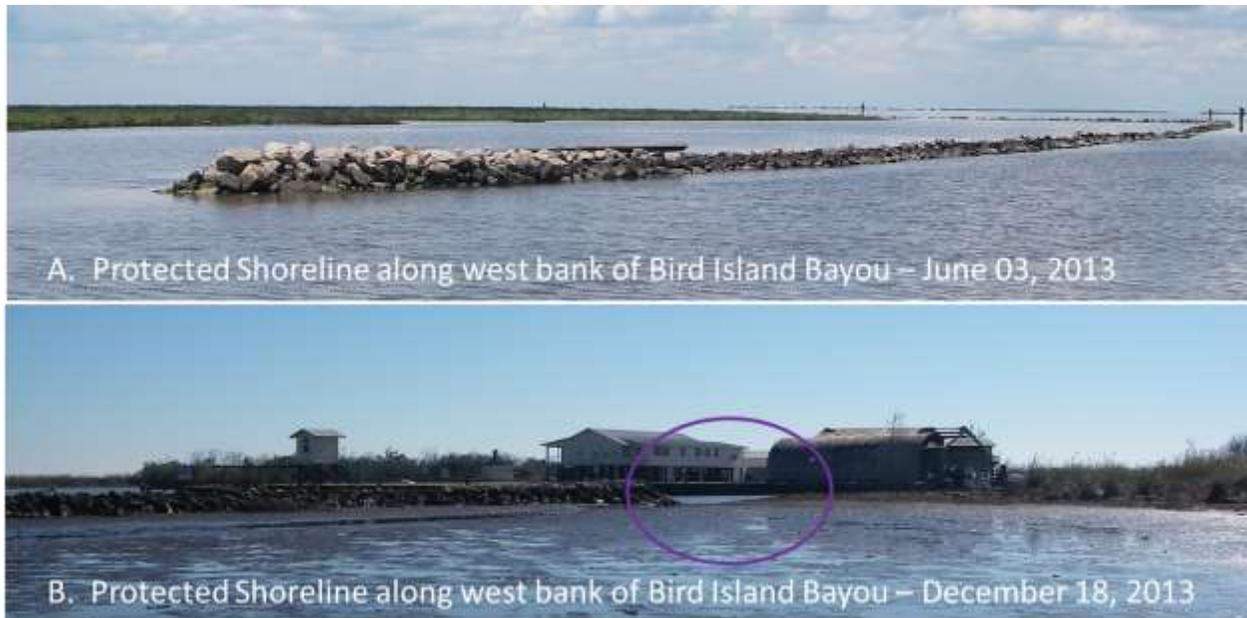
Figure V-9. California bulrush was planted in two double rows behind the foreshore rock dike protecting the shoreline along the mouth of Bird Island Bayou. Pictures were taken from both sides of rocks on the southern end of the west bank. **A** - note the watermark on the higher rocks during typical water levels; this indicates that the dike is overtopped during high water events. **B** - note the small opening between the dike and shoreline where water exists as water levels recede into Bird Island Bayou; also note the Louisiana Department of Wildlife and Fisheries Refuge camp.

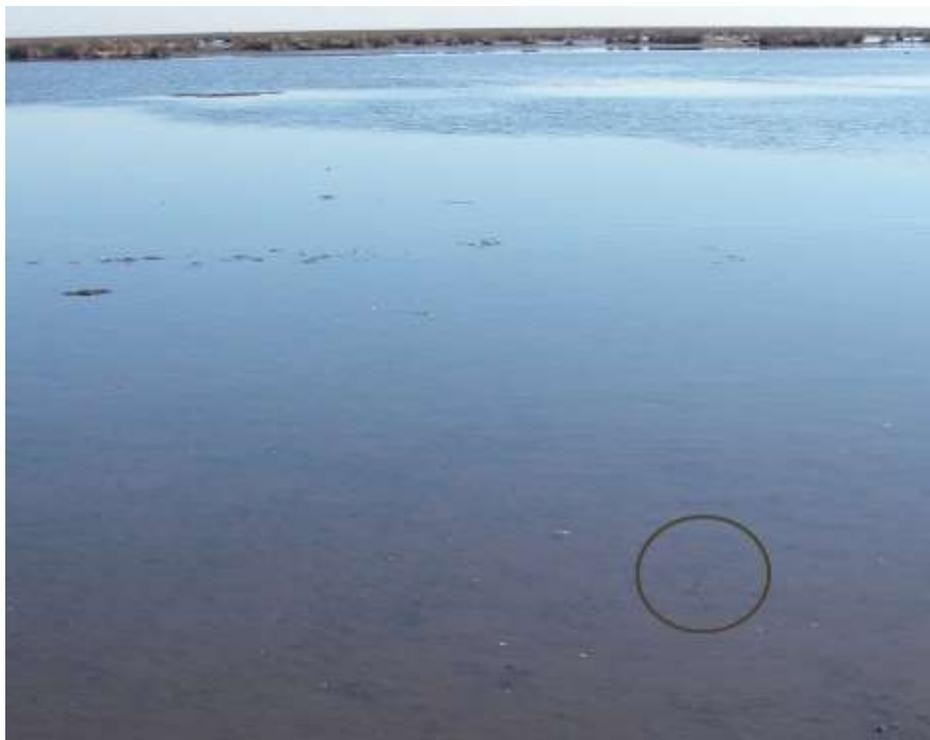
Figure V-11. The Oyster Bayou planting area was photographed on 12/18/2013 during very low water level; however, the area was still inundated with a couple inches of water. Note the potential remnant of a planting in the circle.

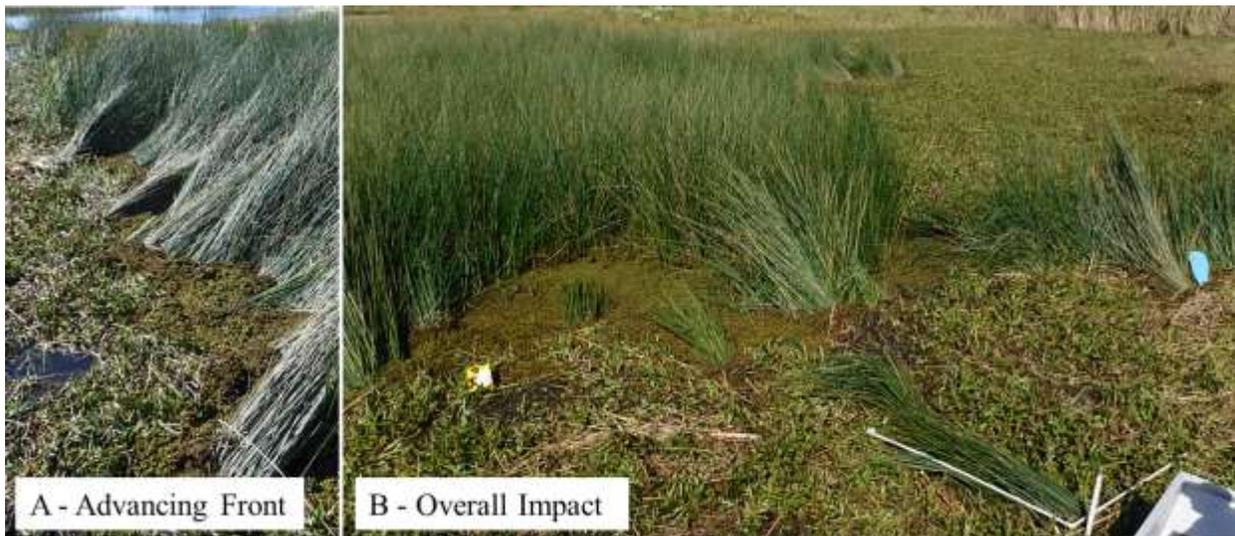
Figure VI-13. Progression of floating vegetation impacts on pond area plantings.

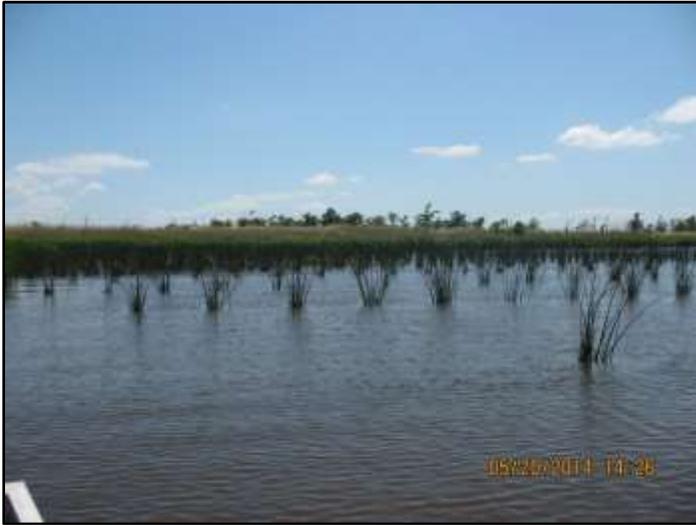
Figure VII-2. Double row planting area 3A of LA-0039 Year 2 The Prairie was photographed during the May 2014 vegetation survey.

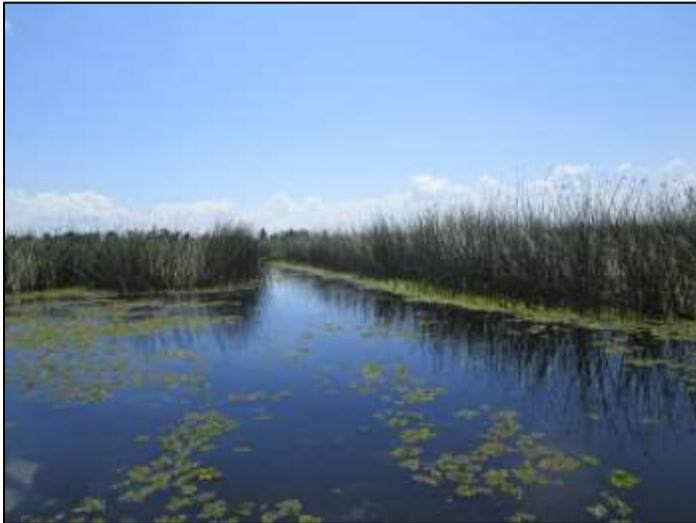
Figure VII-3. Double row planting area 3A of LA-0039 Year 2 The Prairie, photographed during the June 2015 vegetation survey.

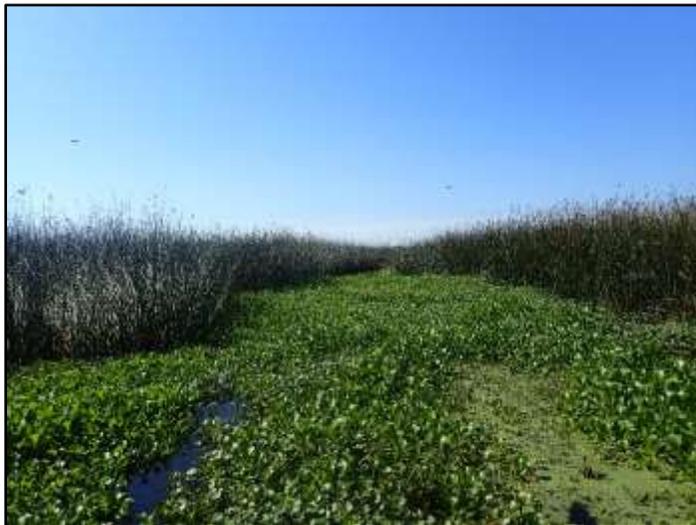
Figure VII-4. Double row planting area 3A of LA-0039 Year 2 The Prairie was photographed during the May 2019 vegetation assessment.

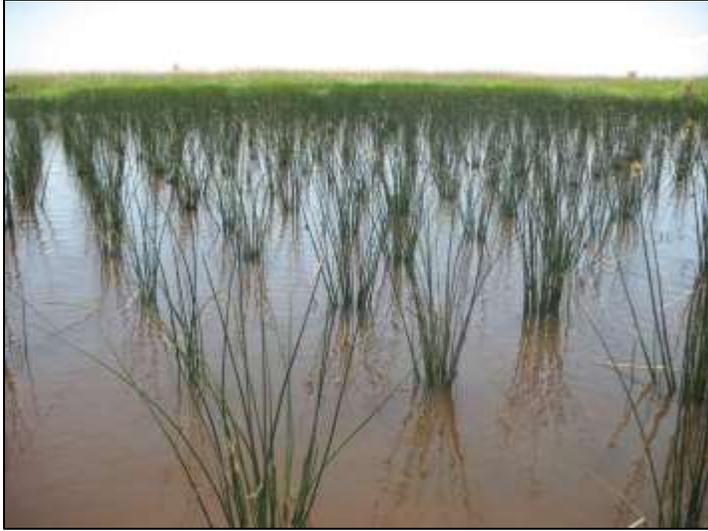
Figure VII-5. Area planting 2A of LA-0039 Year 2 The Prairie was photographed during the May 2014 vegetation survey.

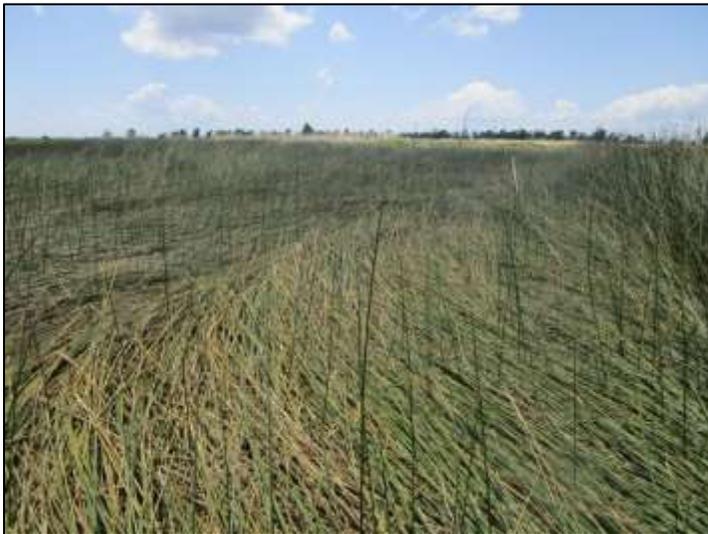
Figure VII-6. Area planting 2A of LA-0039 Year 2 The Prairie was photographed during the June 2015 vegetation survey. The SW marker pole for the survival plantings for station P08 Visible in the photograph was accessible in May 2014. Note the laid over *S. californicus* stems.

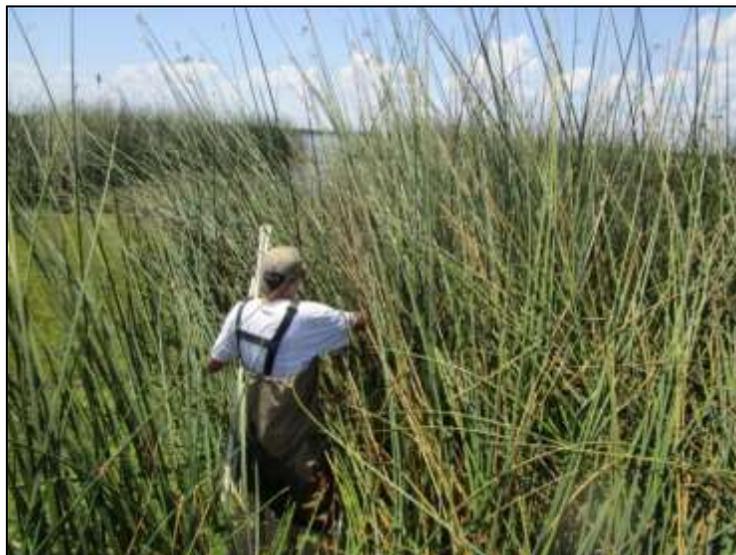
Figure VII-10. Ten-foot tall *S. californicus* photographed in double row planting Area 3A LA-0039 Year 2 The Prairie.

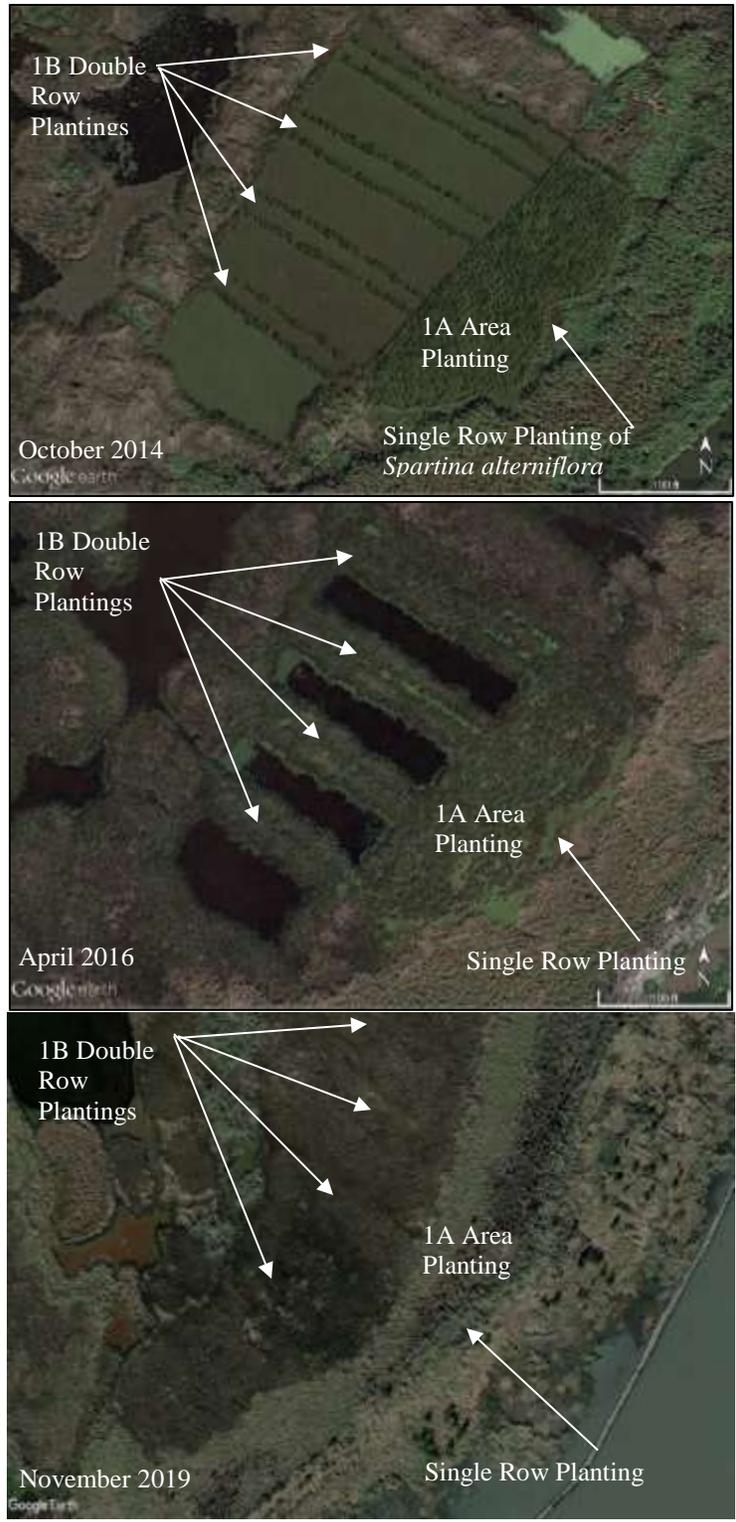
Figure VII-11. Google earth imagery taken October 2014, April 2016, and November 2019 of planting Area 1 LA-0039 Year 2 The Prairie. The 1B double rows of *S. californicus* have largely grown together as well as the 1A area plantings. The single row of *Spartina alterniflora* planted along southeast 1A Area was not discernible by 2016.

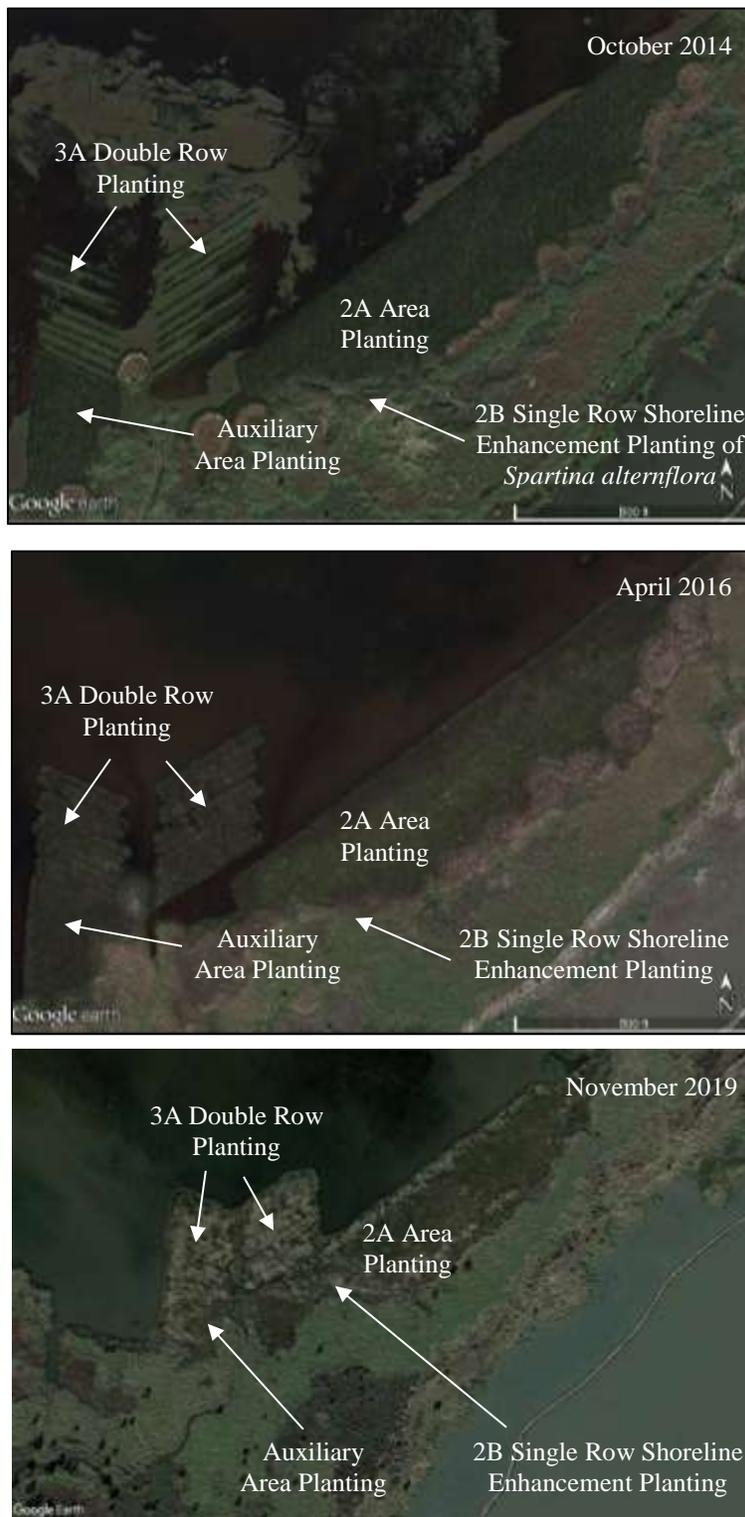
Figure VII-12. Google earth imagery taken October 2014, April 2016 and November 2019 of planting areas 2, 3, and the Auxiliary planting areas of *Schoenoplecus californicus* in LA-0039 Year 2 The Prairie. All plantings have flourished and grown together. The single row of *Spartina alterniflora* was not discernible by 2016.

Double rows were planted with approximately 20 feet between each row in two areas (1B and 3A). The double rows were intended to converge as the plants proliferate. *Schoenoplectus californicus* spreads primarily through rhizomes and under appropriate conditions can expand its coverage 8–10 feet within one growing season (Materne and Fine 2000). This rate of expansion could result in each double row merging into one row within one to two growing seasons in ideal conditions. In planting Area 1B, the mean distance between rows as measured at vegetation stations declined from 20 ft in May 2014 to 4 ft by June 2015 (N=4 for both years). In planting area 3A, the mean distance between rows declined from 19 ft in May 2014 (N = 3) to 5 ft by June 2015 (N = 4). At this rate of expansion, the double rows were expected to unite into a single row by the 2017 survey, which did indeed happen (Figs. VII – 11 and 12). Spaces between double rows completely filled with new vegetation, which has allowed for the sediment around the plantings to become more solidified. This expansion continued through 2019 as sets of double rows have expanded to each other in Areas 1 and 3 and double rows from Area 3 have converged with the Auxillary plantings and Area 2 (Figs. VII – 12-14).

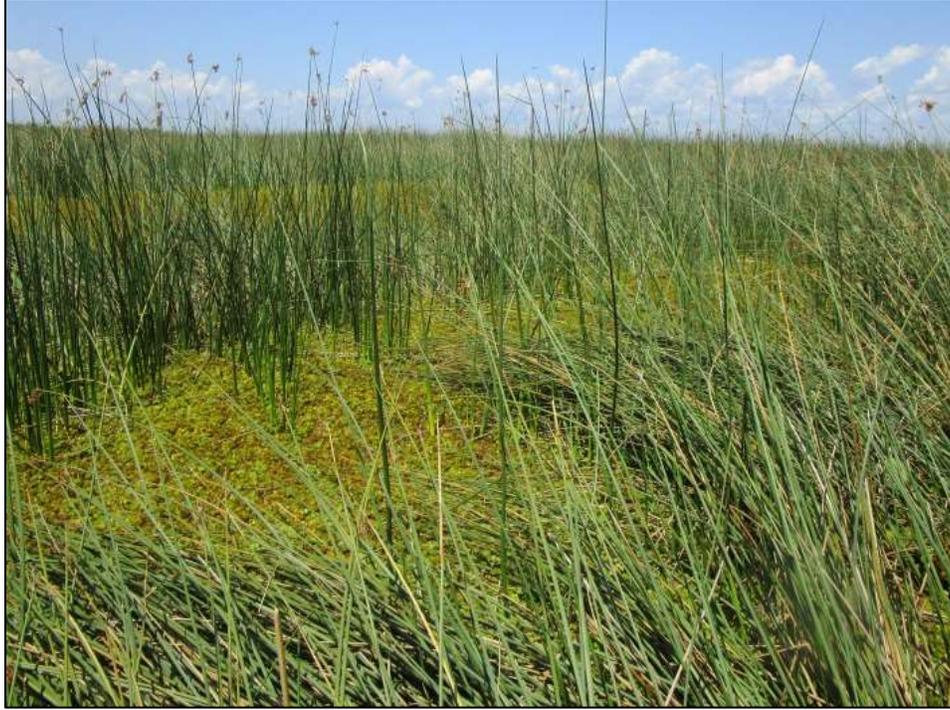
Figure VII-13. New *S. californicus* stems are Visible growing between a double row during the 2015 vegetation survey in Area 1B LA-0039 Year 2 The Prairie. *Salvinia molesta* covers the surface of the water.

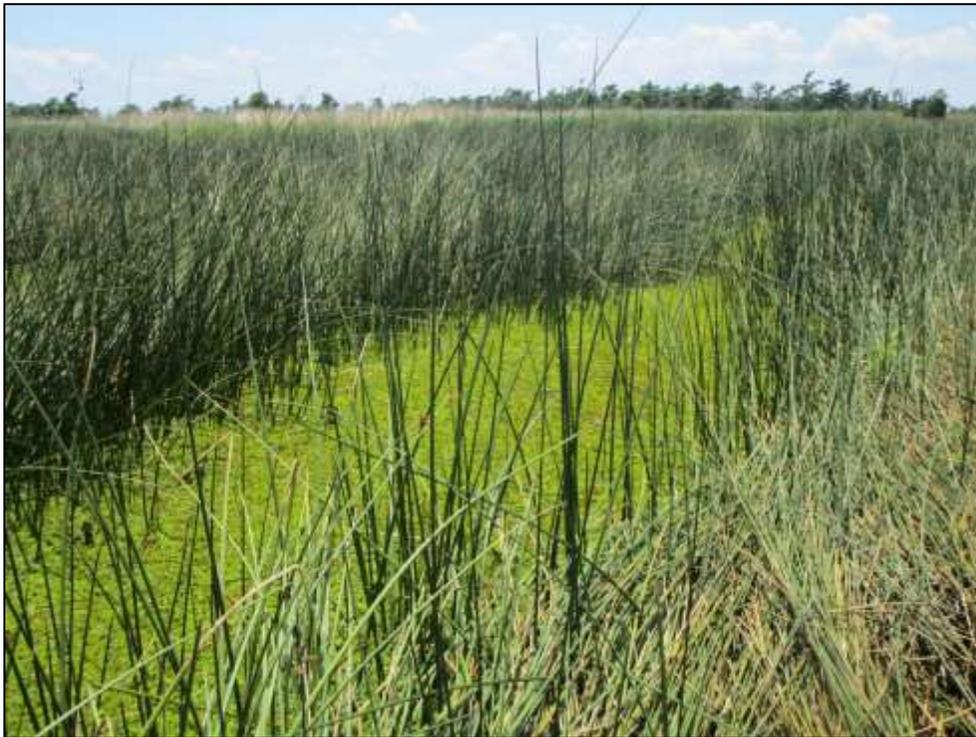
Figure VII-14. Approximately 5 ft remained between the double row of *S. californicus* during the 2015 vegetation survey in Area 3A LA-0039 Year 2 The Prairie. *Salvinia minima* covers the surface of the water.

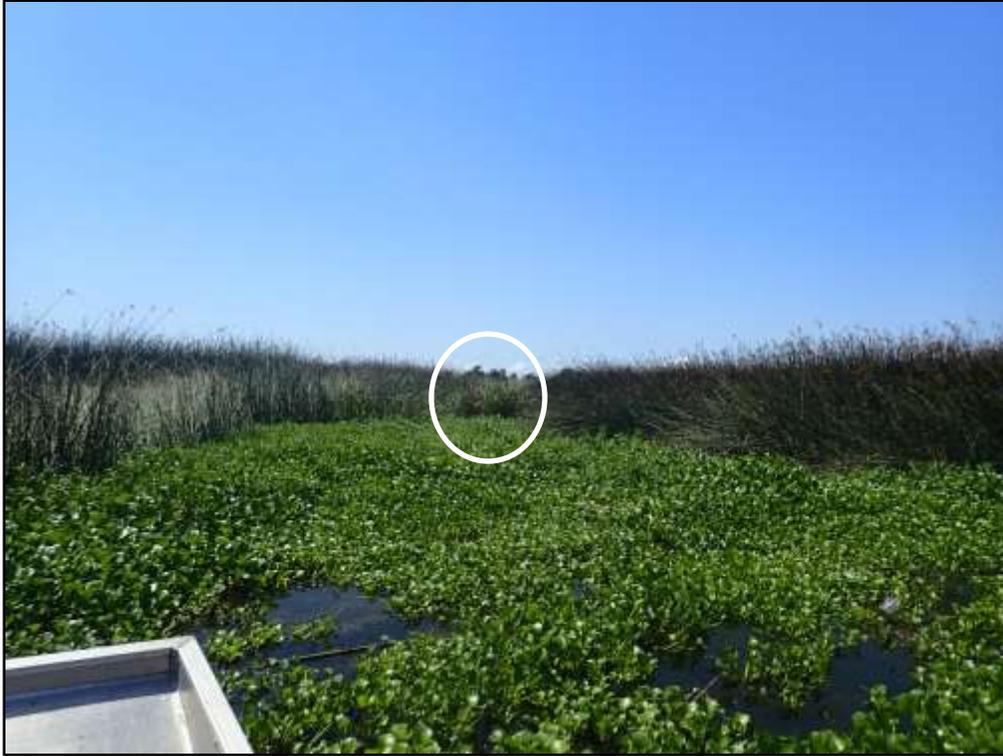
Figure VII-15. Encroachment of double row *S. californicus* plantings in area 3A of LA-0039 Year 2 The Prairie. Note *Zizaniopsis miliacea* establishing between the double row plantings (white circle) and the floating aquatic vegetation, *Eichornia crassipes* (water hyacinth).

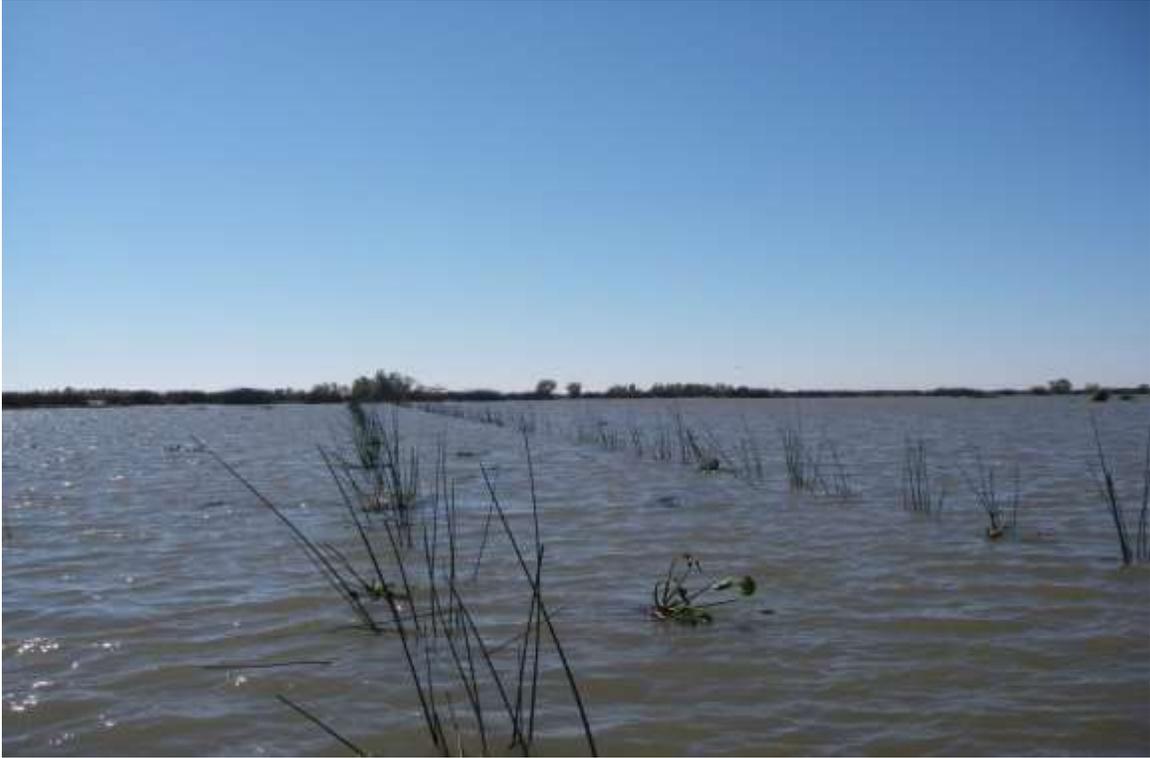
Figure VIII-3. Typical view of a double row planting at LA-0039 Year 3 - The Jaws in November 2014.
