2021 Operations, Maintenance, and Monitoring Report

Coastwide Vegetative Planting Project (LA-0039)

State Project Number LA-0039
Priority Project List 20

September 2021

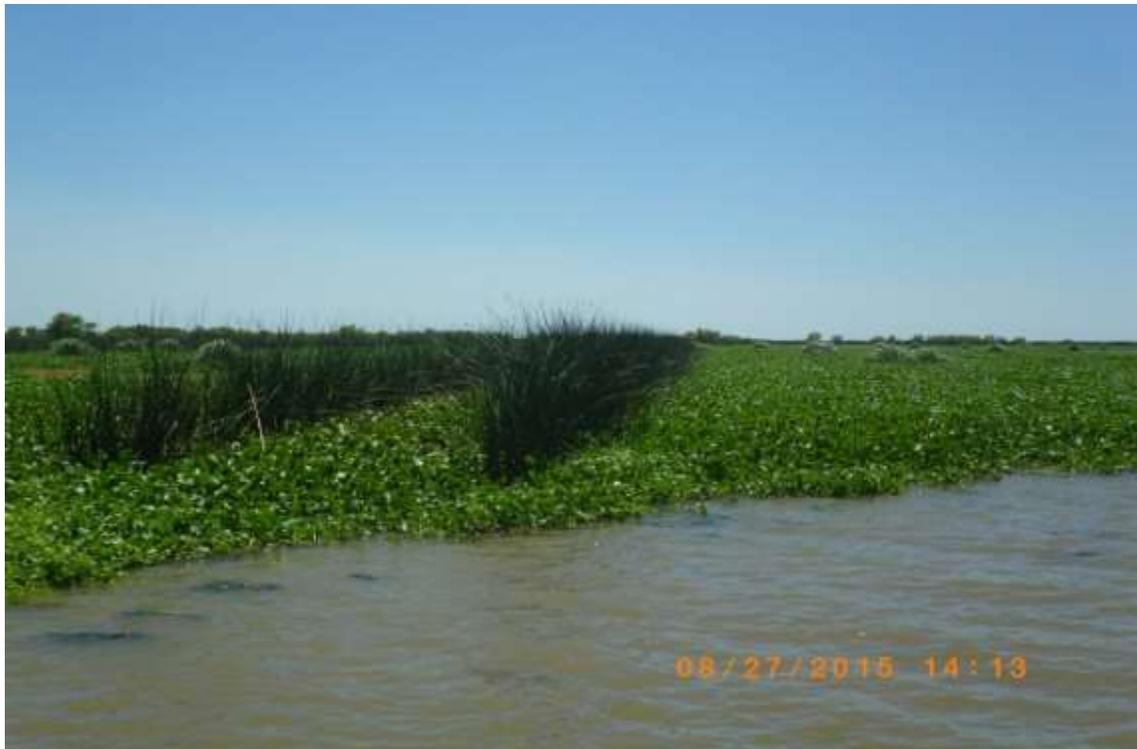
Figure VIII-4. Typical view of a double row plantings at LA-0039 Year 3 - The Jaws just prior to the September 2015 sampling. Note accumulation of *Eichhornia crassipes*.

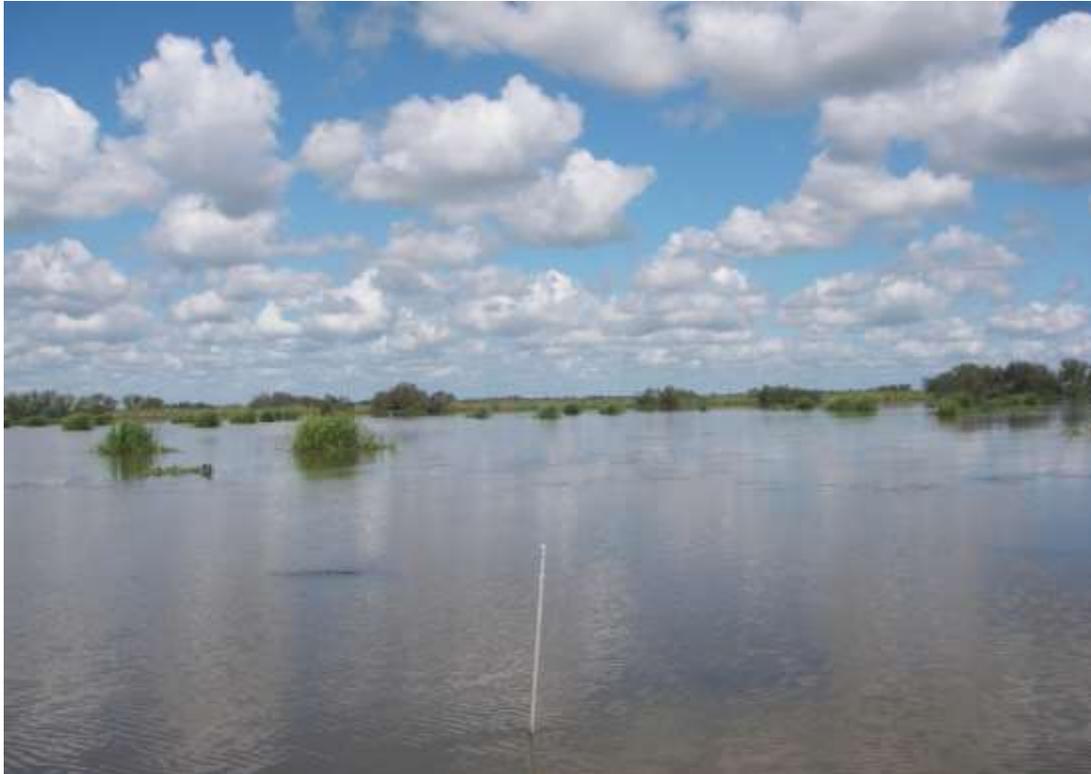
Figure VIII-5. Typical view of a double row plantings at LA-0039 Year 3 - The Jaws during September 2017 sampling. Note the absence of *Schoenoplectus californicus* and presence of naturally occurring *Zianiopsis miliacea*.

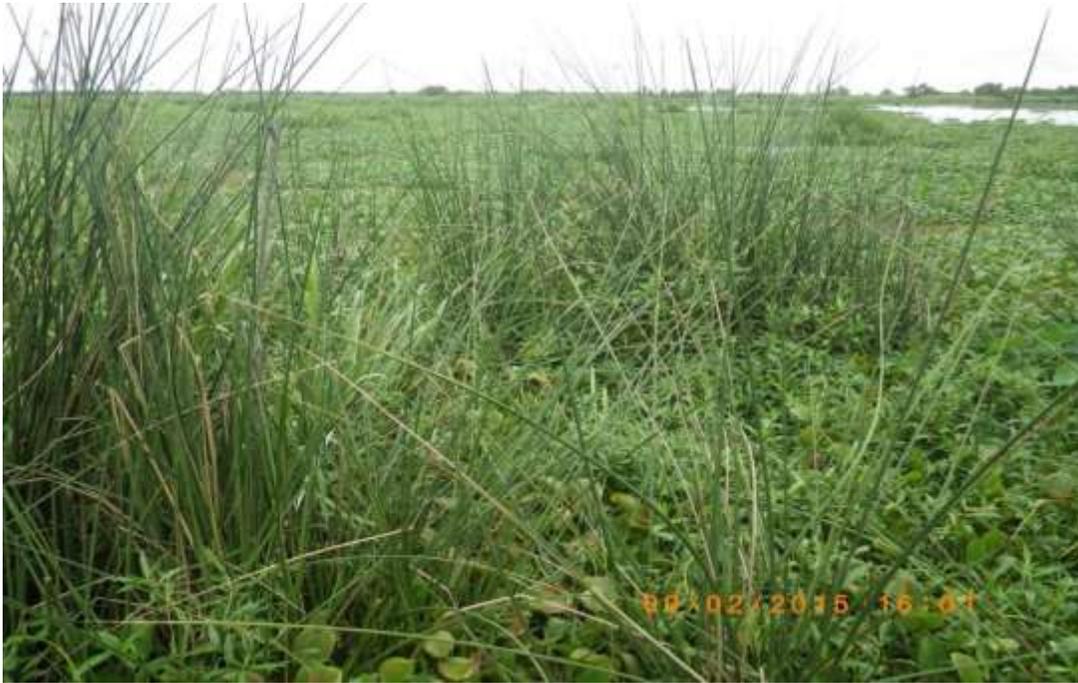
Figure VIII-7. Recruited species growing in and among the double row plantings during September 2015 sampling including *Alternanthera philoxeroides* and *Zizaniopsis miliacea*.

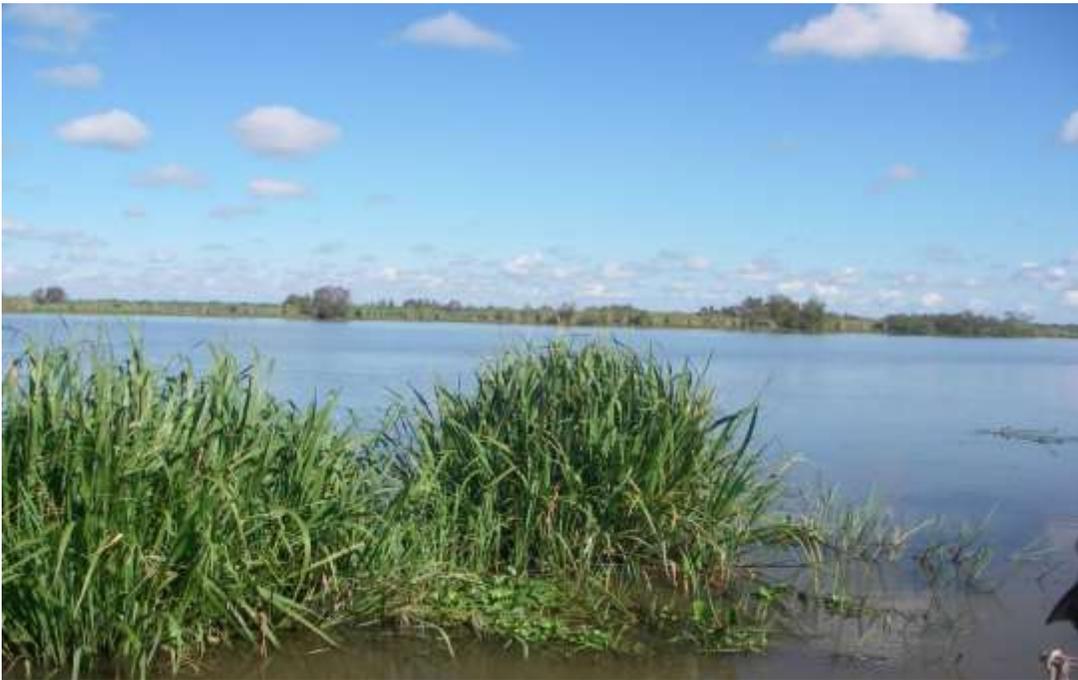
Figure VIII-8. Recruited species remaining after the double row plantings is gone in September 2017 consisted of *Zizaniopsis miliacea* (giant cutgrass).

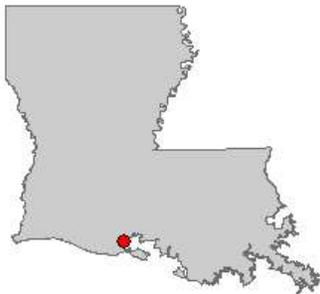
Figure IX-1. LA-0039 Year 3 Little Vermilion Bay East Plantings site map shows location of plantings between TV-0018 terraces and vegetative monitoring stations.

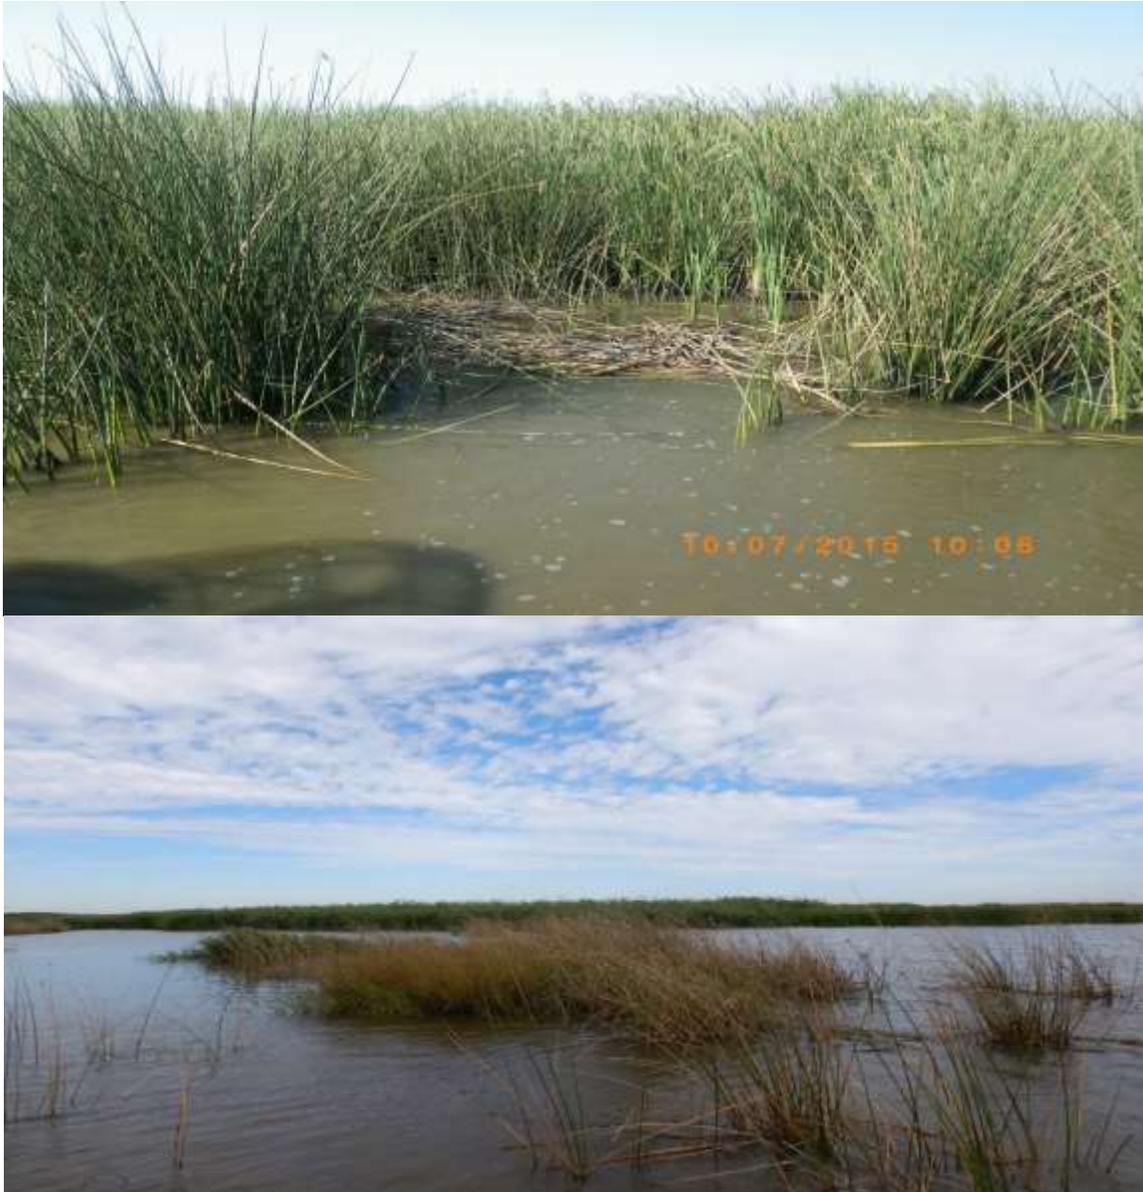
Figure IX-3. View of minor herbivory damage of *Schoenoplectus californicus* in the LA-0039 Year 3 Little Vermilion Bay East double rows in October 2015 and November 2019 (the standing brown stems are scened).

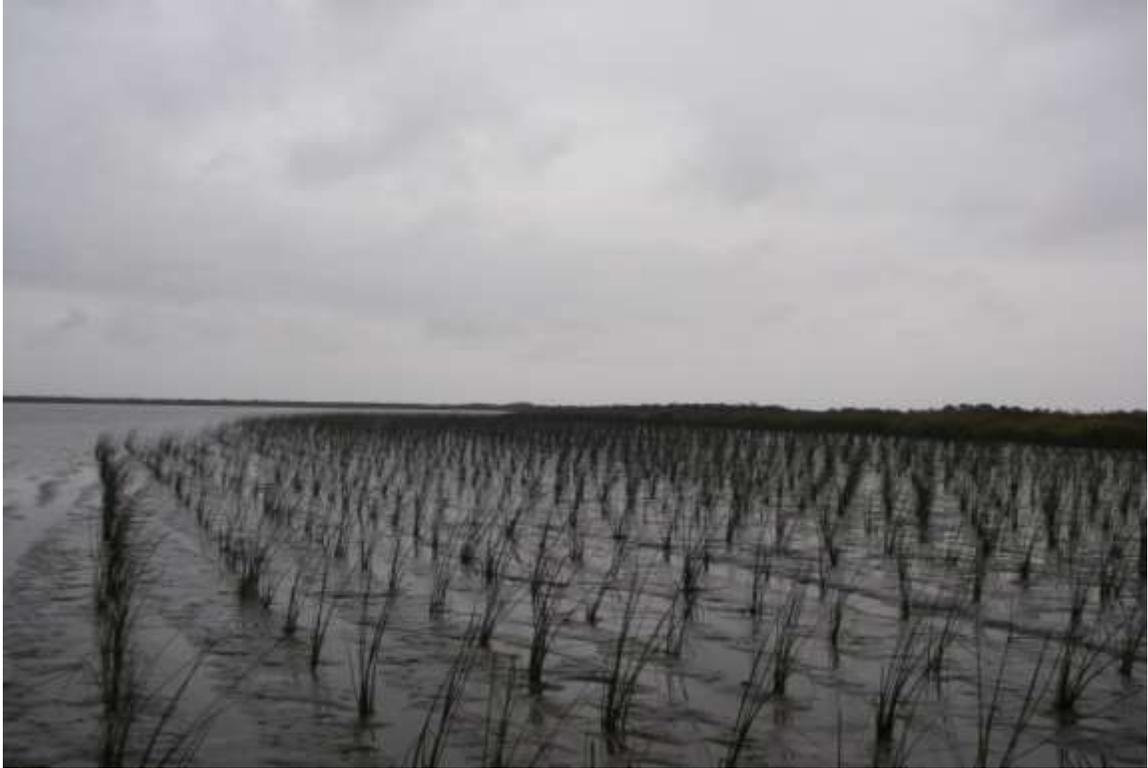
Figure IX-6. Typical view of a LA-0039 Year 3 Little Vermilion Bay West area planting at low tide during November 2014.

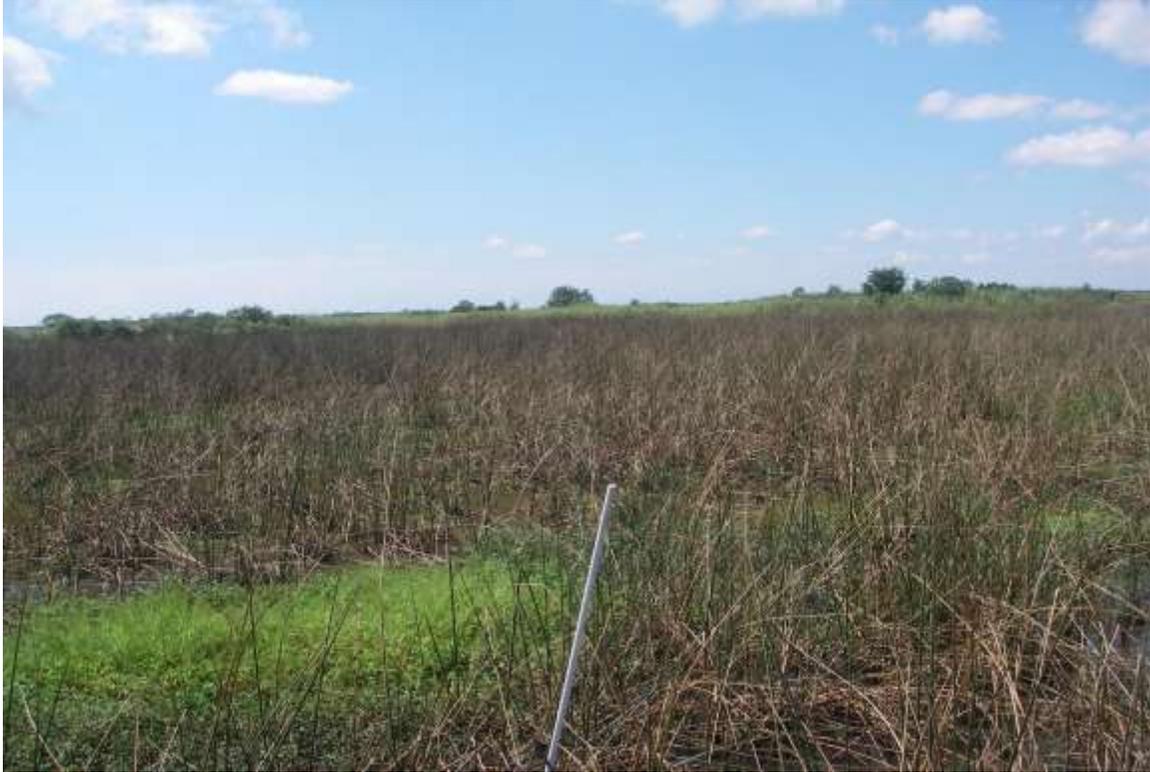
Figure IX-8. Typical view of a vegetation station in a LA-0039 Year 3 Little Vermilion Bay West area planting in Sept 2017, additional species now clearly visible.

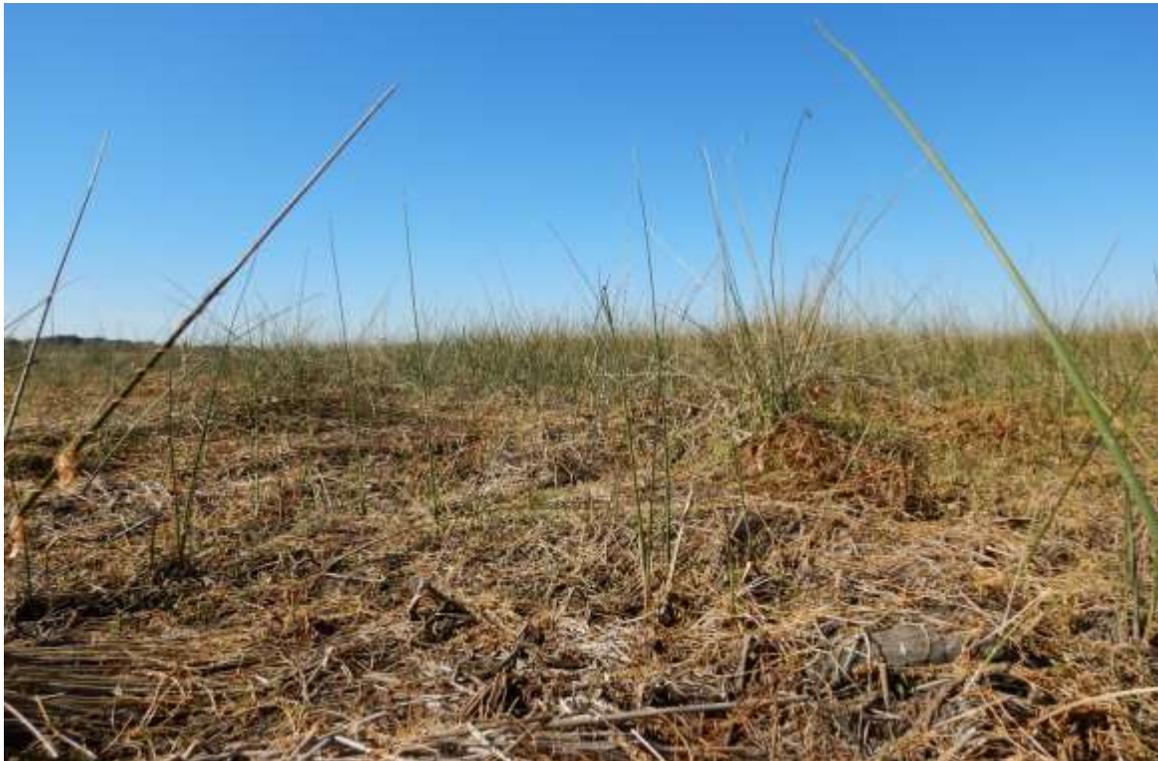
Figure IX-9. Note wrack deposition and surviving plants after Hurricane Barry in a LA-0039 Year 3 Little Vermilion Bay West area planting in November 2019.

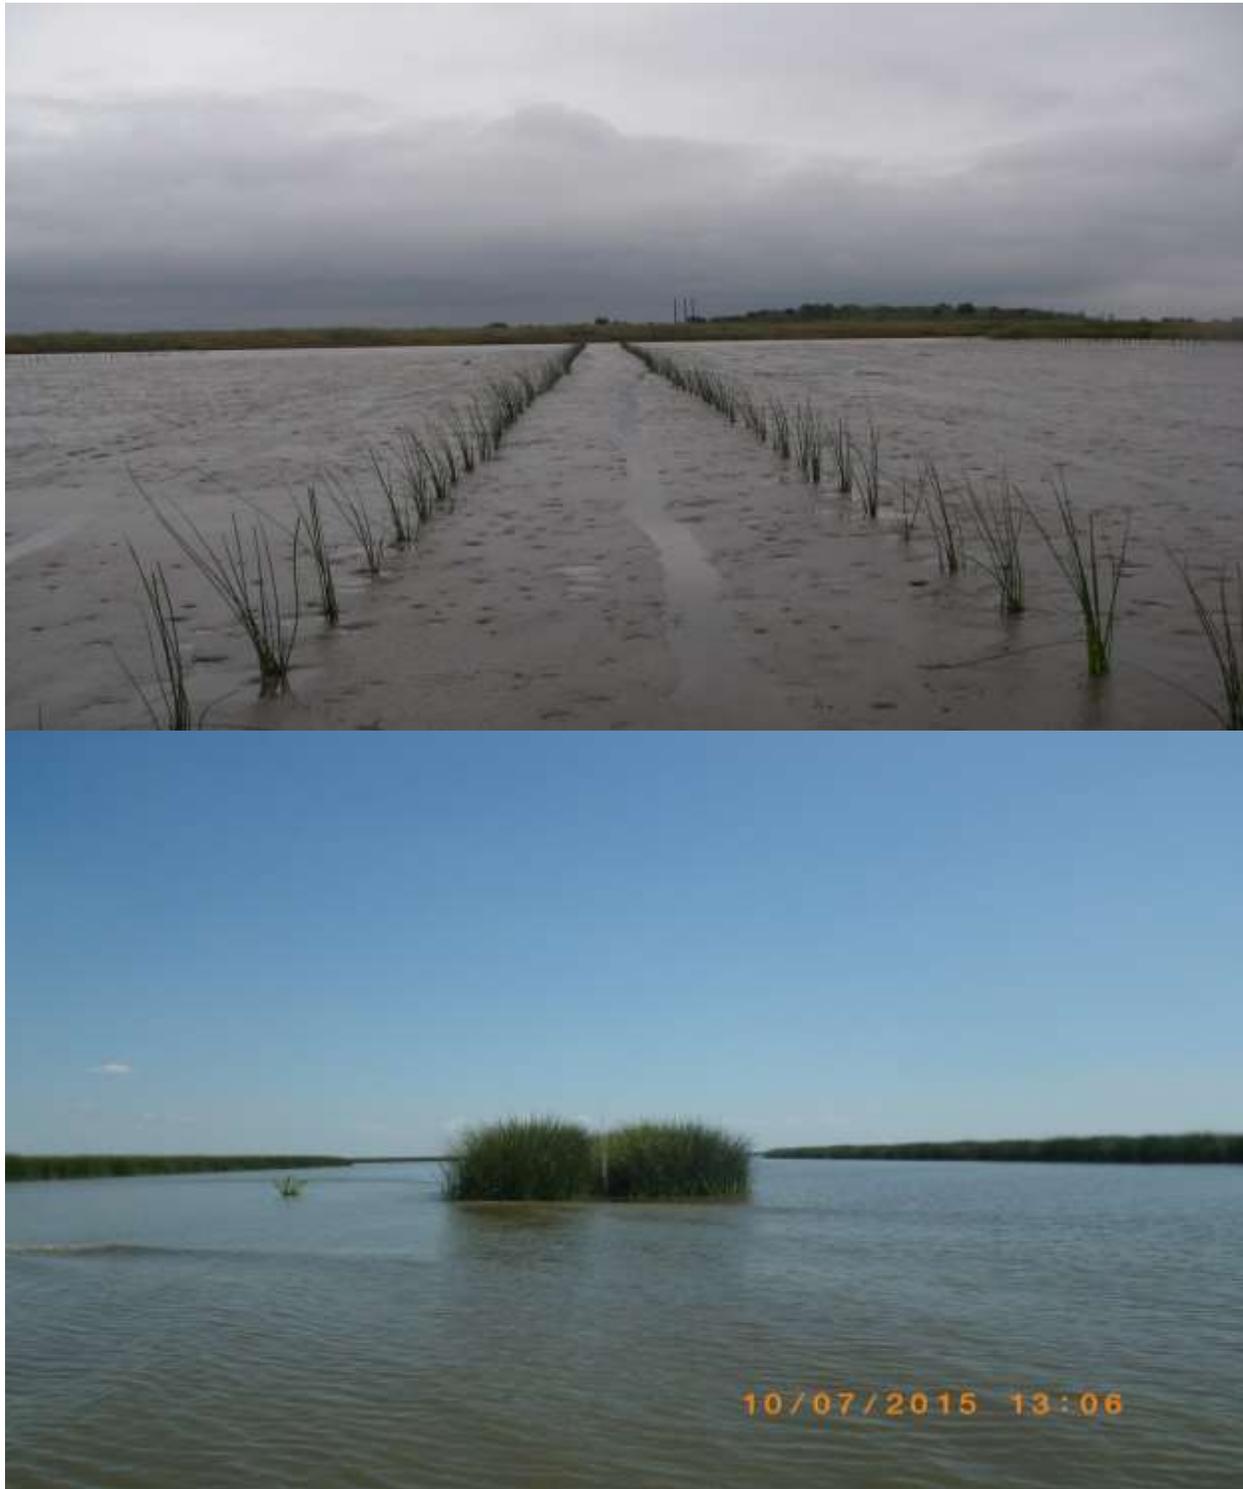
Figure IX-10. The growth over the first year after planting (November 2014 - October 2015) of a typical double row in the LA-0039 Year 3 Little Vermilion Bay West plantings.

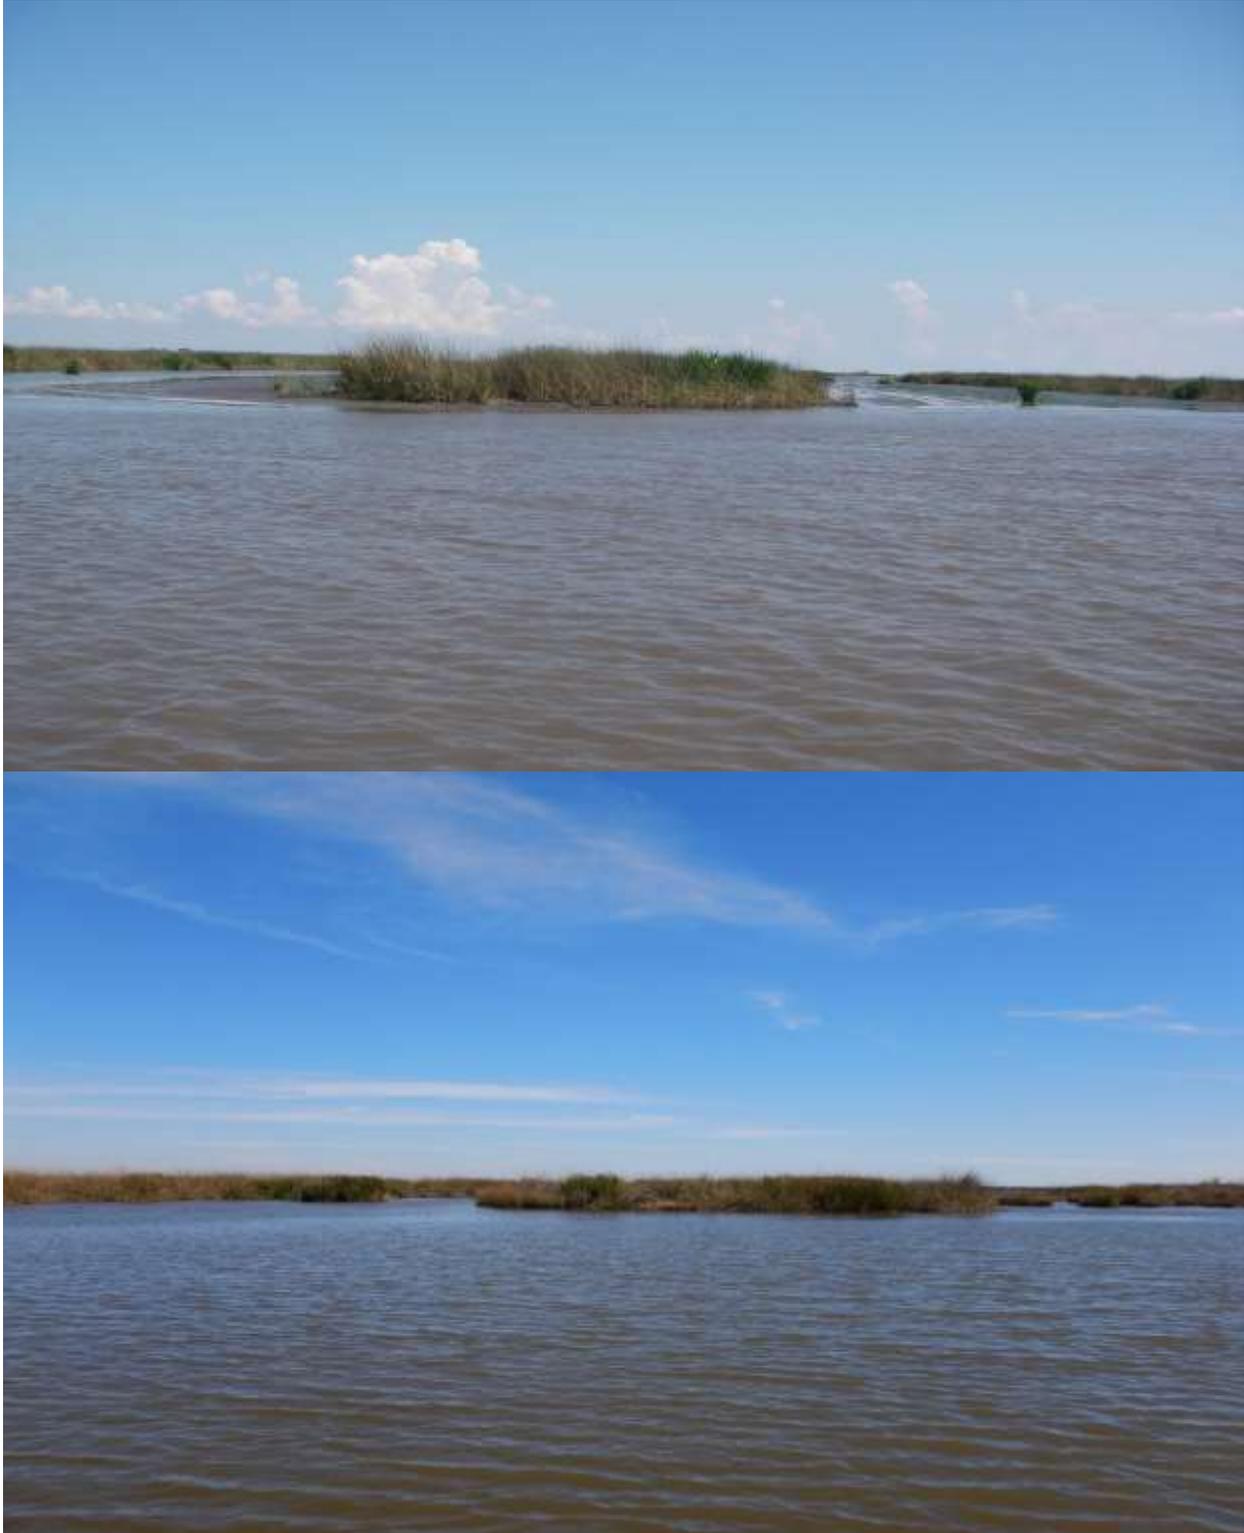
Figure IX-11. The growth from September 2017 (upper) – November 2019 (lower) of a typical double row in the LA-0039 Year 3 Little Vermilion Bay West; hedgerows now resemble earthen terraces, gaining both horizontally and vertically.

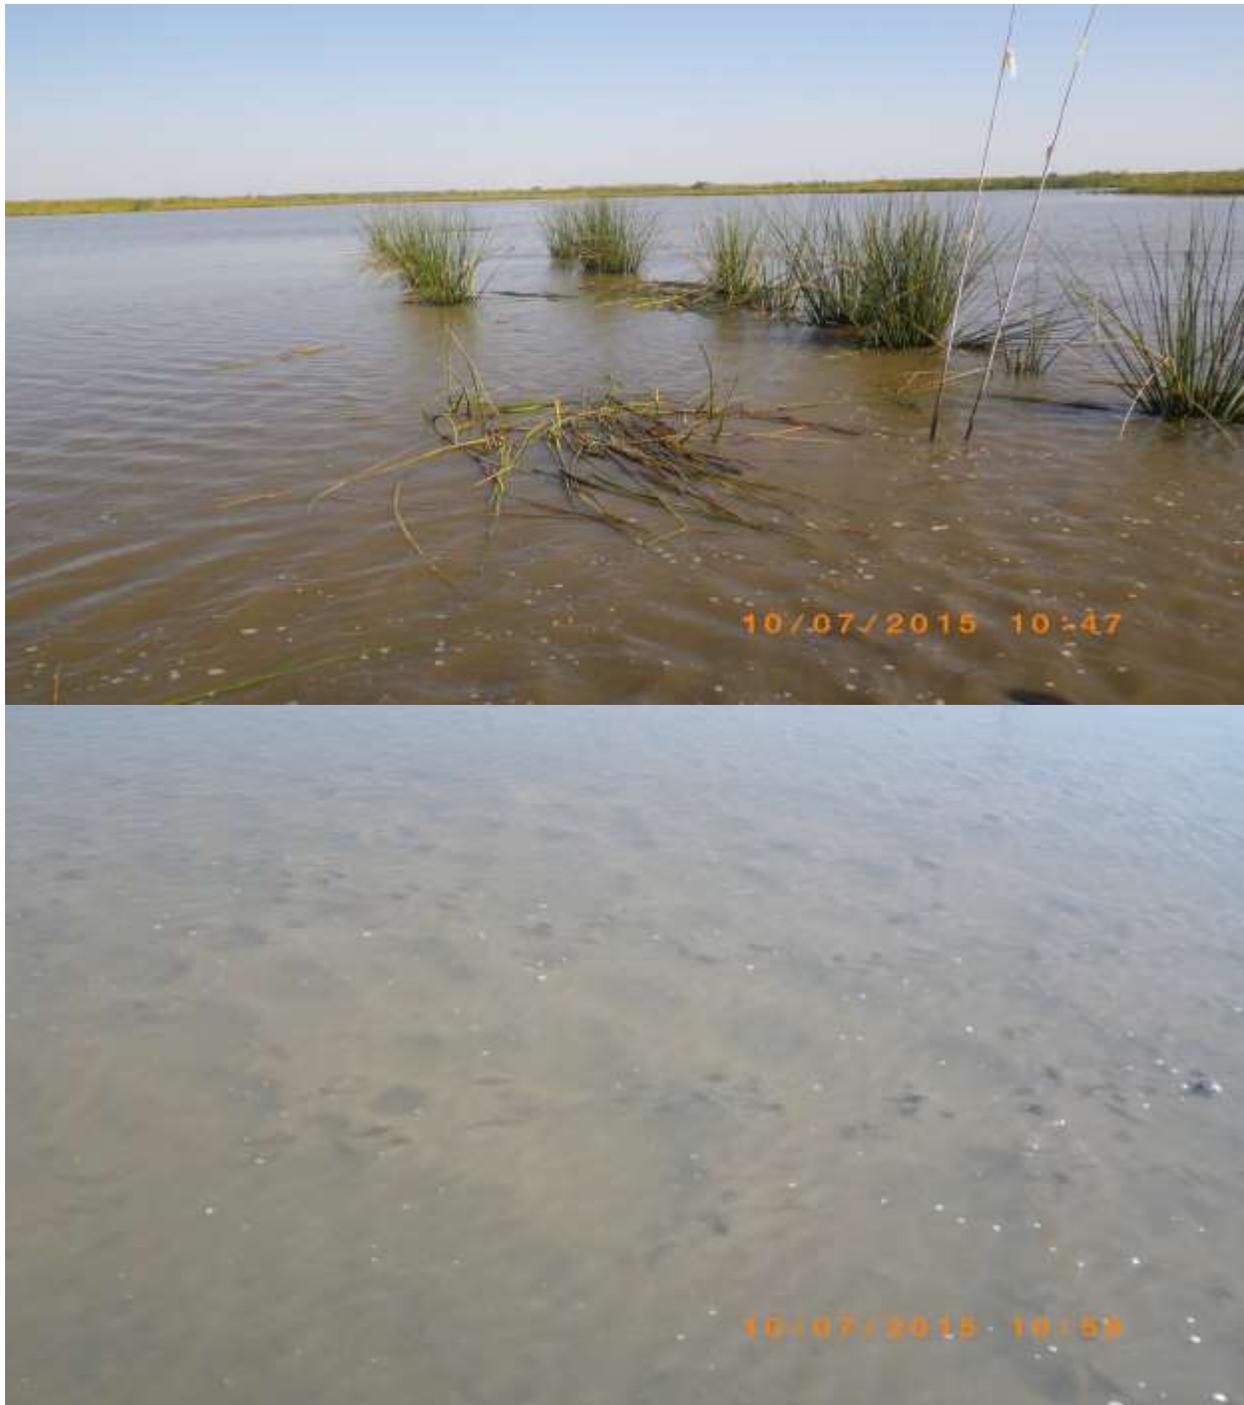
Figure IX-14. Upper frame - Active herbivory damage to the planted double rows in LA-0039 Year 3 Little Vermilion Bay East during the October 2015 sampling. The double row had extended to the terrace to the north in the background prior to herbivory. Lower frame - Herbivore tracks in and among the planted double rows in the LA-0039 Year 3 Little Vermilion Bay East.

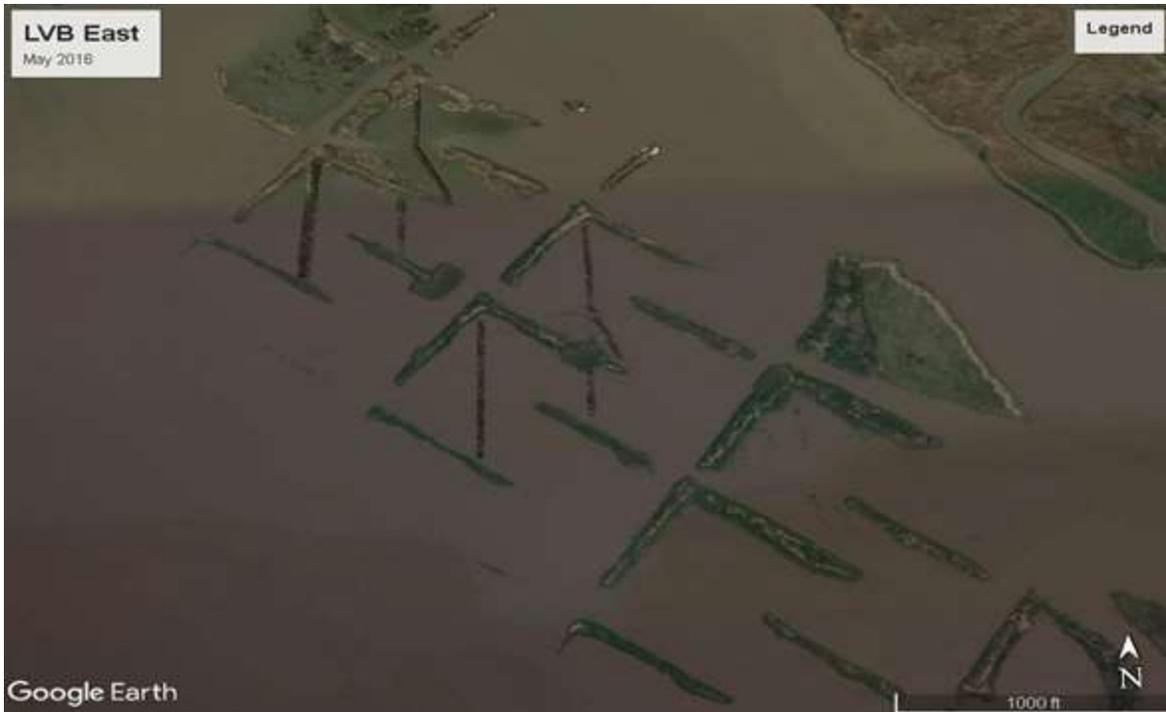
Figure IX-15. Google Earth imagery of LA-0039 Year 3 Little Vermilion Bay East plantings taken on 5/6/2016. The northeastern and middle sets of double rows expanded, whereas, the southeastern set of double rows were mostly removed by herbivory.

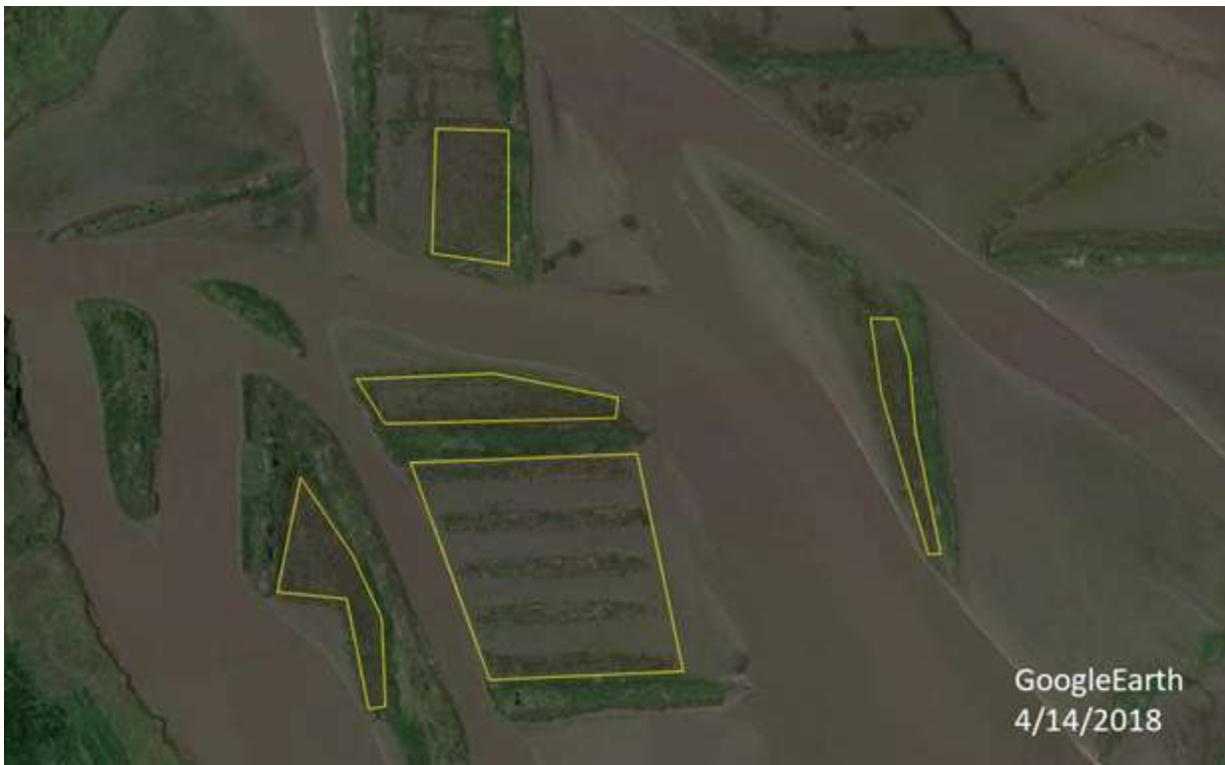
Figure IX-16. Google Earth imagery of the taken on 4/14/2018 shows the robust LA-0039 Year 3 - Little Vermilion Bay West plantings three and half years after installation.

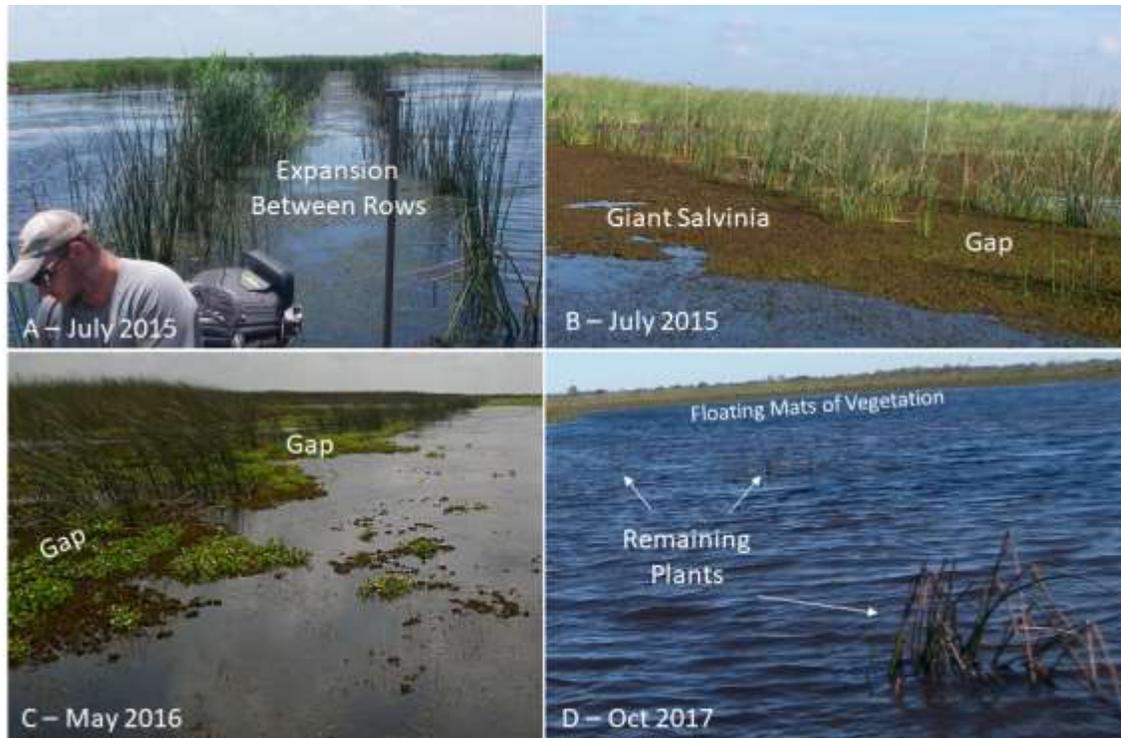
Figure X-2. Double row plantings in the LA-0039 Year 3 Willow Lake - West area were expanding nine months after planting (A), and gaps in the plantings were probably caused by floating mats of giant Salvinia (B). A year later, standing plantings had grown, but gaps increased as floating vegetation mats expanded to include water hyacinth (C). By three years after planting, planting survival was sparse and remaining plants were physically battered (D).

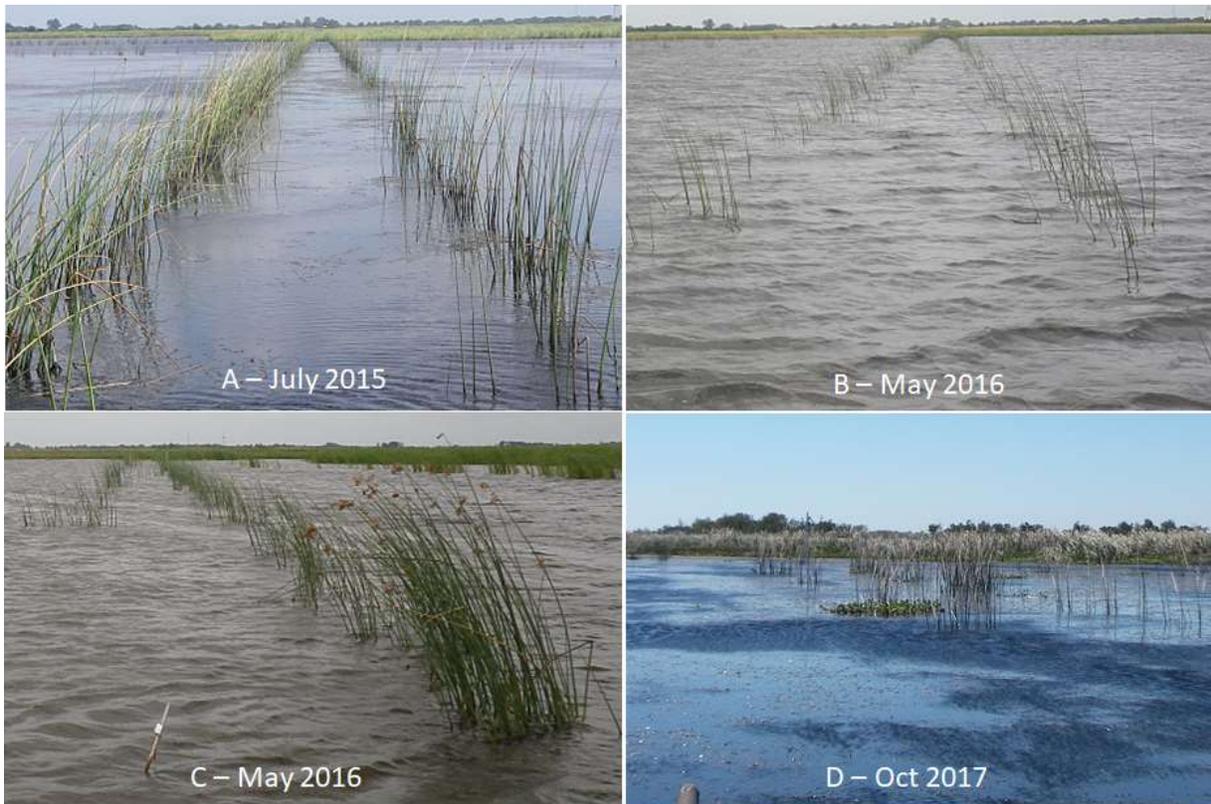
Figure X-4. The LA-0039 Year 3 Willow Lake - South area. The foreground is between rows of a south to north double row with west to east double rows in the background. Plants expanded towards the middle despite not being as big as in other areas about nine months after planting. Although still healthy looking, plantings did not expand over the next year (B and C) nor by three years after planting (D); note the larger flowering plants in (C) which are typical of plants in other areas. Water levels were about 1 foot lower in A and D than in B and C.

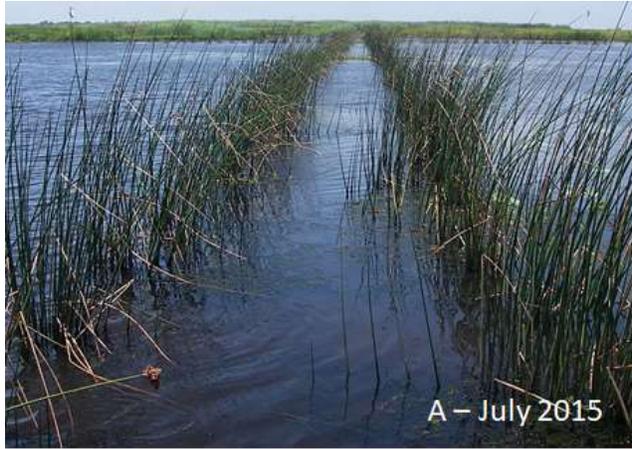
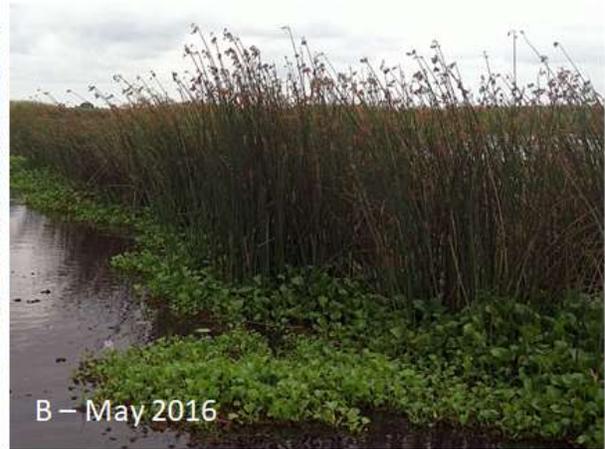
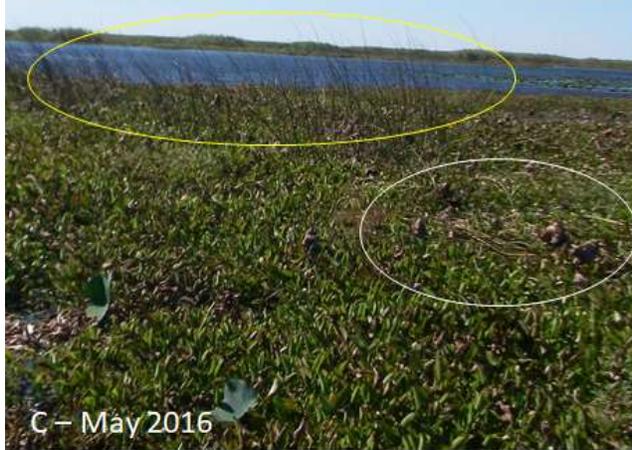
Figure X-5. The planting in the East area of the LA-39 Year 3 Willow Lake site were the most robust. Plants were growing across the double rows nine months after planting (A). The double rows were almost indistinguishable and the stems were 10+ feet tall by about a year and half after planting (B). Broad, complex mats of floating vegetation felled much of the plantings (white oval) by three years after planting, but surviving stems (yellow oval) were still robust (C).

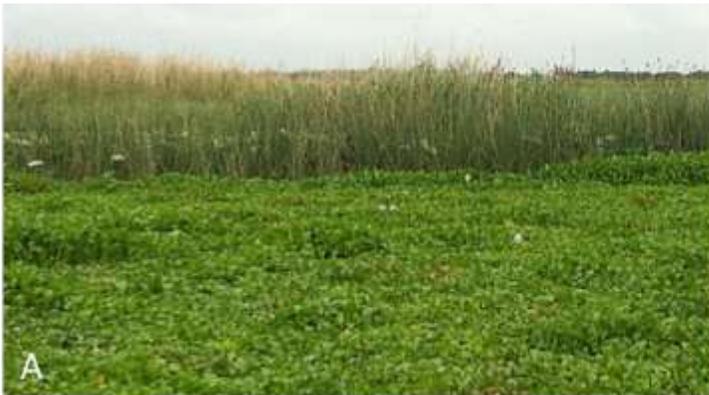
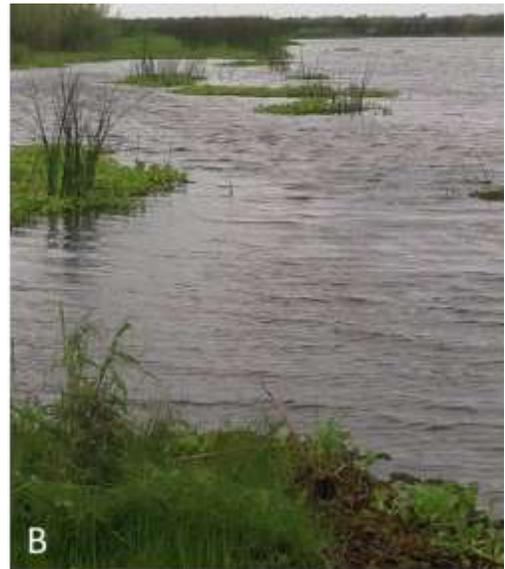
Figure X-6. Large floating vegetation mats lead to planting loss even among the more robust plantings in the LA-39 Year 3 Willow Lake - East area. Floating mats consisted of water hyacinth (A) and combinations of water hyacinth, giant Salvinia, and otherwise emergent vegetation (B).

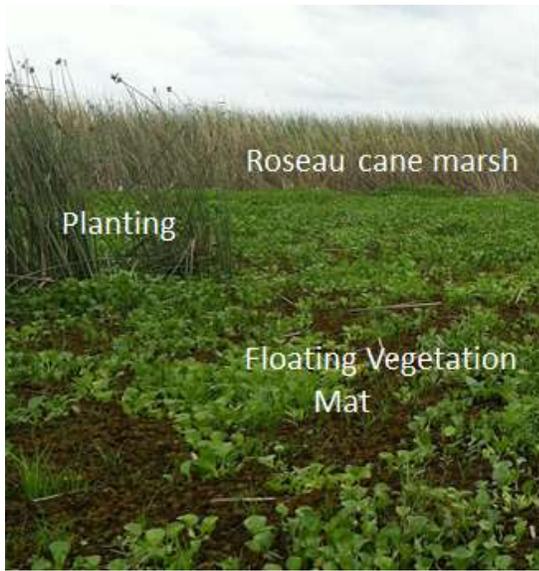
Figure X-7. Damage from floating vegetation mats was noted to be more severe where the plantings were closer to the existing marsh within the LA-0039 Year 3 Willow Lake site, especially along the northern portion of the West and East areas, over the first year and a half after planting. Damage spread throughout the site four and a half years after planting by May 2019 with most of the surviving plants being away from the shoreline.

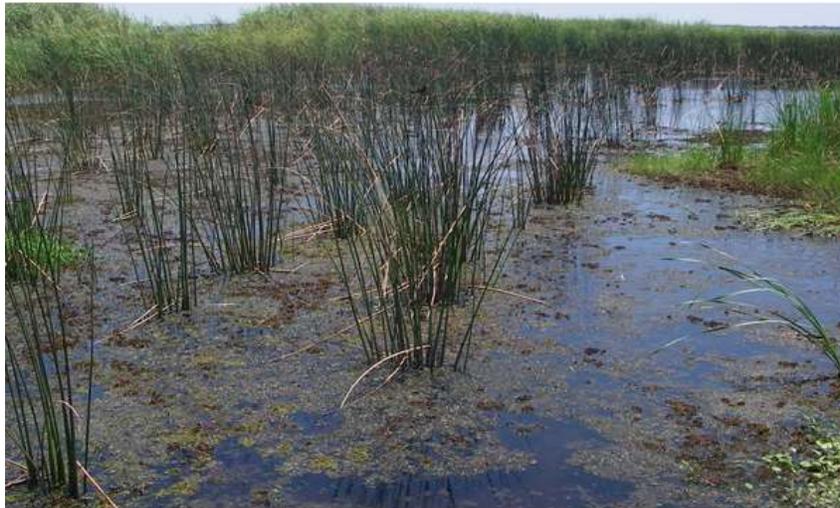
Figure X-8. LA-0039 Year 3 Willow Lake Auxiliary plants were used for area plantings to help vegetate areas at risk of breaching from Willow Lake are pictured in July 2015 (A) and October 2017 (B, yellow oval) along with newer replacement plants to compensated for poisoned plantings (white oval).

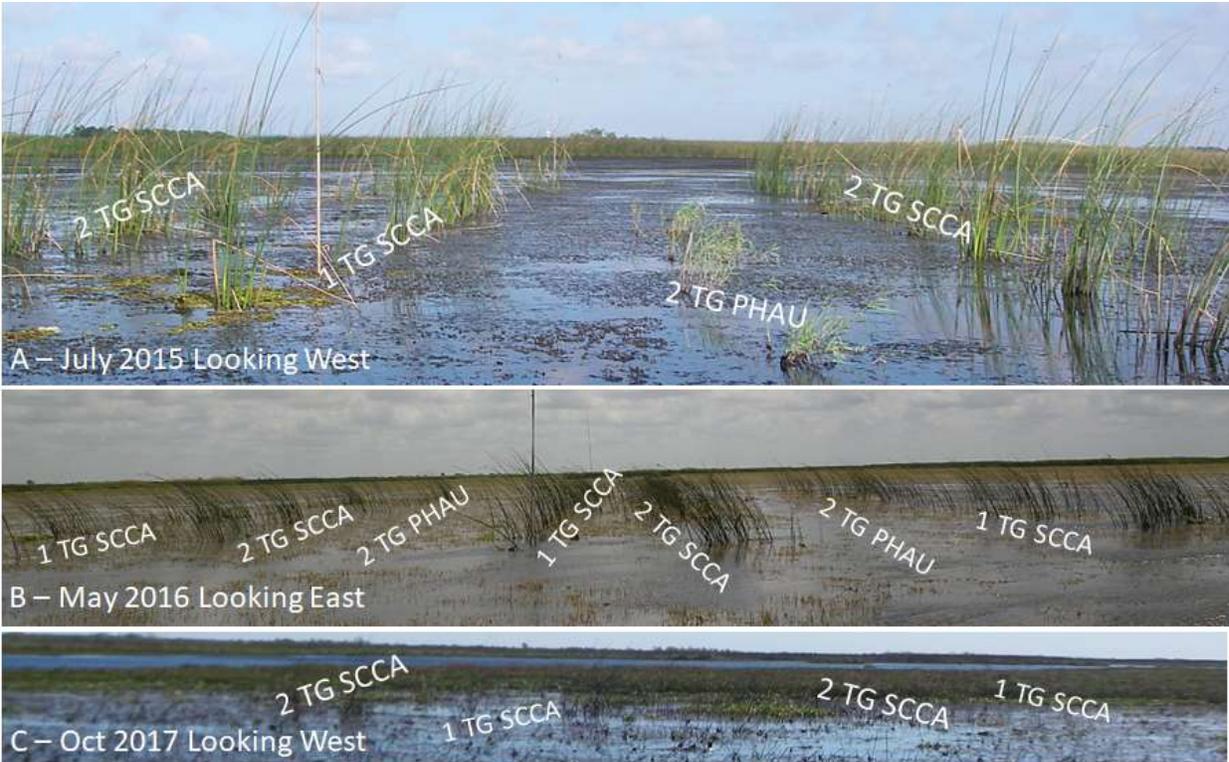
Figure X-11. The deeper test plots from LA-0039 Year 3 Willow Lake were observed on 07/25/2015 (A) and 05/26/2016 (B). The test plots consisted of rows of 1 and 2 Trade Gallon sized (1 and 2 TG) *Schoenoplectus californicus* (SCCA, California bulrush) and 2 TG *Phragmites australis* (PHAU, Roseau cane). The submerged aquatic vegetation is *Cabomba caroliniana* in all years. Note the absence of visible PHAU in 2016 (B, see Fig. X-12). Note the rafts of floating aquatic vegetation and dead water lotus stems in 2017. Water was about one foot deeper in 2016 than 2015 and 2017.

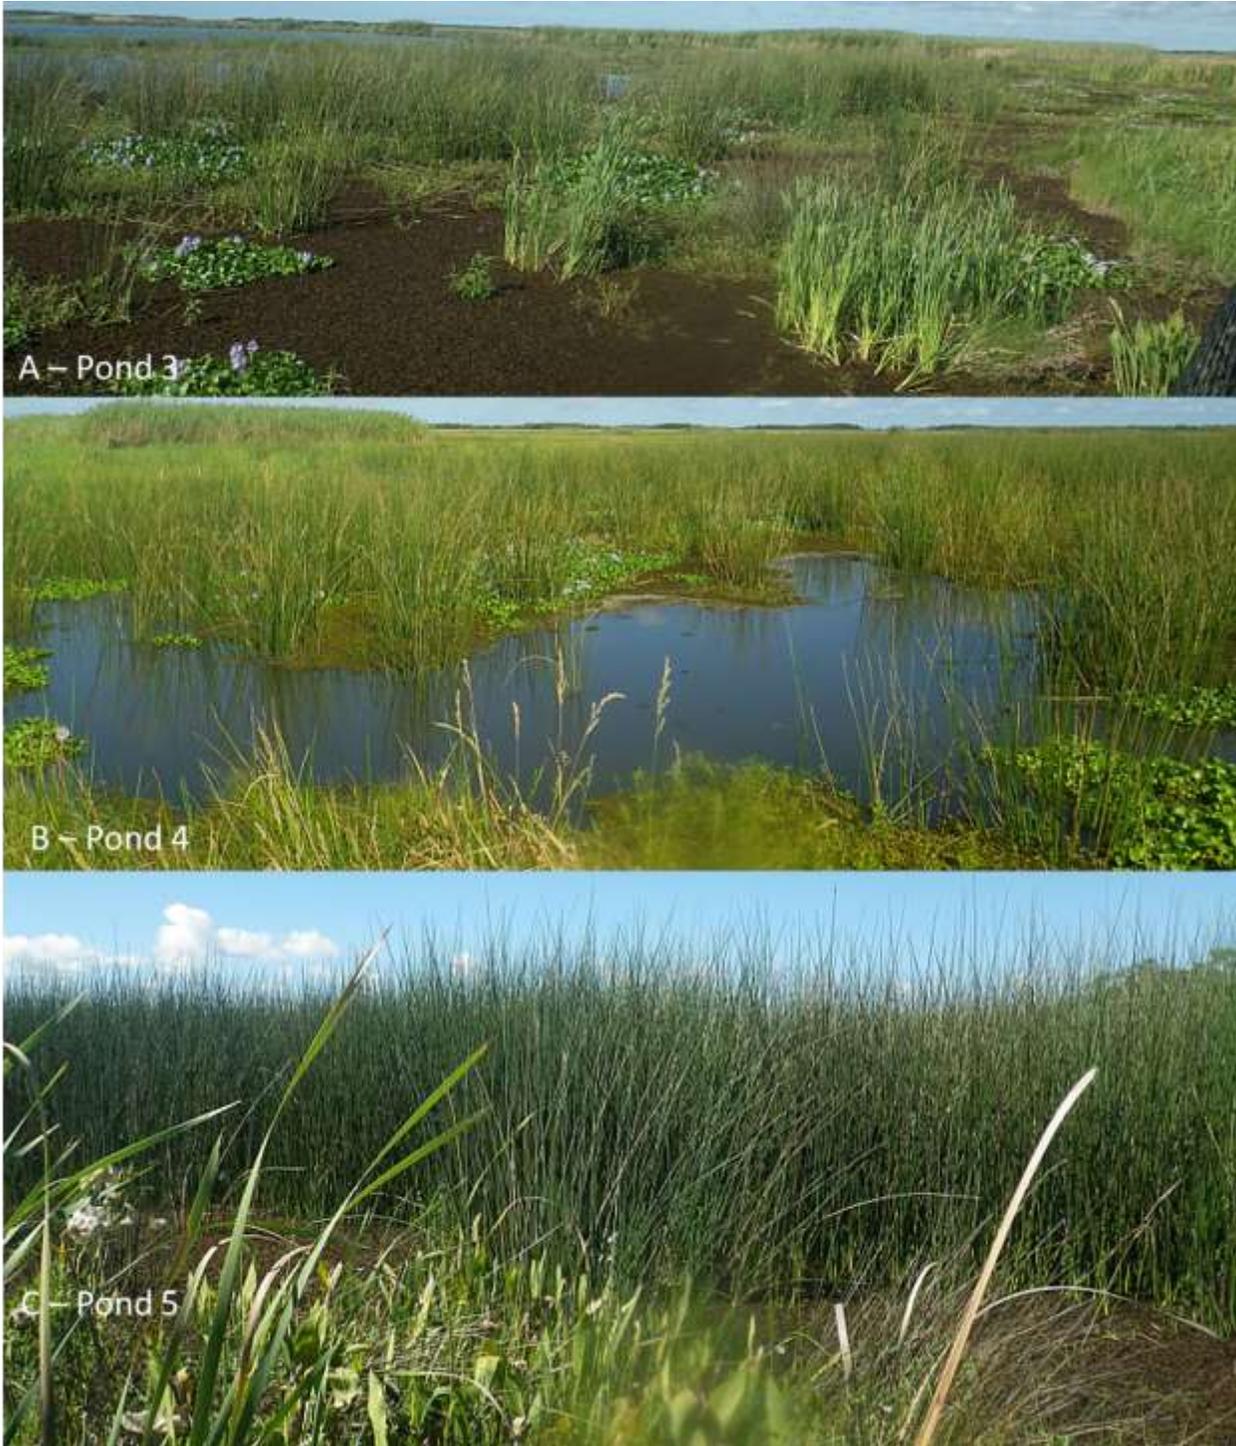
Figure XI-4. Area Plantings – The northern half of the West area experienced varying degrees of success. (A) Pond 3 had the least survival and growth (stems 6-7 ft tall) which was limited to the middle of the pond while survival and stature of plant decreases towards the edges. (B) Pond 4 also had a similar pattern as Pond 3 but with greater survivorship and growth (stems 7-8 ft tall). (C) Pond 5 had excellent survivorship and growth (stems 8-10 ft tall); individual plantings are indistinguishable with a small gap along the pond edge. Coincidentally, the water bottom was noticeably firmer from Pond 3 to Pond 5. These conditions persisted by May 2021.
