2021 Operations, Maintenance, and Monitoring Report

Coastwide Vegetative Planting Project (LA-0039)

State Project Number LA-0039
Priority Project List 20

September 2021

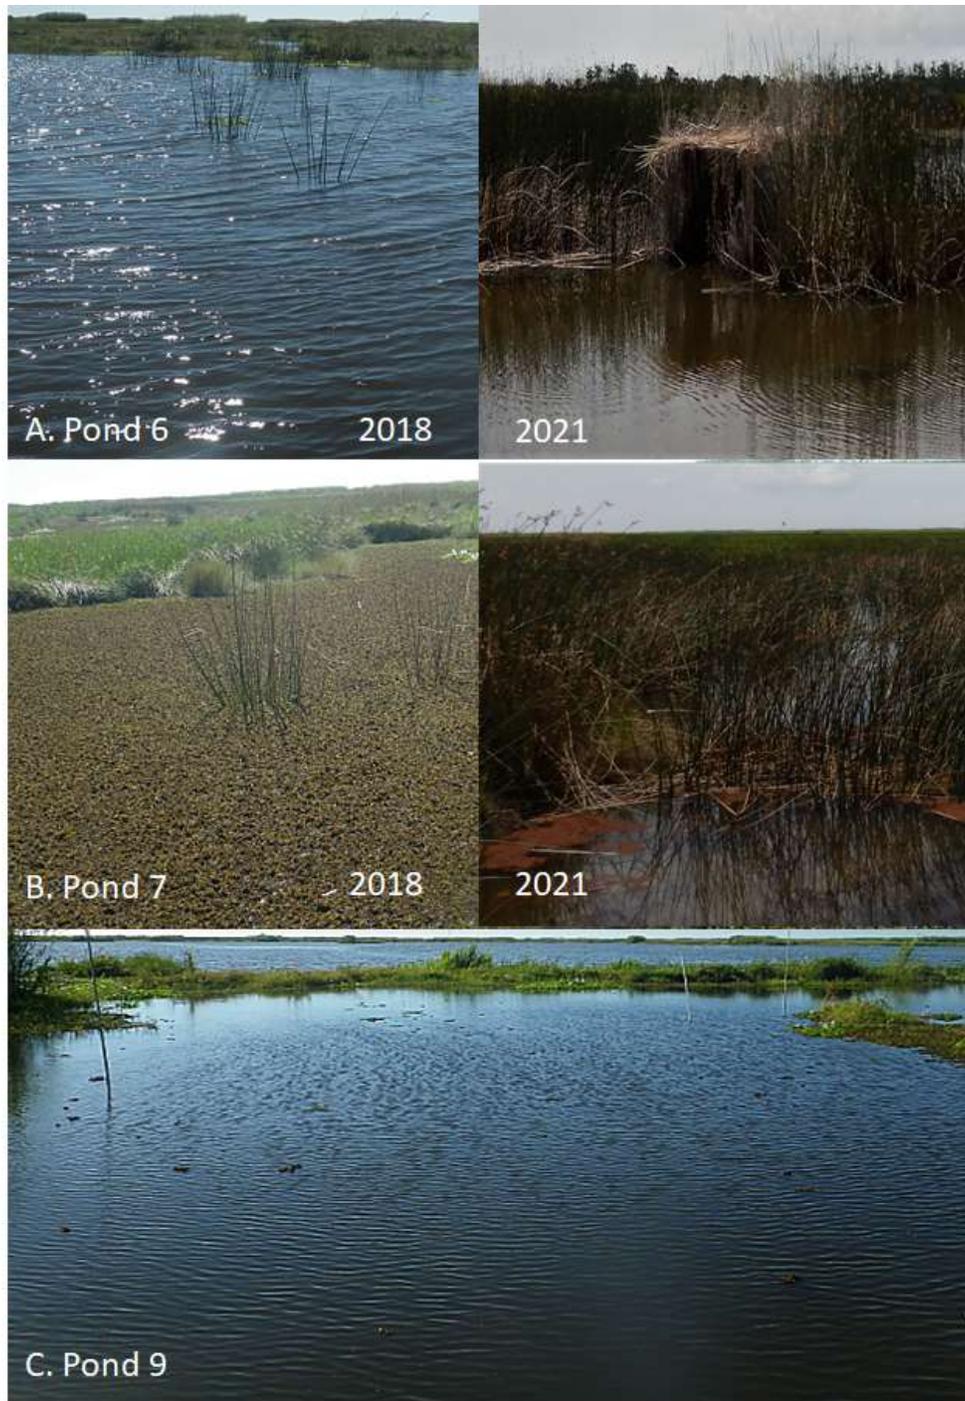
Figure XI-5. The southern portions of the west and southwest areas had very low success. Survival was limited to the middle of Southwest Area Ponds 6 (A) and 7 (B). In 2018, surviving plants were dark green but had not grown much; individual plants were ~6ft tall and highly distinguishable. Survival was sparser in Pond 7, possible because of the high occurrence of giant Salvinia. By 2020, pockets of vigorous California bulrush was present. (C) Pond 9 had no survival since 2016.

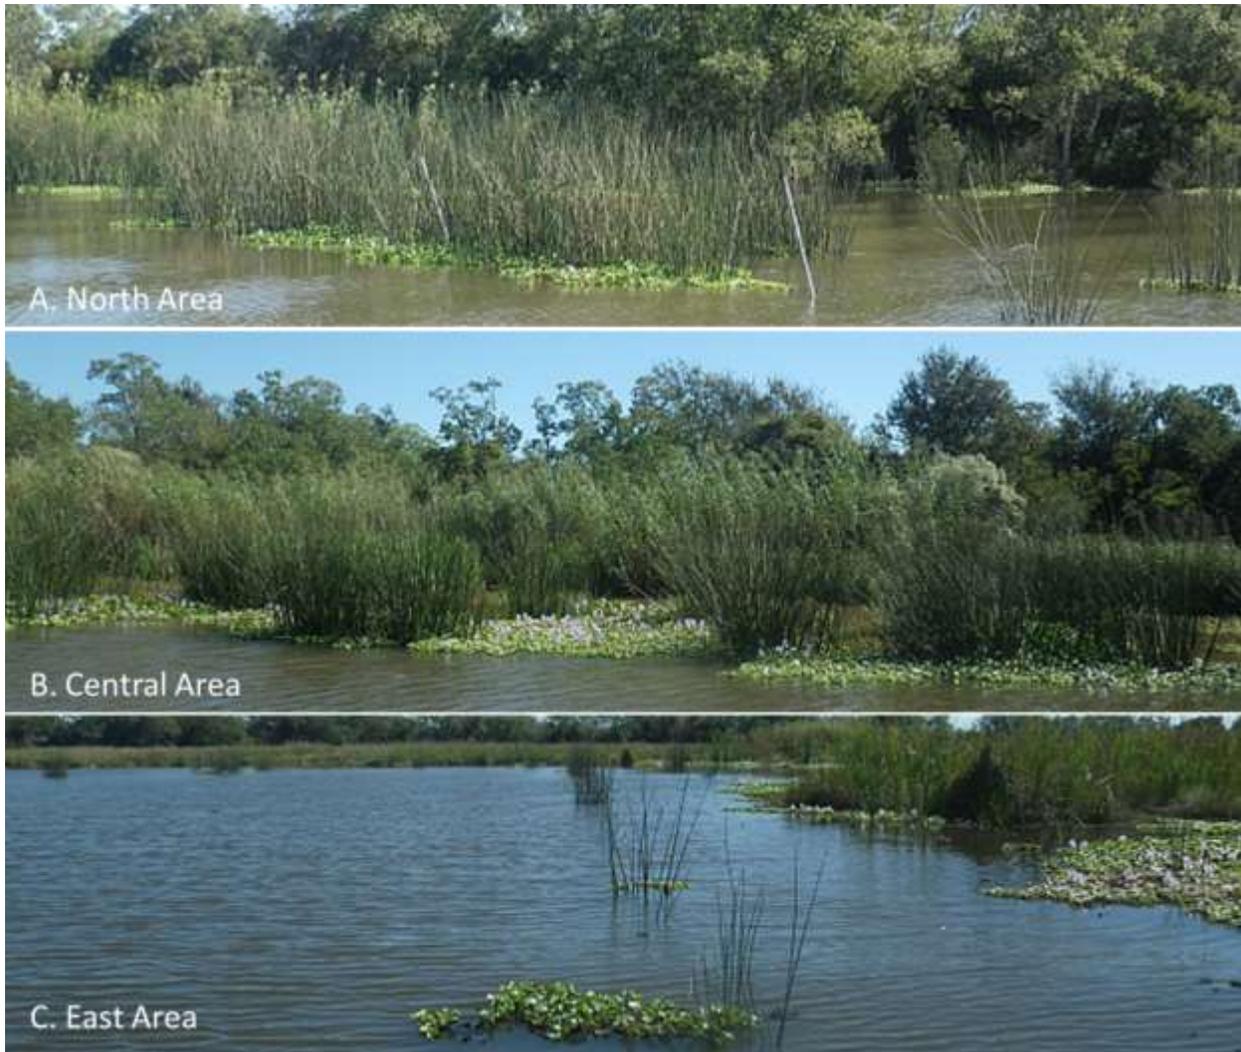
The double row plantings were moderately successful and highly variable (Figs. XI-2A, B, and 6). After an initial loss of 35 percent over the first two months after planting, the double row plantings only lost another 15 percent over the next year. By one year after planting, vegetative cover increased by ~16 % and stem heights grew by ~3.3 ft. By October 2018, percent cover had almost doubled and stem heights increased slightly, less than a foot. The North Area had greater survival and growth; the Central area was intermediate; and, the East Area has the least survival and growth (Table XI-1; Fig. XI-6). This trend continued as of the most recent sampling in October 2018.

Figure XI-6. Double rows were planted in the North, Central, and East areas. (A) The North had 40-70% survival; plants are growing well (8-10 ft stems) and expanding. (B) The Central had highly variable survival (0-70%) among reaches; plants are growing well (stems ~8 ft) and expanding. The marshside row is performing better than the pondside row. (C) The East had ~40% survival but not much growth (stems 5-6 ft tall) or expansion of surviving plants.

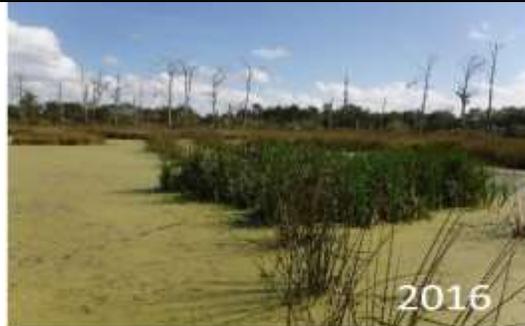
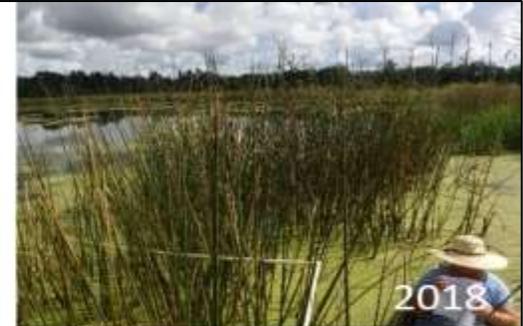
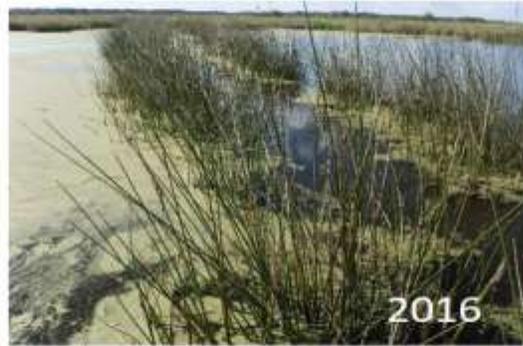
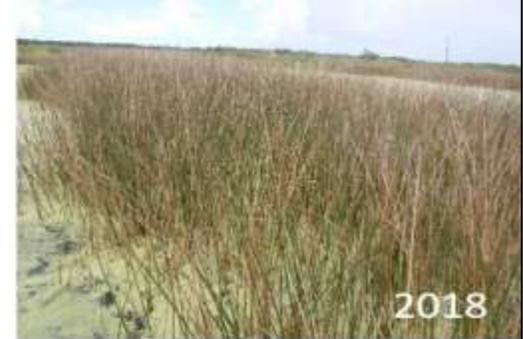
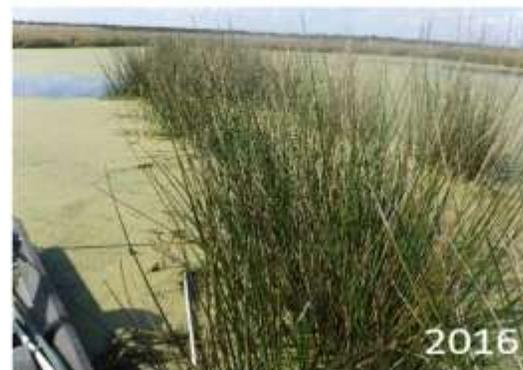
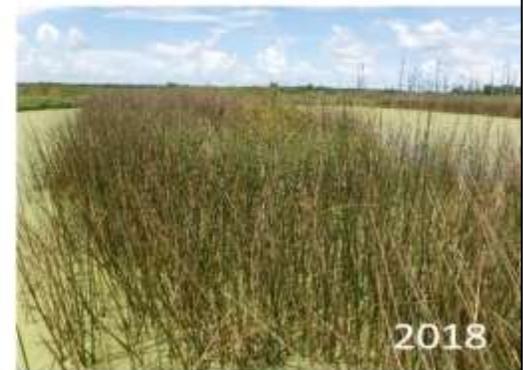
Growth and expansion
of double row
plantings in the
vicinity of stations 9
and 10.

Growth and expansion
of double row
plantings in the
vicinity of stations 11,
12, and 13.

Growth and expansion
of double row
plantings in the
vicinity of stations 17
and 18.

Figure XII-4: Comparative photographs of plantings in the northern (Stations 6-10), central (Stations 11-13), and southeastern (Stations 14-18) portions of LA00-39 Year 4 Pointe-aux-Chenes plantings from one (November 2016) and three (August 2018) years after planting.

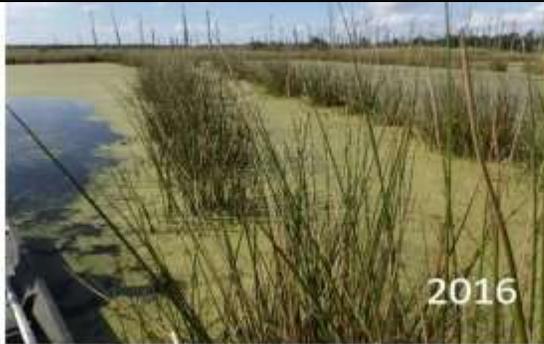
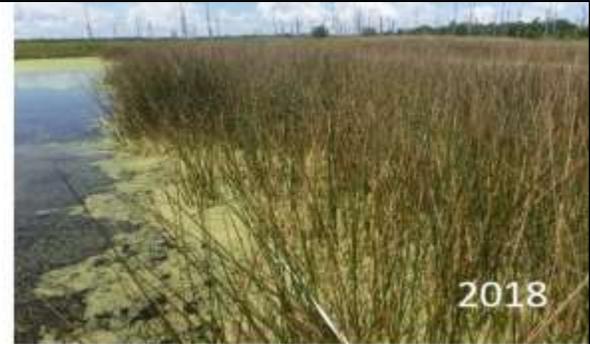
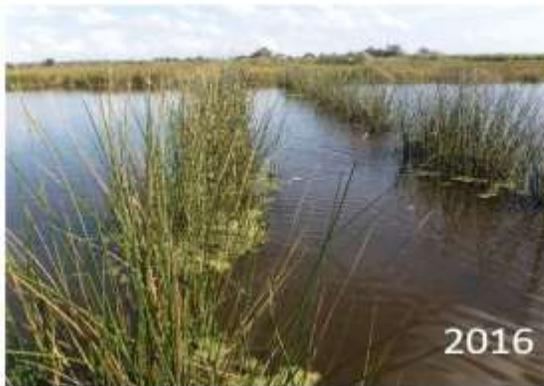
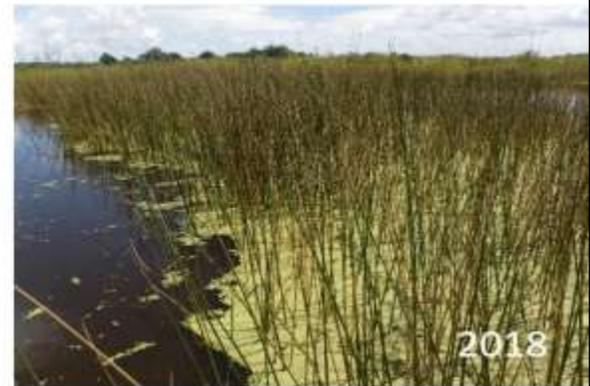
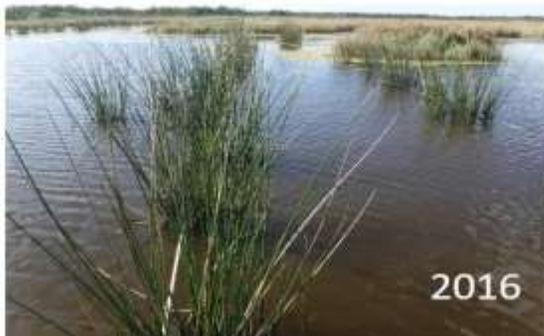
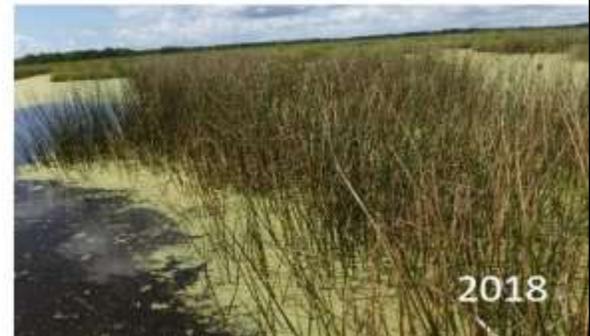
Growth and expansion
of double row
plantings in the
vicinity of stations 14,
15, and 16.

Growth and expansion
of double row
plantings in the
vicinity of stations 19
and 20.

Growth and expansion
of double row
plantings in the
vicinity of stations 21
and 22.

Figure XII-5: Comparative photographs of plantings in the southeastern (Stations 14-18) and southern (Stations 19-22) portions of LA00-39 Year 4 Pointe-aux-Chenes plantings from one (November 2016) and three (August 2018) years after planting.

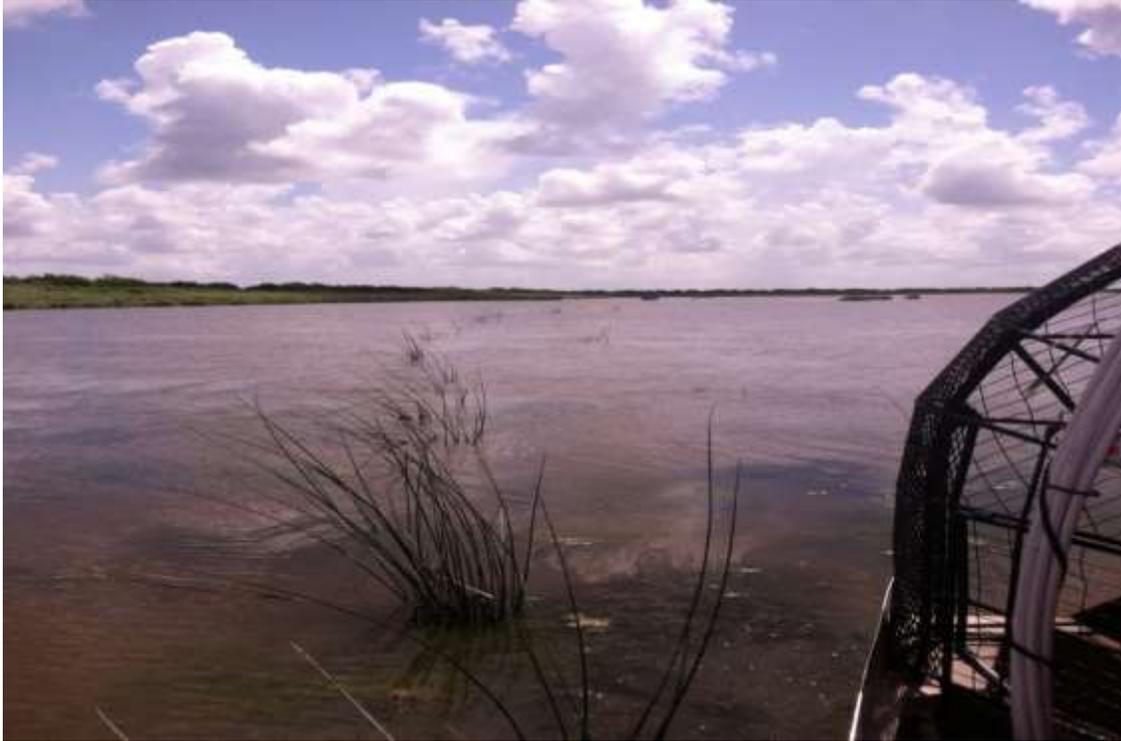
Overall, percent survival of the plantings was low at around 25% four months after planting during the August 2015 sampling (Table XIII-1). Lowest survival occurred along rows planted in large open water areas. In these areas, plant survival was limited to the ends of rows near the shoreline, and even these plants appeared somewhat sparse and stressed (Fig. XIII-2). Orientation of the rows did not seem to matter as much as the size of the pond area. Moderate survival was observed in areas that were planted near terraces or within broken marsh sections that provided the plantings with protection from wind and wave action. In these areas, percent survival as high as 85% was observed.

Figure XIII-2. View of surviving *Schoenoplectus californicus* plantings on end of row across northern open water area in August 2015 in LA-0039 Year 4 - Rockefeller Unit 4.

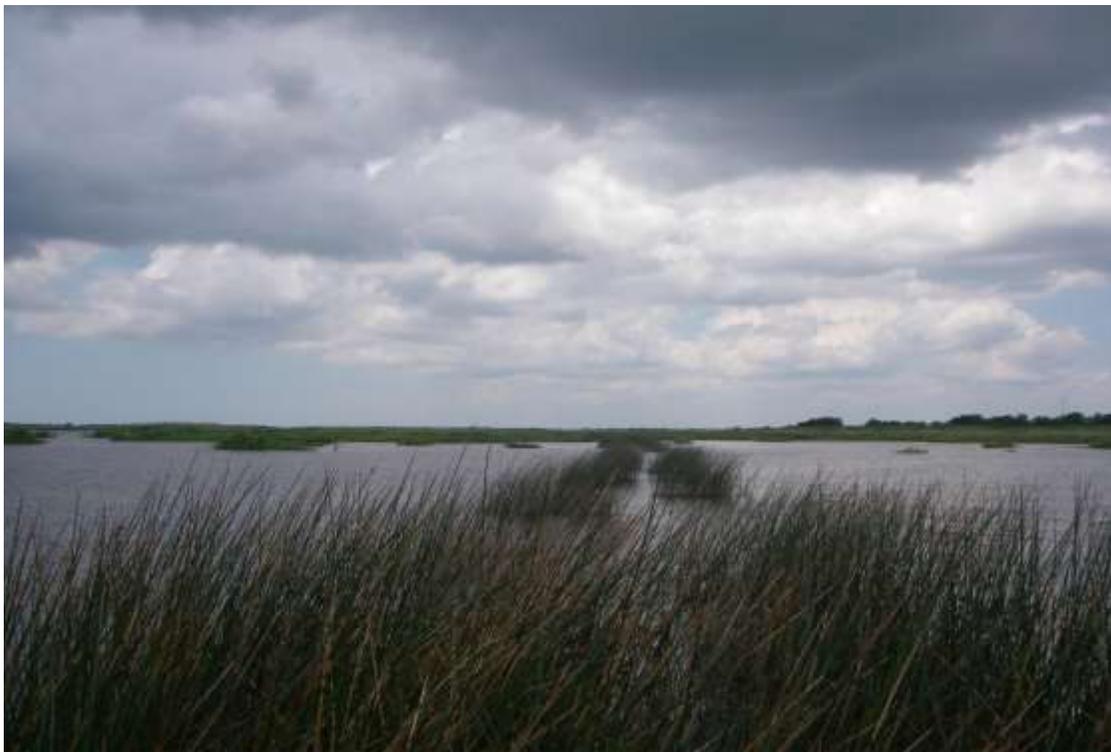
In August 2016, percent survival dropped even further to 16%, but the remaining plantings looked healthy and were forming clumps and even spreading some in the northeastern protected area (Fig. XIII-3). This trend continued into 2018 as overall percent survival dropped to 10% with the remaining surviving plantings clustered at the ends of the rows near the shoreline. The few individual plantings that had survived in the middle of deeper open water areas were no longer present (Fig. XIII-4). As on previous surveys, the plantings in protected broken marsh areas showed much higher survival rates (Fig. XIII-5). The remaining plantings look healthy for the most part, with some stress evident in a few locations on the outer edges. The percent cover of the vegetation stations increased from 3% per sampling plot to near 17% over the course of one year, then remained the same through 2018 (Fig. XIII-7). Average stem height nearly doubled as well from 4.2 ft in 2015 to ~8 ft in 2016, but decreased by 2018 to 5.8 ft, indicating perhaps a nutrient drain by the plantings in the initial years (Fig. XIII-8).

Figure XIII-3. View of healthy *Schoenoplectus californicus* forming clumps in the protected, northeast double row in August 2016 in LA-0039 Year 4 - Rockefeller Unit 4.

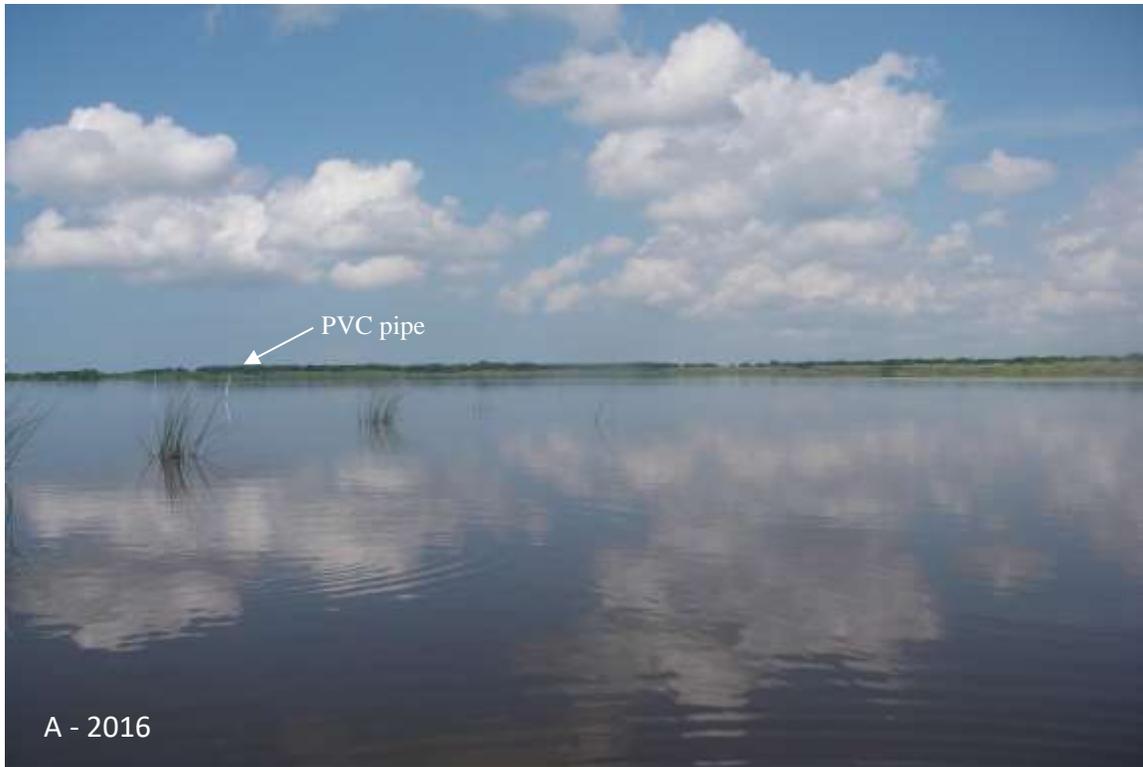
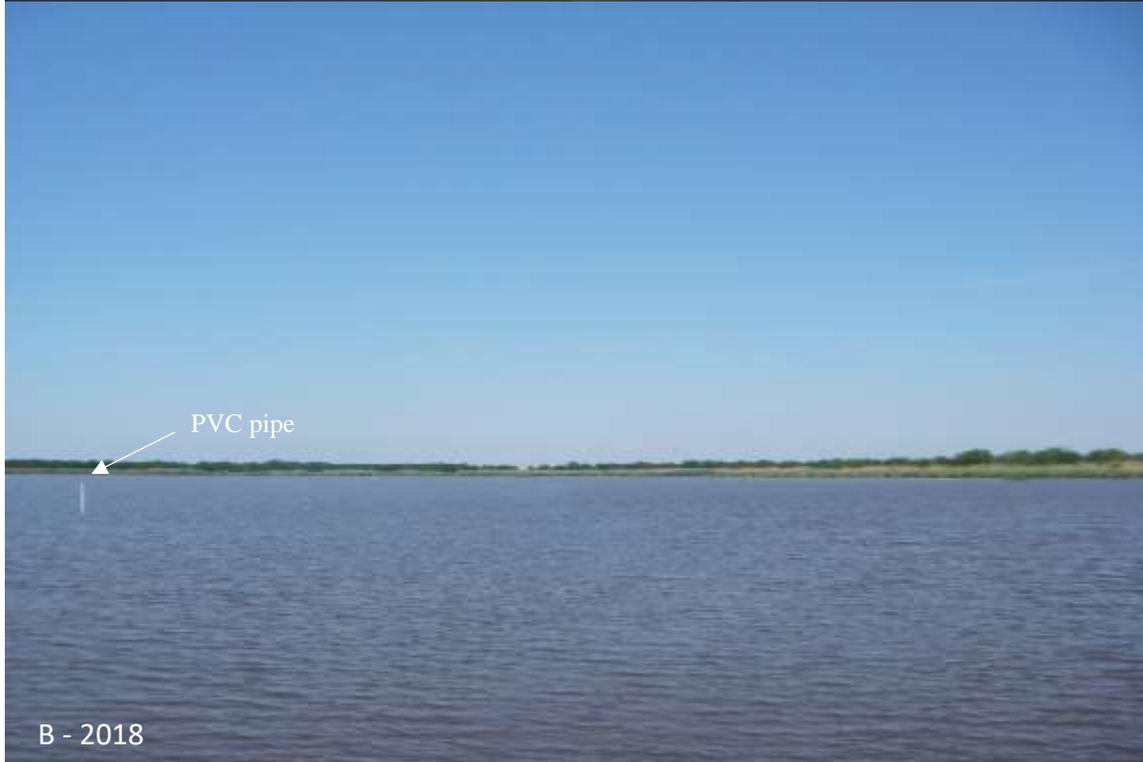
Figure XIII-4. A few plantings survived in open water areas into 2016 (A), but had disappeared by 2018 (B) in LA-0039 Year 4 - Rockefeller Unit 4.

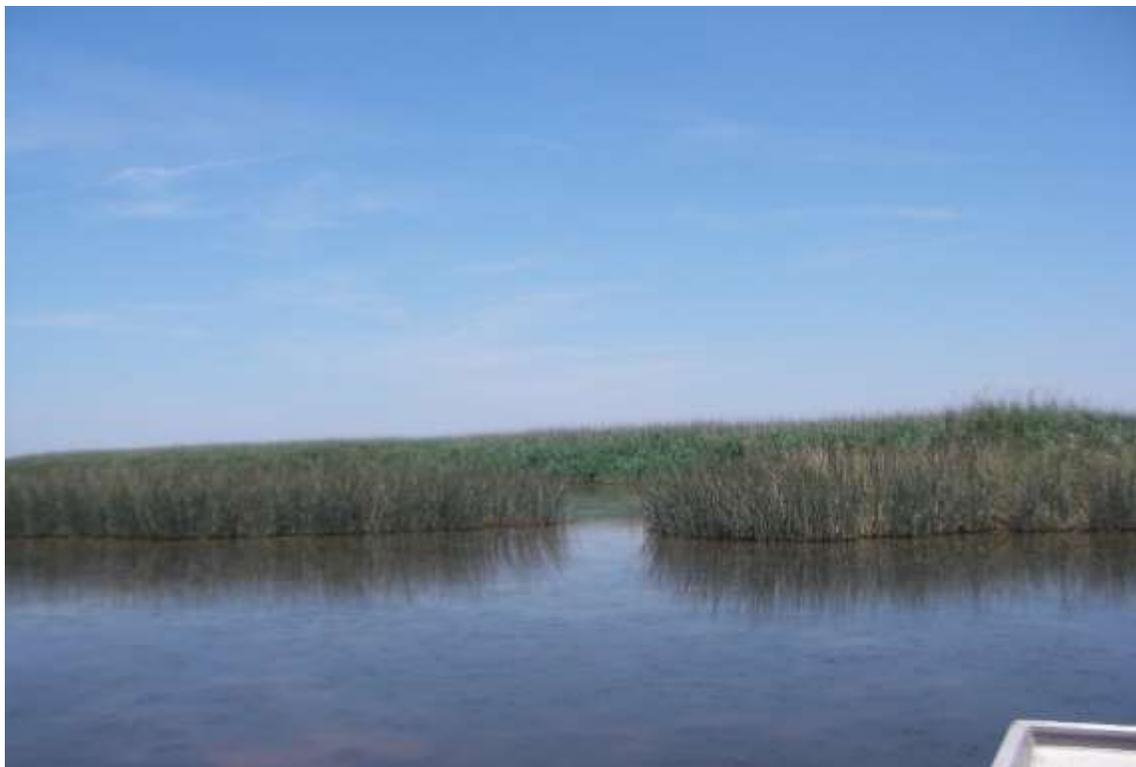
Figure XIII-5. View of healthy *S. californicus* clump in the protected, southern portion of the LA-0039 Year 4 - Rockefeller Unit 4 in May 2018.

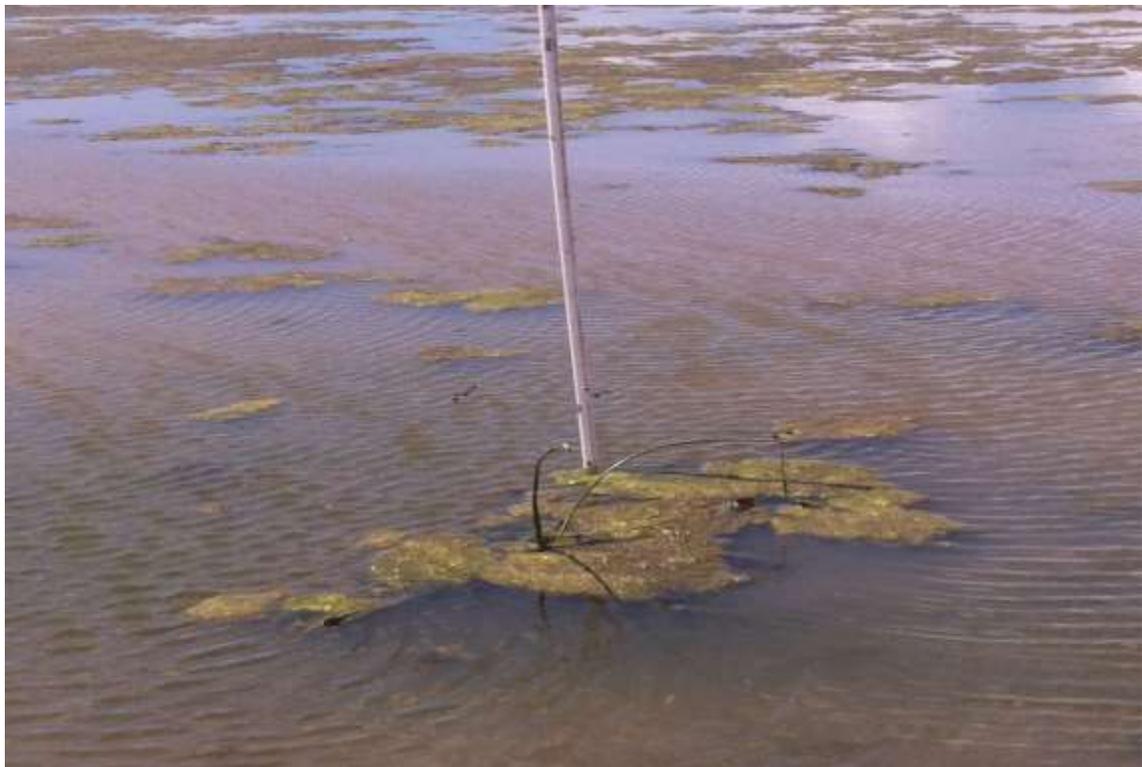
Figure XIII-10. Example of algal rafts collecting on a stressed *S. californicus* planting in August 2015 in LA-0039 Year 4 -Rockefeller Unit 4.

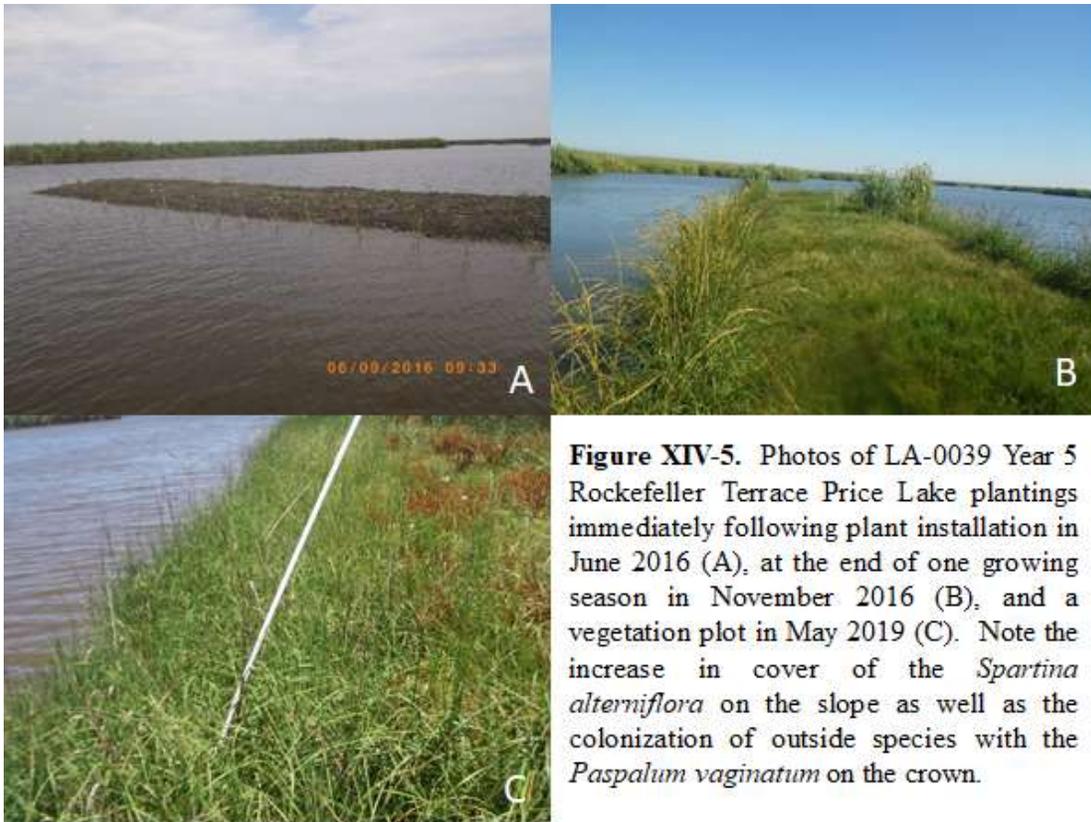
Figure XIV-5. Photos of LA-0039 Year 5 Rockefeller Terrace Price Lake plantings immediately following plant installation in June 2016 (A), at the end of one growing season in November 2016 (B), and a vegetation plot in May 2019 (C). Note the increase in cover of the *Spartina alterniflora* on the slope as well as the colonization of outside species with the *Paspalum vaginatum* on the crown.

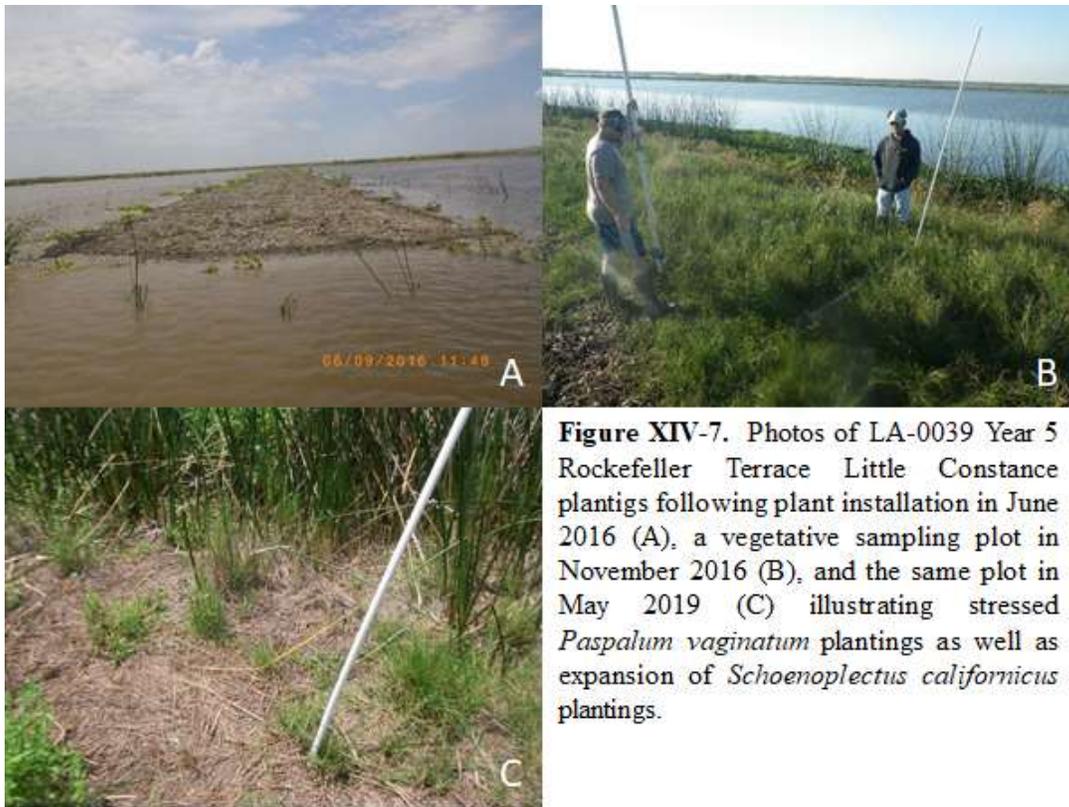
Figure XIV-7. Photos of LA-0039 Year 5 Rockefeller Terrace Little Constance plantings following plant installation in June 2016 (A), a vegetative sampling plot in November 2016 (B), and the same plot in May 2019 (C) illustrating stressed *Paspalum vaginatum* plantings as well as expansion of *Schoenoplectus californicus* plantings.

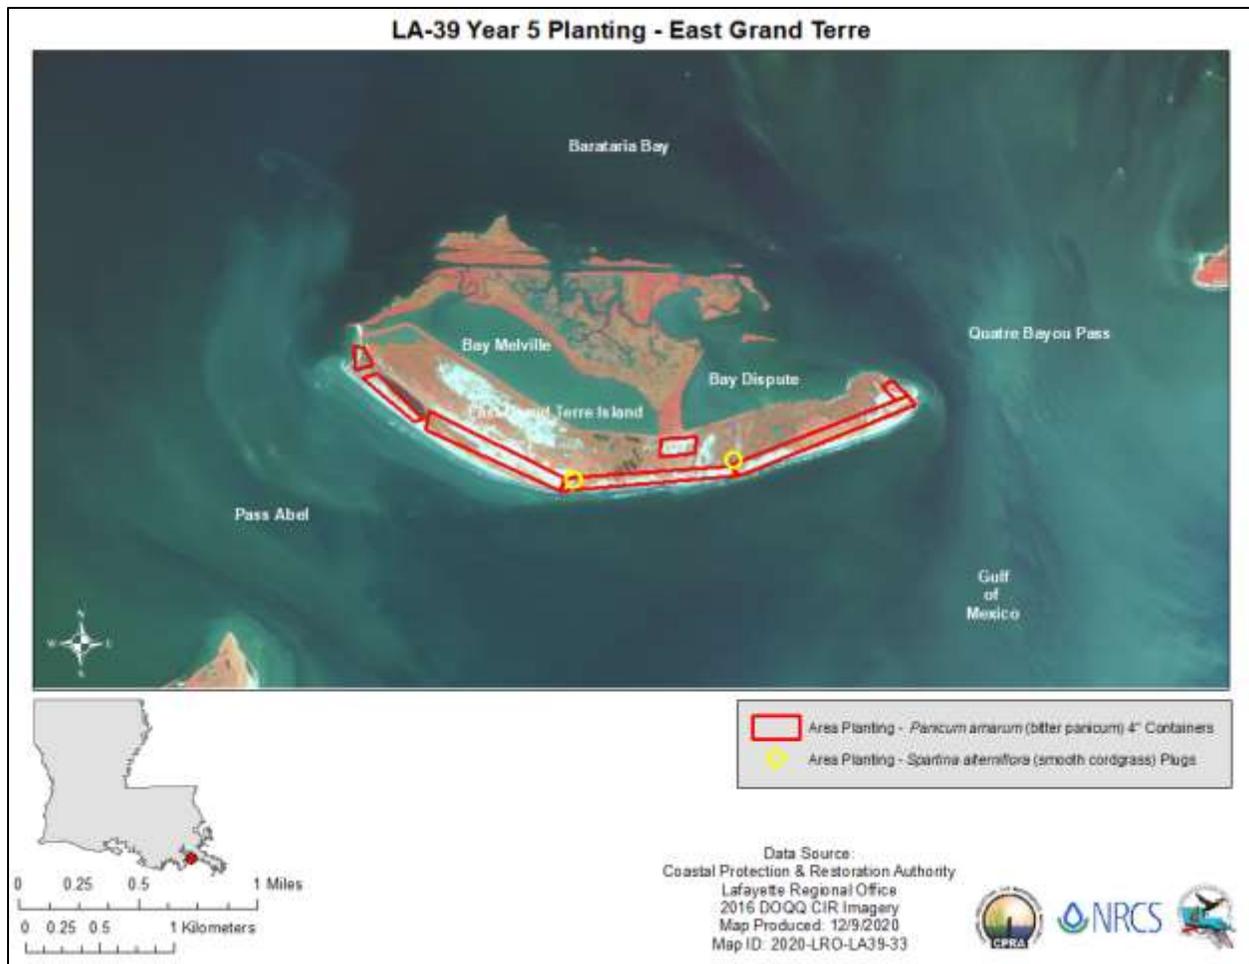
Figure XV-1. LA-0039 Year 5 East Grand Terre Island features from planning efforts.

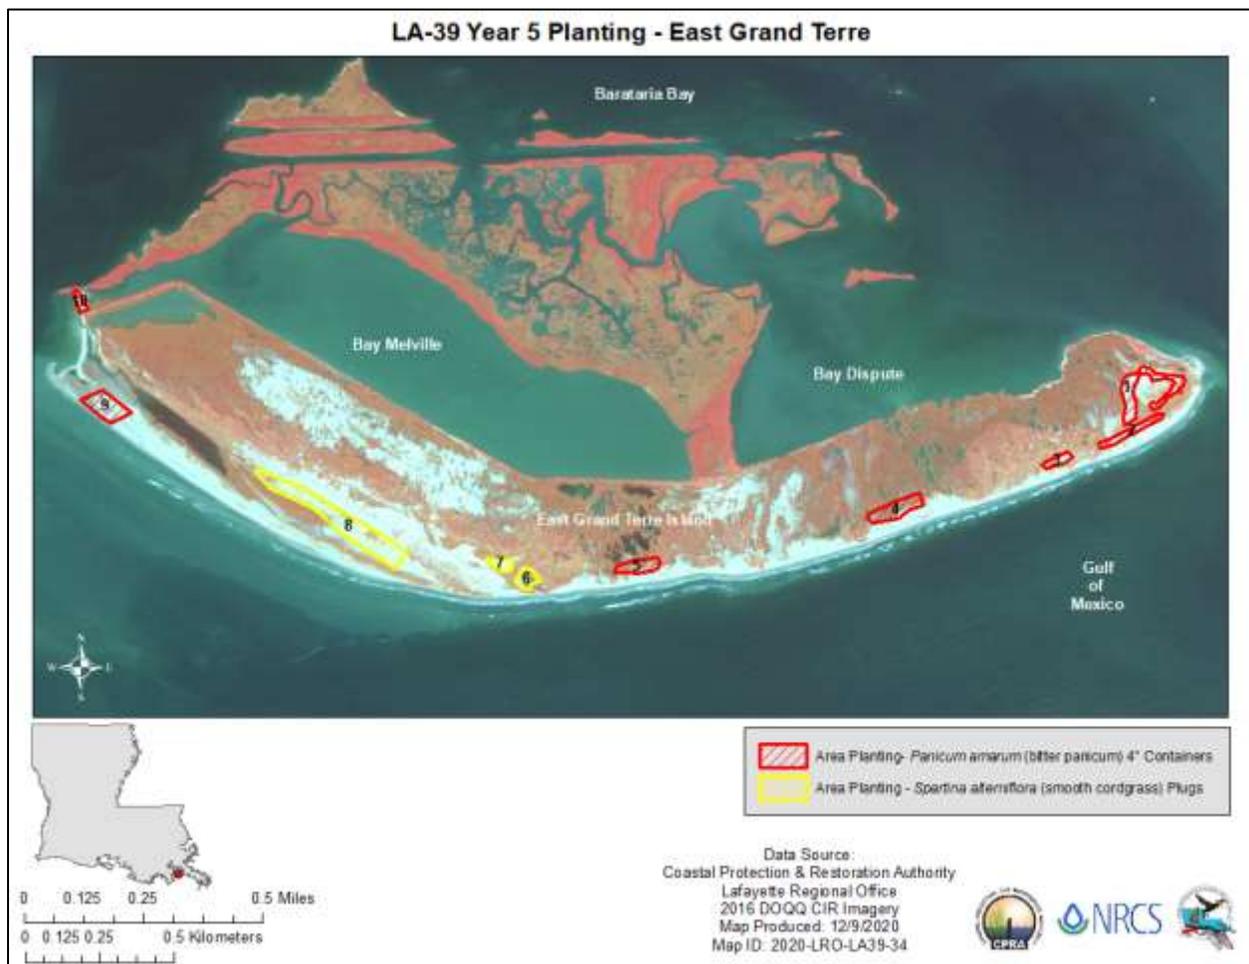
Figure XV-2. Map of LA-0039 Year 5 Site – East Grand Terre shows the planting types and areas where vegetation monitoring data was collected.

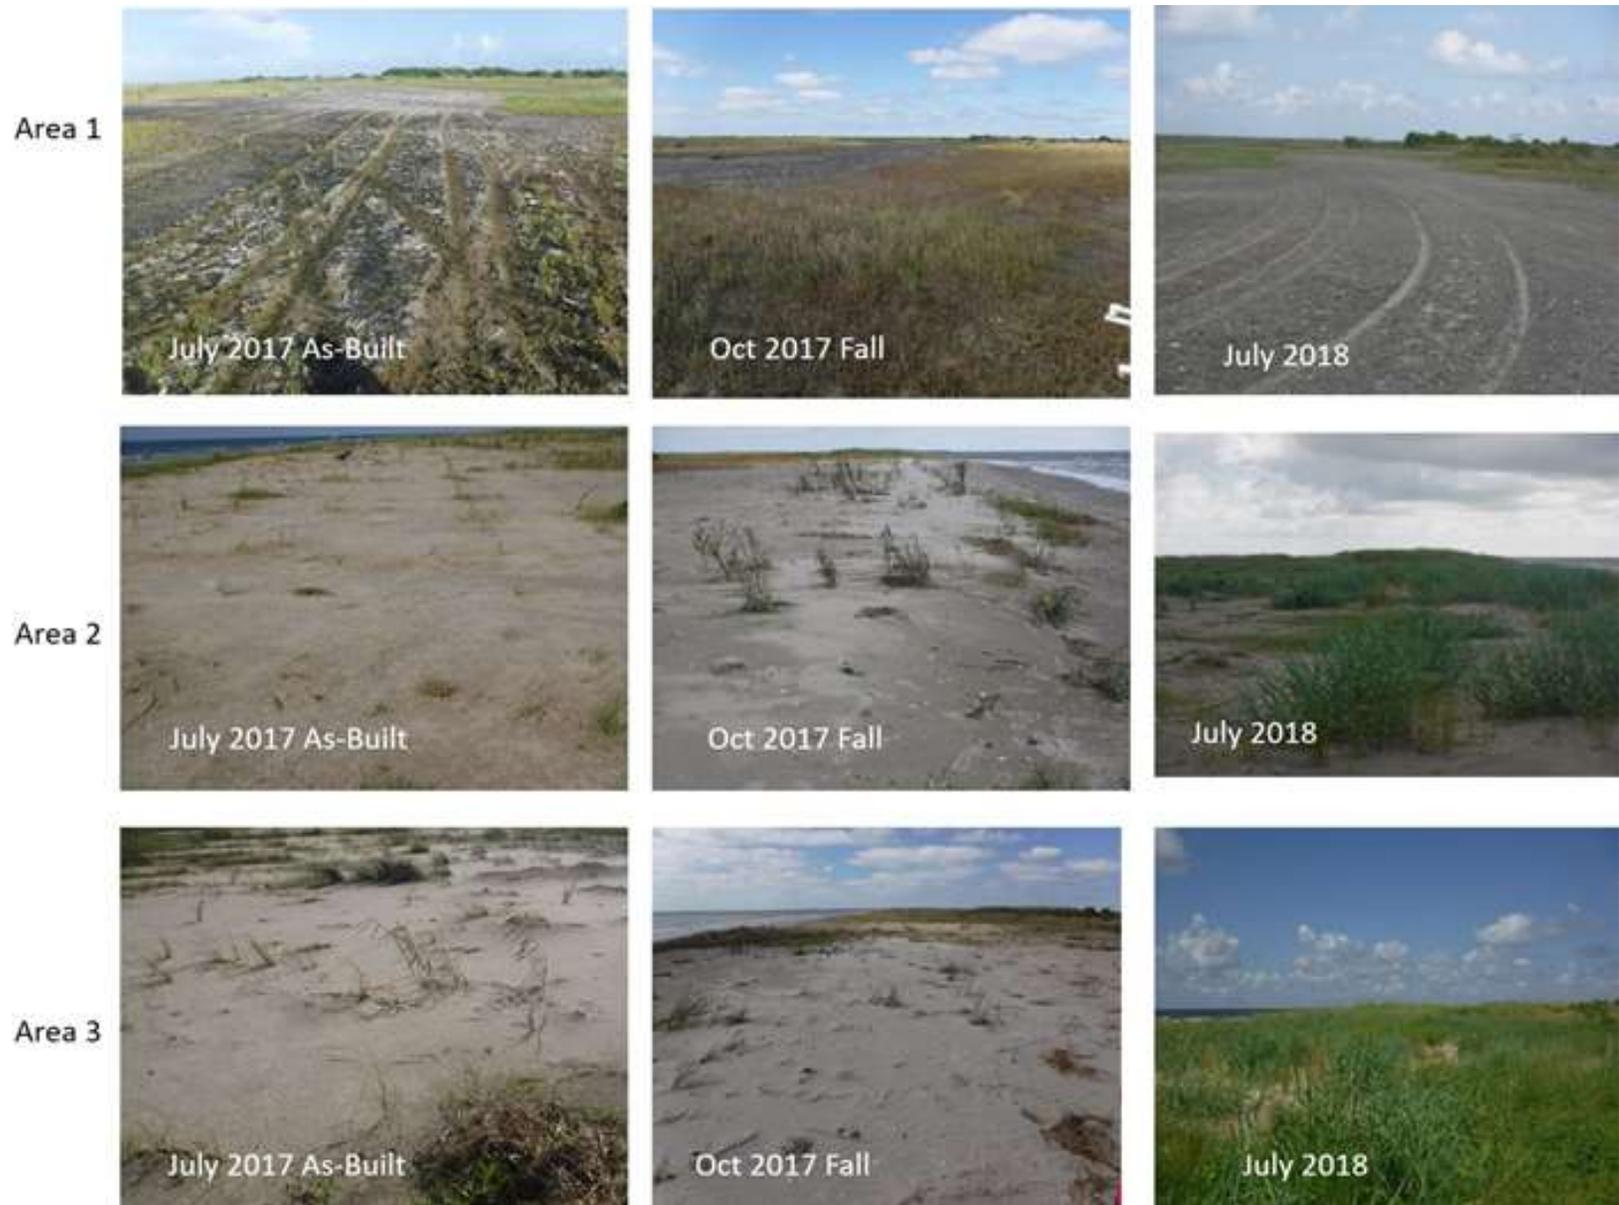
Figure XV-3. Bitter Panicum plantings (Areas 1, 2, and 3) at the LA-0039 Year 5 EGT in 2017 and 2018.

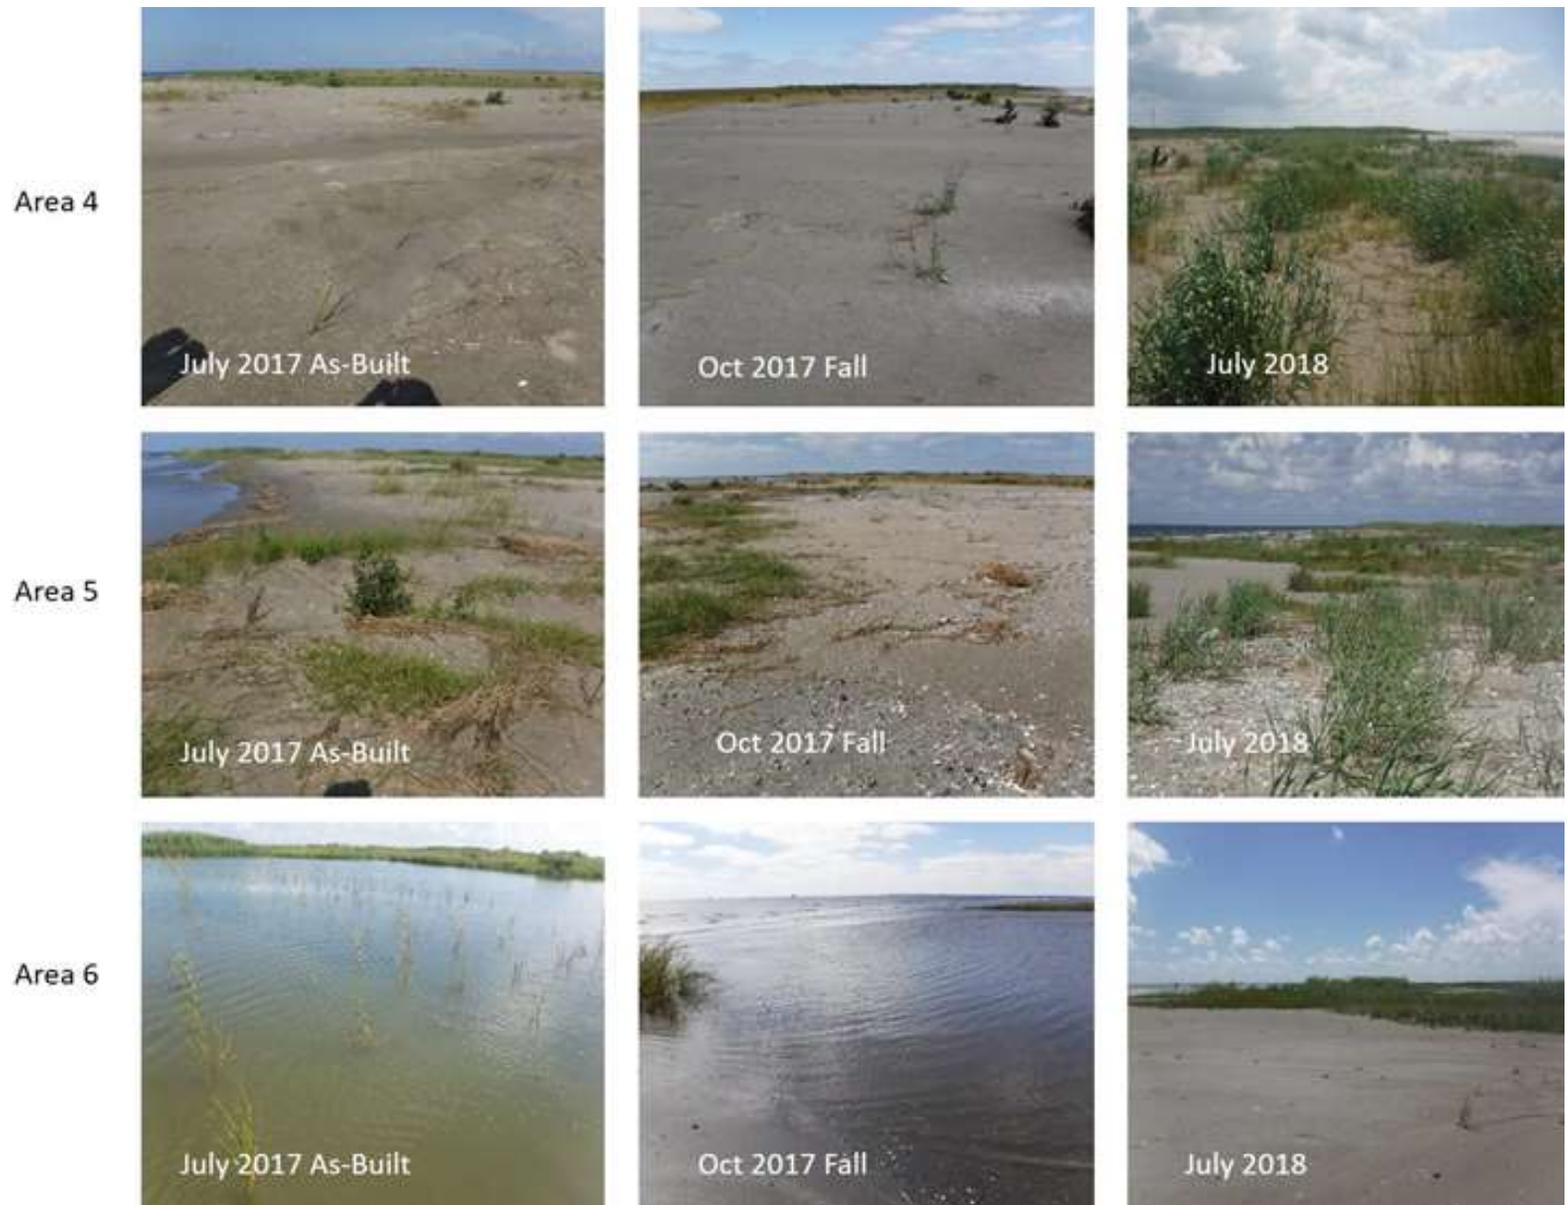
Figure XV-4. Bitter Panicum (Areas 4 and 5) and smooth cordgrass (Area 6) plantings at the LA-0039 Year 5 EGT in 2017 and 2018.

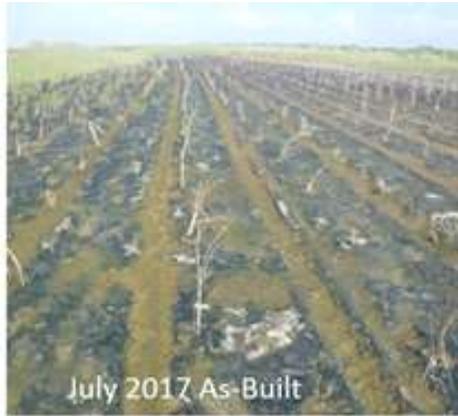
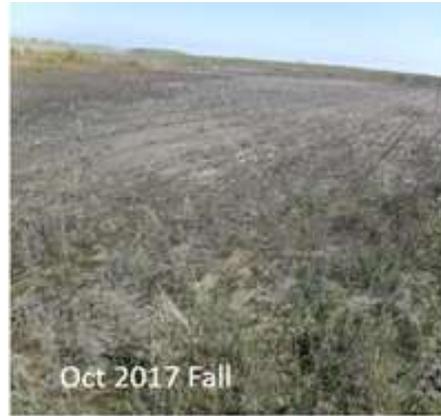
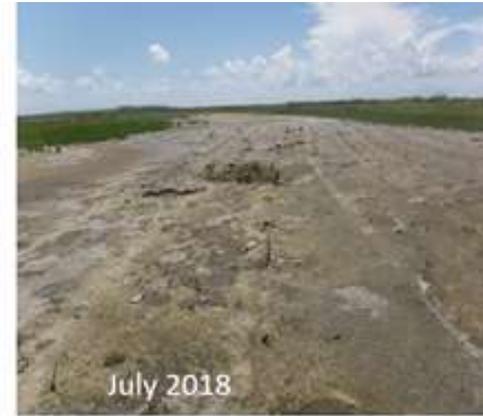
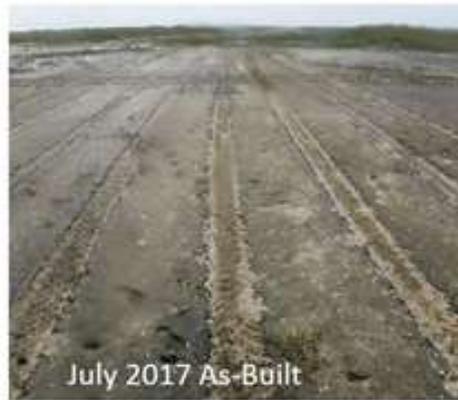
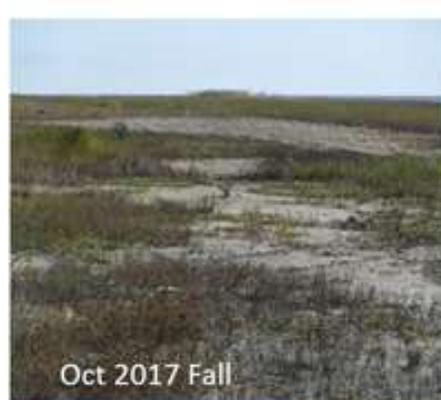
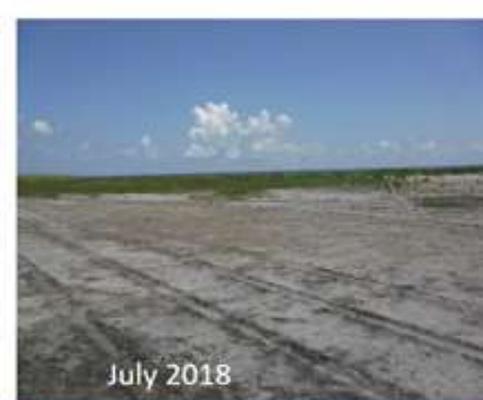
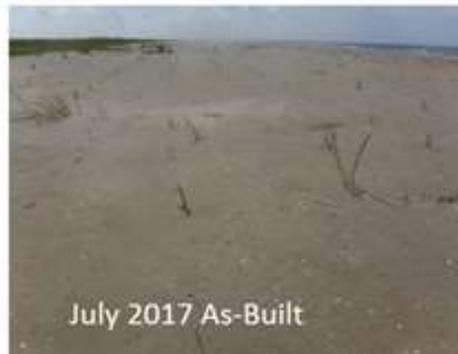
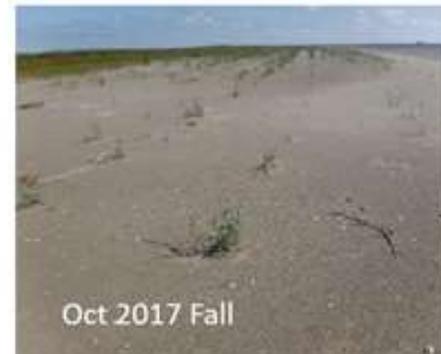
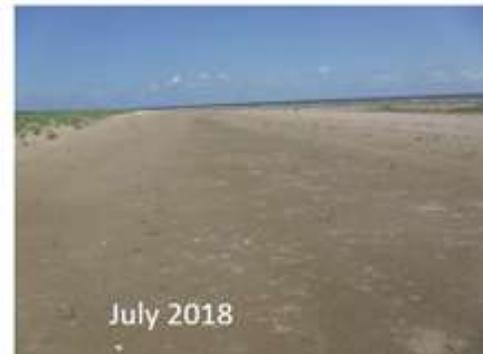
Figure XV-5. Smooth cordgrass (Areas 7 and 8) and bitter Panicum (Area 9) plantings at the LA-0039 Year 5 EGT in 2017 and 2018.

There is no recommendation to replant EGT. Bitter Panicum should be planted above the high tide zone on the beach/dune complex.

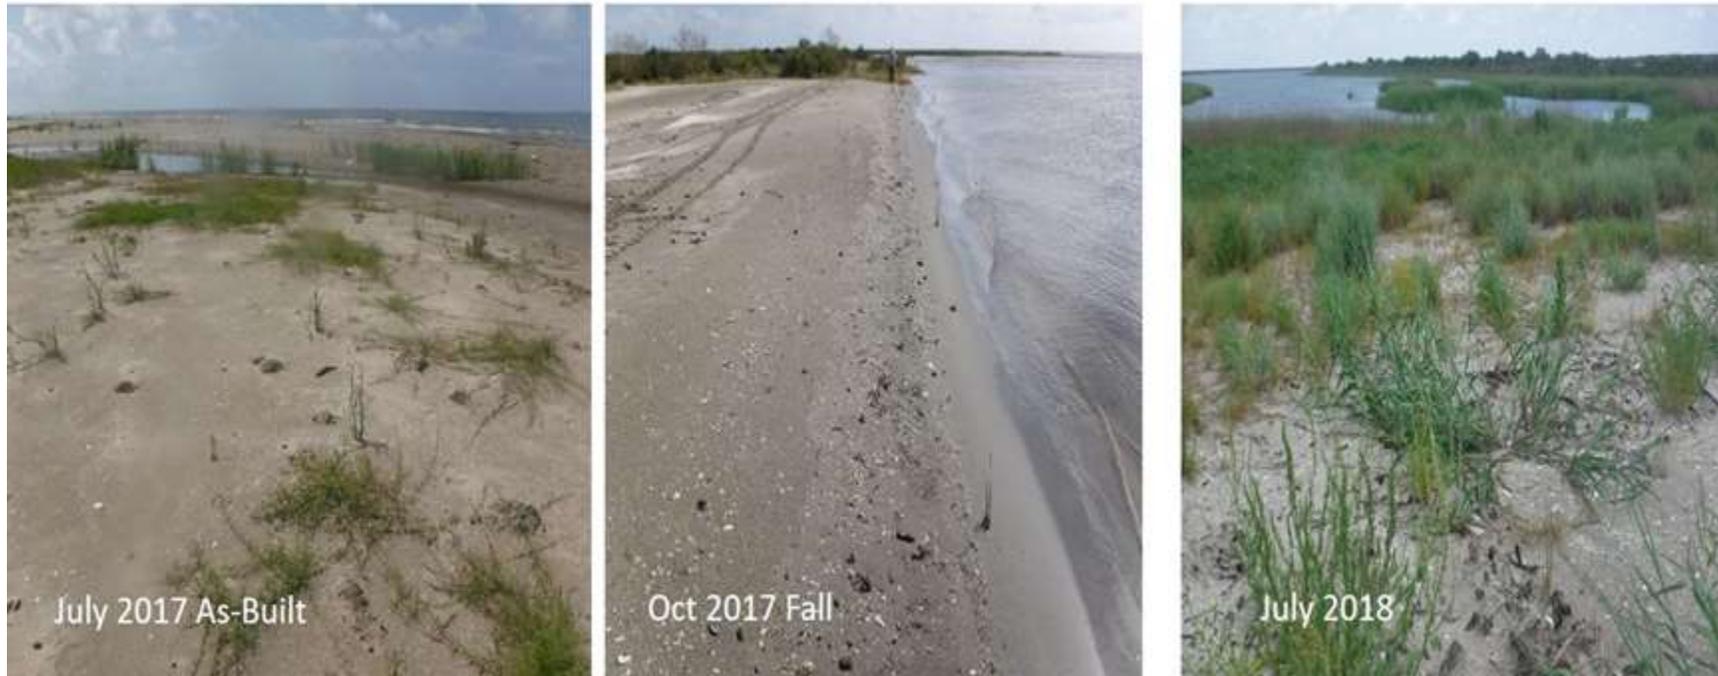
Figure XV-6. Bitter Panicum plantings (Area 9) at the LA-0039 Year 5 EGT in 2017 and 2018.

Within the beach/dune complex, bitter panicum plantings were more successful above the high tide zone (supratidal) but failed below the high tide zone (intertidal), especially when open to the Gulf of Mexico waves.
