2021 Operations, Maintenance, and Monitoring Report

Coastwide Vegetative Planting Project (LA-0039)

State Project Number LA-0039
Priority Project List 20

September 2021

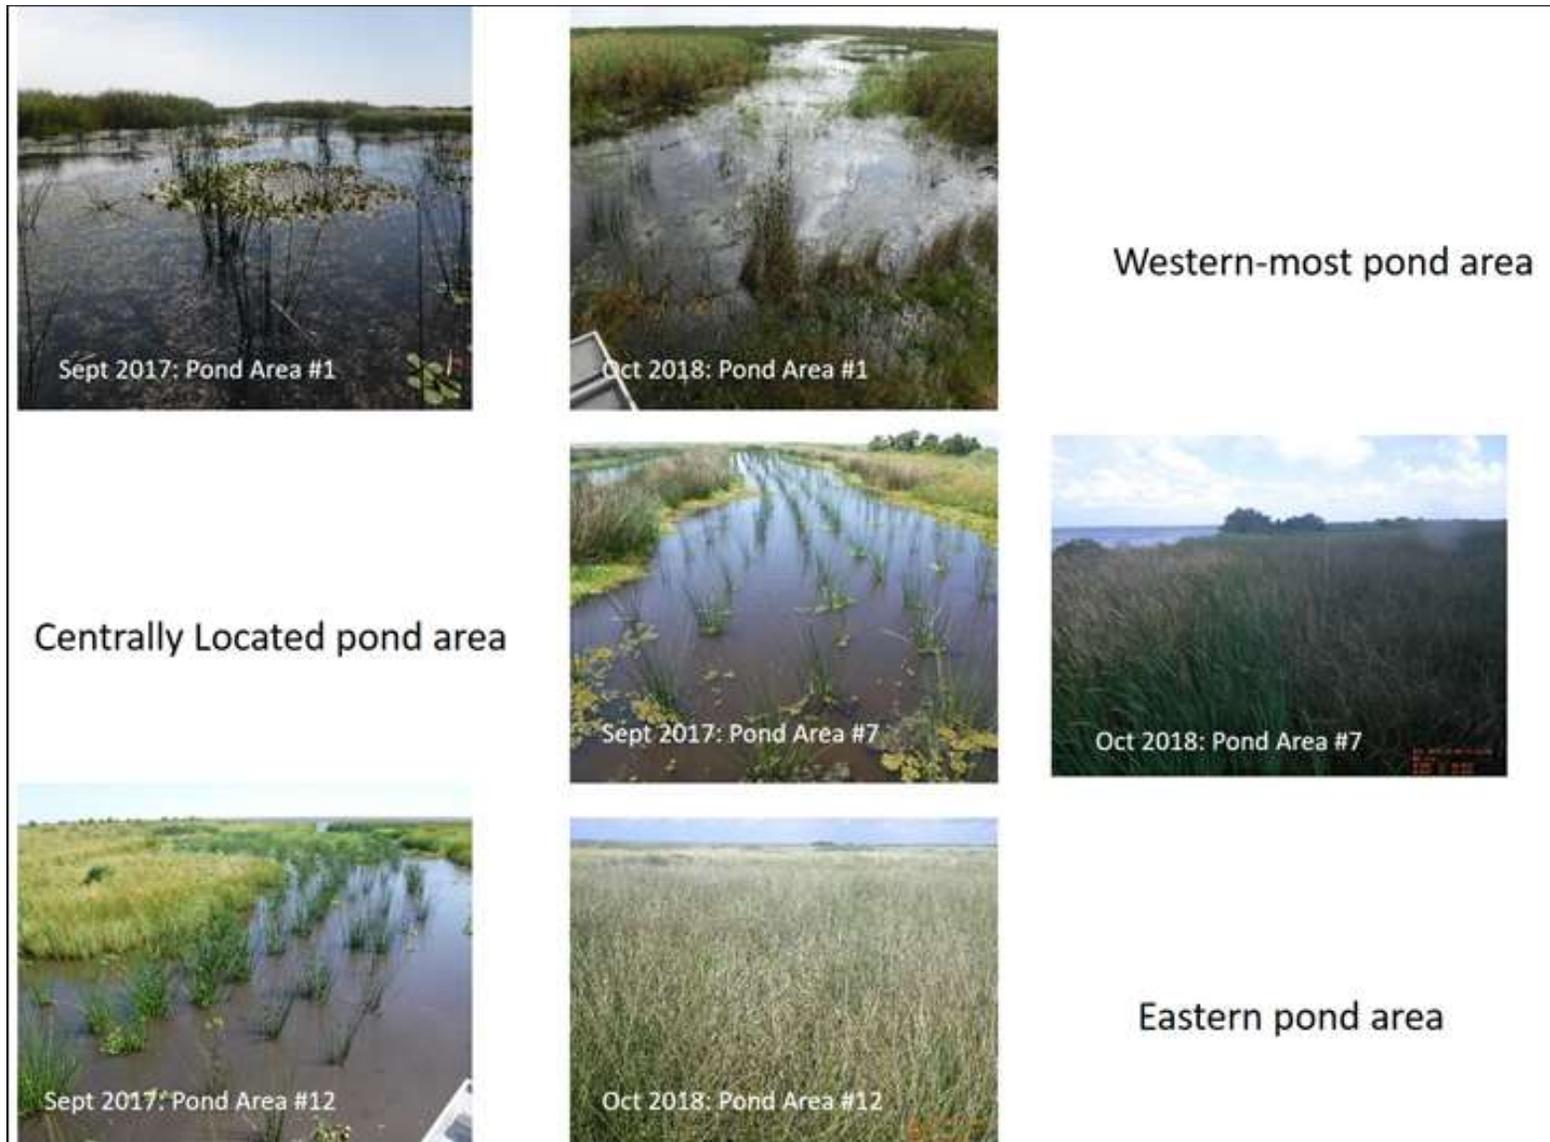
Figure XVI-3. LA-0039 Year 6 West Little Lake #2 photographs of a variety planting survival, health, and success within selected ponds throughout the planted area a growing season (Sep 2017) and a year and a half (Oct 2018) after planting in May 2017.

The planted species did not expand well. This pond area had the lowest cover out of the thirteen ponds. It is the farthest to the west, inside of a broken, intermediate marsh surrounded by thick stands of *Typha* sp. (cattails), *Phragmites australis* (Roseau cane), *Sagittaria lancifolia* (bulltongue), and *Schoenoplectus americanus* (three-square bulrush). This area is continuously inundated. There is a heavy presence of submerged aquatic vegetation (SAV) and floating aquatic vegetation (FAV) throughout. Thick mats of *Ceratophyllum demersum* (coontail), *Nuphar lutea* (Yellow water lily), *Eichhornia crassipes* (water hyacinth), *Salvinia molesta* (giant Salvinia) were observed throughout this pond. The frequent flooding and heavy SAV/FAV presence may have contributed to the lack of expansion of the planted species. Though plants observed in 2017 were healthy and robust from the onset, by 2018 they were spindly and short in comparison which is a sign of physical and competitive stress. See Figure XVI-3.

The 2017 plantings were healthy and beginning to expand with few missing plants. The Year 2 WLL planting survivors formed dense hedge rows between these newer WLL#2 plantings. There was heavy presence of FAV (*E. crassipes*) in 2017. By 2018 the plantings were successful and robust. The cover was excellent and plants had highest average heights of all the pond areas. FAV was present but not as thick as in 2017, and mainly consisted of *Salvinia minima* (water spangles), *S. molesta*, and *Oxycaryum cubense* (Cuban sedge). Auxiliary pond areas 1 and 2 were very similar in species mix and cover success. See Figure XVI-3.

In 2017 and 2018 the conditions and species mix were very similar to pond area 11. Though the northeast end of the pond area did not have direct exposure to the lake, inundation was similar to pond area 11. By 2018, survival was very successful (over 90% cover) and thick, dense stands of the planted species were evident throughout the entirety of pond area 12. See Figure XVI-3.

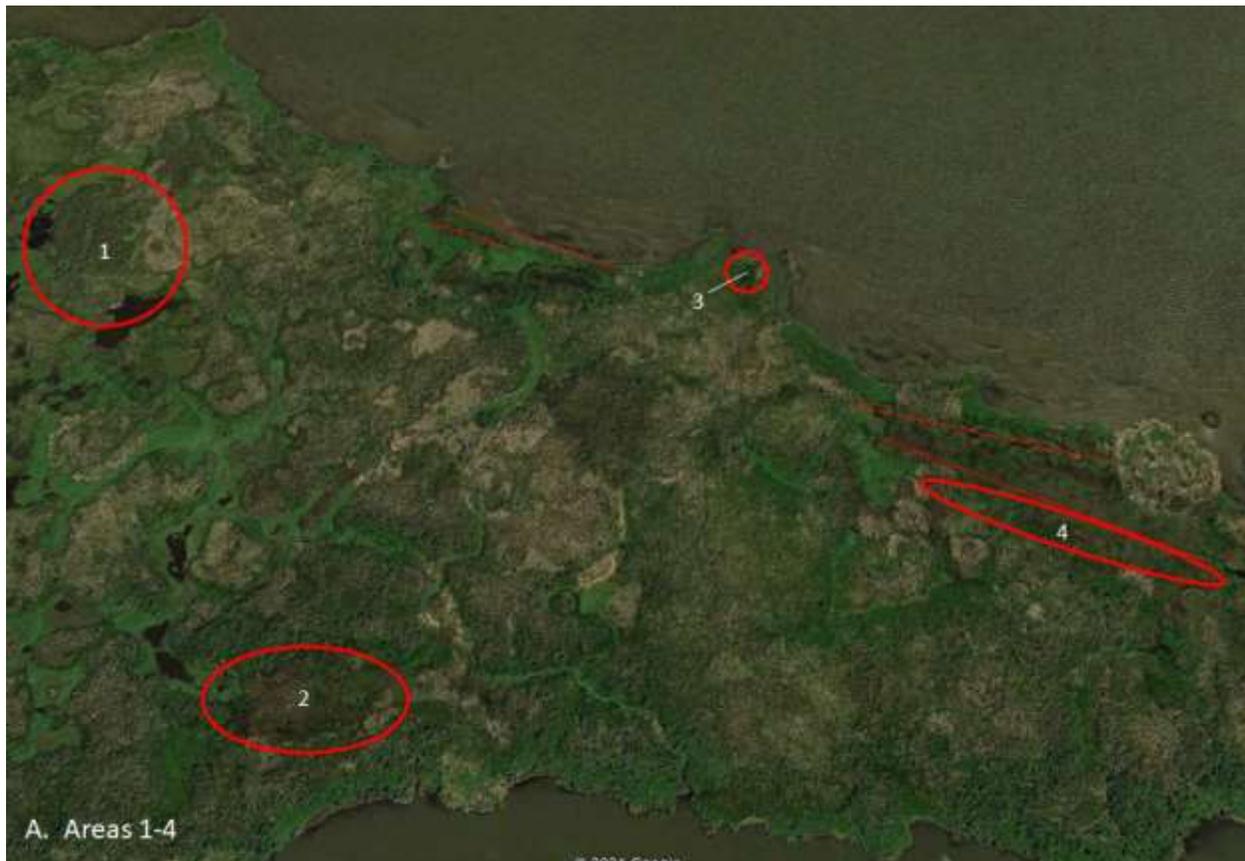
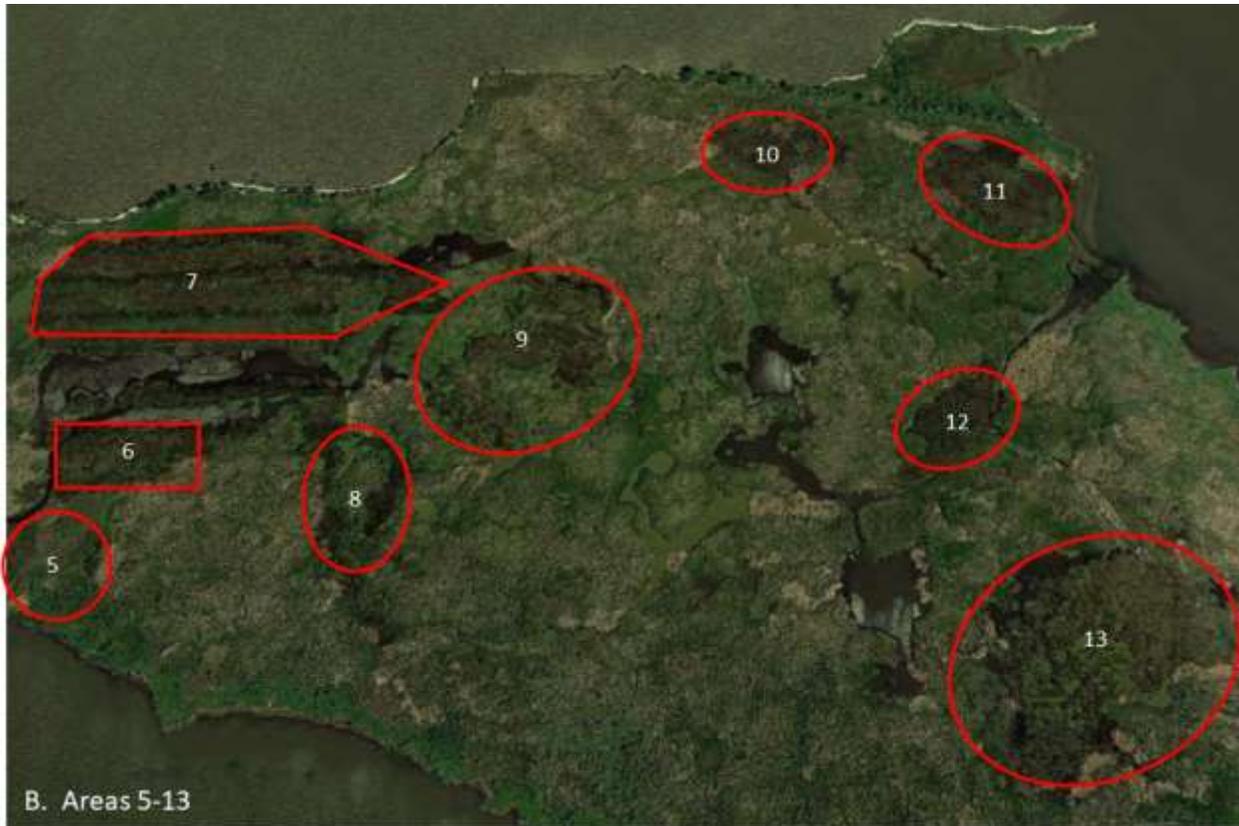
Planting survival and coverage in Pond Area plantings from October 2018 persisted and potentially expanded into March 2019 (Figures VXI-4).

Figure XVI-4. Aerial imagery at LA-0039 Year 6 West Little Lake #2 from Google Earth Pro© from March 20, 2019 showing expansion in western (A) and eastern (B) Pond Area plantings.

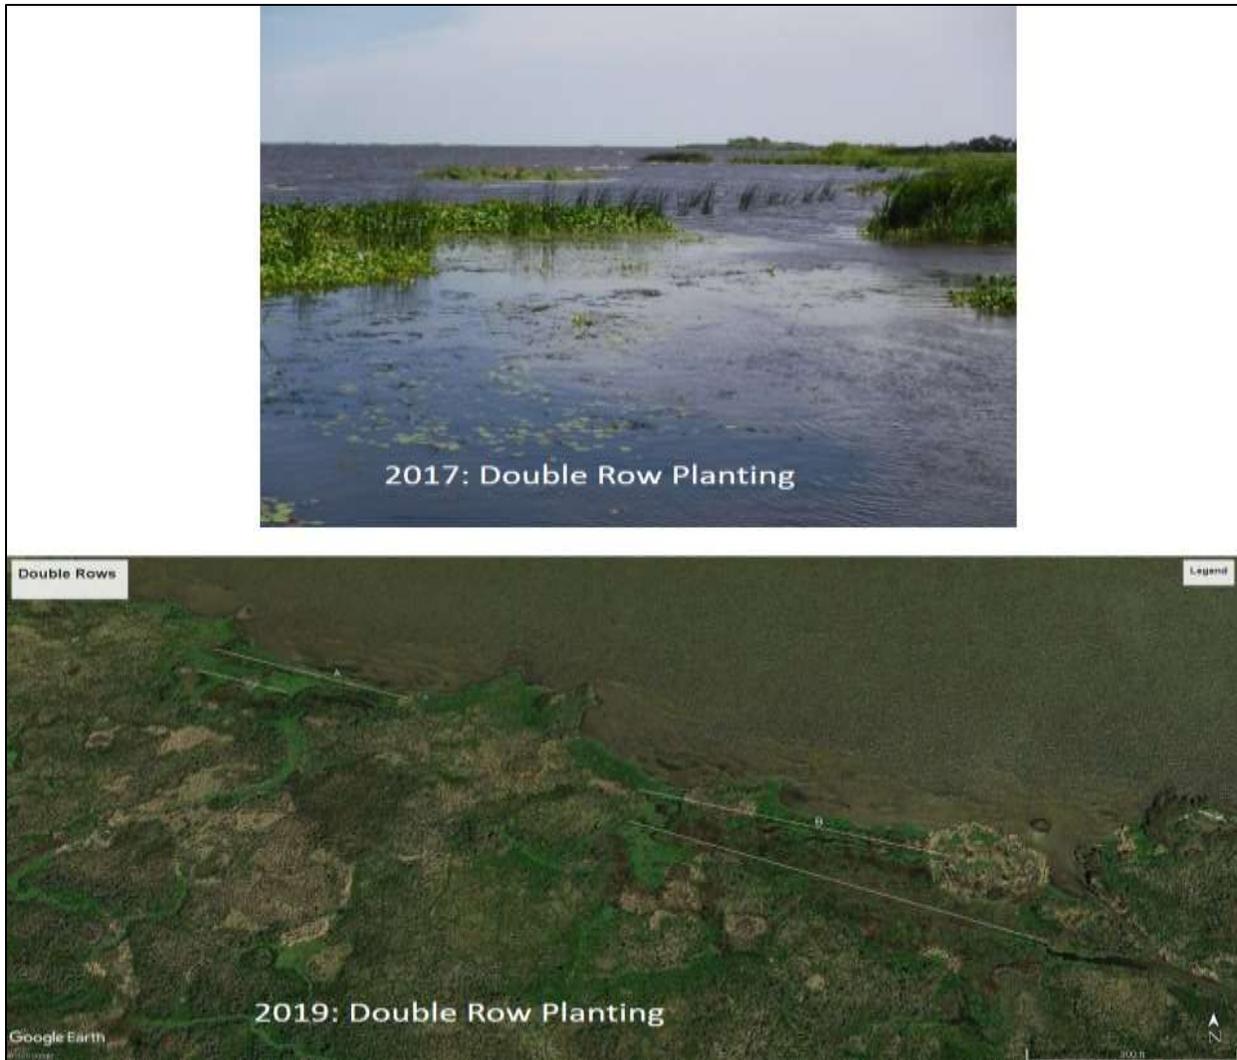
In 2017 the plants in both areas were healthy, expanding slightly in size, and still upright despite the wave action from the lake. There were large mats of *E. crassipes* stacked up on the periphery of the plantings from the lake side, but no rafting occurred to the extent that it would bend the plants over and cover them. Wave energy was dampened somewhat by the shallow former marsh platform extending between plantings and open lake. Dense presence of SAV included *N. lutea* and *C. demersum*. In 2018 the plants in both areas expanded substantially both laterally and in height. There were gaps in the planting rows, but survival was good. Wind driven waves and continuous inundation of the planting rows did not appear to have a negative impact on their expansion. FAV and SAV remained dense. The installation of the plants in the shallows adjacent to the shoreline has helped to protect them to some extent by dampening the wave energy. The Google Earth Pro© imagery from March 2019 indicates that there are some gaps in the rows, but survival was good (Figure XVI-5).

Figure XVI-5. Typical double row planting at LA-0039 Year 6 West Little Lake #2 photographed in September 2017 (upper). Google Earth Pro© imagery from March 2019 indicating location and expansion of double rows along the Little Lake shoreline (lower).

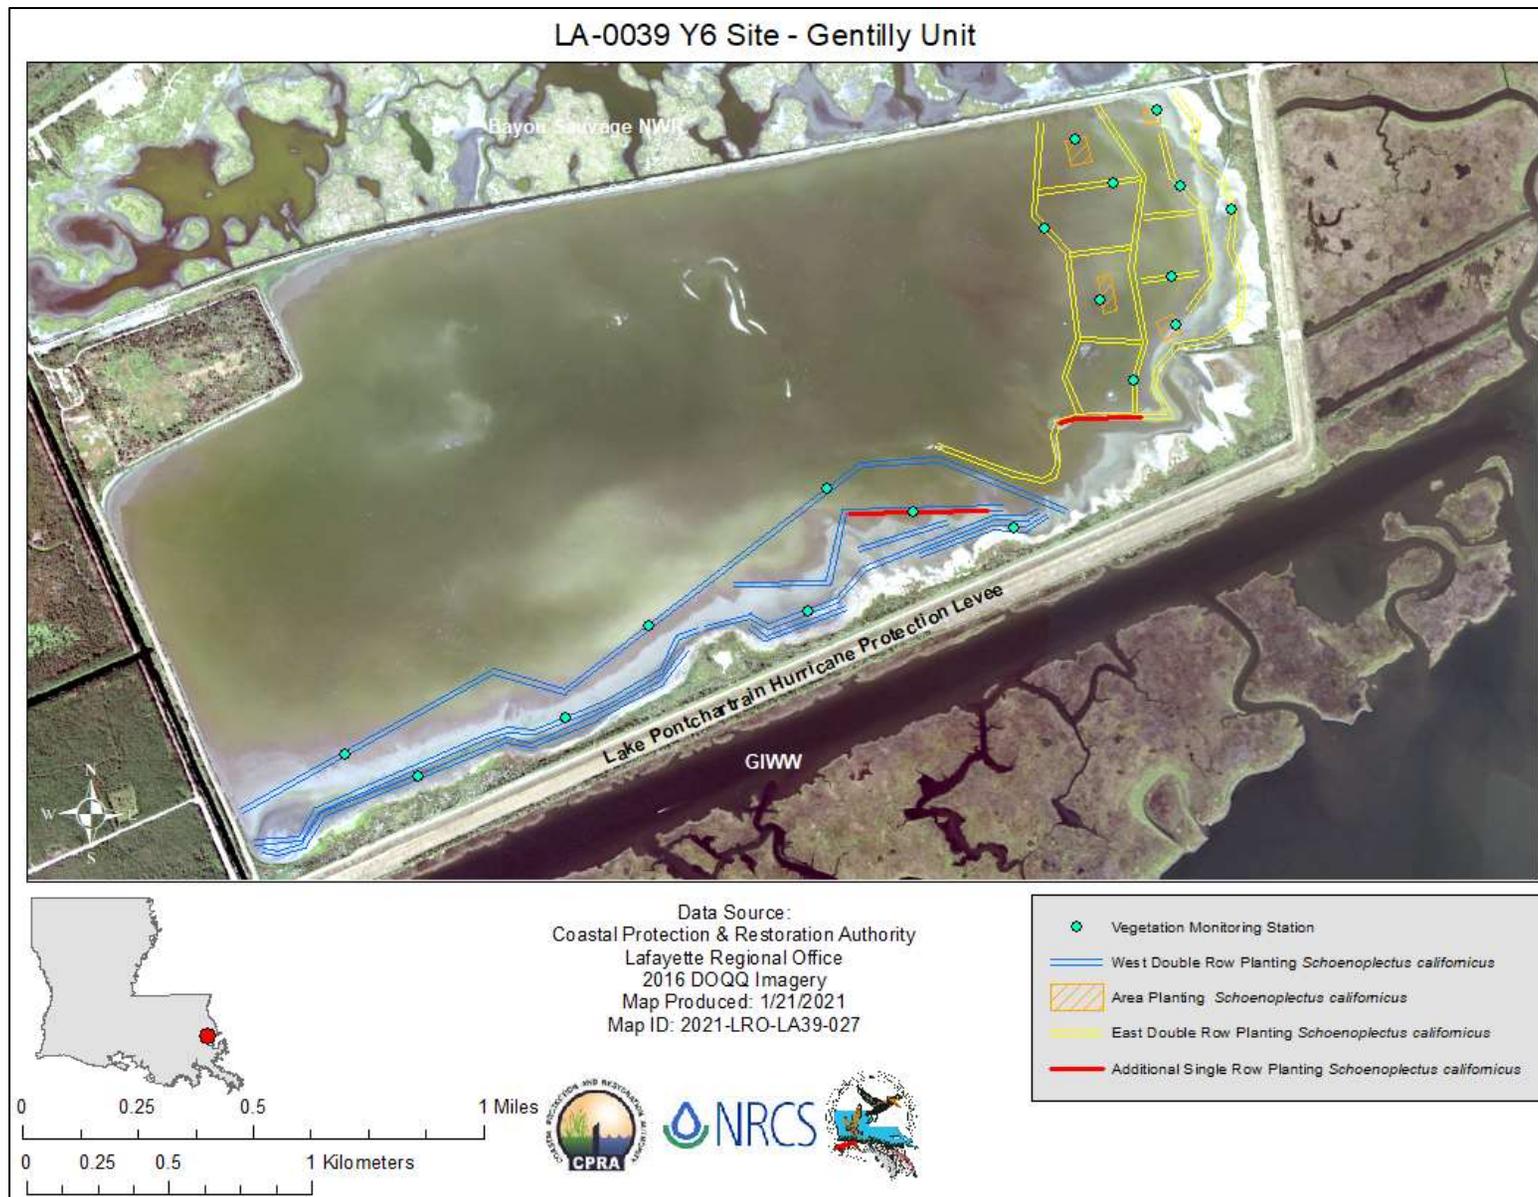
East Area Plantings: *Schoenoplectus californicus* was planted in parallel rows seven feet apart on seven-foot alternating centers. The four area plantings range from 0.7 to 1.6 acres and are interspersed among the east double-row plantings (Figure XVII-1). A total of ~4,400 TG plants were installed in the area plantings: ~1,430 in Area 1, ~630 in Area 2, ~1,340 in Area 3, and ~1,000 in Area 4.

Figure XVII-1. LA-0039 Year 6 Gentilly Unit site map showing east and west plantings and vegetation monitoring stations.

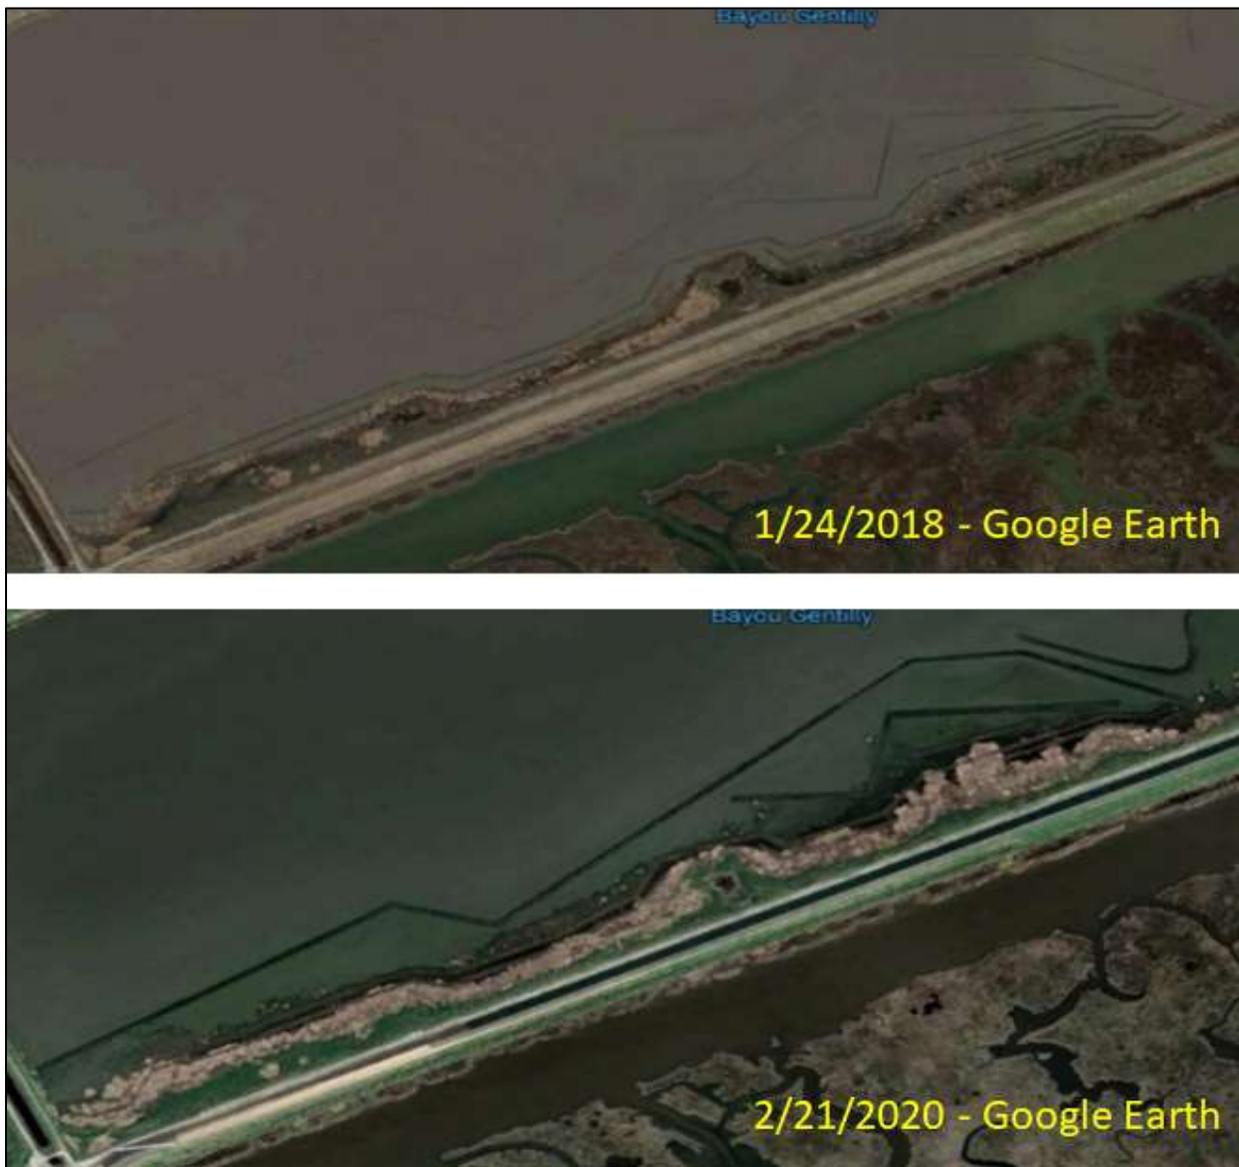
Figure XVII-10. Google Earth imagery of the LA-0039 Year 6 Gentilly Unit – West. In the 2018 imagery, the transects closer to the shoreline appear more robust. In the 2020 imagery, all transects appear densely vegetated, and natural marsh has expanded inwards from the perimeter of the Gentilly Unit, merging with the more southern planted transects.

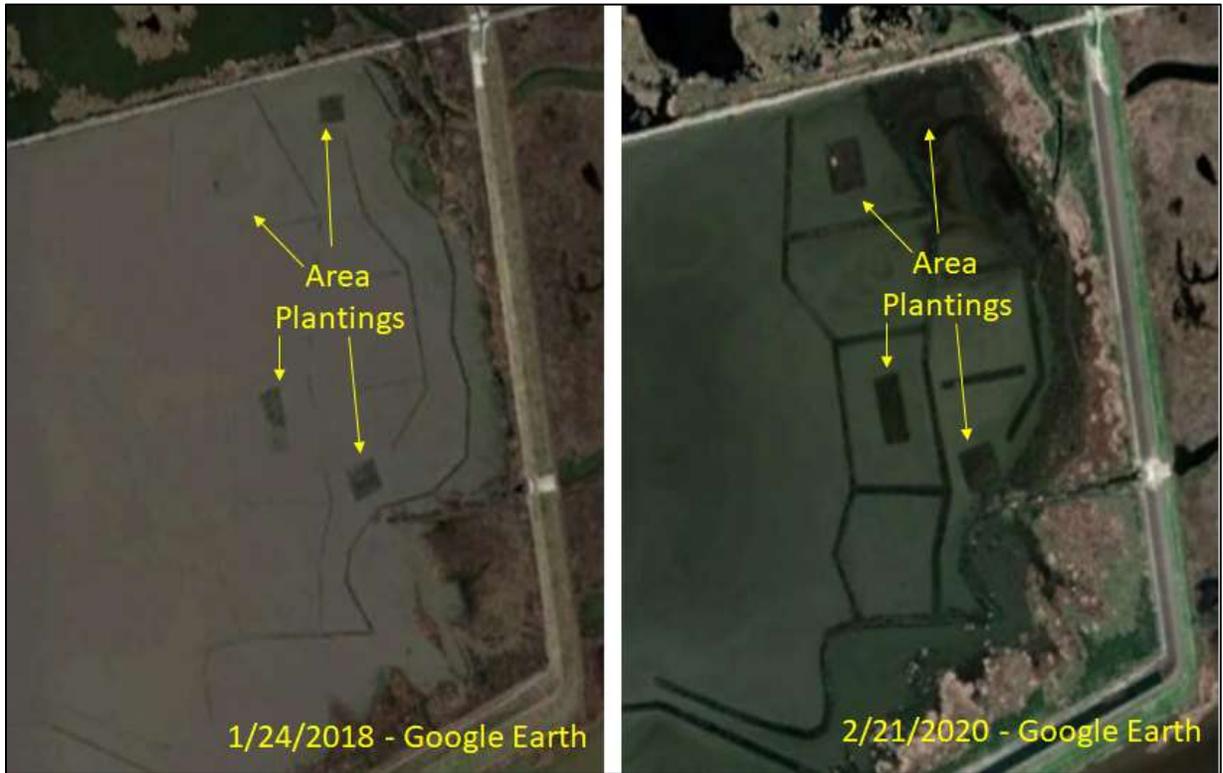
Figure XVII-11. Google Earth imagery of the LA-0039 Year 6 Gentilly Unit – East. In the 2018 imagery, the double-row transects and area plantings closer to the shoreline appear more robust. In the 2020 imagery, all double-row transects and planting areas appear densely vegetated and natural marsh has expanded inwards from the perimeter of the Gentilly Unit.

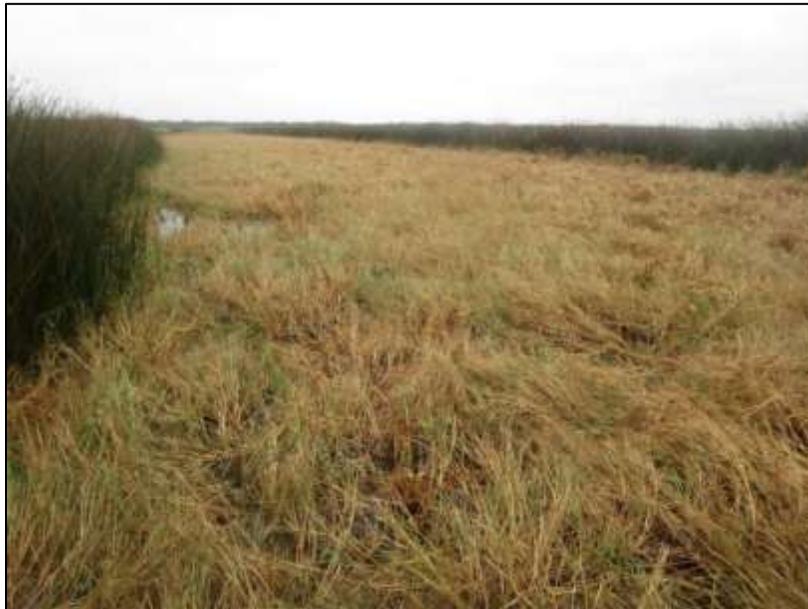
Figure XVII-12. Natural marsh habitat expansion between planted *S. californicus* transects, as photographed during the October 26, 2018 vegetation survey.

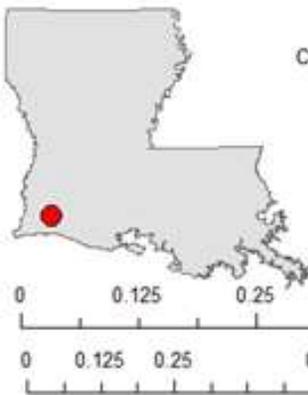
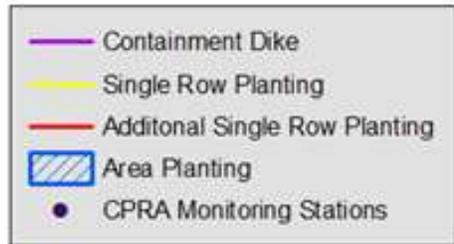
Figure XVIII-1. LA-0039 Year 6 Site – Sabine Unit 1 Overflow site map showing planting areas, planting strategies and vegetative monitoring stations.

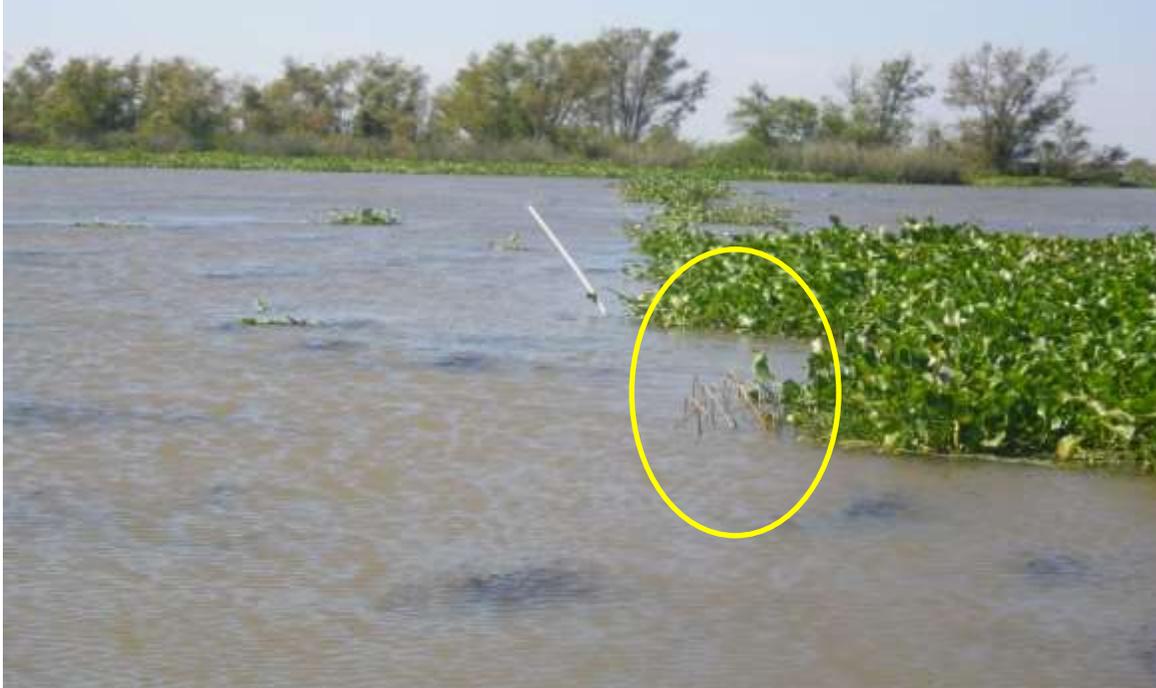
Figure XIX-3. *Schoenoplectus californicus* plantings (yellow circle) in LA-0039 Year 6 The Jaws 2 Central zone were already severely affected by rafting from *E. crassipes* rafts by October 2018.

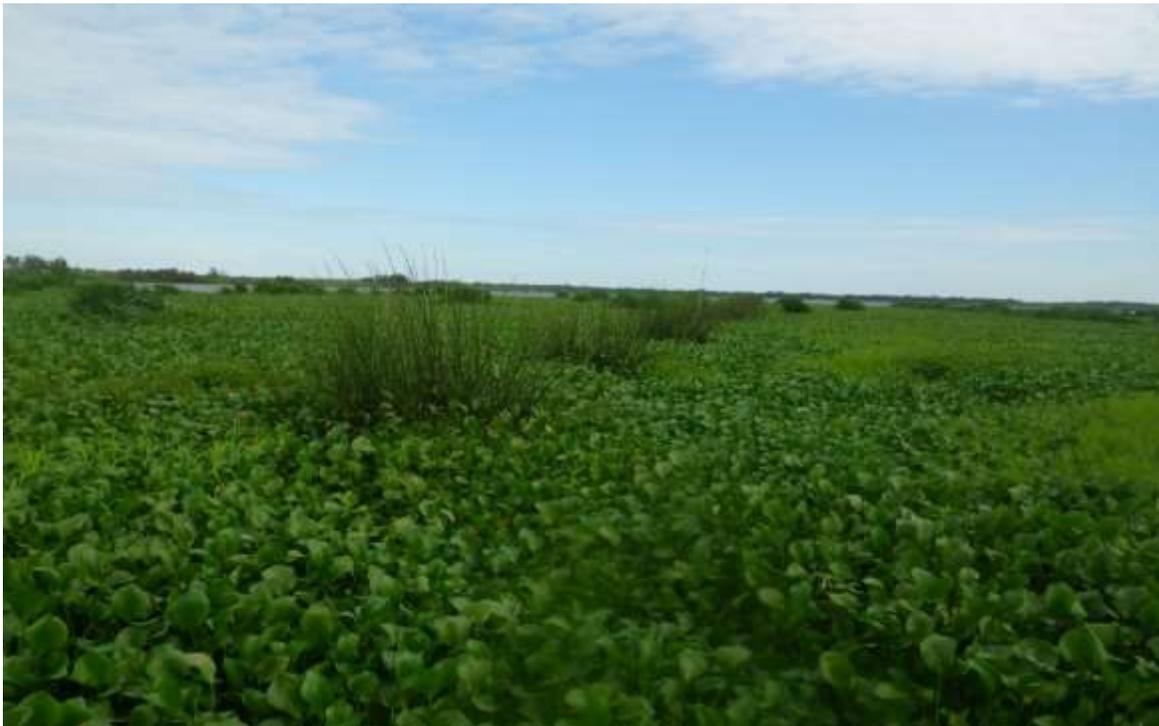
Figure XIX-4. View of cluster plantings at LA-0039 Year 6 The Jaws 2 Central zone in October 2018; *Z. miliacea* is in the center, and *S. californicus* are off to the left and right in the distance. This was representative of some zones which were completely covered with *E. crassipes* among other floating aquatics.

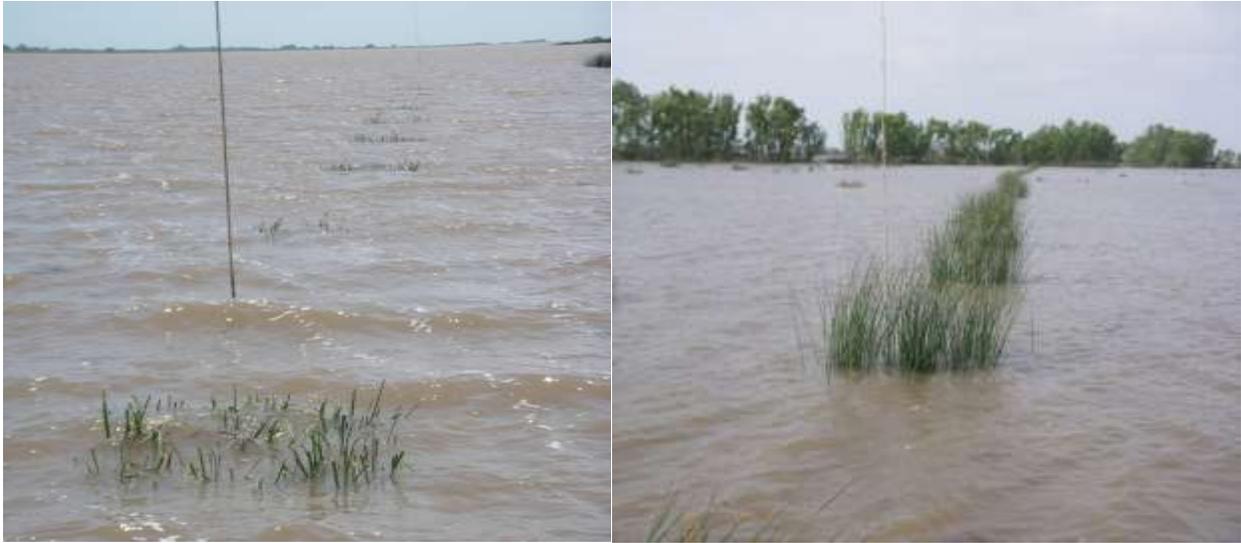
Figure XIX-6. Typical view of nine plant cluster plantings at LA-0039 Year 6 The Jaws 2 North zone in May 2018 (planted in Oct 2017); *Z. miliacea* is on the left and is notably shorter than *S. californicus* under high water conditions.

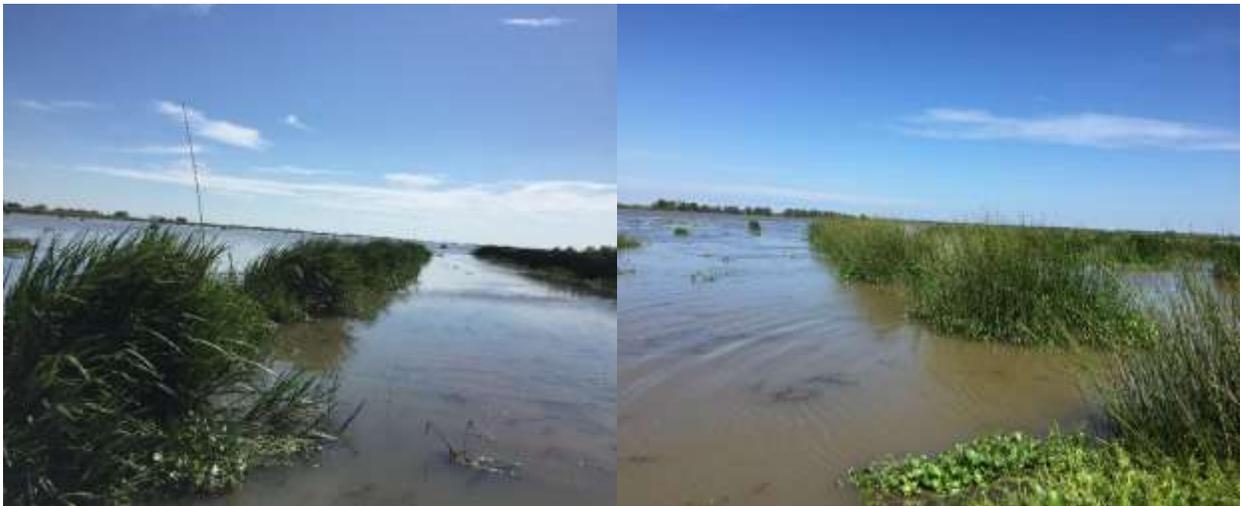
Figure XIX-7. Typical view of nine plant cluster plantings at LA-0039 Year 6 The Jaws 2 North in Oct 2018 (planted Oct 2017). *Z. miliacea* is on the left and is similar in stature to *S. californicus*; both have experienced substantial growth over the 2018 growing season.

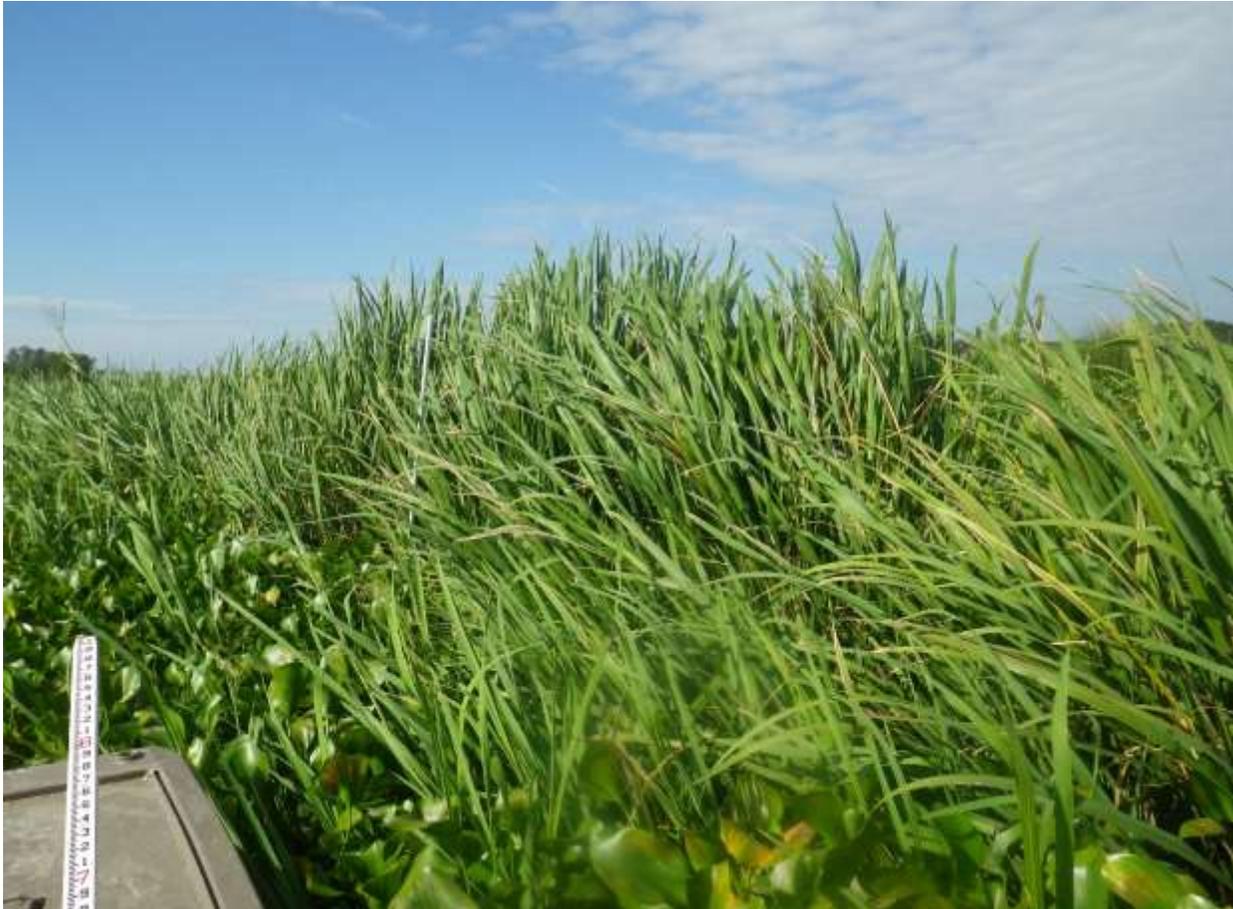
Figure XIX-9. In some LA-0039 Year 6 The Jaws 2 locations (East Zone pictured), *Zianiopsis miliacea* 16-plant clumps were growing out away from the monitoring station and becoming contiguous with naturally occurring stands of the same species by October 2018. They could start to build elevation and recruit emergent vegetation if the plants can withstand the *Eichornia crassipes* rafts during the winter months.

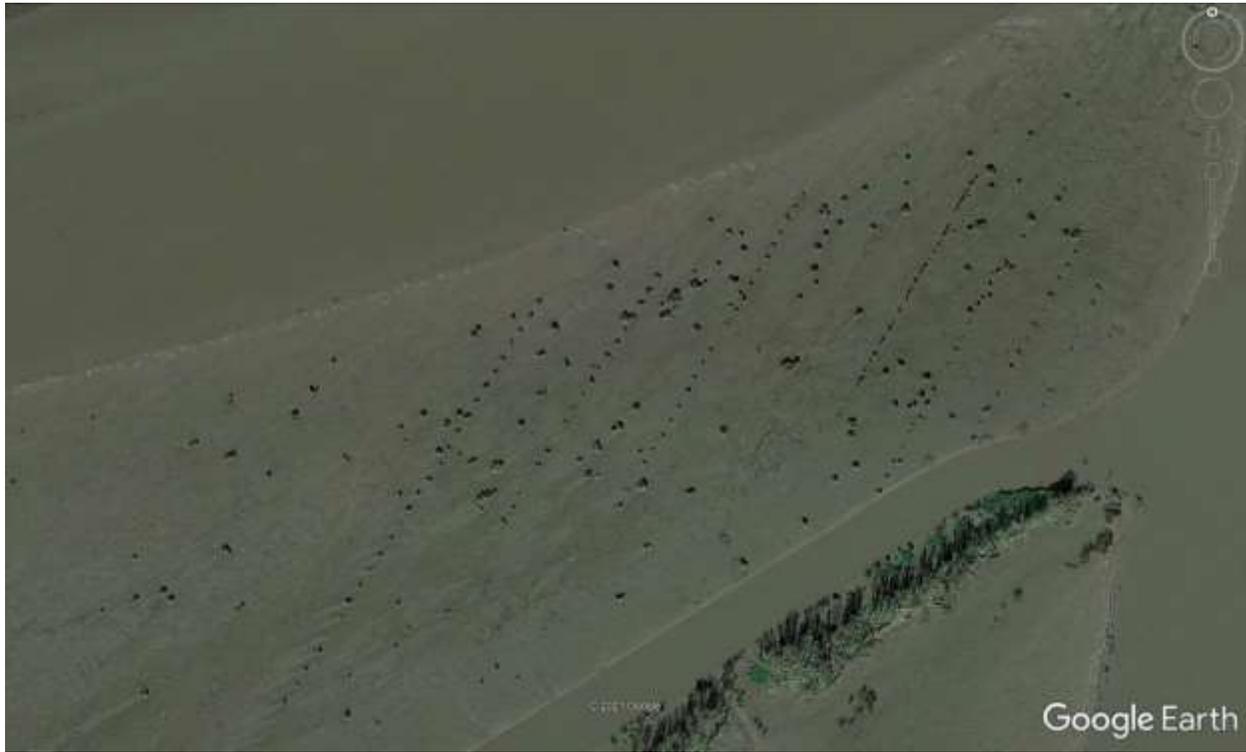
Figure XIX-11. Google Earth imagery for the LA-0039 Year 6 The Jaws 2 on 11-16-2020 North zone.

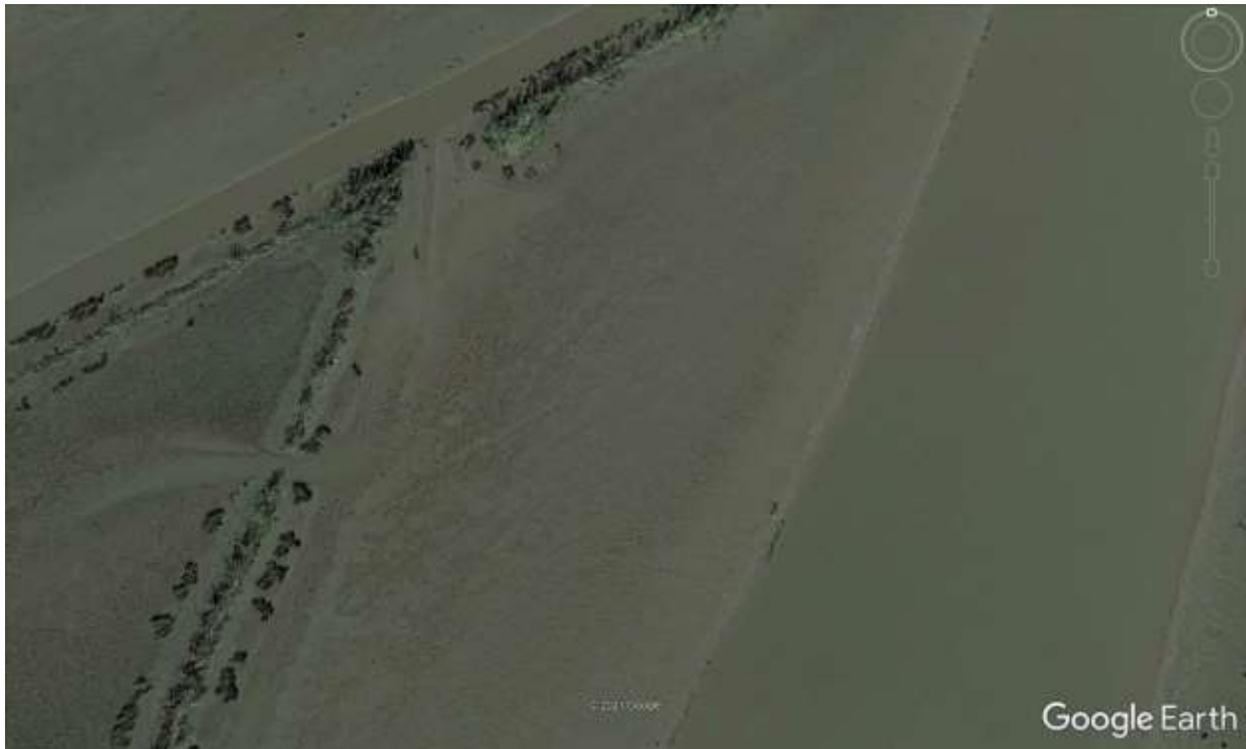
Figure XIX-12. Google Earth imagery for the LA-0039 Year 6 The Jaws 2 on 11-16-2020 Central zone.

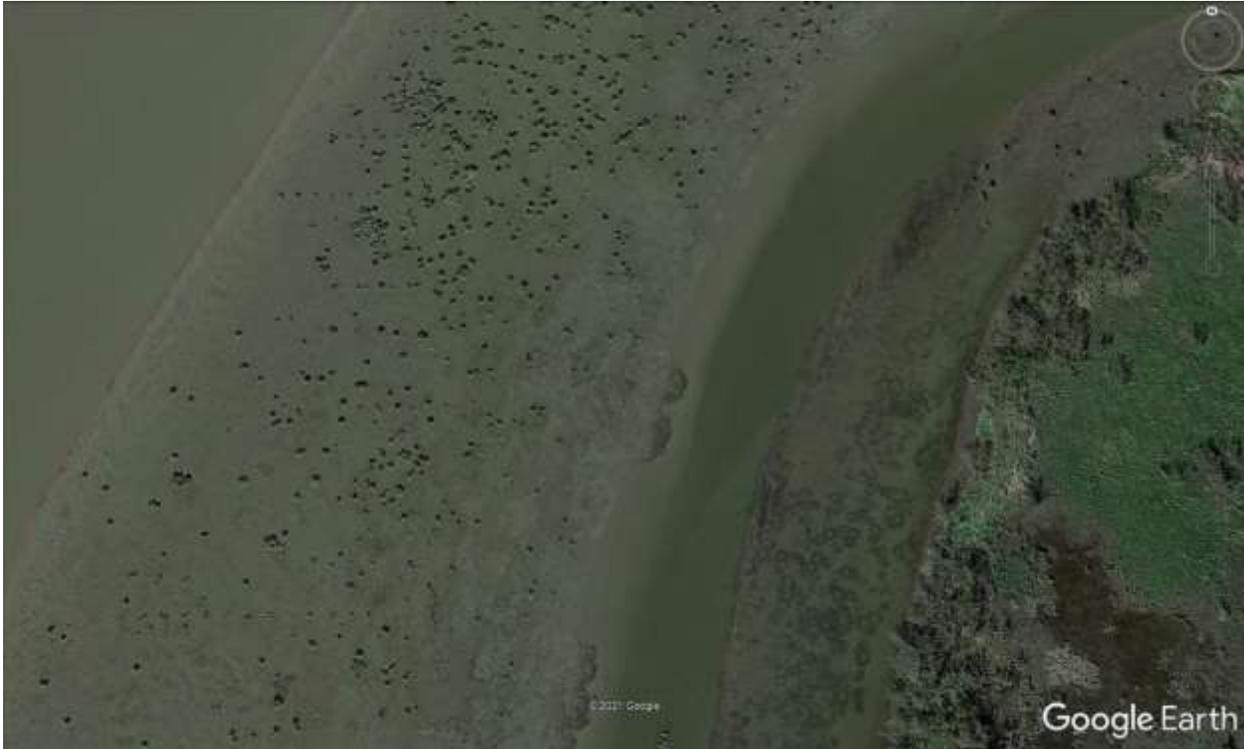
Figure XIX-13. Google Earth imagery for the LA-0039 Year 6 The Jaws 2 on 11-16-2020 East zone.

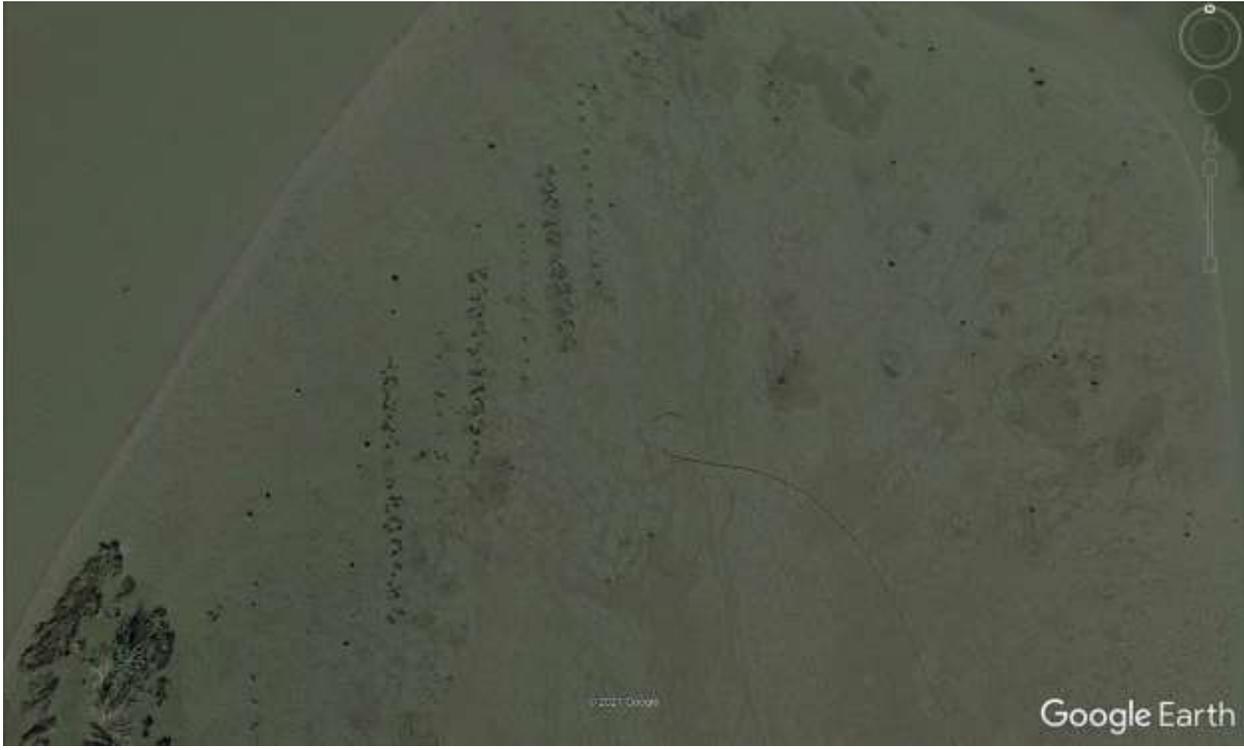
Figure XIX-14. Google Earth imagery for the LA-0039 Year 6 The Jaws 2 on 11-16-2020 South zone.

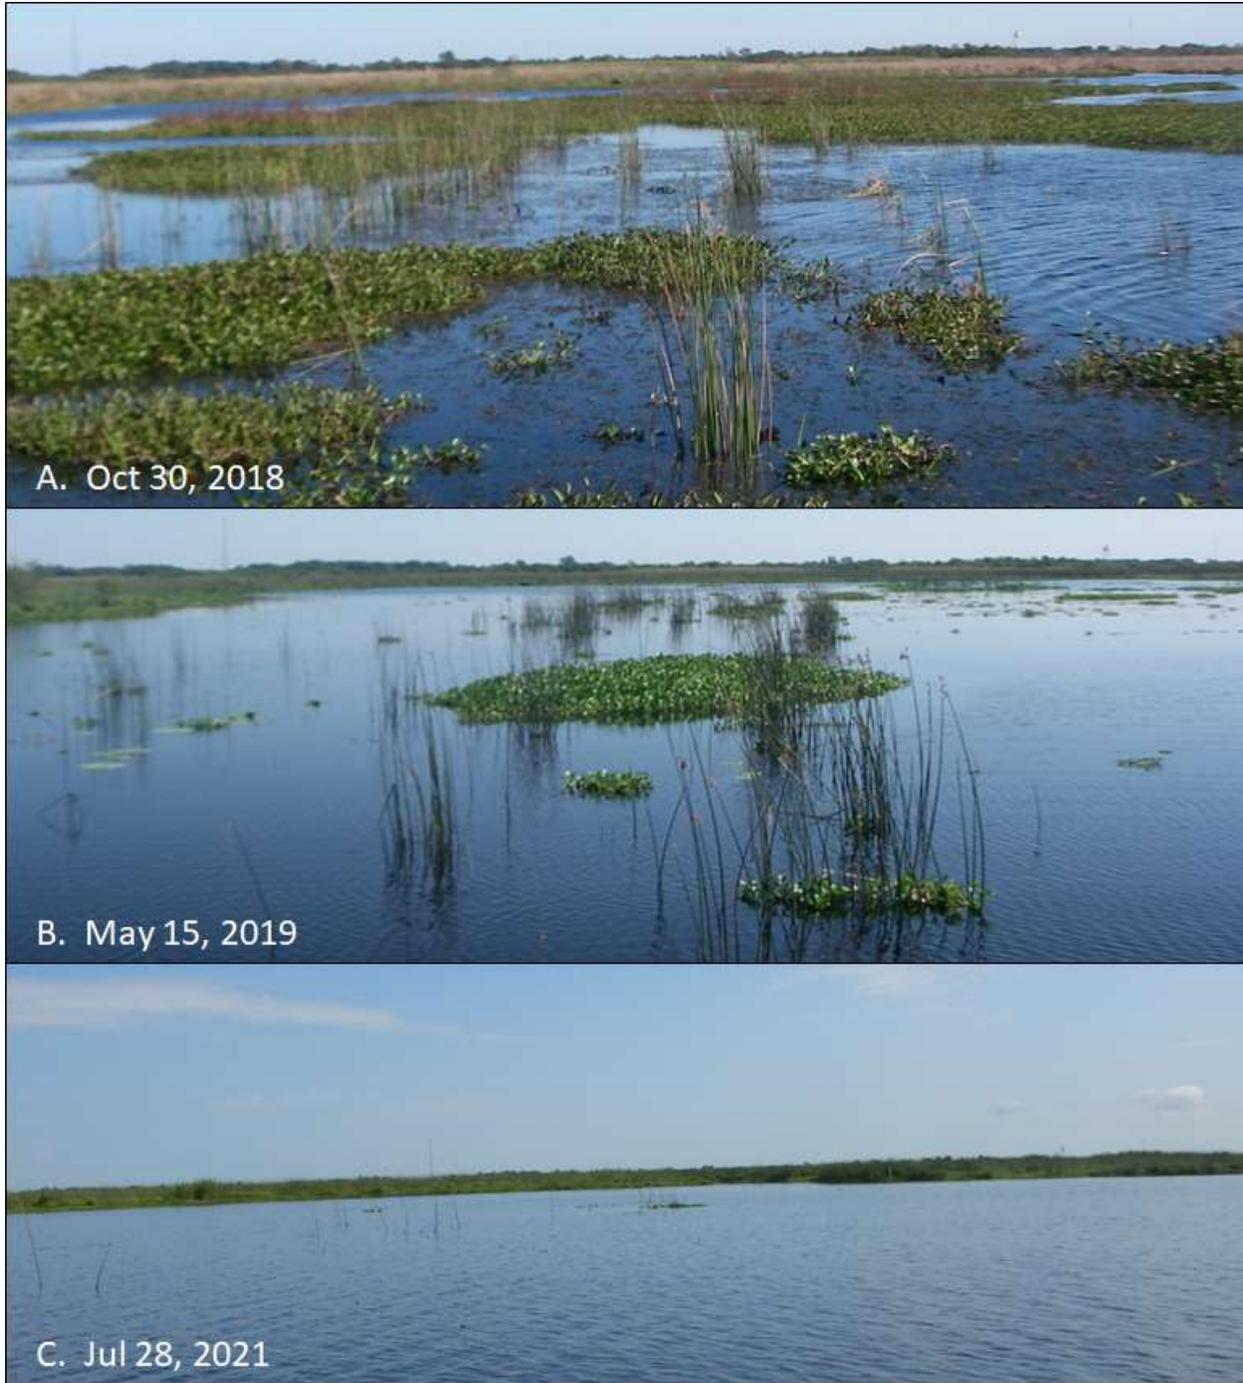
Figure XX-2. Photo comparison of a typical Area Planting at LA-0039 Year 6 Willow Lake 2 five to six months (A), one year (B), and three years after installation. Note the heavy rafting by floating aquatics in October 2018 (A).
