2021 Operations, Maintenance, and Monitoring Report

Coastwide Vegetative Planting Project (LA-0039)

State Project Number LA-0039
Priority Project List 20

September 2021

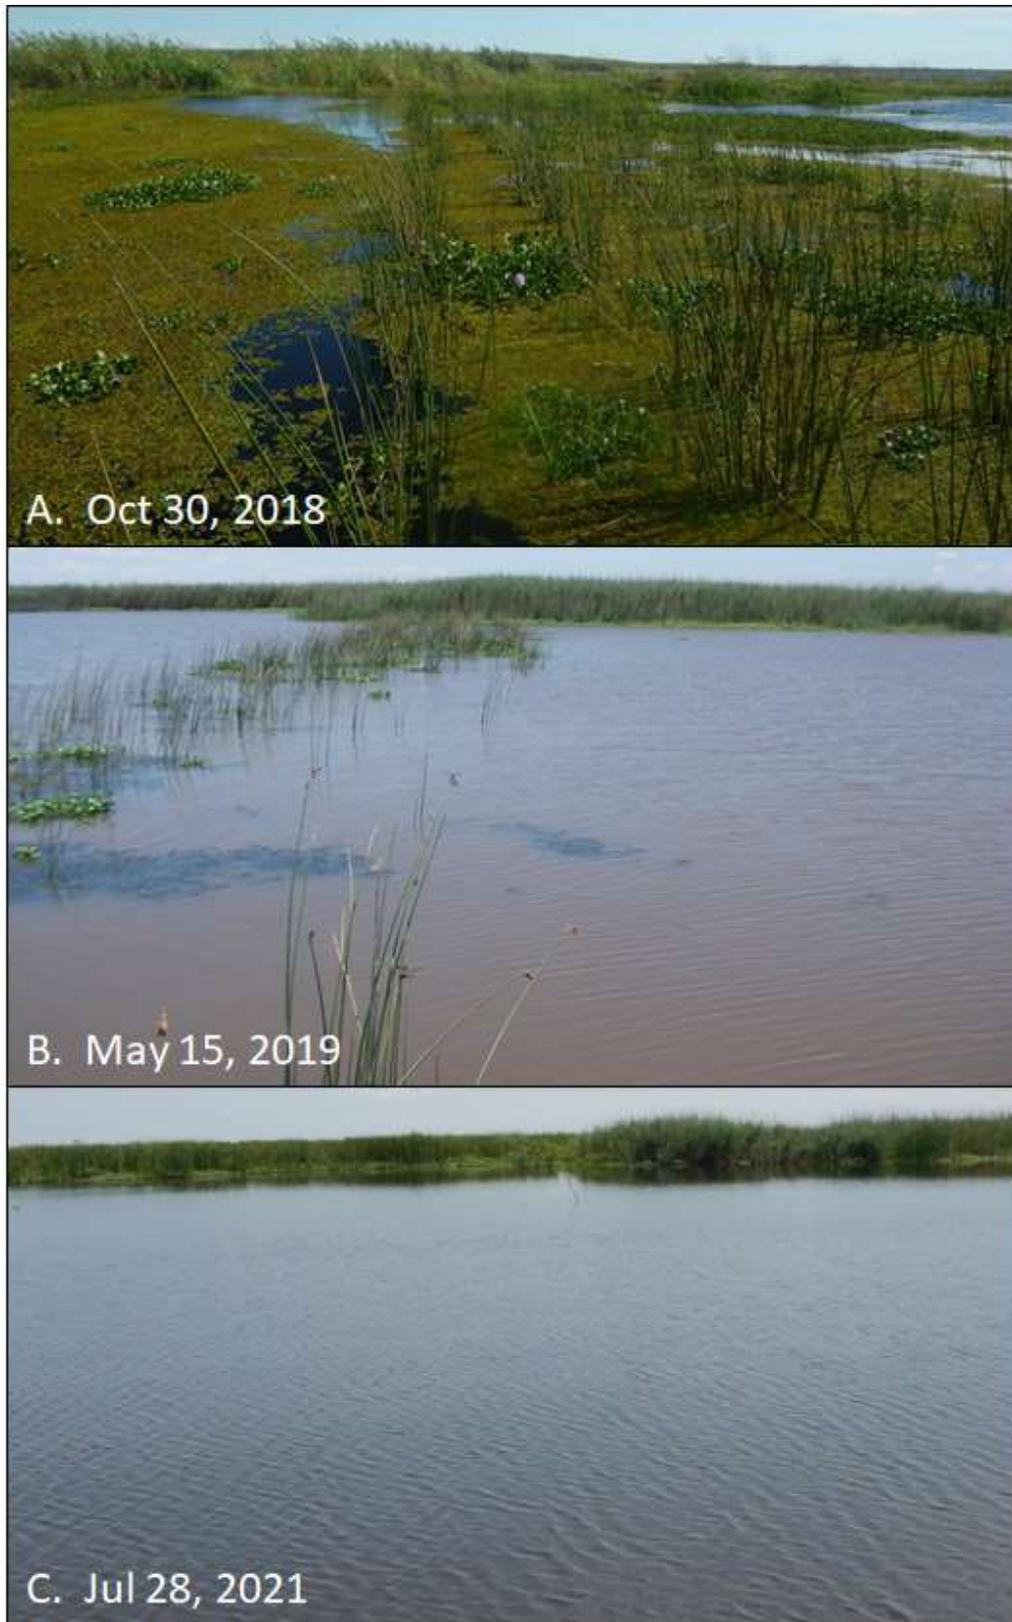
Figure XX-3. Photo comparison of a typical Hedgerow Planting at LA-0039 Year 6 Willow Lake 2. Note the heavy rafting by floating aquatics in October 2018.

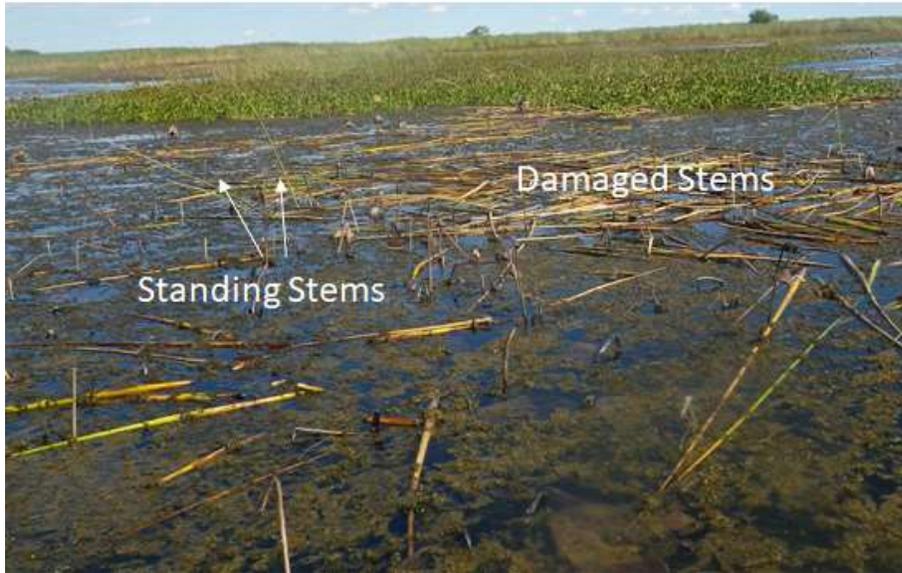
A combination of factors contributed to the lack of planting expansion in LA-0039 Year 6 Willow Lake 2. The water bottoms in the Willow Lake area are highly organic, unconsolidated, weak soils, as evidenced by the failed terraces at CS-11b (Miller and Guidry 2011), and provide a weak foundation for plantings. Sustained high water levels detailed in LA-0039 Year 3 Willow Lake (see Chapter X.B.3.b. Hydrology and c. Planting Failure/Success Causation) from COE management of the area for agricultural irrigation purposes provides stressful water-level conditions for new plants; the plantings are typically in at least 2.5 – 3.0 ft of water. As a point of reference, during the May 2019 monitoring trip, naturally occurring *S. californicus* coming out from the marsh stopped at ~1.2 ft deep and some cutgrass (*Zizaniopsis miliaceae*) stopped at 2 ft deep, whereas planted vegetation averaged 3.5 ft deep. In addition, high densities of floating and submerged aquatic vegetation created rafts of vegetation (Figure XX-2 and 3) that physically battered the plantings soon after planting. Also, mammalian (typically muskrat or nutria) herbivory was noted in the eastern-most area plantings during Oct 2018 monitoring trip (Figure XX-5).

Figure XX-5. Herbivory (typically muskrat or nutria) damage of *Schoenoplectus californicus* (California bulrush) plantings in the East Area site of LA-0039 Year 6 Willow Lake 2 was photographed in October 2018, about eight months after planting. Also note the submerged and floating aquatic vegetation which forms rafts that also damaged the plantings.

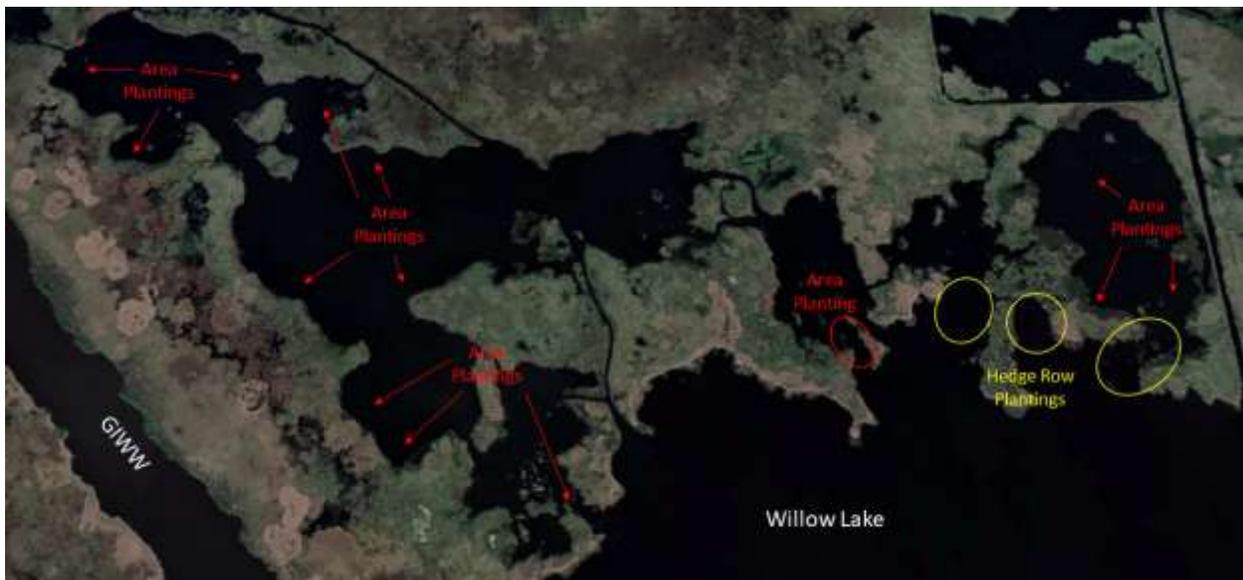
More marsh around LA-0039 Year 6 Willow Lake 2 was converted to open water and opened up to Willow Lake after Hurricanes Laura and Delta in 2020. No plantings were observable in the post hurricanes aerial imagery from September 2020, and breaches from Willow Lake formed in vulnerable areas where a couple of area plantings were installed (Figure XX-6). The already weakened plantings were susceptible to removal by the hurricanes. This observation was confirmed during the three-year post construction monitoring in July 2021; however, whether or not the plantings had survived by the 2020 hurricane season is unknown.

Figure XX-6. Aerial imagery from Google Earth shows that more of the marsh around LA-0039 Year 6 Willow Lake 2 was converted to open water and opened up to Willow Lake following the 2020 Hurricane season (see Figure XX-1 for comparison to 2018). The imagery is dated as 09/28/2020.

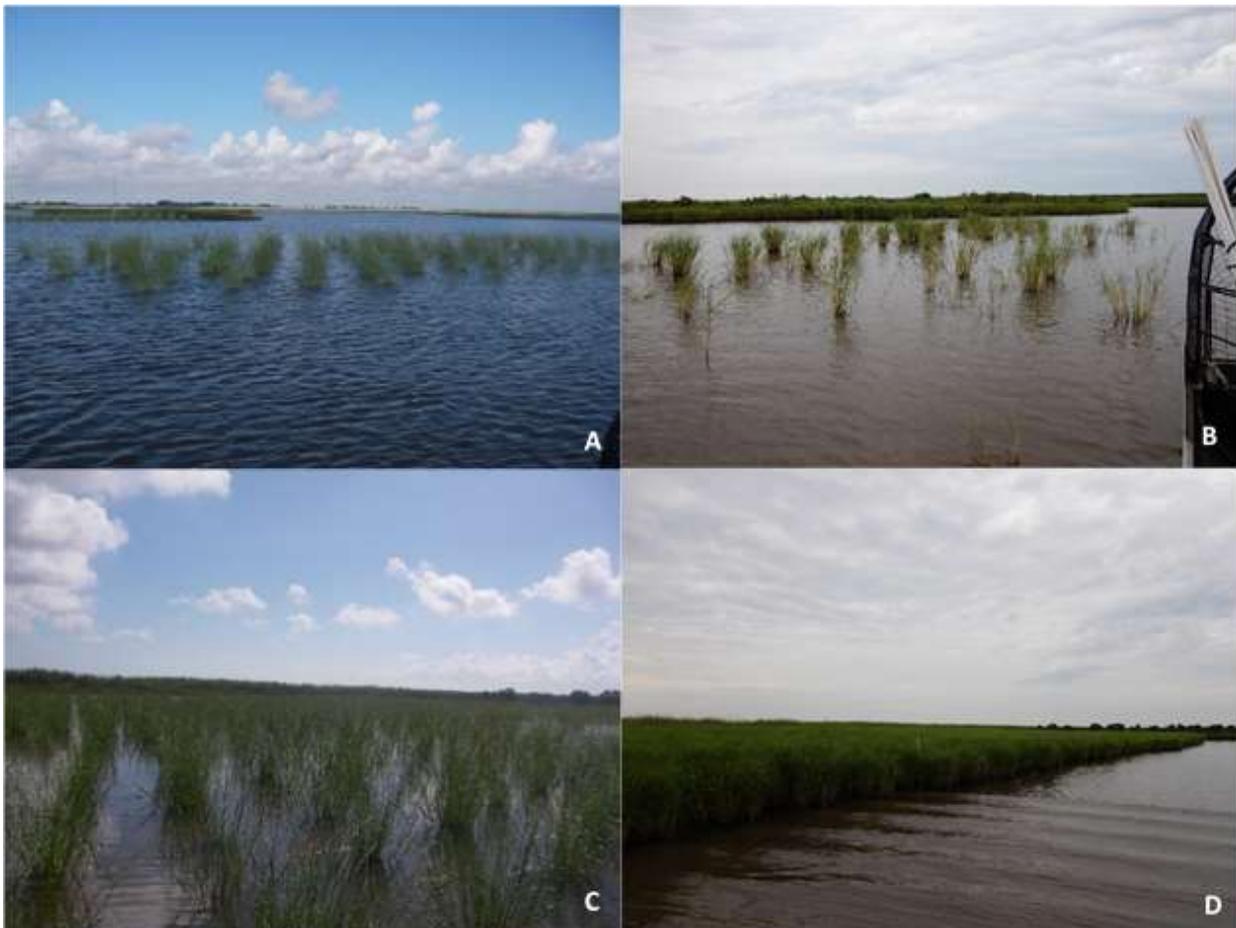
Figure XXI-5. Photos of *Spartina alterniflora* Areas 1 and 2 plantings in 2018 (A), Area 3 plantings in 2019 (B), Area 4 plantings in 2018 (C) and 2019 (D) at LA-0039 Year 6 Belle Isle Lake.

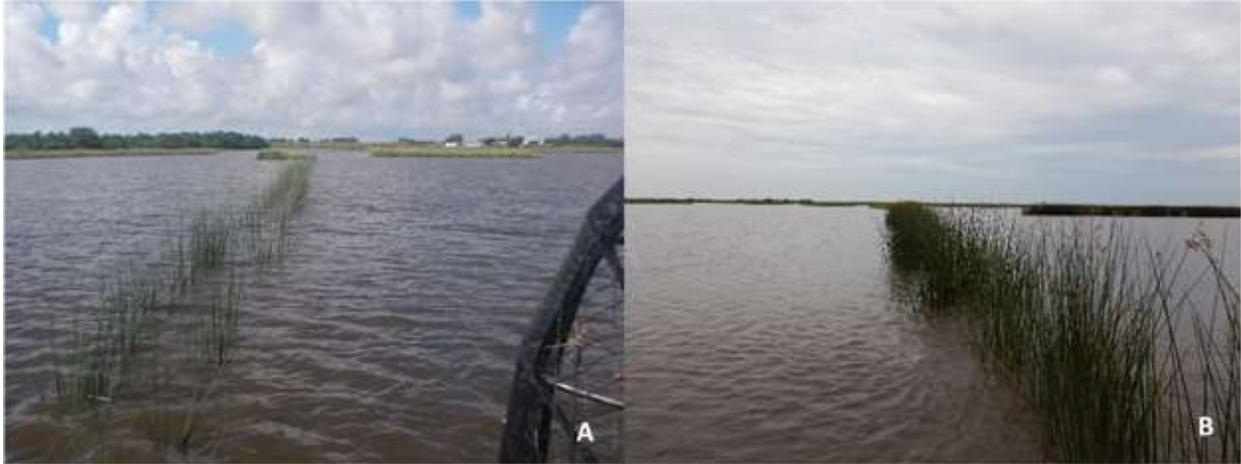
Figure XXI-6. Photos of *Schoenoplectus californicus* Double Row plantings in 2018 (A) and 2019 (B) at LA-0039 Year 6 Belle Isle Lake.

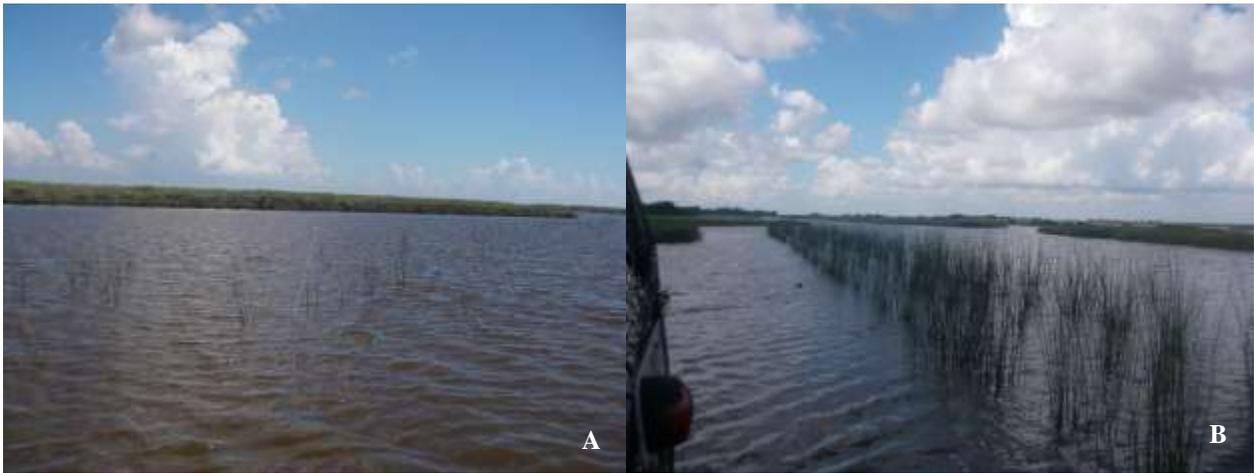
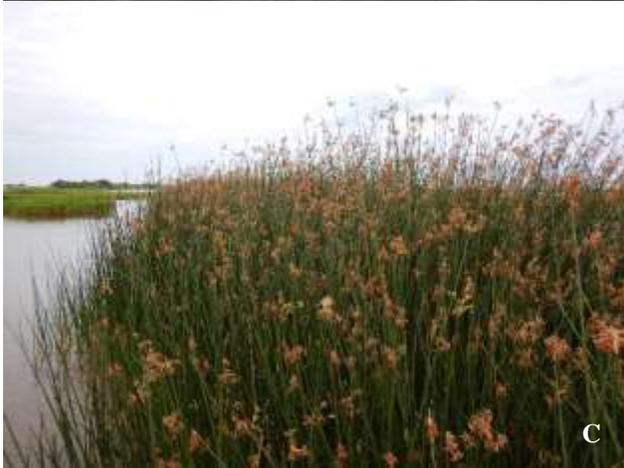
Figure XXI-7. Photos of *S. californicus* Five Row Plantings in 2018 at northwestern corner of project area (A), southern part of project area in 2018 (B), and southern part of project area in 2019 (C) at LA-0039 Year 6 Belle Isle Lake.

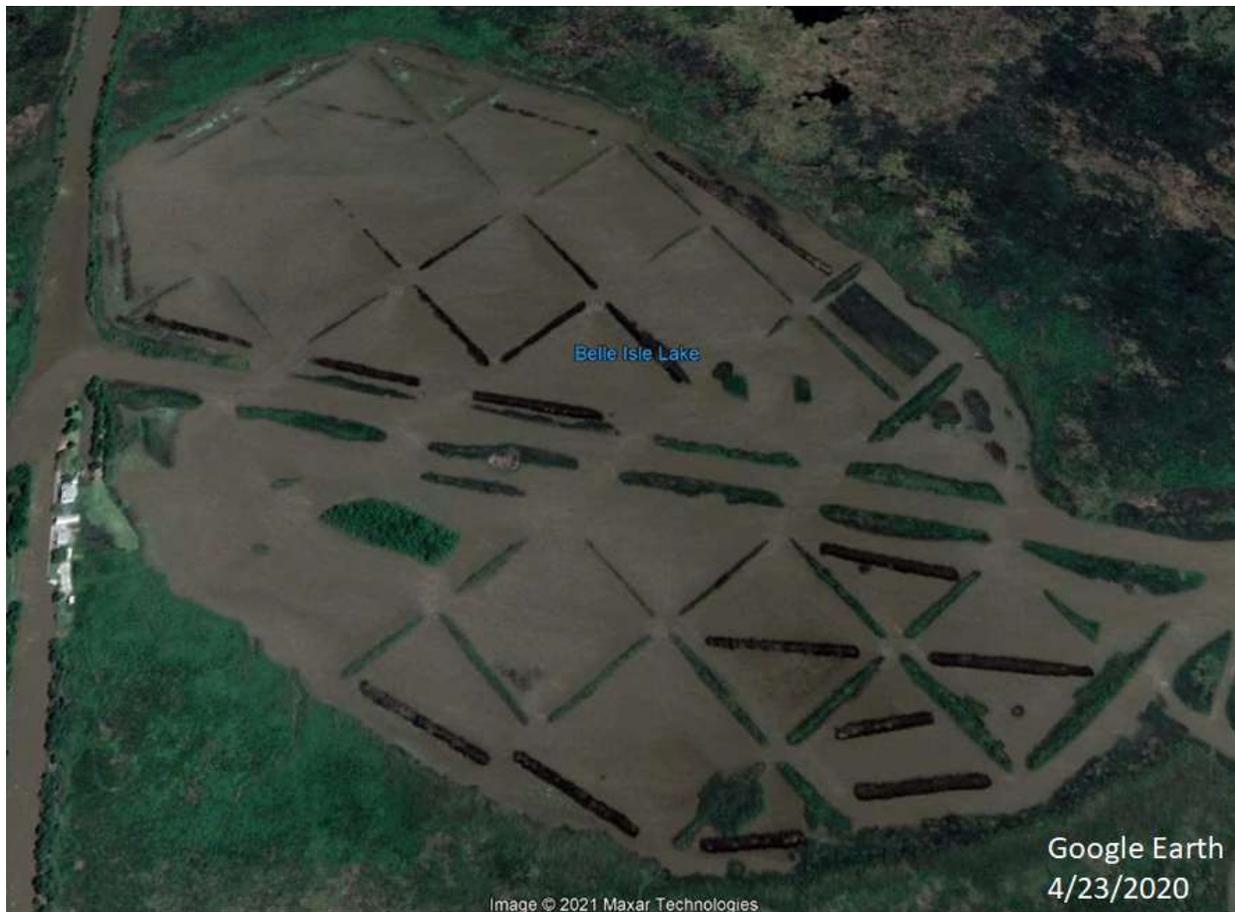
Figure XXI-9. Aerial imagery taken almost two (2) years after planting of LA-0039 Year 6 Belle Isle Lake shows the robust row (*Schoenoplectus californicus*) and area (*Spartina alterniflora*) plantings in shallower water and less robust, stressed plantings in deeper water. See site map for planting layouts (Figure XXI-1).

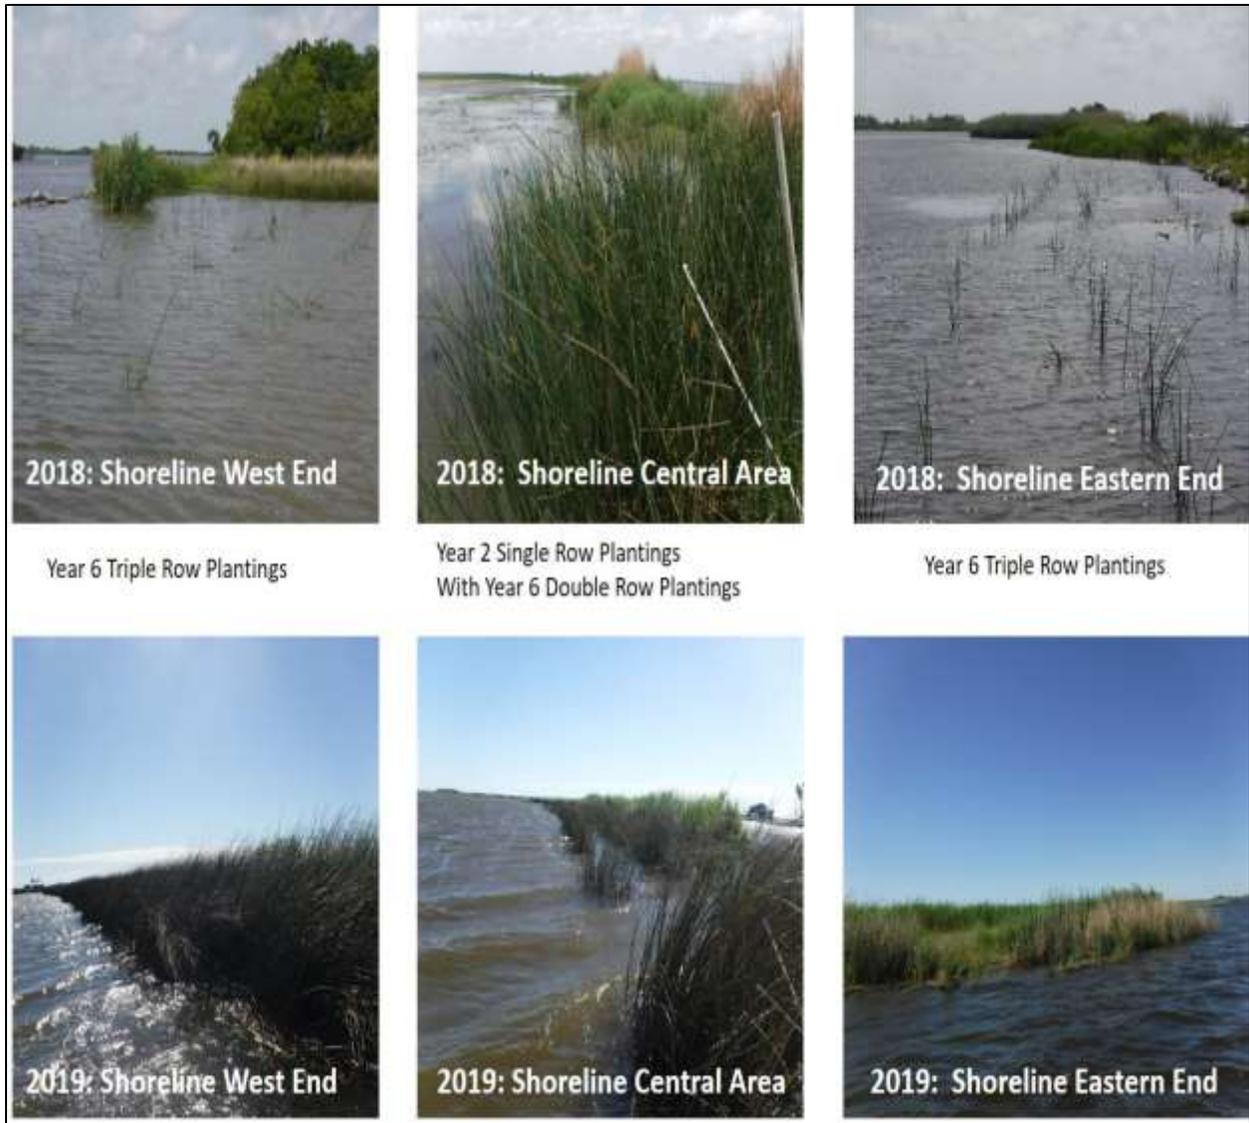
Figure XXII-6: Year 2 (installed fall 2016) and Year 6 (installed spring 2018) plantings were photographed in 2018 and 2019 at the Section 2 interior shoreline plantings north of Bayou DeCade at the LA-0039 Year 6 DeCade Vicinity plantings.

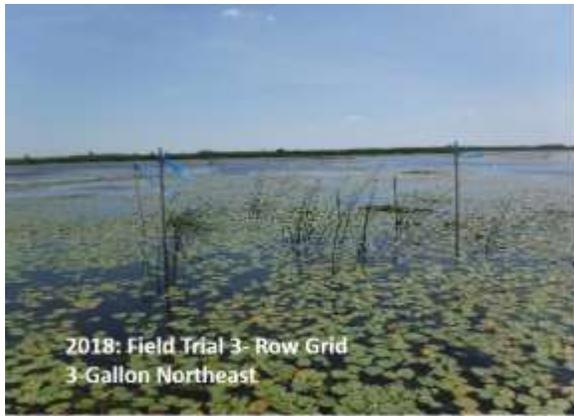
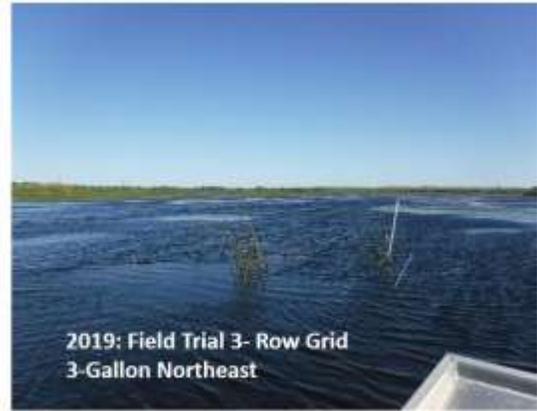
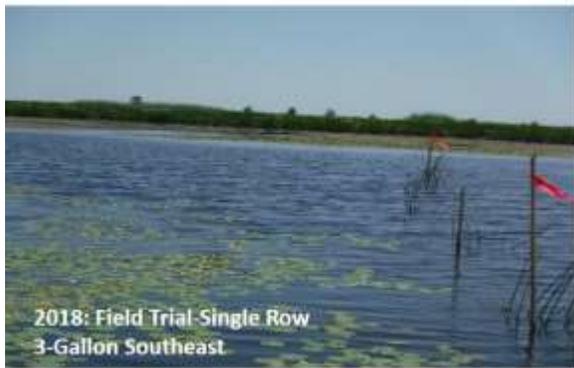
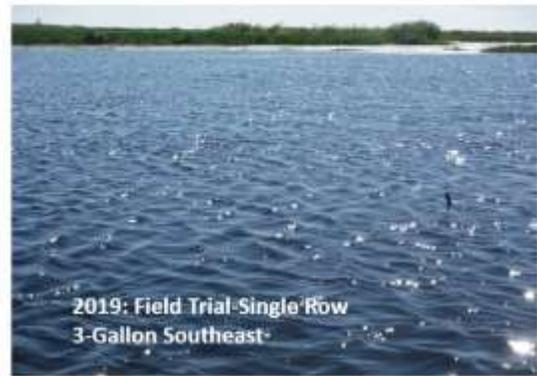
Figure XXII-12. Year 6 DeCade Vicinity 3-gallon field trial plantings for the data collection periods in 2018 and 2019.

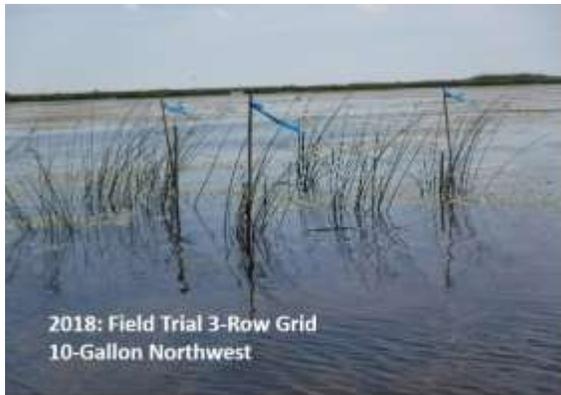
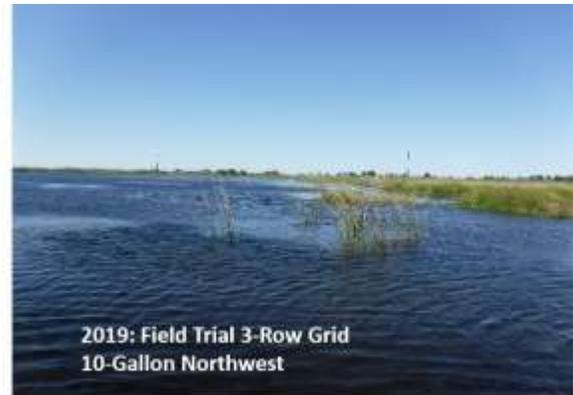
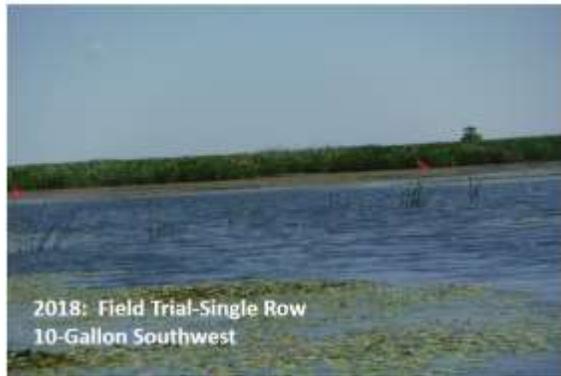
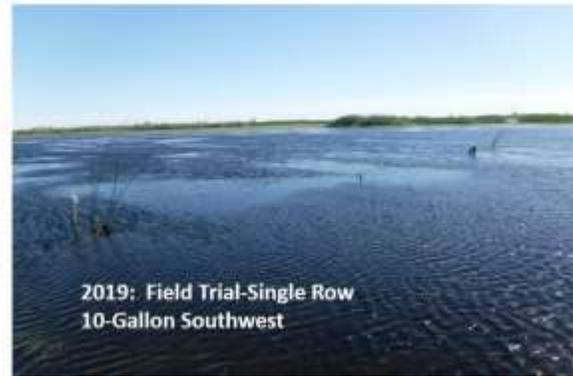
Figure XXII-13. Year 6 DeCade Vicinity 10-gallon field trial plantings for the data collection periods in 2018 and 2019.

Larger-sized *S. californicus*, grown in 3- or 10-gallon sized containers, tolerated deeper (3+ ft) planting conditions than the standard depth maximum of 2 ft. Surprisingly, the 3-gallon plants have outperformed the 10-gallon plants, but the reason is unknown. 3-gallon plants would be less expensive and easier to handle.

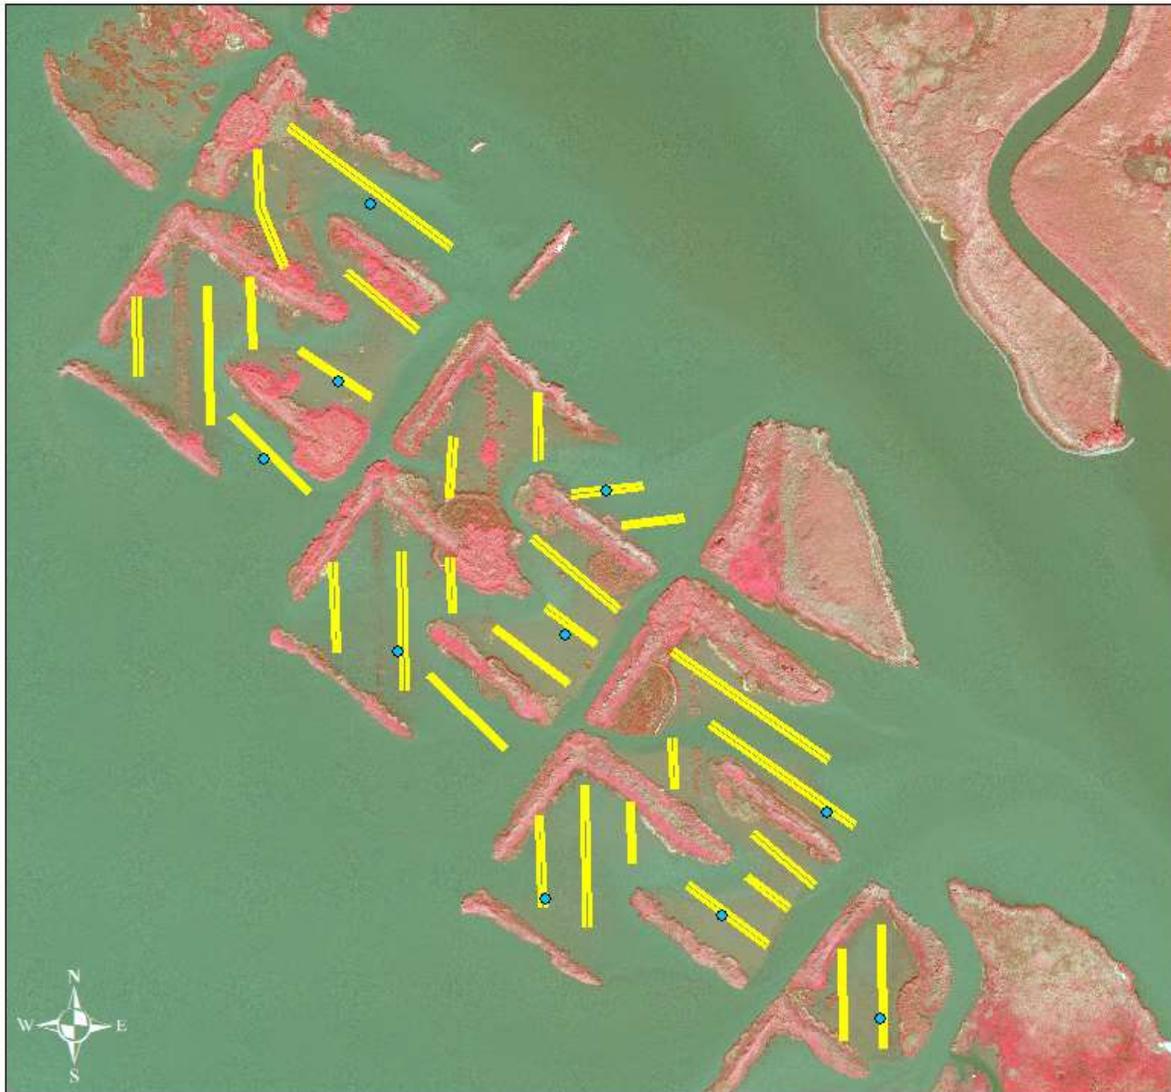
LA-0039 Year 7 Site - Little Vermilion Bay 2 (East Site)

Figure XXIII-1. LA-0039 Year 7 Little Vermilion Bay 2 planting sites overview map showing location of plantings and vegetative monitoring stations. All plants were trade-gallon sized.

- East Site Double Row Planting *Schoenoplectus californicus*
- Vegetation Station

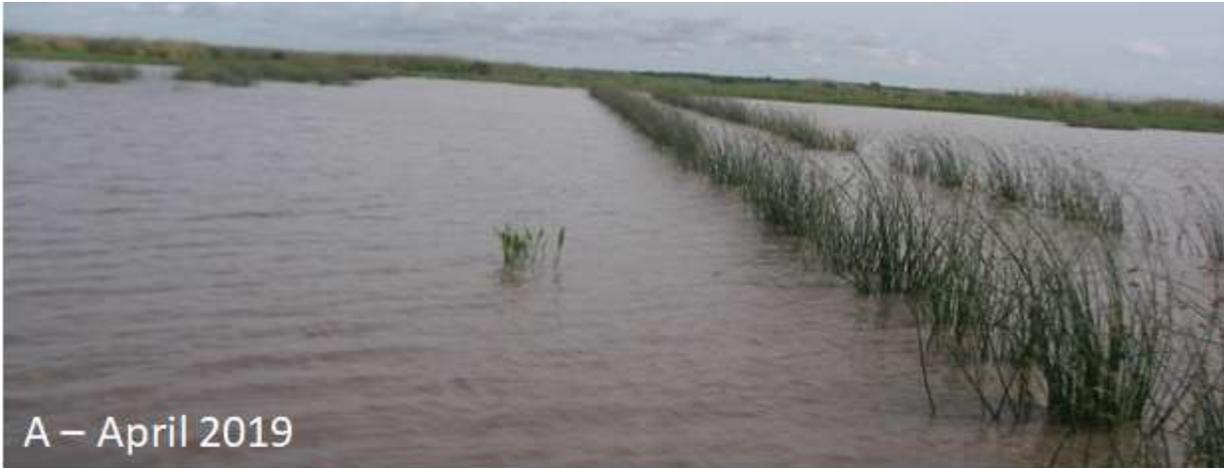
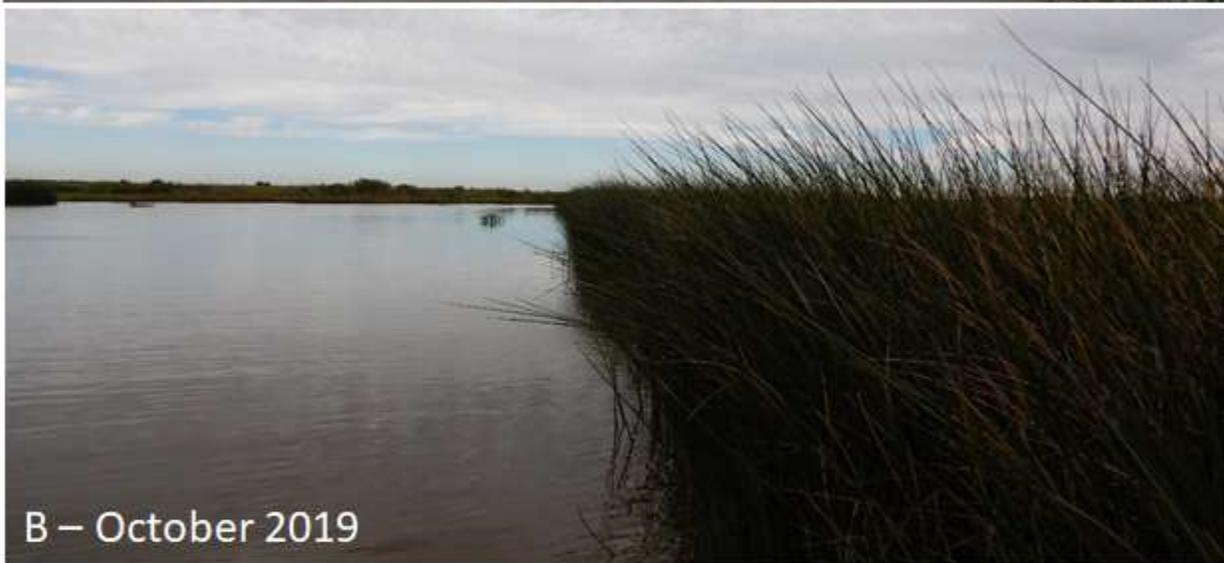
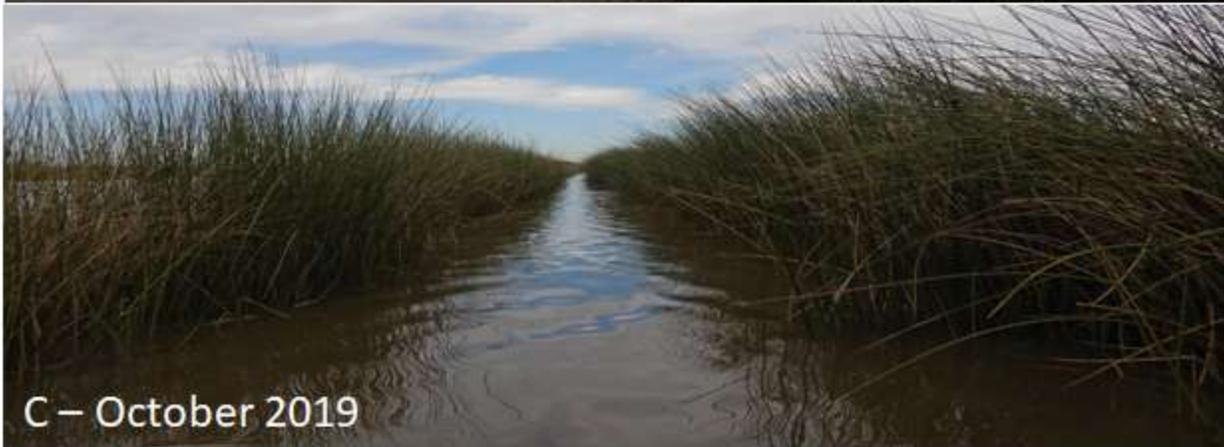
Figure XXIII-5. View of a more protected double row across an expansive tidal flat in LA-0039 Year 7 Little Vermilion Bay 2 East about six months (A – April 2019) and a year (B and C - October 2019) after planting. C is looking down the center of the double row a year after planting.

In terms of total percent cover at vegetation stations after one year, the LA-0039 LVB 2 West plantings (~55% cover) have generally outperformed the East plantings (~40 %); the West has area plantings in addition to double row plantings and is generally more protected from wave and wake damage (Fig. XXIII-6A). The 20% increase of cover in the West is impressive in the aftermath of Hurricane Barry. Percent cover of the East stations has remained stable from the April to October 2019 sampling (Fig. XXIII-6A). The area plantings, which tend to rapidly grow together (27 % increase of cover) forming dense stands of *Schoenoplectus californicus*, were planted less densely (alternating 10 ft centers) than the double rows (alternating 5 ft centers) and, therefore, had greater potential for increasing cover (Fig. XXIII-6B). The double row planting had a slight percent cover increase but given the error around the means should be considered to have remained stable during the 2019 growing season at approximately 45% (Fig. XXIII-6B). Some of both types of planting arrangements were experiencing significant intraspecific competition at the end of one growing season, even though spacing on the area plantings had been increased over previous efforts. As the plants continue to grow, other emergent marsh species will likely recruit to the area as has happened in the previous LVB planting (Figs. XXIII-4 and 5).

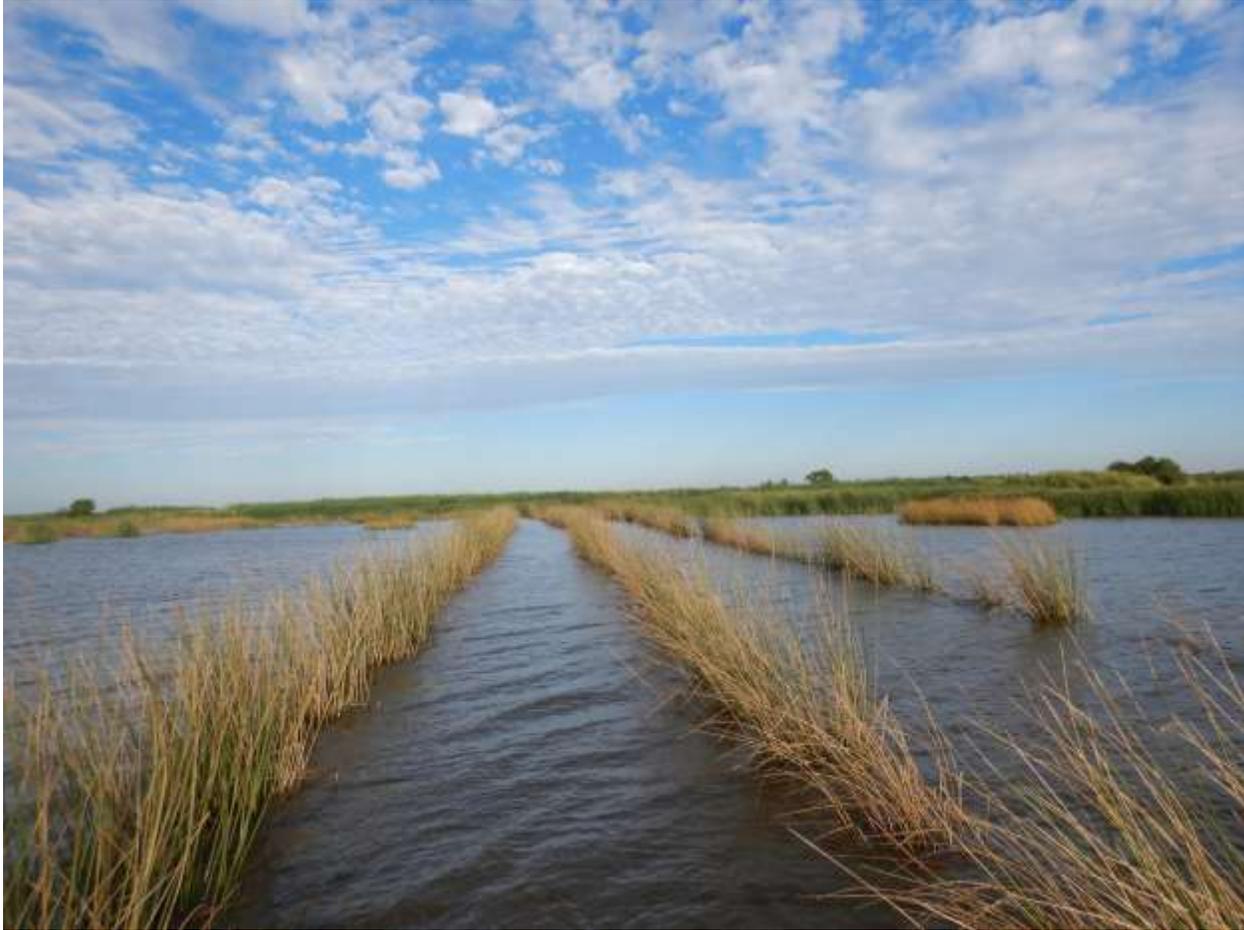
Figure XXIII-8. Image of a LA-0039 Year 7 Little Vermilion Bay 2 East planting (double row with an additional row of auxillary plants) taken as part of the monitoring effort in October 2019. Although still alive at the time of monitoring, some planted and naturally occurring vegetation in the East suffered damage from wind and wave energy, presumably from Hurricane Barry.

As of the fall 2019 sampling effort, there was little in the way of systemic stress-related plant failures; however, there were abundant stressed individuals among the double rows on the Vermilion River Cutoff Canal side of the east planting area and physical damage to the north-south double row segments connecting the older double rows. The East double rows were damaged in large part due to the wind and surge produced in the area via Hurricane Barry; naturally occurring plants of various species also appeared damaged. These individuals were expected to recover as of the spring of 2020, but after two devastating tropical events in the fall of 2020, those expectations are tempered. A future sampling in the fall of 2021 will help to evaluate this planting's success or failure under these unprecedented conditions. The north-south double row segments in the West were damaged by floating debris, channelization, and boat traffic between the older Year 4 LVB double rows.
