2014 Operations, Maintenance, and Monitoring Report

Freshwater Bayou Canal Wetland Protection

State Project Number ME-04
Priority Project List 2

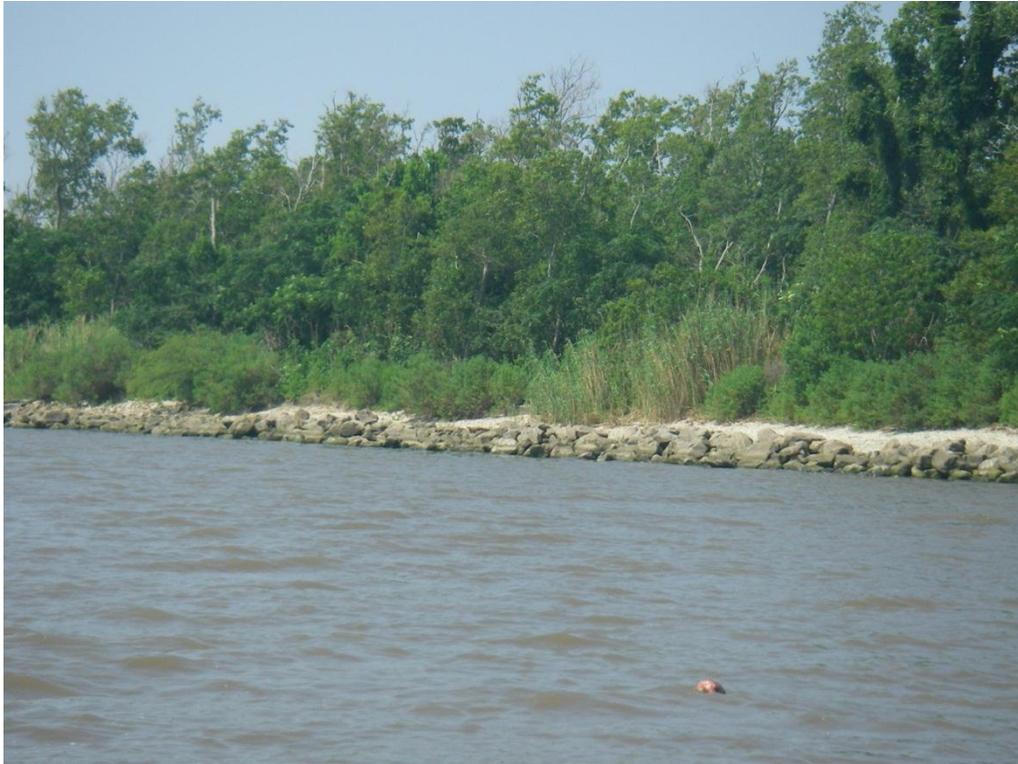
Photo No. 1, Typical Rock Dike

The inspection revealed the 11,420 linear feet of foreshore rock dike repaired in the 2005 maintenance project is in good condition. (Appendix A, Photos 1-3) The inspection noted numerous sections of foreshore rock dike that were below elevation 4.0 NAVD causing evident bank erosion. NRCS personnel previously performed a centerline profile survey of the foreshore rock dike along with cross-sections to determine the deficient reaches of the foreshore rock dike. Based on the surveys, NRCS and CPRA agreed to repair the deficient reaches of the foreshore rock dike to elevation 3.5' NAVD. Based on the survey information, NRCS computed the volume of rock required to cap the deficient reaches of the foreshore rock dike. CPRA utilized the information from NRCS to prepare cost estimates for an O&M Funding Increase Request to the CWPPRA Task Force in the fall of 2012. (Appendix A, Photos 4 - 6)

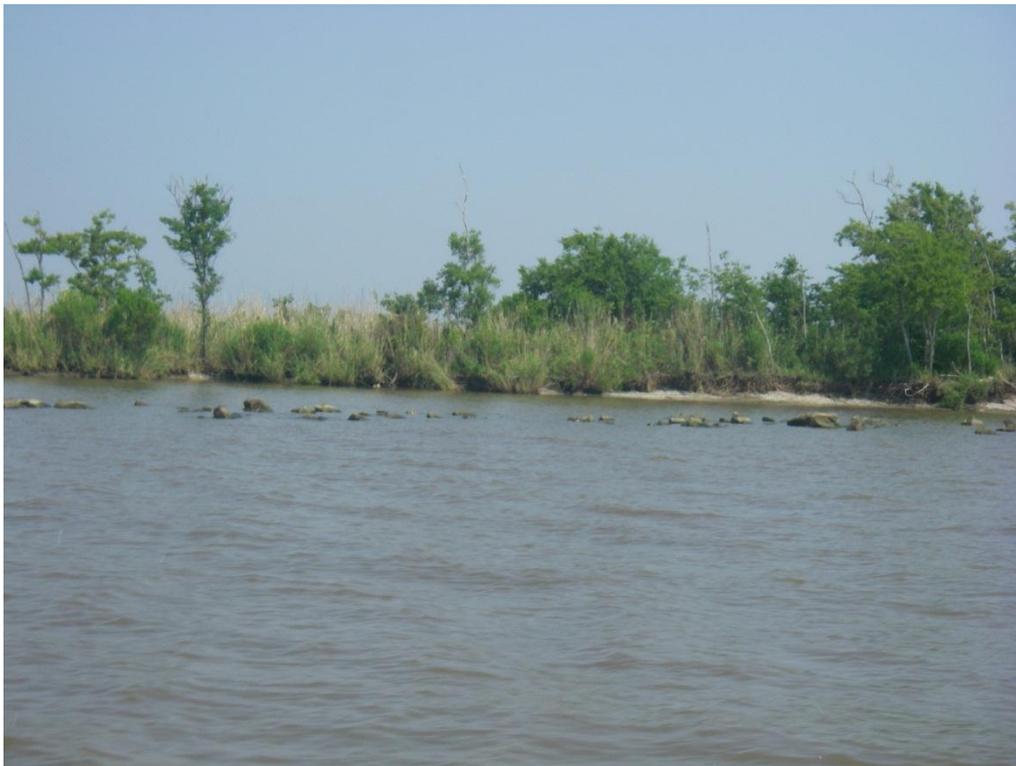
Photo No. 4, Low Areas in Rock Dike, Erosion of Bank

There are several sections of foreshore rock dike along Freshwater Bayou that has settled below the design elevation 4.0 NAVD which is allowing bankline erosion. The rock dike will be capped in an upcoming maintenance event to address the problem areas.

Overall the Freshwater Bayou Wetlands Project rock dike is in operational condition; however the portions of the foreshore dike that have settled below the designed elevation need to be capped to prevent further bankline erosion. A funding request was approved by the CWPPRA taskforce in 2012 and construction is likely to begin in the 2014-2015 timeframe.
