2024 Operations, Maintenance, and Monitoring Report

Rockefeller Refuge Gulf Shoreline Stabilization

State Project Number ME-0018
Priority Project List 10

June 2025
Cameron Parish

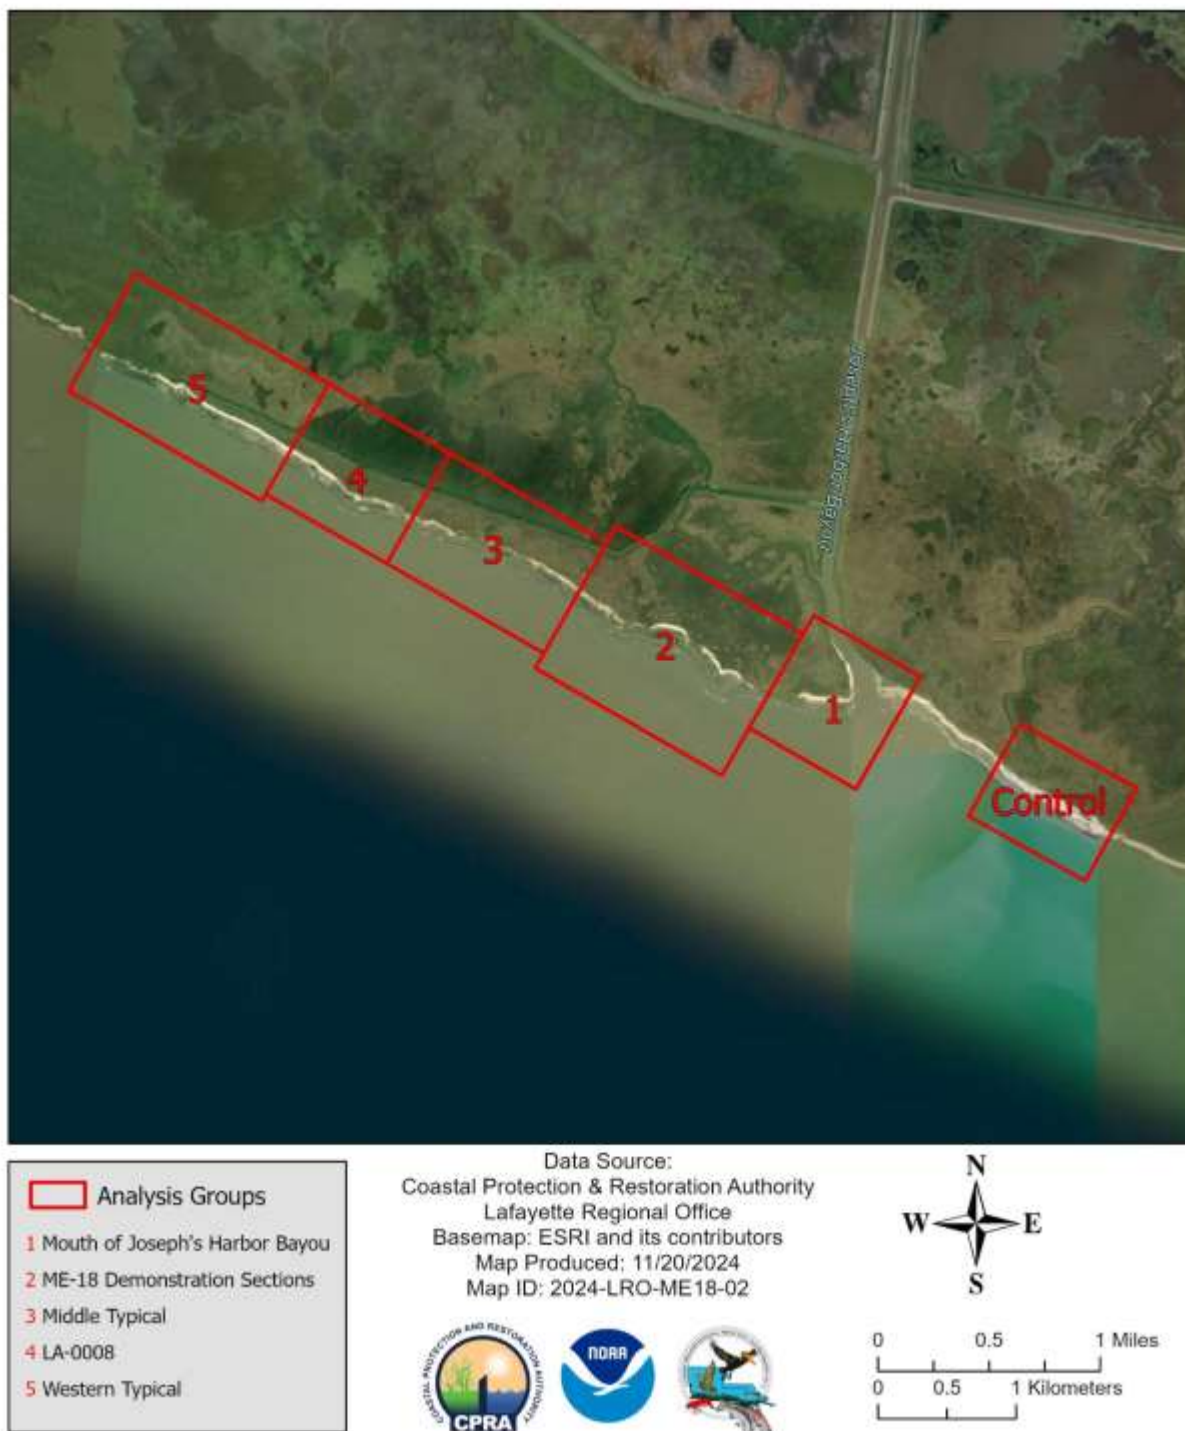
Figure 3. ME-0018 Analysis Group locations and descriptions including Control area east of Joseph's Harbor Bayou

The shoreline protected by the project was divided into five analysis groups for a geospatially explicit analysis of hurricane impacts across the project area (Figure 3). These groups were carried over from the Post-Hurricane Report to provide a greater level of detail for shoreline movement since the hurricane impacts were incurred. The analysis groups are described below:

Group 1 (Mouth of Joseph Harbor Bayou) is the easternmost portion of the study area. It is located west of the mouth of Joseph Harbor Bayou (Joseph Harbor) and includes 2,700 ft of shoreline. This area was selected to capture the influence of Joseph Harbor on shoreline movement within the project area. This analysis group also includes 350 ft of shoreline north of the breakwater structures with open exposure to Joseph Harbor.

Group 2 (ME-0018 Demonstration Sections) spans 5,700 ft of shoreline which includes the area of the two demonstration sections completed in December 2009 and the more recently constructed breakwater structures in the vicinity. The demonstration areas differ from other construction locations in the study area in two ways: 1) the pre-construction shoreline extended into the Gulf relative to the remainder of the study area that had a relatively flat or linear shoreline geomorphology and 2) the breakwater alignment was updated during construction to accommodate the change in shoreline and bathymetry due to the demonstration features and to incorporate the demonstration features into the overall system.

Group 3 (Middle Typical) is the center-most analysis group and includes 4,400 ft of shoreline. This analysis group is generally characterized by the typical linear shoreline geomorphology and breakwater construction technique.

Group 4 (LA-0008) spans 3,500 ft of shoreline and includes the LA-0008 demonstration project which was constructed in April 2012 and was incorporated into the ME-0018 project in 2022. This analysis group is functionally similar to Group 2 in that the shoreline had been influenced by another structure before construction of ME-0018.

Group 5 (Western Typical) is the westernmost analysis group and includes 5,300 ft of shoreline. Like Group 3, this analysis group is generally characterized by the typical linear shoreline geomorphology and breakwater construction technique.

Control - a control area was established prior to the Post-Hurricane Survey 3,650 ft east of Joseph Harbor along 2,950 ft of shoreline without a breakwater system. This shoreline is directly exposed to waves and currents from the open Gulf of Mexico including high tides, storms, and hurricane events. The control area has a similar pre-construction shoreline geomorphology as the typical shoreline segments. The beaches are composed of similar soft marine clays and crushed shell and are both backed by similarly vegetated marshland. Although the Control was not included in the As-built survey, it will be used through the project's 20-year design life to measure project performance.

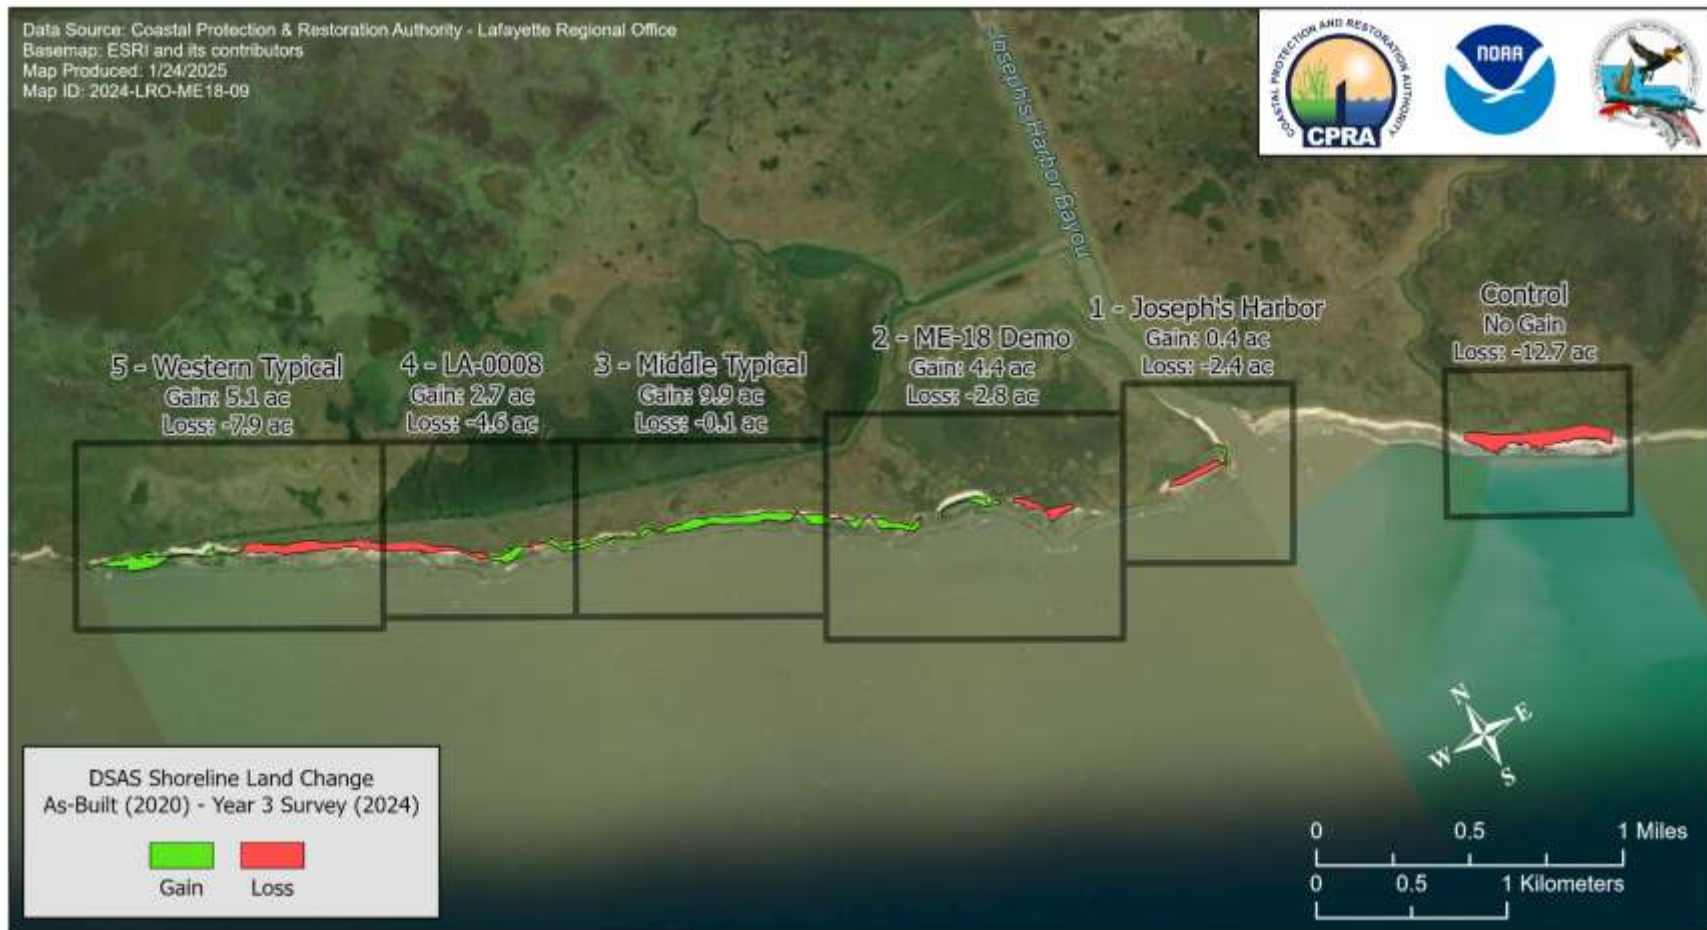
ME-0018 DSAS Land Change Analysis – As-Built (February/May 2020) to Year 3 Survey (April 2024)

Figure 6. Shoreline land change acreages calculated from DSAS analysis of As-Built (May 2020) and Year 3 (April 2024) survey data.

The total acres of land lost in the Control Area from the As-Built survey (May 2020) to the Year 3 survey (April 2024), was 12.7 acres (Table 6). Unlike the elevation data, the DSAS calculations include the impacts from Hurricanes Laura and Delta immediately following construction. Although the Project area actually gained land during the same time period (4.6 acres), it was counted as a neutral/ stable value. This was done for the sake of conservative calculations as well as the limitation of land building up to the breakwater structure. A total of 31.7 acres were retained per linear breakwater mile, which is 122.2 acres total project benefit over the entire project area. A conservative estimate for comparable construction costs (excluding Engineering, Design, Permitting, etc.) for marsh creation projects was used (\$80k/acre) to calculate a value for this land

area retained. Using this value, the project benefit of the land retention from May 2020 to April 2024 was \$9.7 million (\$2.5 million per linear mile). When this value is integrated with the construction costs at ME-0018, an annual return on investment of \$2.5 million (9%) with a break even period of 11.5 years.

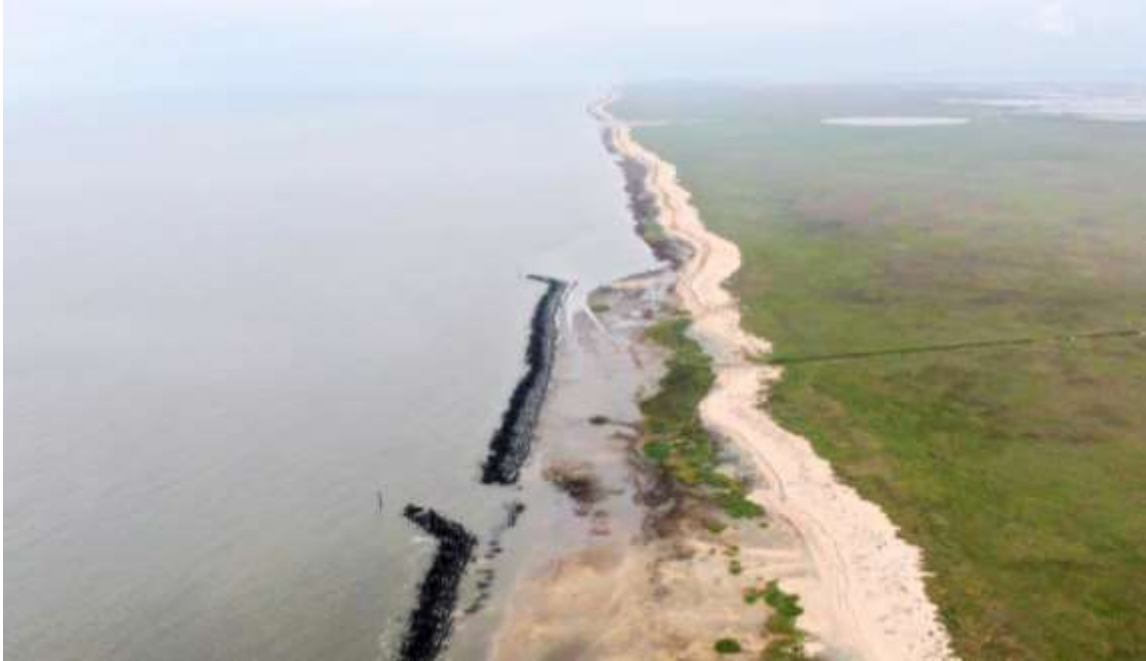
Figure 10. Photograph provided by Philip Trosclair, Rockefeller Refuge Manager taken on 11/16/2023 facing west at the western end of ME-37, which is a continuation from the western extent of ME-0018. This photograph demonstrates the sediment stabilization behind the structure.

Expansion of the Project Area to the west would enhance existing shoreline protection (as demonstrated by the effect of the ME-37 project on the western end of ME-0018) and stabilize more coastal land area within Rockefeller Refuge. With some of the highest rates of shoreline loss anywhere on the Louisiana Gulf Coast, time is of the essence for shoreline stabilization in this area.

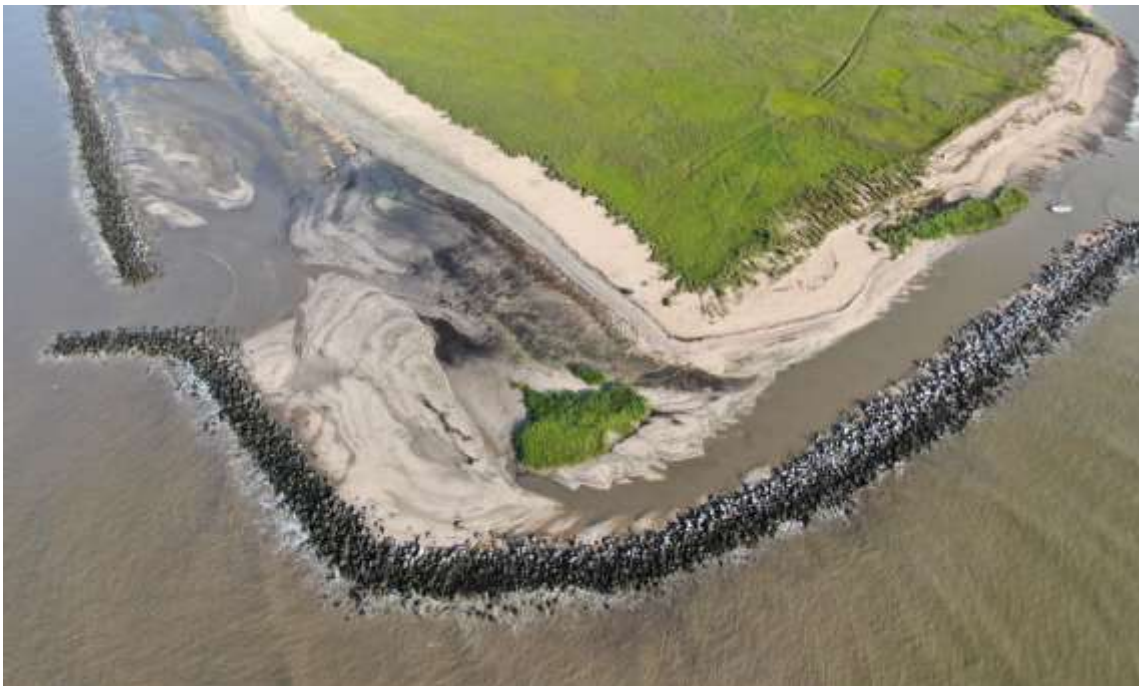
Figure 11. Photograph provided by Philip Trosclair, Rockefeller Refuge Manager taken on 4/20/2020 demonstrating the enhance edge habitat behind the structure and utilization by recreational fishing boat.

Beyond land building and inland protection, the reef component of the project also provides significant ecological benefits to the region. The breakwater structure has effectively created an artificial reef which supports an abundance of new oyster cultures, and provides extensive edge habitat on both sides of the reef. Observations by the refuge manager (Figure 12; personal communication, Philip Trosclair May 5 2025) include enhancing water quality via lower water turbidity behind the breakwater structure, shoreline surveys which identify onshore protection of nesting birds, and vastly improved fisheries habitat. In fact, the breakwater has created a previously absent inshore recreational fishery with red drum, speckled trout, and southern flounder. The project area has become a popular fishing spot with both locals and travelers.

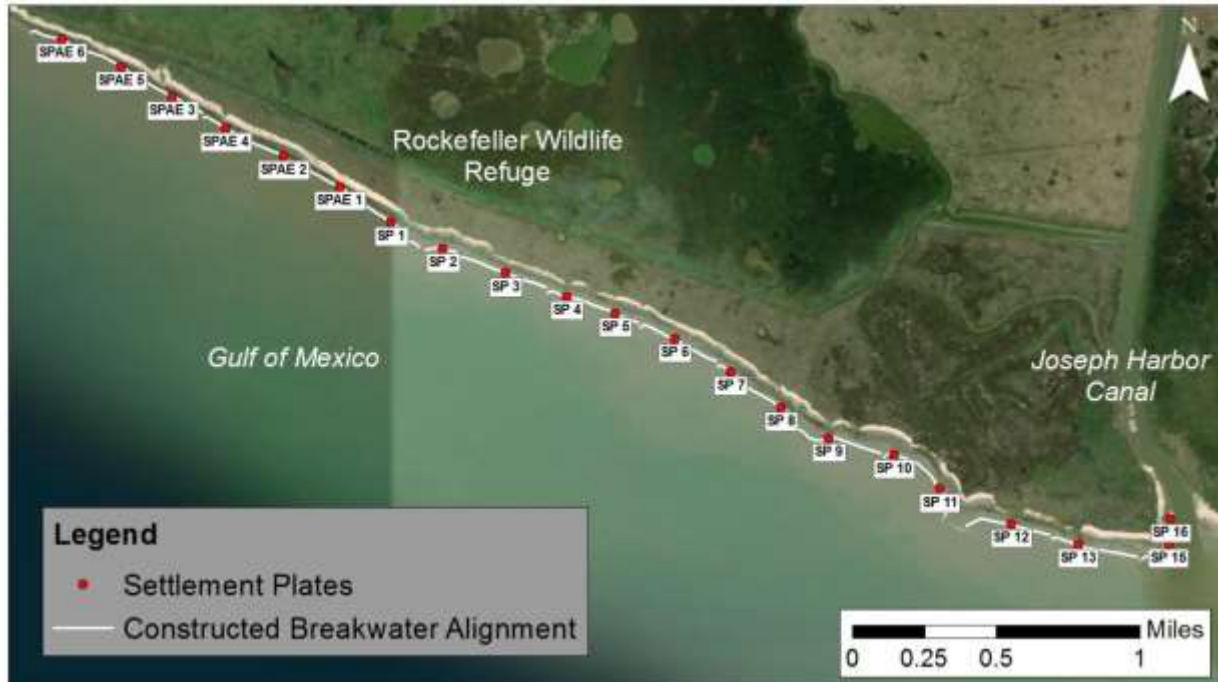
Figure 13. Settlement Plate Locations across Project Area taken from HDR Engineering Inc, 2021.

Table 8 shows settlement plate elevation change measured across all survey events. Total change from construction to the 3-year monitoring survey was -2.1 ft. The general trend for the higher average settlement was observed in the eastern reach of the project area, however the highest values of settlement were observed in two settlement plates on the west side of the project (SPAE 6: -3.35, SPAE 1: -3.23; Table 8 and Figure 13). The settlement value from the as-built to the hurricane survey was isolated from the total elevation change to identify how much of total settlement can be attributed to the 2020 hurricane season. An average of 29% of all settlement from construction to the Year 3 survey can be attributed to the 7 month period between the as-built survey and the hurricane survey. With the exception of one settlement plate (SPAE 5), all settlement values for the 3 years from the hurricane survey and the Year 3 survey are comparable or less than the settlement experienced in the relatively brief period between the as-built and hurricane survey.

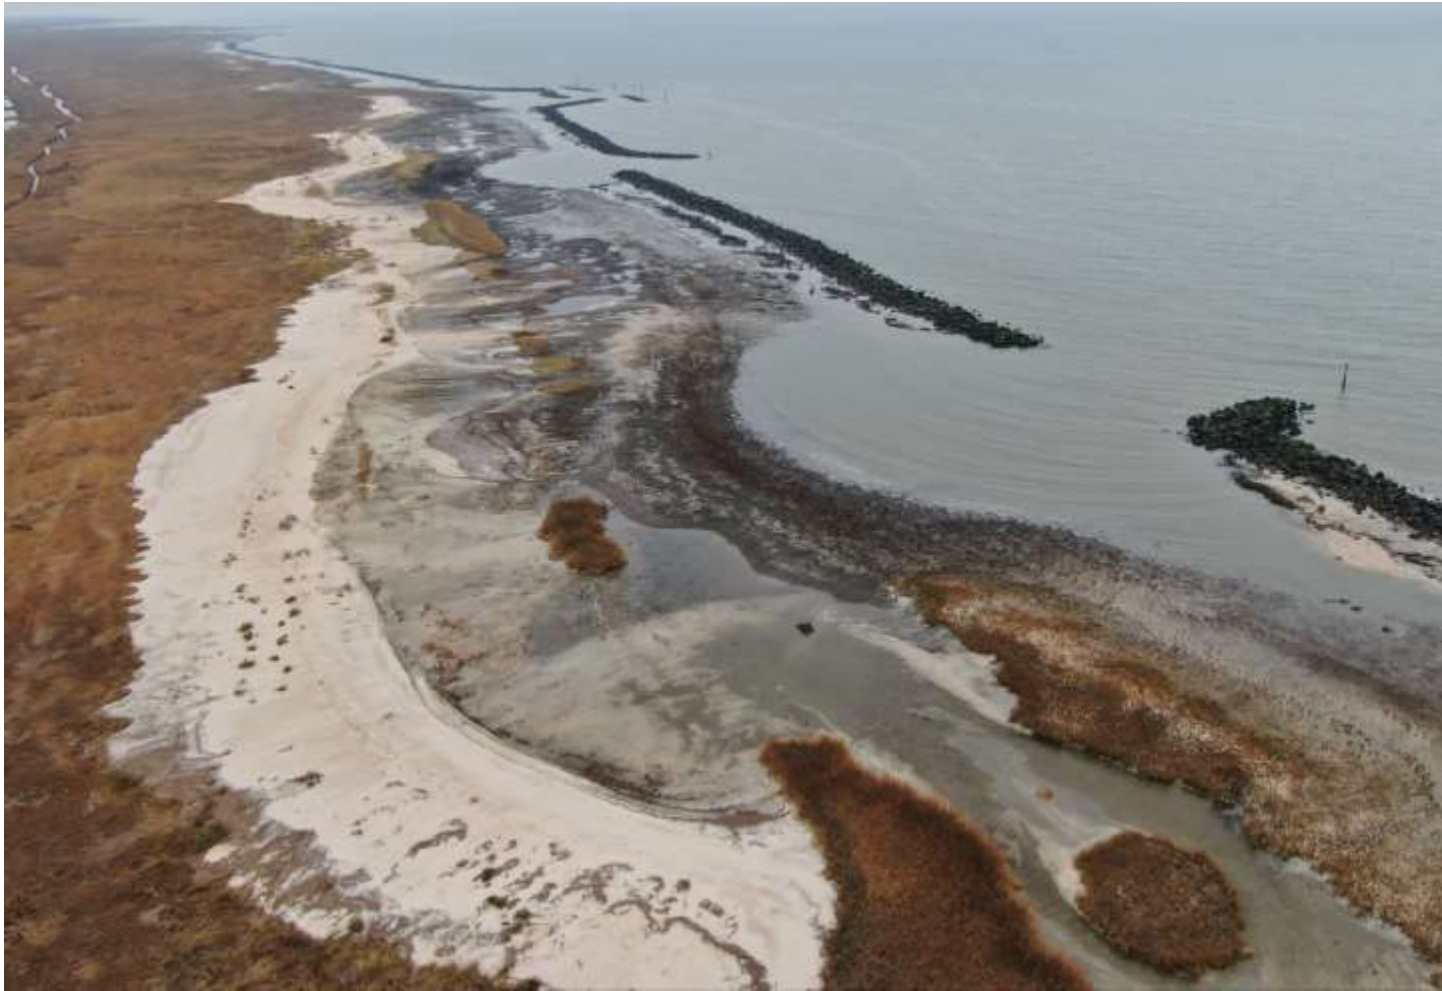
Photo A2: Taken January 29, 2025 facing southeast towards wider fish gaps west of LA-0008. The enhanced erosion is apparent by the concave shoreline and fragmented, degrading vegetation.

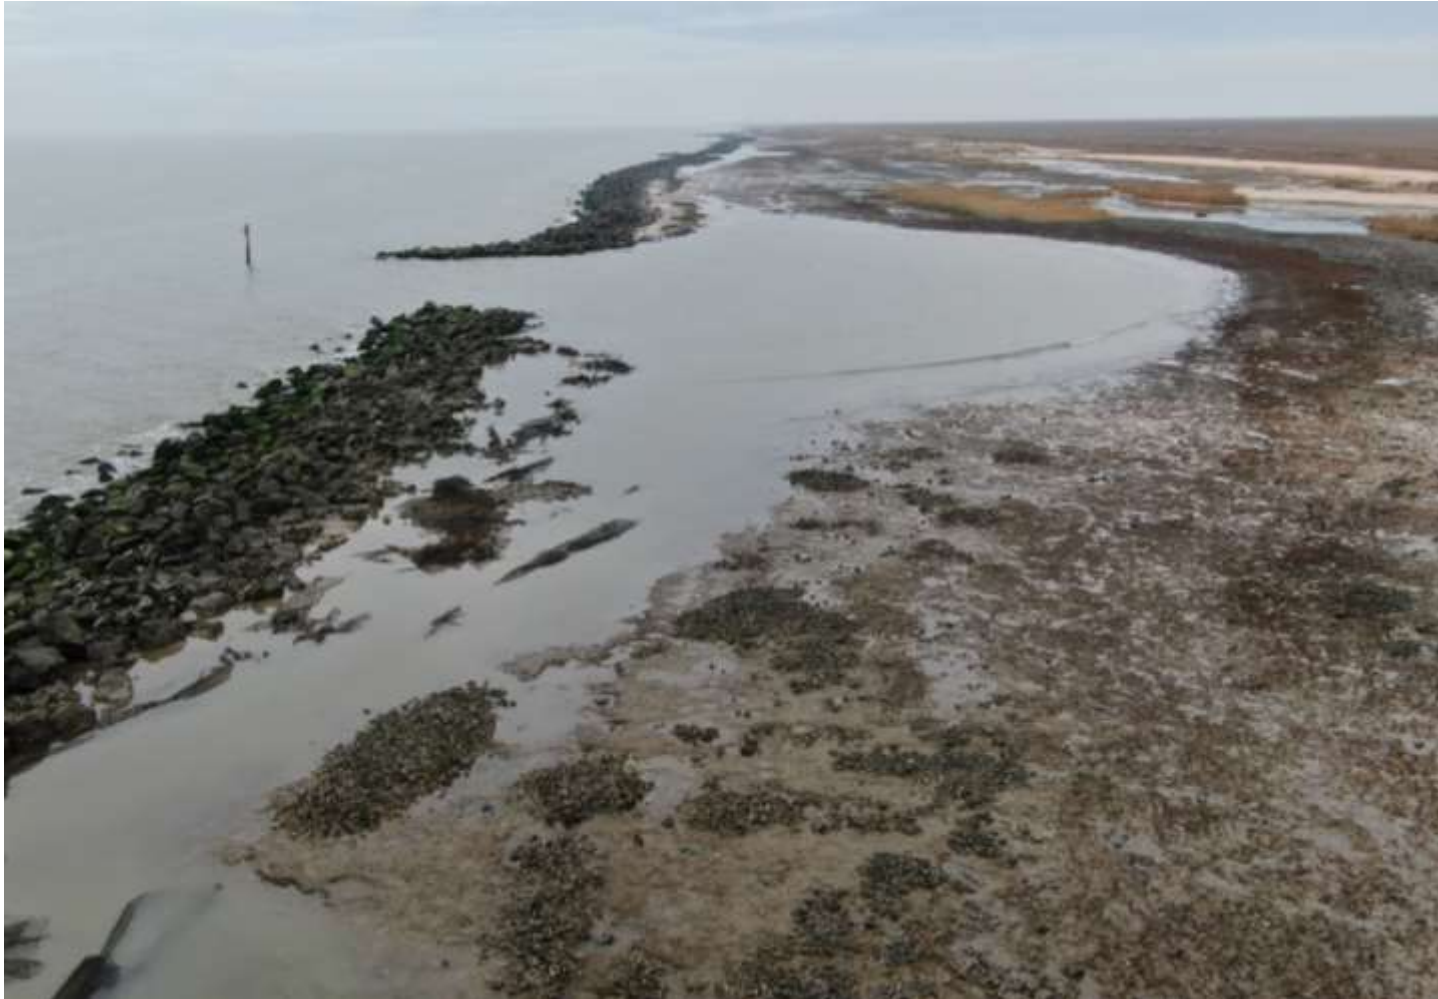
Photo A3: Taken January 29, 2025 facing northwest towards westernmost of the two location with wider fish gaps west of LA-0008.

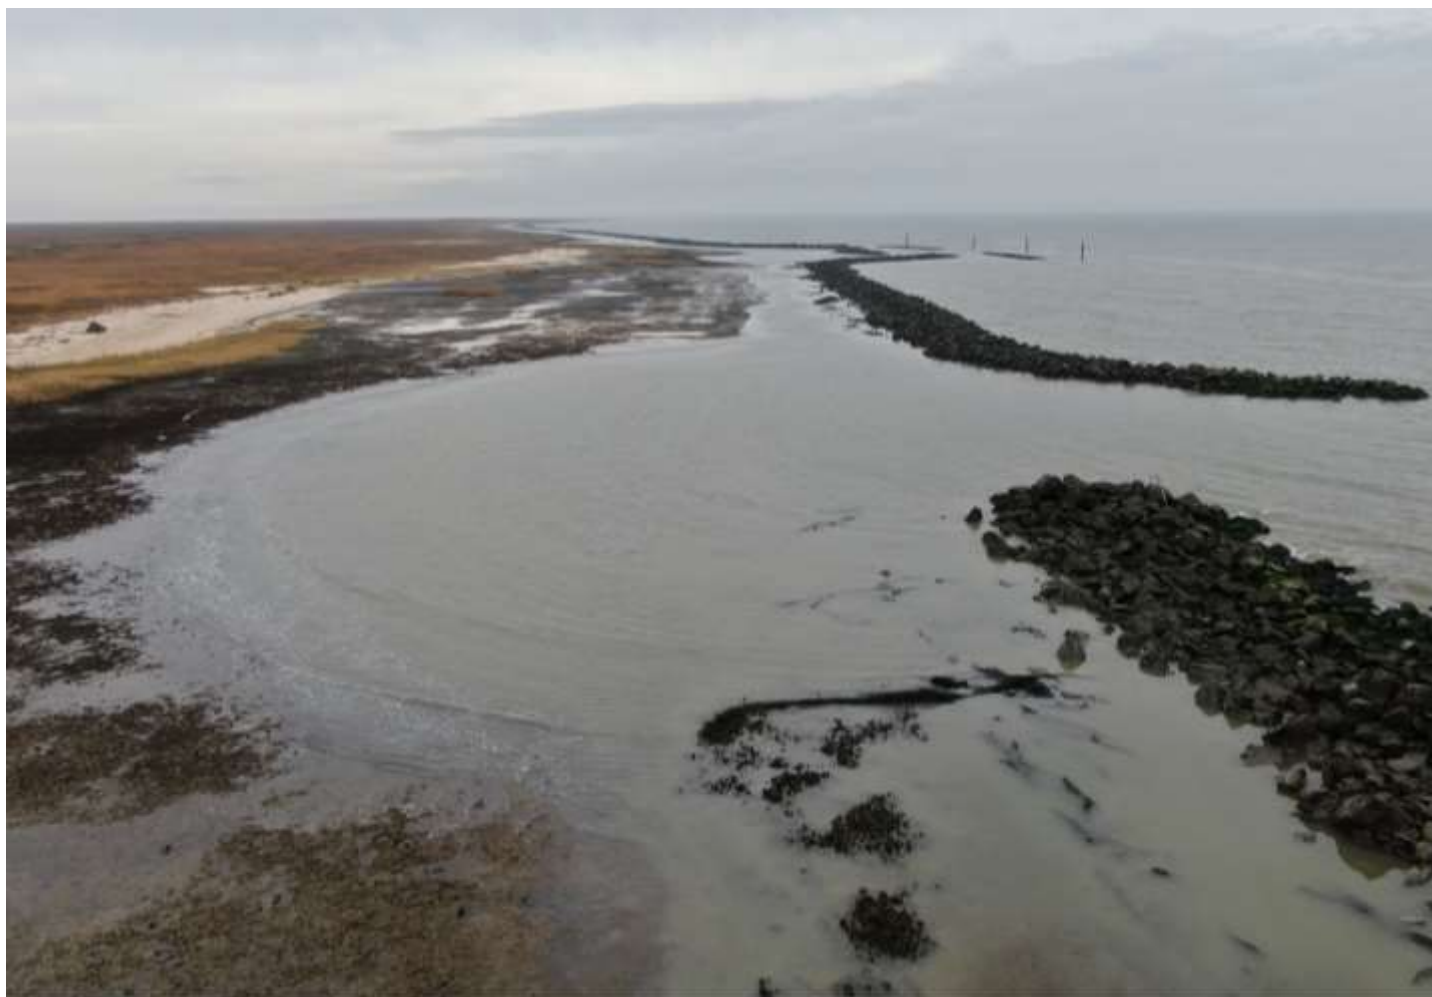
Photo A4: Taken January 29, 2025 facing southeast towards easternmost of the two location with wider fish gaps west of LA-0008.
