2017 Operations, Maintenance, and Monitoring Report

Channel Armor Gap Crevasse (MR-06)

State Project Number MR-06
Priority Project List 3

January 2018
Orleans Parish

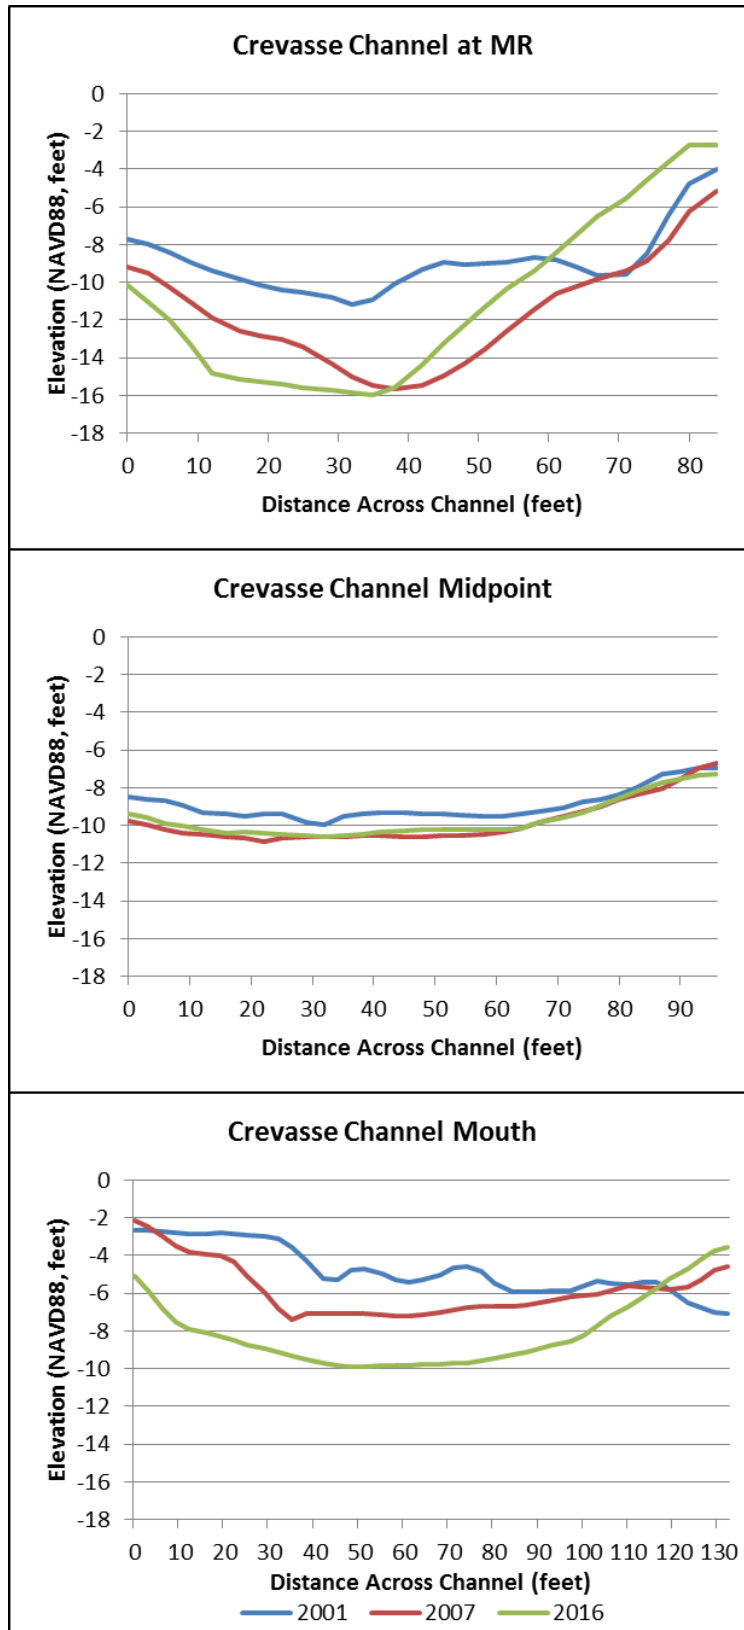
Figure 10. Elevation profile of MR-06 crevasse channel for 2001, 2007, and 2016 at three locations: Crevasse Channel at Mississippi River (top), Crevasse Channel Midpoint (middle), and Crevasse Channel Mouth (bottom).

places. Examination of cross-sections of the crevasse channel reveals that the elevations at the channel midpoint have remained largely unchanged from 2001 to 2016 (Figure 10). However, cross-sections at the ends of the crevasse channel where it joins the Mississippi River and the receiving bay show that elevations in these areas have decreased up to 6 ft over the same time period.

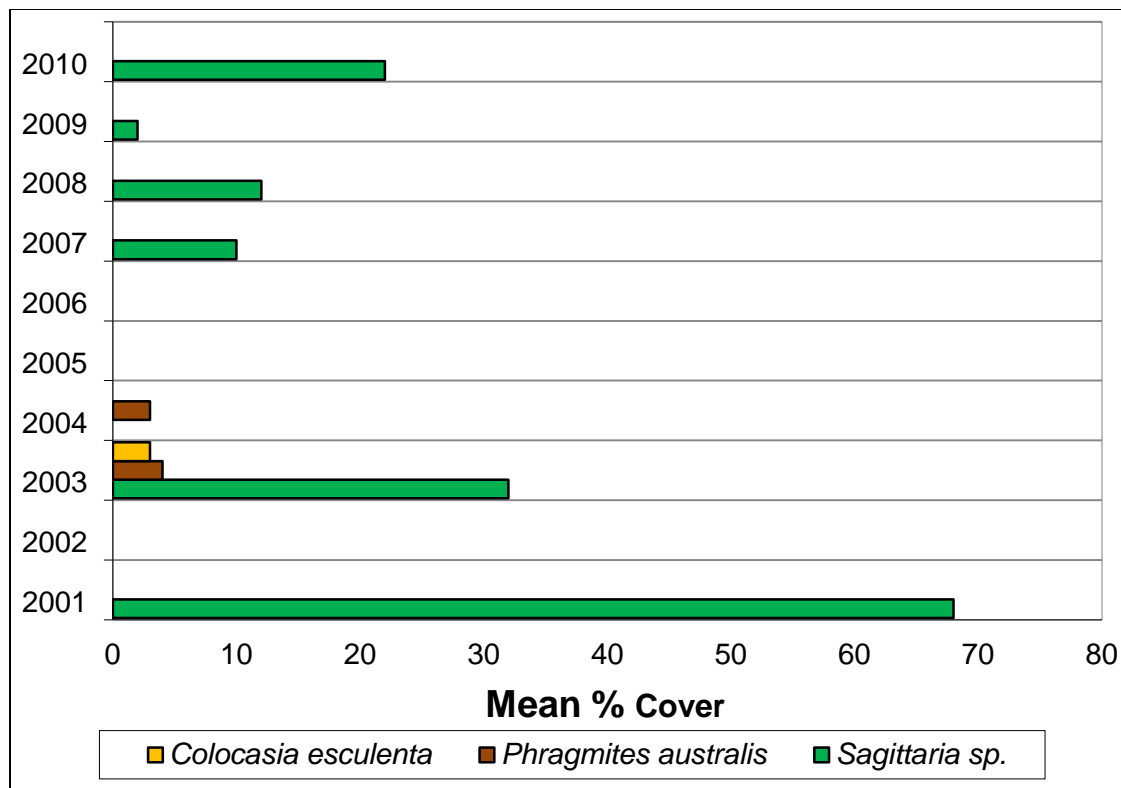
Figure 19. Mean percent cover of emergent vegetation species from 2001 to 2010 (2001 – 2002 n=2; 2003 – 2007 n=7; 2008 – 2009 n=8; 2010 n=9). No vegetation was observed in 2002, 2005, or 2006

Vegetative cover recovered somewhat in the 2007 – 2010 surveys, although in each of these years vegetation was found in 2 or fewer plots. Mean percent cover ranged from 2% to 22% (Figure 19) across all stations. One new station was added to Transect 1 in 2008, along with another in 2010; both were located on the northern end of the transect. The only species observed during these surveys was *Sagittaria* sp.

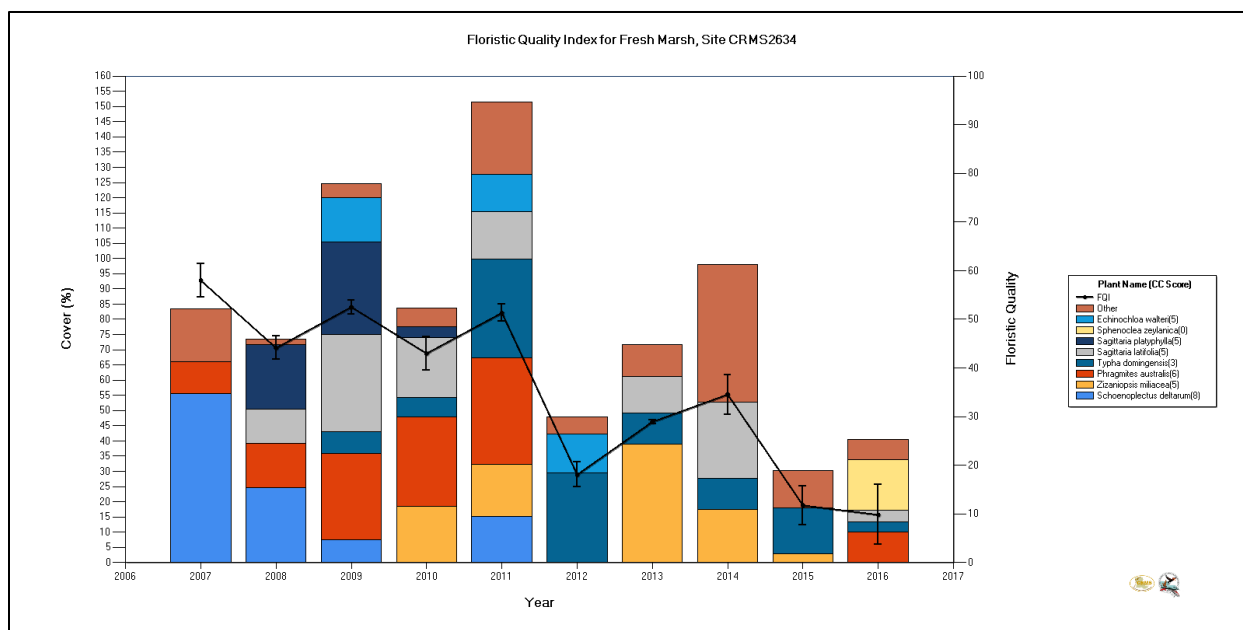
Figure 20. Mean % cover of major species and FQI score at CRMS2634 vegetation plots in years 2007 through 2016.

FQI scores at CRMS2634 remained relatively stable from 2007 to 2011, ranging from a low of 43 in 2010 to a high of 58 in 2007 (Figure 20). Total mean percent cover values showed a general upward trend for the same period, with the highest values seen in 2009 and 2011. There was also a shift in the species composition, from a community dominated by *Schoenoplectus deltarum* (delta bulrush) and *Sagittaria* sp. (bulltongue) to one dominated by *Phragmites australis* (common reed) and *Typha domingensis* (southern cattail). For the period from 2012 to 2016, FQI scores and total percent cover followed a generally downward trend with a slight uptick in 2013 and 2014. This was accompanied with another shift in species composition as percent cover of *Phragmites australis* was absent or greatly reduced while *Typha domingensis* and *Zizaniopsis miliacea* (giant cutgrass) increased. FQI scores for the MR-06 project area were mostly higher than other fresh marsh CRMS project and reference sites within the MRD hydrologic basin from 2007 to 2016 (Figure 21), with the exception of 2015 and 2016. The decrease in FQI observed at CRMS2634 in recent years appears to be consistent with a general downward trend in FQI among MRD CRMS sites.

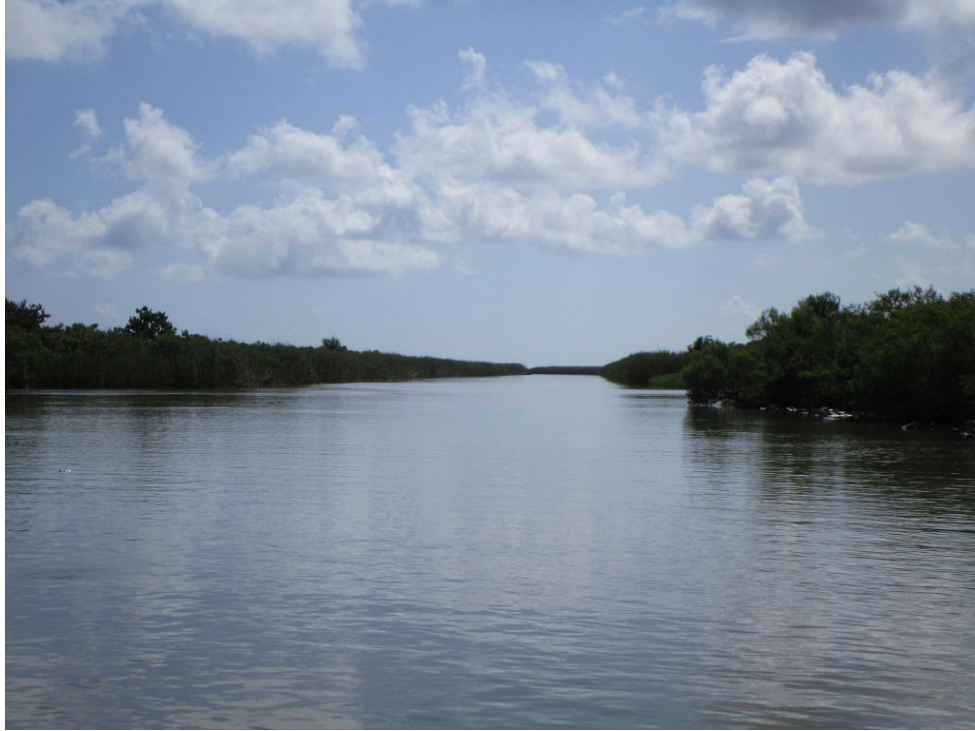
The crevasse channel remains open from the Mississippi River to the receiving bay. Water flow was observed through the channel at the time of the inspection. Several distributary channels are apparent in the receiving bay, with the flow from the crevasse channel moving generally to the north. The flow from the crevasse channel then joins the flow entering through the oilfield canal from Main Pass, and exits the project area to the north. Emergent vegetation was observed throughout the receiving bay, with the greatest concentrations in the area at the mouth of the crevasse channel, extending to the north. Several large roseau cane (*Phragmites australis*) islands are present at the mouth of the crevasse channel. Other areas were primarily dominated by delta duck potato (*Sagittaria platyphylla*) and giant cutgrass (*Zizaniopsis miliacea*). The area to the south of the crevasse mouth was primarily shallow open water bordered by roseau cane. Multiple species of submerged aquatic vegetation (SAV) were observed throughout the project area.

Photo 1. View of the MR-06 crevasse channel from the Mississippi River toward receiving bay

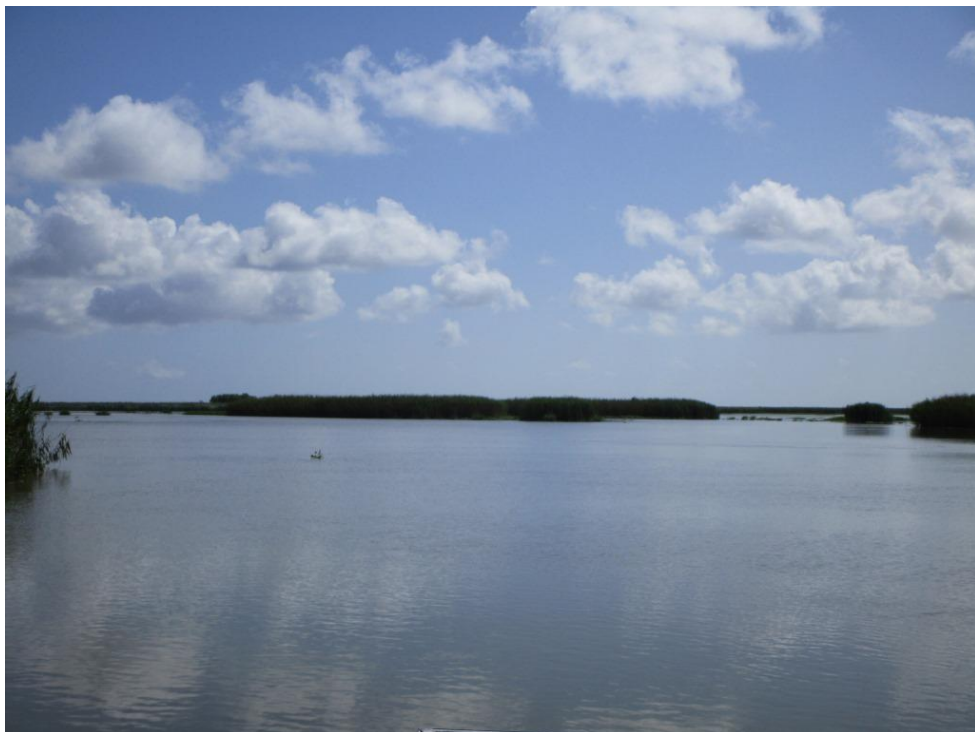
Photo 2. View from the mouth of the MR-06 crevasse channel toward receiving bay

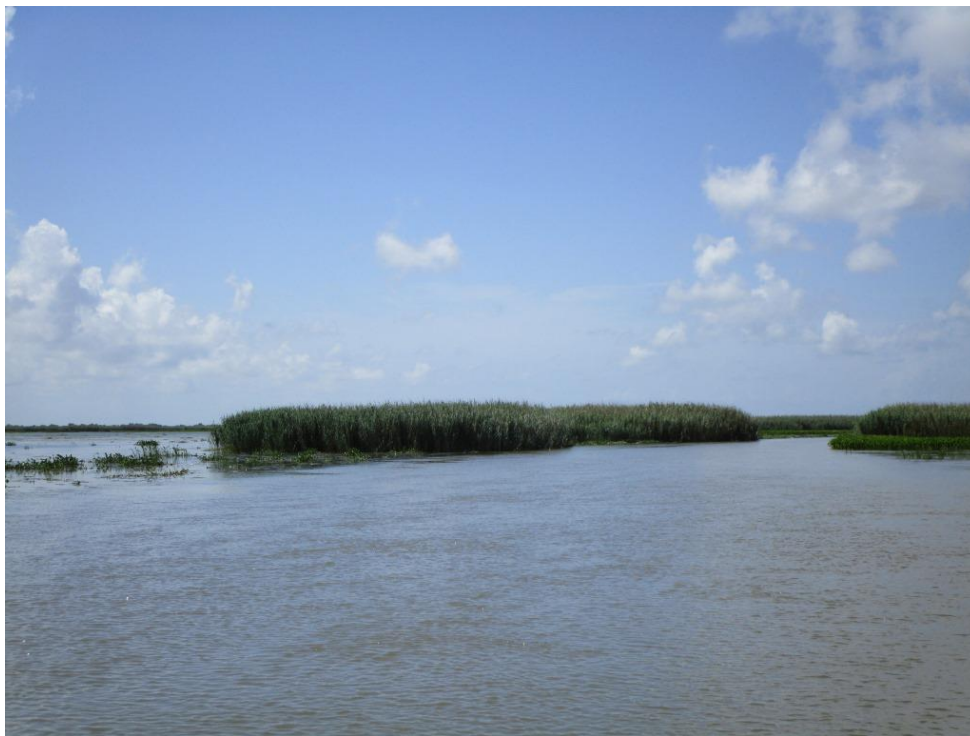
Photo 3. Roseau cane islands at the mouth of the crevasse channel

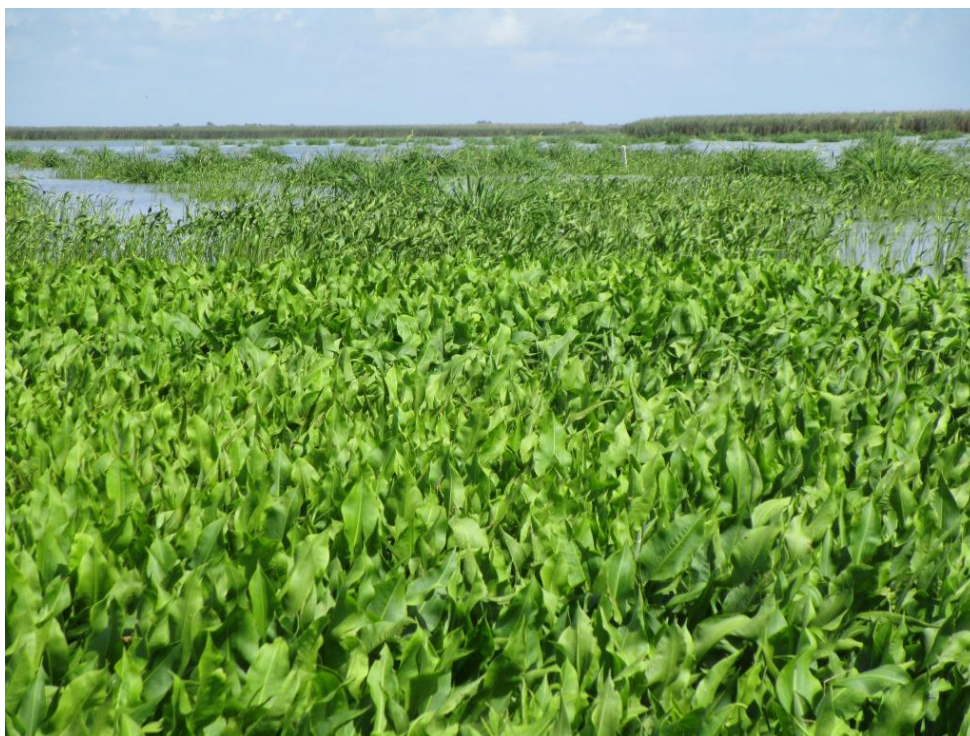
Photo 4. Emergent vegetation in the receiving bay to the north of the crevasse mouth

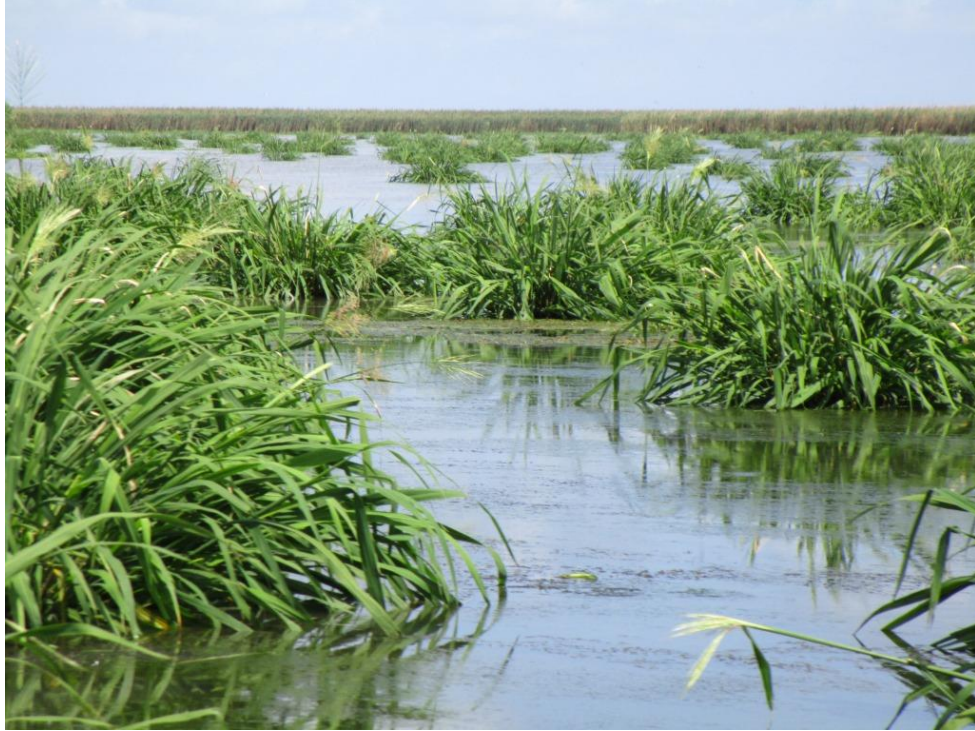
Photo 5. Emergent vegetation in the receiving bay to the north of the crevasse mouth

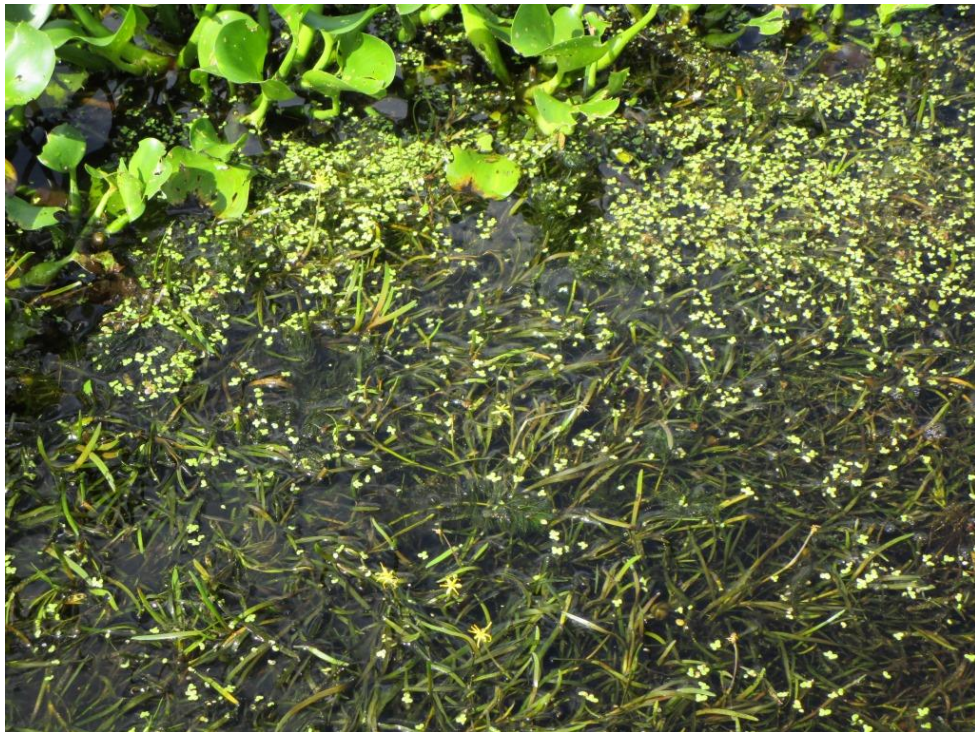
Photo 6. Submerged aquatic vegetation in the receiving bay
