OYSTER BAYOU MARSH RESTORATION PROJECT (CS-59) *PROJECT COMPLETION REPORT*

Contract Number 4400007082

August 2019
FINAL

PREPARED BY:
APTIM ENVIRONMENTAL & INFRASTRUCTURE, LLC.
4171 ESSEN LANE
BATON ROUGE, LA 70809

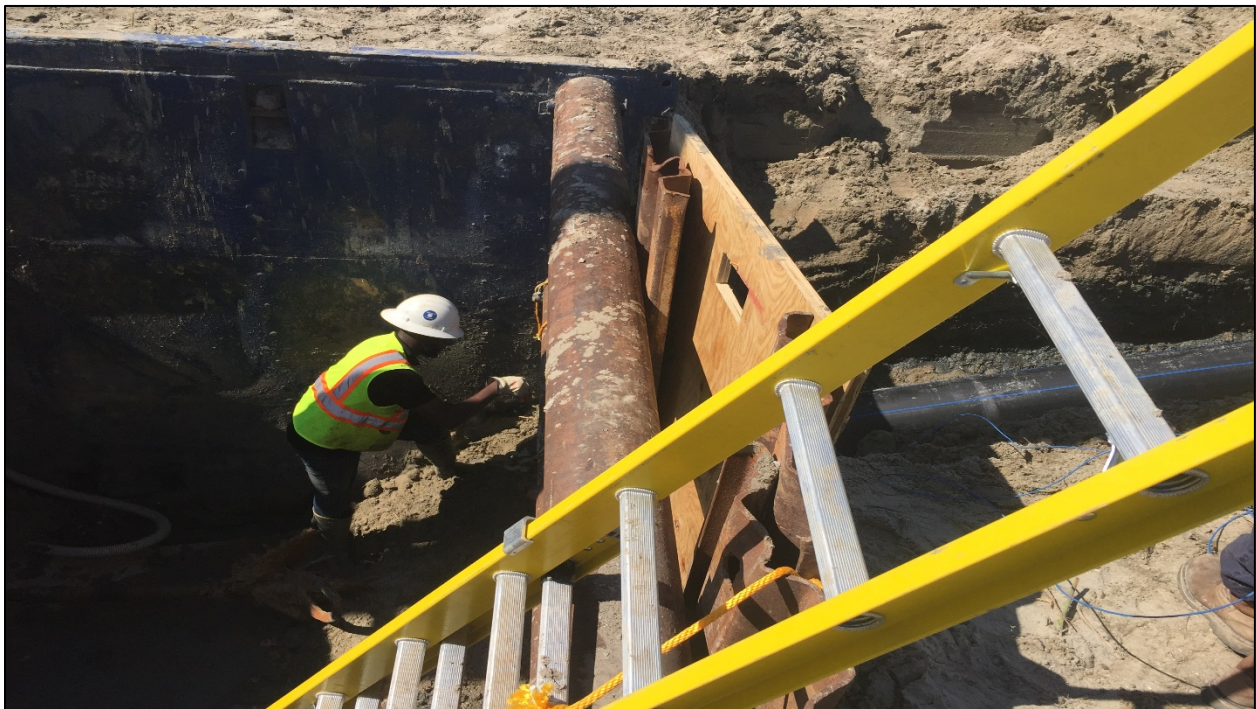
Figure 2: Waterline Relocation – View of the Trench Box and HDPE Pipe During the Waterline Relocation

In order to place the sediment pipeline from the Gulf of Mexico borrow area to the fill area, the pipeline had to be placed under Highway LA27/82. Therefore, an existing waterline had to be relocated. The existing waterline ran parallel to LA 27/82 at a depth of approximately five feet below grade. Water service was able to be maintained throughout the relocation work through the use of two (2) tapping sleeves. One (1) twelve inch (12”) HDPE line was installed according to the lines and grades shown in the project Plans and Specifications. Following installation, the new line was chlorinated, flushed, and tested. The tapping sleeves were used to redirect the flow of water to the new waterline. Details of the waterline relocation are provided in Section 14.5. Figure 2 shows the waterline relocation.

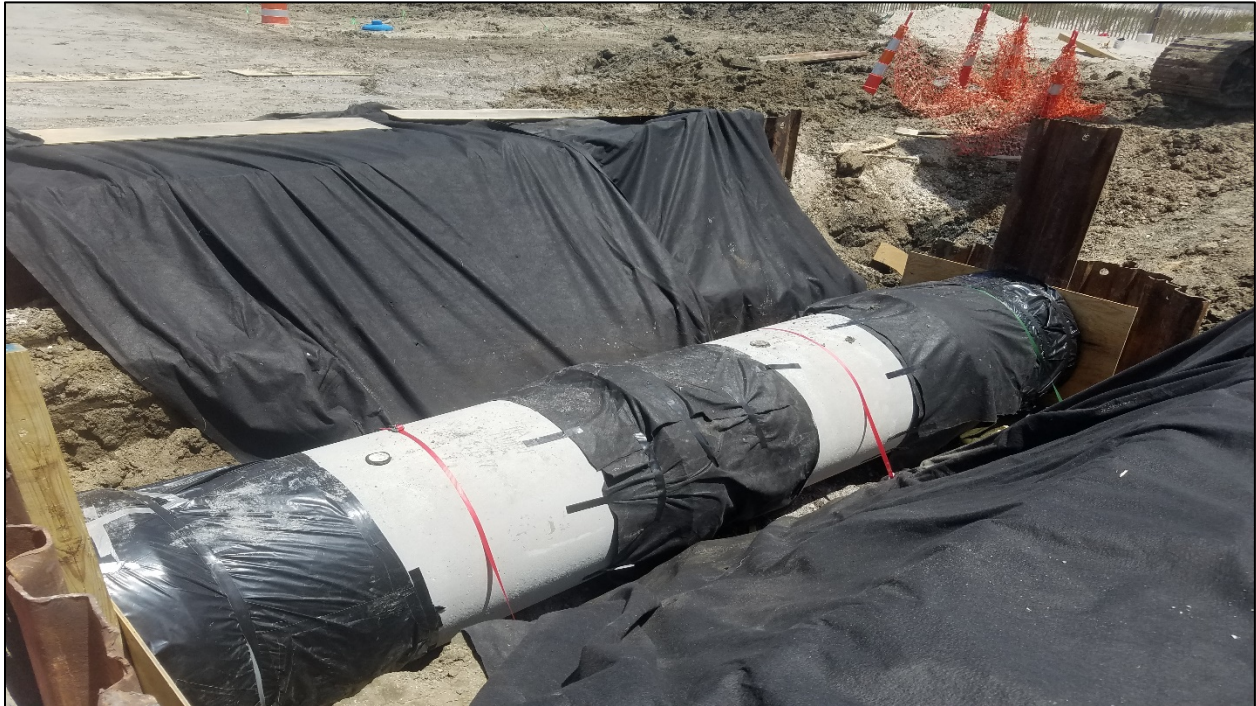
Figure 3: Concrete Casing Pipe Installation (Eastbound Lane on 5/16/2017)

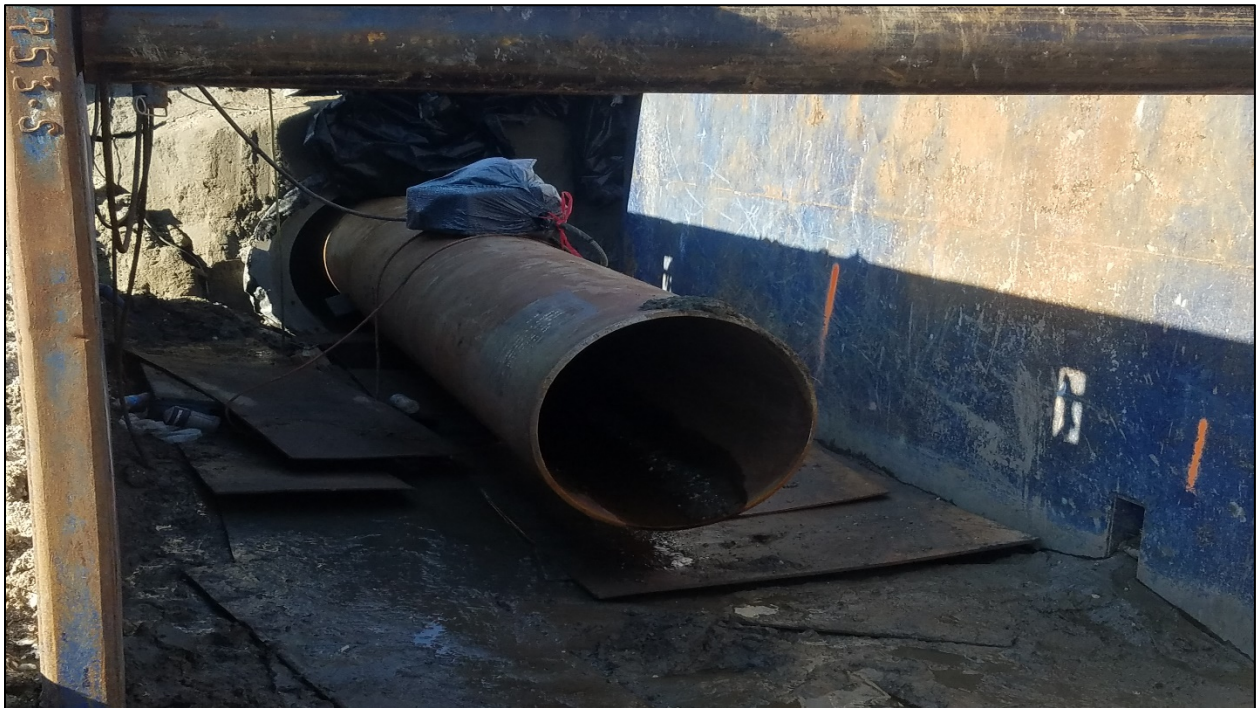
Figure 4: View of the temporary sediment pipeline installation within the concrete casing pipe

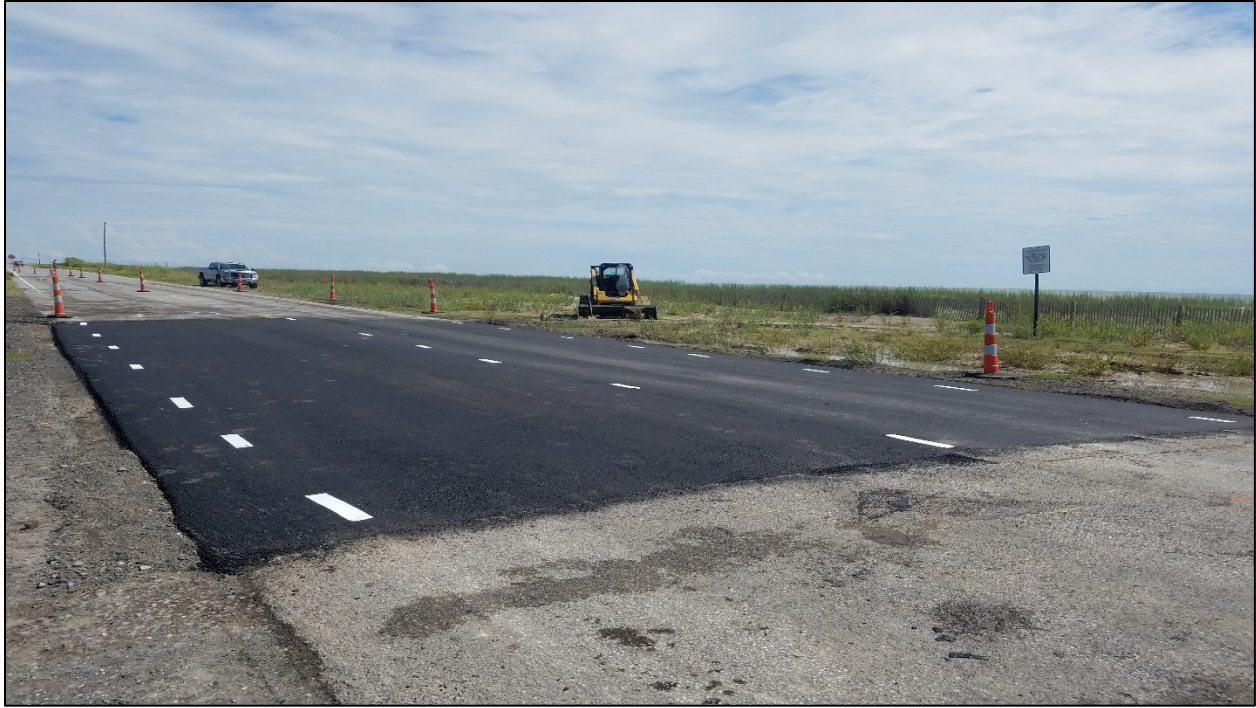
Figure 5: Completed Highway Crossing Following the Highway Rehabilitation (9/24/2018)

the temporary sediment pipeline and concrete casing pipe. Figure 5 shows the completed asphalt patch following the highway rehabilitation.

Change Order 007 was issued on July 27, 2018 to rehabilitate the Oil Field Road and restore a dip observed at the highway crossing pavement patch. RC Paving, a subcontractor of WMI and Tarpan, constructed a fifty-six (56) foot mill and overlay of the highway crossing beginning on September 24, 2018 at the request of DOTD.

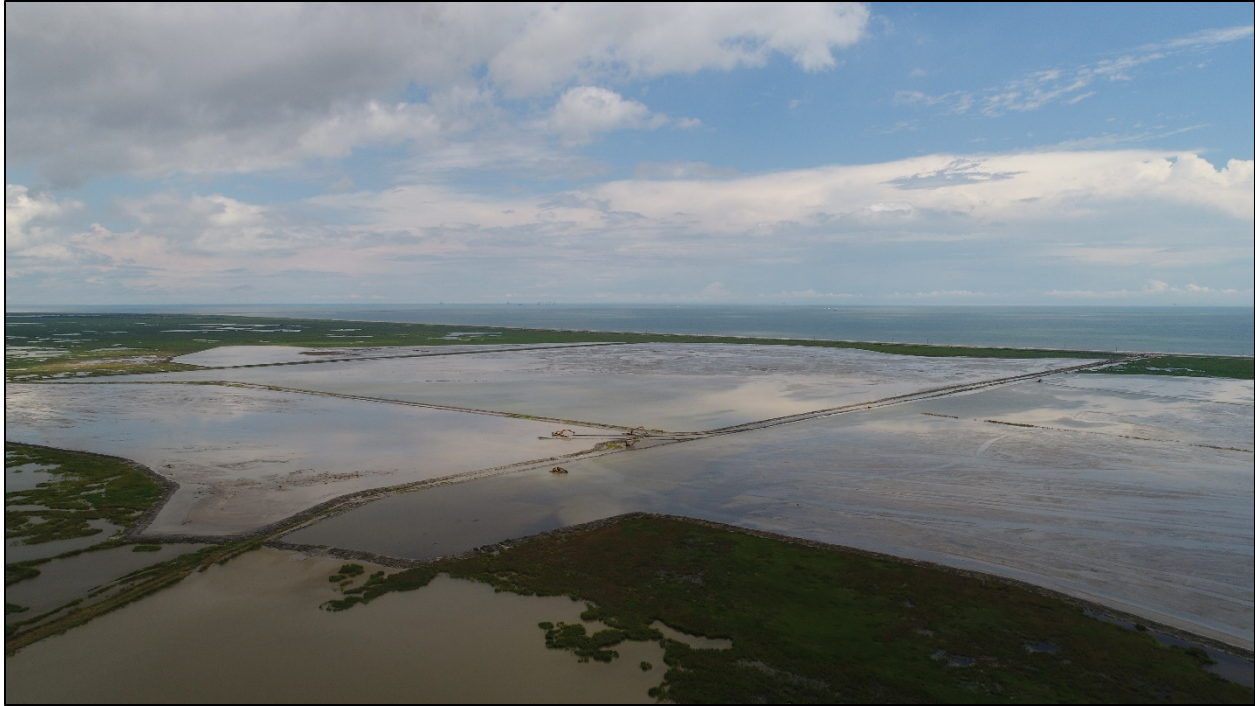
Figure 6: Aerial of Completed Marsh Creation Areas

Marsh fill material was placed within five (5) marsh creation areas constructed with primary containment dikes north of LA 27/82. Marsh fill was also placed via unconfined disposal north of MCA 2 and south of the terrace fields (Area 6). The marsh creation areas were constructed with a minimum target elevation of +2.5 feet (NAVD88). The maximum width of the constructed marsh platform was 5,635 feet, which occurred within MCA 1 and MCA 5A between Station 18+50 and Station 75+00.

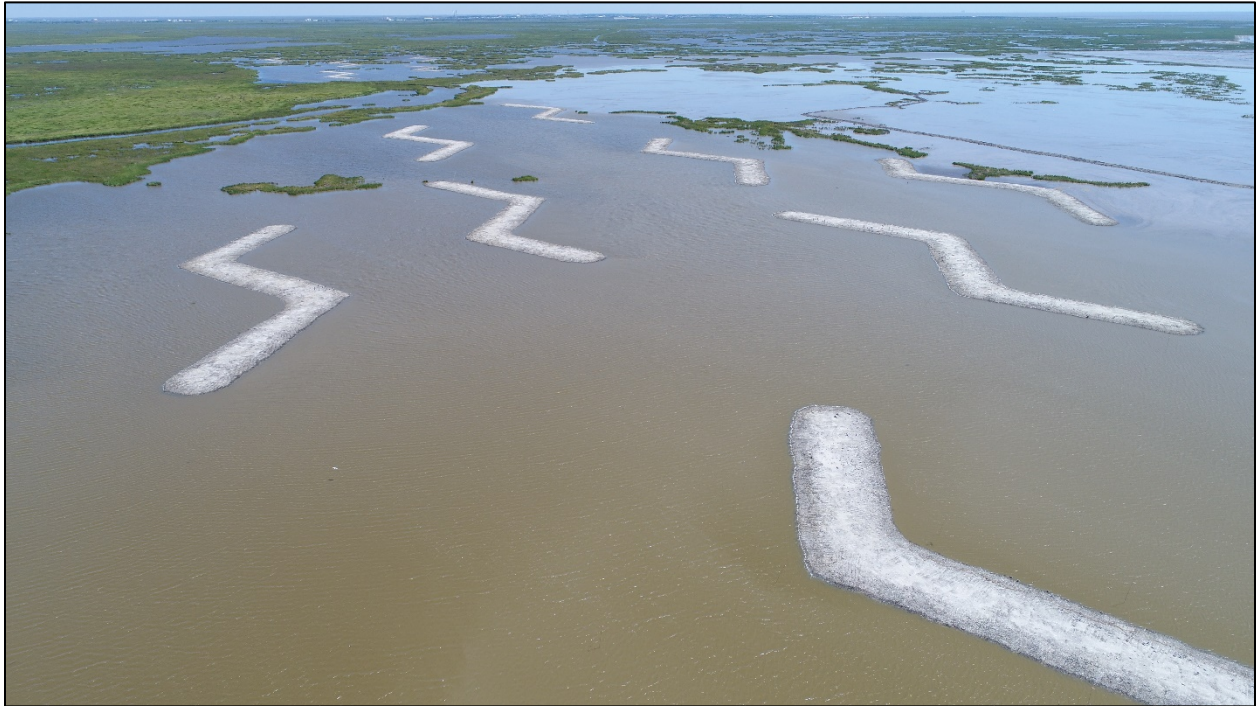
Figure 7: Constructed Terrace Field

Earthen Terraces	Volume Excavated (cy)	Volume Placed (cy)	Pit-to-Fill Ratio
Total Earthen Terraces	99,929	90,446	1.10

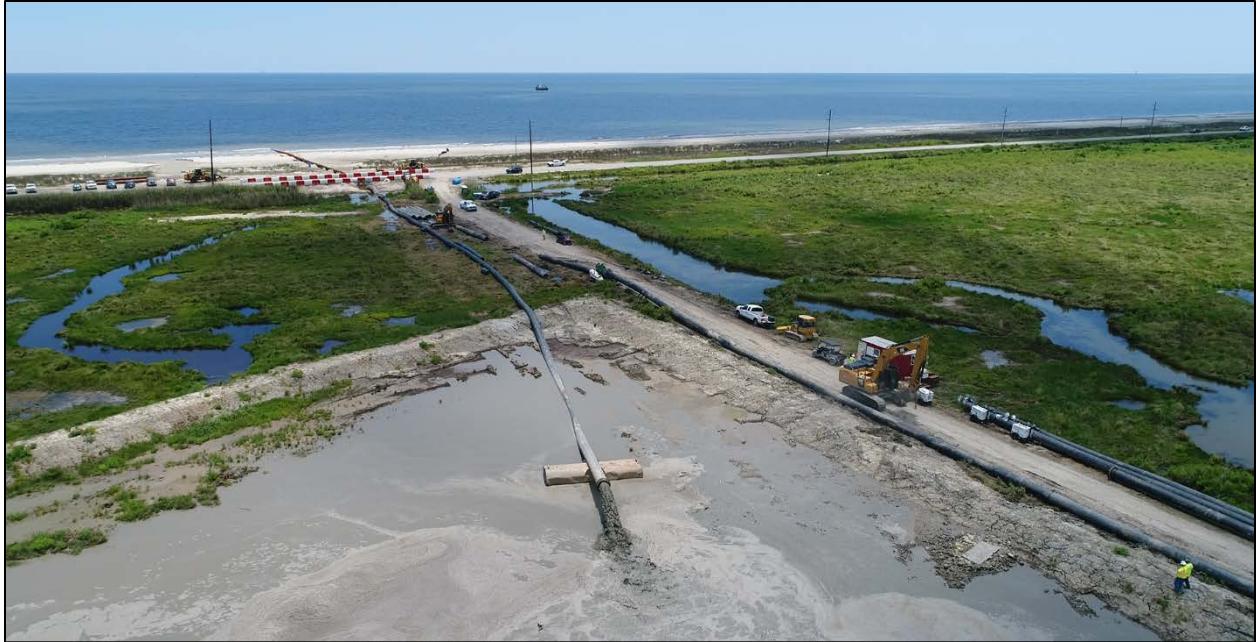
Figure 9: Aerial of WMI Placing Marsh Fill Within MCA 3

Dredging operations commenced on June 6, 2017 following the completion of the temporary sediment pipeline installation. WMI crews began marsh creation operations by pumping marsh fill material into the southwestern corner of MCA 3. Weir boxes were installed in the northeastern corner of MCA 3 to facilitate dewatering of the marsh fill material. Figure 9 shows WMI crews pumping marsh fill material into MCA 3 at the beginning of the project.

WMI crews continued to pump marsh fill material into MCA 3 up to an elevation ranging from +2.5' to 3.5' NAVD88. As marsh fill material approached the weir boxes in the northeast corner of MCA 3, boards were added in an effort to prevent marsh fill material from exiting into the adjacent canal running between MCA 3 and 4. Following the 30-day settlement period, marsh fill elevations within MCA 3 ranged between +2.1' NAVD88 to 3.4' NAVD88.
