**State of Louisiana
Coastal Protection and Restoration Authority**

2016 Operations, Maintenance, and Monitoring Report

Bayou Sauvage National Wildlife Refuge Hydrologic Restoration, Phase 1 (PO-16)

November 2016
Orleans Parish

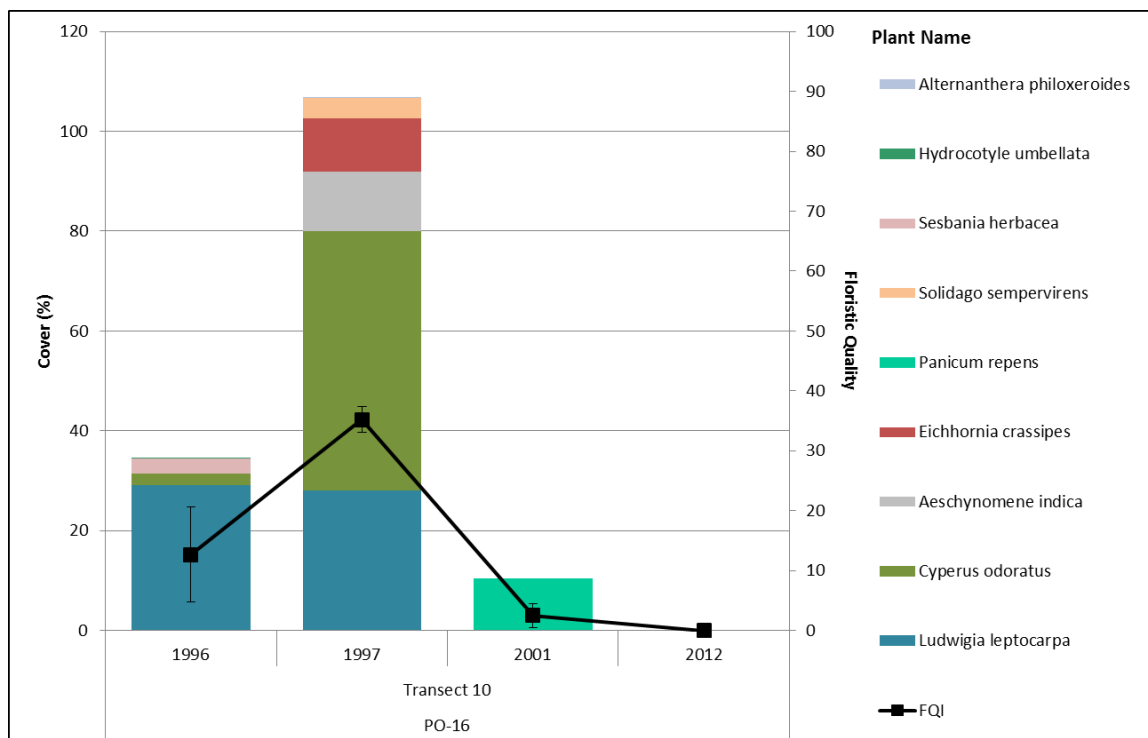
Figure 12. Mean percent cover of species along Transect 10 within the south unit of the PO-16 project area and the Floristic Quality Index (FQI) score from 1996 to 2012.

In 1996 and 1997, the vegetation community within the project area plots was a diverse fresh to intermediate marsh (Figure 9). Major species in the project area in 1996 and 1997 were *Panicum dichotomiflorum*, *Cyperus odoratus*, *Bacopa monnieri*, *Ludwigia leptocarpa*, and *Spartina patens*. Total percent cover of vegetation within the project area plots increased from 1996 to 1997, but then showed sharp declines in 2001 and 2012. By 2012, only four plots contained live vegetation, all within the north unit: two on Transect 7 and two on Transect 8. Transect 10, which was located on a thin strip of vegetation on the western side of the south unit had converted to open water by 2012. There were distinct differences in the vegetative community between the three project area transects. While Transect 7 was dominated by *S. patens* in 1996 and 1997, *S. patens* was not present at Transect 8 until 2012 (Figures 10 and 11). Transect 8 was a more diverse community dominated by *P. dichotomiflorum* and *B. monnieri*, but showed a steady decline of *P. dichotomiflorum* over the four sample years. Transect 10 was dominated by *L. leptocarpa* in 1996, *C. odoratus* in 1997, and *Panicum repens* in 2001 before converting to open water by 2012 (Figure 12).

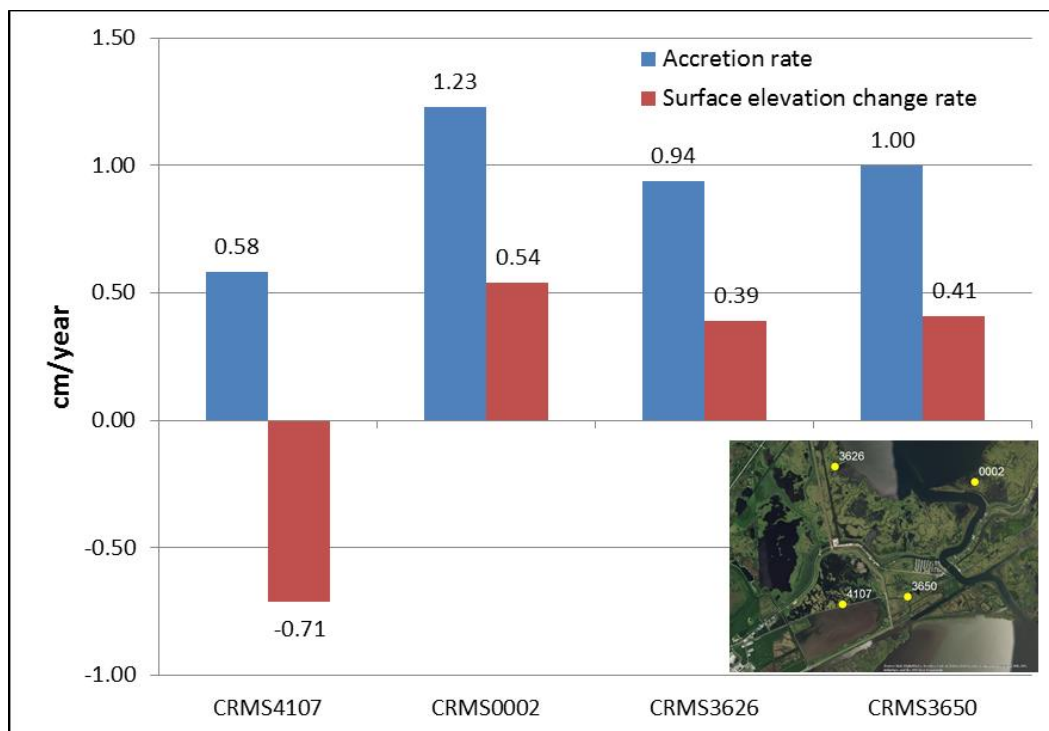
Figure 20. Long-term accretion and surface elevation change rates (cm/yr) at four CRMS sites within the Bayou Sauvage NWR. CRMS4107 is the only impounded site.

Trends in soil elevation data at several CRMS sites within the Bayou Sauvage NWR indicate that marshes within the PO-16 impoundment may be increasingly vulnerable to submergence in the future. Over five years of RSET (rod-surface elevation table) and accretion data were used to calculate elevation trends at CRMS4107 and at three unimpounded sites (CRMS0002, CRMS3626, CRMS3650) within the Bayou Sauvage NWR. Data show that accretion rates are nearly double at sites outside of the impoundment (Figure 20). RSET measurements at the three unimpounded sites also showed positive elevation change rates of 0.4-0.5 cm/yr, while CRMS4107 had a negative elevation change rate of -0.71 cm/yr. Proper management and operation of the PO-16 pumps may be increasingly critical for the health of the PO-16 marsh community if these trends continue. In summary, it appears that although there was some success in lowering water levels through PO-16 pump operation early in the project life, inundation in the project area was above target range more often than the reference area in a majority of seasons where data are available. In addition to the pumps being offline for approximately 28% of the project life, it appears that there were several seasons where pump operation could potentially have occurred to reduce water levels within the project area.

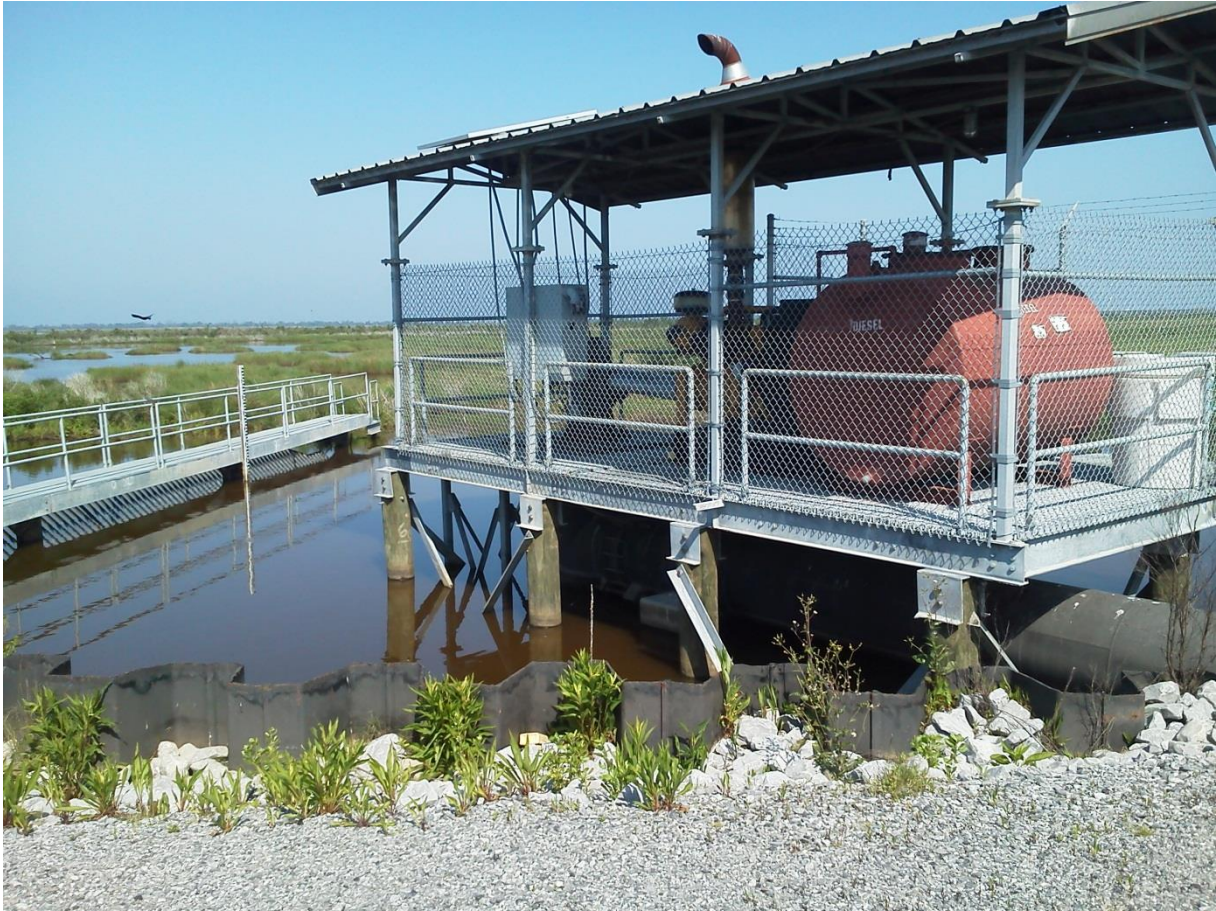
PHOTO 2: Pump 5

Pump #5 is working as designed.
