**State of Louisiana
Coastal Protection and Restoration Authority**

2017 Operations, Maintenance, and Monitoring Report

Bayou Sauvage National Wildlife Refuge Hydrologic Restoration, Phase 2 (PO-18)

December 2017
Orleans Parish

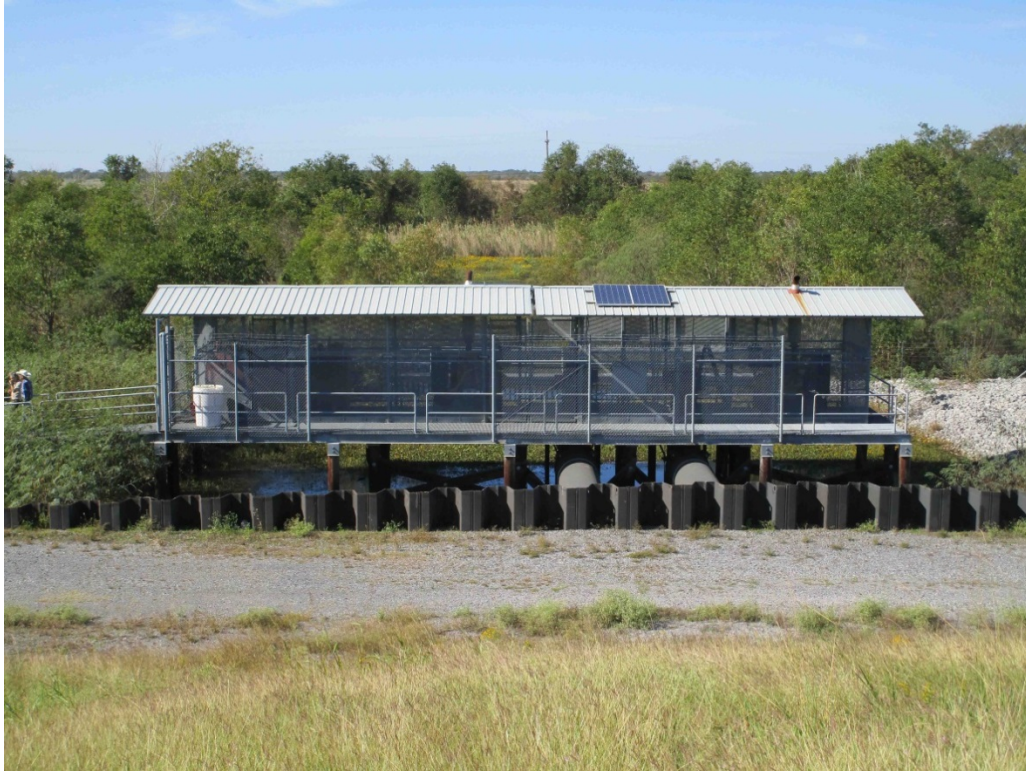
Photo #1 – Pump Platform

Item	Condition	Physical Damage	Corrosion	Photo #	Observations and Remarks
Platform	Good	None	Moderate	1	
Trash Rack	Good	None	N/A		
Fuel tank	Good	None	None	8	
Pump Drive Engines	Good	None	None	4, 5	Both engines started and ran.
Pump gear boxes	Good	None	None	6, 7	A little rough to engage but both worked.
Piping	Good	None	None	2, 3

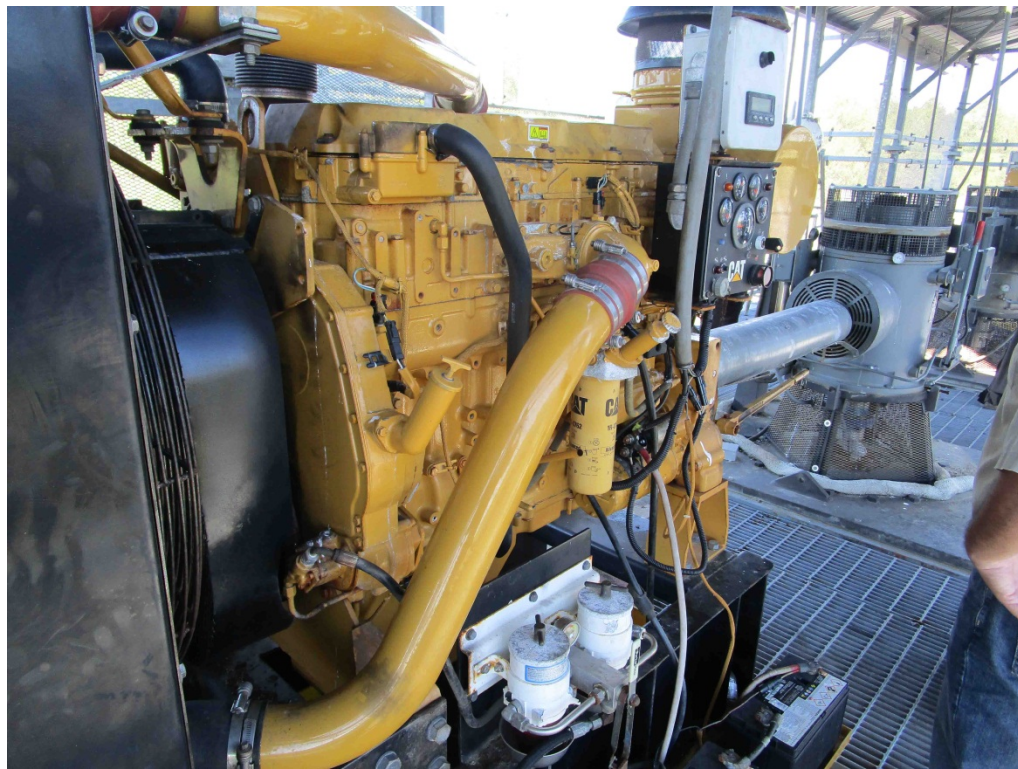
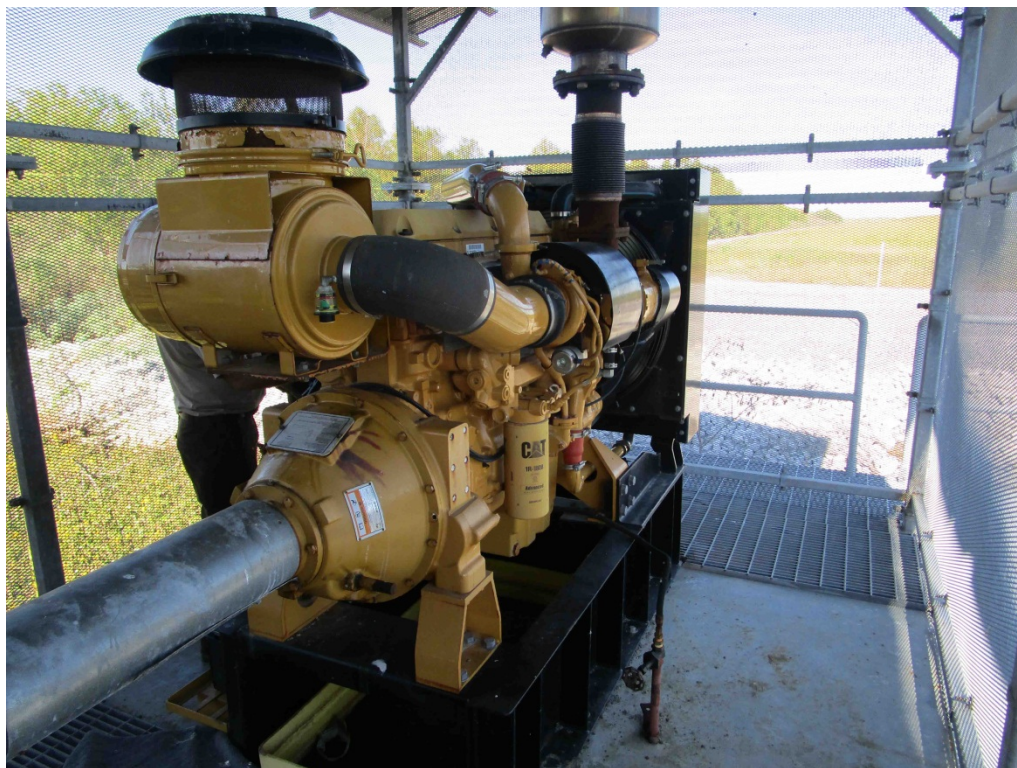
The pump is working as designed.

Photo #4 – Pump Engine

Photo #5 – Pump Engine

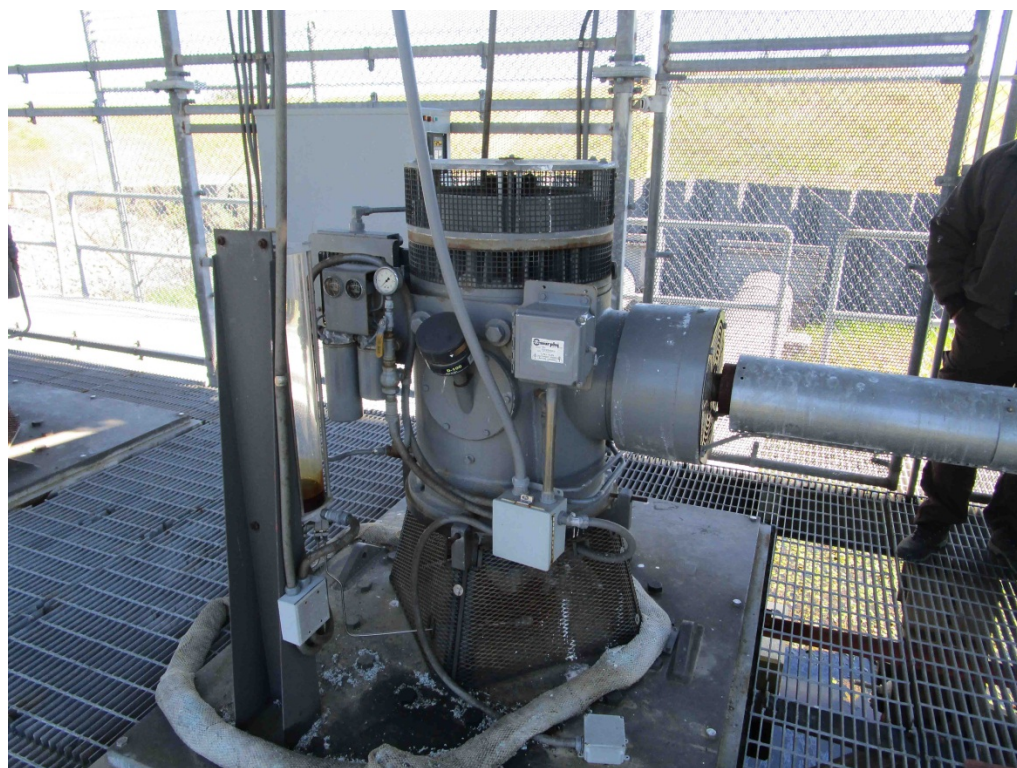
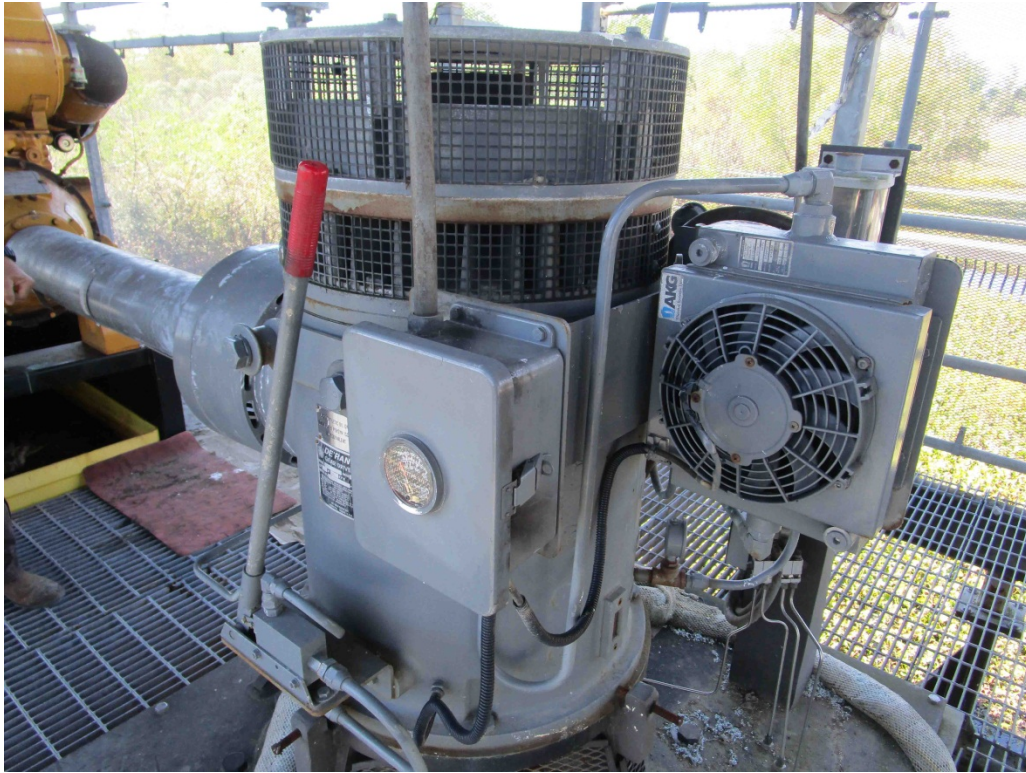
Photo #6 – Pump Gear

Photo #7 – Pump Gear
