**2014 Operations, Maintenance, and
Monitoring Report**

**Hopedale Hydrologic Restoration
(PO-24)**

State Project Number PO-24
Priority Project List 8

September 1, 2014
St. Bernard Parish

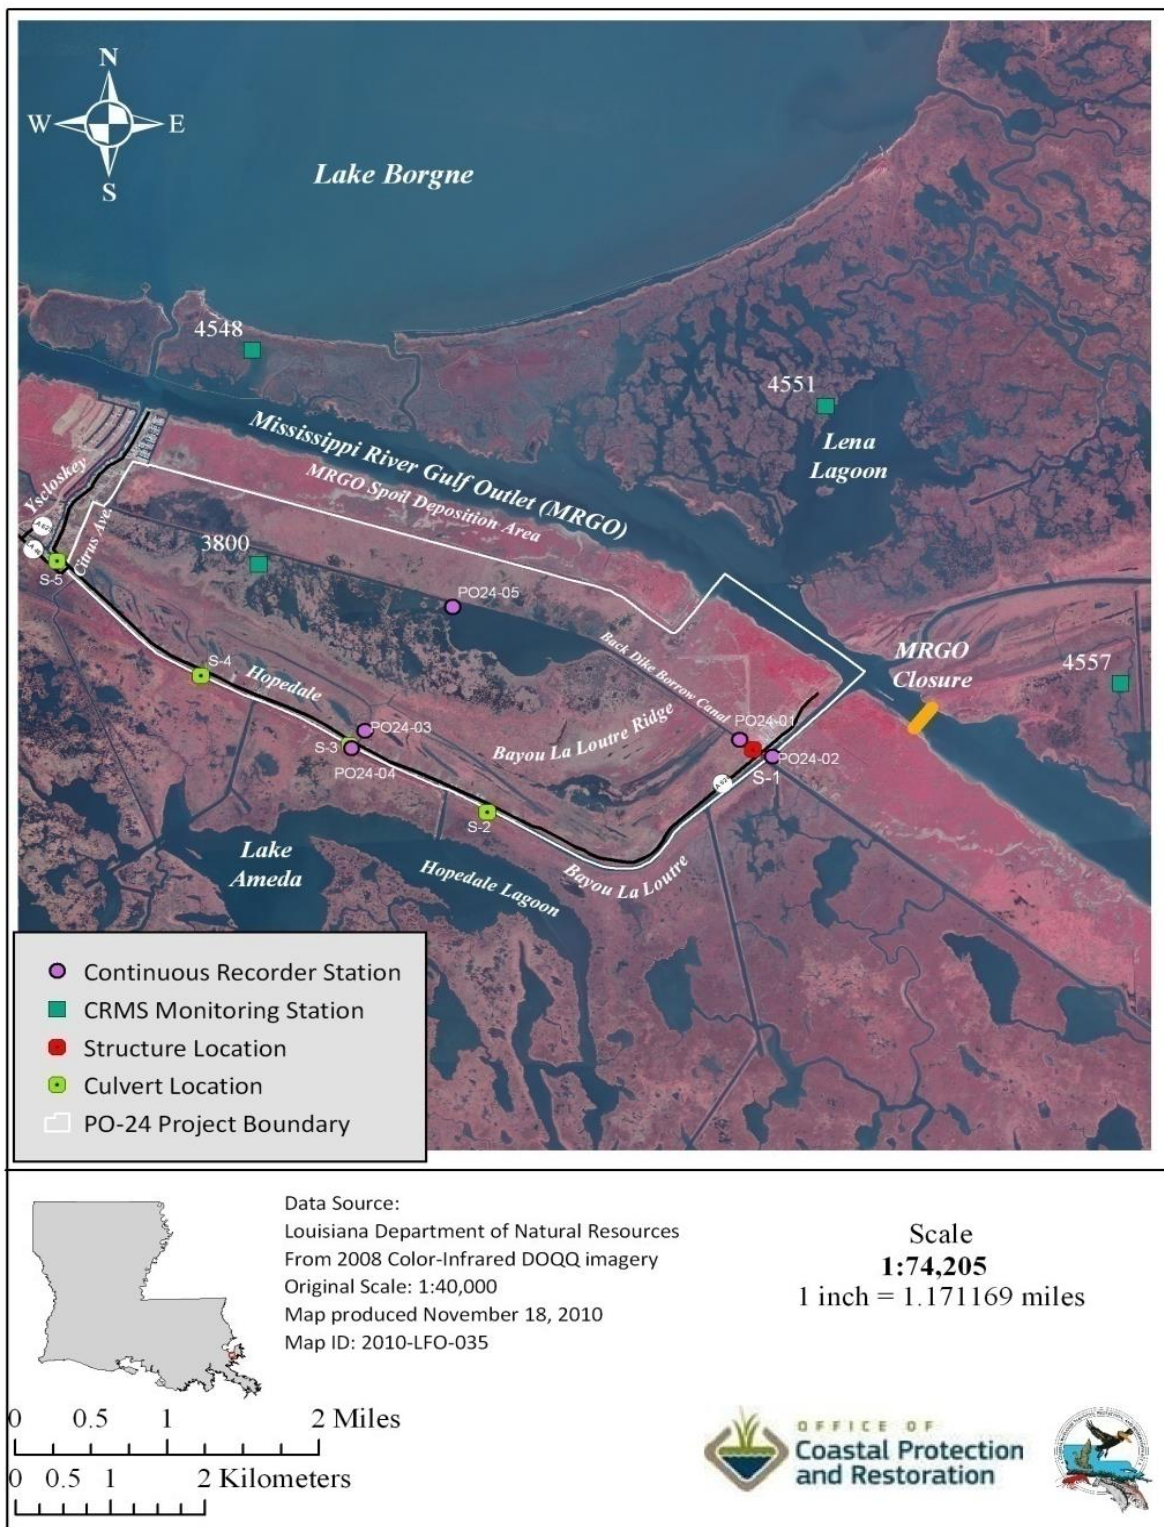
Figure 1. Hopedale Hydrologic Restoration (PO-24) project location and features.

- A sheet pile/pipe pile wall, which spans the channel and extends past both banks with an overall length of 137.9'. The top of cap plate elevation is set at +8.0' NAVD88.
- Three 82" diameter Whipps combination gates (flap/sluiice gates) and two 24"x 84" Whipps fisheries access slots (fish gates) with the inverted elevation at -7.0' NAVD88.
- A walkway with guardrails and warning signs on each side of the structure for operating the gates safely and for prohibiting unwanted access. The channel spans 115' from the canal banks and is covered with riprap (1' thick 10-lb. and 1.5' thick 55-lb.). The top of 55-lb. riprap along the canal bottom is set at elevation -8.0' NAVD88.

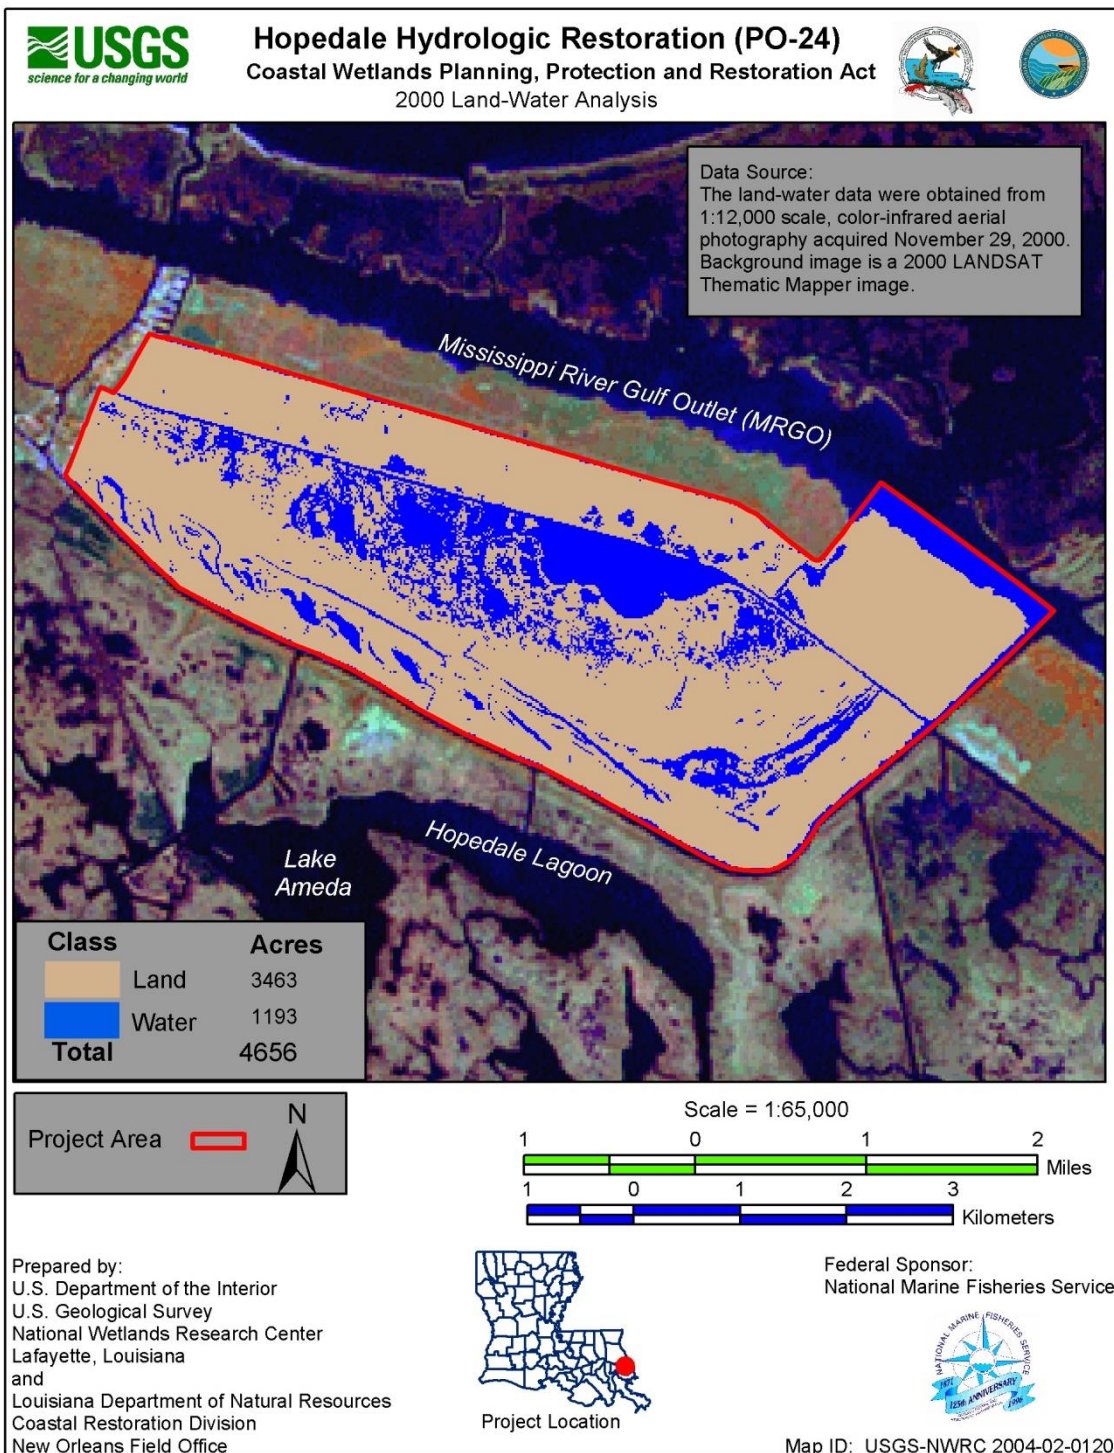
Land-water analysis of the aerial photography acquired in 2000 indicates that there were 3,463 ac of land and 1,193 ac of water within the 4,656-ac project area prior to construction (Figure 2). This amounts to 74.4% land and 25.6% water. The 2012 land-water analysis indicates that there are currently 3,509 ac of land and 1,147 ac of water within the project area, or 75.4% land and 24.6% water (Figure 3). This represents a net gain of 46 ac or 1% of land over the 12-yr period.

Figure 2. Land/water classification of 2000 aerial photography for PO-24.

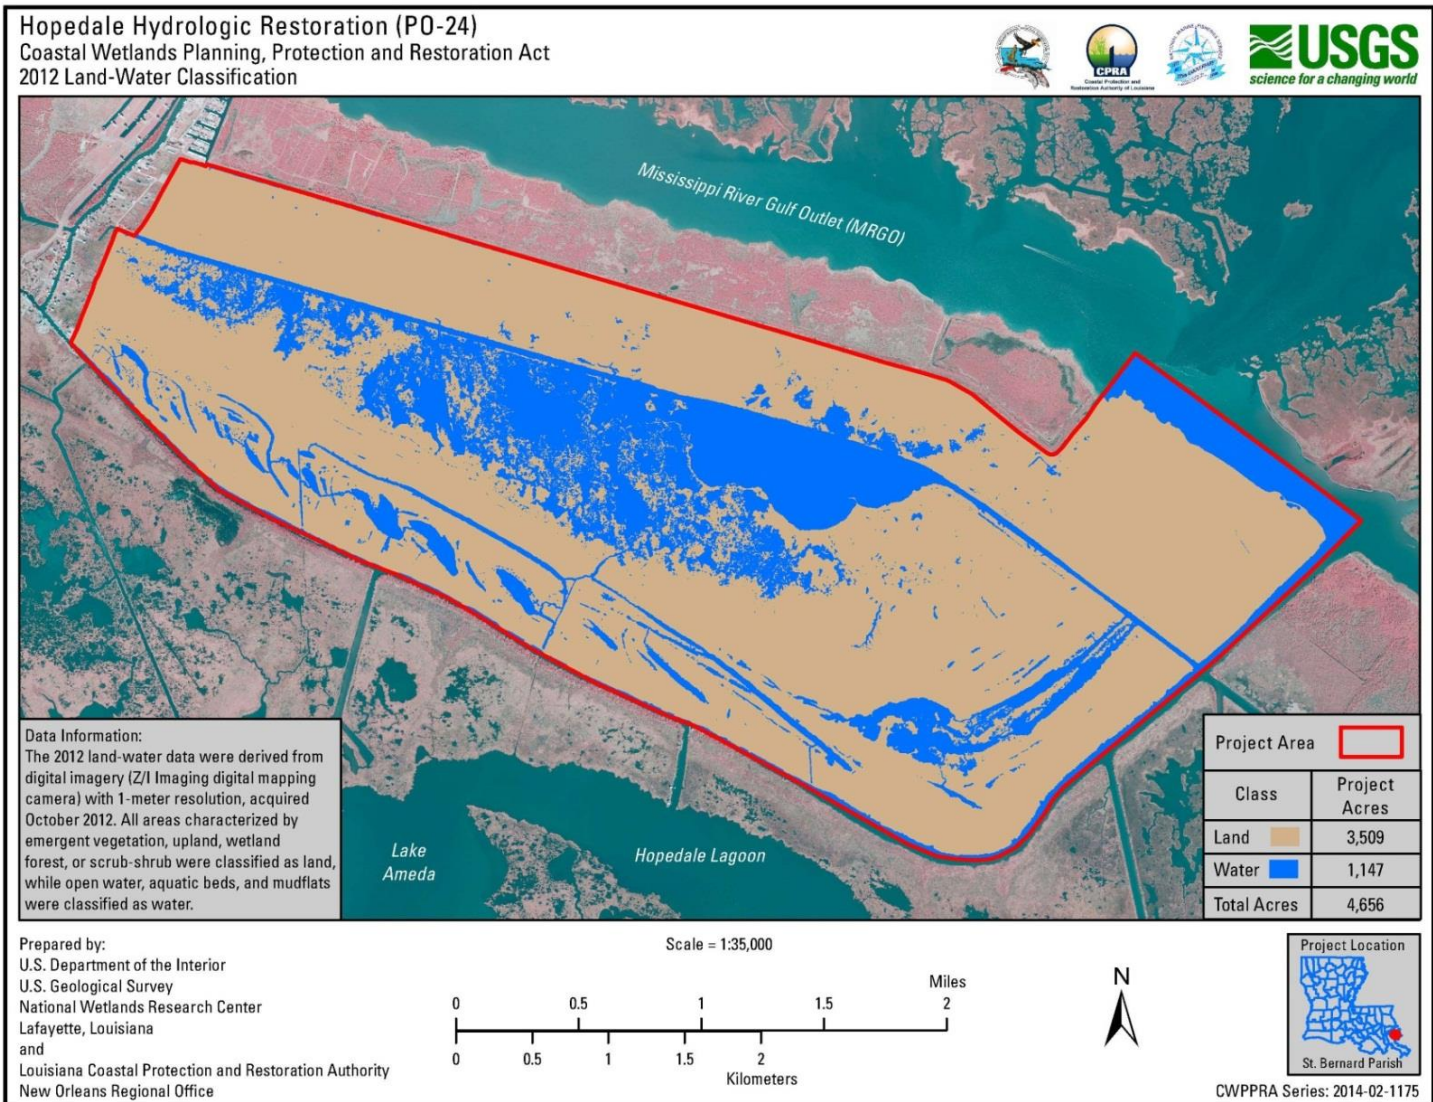
Closer inspection of the 2000 and 2012 land-water analysis reveals that much of the land gain appears in two main areas; 1) north of the back dike borrow canal and 2) an area immediately south of the back dike borrow canal in the eastern portion of the project area. The land gain in the latter area can be attributed to the placement of spoil from a maintenance dredging event of the MRGO that took place in 2005 (Figure 4). The dredged spoil was placed in an area of broken marsh approximately 150 ac in size and has subsequently vegetated. Despite the gains in land acreage, there were land losses in the central portion of the project area between the back dike borrow canal and the Bayou La Loutre Ridge. This land loss is due to the continued degradation of the fragmented marsh in the area.

Figure 3. Land/water classification of 2012 aerial photography for PO-24.

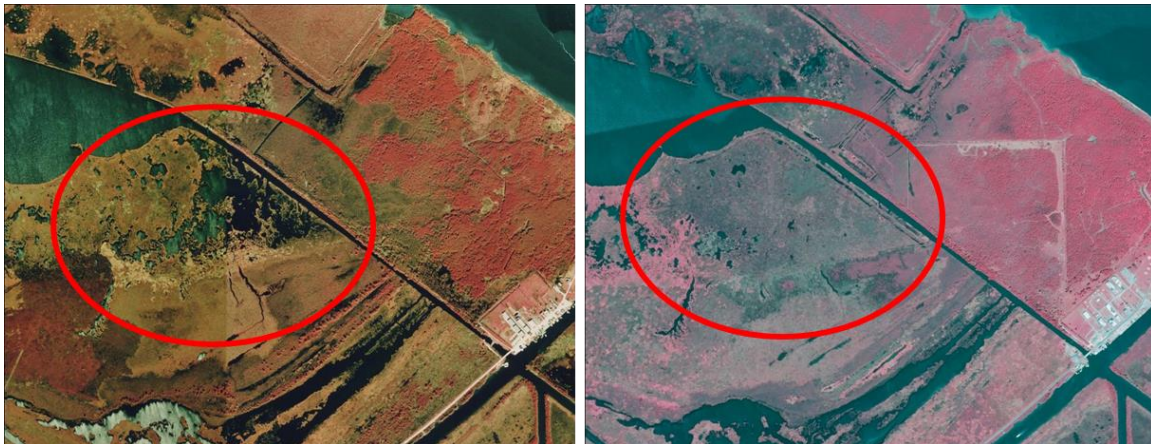
Figure 4. Location of MRGO spoil deposition within the PO-24 project area in 1998 (left) and 2012 (right).

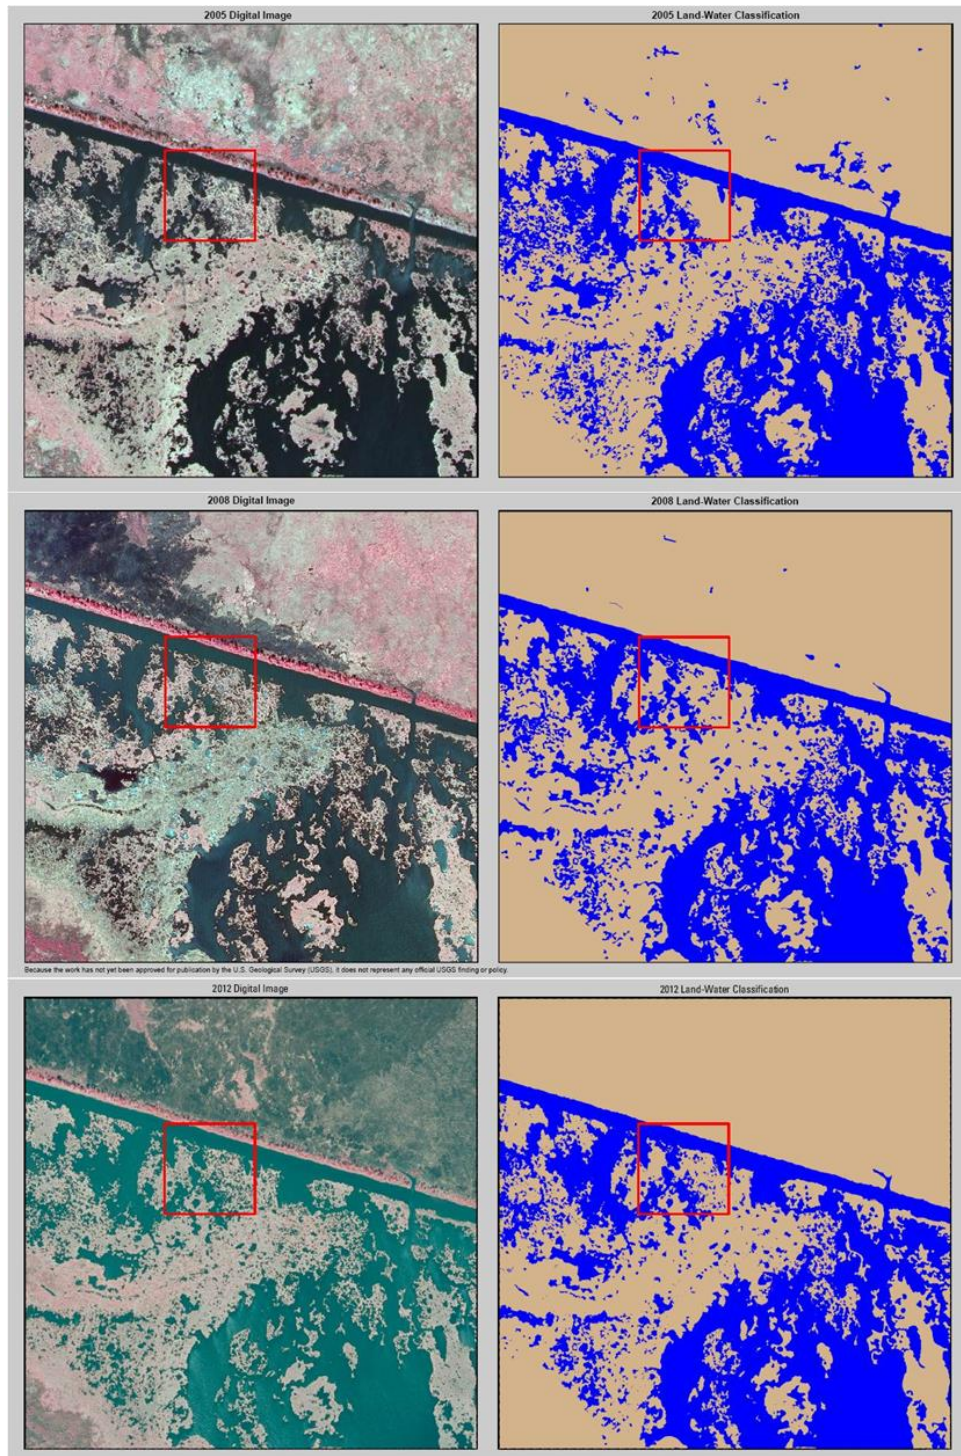
CRMS land-water analyses were conducted in 2005, 2008, and 2012 (Table 2). Although all of these analyses took place after project construction, they still offer a comparison of trends within the project and reference areas. The 1-km² area for land-water analysis at CRMS3800 is contained entirely within the PO-24 project area. Land:water ratios at this site have remained relatively steady; with land area increasing slightly between 2005 and 2008, then decreasing in 2012 but showing a net gain overall (Figure 5). There is no clear trend in land:water ratios among the three reference sites. CRMS4548 exhibits a similar trend as CRMS3800 (Figure 6). There was a net loss in land area at CRMS4551; with land area decreasing slightly with each analysis (Figure 7). Finally, there was a net gain at CRMS4557; with land area holding steady between 2005 and 2008 and increasing in 2012 (Figure 8).

Figure 5. Color infrared aerial imagery and land-water analysis of 1-km² area at CRMS3800 for years 2005 (top), 2008 (middle), and 2012 (bottom).

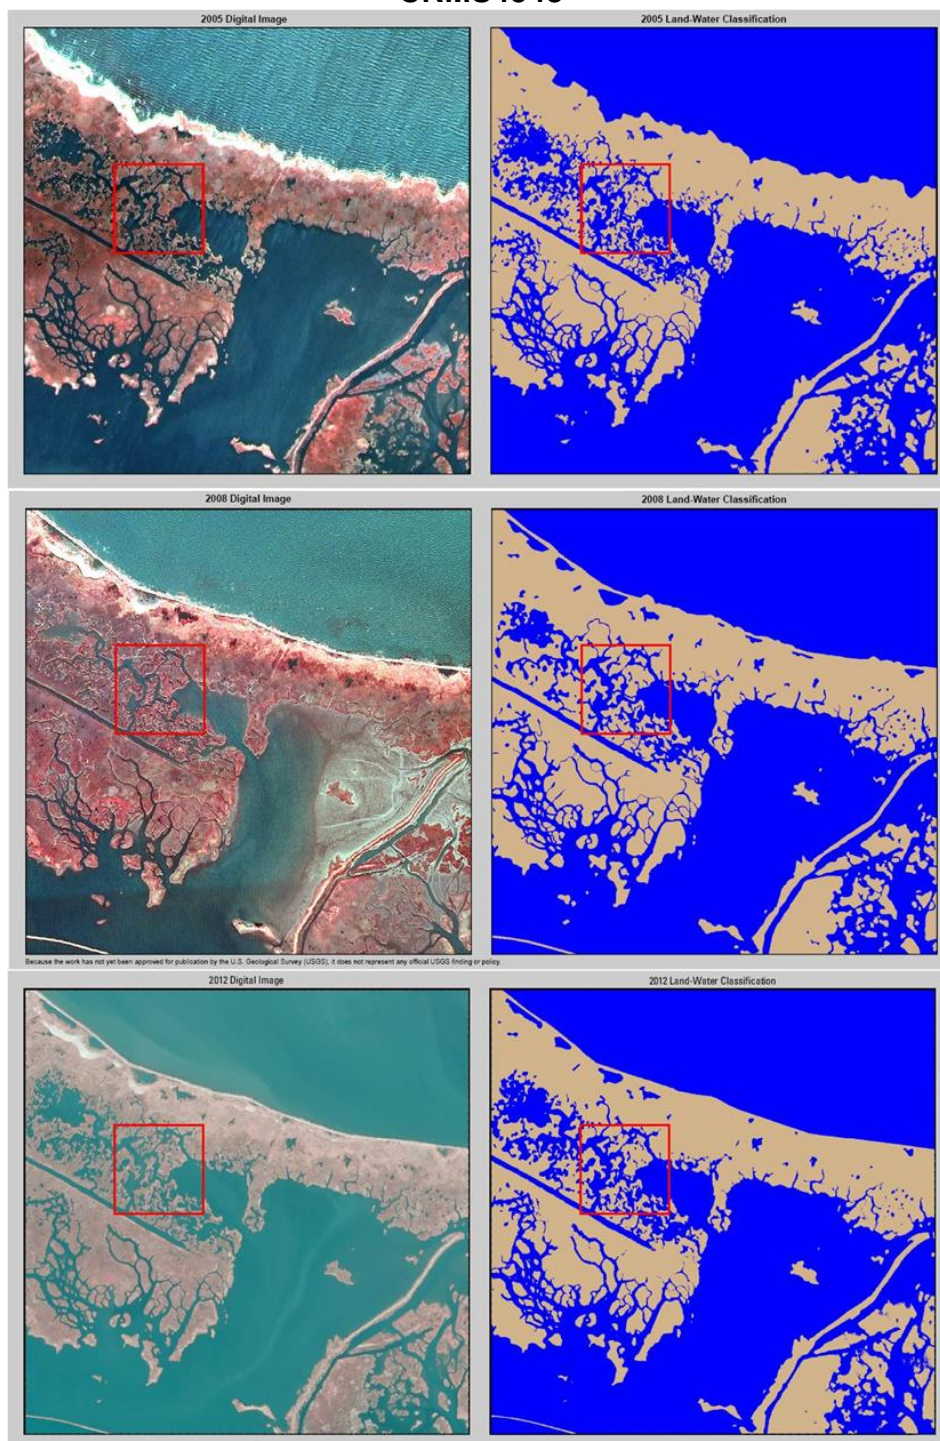
Figure 6. Color infrared aerial imagery and land-water analysis of 1-km² area at CRMS4548 for years 2005 (top), 2008 (middle), and 2012 (bottom).

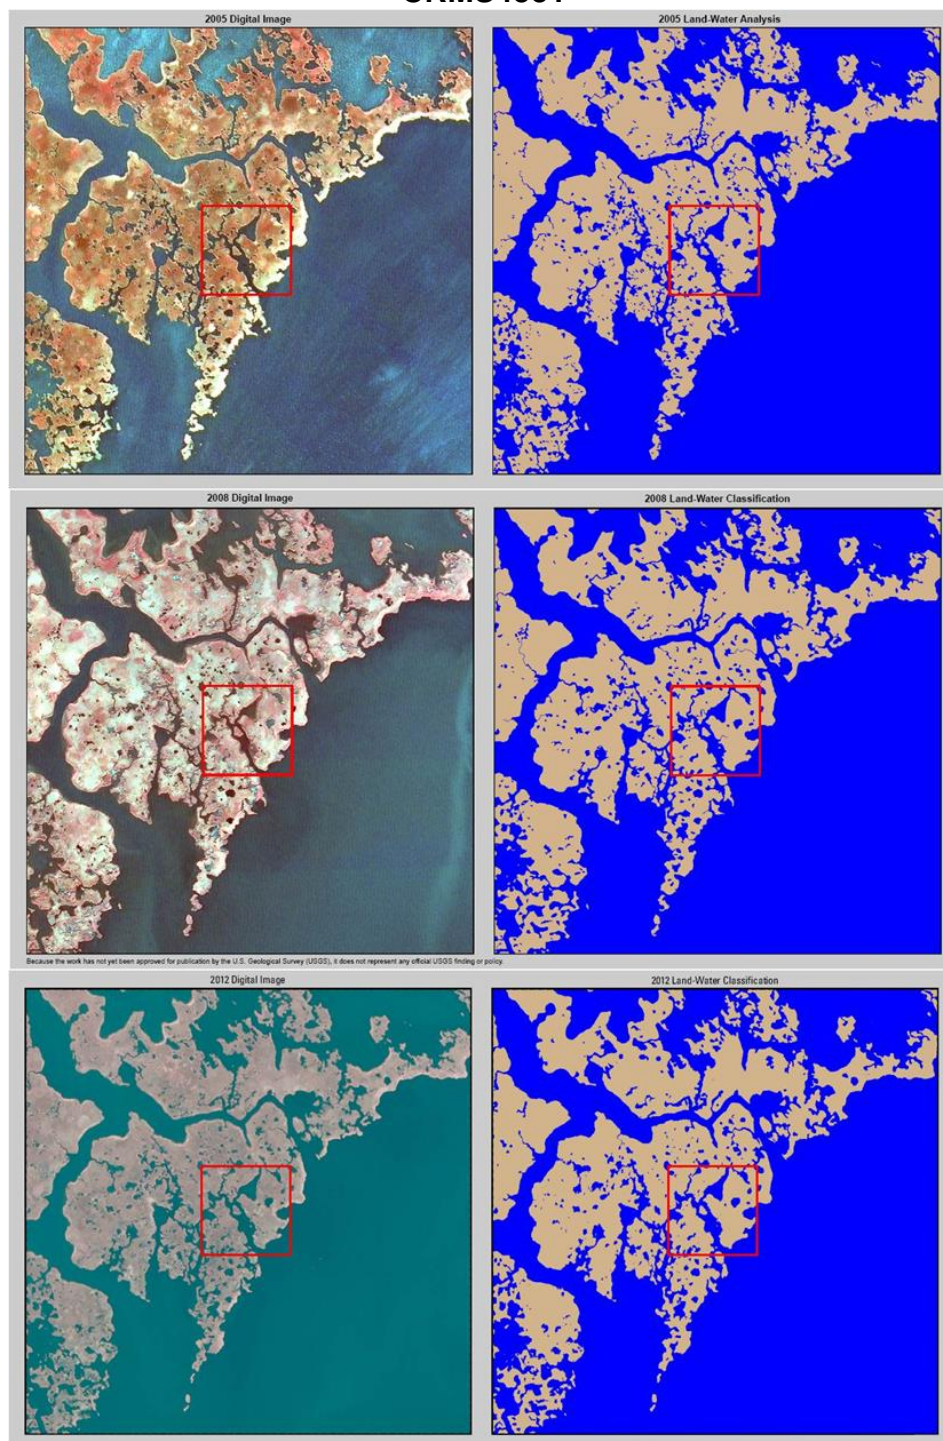
Figure 7. Color infrared aerial imagery and land-water analysis of 1-km² area at CRMS4551 for years 2005 (top), 2008 (middle), and 2012 (bottom).

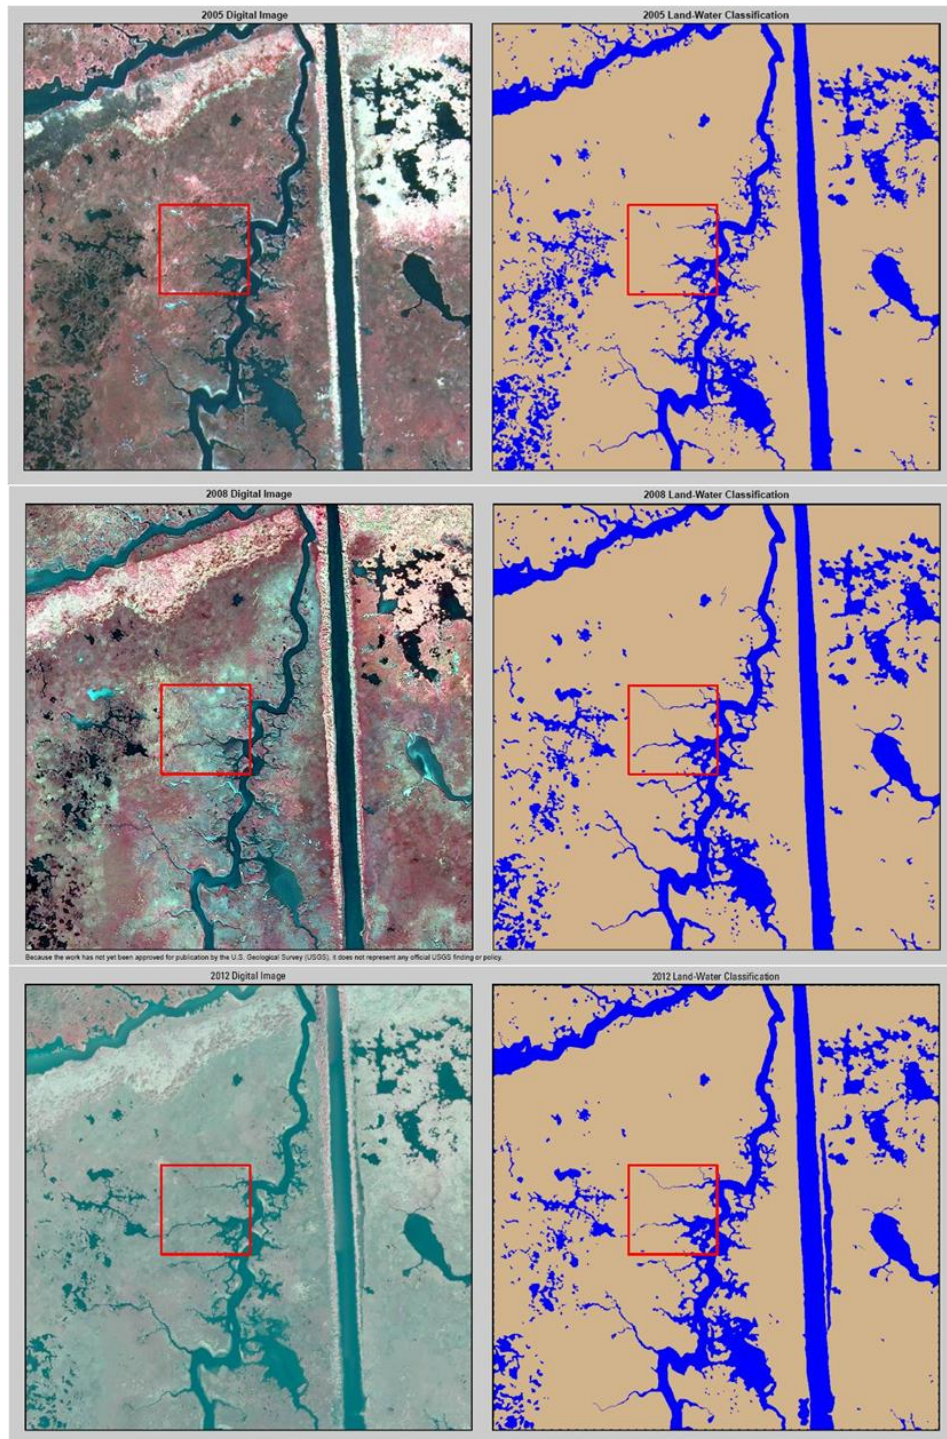
Figure 8. Color infrared aerial imagery and land-water analysis of 1-km² area at CRMS4557 for years 2005 (top), 2008 (middle), and 2012 (bottom).

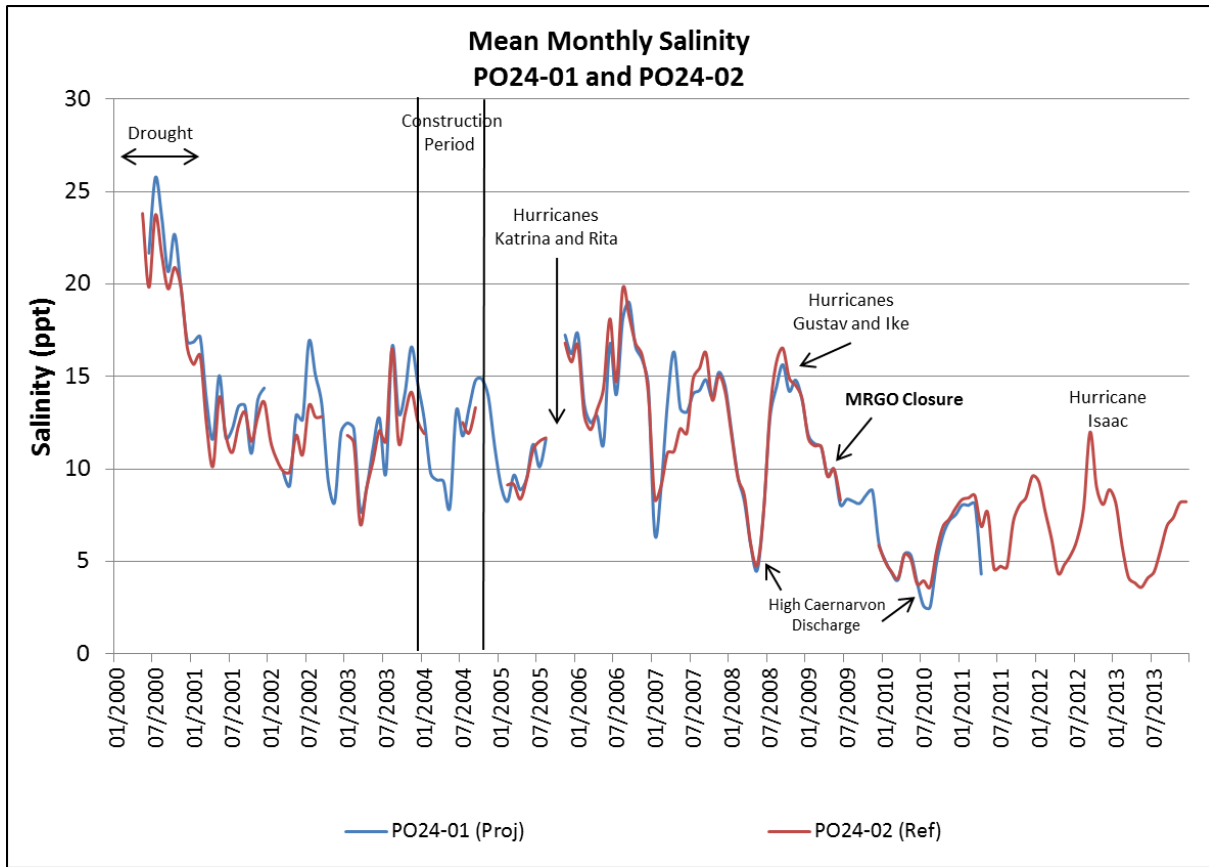
southeast Louisiana from August 1999 to December 2000 during which time widespread dieback of marsh vegetation occurred throughout Louisiana's coastal zone (locally known as the Brown Marsh Dieback). Figures 9 and 10 depict salinity signals over the entire data record. The PO-24 stations recorded the highest salinity levels for the entire 13-year period of record during the drought with salinity values registering up to 10 ppt greater than normal conditions. Salinity incursions also occurred during tropical events and during periods of sustained strong east winds, which can be identified by spikes in Figures 9 through 11. The spikes from these meteorological events were short-lived compared to the increase in salinity associated with the drought at the beginning of data collection.

Figure 9. Mean monthly salinity for project station PO24-01 and reference station PO24-02 for the Hopedale Hydrologic Restoration (PO-24) project.

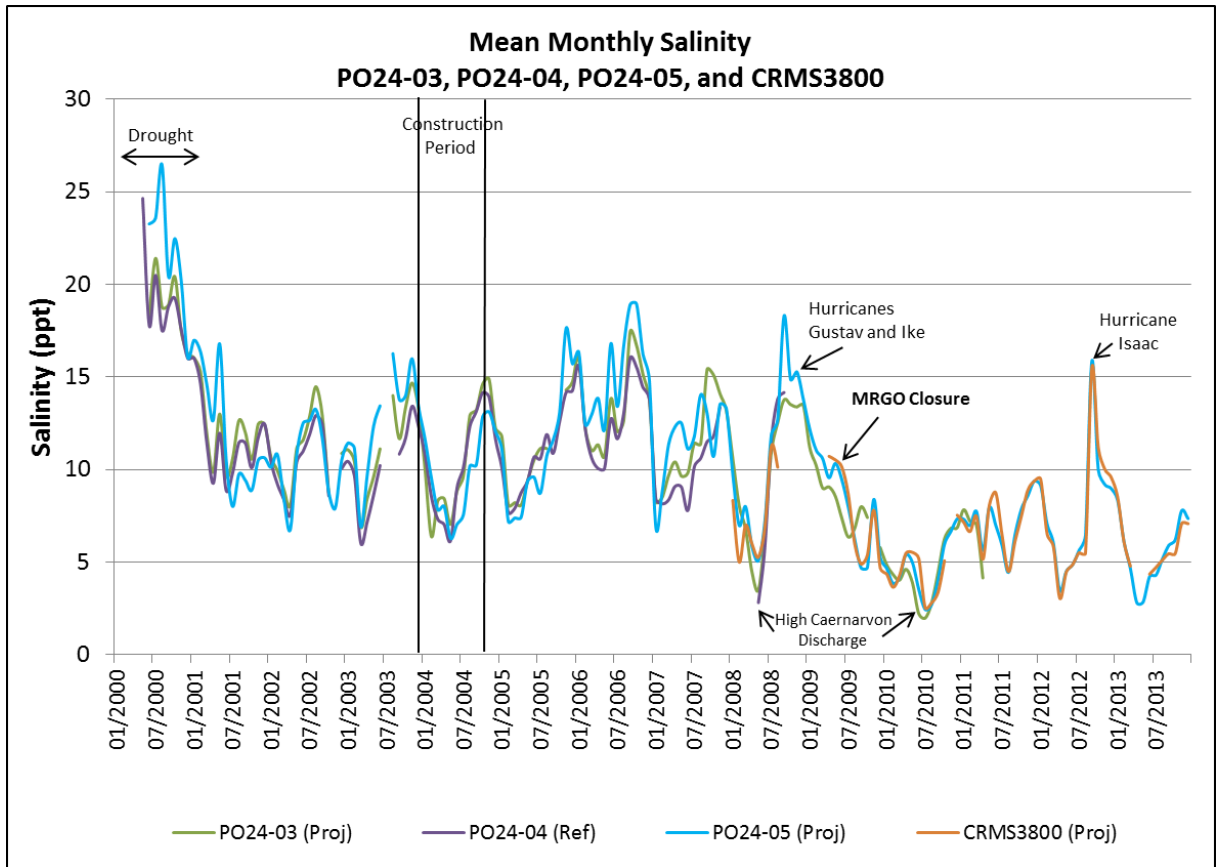
Figure 10. Mean monthly salinity for project stations PO24-03, PO24-05, and CRMS3800 and reference station PO24-04 for the Hopedale Hydrologic Restoration (PO-24) project.

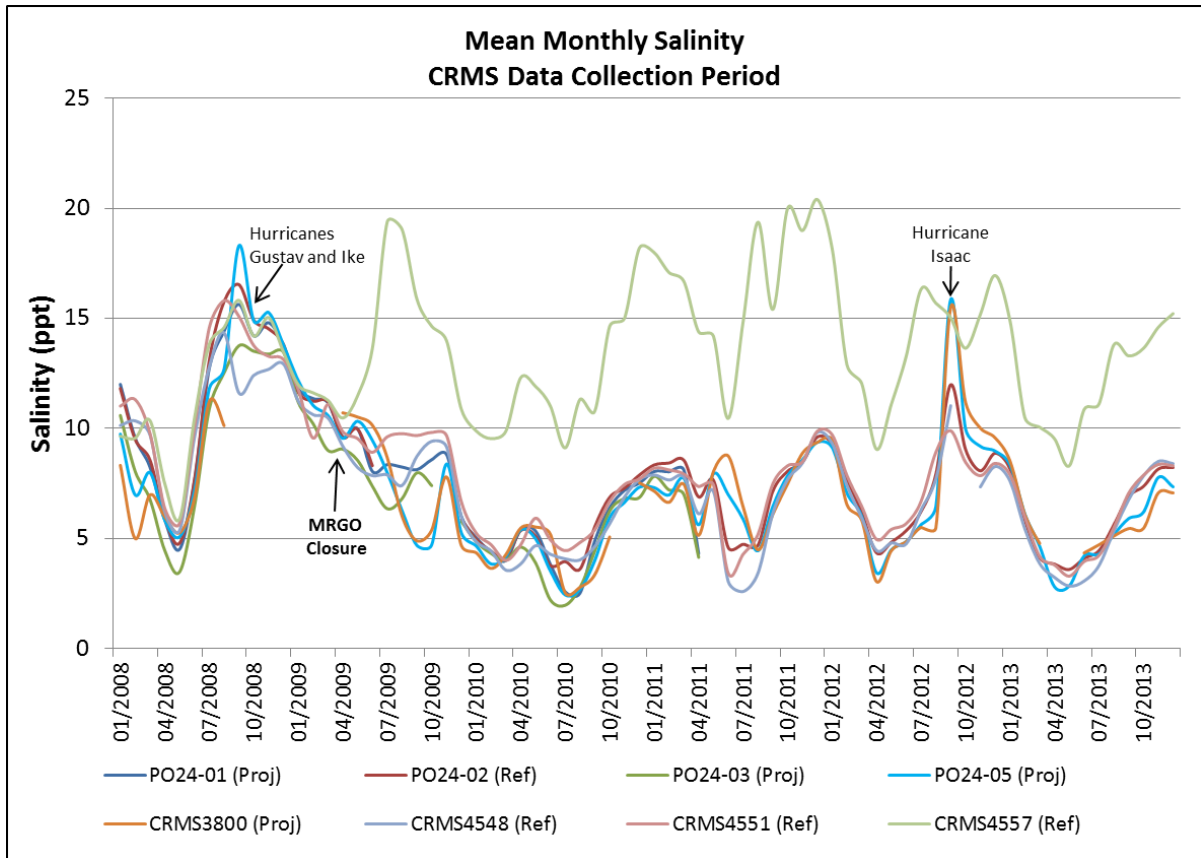
Figure 11 compares salinity data for the period of record containing CRMS data (beginning Jan 2008). Beginning in mid-2009, salinity values at CRMS4557 diverge from surrounding sites and increase by up to 10 ppt. The closure of the MRGO navigation channel during this same time period appears to have caused this divergence, as CRMS4557 is the only station southeast of the closure structure. Stations PO24-02 and PO24-05 have the longest period of record before and after the closure of the MRGO and were used to compare salinities before and after the MRGO closure. Approximately 5 years pre-closure and 5 years post-closure were compared (1/1/05-4/15/09 (PRE), 4/16/09-12/31/13 (POST). There was a significant decrease in mean weekly salinity of 5-6 ppt in the period following MRGO closure at both sites (ANOVA, $p < 0.0001$) (Figure 12). There was no significant difference between the salinity response inside (PO24-05) and outside (PO24-02) of the project area based on a 2-sample median test of paired weekly means ($p = 0.0750$).

Figure 11. Mean monthly salinity for PO-24 and CRMS stations near the Hopedale Hydrologic Restoration (PO-24) project from 1/2008 to 12/2013.

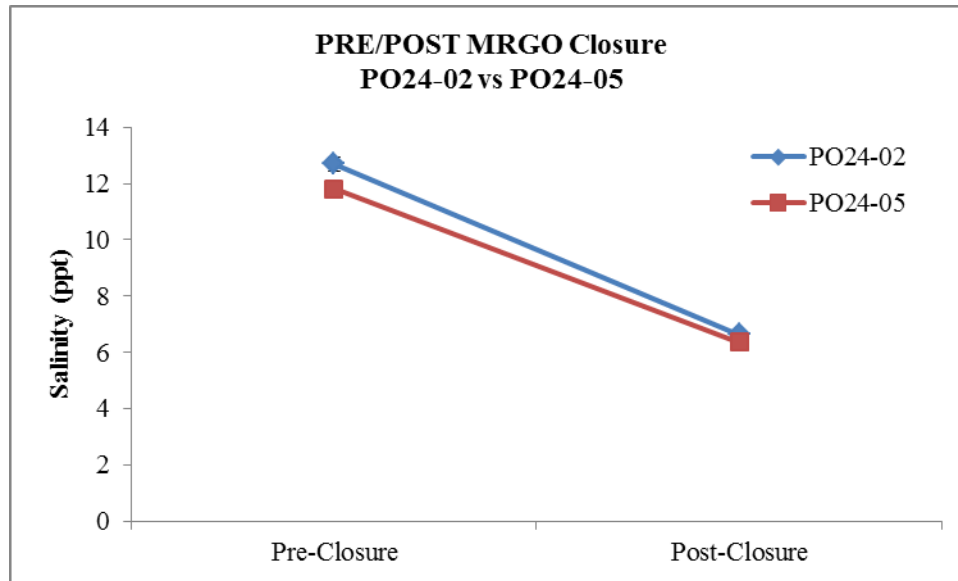
Figure 12. Change in salinity at PO24-02 (reference) and PO24-05 (project) following the closure of the Mississippi River Gulf Outlet (MRGO) in 2009.

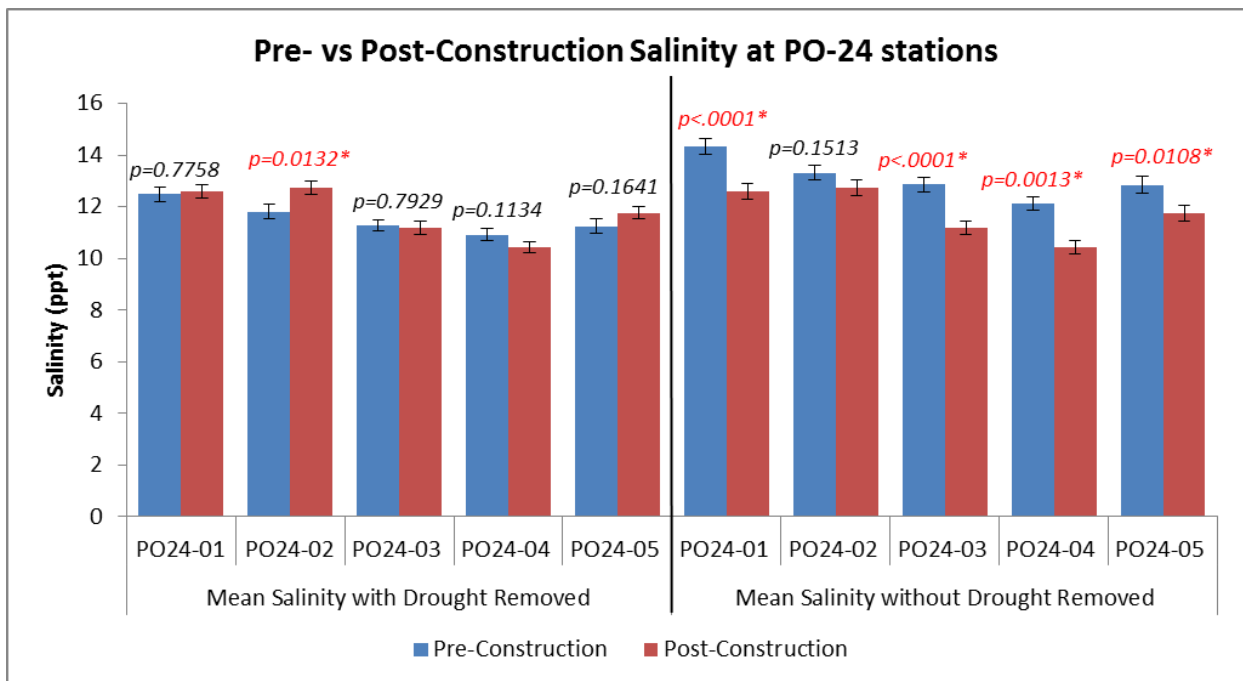
To test for PO-24 project effects in the pre- vs post-construction periods, the pre-construction period was defined as 3/1/2001-12/31/2003 and the post-construction period was defined as 12/1/2004 to 9/15/2008. Data was not included past 9/15/08 because of the effects of the MRGO closure and because that is the end of the data record for PO24-04. The mean weekly salinity concentrations were significantly lower during the post- construction period at all PO-24 stations except for PO24-

02; however, removing the drought from the pre-construction period caused the differences to be no longer significant (Figure 13). To test the interaction between project and reference sites in pre-construction and post-construction time periods, non-parametric Before After Control Impact (BACI) paired series analyses were performed. For this analysis, sondes were “paired” based on the field design. Differences were calculated by subtracting mean weekly salinity at the impacted (project) site from the control (reference) site (difference = reference – project). A 2-sample median test (a non-parametric analog of a 2-sample t-test) was used to compare the site differences before and after construction. The test is a non-parametric One-way ANOVA with a median test of Chi Square values, which was run using JMP 11.0.0 statistical software. The statistical model depends on simultaneous measurements among the paired sondes, therefore, only weeks in which there were data available to calculate differences were used in the analysis. In this case, the drought period was not removed because one of the statistical assumptions of the paired design is that the drought would affect both stations equally.

Figure 13. Average of mean weekly salinity for the pre- and post-construction periods of the Hopedale Hydrologic Restoration (PO-24) project. Removing the drought period caused no significant difference between pre/post periods at four of the stations. Statistics computed using ANOVA. Error bars represent the standard error of the mean.

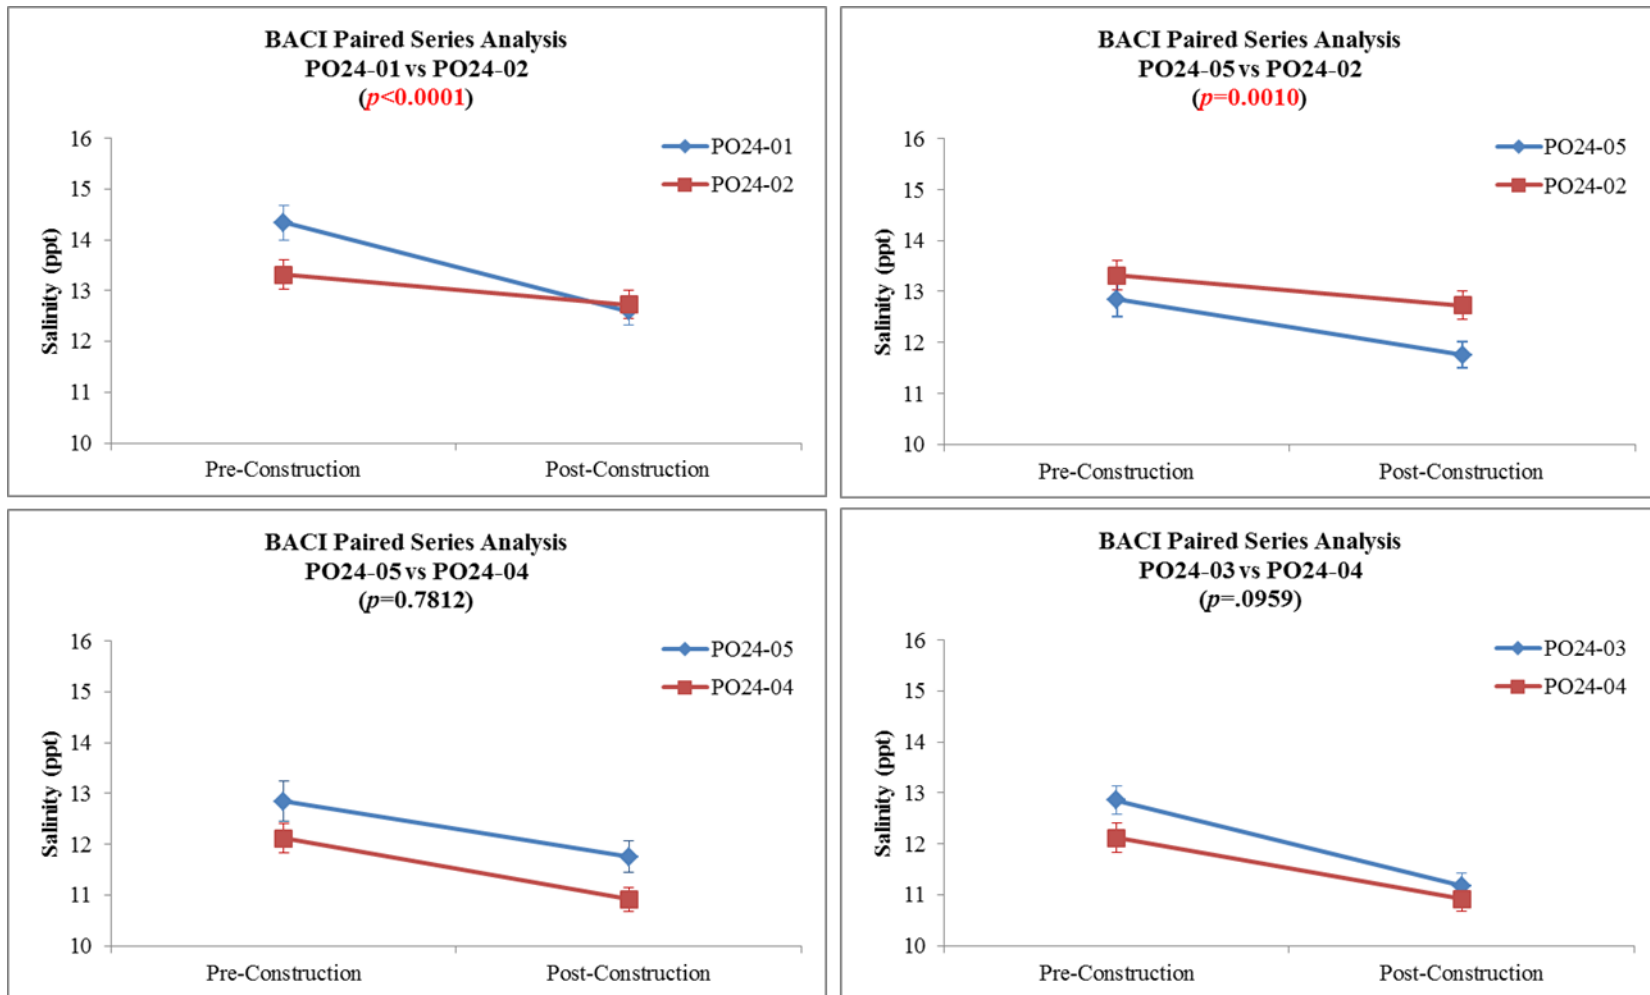
Results of the BACI paired analysis indicate significant interactions between project sites with reference site PO24-02, but no significant interaction between project sites with reference site PO24-04 (Figure 14). PO24-01 and PO24-05 (project sites) both had a significantly greater decrease in salinity in the post-construction period compared to PO24-02 (reference), which shows up as lines out of parallel in Figure 14. Salinity change in the post-construction period was about 1.2 ppt greater ($p < 0.0001$) at PO24-01 and about 0.5 ppt greater ($p = 0.0010$) at PO24-05 than the change at PO24-02. The level of decreased salinity was very small compared to the target salinity range for this marsh type (mesohaline, 5-18 ppt) suggesting that a change in marsh community is not likely. There were no significant interactions between project sites PO24-03 and PO24-05 with reference site PO24-04 (Figure 14) with both project sites showing a similar post-construction decrease in salinity as the reference site. Due to its location, reference site PO24-02 was more heavily influenced by the MRGO before its closure and therefore showed the greatest difference from the sites within the project area. In summary, while there was a significant difference in salinity reduction in the project area compared to reference site PO24-02, the ecological significance of this change is small. Future changes in the marsh community within the project area would more likely be attributed to the closure of the MRGO which reduced mean salinities in the area by 5-6 ppt.

Figure 14. BACI paired series analysis graphs for salinity.

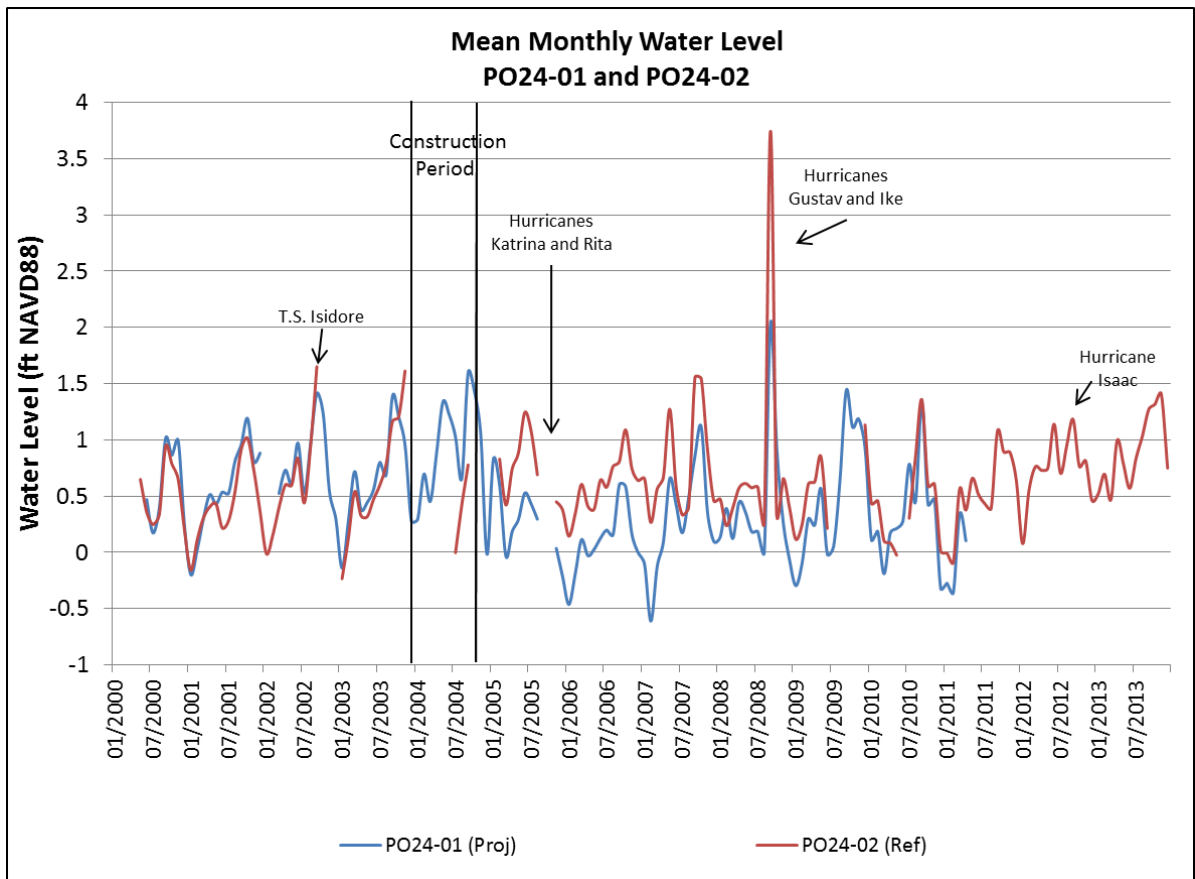
Visual observation of mean monthly water level shows project stations, PO24-01 and PO24-05, tracking closely with reference stations during the pre-construction period and then maintaining lower water elevations than reference stations during the post-construction period (Figures 15 and 16). The exception is PO24-03, which tracks closely with nearby reference station PO24-04 before and after construction. Figure 17 shows project and reference stations during the period of CRMS data collection from 2008 to 2013. Project stations PO24-01, PO24-05, and CRMS3800 generally track lower than the other stations during this data period, including project station PO24-03. Impacts from the closure of the MRGO on water levels are visually less evident than impacts on salinity; however, a comparison of weekly mean water level before and after the closure showed a significant increase in water level of 0.22 ft at project station PO24-05 ($p < 0.0001$) in the post-closure period, while water level at reference station PO24-02 was not significantly different ($p = 0.2978$) in the post-closure period (Figure 18).

Figure 15. Mean monthly water level for project station PO24-01 and reference station PO24-02 for the Hopedale Hydrologic Restoration project.

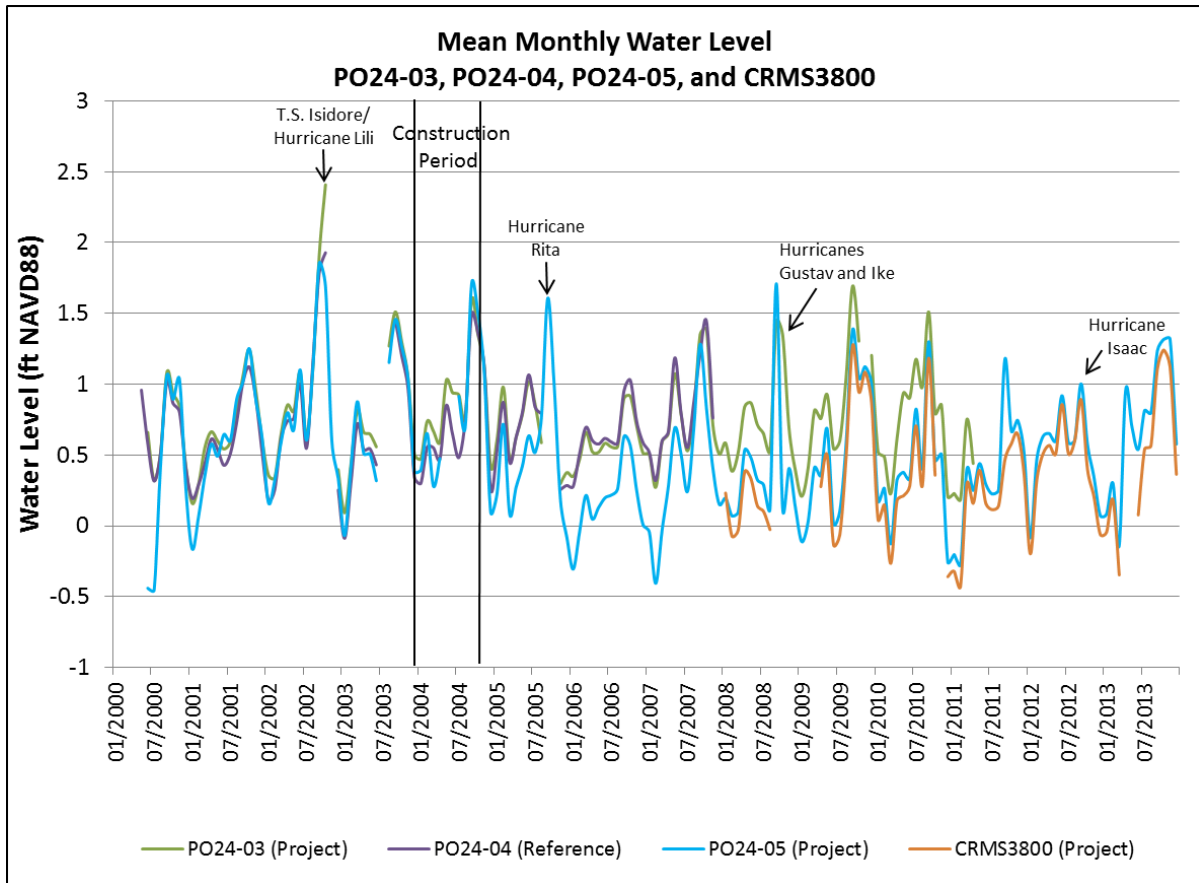
Figure 16. Mean monthly water level for project stations PO24-03, PO24-05, and CRMS3800, and reference station PO24-04 for the Hopedale Hydrologic Restoration project.
