**2014 Operations, Maintenance, and
Monitoring Report**

**Hopedale Hydrologic Restoration
(PO-24)**

State Project Number PO-24
Priority Project List 8

September 1, 2014
St. Bernard Parish

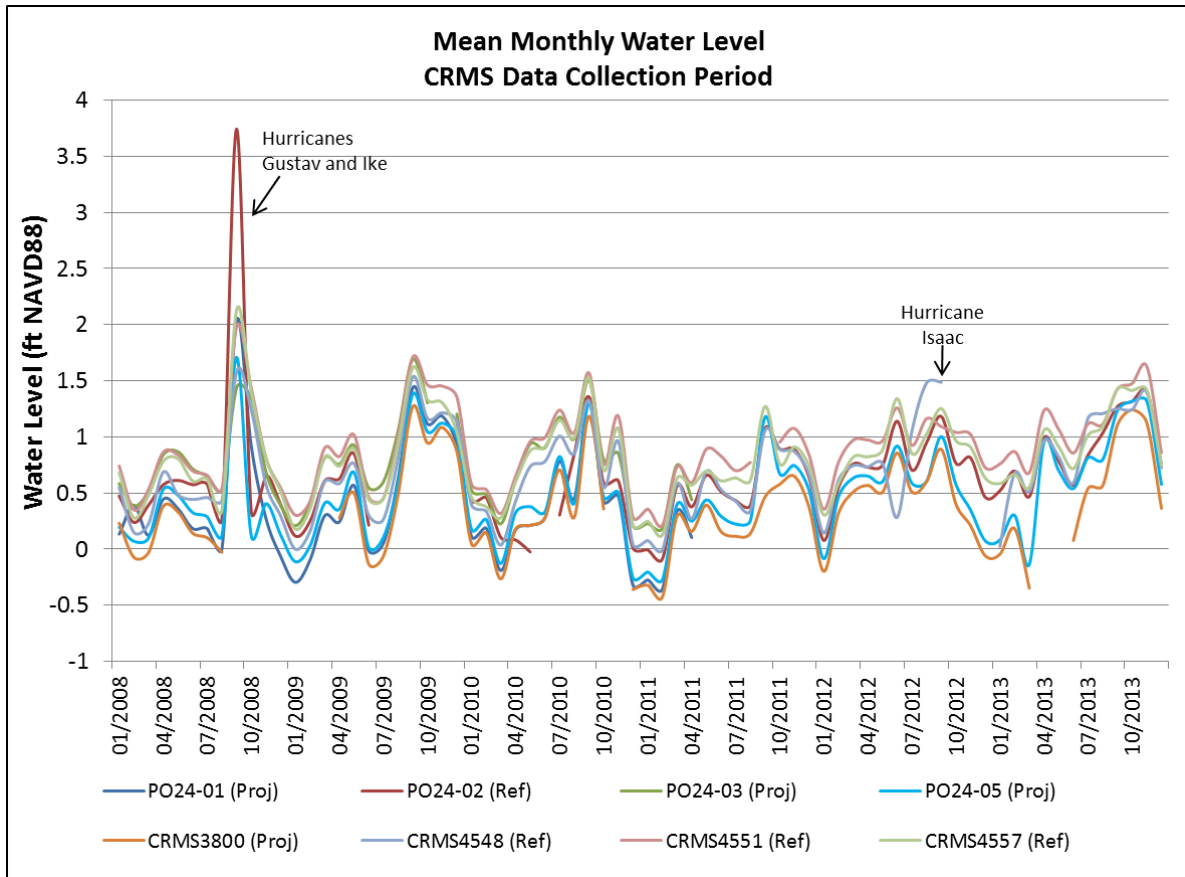
Visual observation of mean monthly water level shows project stations, PO24-01 and PO24-05, tracking closely with reference stations during the pre-construction period and then maintaining lower water elevations than reference stations during the post-construction period (Figures 15 and 16). The exception is PO24-03, which tracks closely with nearby reference station PO24-04 before and after construction. Figure 17 shows project and reference stations during the period of CRMS data collection from 2008 to 2013. Project stations PO24-01, PO24-05, and CRMS3800 generally track lower than the other stations during this data period, including project station PO24-03. Impacts from the closure of the MRGO on water levels are visually less evident than impacts on salinity; however, a comparison of weekly mean water level before and after the closure showed a significant increase in water level of 0.22 ft at project station PO24-05 ($p < 0.0001$) in the post-closure period, while water level at reference station PO24-02 was not significantly different ($p = 0.2978$) in the post-closure period (Figure 18).

Figure 17. Mean monthly water level for the Hopedale Hydrologic Restoration project and reference stations during the CRMS data collection period.

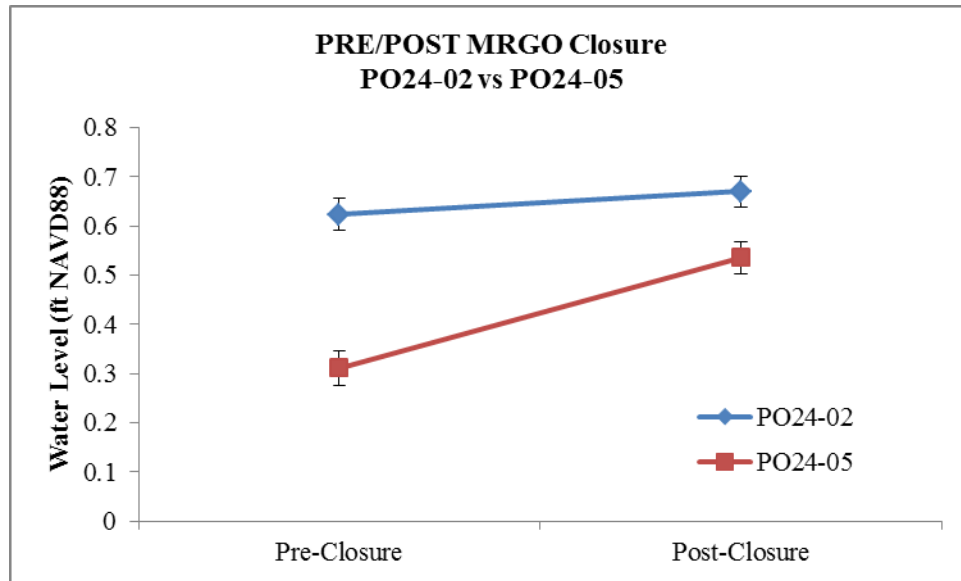
Figure 18. Change in water level at PO24-02 (reference) and PO24-05 (project) following the closure of the Mississippi River Gulf Outlet (MRGO) in 2009.

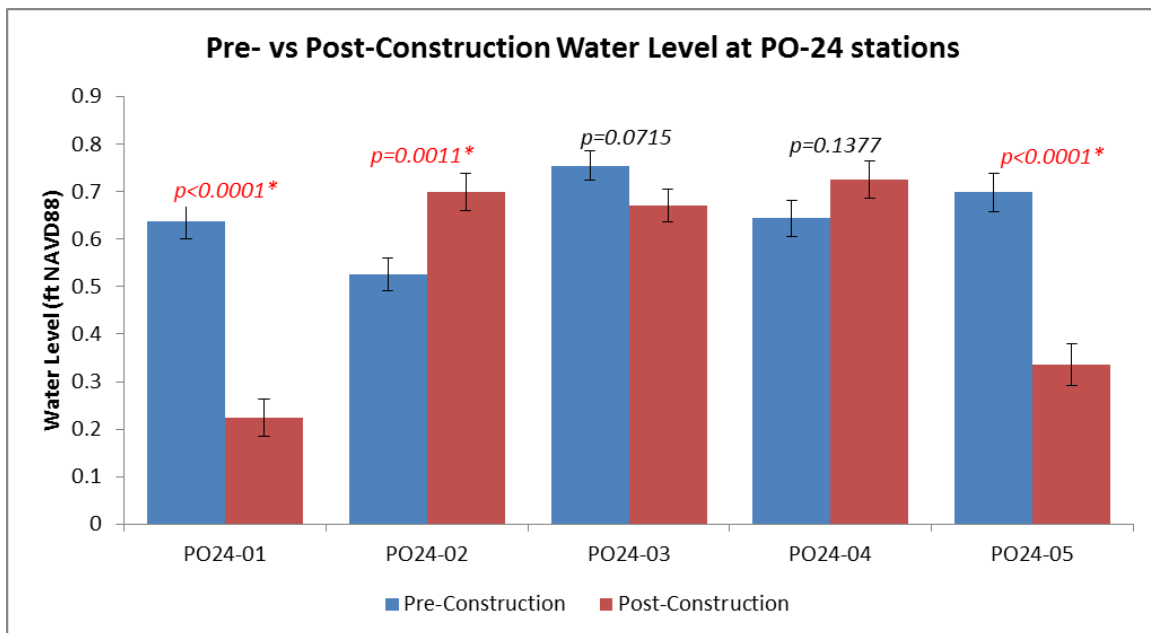
Figure 19 shows a significant decrease in mean weekly water levels of approximately 0.4 ft at project sites PO24-01 and PO24-05 ($p < 0.0001$) during the post-construction period. Removing the drought period from the pre-construction period did not alter the results as was seen with the salinity data. Station PO24-03 showed a slight decrease in water level but this decrease was not significant. The reduced project effect on water level at station PO24-03 is reasonable considering its location within the project area. Station 03 is located in a small unnamed bayou on the south side of the Bayou La Loutre ridge, near the south central boundary of the project area. The connection of this small bayou with Bayou La Loutre is through three 36" non-gated culverts which run under Hwy 624. These open culverts allow water to flow in and out of the project area freely, as opposed to the structure near station PO24-01 which only allows water out. Reference

stations PO24-02 and PO24-04 both showed increases in mean weekly water level following construction (Figure 19), however, only station 02 was significant ($p=0.011$). A comparison of CRMS reference stations (CRMS4548, CRMS4551, and CRMS4557) and project area stations (PO24-05 and CRMS3800) during the CRMS data collection period indicate that water levels inside the project area were significantly lower than those outside of the project boundaries (Figure 20).

Figure 19. Average of mean weekly water level for the pre- and post-construction periods of the Hopedale Hydrologic Restoration project. Statistics computed using ANOVA.

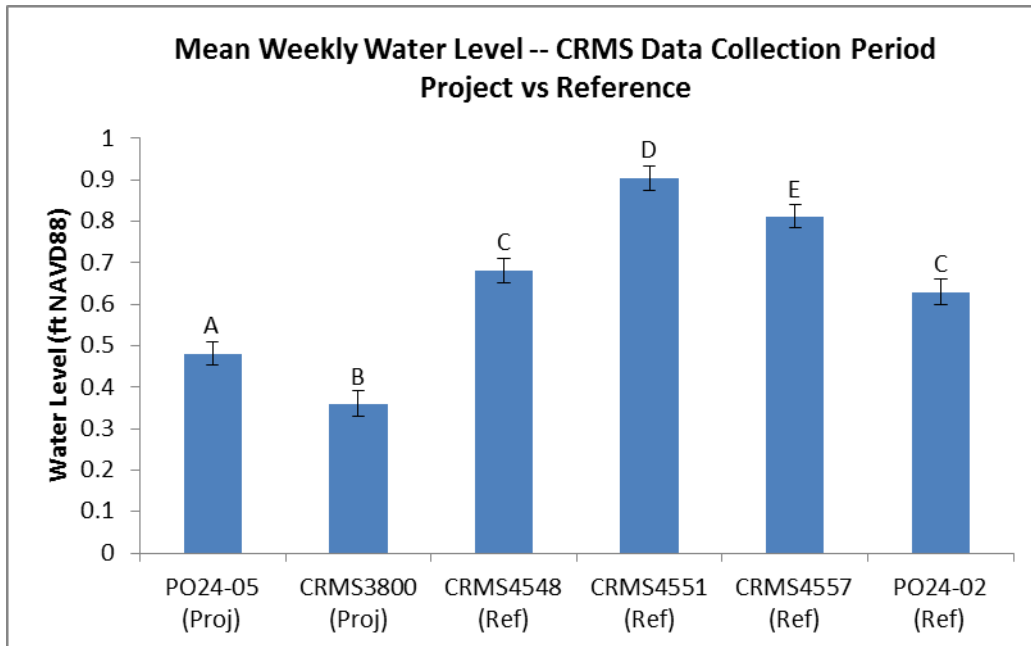
Figure 20. Average of mean weekly water level for project and reference stations during the CRMS data period, 1/1/08-12/31/13. Statistics computed using ANOVA. Different letters indicate significant difference.

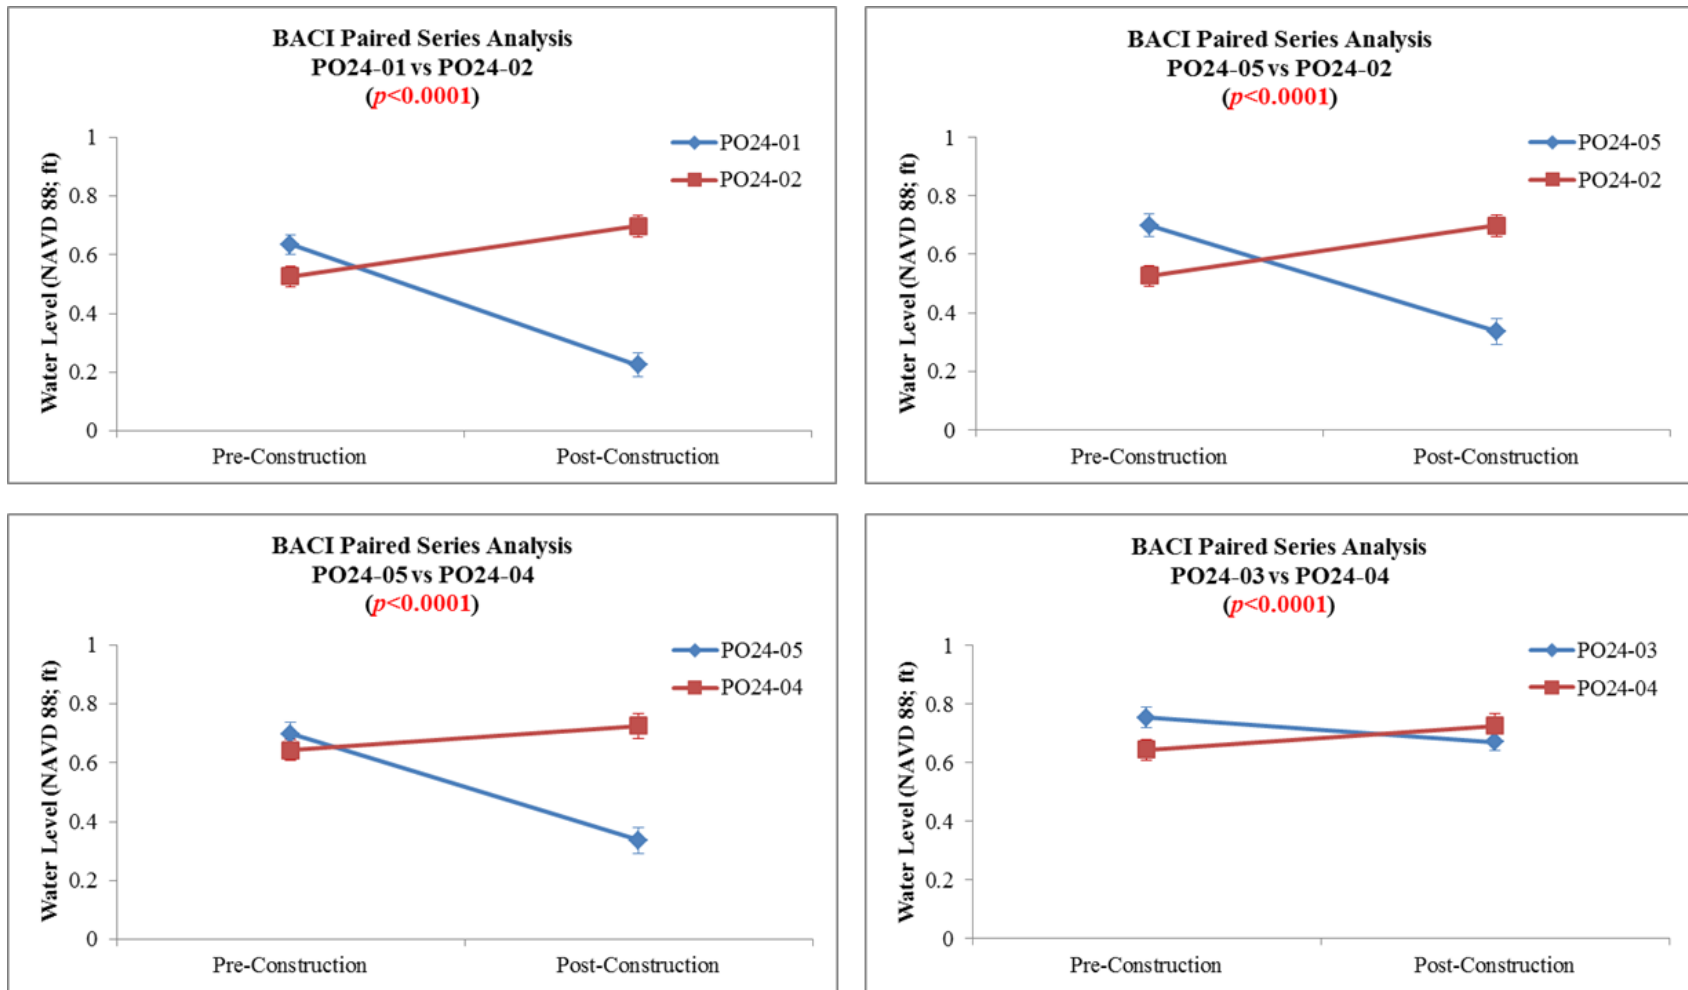
To test the interaction between project and reference sites in pre-construction and post-construction time periods, mean weekly water level measurements were analyzed by the same method described for salinity data in the previous section. Results of the paired sites were significant for all comparisons (Figure 21) with water levels at PO24-01 and PO24-05 approximately 0.4 feet lower than what would be expected if the project had no impact. The project impact was reduced at PO24-03, yet still significant. When averaged, the project site water levels decreased from 0.70 ft to 0.41 ft, while reference site water levels increased from 0.58 ft to 0.71 ft between pre- and post-construction.

Figure 21. BACI paired series analysis graphs for water level.

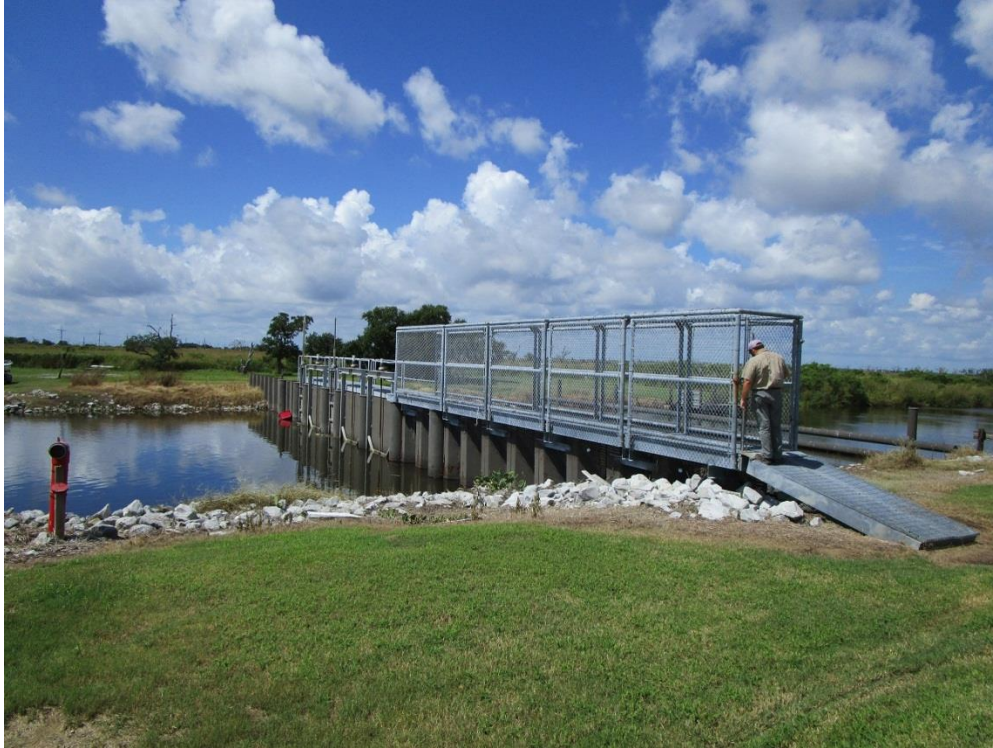
Photo 1. Water Control Structure

The fish gates were open at the time of the inspection in accordance with the Operation and Maintenance Plan. The flow through the project structure was generated from an approximated 0.5 ft. of head. The structure was observed to be in generally good condition, although one of the fish gate stem covers was damaged (Photo #2). The Field Inspection Form is included in Appendix C.

Item	Condition	Physical Damage	Corrosion	Photo #	Observations and Remarks
Swing Gates 84" D	Good	None	None	1	
Fish Gates 24" x 84"	Good	See Remarks	None	2	
					Stem cover damaged/missing on northeast fish gate
Handrails Grating Hardware etc.	Good	None	None	1	
Galv. Pile Caps	Good	None	None	1	
Signage /Supports	Good	None	None	1	
Riprap	Good	None	None	1	
Silt/Fill	Good	None	None	1
