## 2019 Operations, Maintenance, and Monitoring Final Report

### Lake Chapeau Sediment Input and Hydrologic Restoration, Point Au Fer Island (TE-26)

State Project Number TE-26  
Priority Project List 3

April 2019  
Terrebonne Parish

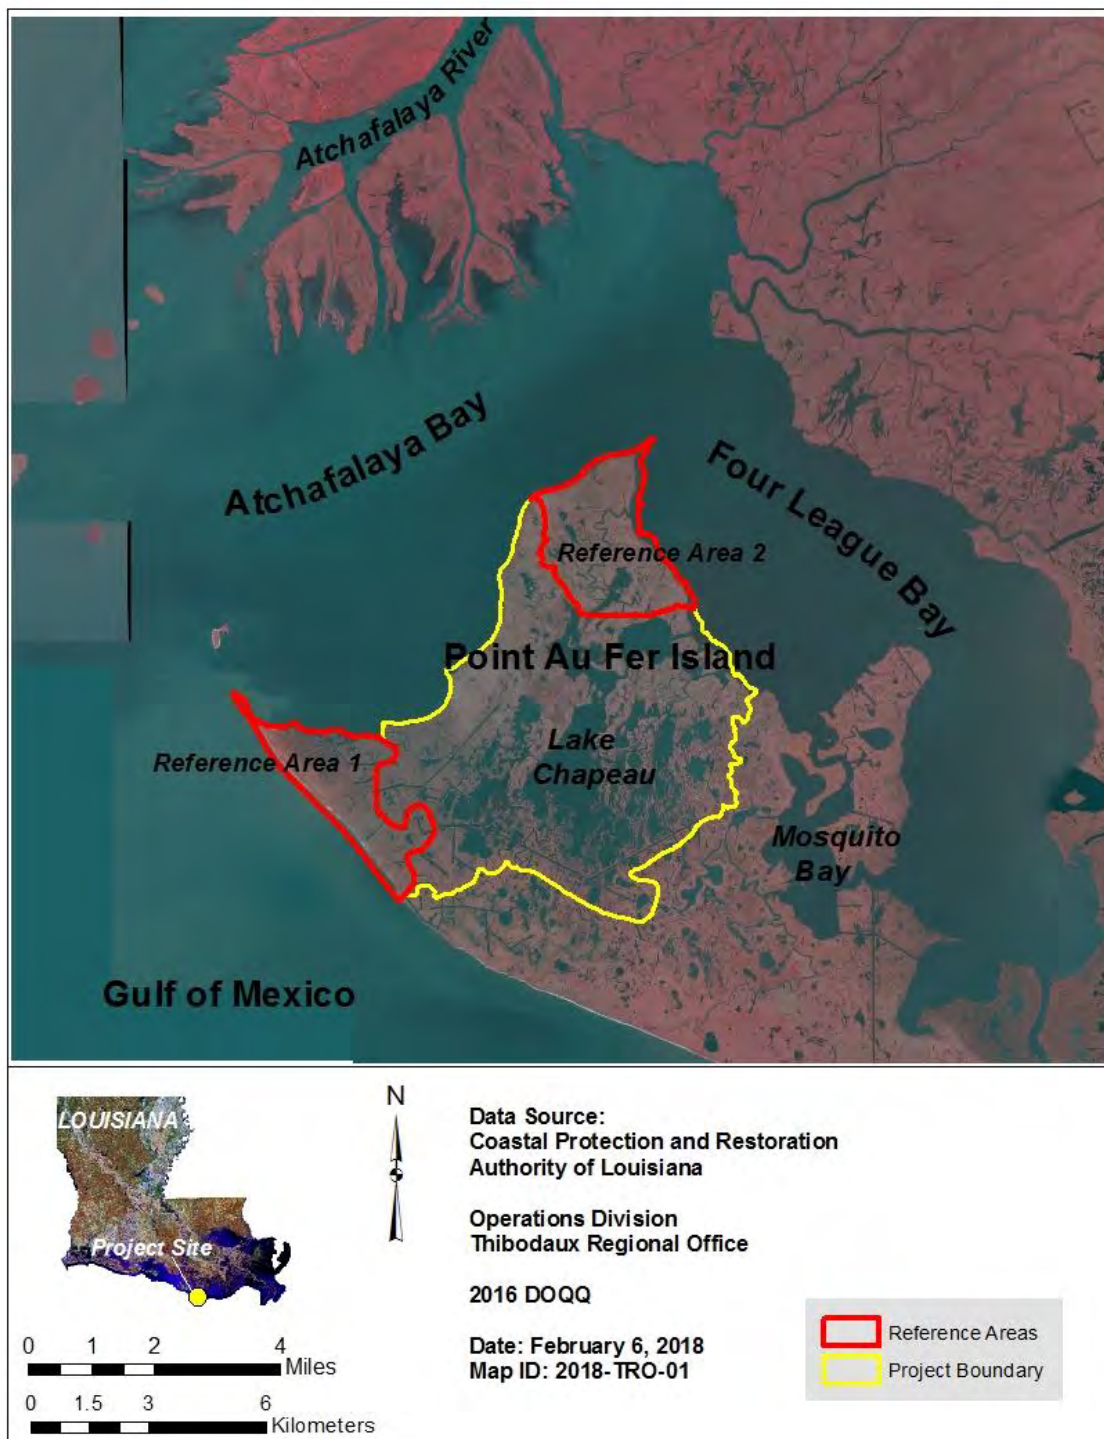
**Figure 1.** Lake Chapeau Sediment Input and Hydrologic Restoration, Point Au Fer Island (TE-26) project and reference area boundaries.

The 2016 project area contains 7,654 acres (3097 hectares) of brackish to intermediate marsh plus 6,156 ac (2491 ha) of open water (Appendix A, Figure 5). This project, located on Point Au Fer Island, is bound to the northwest by Atchafalaya Bay, to the northeast by Four League Bay, and to the south by the Gulf of Mexico. It is located approximately 13 mi (20.9 km) southeast of the mouth of the Atchafalaya River in Terrebonne Parish, Louisiana (Figure 1).

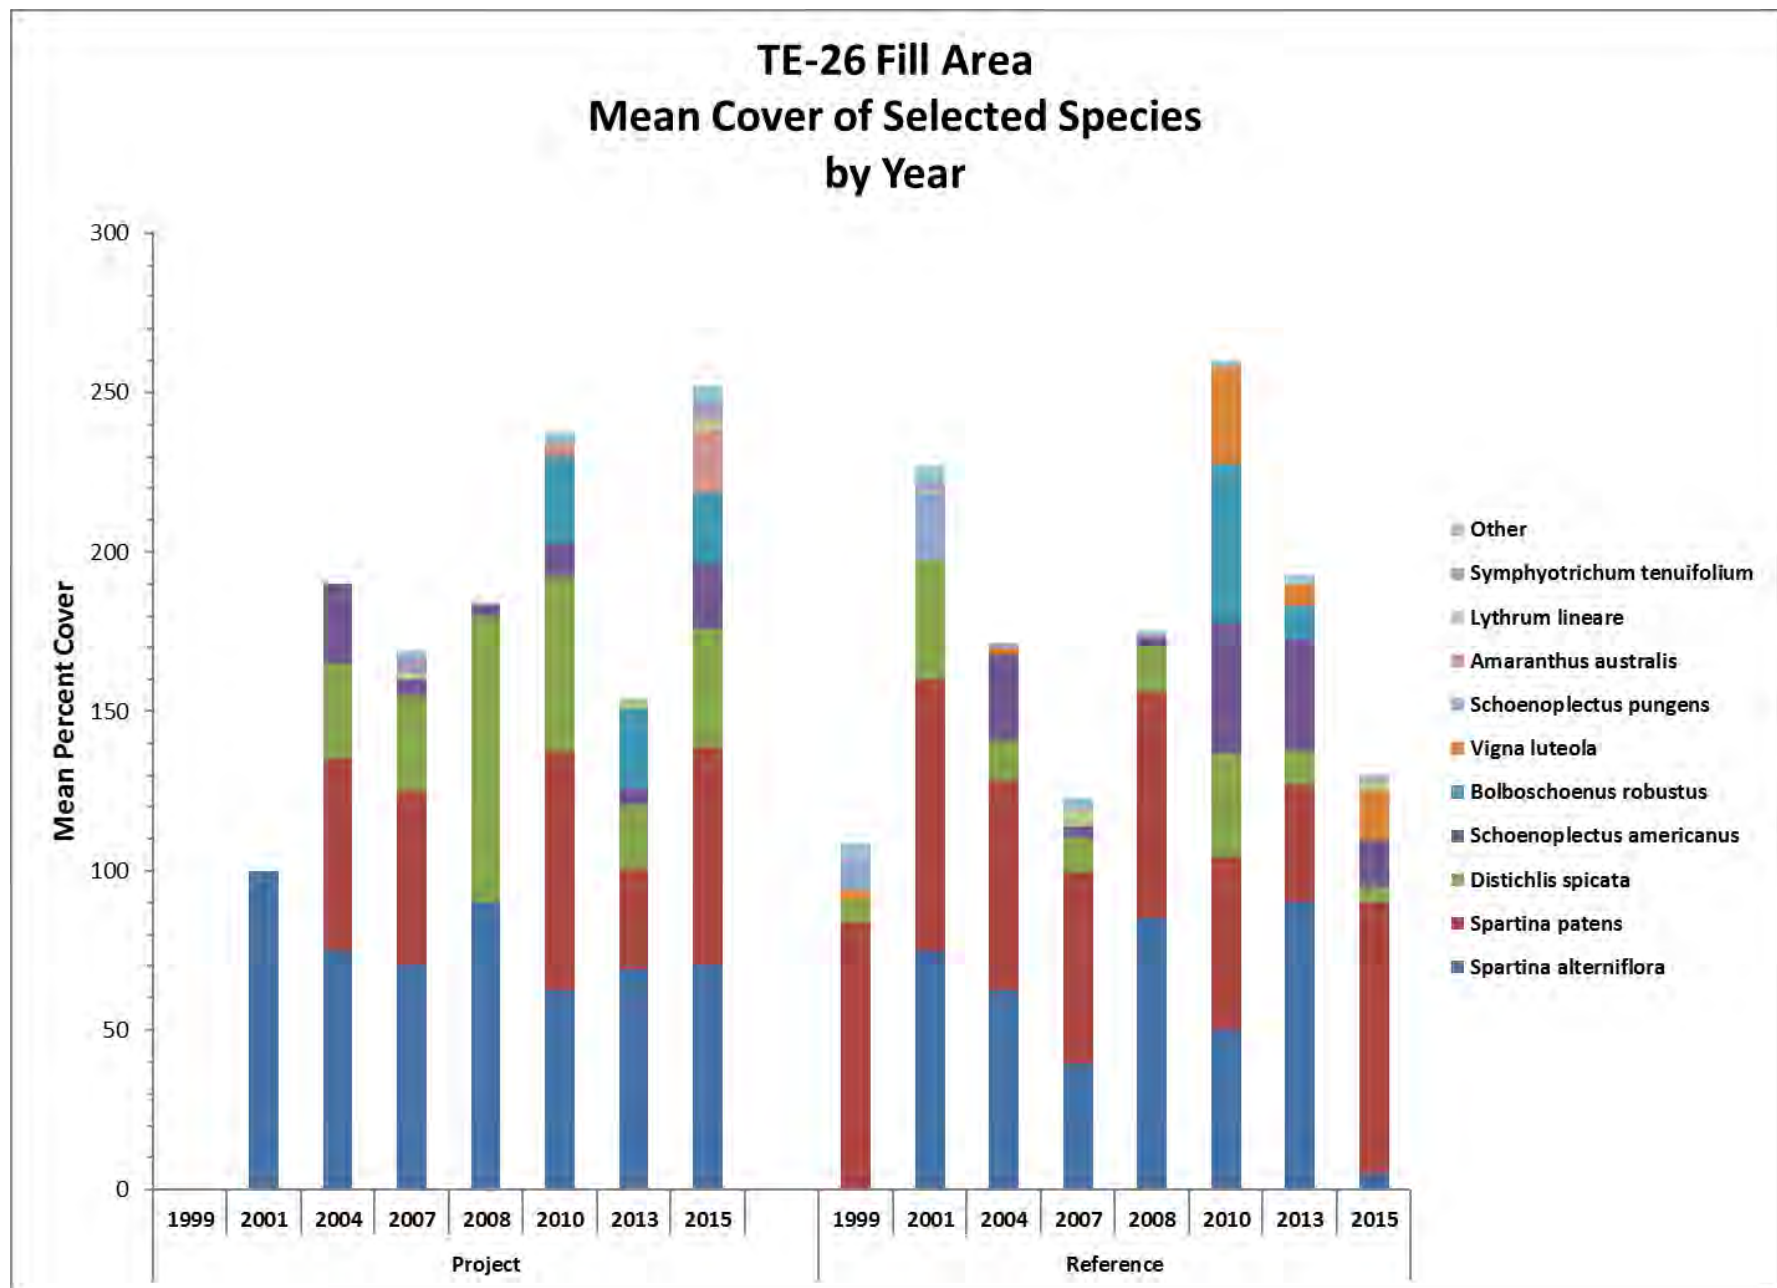
**Figure 11.** Mean percent cover for selected species to date, inside of project and reference 4 m<sup>2</sup> Braun-Blanquet vegetation plots. For the Lake Chapeau Sediment Input and Hydrologic Restoration, Point Au Fer Island (TE-26) project.

Project-specific vegetation data were collected during the fall of 1999, 2001, 2004, 2007, 2008, 2010, 2013 and 2015 inside and adjacent to the fill area. The data were analyzed for mean cover (Figure 11).

The 1999 vegetation sampling did not find vegetation within the project area plots. The reference plots outside of the fill area were dominated by *Spartina patens* (Figure 11). By 2001, two growing seasons post-planting, mean percent cover of the planted species *S. alterniflora* had reached 100% in the project plots and it was the only species present. By comparison, the reference area plots showed substantial natural recruitment of the planted species. The mean percent cover of *S. alterniflora* decreased by 2007 in both the fill area and reference area plots but rebounded by 2008, and though *S. patens* was the dominant species in the reference area it was still absent from the adjoining fill area altogether (Figure 11). *S. patens* and *Distichlis spicata* were found in the fill area plots in 2010, which indicated natural recruitment of species from the surrounding reference area marsh. Combined mean cover of all species in both the fill area and reference area plots increased in 2010, though the mean cover for the planted species decreased.

In 2013, twelve growing seasons post-planting, *S. alterniflora* remained the dominant species in the fill area. In addition, diversity increased in the fill area in 2013. Also, by 2013 the planted species had spread into all reference plots and experienced its highest mean cover than in all previous years of sampling (Figure 11).

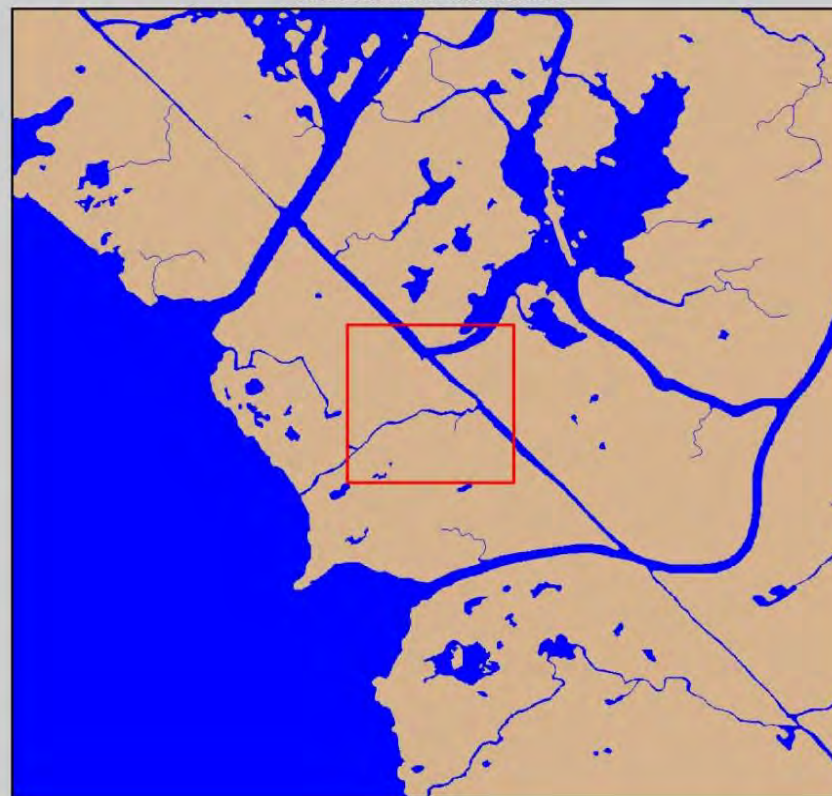
2008 Land-Water Classification

Data Source:  
The land-water data were obtained from  
digital imagery (Z/I Imaging digital mapping  
camera) with 1-meter resolution, acquired  
October-November 2008. All areas  
characterized by emergent vegetation,  
upland, wetland forest, or scrub-shrub were  
classified as land, while open water, aquatic  
beds, and mudflats were classified as water.

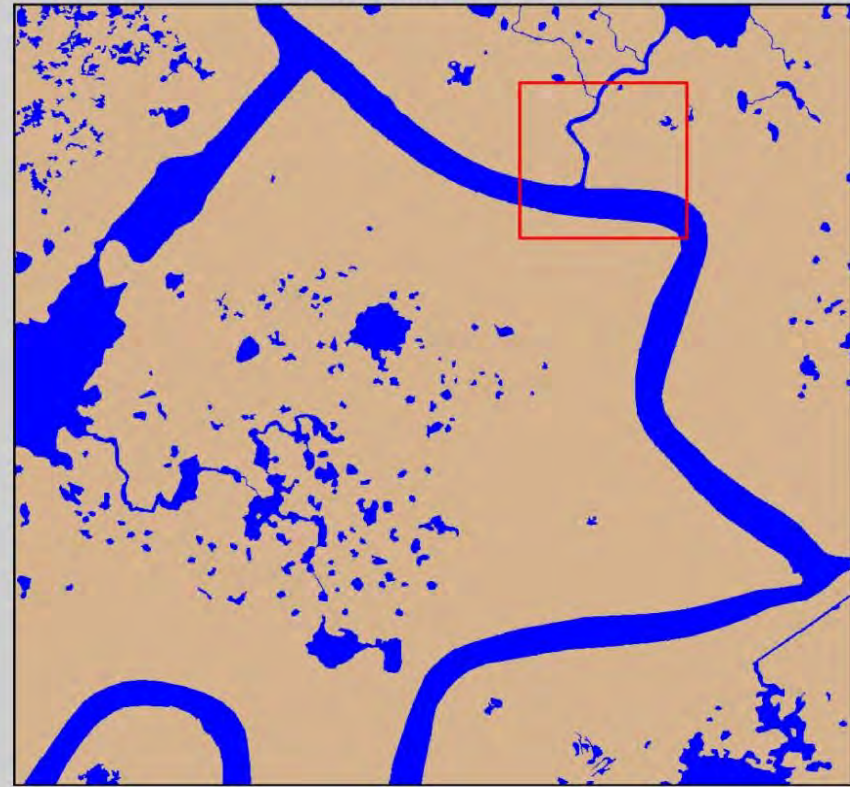
2008 Land-Water Classification

Data Source:  
The land-water data were obtained from  
digital imagery (Z/I Imaging digital mapping  
camera) with 1-meter resolution, acquired  
October-November 2008. All areas  
characterized by emergent vegetation,  
upland, wetland forest, or scrub-shrub were  
classified as land, while open water, aquatic  
beds, and mudflats were classified as water.
