PROJECT COMPLETION REPORT

Project Name: Raccoon Island Breakwater Rehabilitation Project

State Project No. TE-48

By: Aptim Environmental & Infrastructure, Inc.

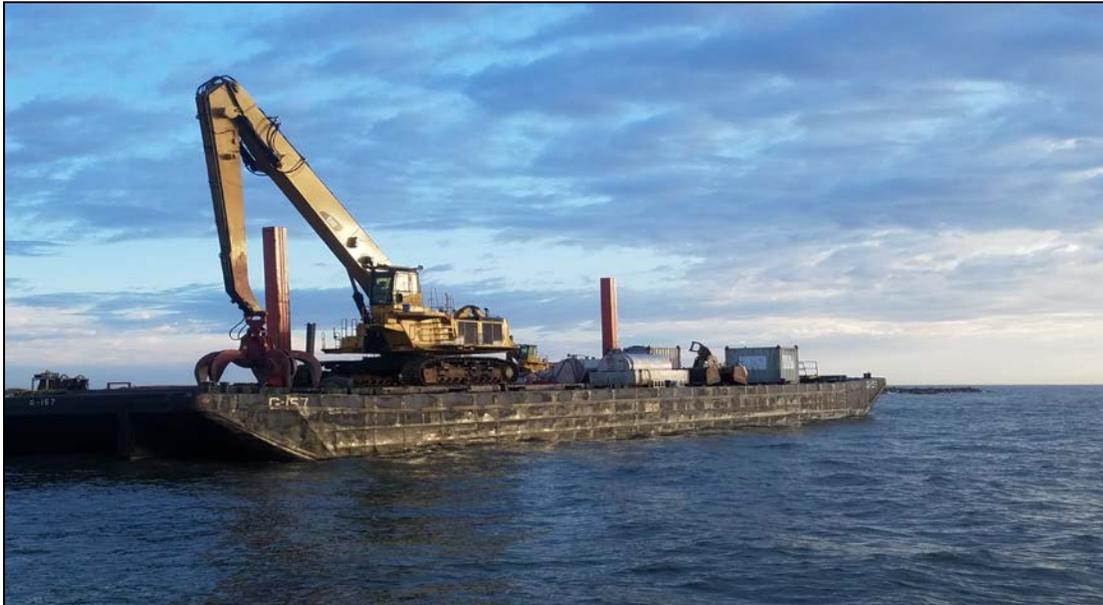
Figure 2: Major equipment mobilized to the project site

- 1 Short Reach Marsh Buggy
- 1 Long Reach Marsh Buggy
- 1 Ramp Barge with Spuds
- 2 Excavator Barges
- 6 Rock Barges
- 2 Crew Boats
- 1 Small craft/transport vessel

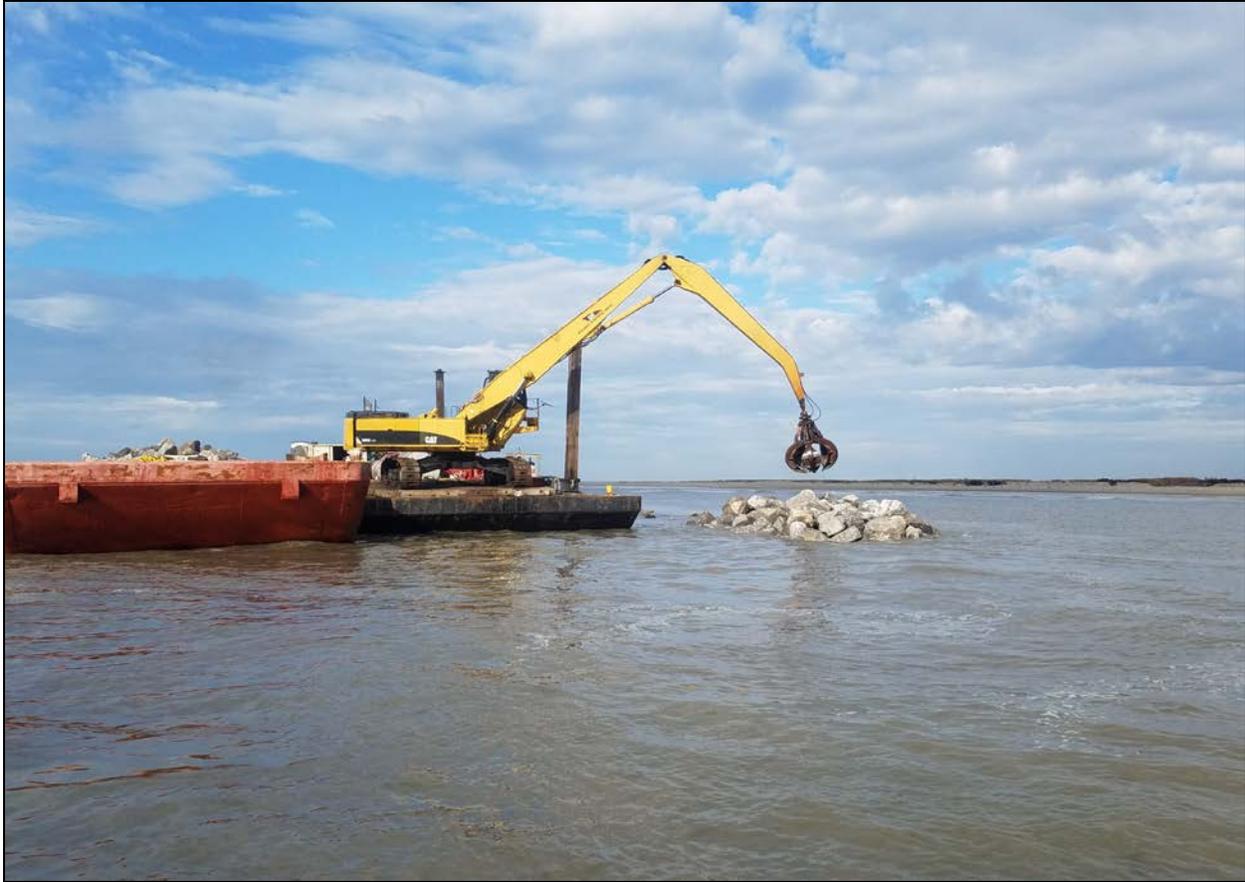
Figure 4: Typical Armor Stone Installation

LeBlanc Marine utilized two (2) tug boats to transport armor stone barges and excavator barges to the south side of Raccoon Island. Armor stone was relayed from the rock barge to the breakwaters via the excavator barge grapple. Typical armor stone installation is shown in Figure 4. Armor stone from the first shipment of rock was placed along the breakwater and groin crests as stakes had not yet been placed to denote the limits of installation. Approximately ten percent (10%) to fifteen percent (15%) of the armor stone delivered in the first shipment was observed to be deficient in size. Deficient armor stone was brought back to the staging area in the HNC and eventually shipped back to the quarry.

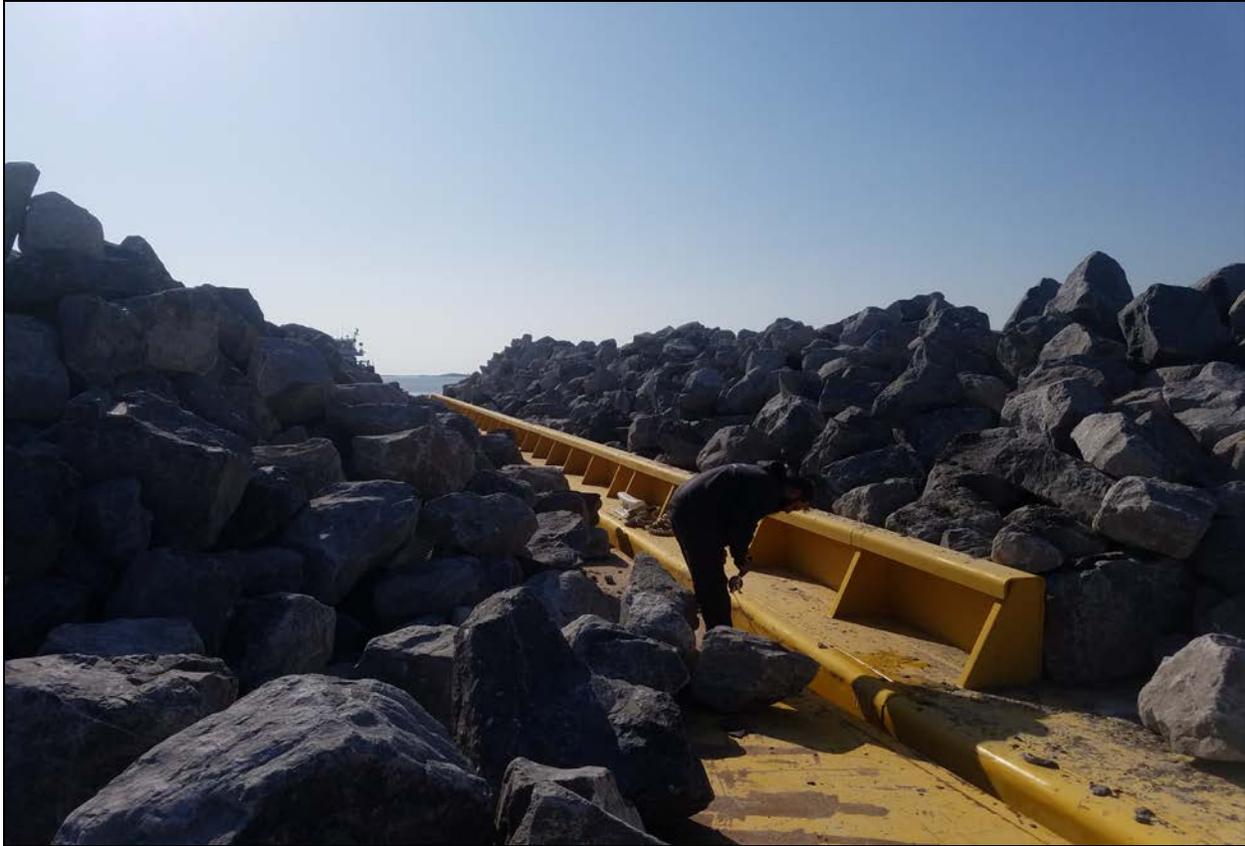
Figure 5: Draft Surveys on Fully Loaded Rock Barges

The second shipment of armor stone was delivered to the project area via rock barges shipped from the Vulcan Quarry in Grand Rivers, Kentucky. Barge draft (displacement) surveys were conducted on each of the rock barges in the LeBlanc Marine staging area in the Houma Navigation Canal (HNC) near Coco Marina. Draft surveys were conducted by LeBlanc Marine personnel and observed by APTIM personnel on February 1, 2018. A total of six (6) rock barges were observed in the second shipment of armor stone. A majority of the armor stone shipment was determined to be too small for placement on the project site. After the initial draft surveys of the second shipment were conducted, LeBlanc Marine crews separated armor stone within project specifications from the deficient armor stone. A second draft survey was conducted on February 5, 2018, on five (5) barges containing armor stone within project specification limits. A total of 5,245 tons of armor stone (within the limits of the project specifications) were delivered to the project site in the second shipment. Figure 5 shows draft surveys being conducted on fully loaded barges.

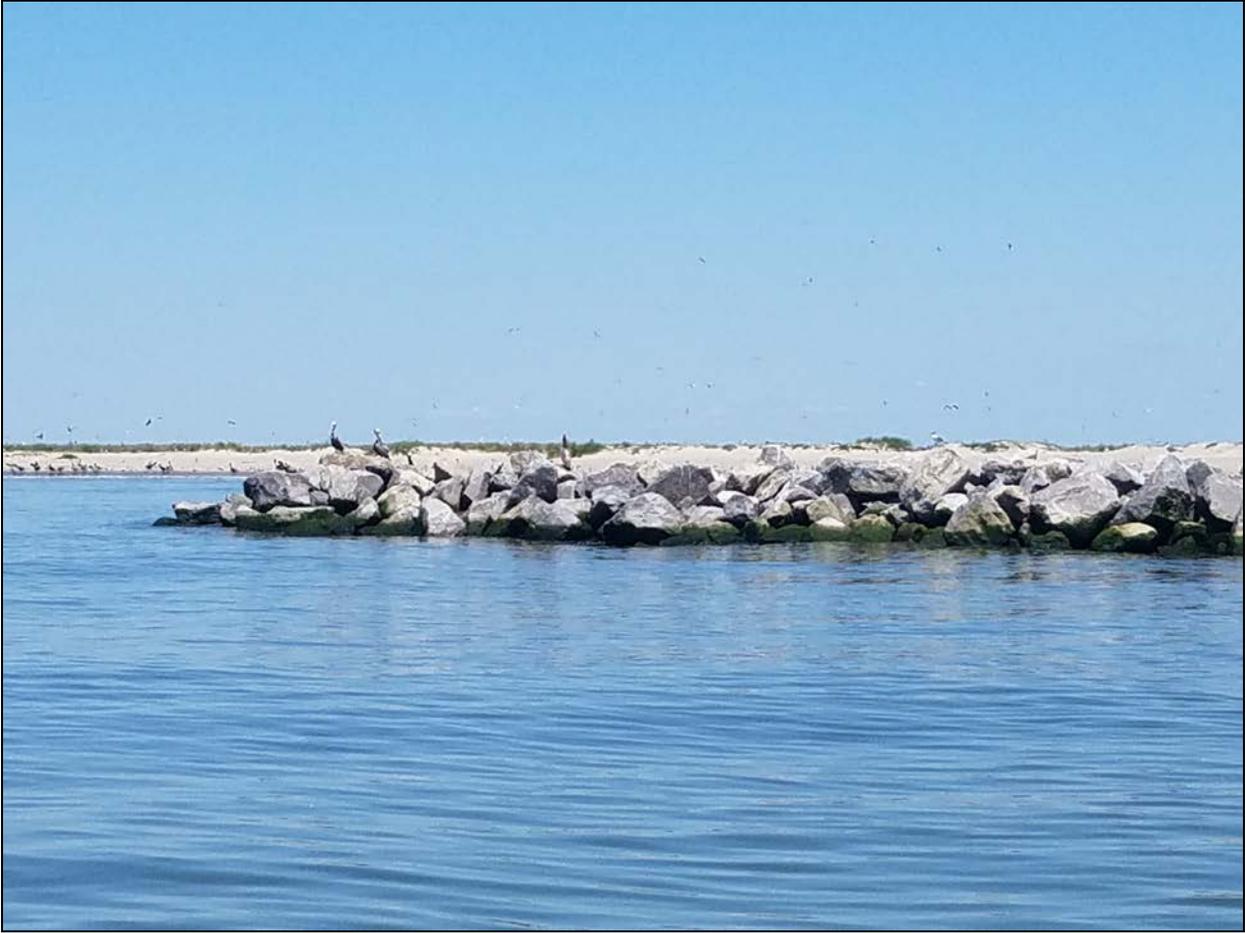
Figure 6: View of Breakwater 2 – Post-Construction

The final inspection was held on April 25, 2018. During the final inspection, it was determined that the project appeared to be substantially complete, and no issues were identified. All armor stone installed on the breakwaters appeared to have been interlocked with no major gaps or extreme variations in installed elevations. Substantial completion was issued pending the review of the as-built survey data. Figure 6 shows a portion of the completed Breakwater 2 as observed during the final inspection.
