**Coastal Protection and Restoration
Authority of Louisiana (CPRA)**

2015 Operations, Maintenance, and Monitoring Report

Terrebonne Bay Shore Protection Demonstration (TE-45)

State Project Number TE-45
Priority Project List 10

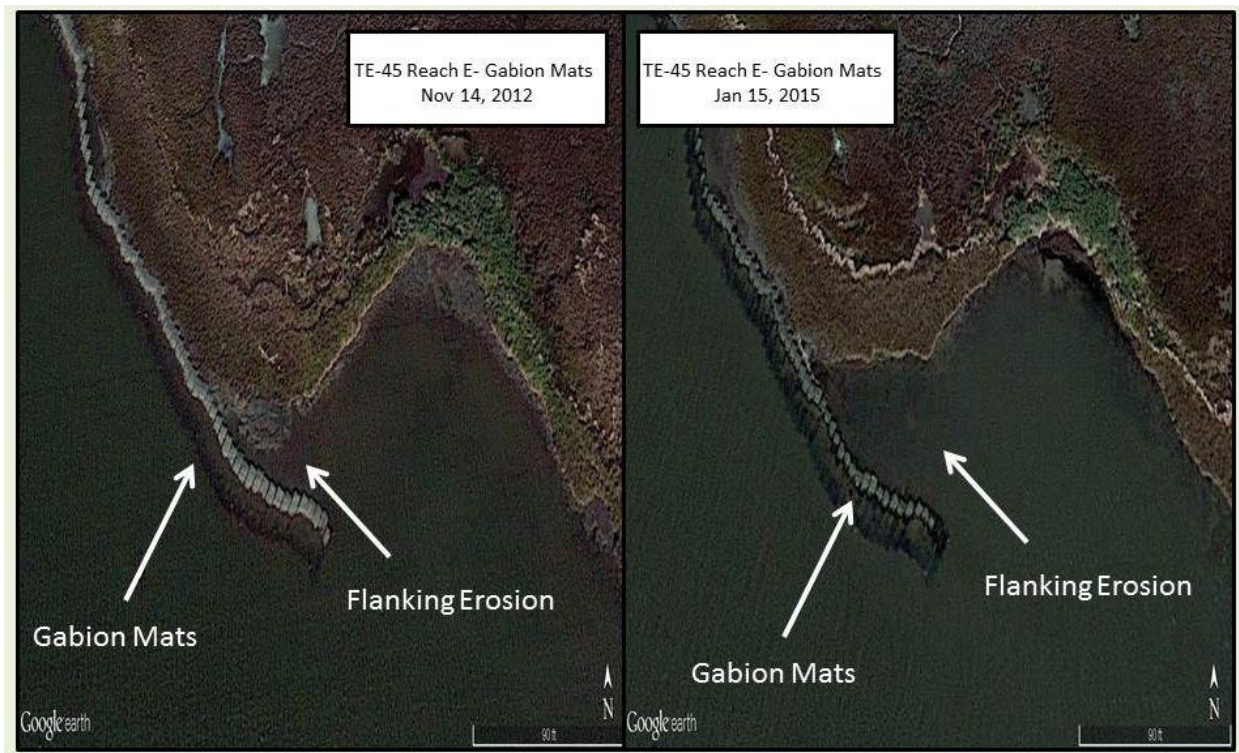
Figure 19. November 14, 2012 and January 15, 2015 images depicting flanking erosion behind the Reach E Gabion Mat treatment at the Terrebonne Bay Shore Protection Demonstration (TE-45) project. Note the increased erosion in 2015. Images reproduced from Google Earth.

maintenance budget to replace signage, we are not recommending replacement at this time. As for the condition of the existing marsh, we did note erosion near the southern point of the marsh island along Reach E behind the gabion mat treatment units. Overall the project appeared to have halted or slowed erosion along all of the reaches with small isolated areas of erosion.

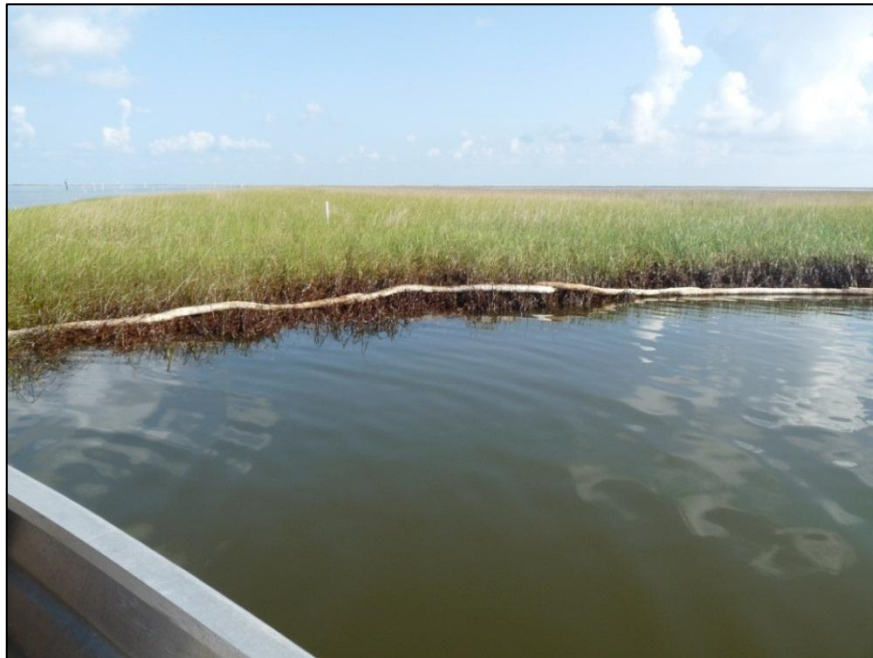
Figure 29. Moderate oiling in summer 2010 at Reach-E from the DWH oil spill. White oil boom is also seen in the photo.

The 2010 spring spawn occurred at the same time when oil from the Deepwater Horizon spill (DWH) was observed in the waters of northern Terrebonne Bay, and actually made landfall at Reach E (Figure 28). Also noteworthy to document is that efforts by cleanup crews to lay boom along the shoreline at Reach-E to prevent inner marsh oiling (Figure 29) may have

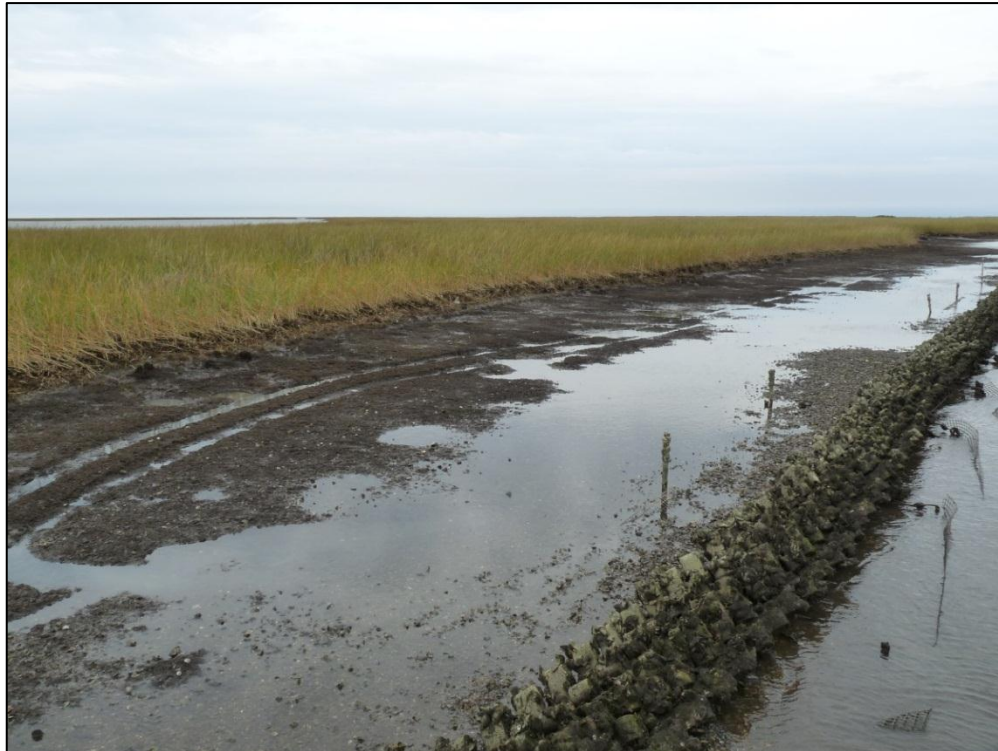
Figure 30. Boat dual-propeller tracks remain behind A-Jacks at Reach-E showing how activities associated with laying oil boom impacted marsh shoreline. Winter 2010 photo several months after crews had removed the oil boom from the marsh. Similar tracks observed at Reach-E behind ReefBlks.

compromised the site for determining erosion estimates due the high volume of boat traffic between the marsh shoreline and the A-Jack and ReefBlks structures (Figure 30). Reach-E was the only location where this activity occurred within the study. All Reaches and structures within each experienced oyster spat failure in spring 2010. However, a visual comparison of oyster survival and oyster spat recruitment during 2010 did not differ between structure types or Reaches.

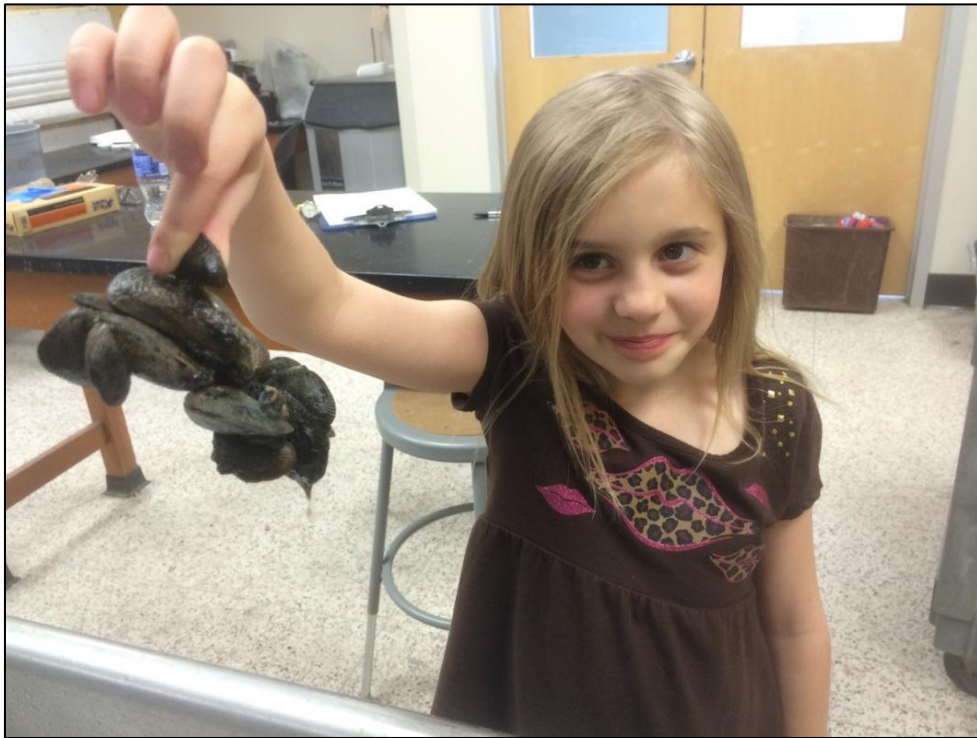
Figure 43. One hooked mussels supporting a large cluster of mussels by its byssal threads. The large mussel below the hooked mussel being held is a ribbed mussel but others are hooked mussels. Greater than 98% of mussels found on the bio-engineered reefs were hooked mussels.

ReefBlks (Melancon et al. 2013). Besides its competition for space and food, it becomes a surface upon which oyster spat will settle. This oyster spat settlement on hooked mussels has been observed numerous times during this study. The mussel attaches to a substrate by byssal threads that are very strong and can easily hold the weight of an oyster and many mussels (Figure 43). Unfortunately, when the mussel dies the byssal threads will eventually decompose and the animal will detach from its substrate. Particularly for fabricated structures with significant vertical relief, such as the A-Jacks and Gabion Mats, this creates a dilemma. Oysters that attach to the hooked mussel have the potential to fall off into the underlying sediments and suffocate or be washed away by wave and currents; this scenario has been observed in this project. The largest hooked mussels were 65 mm in shell height.

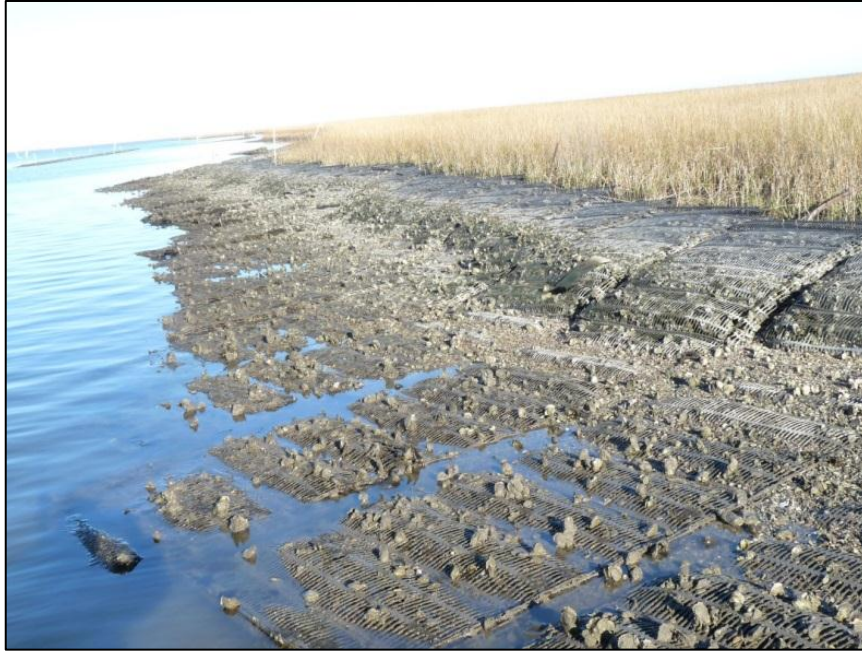
Figure 46. Photo showing the distribution of oysters and emergent reef across Gabion Mats at Reach- B during the winter 2014 survey, seven years post construction.

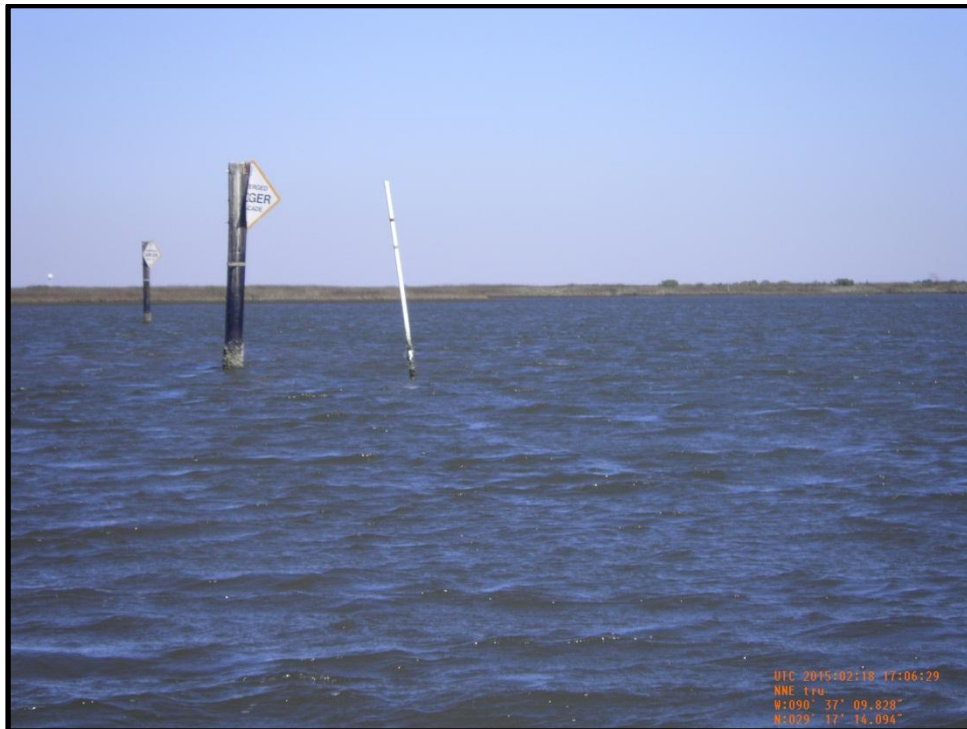
The only damage noted along Reaches A, B and E was a couple of damaged warning signs on the lake side of the shoreline treatments. The timber piling supports were in good condition, but the signs were bent and distorted around the piling.

Photo 12: View of damaged warning sign offshore along Segment B.

Based on the 2015 Annual Inspection, there was no noticeable damage or deficiencies to the shoreline protection treatments related to the Terrebonne Bay Shoreline Demonstration (TE-45) project. It was noted that some of the aluminum warning signs at Reaches B and E were damaged from apparent extreme weather events. The signs were still visible but were bent and contorted around the timber pilings. Since there are no funds in the operations and

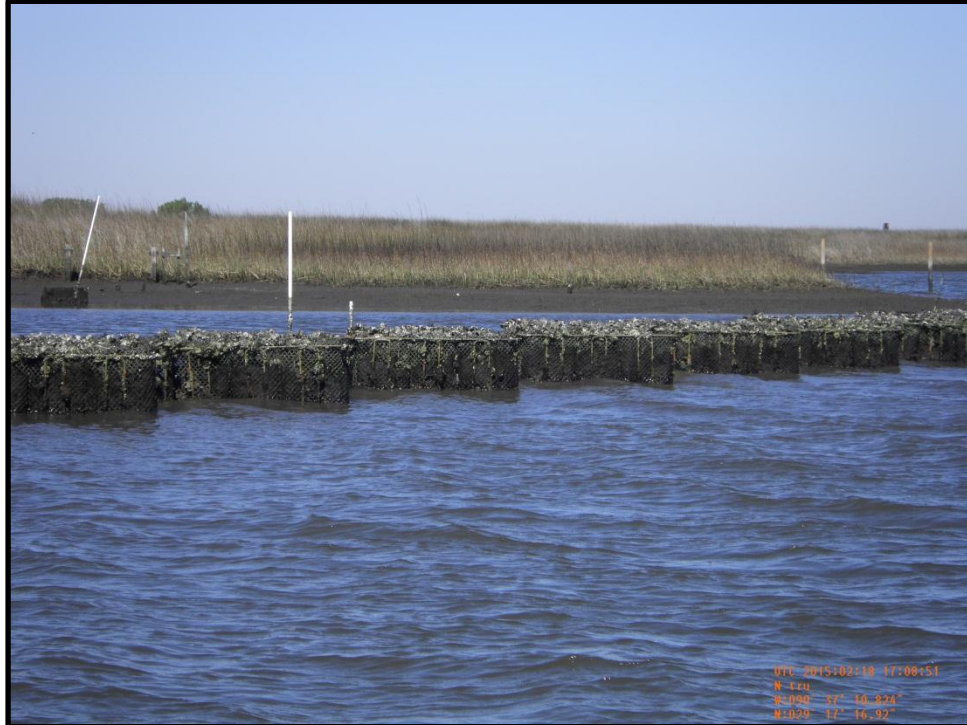
Photo B-13: View of ReefBlks along Segment B.

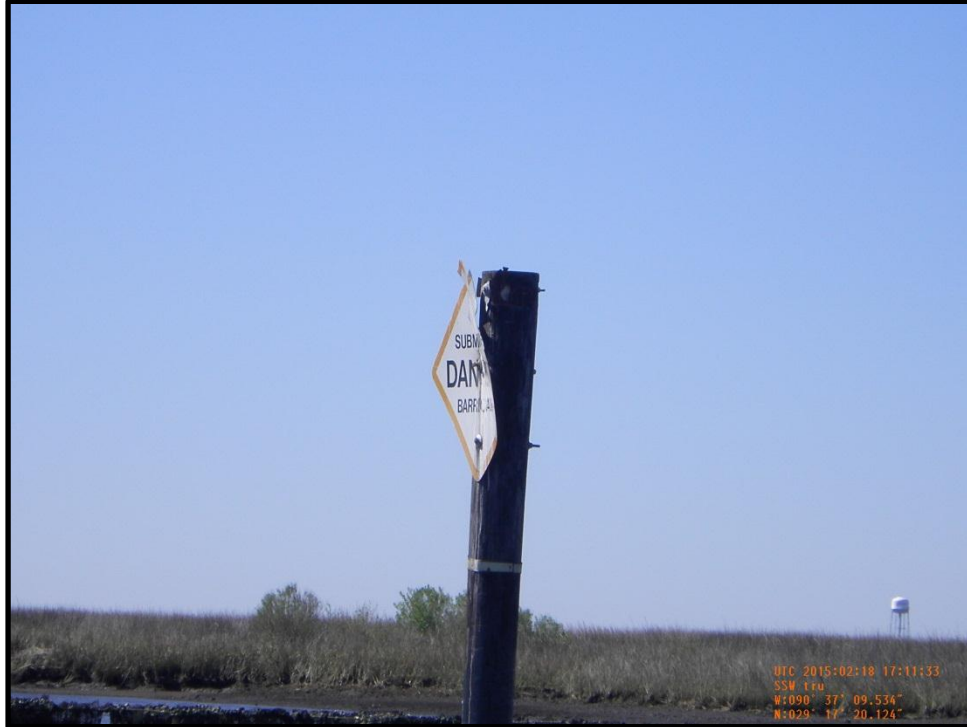
Photo B-15: View of damaged warning sign offshore along Segment B.

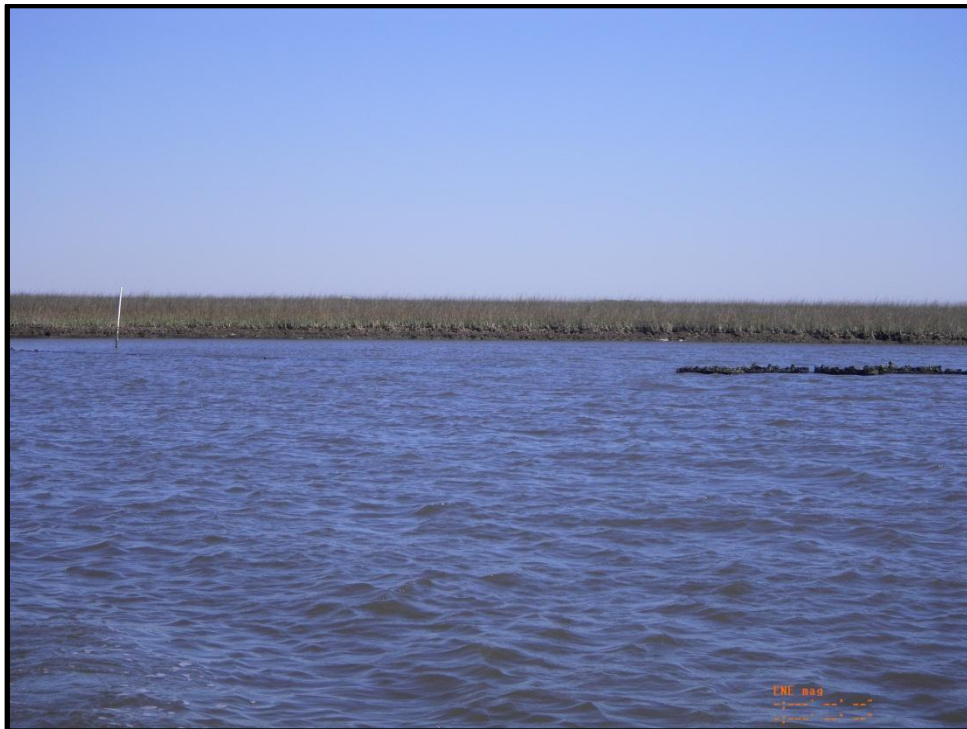
Photo B-16: View of A-Jacks connecting shoreline to ReefBlks along north side of Segment E.

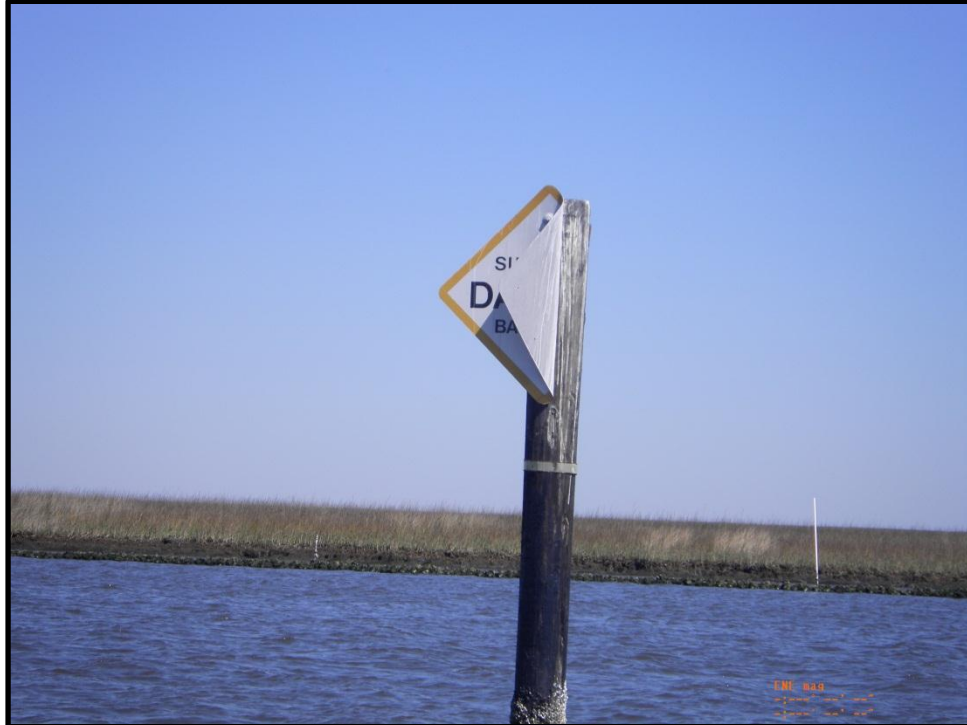
Photo B-17: View of damaged warning sign offshore from A-Jacks on Reach E.

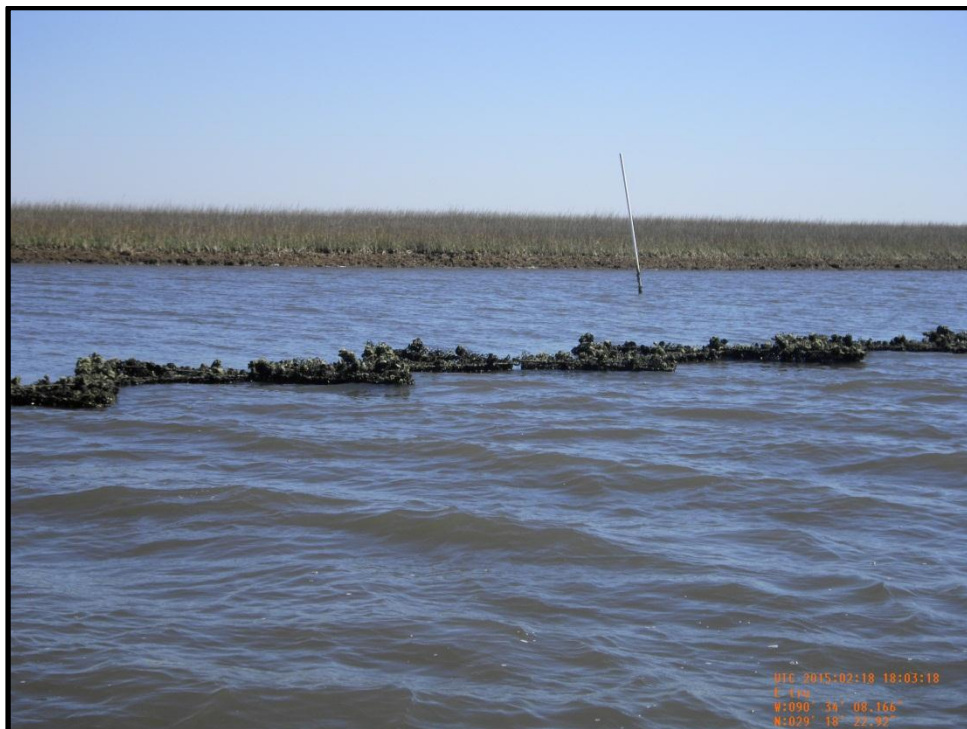
Photo B-18: View of offshore ReefBlk units along Reach E.
