## **2013 Operations, Maintenance, and Monitoring Report**

### **Raccoon Island Shoreline Protection/Marsh Creation (TE-48)**

State Project Number TE-48  
Priority Project List 11

July 2013  
Terrebonne Parish

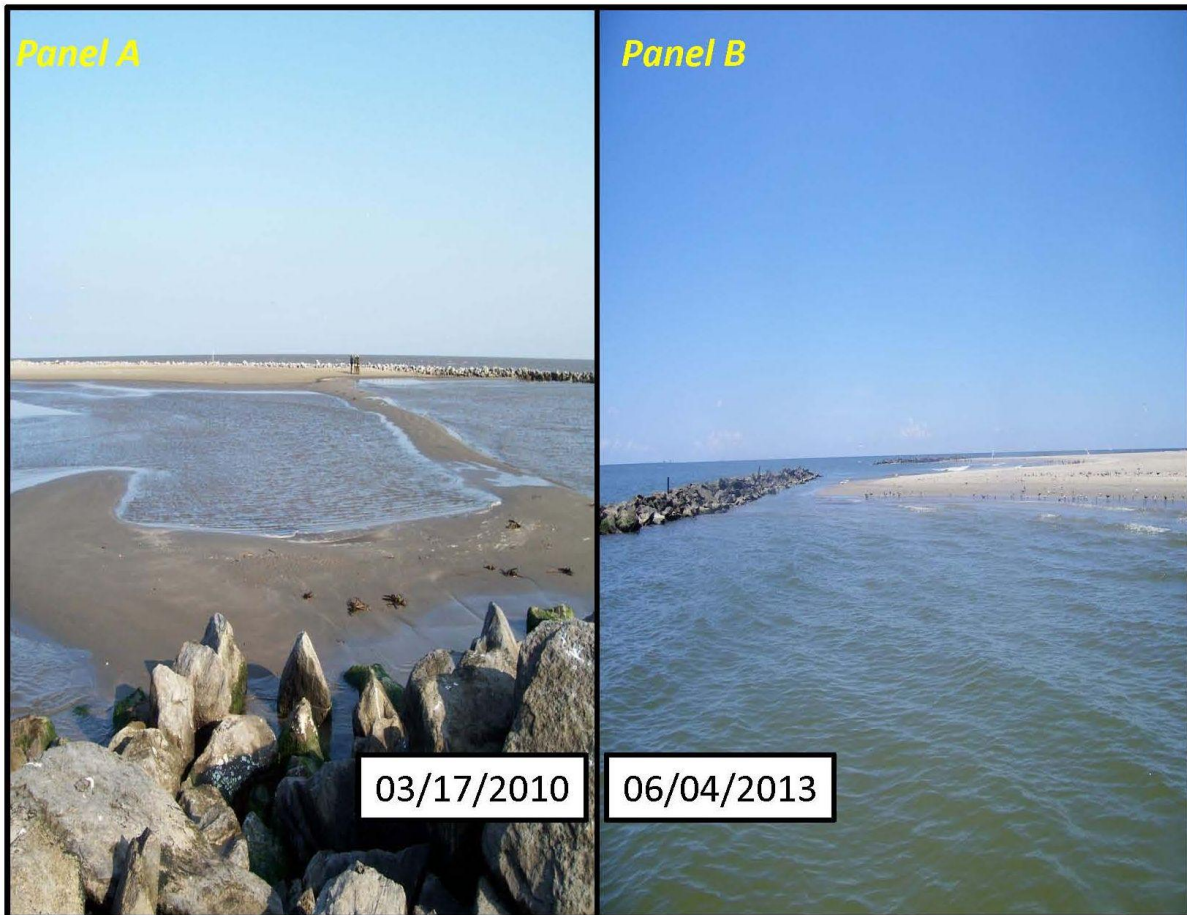
**Figure 22.** Oblique photographs showing the area behind breakwater 1 in 2010 (Panel A) and 2013 (Panel B). Note the tombolo formation in 2010 and transgression into a salient in 2013.

The TE-48 structures have been successful in capturing sediment and aggrading shoreline positions (Table 1). The construction of the groin caused considerable volume increases (Figures 12, 13, and 14), expanded the eastern tip of the island by approximately 665 ft (203 m) (Figures 19, 20, and 21), and closed the greater than 10 ft (3 m) deep channel that developed behind breakwaters #0 and #1 (Figures 12, 13, and 14) as postulated by Stone et al. (2003). In addition, the tombolo that formed behind breakwater #1 in 2010 has transgressed slightly; however, this geomorphic feature is still a very prominent salient (Figures 13, 14, and 22). While the area surrounding the groin gained volume, the volume behind breakwaters #2 through #6

Hurricane Gustav (Sep 2008) can be attributed with causing part of the post-construction volume losses. This storm which passed within 20 mi (32 km) of Raccoon Island (Figure 23) transgressed the spit shoreline 326 ft (99 m) (Table 2), reopened the breach separating Raccoon Island and the spit leaving an approximate 1,500 ft (457 m) divergence (Figures 5, 6, 7, 19, and 24), and damaged brown pelican nesting habitat (Figure 25).

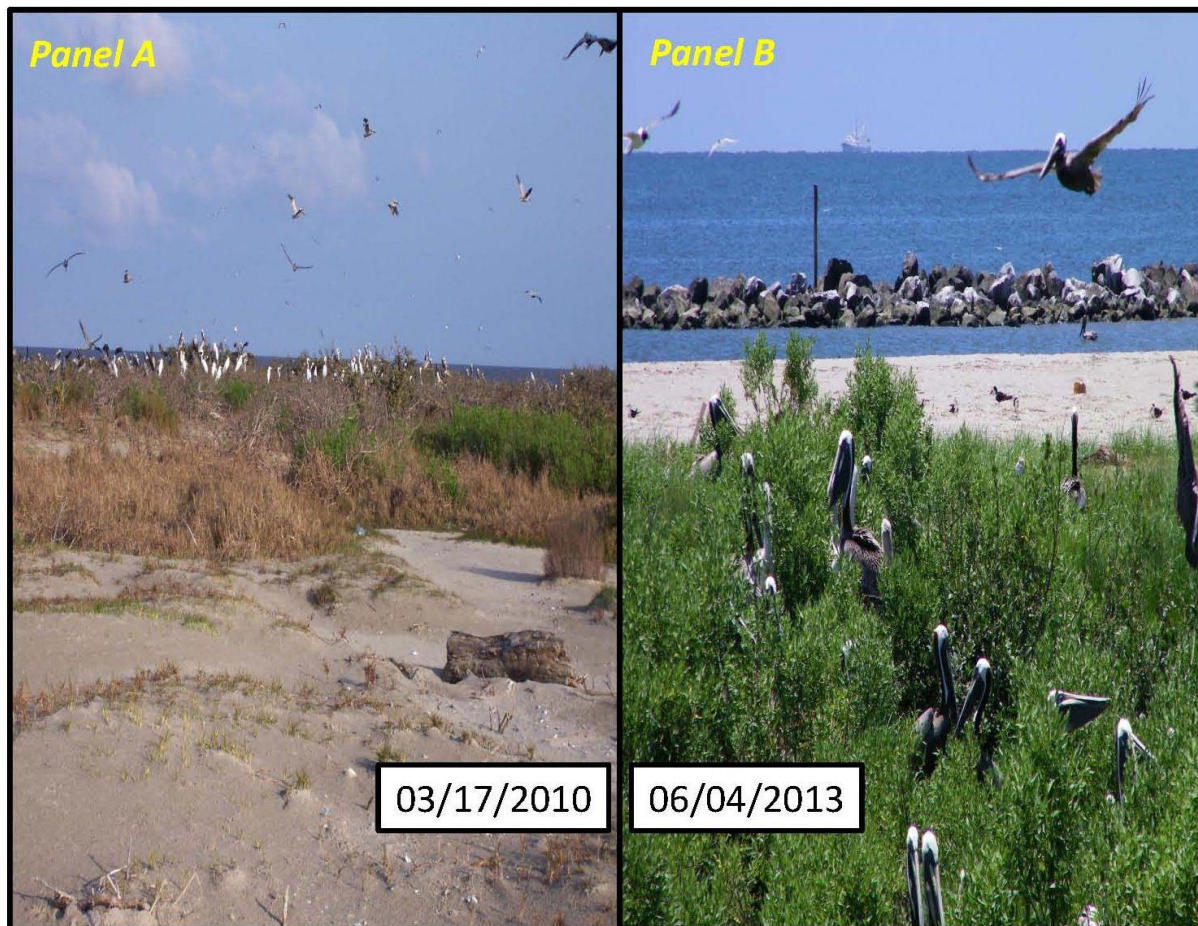
**Figure 25.** Oblique photographs showing Raccoon Island in 2010 (Panel A) and 2013 (Panel B). Note the stressed condition of the brown pelican nesting habitat in 2010 and the partial recovery of these habitats by 2013.

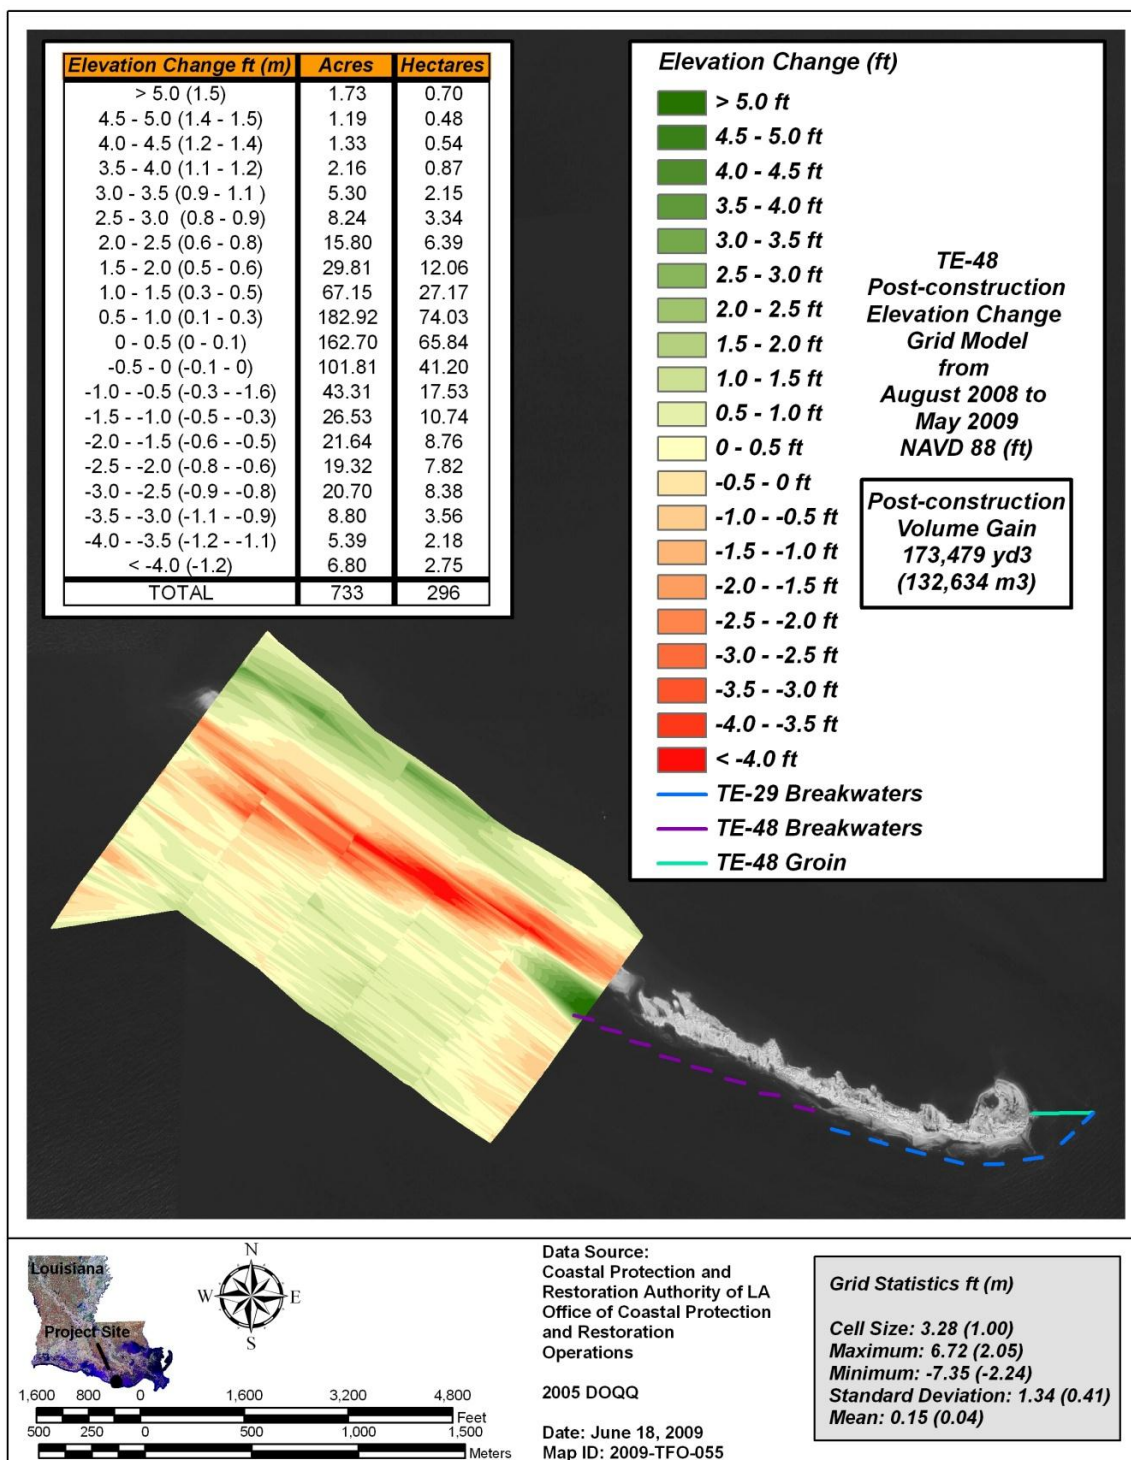
Figure 26. Elevation and volume change grid model for the spit from post-construction (Aug 2008) to post-construction (May 2009) at the Raccoon Island Shoreline Protection/Marsh Creation (TE-48) project.

volume was conserved and elevations were raised in the shallow reaches of Caillou Bay (Figures 13, 14, 16, 26, and Table 2). Moreover, the large volume gain behind breakwater #15 immediately after Hurricane Gustav (Figure 26) aggraded a part of the shoreface that appeared to be scoured by the breakwaters (Figure 15), and brown pelican nesting habitat partially recovered from Hurricane Gustav damage by 2013 (Figure 25). In contrast, the spit exhibited negligible subaerial expansion to the west having migrated only 3.41 acres (1.38 ha) from Feb 2008 to Nov 2012.

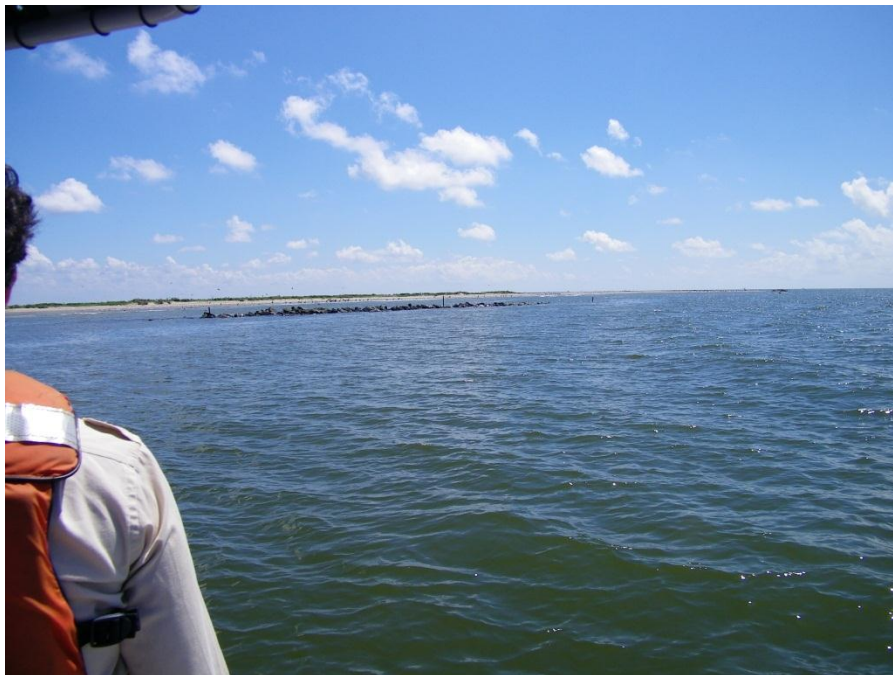
1. Two of the original TE-29 breakwaters (#3 & #4) have crest elevations lower than the other breakwaters, and shoreline configurations behind these structures indicate that these lower elevations are affecting the performance (Appendix A).

Photo 1: Gulf Shoreline near TE-29 breakwater #4 looking east (Raccoon\_038). Note low elevation of TE-29 breakwater 4 and 3 in background.

Due to the obvious deterioration of the two TE-29 breakwaters and their effect on sediment processes and volume capture within the breakwater field, CPRA recommends recapping these and any other breakwaters found below design heights, as soon as an approved O&M plan is completed. A complete survey of the breakwaters, both TE-29 and TE-48 should be conducted and plans should be developed to repair any deficiencies necessary. These project features have accomplished the CWPRRA goals set forth and should be maintained in order to perform as designed within overall State Master plan goals for Raccoon Island.

Several improvements would enhance the sustainability and analysis of the Raccoon Island Shoreline Protection/Marsh Creation (TE-48) project. First, TE-29 breakwaters #3 and #4 have settled and should be repaired. These structures have recessed and are only partially exposed during higher tides affecting the shoreline response. Currently, no salients are being produced in the lee of these structures and with reduced sediment input due to the erosion of the eastern shoal these breakwaters should be repaired to insure they perform to their maximum efficiency. Once as-built information for the phase B portion of the project is provided and a final O&M plan is approved, a complete survey of the breakwaters themselves, including settlement plates should be conducted and plans for repairs should be developed.

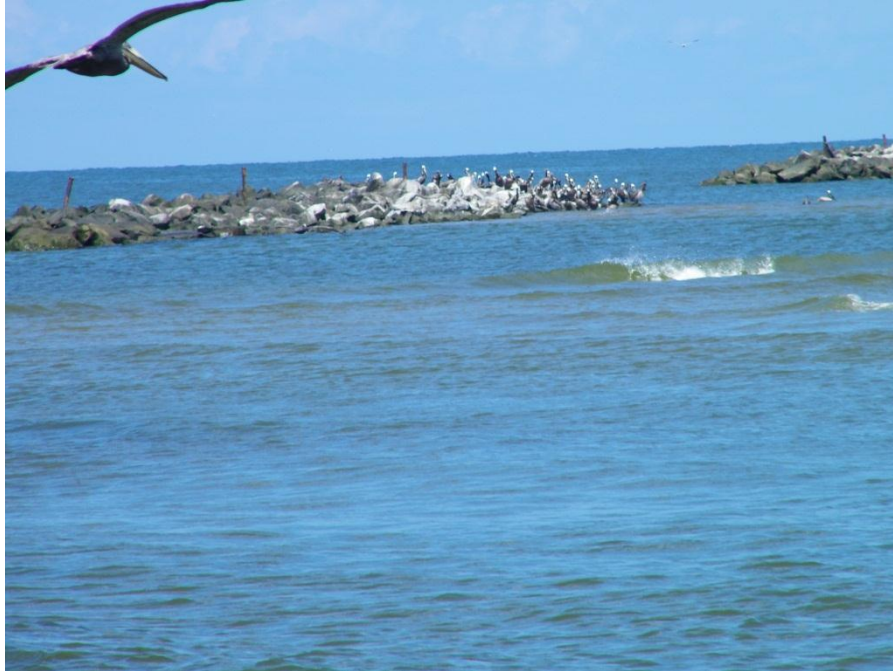
Photo 3: Behind TE-29 breakwater #5 looking west (Raccoon\_042). Note higher crest elevation of breakwaters, and wave diffraction from breakwaters and salients.

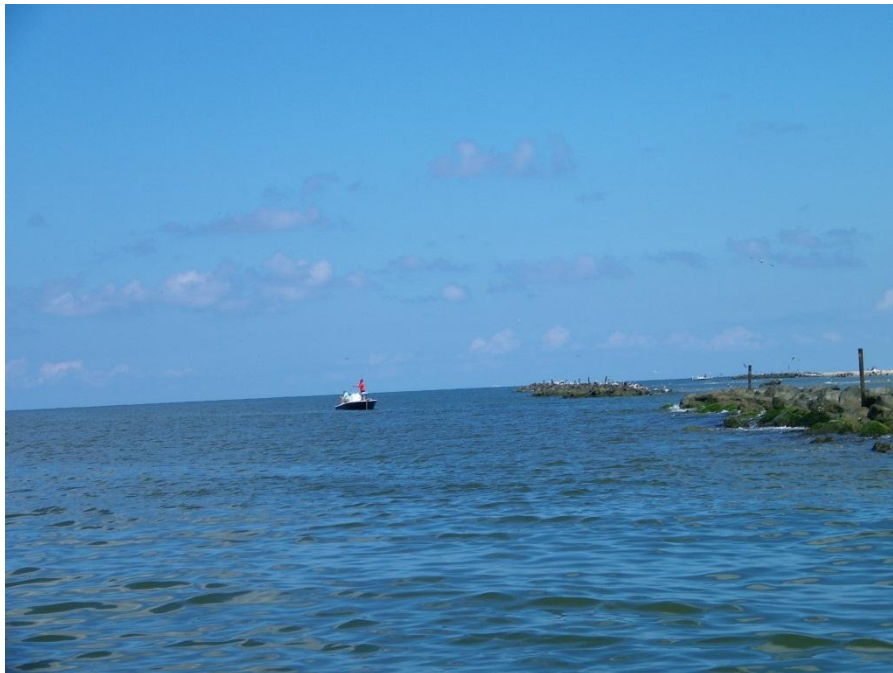
Photo 4: Gulfward of TE-29 breakwater #5 looking west (Raccoon\_046). Note high elevation of TE-29 breakwaters and existing settlement plates. TE-48 breakwaters in far distance closer to shoreline.

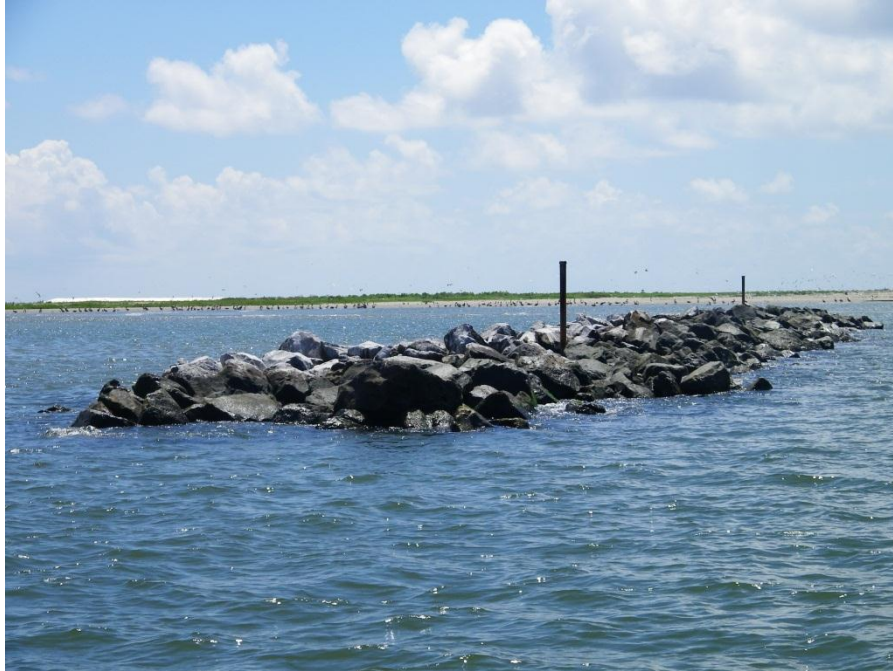
Photo 5: West end of TE-48 breakwater #15 looking west (Raccoon\_052). Note high crest elevation of breakwaters, and intact settlement plates.

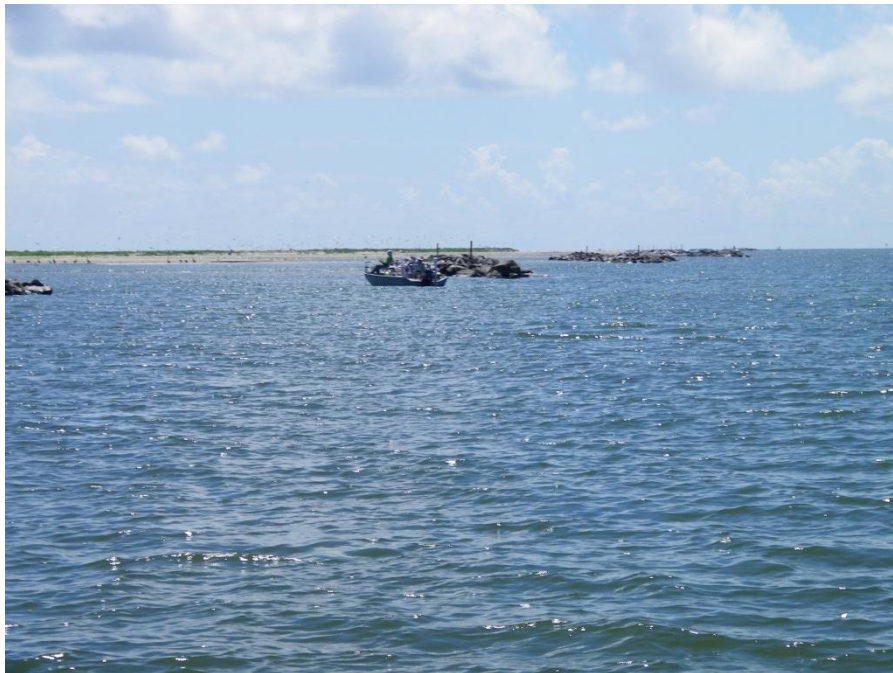
Photo 6: Gulfside of TE-48 breakwater field looking east (Raccoon\_053). Note high elevation of breakwaters and existing settlement plates.

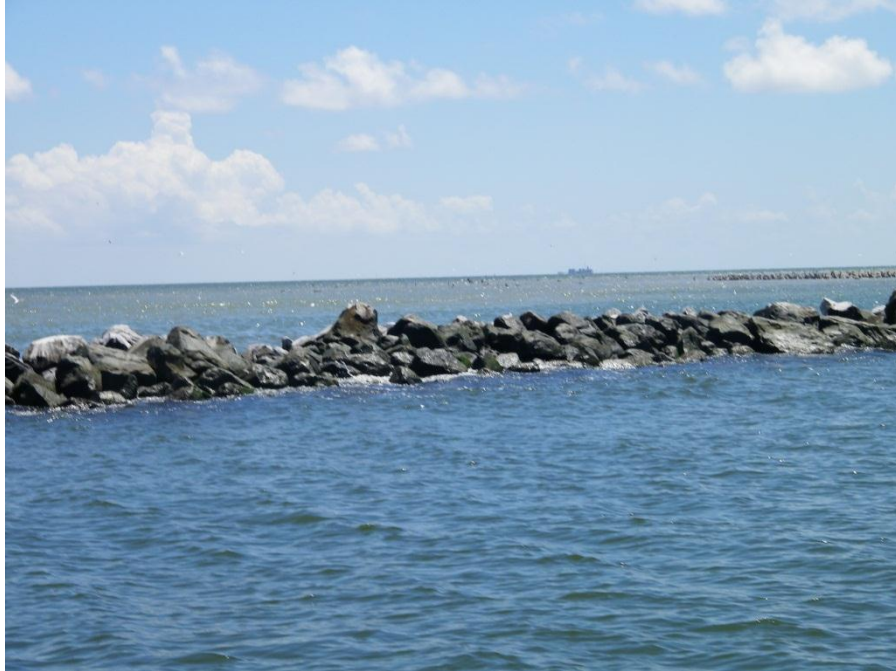
Photo 7: TE-48 breakwater #14 looking north (Raccoon\_052). Note breach in background with obvious shallow shoal.

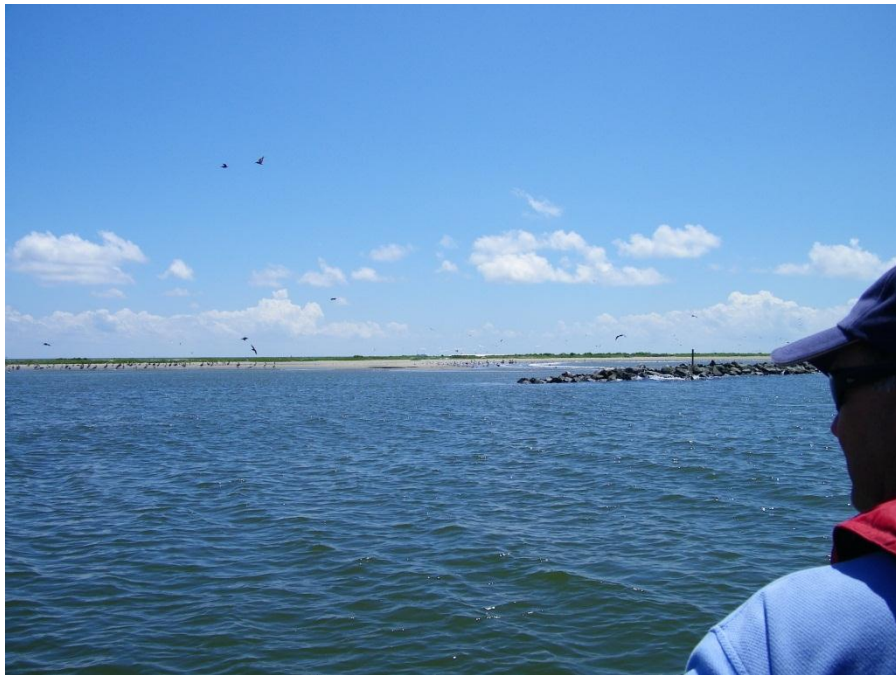
Photo 8: Western end of TE-48 breakwater #12 looking east (Raccoon\_056). Note salient formation behind breakwater and wave diffraction. Also nearest settlement plate appears to be slightly in front of the breakwater.

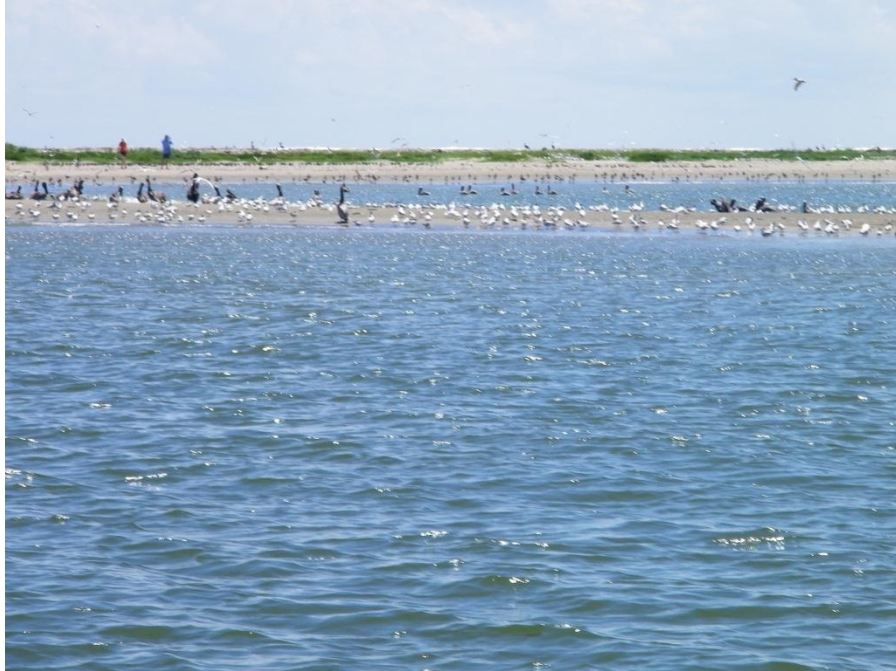
Photo 9: Close-up of tombolo formation behind TE-48 breakwater #11 looking east (Raccoon\_059). Note heavy shorebird use of the island and bird research efforts in the background.

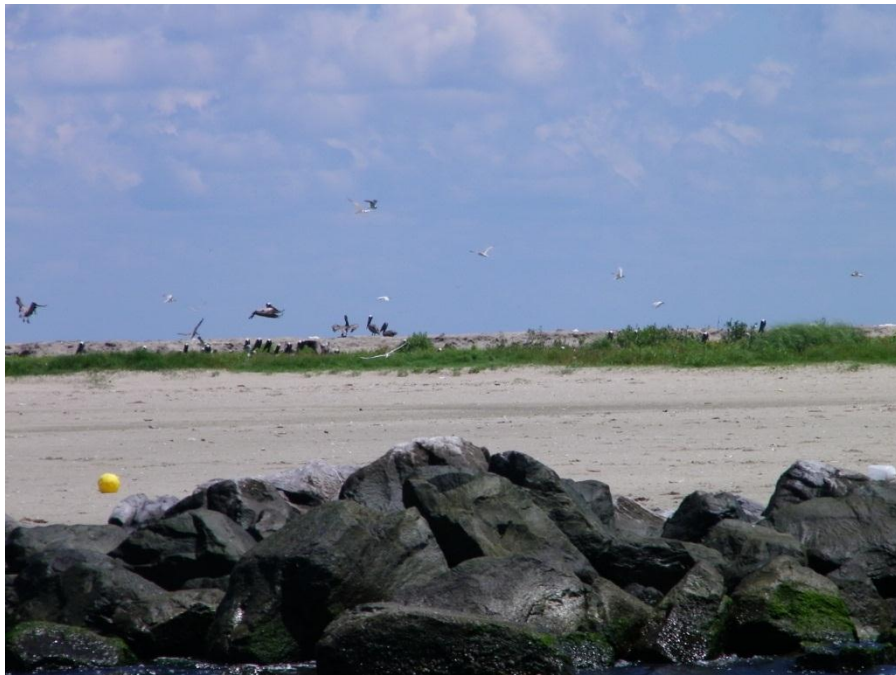
Photo 10: TE-48 breakwater #9 looking north (Raccoon\_068). Note salient formation behind breakwater and narrow existing vegetation behind which is the unvegetated TE-48 marsh platform containment dike.

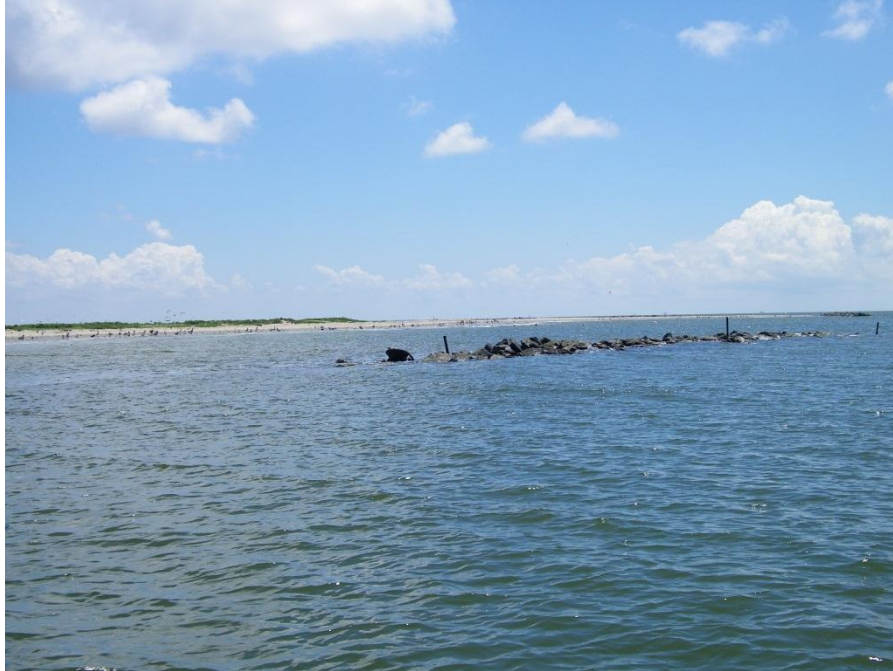
Photo 11: TE-29 breakwater #4 looking northeast (Raccoon\_088). Note low elevation, leaning settlement plates, and lack of wave diffraction behind the breakwater.

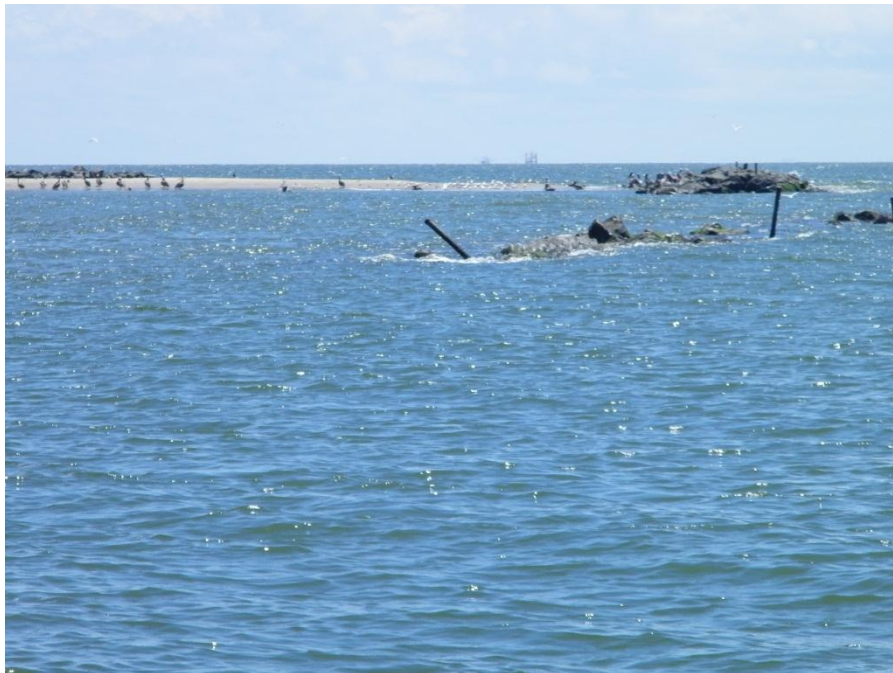
Photo 12: TE-29 breakwater #3 looking north (Raccoon\_068). Note low elevation, leaning settlement plates, and lack of wave diffraction behind the breakwater. Also, note higher elevation of breakwater #1 and #2 in background.

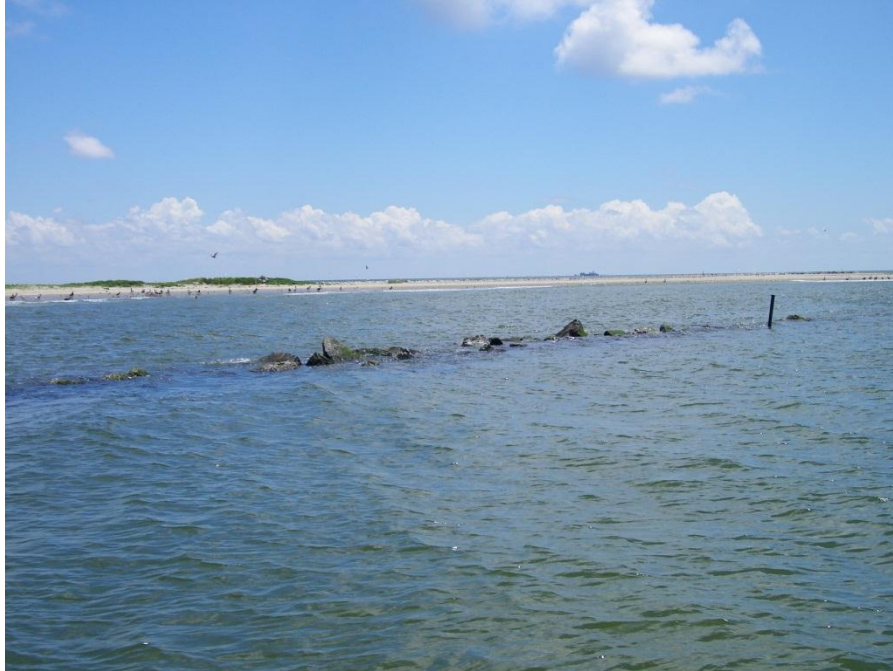
Photo 13: TE-29 breakwater #3 looking north (Raccoon\_095). Note low elevation, lack of wave diffraction behind the breakwater, and no evidence of salient formation.

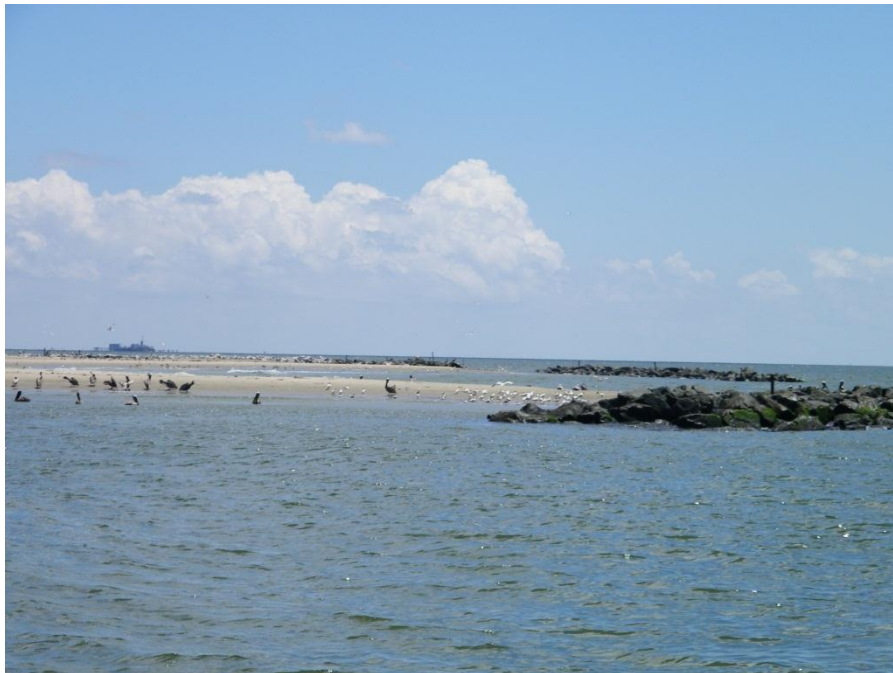
Photo 14: TE-29 breakwaters #2 – 0 and TE-48 eastern terminal groin looking north (Raccoon\_098). Note high elevation, significant salient formation.

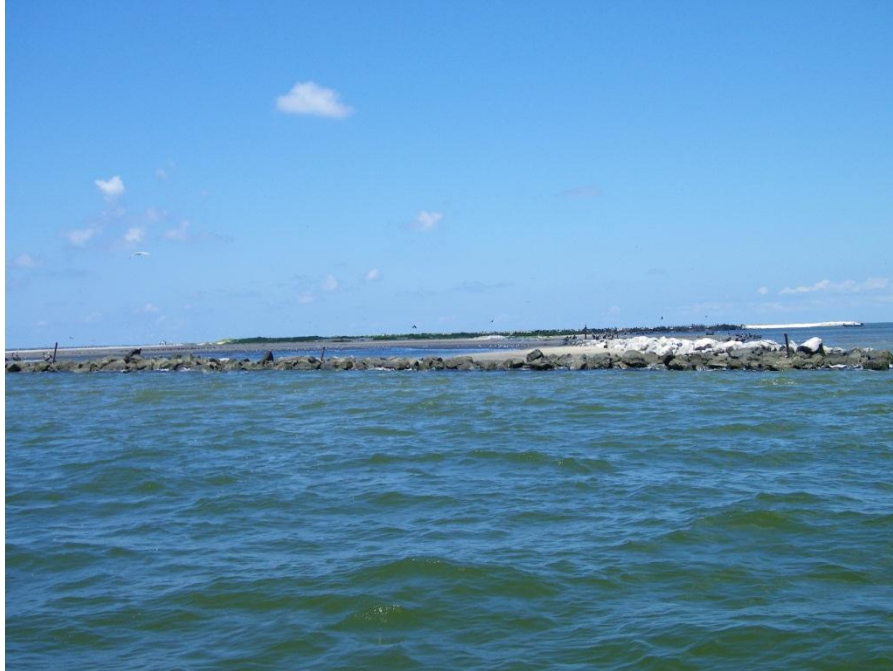
Photo 15: TE-29 breakwater #0 and TE-48 eastern terminal groin looking west (Raccoon\_120). Note high elevation and significant sand accumulation along groin.

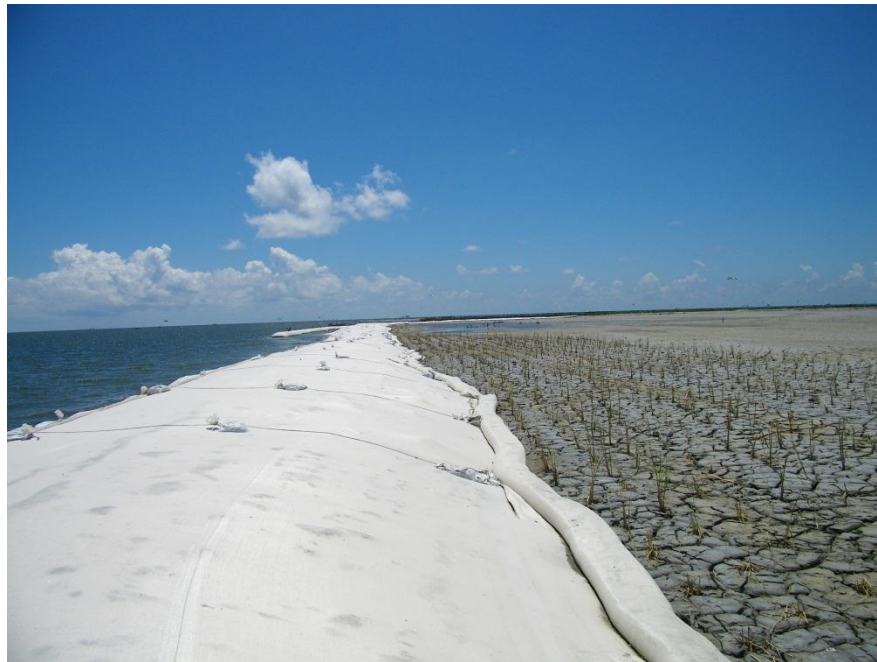
Photo 16: TE-48 marsh creation back dike looking east (Raccoon\_131). Note geotextile coverage of the back dike in an attempt to postpone degradation until sediments consolidate and vegetative plantings spread. Also, note geotubes in background as the first attempt to protect the back dike.

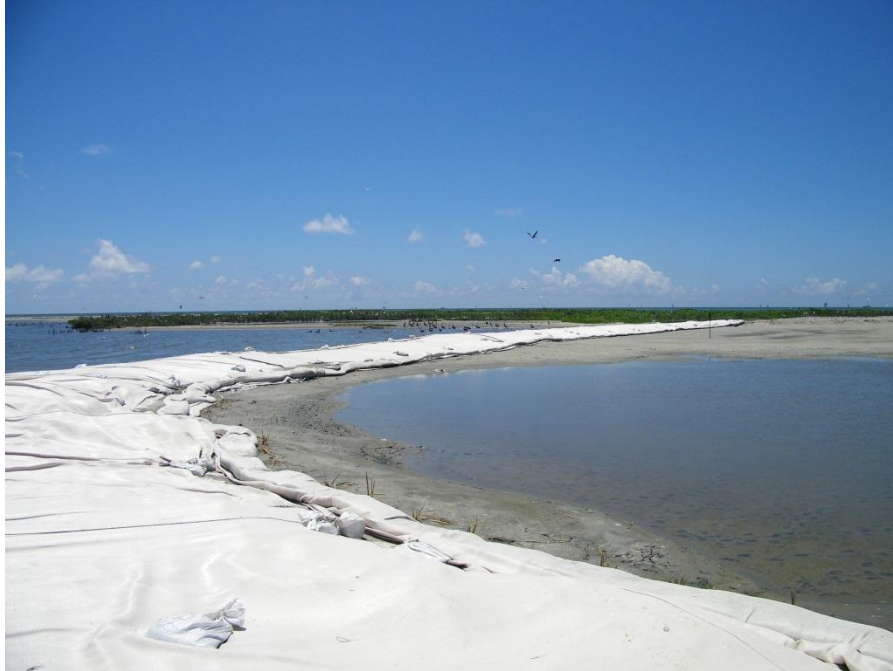
Photo 17: TE-49 marsh creation back dike eastern tie in looking southeast (Raccoon\_141). Note slight low spot in fill area due to pipe wash out.

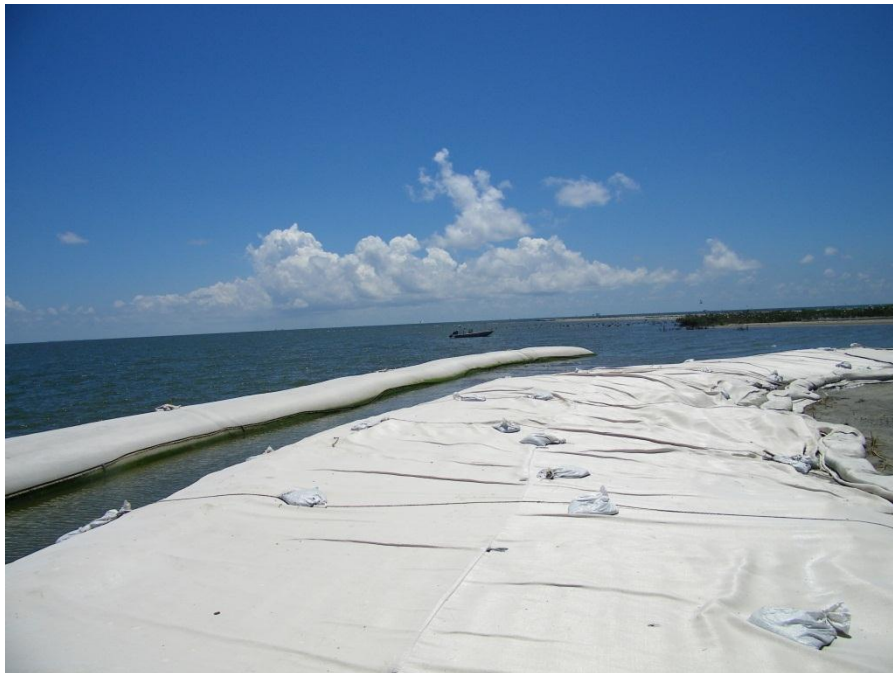
Photo 18: TE-48 marsh creation area back dike looking east (Raccoon\_143). Note geo-tubes in as the first attempt to protect the back dike.

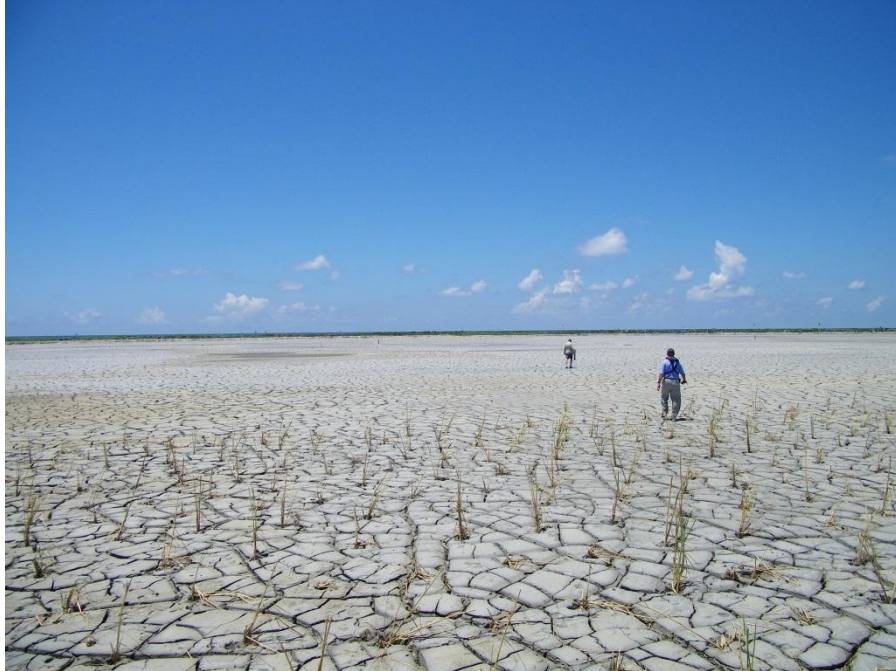
Photo 19: TE-49 marsh creation area looking south (Raccoon\_148). Note persons walking on fill beyond locations plantings contractor could access on previous attempts indicating good settlement and compaction.

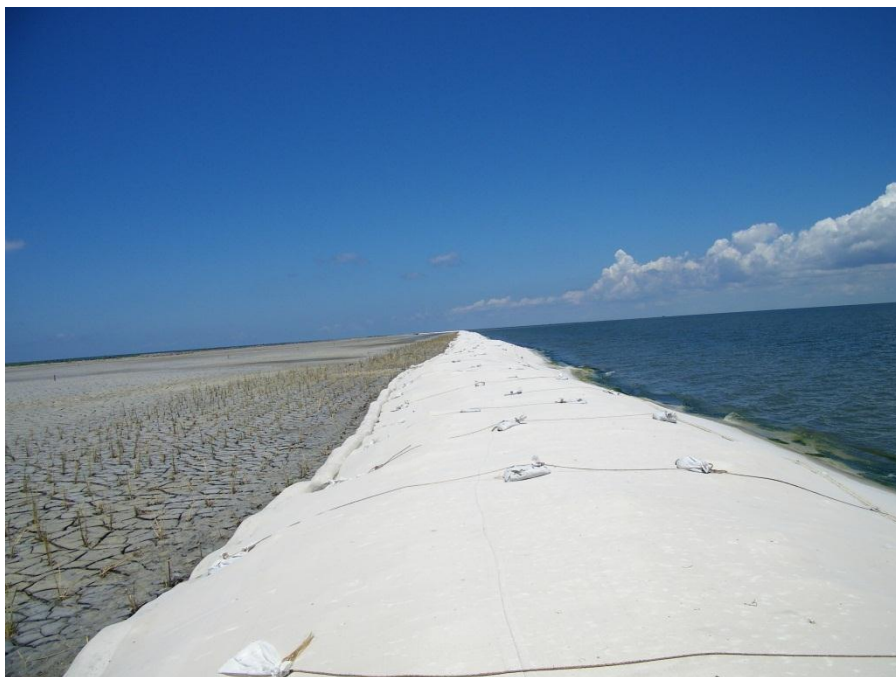
Photo 20: TE-48 marsh creation area back dike looking west (Raccoon\_150). Note geotextile cover on dike and first plantings along inside, indicating where contractor could access.

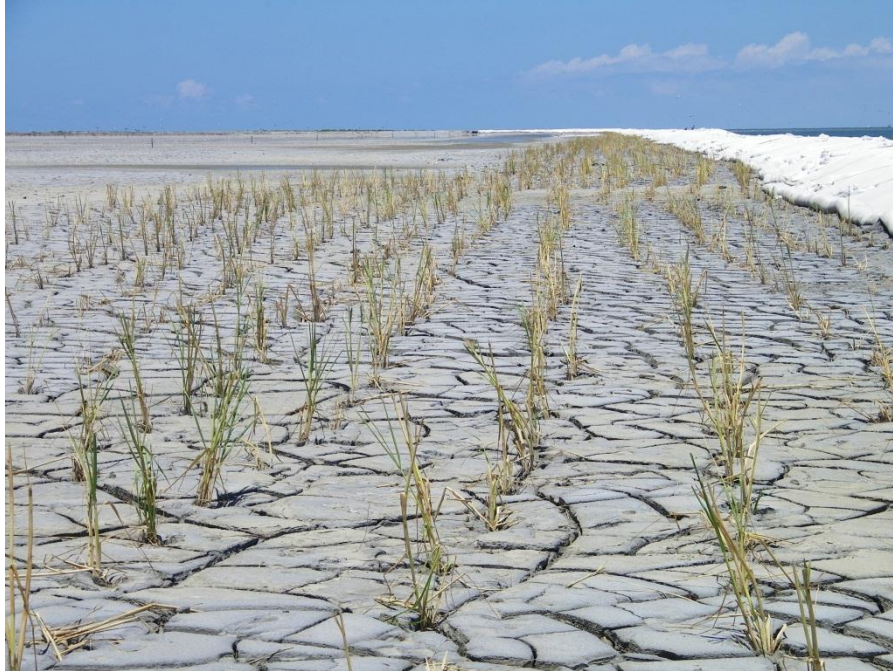
4. Recent vegetative plantings within the fill area are severely stressed at the time of this inspection; however, there is some indication of new growth. These plantings should be accessed again to determine issues before new plantings are attempted (Appendix A).

Photo 21: TE-49 marsh creation area plantings looking west along back dike (Raccoon\_158). Note dry cracked soils and stressed plants. Also, note low borrow ditch in background.

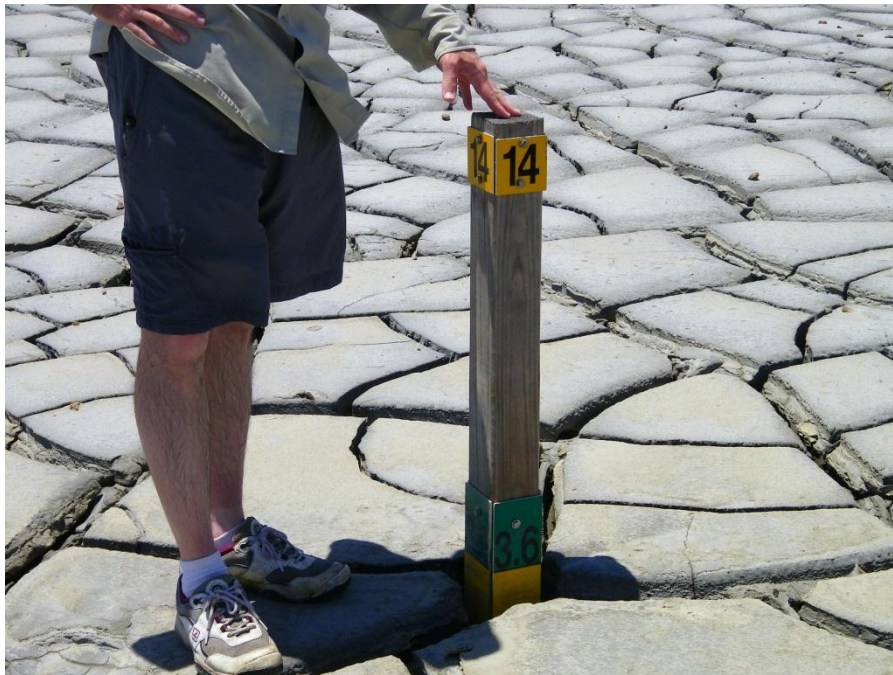
Photo 22: TE-48 marsh creation area settlement gage #14 (Raccoon\_164). Note persons could access by walking and settlement indicated approx. 3.5 ft elevation.

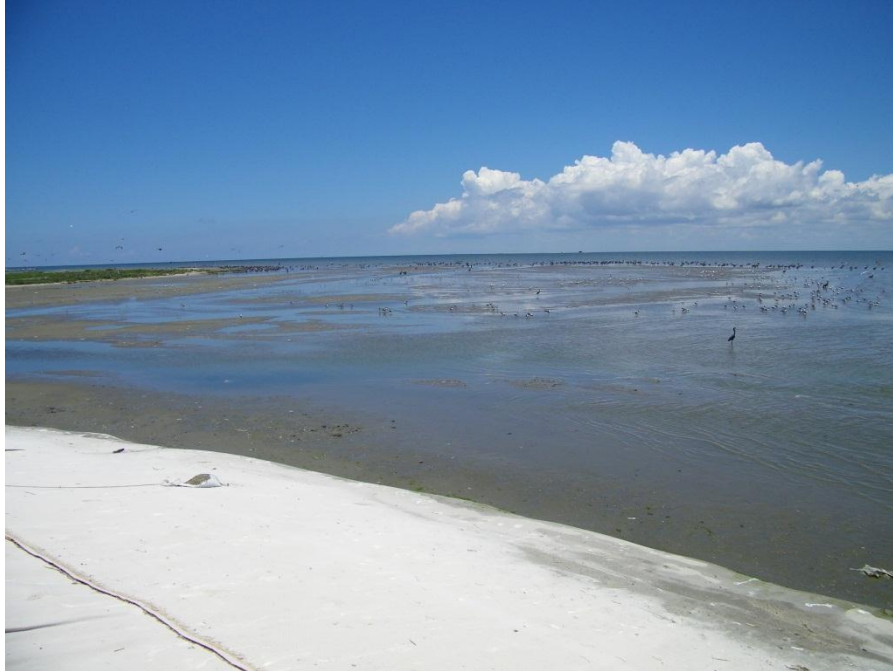
Photo 23: TE-49 marsh creation area outfall area on western end of island looking west (Raccoon\_166). Note shallow flat habitat outside the fill area created by fill and sediment dewatering.

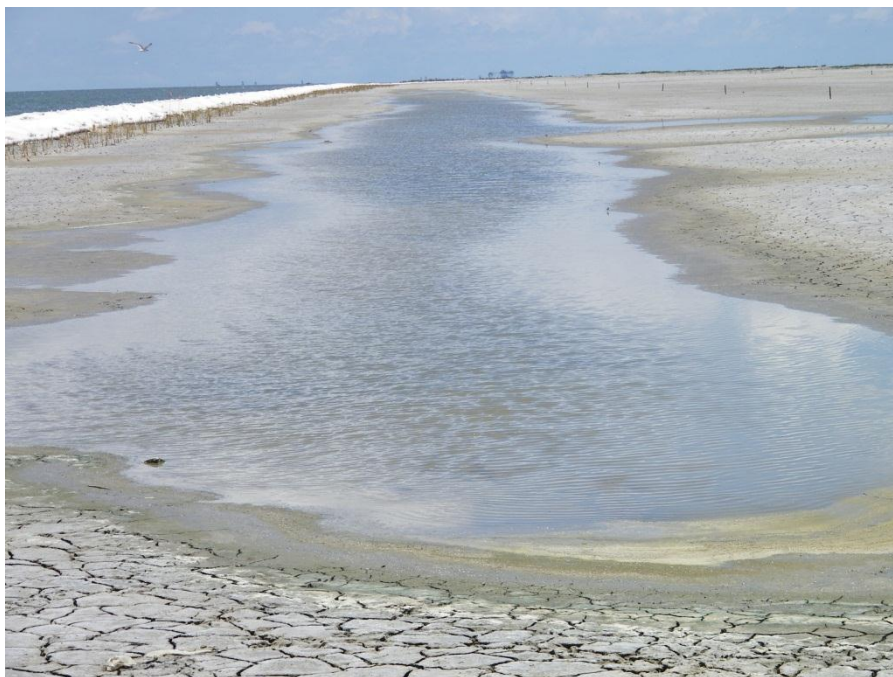
Photo 24: Typical containment borrow channel for the TE-48 marsh creation area (Raccoon\_179). Note differential settlement after filing creates lower elevations in pre-dug areas.

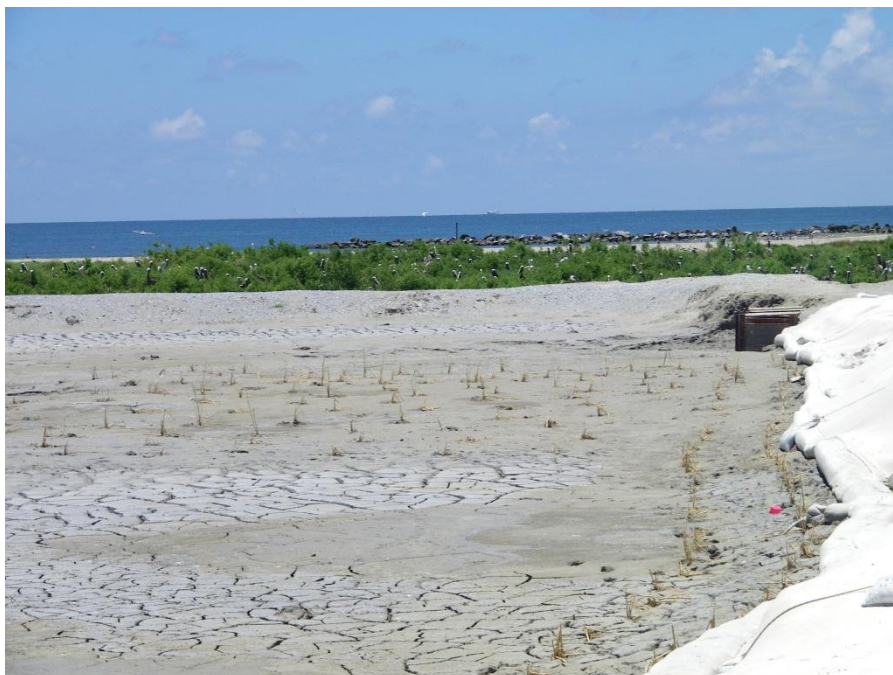
Photo 26: TE-48 marsh creation area western end containment tie-in (Raccoon\_178). Note spill box still in place currently provides water exchange while sediment consolidates.
