## **2015 Operations, Maintenance, and Monitoring Report**

### **West Belle Pass Barrier Headland Restoration (TE-52)**

State Project Number TE-52  
Priority Project List 16

August 2015  
Lafourche Parish

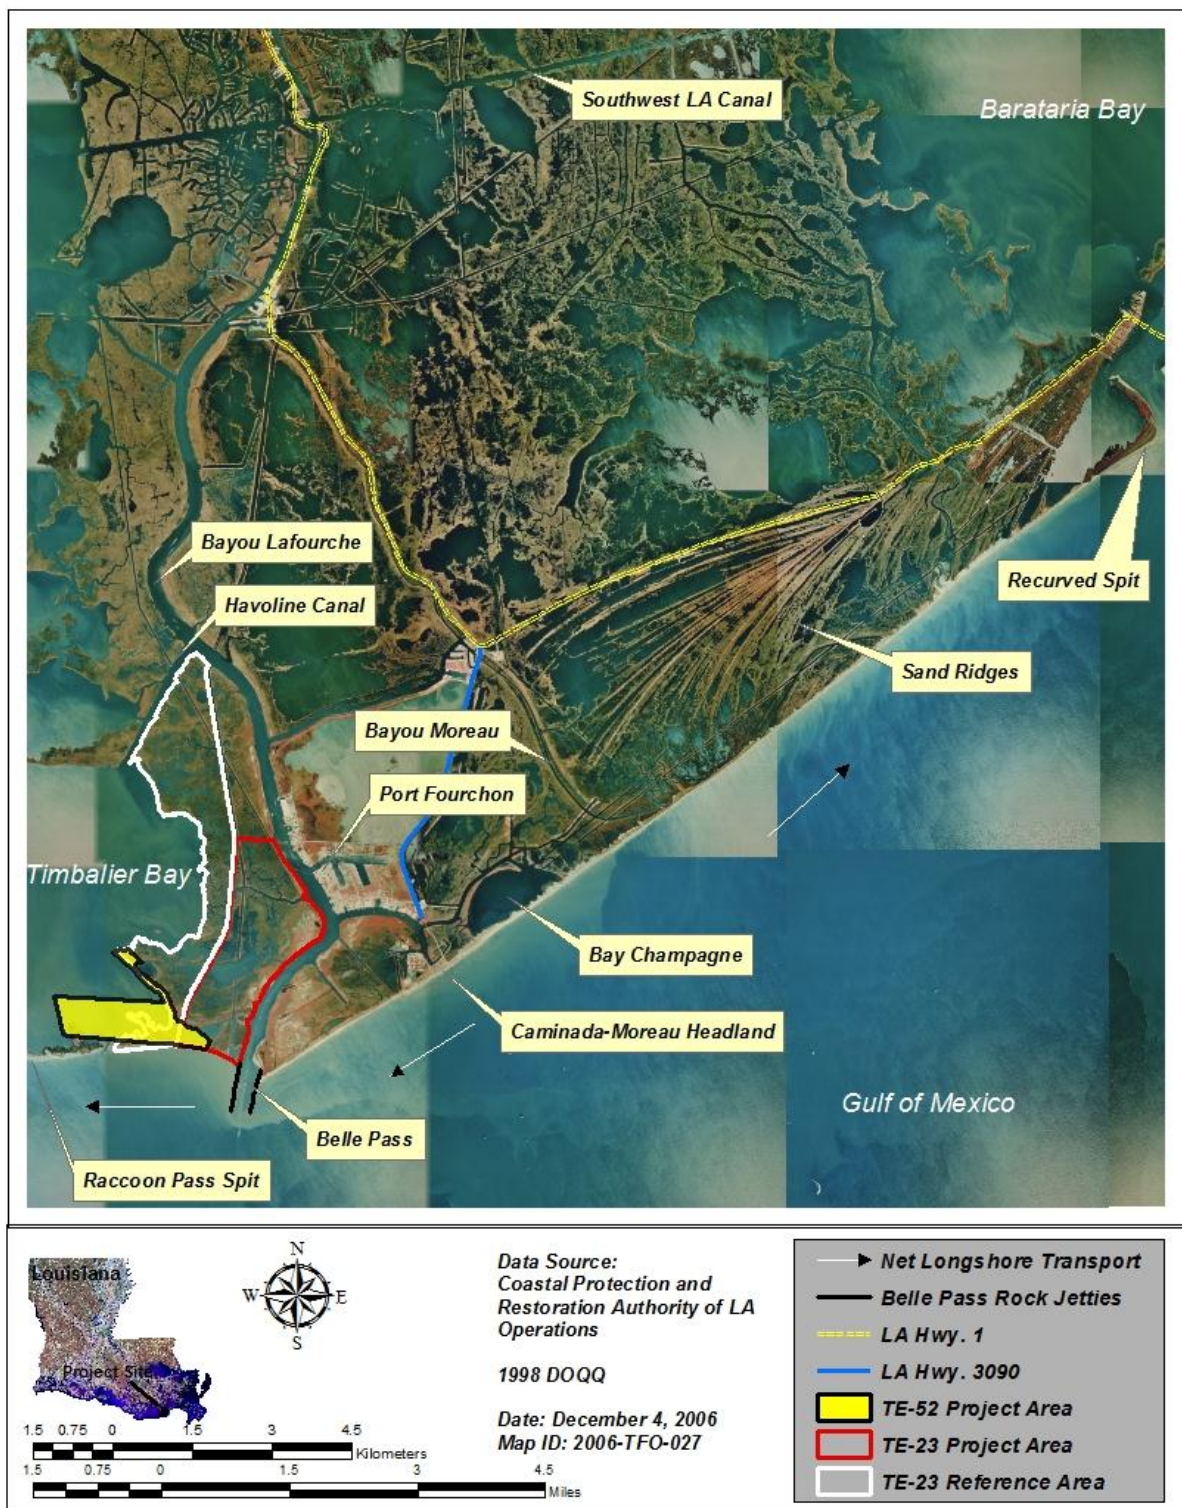
Figure 2. Geomorphic and anthropogenic features of the Caminada-Moreau Headland.

The construction of the Belle Pass Navigation Channel and Rock Jetties (Figures 2 and 3) has altered the TE-52 project area shorelines. Belle Pass dredging and jetty construction began in 1940 by increasing the depth and width of the channel to unspecified dimensions and constructing parallel rock jetties 152 m (500 ft) in length and 61 m (200 ft) in width. The jetties were extended by 90 m (300 ft) in 1945 due to shoreline erosion (Dantin et al. 1978). In 1958, the navigation channel was enlarged to a depth of -4 m (-12 ft) Mean Low Gulf (MLG) and a width of 30 m (100 ft). The channel was expanded to a 38 m (125 ft) bottom width and relocated to the west of the jetties in 1963 leaving only an eastern jetty. A western jetty was installed in 1974, and Belle Pass was dredged to a -6 m (-20 ft) MLG depth and a 91 m (300 ft) wide extent in 1975 (Dantin et al. 1978). In 1980, the jetties were extended to their current 793 m (2,600 ft) length and 366 m (1,200 ft) width (Figures 2 and 3). Finally, the navigation channel was dredged to a -8 m (-27 ft) MLG depth in 2001 (D. Breaux, GLPC, pers. comm.). As previously discussed, the construction of these rock jetties disrupted the longshore transport processes along the Caminada-Moreau Headland considerably reducing

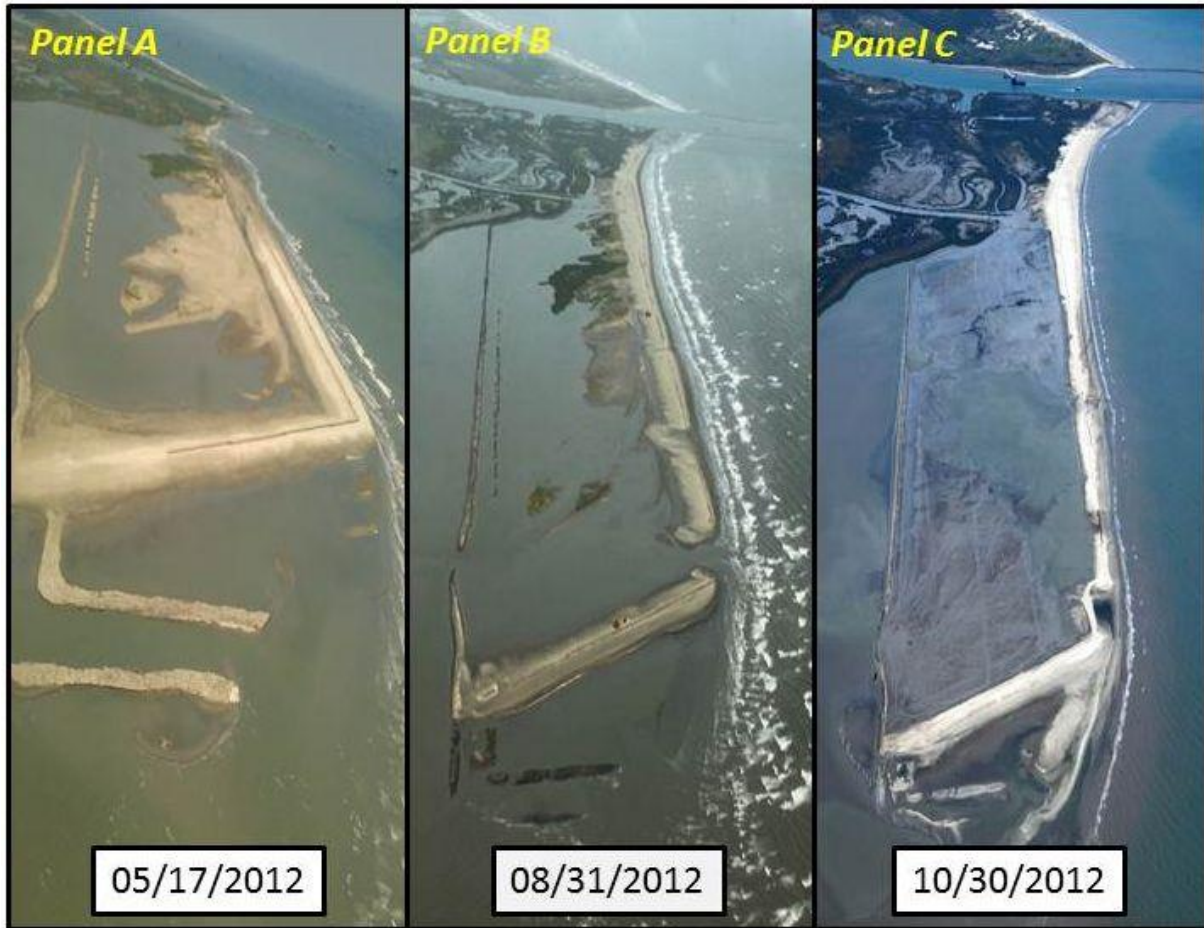
**Figure 10.** Oblique aerial images depicting the West Belle Pass Barrier Headland Restoration (TE-52) project before (Panel A) and after (Panel B) Hurricane Isaac and after dredging operations were complete (Panel C). Panels A and B were taken before marsh creation activates began. The earthen structure in the foreground of Panel A is the floatation channel spoil and can be seen in subsequent photographs. Note the breaching of the primary containment dike and the dune by the hurricane (Panel B) and the embryonic stages of the spit development in Panels B and C. Also note the offset position of the dune in the breached area and erosion along the Gulf of Mexico shoreline in panel C and the large volume of sand that was overwashed into the marsh creation area during beach and dune construction in panel A.

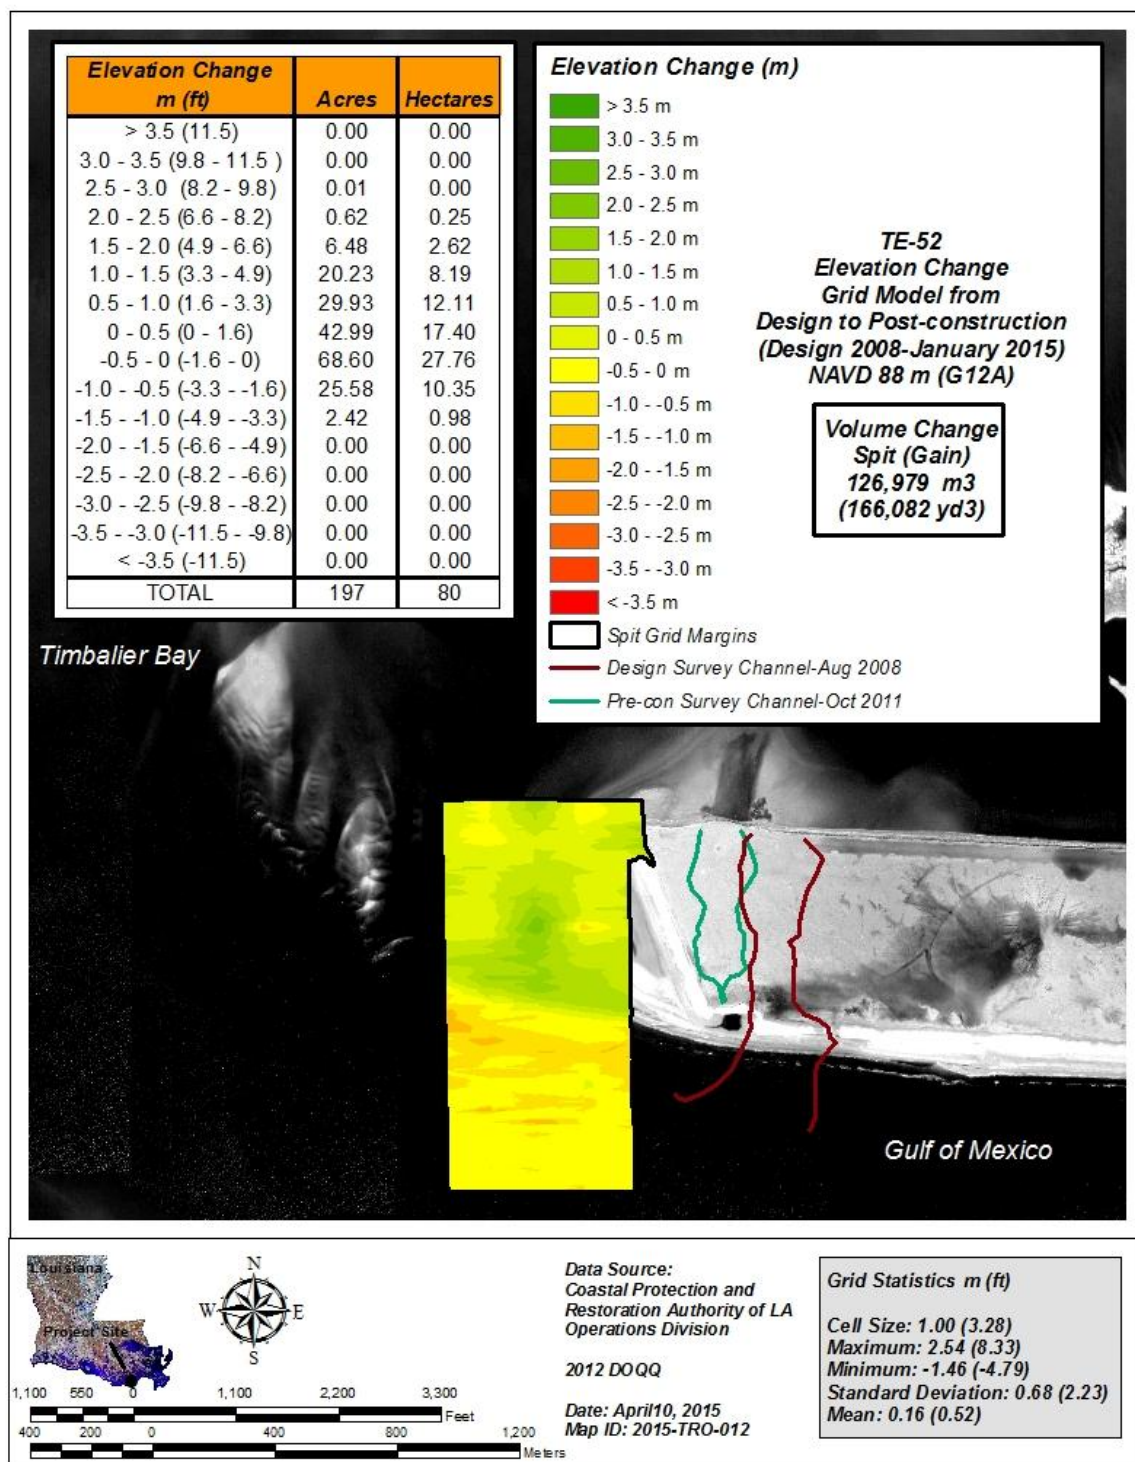
**Figure 16.** Elevation and volume change grid model for the spit area from design (Aug 2008) to post-construction (Jan 2015) at the West Belle Pass Barrier Headland Restoration (TE-52) project.

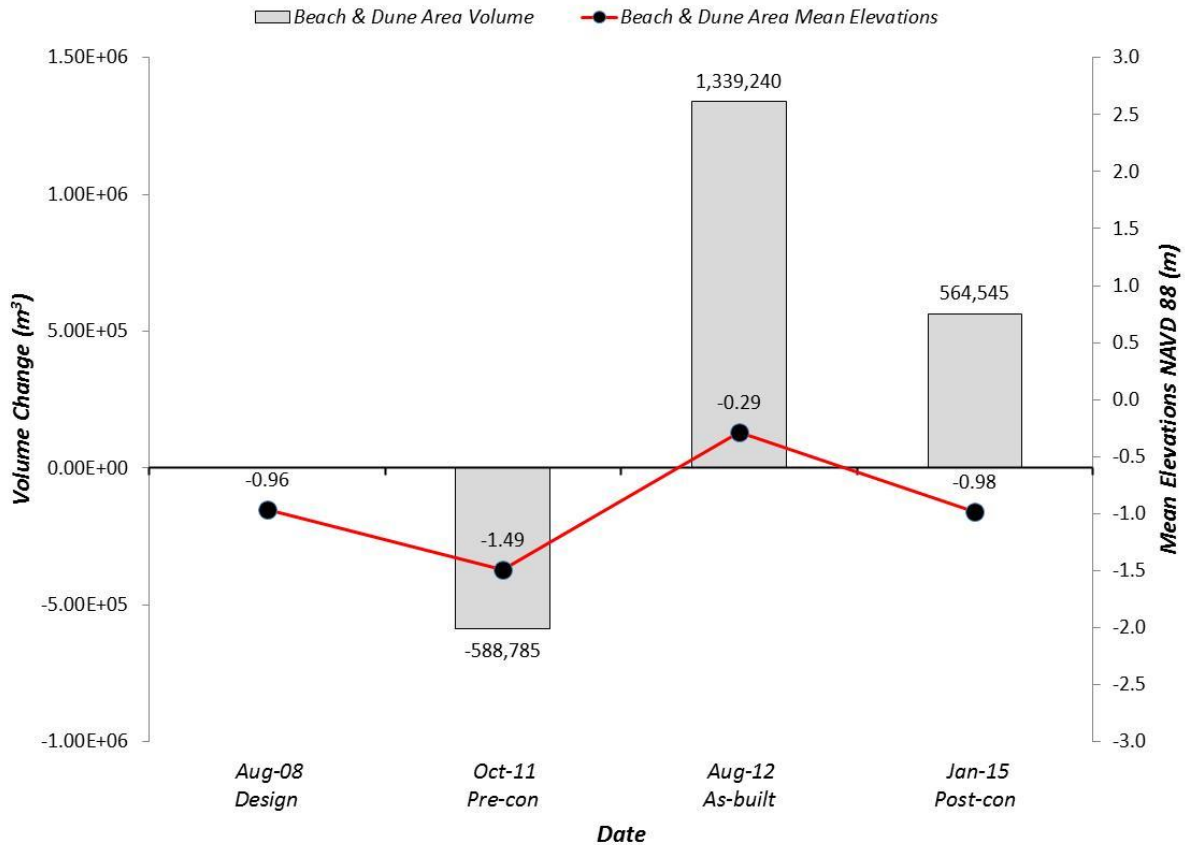
**Figure 17. Sediment volume change and mean elevations over time along the West Belle Pass Barrier Headland Restoration (TE-52) project's beach and dune area.**

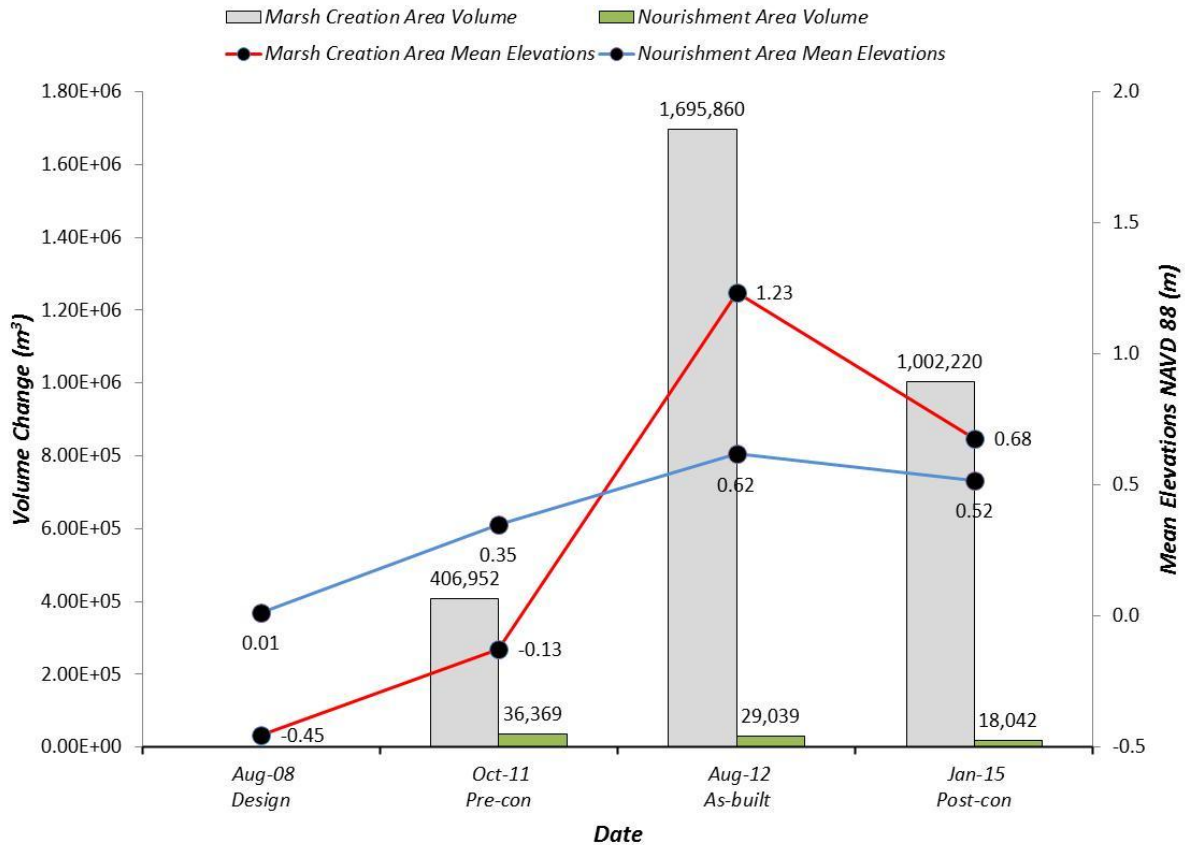
**Figure 18. Sediment volume change and mean elevations over time along the West Belle Pass Barrier Headland Restoration (TE-52) project's marsh creation and nourishment areas.**

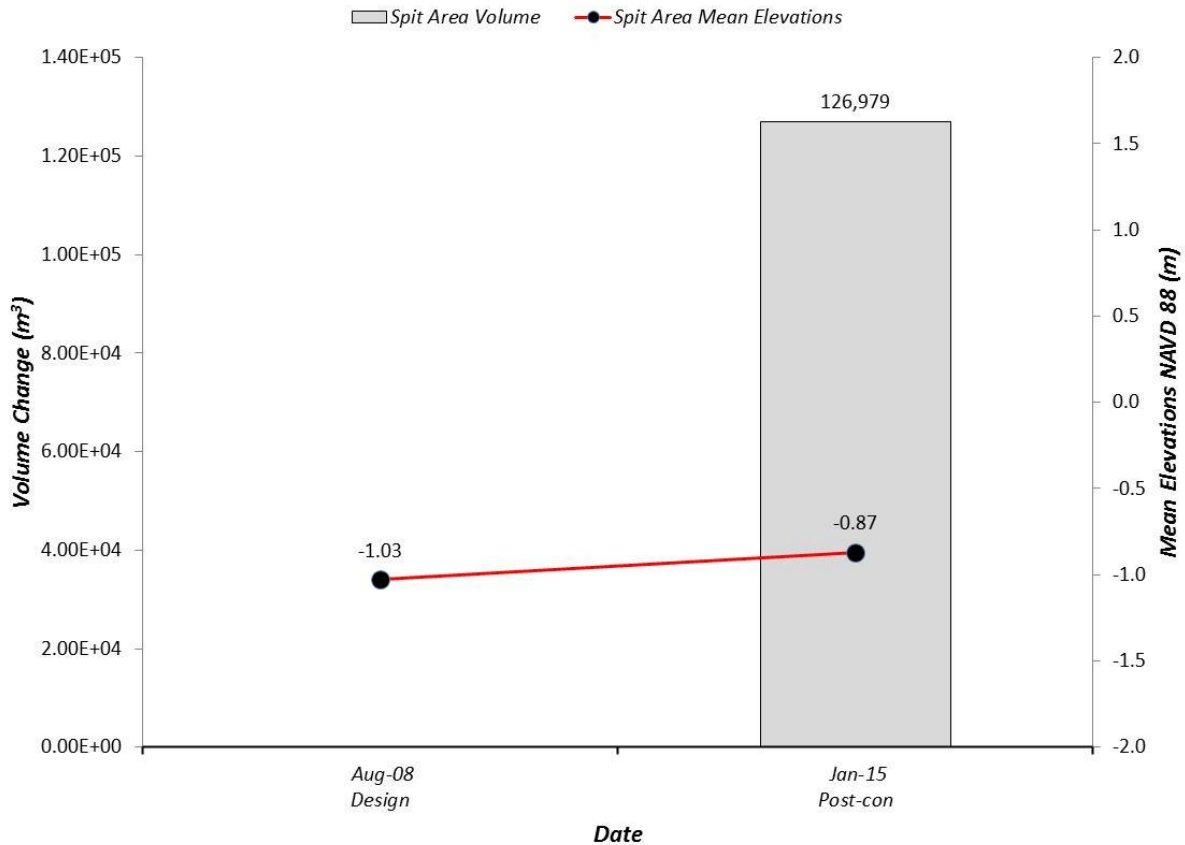
**Figure 19. Sediment volume change and mean elevations over time along the West Belle Pass Barrier Headland Restoration (TE-52) project's spit area.**

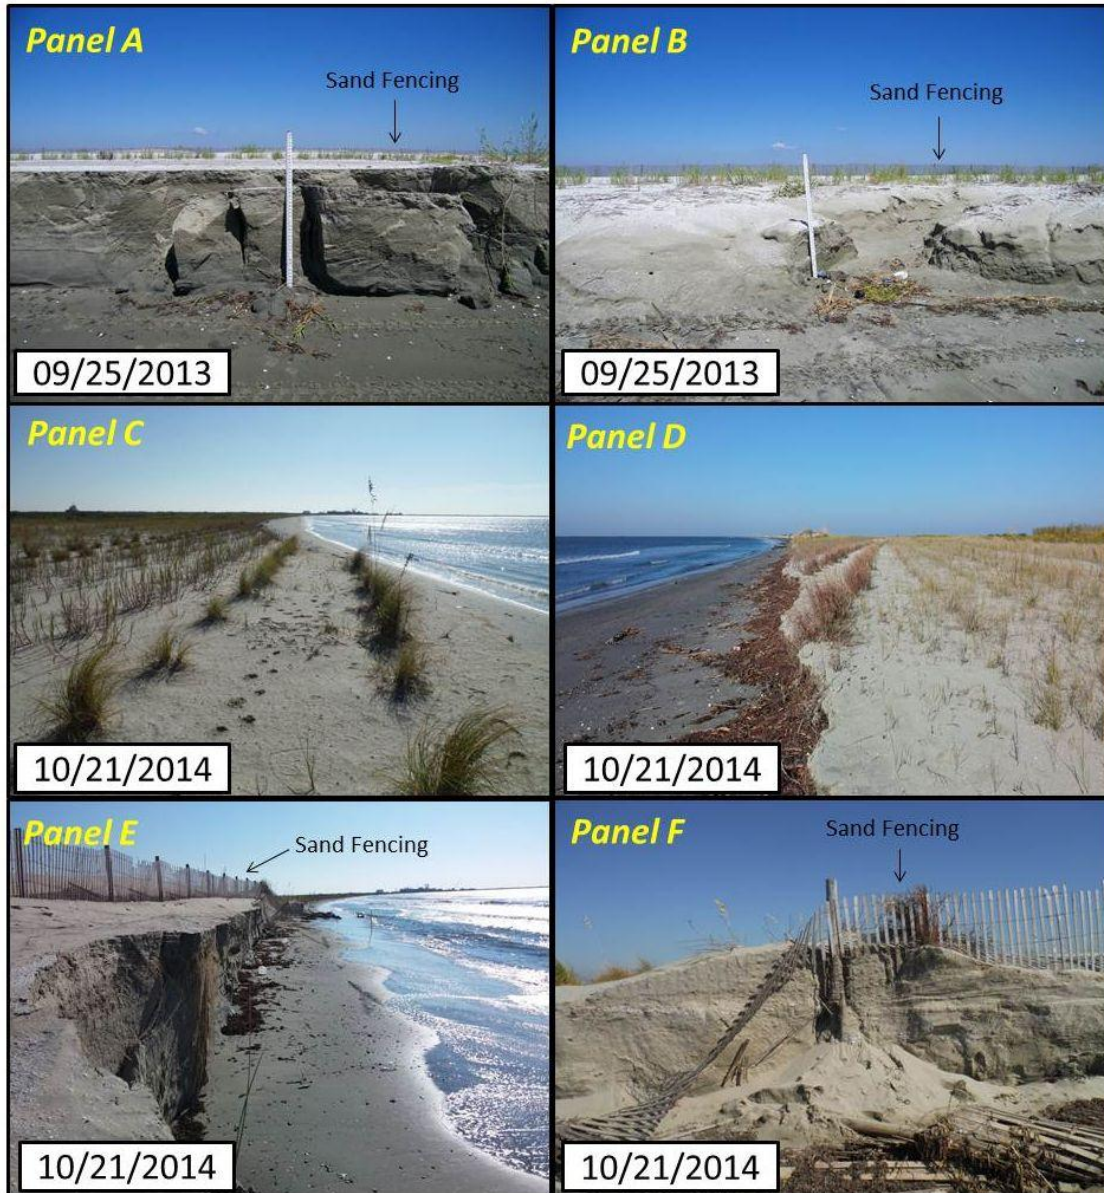
**Figure 21.** Oblique images depicting scarping of the West Belle Pass Barrier Headland Restoration (TE-52) project's dune feature in 2013 and 2014. Note the severe scarping that occurred several months after construction and the distance to the sand fencing in 2013 (Panels A and B). Panel B also shows channel formation during high water events along the eastern reaches of the dune feature. Several channels formed on the supratidal elevated expanded beach and dune template. Panels C and D display the eastern edges of the remaining dune. The dune feature no longer exists along the eastern reaches of the project. The area can be currently classified as washover and dune terrace landforms. Panels E and F exhibit the erosion of the dune all the way to the sand fencing which was placed in the center of the dune. Sand fencing only remains on the western and central reaches of the dune. The sand fencing that was installed on the eastern reaches of the dune has been leveled by wind and wave energy.

The beach fill and marsh fill appear to be functioning as designed. Some scarping of the beach dune is still occurring on the eastern portion of the project as a result of erosional shadowing from the Belle Pass jetty. This scarping has caused extensive damage to the sand fencing that was placed along this stretch of dune. The sand fencing will need to be replaced in the future after the beach and dune has stabilized into its natural position. A large spit of sand has formed on the western end of the headland as a result of longshore sediment transport. The formation of this spit was expected and provides excellent habitat for shorebirds and other marine species. The marsh appears to be in good condition and is not experiencing any excessive settlement. The northern containment dike is beginning to breach, which will help to provide a hydrologic connection to the interior portions of the marsh. If this breach does not occur, measures should be taken to breach the dike in strategic locations in the future. This should be noted during future inspections. There are no recommendations of maintenance to the beach fill, marsh fill, or sand fencing at this time.

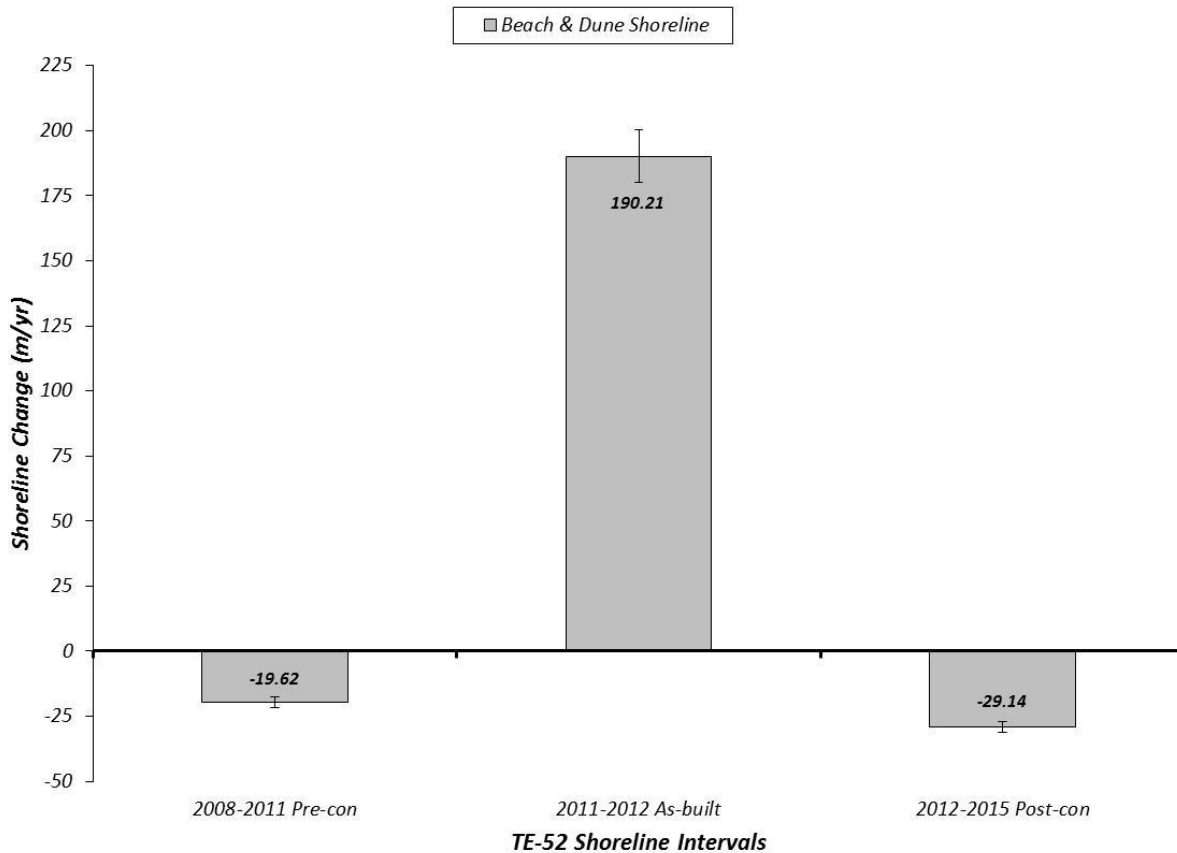
**Figure 22. Shoreline transgressions along the West Belle Pass Barrier Headland Restoration (TE-52) project area from Aug 2008-Jan 2015.**

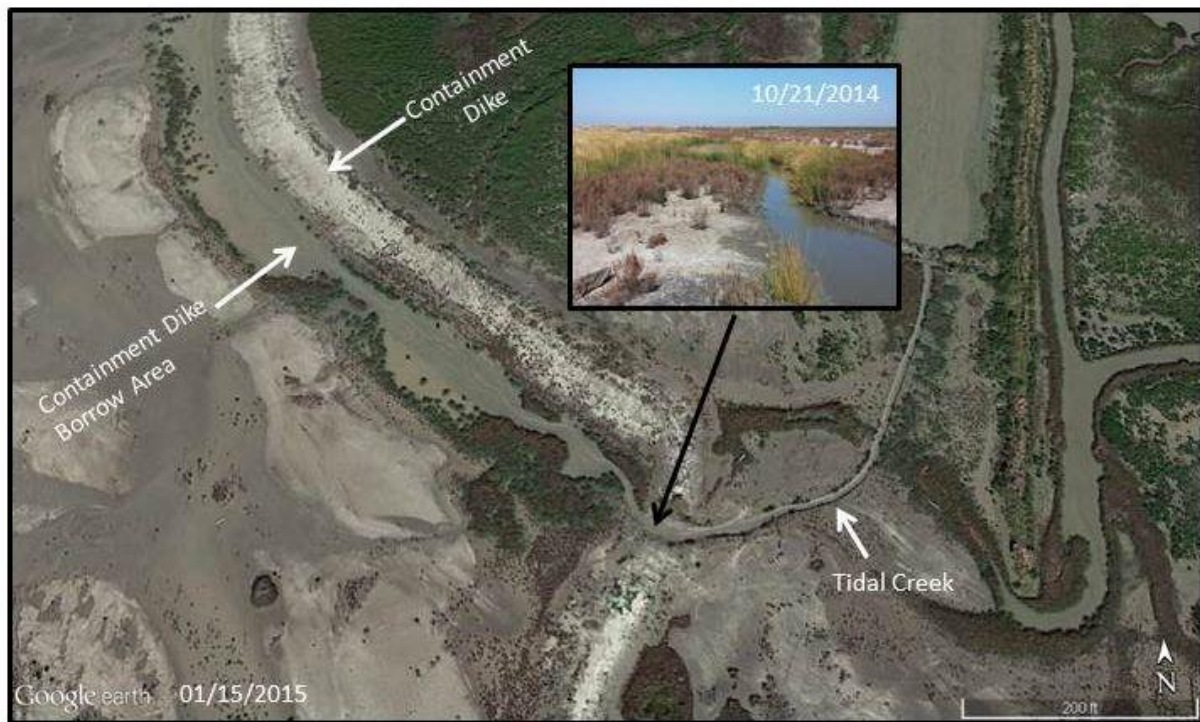
**Figure 27.** Jan 2015 Google Earth image and Oct 2014 oblique image depicting tidal connectivity and vegetation colonization through the gapped containment dike at the West Belle Pass Barrier Headland Restoration (TE-52) project. Note the vegetation colonization along the edges of the low elevated containment dike borrow area.

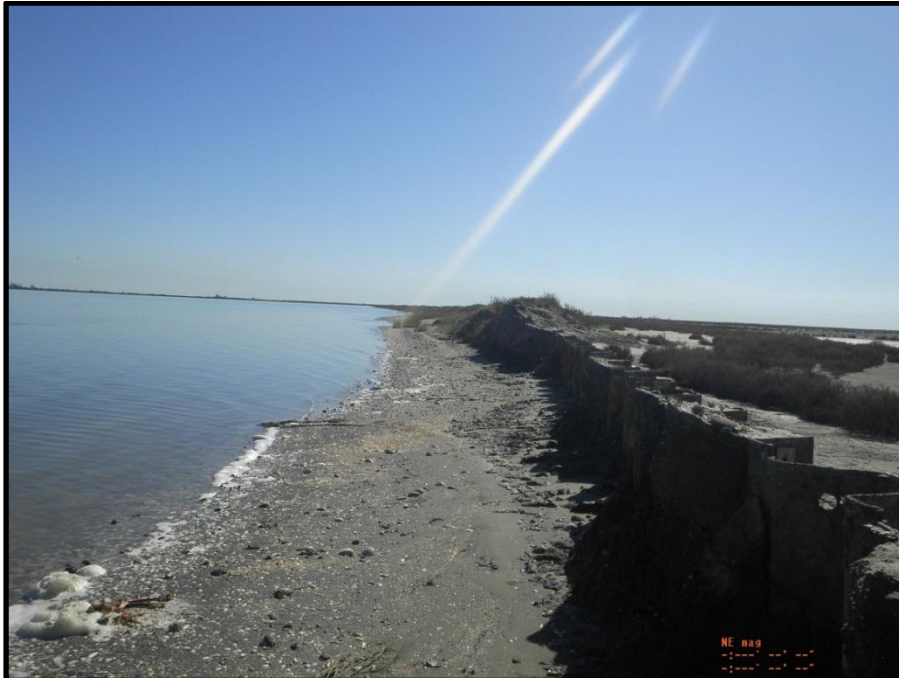
**Photo A-1. View of sheet pile plug in northern containment dike, looking east.**

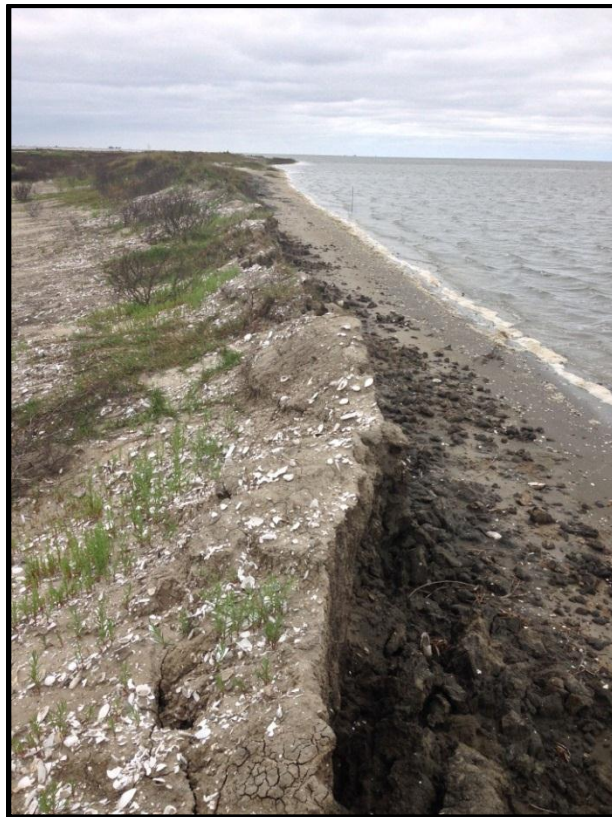
**Photo A-2. View of northern containment dike, looking west.**

The marsh fill appears to be in good condition. There are no signs of extensive settlement and vegetation is continuing to emerge near tidal water sources. All containment dikes are fully intact, with the exception of the outfall area near the eastern adjacent marsh. This gap in the containment dike is providing a hydrologic connection to the channel that was formed as a result of the containment dike borrow area. The northern containment dike will likely form some gaps over the next year and will provide additional connectivity to the interior marsh. The formation of these gaps should be monitored in the future. There are no recommendations for maintenance at this time.

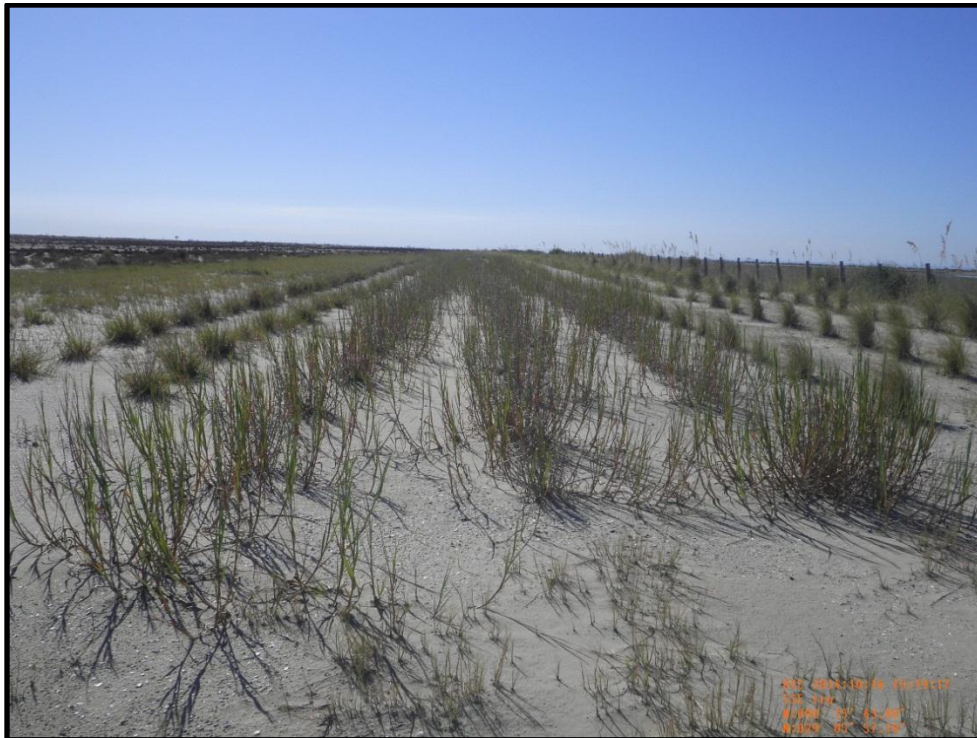
**Photo A-3. View of successful vegetative planting, looking south.**

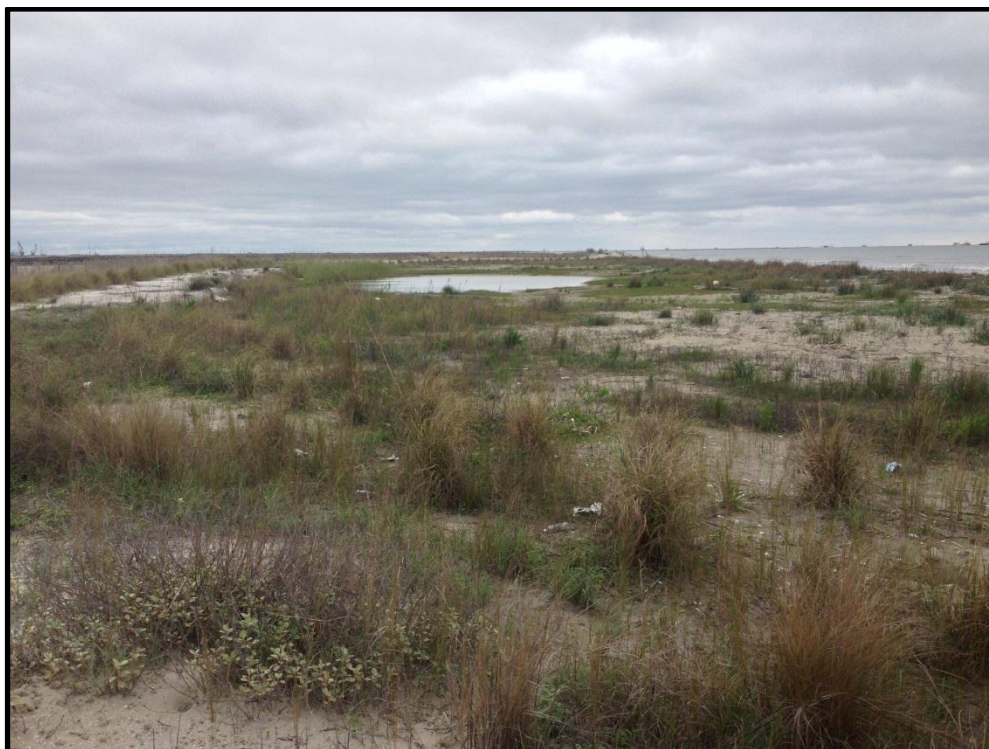
**Photo A-4. View of dune near offset segment of dune, looking east. Note the ponding in the area of low relief between the beach and dune.**

Overall, the beach fill appears to be in good condition. The beach profile is continuing to adapt to the environmental conditions. The dune scarping from Belle Pass to near Sta. 105 is continuing to increase, however there is no sign of immediate breach of the beach dune. The large sand spit on the western extend of the headland is continuing to increase in size. There are no recommendations for maintenance at this time.

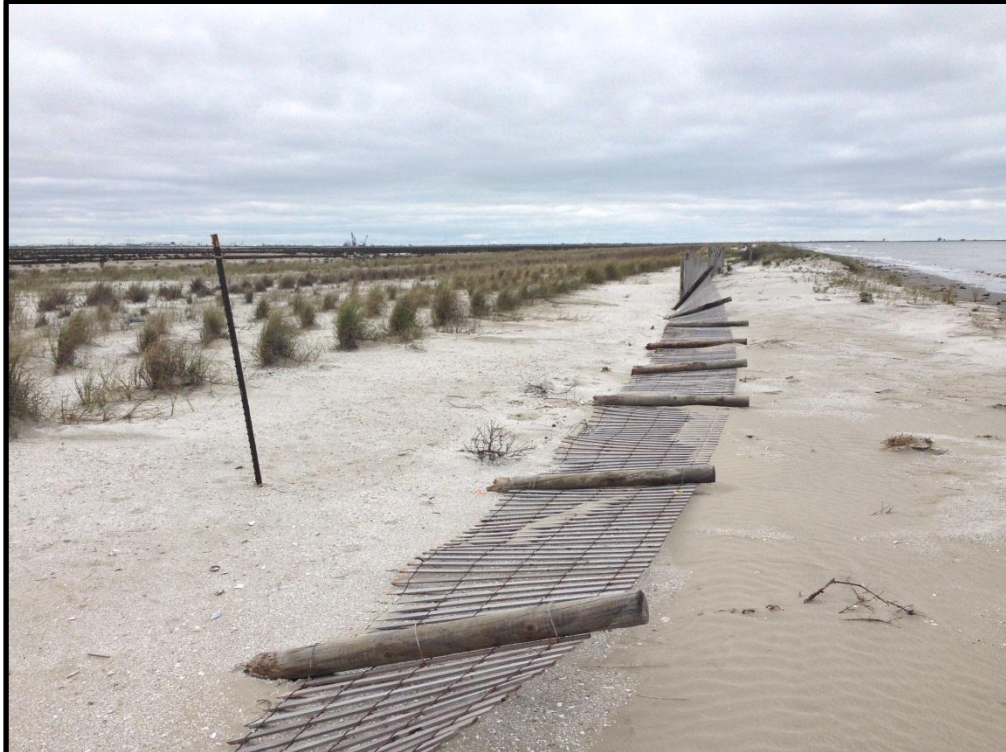
**Photo A-5. View of damaged sand fencing, looking east.**

The sand fencing from Sta. 45+00 to Sta. 105+00 appears to be in good condition. The fence is catching sand as designed and the vegetation is growing around it. The sand fencing from Sta. 105+00 to the eastern extent is badly damaged or nonexistent. The scarp in the dune has reached the fencing and destroyed it. The fencing in this area will need to be replaced after the beach has stabilized to its natural position. There are no recommendations for maintenance at this time.

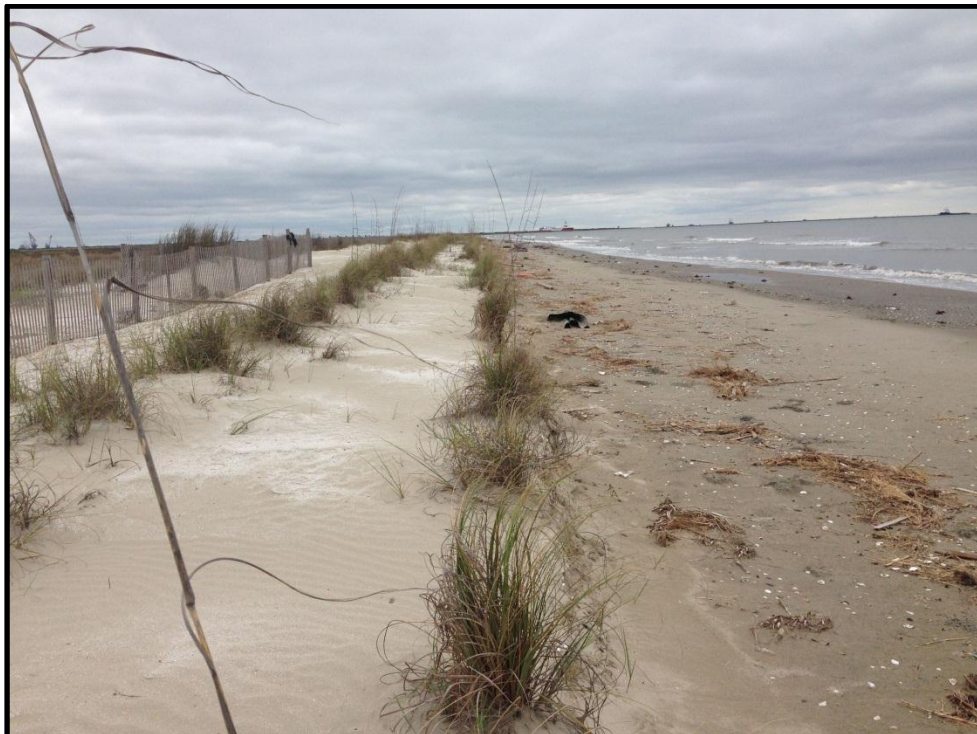
**Photo A-6. View beach and dune with vegetative planting and sand fencing, looking east.**

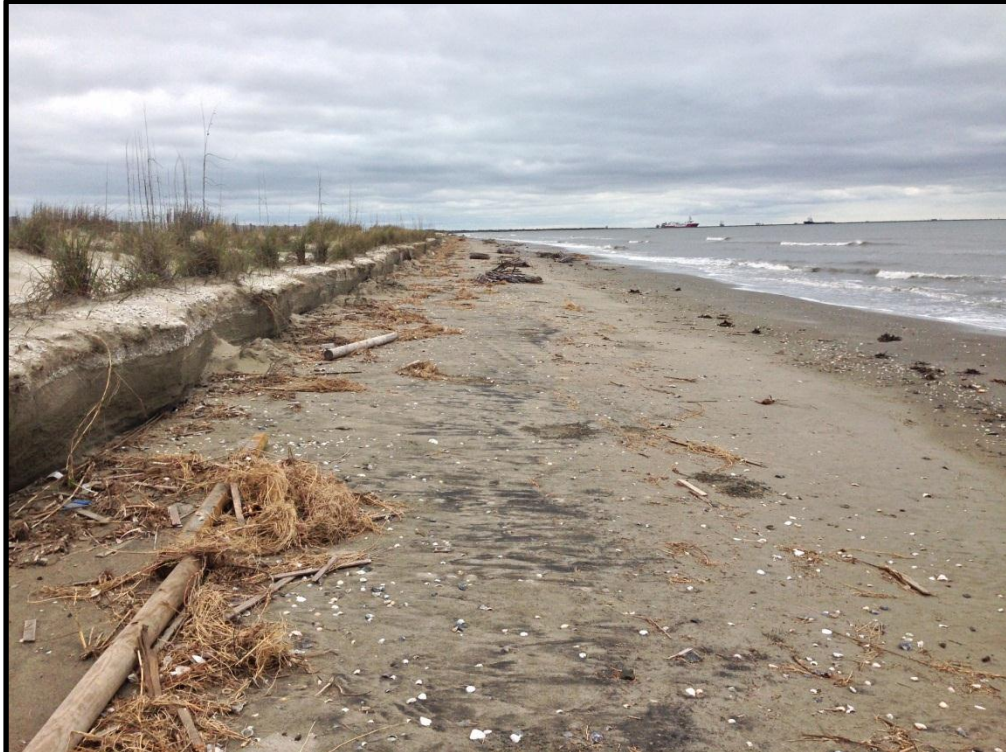
**Photo A-7. View of beach erosion, looking east.**

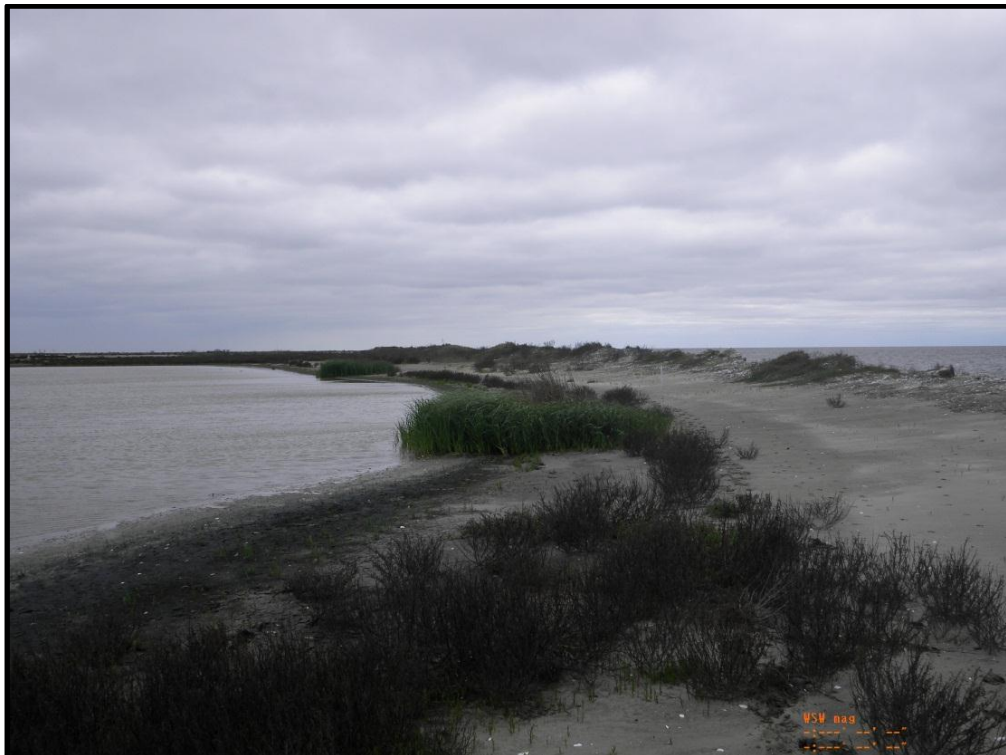
**Photo A-8. View of northern containment dike and emergent vegetation, looking west.**

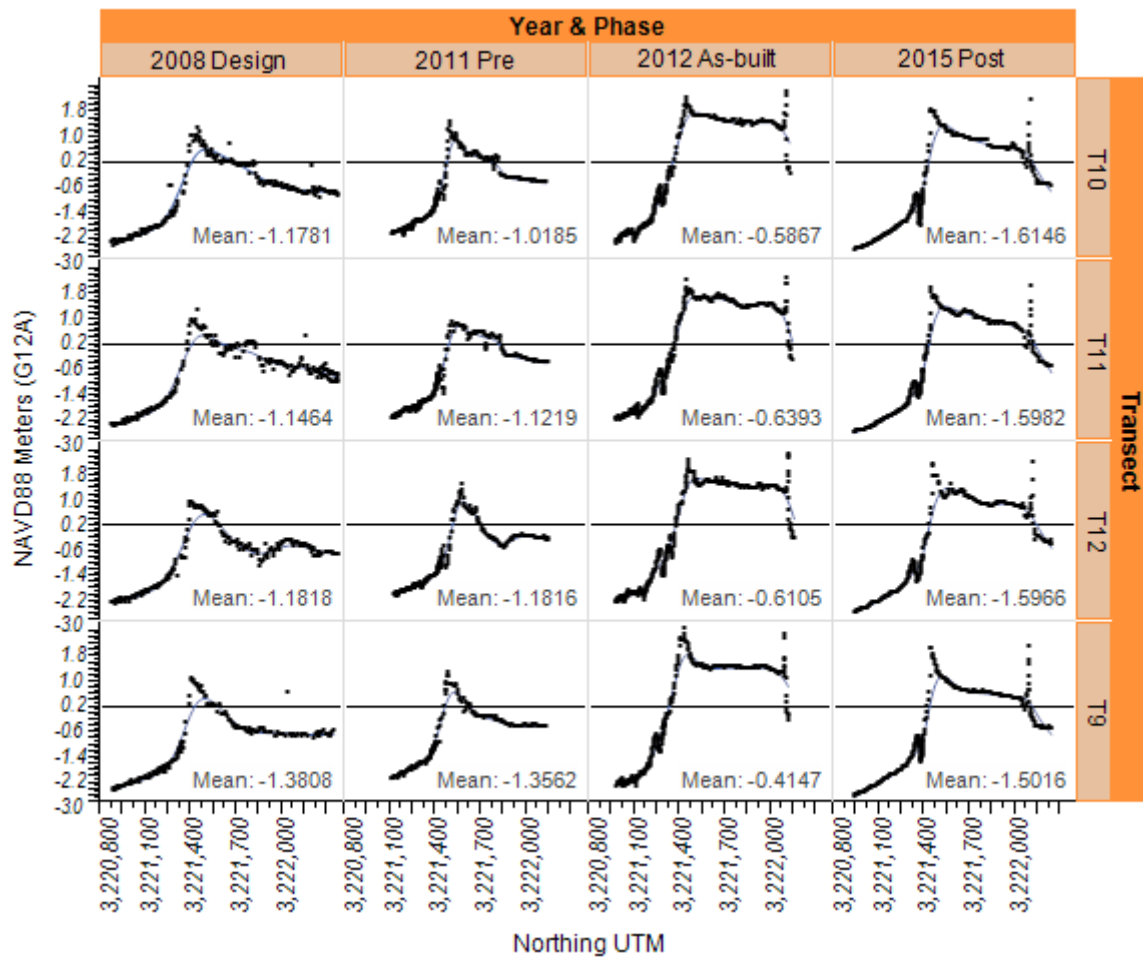
**Figure C-3.** T9 to T12 survey profiles over time at the West Belle Pass Barrier Headland Restoration (TE-52) project. The graphs depict the elevation of the shoreface, beach, dune, and marsh habitats from 2008 to 2015.
