**2024 Operations, Maintenance,
and Monitoring Report**

**West Lake Boudreaux Shoreline
Protection and Marsh Creation
(TE-0046)**

State Project Number TE-0046
Priority Project List 11

April 11, 2024
Terrebonne Parish

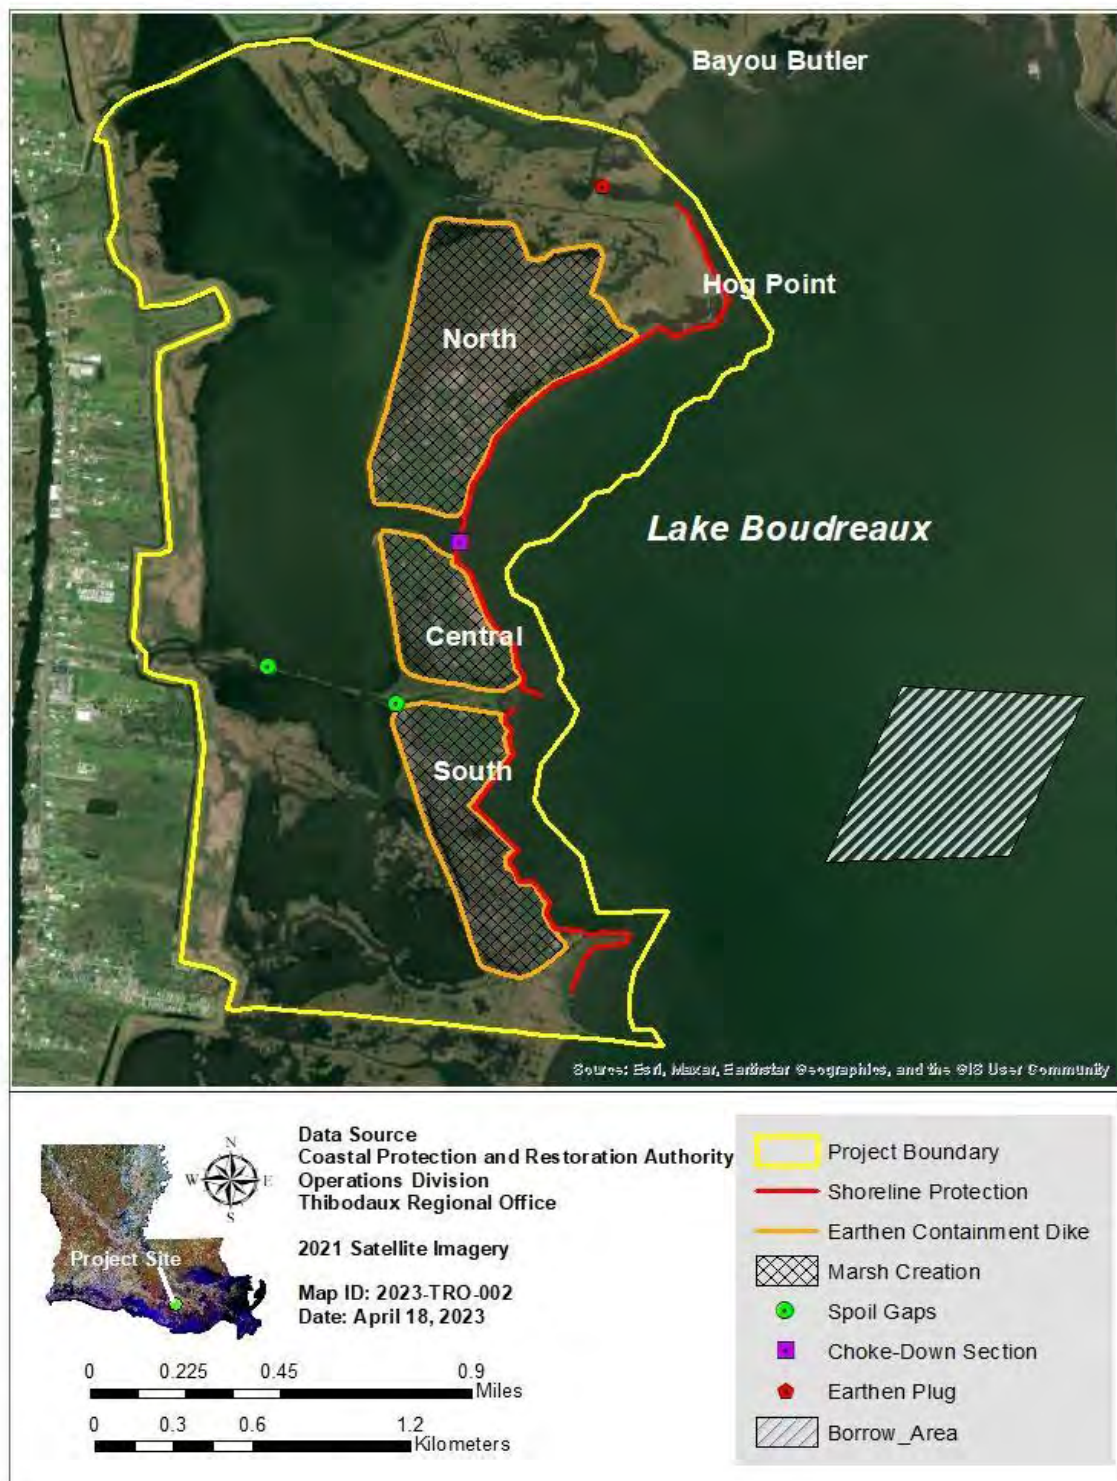
Figure 2. Map indicating the locations and types of constructed features inside the boundary of the West Lake Boudreaux Shoreline Protection and Marsh Creation (TE-0046) project.

- Construction of three segments of foreshore rock dike totaling 12,447 linear ft. (3,794 m) along the western shoreline of Lake Boudreaux (Figure 2) - Northern Segment is 5,350 linear ft. (1,630.6 m), Central Segment is 2,140 linear ft. (652.2 m), and Southern Segment is 4,957 linear ft. (1,510.8 m). The dikes were constructed using rock riprap (ASTM D 6092-97 Riprap R-300) to an elevation of +3.5 feet NAVD88 on top of a geotextile fabric base. The rock dikes had a vertical tolerance of +0.5 feet and a 3-foot crest width with 2.5 to 1 side slopes for the northern segment and 2 to 1 side slopes for the central and southern segment. Galvanized steel settlement plates were installed within the rock dike segments at various locations. Construction of 24,553 linear ft. (7,483.7 m) of earthen containment dike with 10 tidal openings. 10,160 feet (3,097 m) of the earthen containment dikes were degraded in May 2012. (Figure 2).

- Construction of an earthen plug located in the northwest corner of an oil and gas access channel off of Lake Boudreaux at the north end of the project area (Figure 2). It was constructed using dredged material from the oil and gas access channel. The plug was constructed to an elevation of +4.0 feet NAVD88 with an 8-foot top width and 3 to 1 side slopes. The plug is approximately 75 linear ft. (22.8 m).

- Construction of a choke down section located between the southernmost extent of the northern rock dike segment and the northernmost extent of the central rock dike segment (Figure 2). It consists of a 2-foot thick layer of rock riprap (ASTM D 6092-97 Riprap R-300) constructed across the opening in the shoreline between the northern and central marsh creation areas. The choke down section is approximately 150 linear ft. (45.7 m) (direction along the shoreline) by approximately 75 ft. (22.8 m) wide and was constructed to reduce scour in that area.

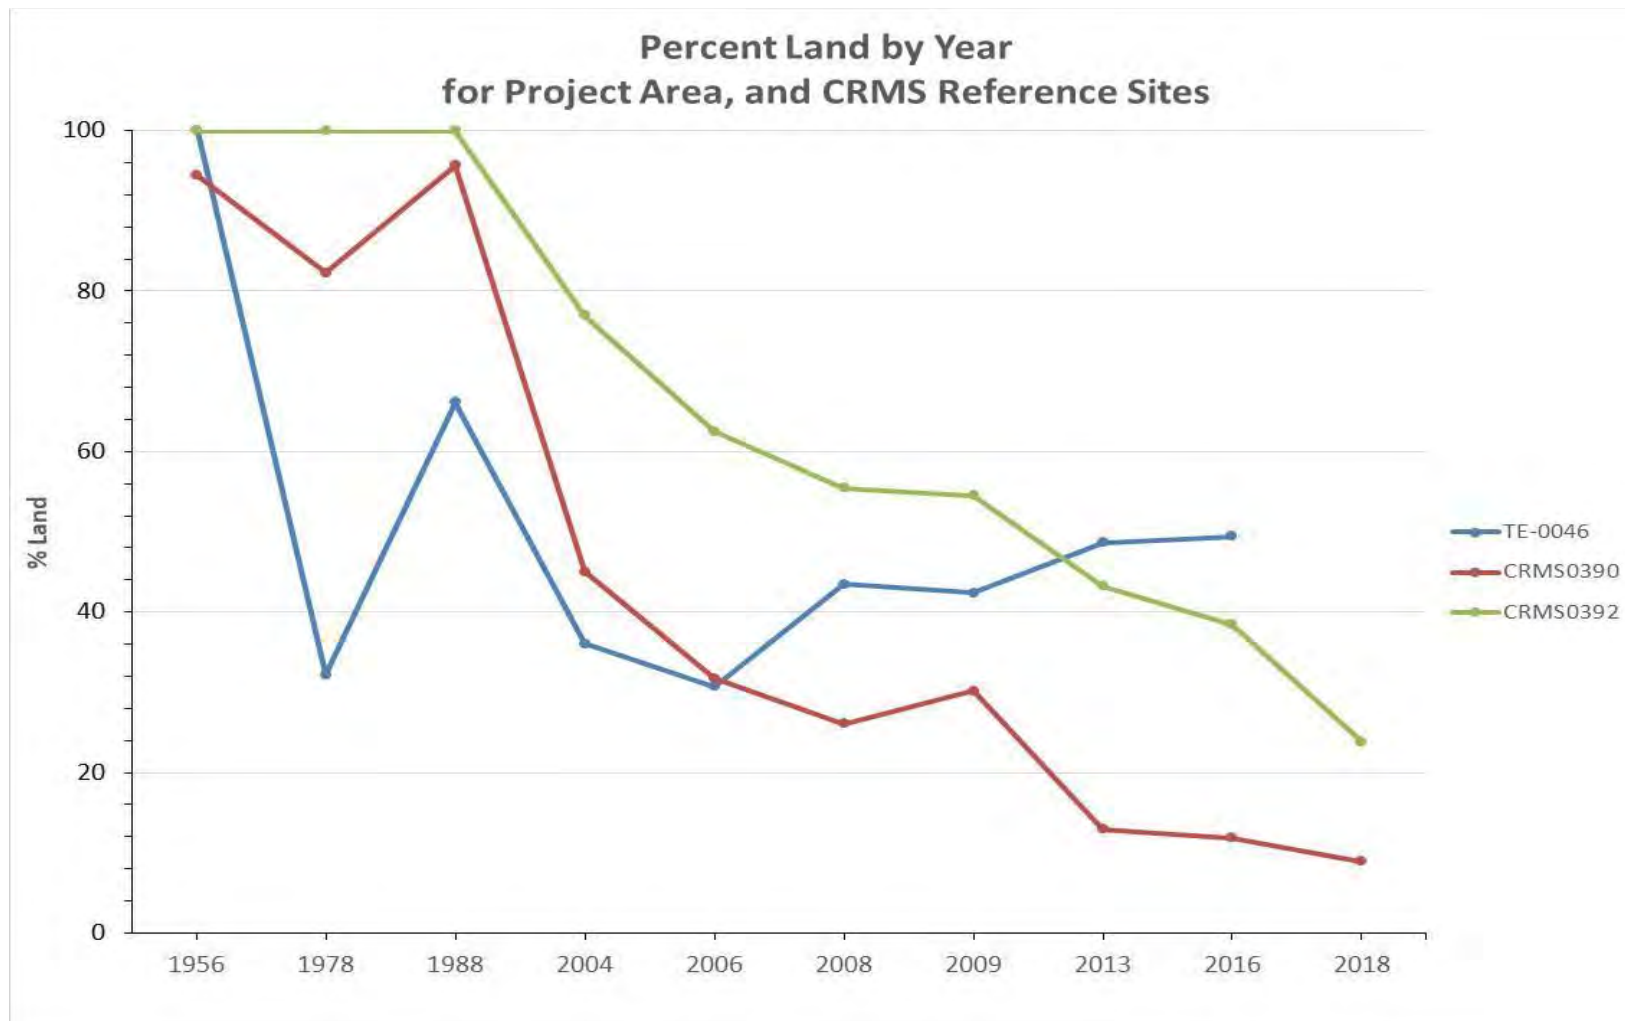
Figure 4. Percent land by year in the TE-0046 project marsh compared to CRMS reference marsh sites (CRMS0390 and CRMS0392). No project area data was available for year 2018. Note that the data displayed above is on a different spatial scale than the data in figures 1 and 2 in appendix A and is for trend examination (CRMS spatial viewer land/water, Barras et al. 2008; CPRA 2023).

The largest amount of land loss, approximately 70% of its original land, occurred between 1956 and 1978 for TE-0046. The largest conversion of land to water occurred between 1988 and 2004 for both of the CRMS sites. The lowest land to water conversion for the CRMS sites as well as TE-0046 occurred between 2013 and 2016. By 2018 land loss continued a downward trend for the CRMS sites, whereas the TE-0046 project area had increased and maintained its acreage since construction.

Assessment of the project area as well as CRMS reference sites utilizing the CRMS spatial viewer was conducted for data through 2018. Since this assessment is on a larger scale than that used for the project- specific 2012 and 2021 land-water classifications by USGS (USGS 2012; USGS/WARC 2021), the results are presented in terms of trends and provide a different perspective of the land to water changes over a period of decades (Figure 4). From 1956 to 1988 CRMS0392 retained 100% land, while TE-0046 and CRMS0390 shifted from land loss to land gain. Between 1988 and 2006 all three areas experienced a steady downward trend. TE-0046 experienced approximately 15% land gain between 2006 and 2008, due to construction of the marsh creation areas in 2007, while CRMS0390 and CRMS0392 continued a steady downward trend of land loss.

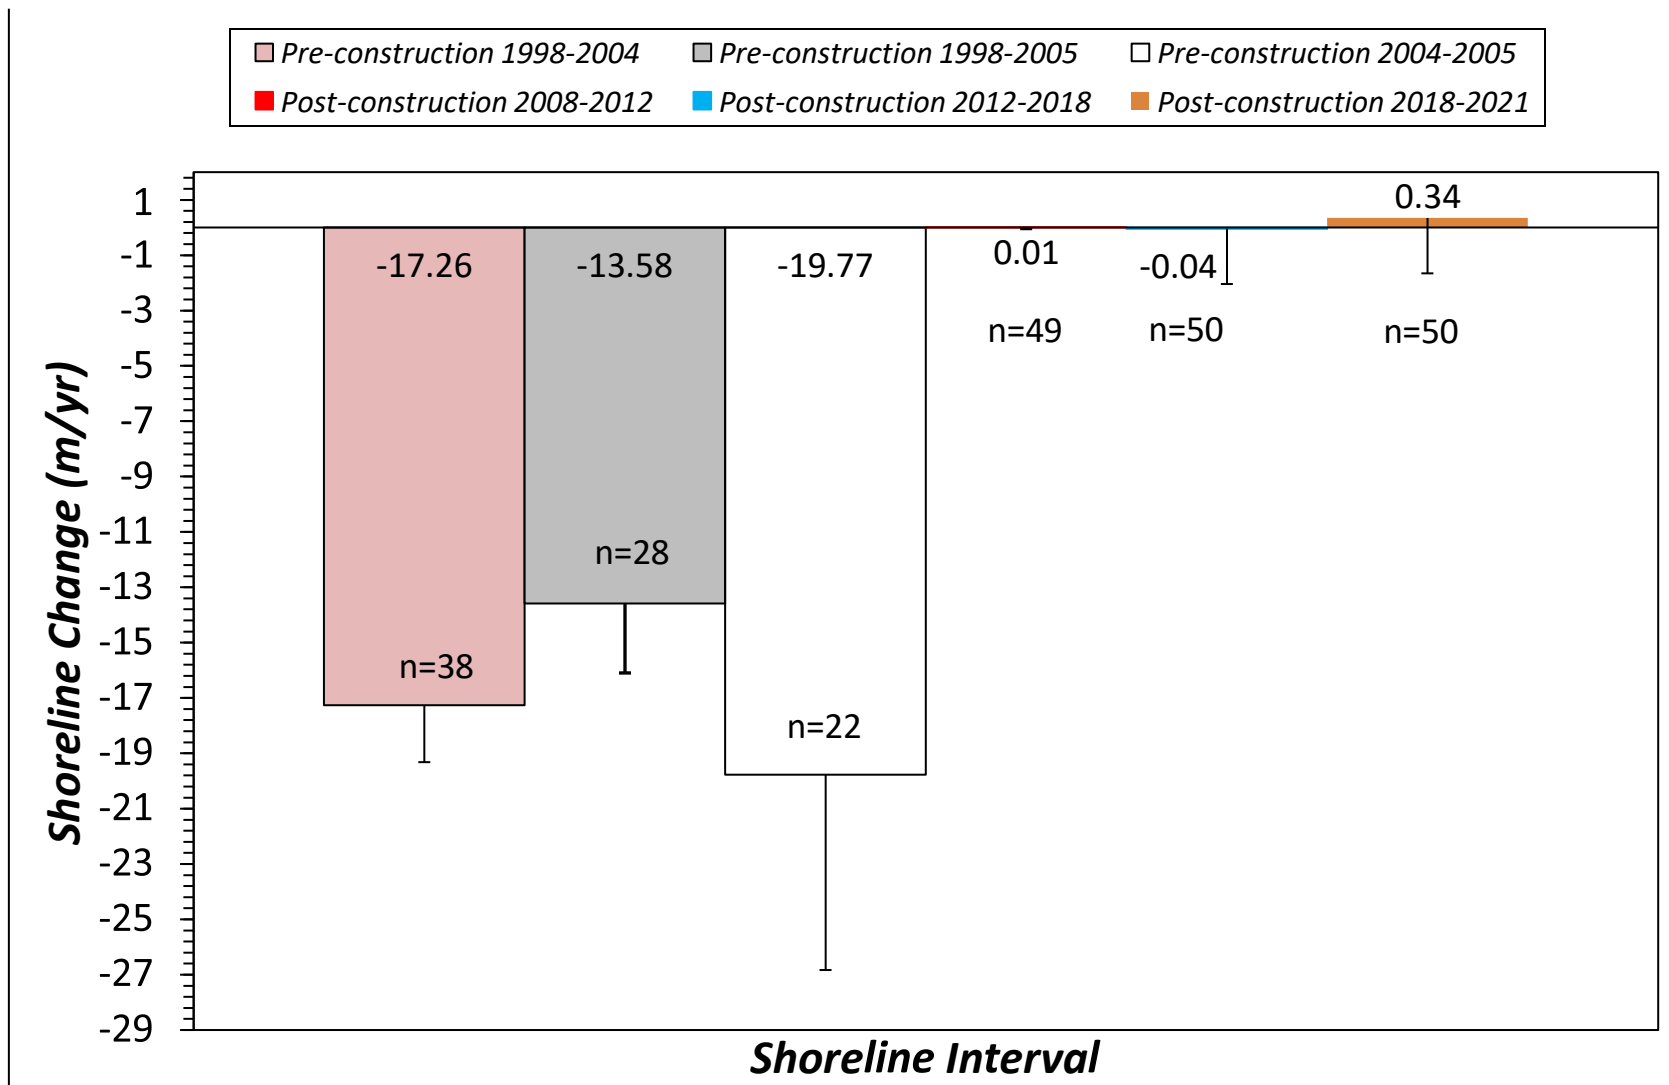
Pre-construction data reveals that the TE-0046 shoreline was transgressing at a rapid rate. The shoreline erosion rates for this 1998-2005 interval averaged -13.58 m/yr (-44.55 ft/yr) (Figure 5). During the ~8-year pre-construction interval, the project area shoreline receded -105 m (-344 ft). Subsequent pre-construction analyses of the TE-0046 shorelines produced erosion rates of -17.26 m/yr (-56.64 ft/yr) for the interval from 1998-2004 and -19.77 m/yr (-64.85 ft/yr) for the interval from 2004-2005 (Figure 5). Approximately, 1,200 m (3,937 ft) of the pre-project shoreline were converted to open water during 1998-2005 interval. As a result, no shoreline change data could be generated for these reaches. Figure 5 illustrates the declining population of shoreline replicates over the pre-construction intervals and indicate that the shoreline was breaking up in place at this time. Although the shoreline erosion rate was exceptionally high for the 1998-2005 interval, the erosion estimates are probably underestimated due to the loss of shoreline reaches. The large erosion values and the small number of shoreline replicates reported for the 2004-2005 interval (Figure 5) reveal that erosion and land-loss rates increased for this interval. Indeed, several narrow shoreline reaches were transformed to open water habitat during the 2004-2005 interval. Therefore, it is evident from the shoreline erosion data that the 2005 hurricane season altered and reshaped the project area shorelines (Figure 5). The passage in quick succession of Hurricane Cindy (Jul 2005), Hurricane Katrina (Aug 2005), and Hurricane Rita (Sep 2005) in close proximity to the project area likely eroded large sections of shoreline. Therefore, the 2005 hurricanes hastened the shoreline retreat in the pre-construction project area and intensified the land-loss and fragmentation of the Lake Boudreaux shorelines.

Since construction, the marsh edge erosion rate has declined in the project area. The average shoreline change rate behind the rock shoreline protection structure was 0.01 m/yr (0.03 ft/yr) from Oct 2008 to Oct 2012 (Figure 5). The post-construction interval from Oct 2012 to Nov 2018 showed a minimal loss of -0.04 m/yr (-0.12 ft/yr). From Nov 2018 to Nov 2021 the change rate was 0.34 m/yr (1.13 ft/yr). Visual inspections of the aerial photographs confirmed that the slight differences in shoreline position are likely the result of fluctuations in vegetation colonization of mudflat areas in the immediate lee of the structure. The combination of the

Figure 5. Shoreline change rates for the area behind the foreshore rock protection structure for various time intervals both pre-construction and post-construction.

foreshore rock shoreline protection structure, sediment additions to the marsh creation area shoreline, and the small fetch behind the rock shoreline protection structure likely facilitated the low post-construction erosion rate. This grouping of shoreline protection and marsh creation features has proven to minimize shoreline transgressions on other restoration projects (Curolle and Ledet 2012).

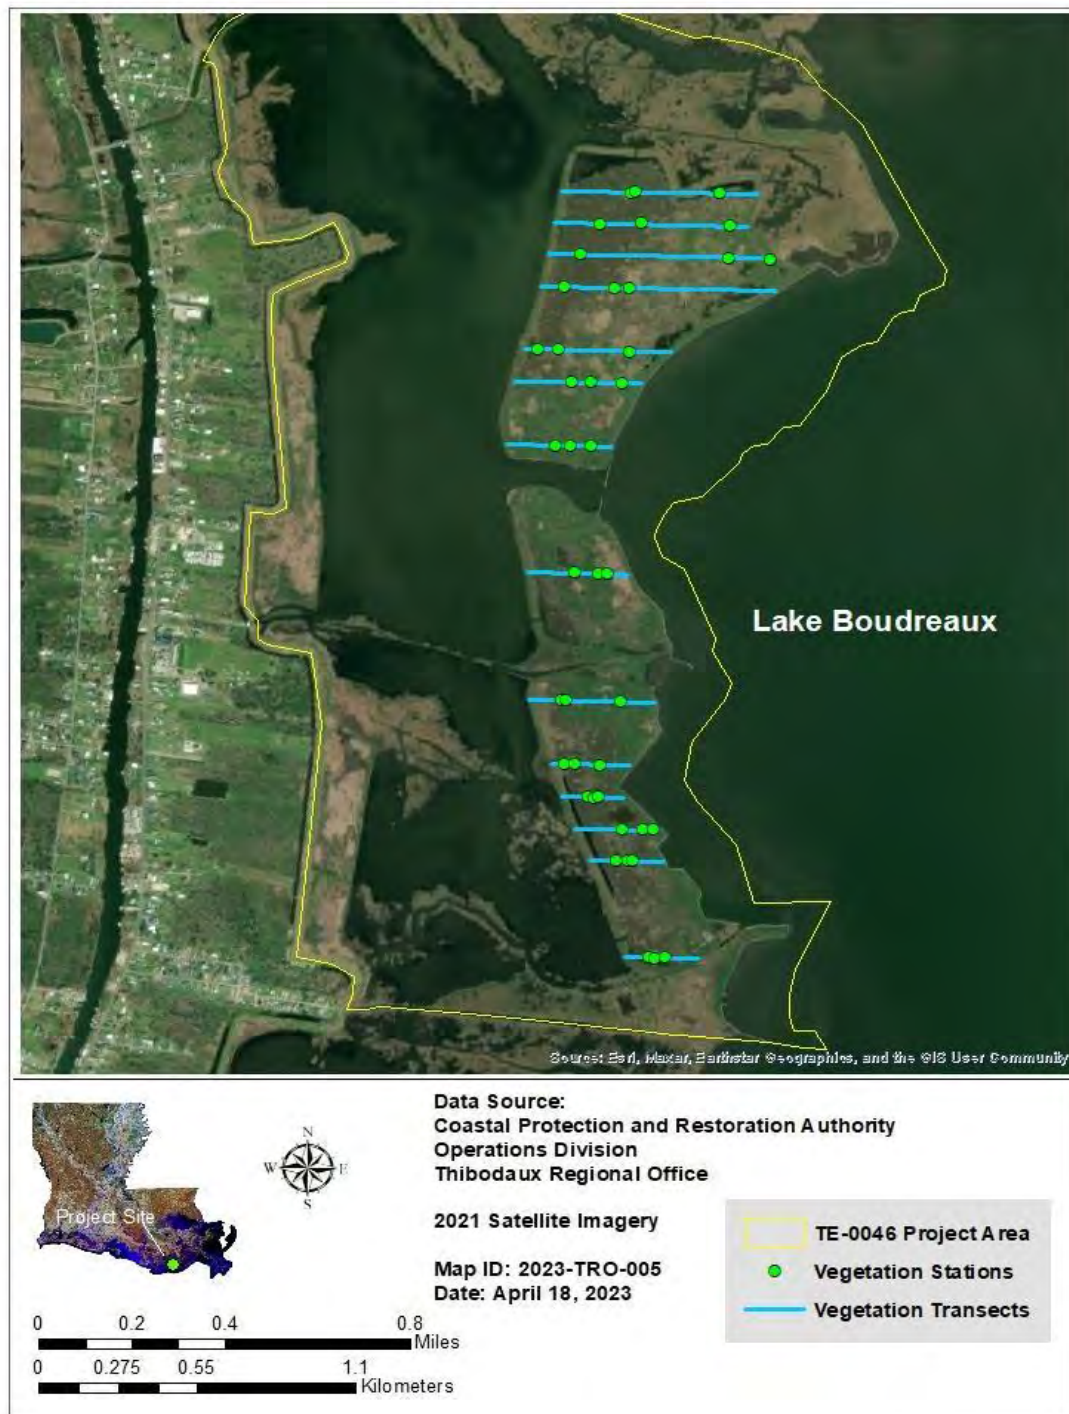
Figure 6. Location of the randomly selected project-specific vegetation stations inside the three marsh creation areas for the TE-0046 project. The three southernmost stations in the north creation area were not sampled in 2021.

Data collection for the TE-0046 project area occurred in October 2012 (3 years post-construction) and October 2021 (12 years post-construction). CPRA personnel originally collected percent cover and species composition data from 42 randomly selected stations located along 14 east-west transects inside the three marsh creation areas in 2012 (Figure 6). In 2021, the three southernmost stations in the north creation cell were not sampled. Dense stands of woody shrubs and impenetrable undergrowth made airboat and foot traffic impossible therefore, data from these three stations were not utilized in the project-specific analysis for this report. In addition to mean percent cover, the mean Floristic Quality Index (FQI) for the project area was estimated using the Cretini et al. protocol (2011). Vegetation composition in the project's marsh creation areas included a mix of *Spartina alterniflora* (smooth cordgrass), *Distichlis spicata*, *Iva frutescens* (bigleaf sumpweed), *Bolboschoenus robustus* (sturdy bulrush), as well as other species indicative of a mainly saline marsh habitat (Figure 7). *S. alterniflora* and *D. spicata* were the species with the greatest mean cover values, with *S. alterniflora* as the dominant species. The project FQI improved between 2012 and 2021. FQI was 57 and 68 respectively, (Figure 7).

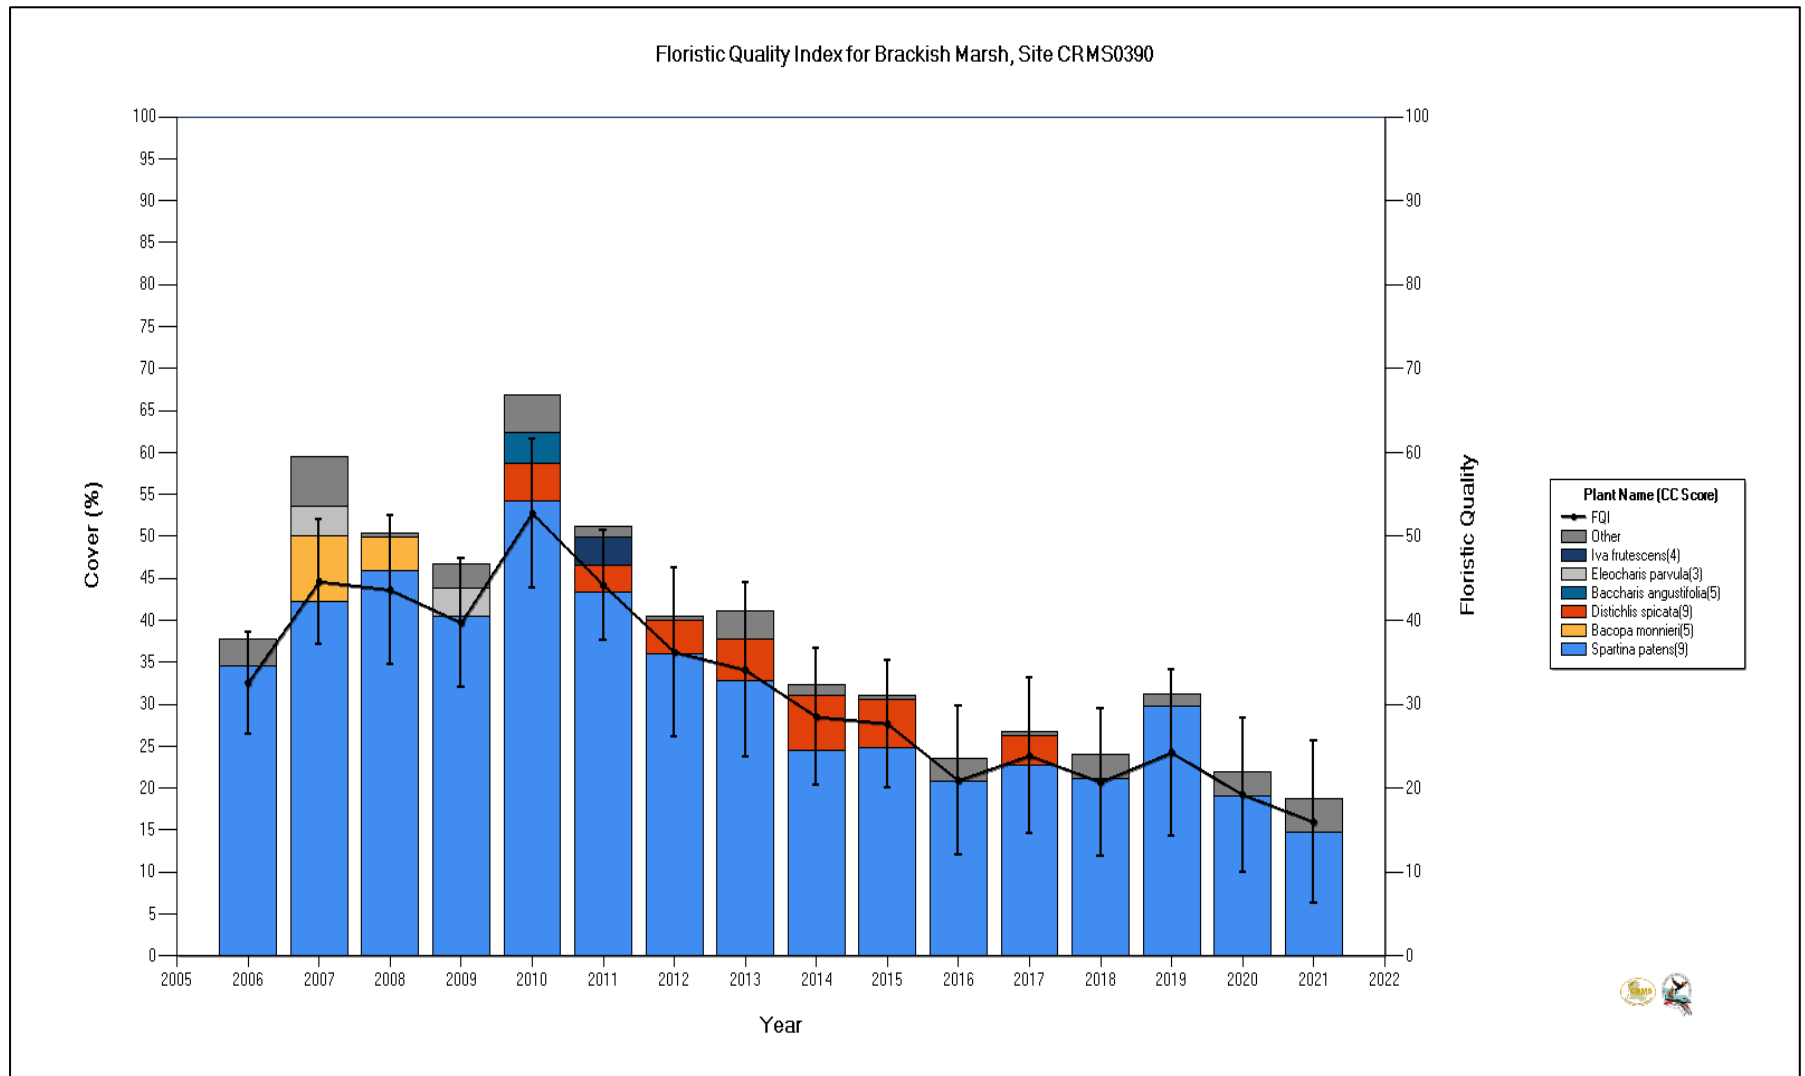
In 2021 reference site CRMS0390 was classified as a brackish marsh and the dominant species was *S. patens* for all 16 years of data collection (Figure 8). The FQI and mean cover of *S. patens* generally exhibited a downward trend throughout those years. Species cover and FQI were at their peak in 2010 and at their lowest levels in 2021. The low 2006 score was likely a response to the damage from the impacts of hurricanes Cindy and Katrina in 2005. It is interesting to note that a vegetation shift occurred by 2010, in which species with lower cc scores like *Bacopa monnieri* (coastal waterhyssop) and *Eleocharis parvula* (dwarf spikeseedge) disappeared, and *D. spicata*, which had a higher cc score for this marsh type naturally colonized the area. By 2016 *D. spicata* cover dwindled. By 2021 the FQI score for this site (15.96) was noticeably lower than all CRMS sites within the same marsh type, hydrologic basin, and across the entire Louisiana coastal zone (Figure 10). Additionally, CRMS0390 shifted from an intermediate marsh classification to a brackish marsh classification by 2009 and has remained a brackish marsh through 2021 (Figure 12).

Figure 8. FQI and species composition with mean cover for brackish marsh site CRMS0390.

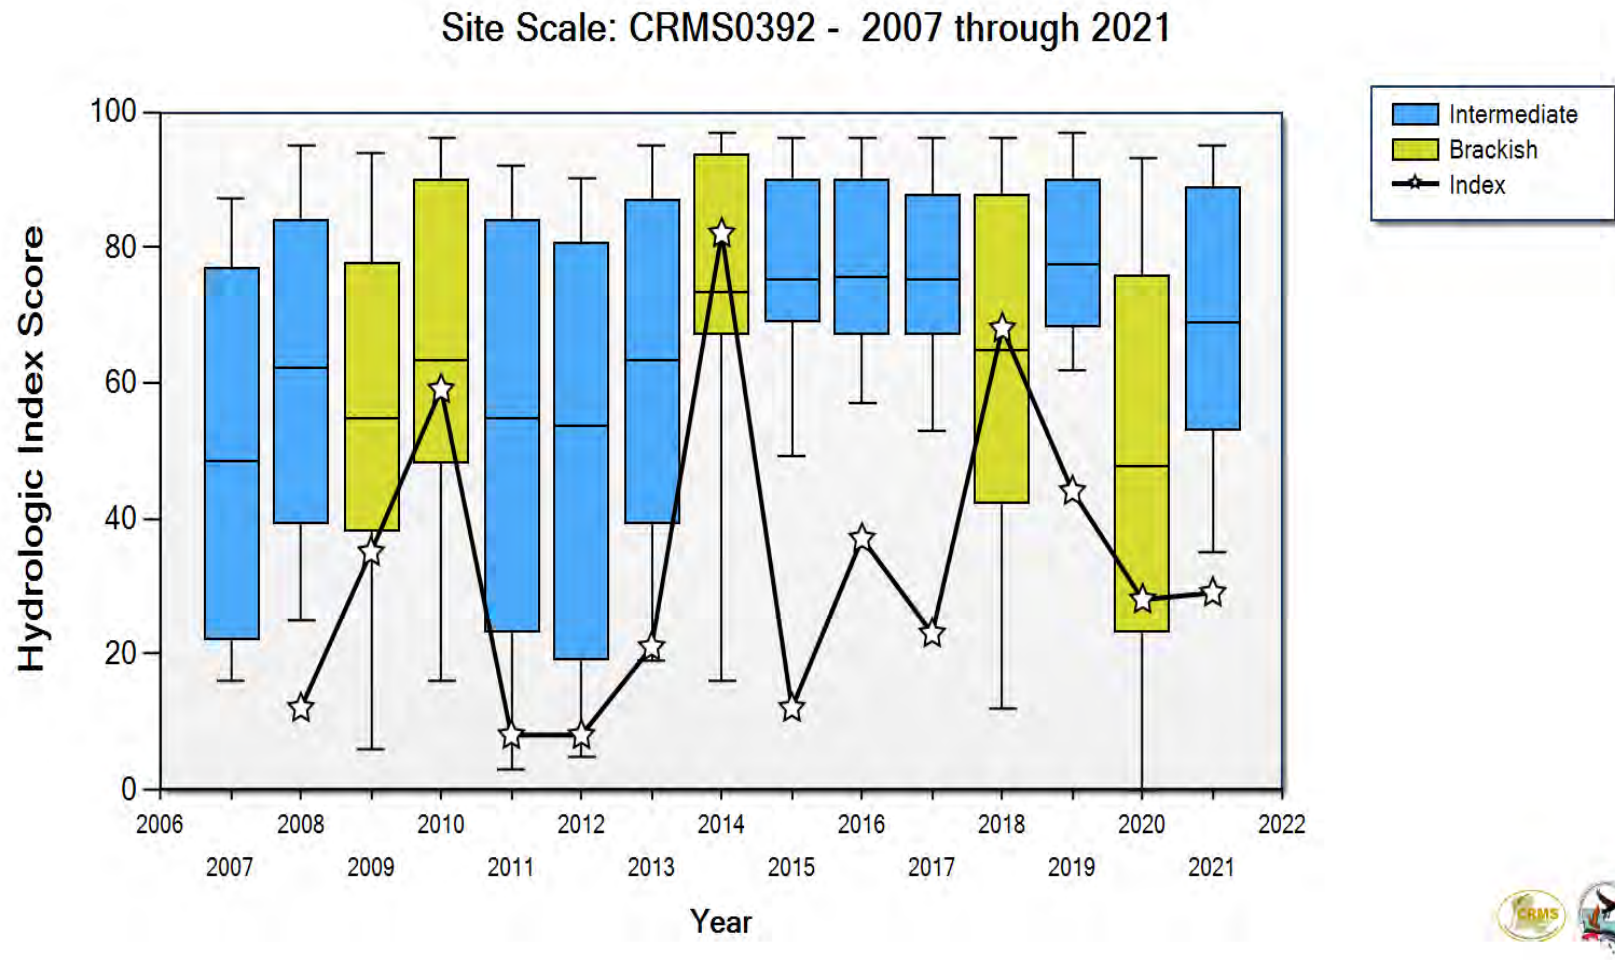
The HI scores for CRMS0392 are not shown for water year 2007 because the data sets did not meet the data completeness threshold (Figure 18). Marsh classifications transitioned between intermediate and brackish in some years, but the majority of the time this site was classified as intermediate marsh. The majority of the HI scores for CRMS0392 were lower than comparative CRMS sites, with the exception of 2014 and 2018. The large amount of land loss at this site has likely contributed to the lower scores.

Figure 18. A time series of Hydrologic Index scores for CRMS0392 relative to the box plot of the scores for all the sites within the same marsh type each year. The HI score for CRMS0392 is not shown for 2007 because the data set for this water year did not meet the data completeness threshold of >70%.

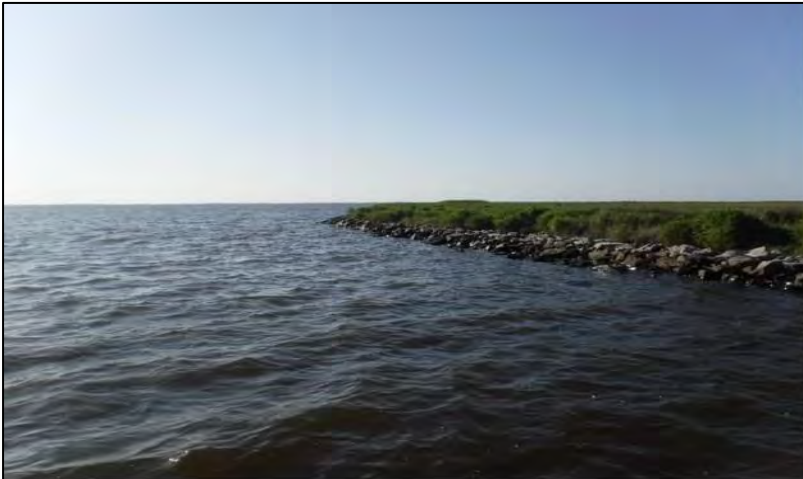
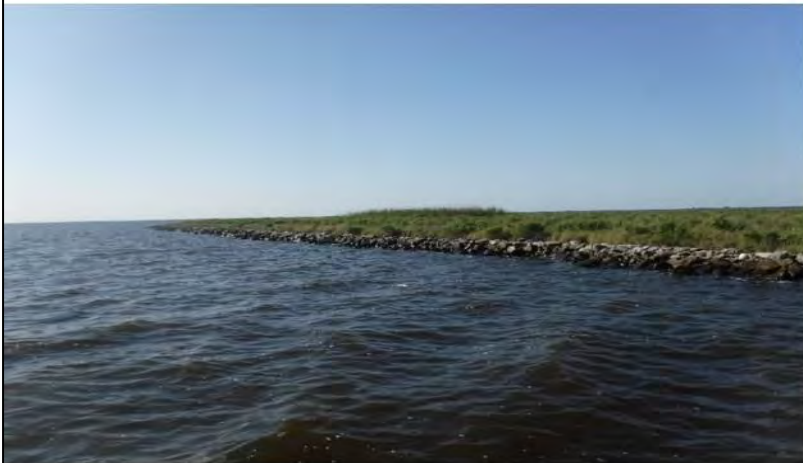
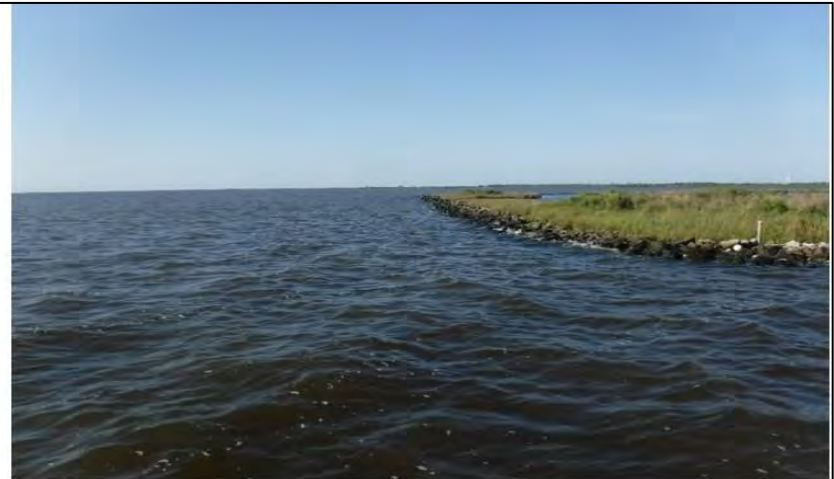
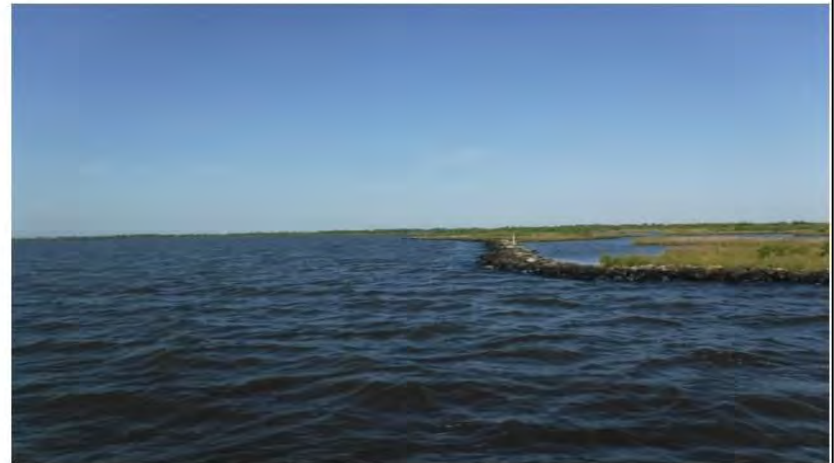
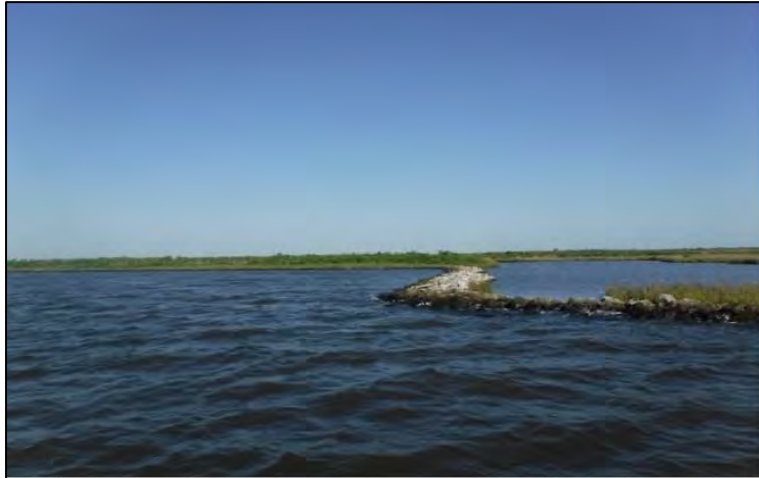
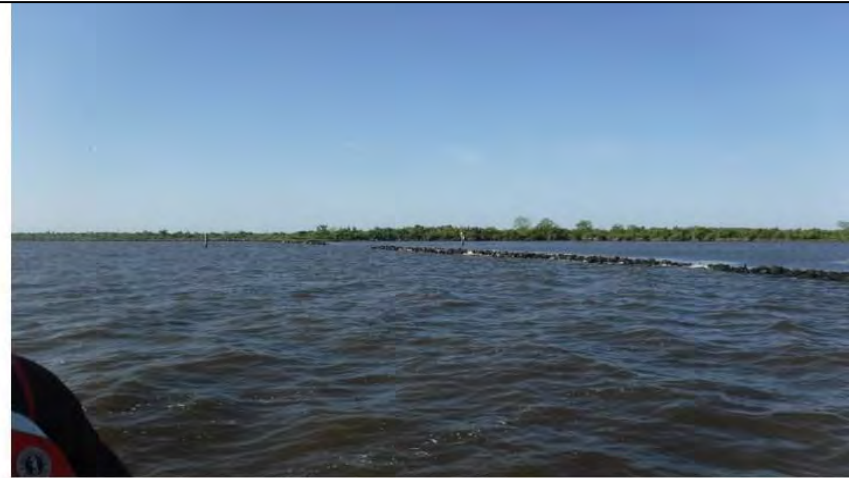
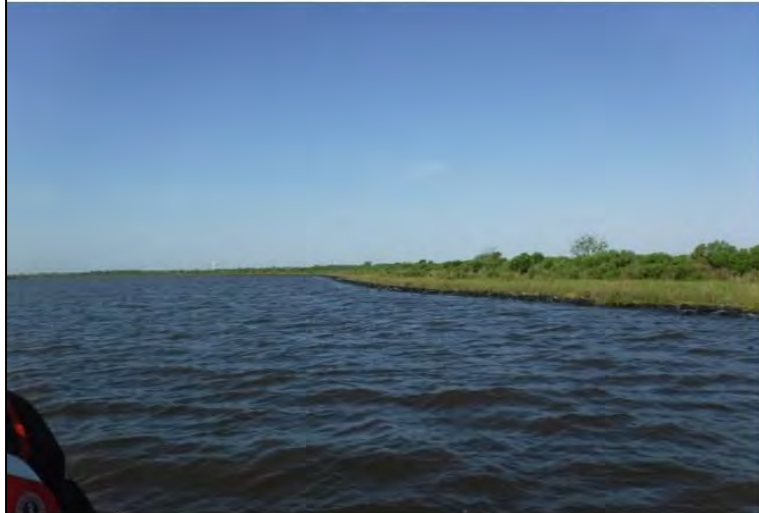
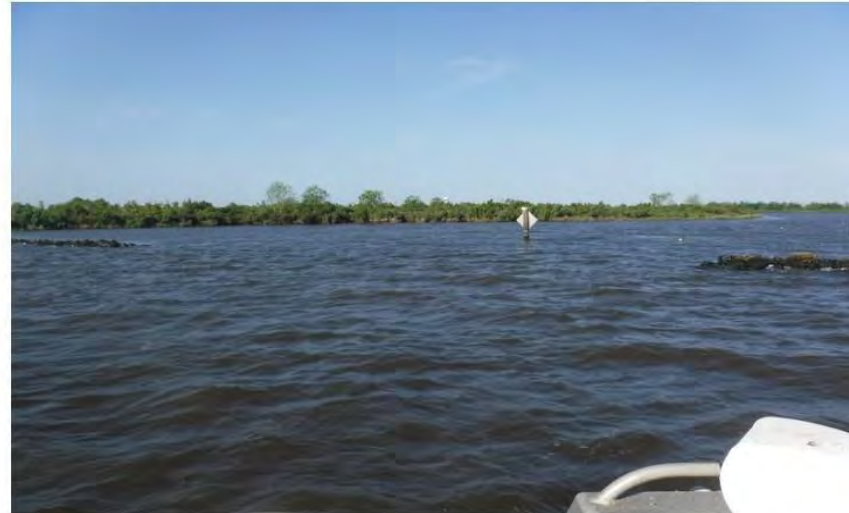
The northern segment of the rock dike appeared to be in fair to good condition with some isolated areas showing signs of settlement. Considering the hurricanes and tropical events of the past several years, the rock structure is showing no signs of rock displacement or distortion

of the designed rock section. The very northern end of the rock dike structure has moderate shadowing as reported on previous inspections. The shadowing effect or erosion of marsh where the rock structure abruptly ends is common and will require monitoring on future inspections. The marsh behind the northern segment was very healthy and well vegetated. To evaluate the full length of the rock dike and identify low areas a survey was performed in June 2023. (See Appendix B, Photos 1 through 8)

Photo No.1 (8291) – near Sta. 110+00 – rock dike shoreline (Northern Segment).

Photo No.3 (8295) – near Sta. 111+00 – rock dike shoreline (North Segment).

Photo No.2 (8292) – near Sta. 110+00 – rock dike shoreline (North Segment)

Photo No.4 (8296) – near Sta. 116+00 – rock dike shoreline (North Segment).

Photo No.5 (8297) – near Sta. 120+00 – rock dike shoreline (North Segment).

Photo No.7 (8301) – near Sta. 150+00 – rock dike shoreline near bank opening (end of North Segment).

Photo No.6 (8299) – near Sta. 130+00 – Low section of rock dike shoreline (North Segment).

Photo No.8 (8302) – near Sta. 154+00 – rock dike gap with warning signs (End of North and Beginning of Central Segment).

All segments (northern, central and southern) of the rock dike along the West Lake Boudreaux Shoreline Protection and Marsh Creation (TE-46) project appear to be in fair to good condition with visual settlement in isolated areas of the northern and southern segments. The rock dike consolidation and shape appear to be consistent along all segments with no noticeable rock displacement or distortion of the rock section. Overall, the rock dike structure has held up well since construction considering the number of tropical events that has occurred since construction of the project. The marsh, in the marsh creation area, behind the structure was plentiful and healthy with no measurable erosion other than the area at the termination point of the southern segment. Although we are not recommending any maintenance to the rock dike at this time, we will continue to monitor

the condition of the rock dike and other project features for the remainder of the 20 year life of the project which ends in November of 2029. We are also recommending that signs and warning markers that are missing or damaged be refurbished and/or replaced prior to project close-out.

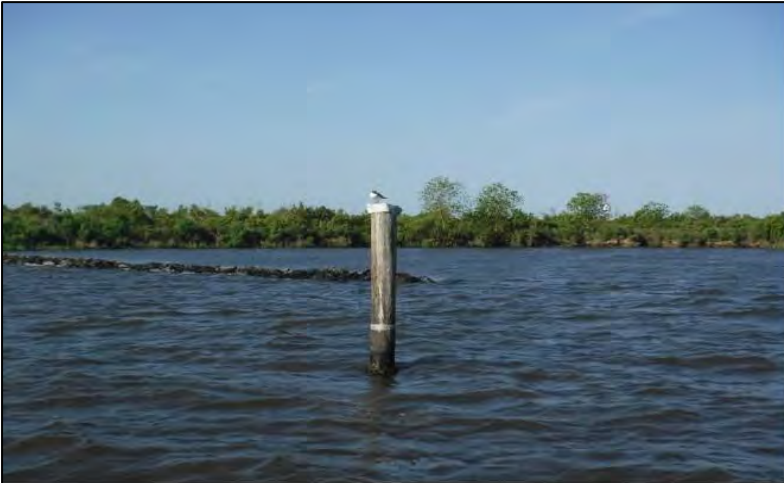
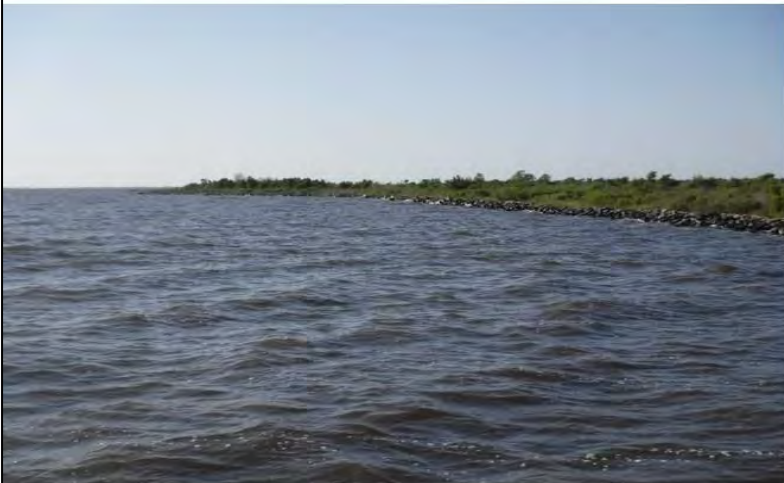
The central segment of the rock dike appeared to be in good condition with not as much visual settlement as the northern segment. There are no obvious signs of rock displacement or shifting of the rock section along length of the central segment. At the pipeline channel between the central and southern segments, there is a warning marker with a missing sign. It is recommended that the sign and metal sheet pile cap on the piling of this marker be replaced during next maintenance event. As a result of this inspection we recommended that a survey profile be conducted to determine if any corrective actions were needed. The survey was performed in June 2023. (See Appendix B, Photos 9 and 10)

Photo No.9 (8303) – near Sta. 154+00 and 300+00 – missing sign at rock dike gap (End of North and beginning of Central Segment).

Photo No.10 (8305) – near Sta. 305+00 – rock dike shoreline (Central Segment).

All project features are in good shape. It is recommended that the missing warning sign on the lake side of the choke down section be replaced as it is the only indicator of the submerged structure for vessels traveling in that direction.
