**2024 Operations, Maintenance,
and Monitoring Report**

**West Lake Boudreaux Shoreline
Protection and Marsh Creation
(TE-0046)**

State Project Number TE-0046
Priority Project List 11

April 11, 2024
Terrebonne Parish

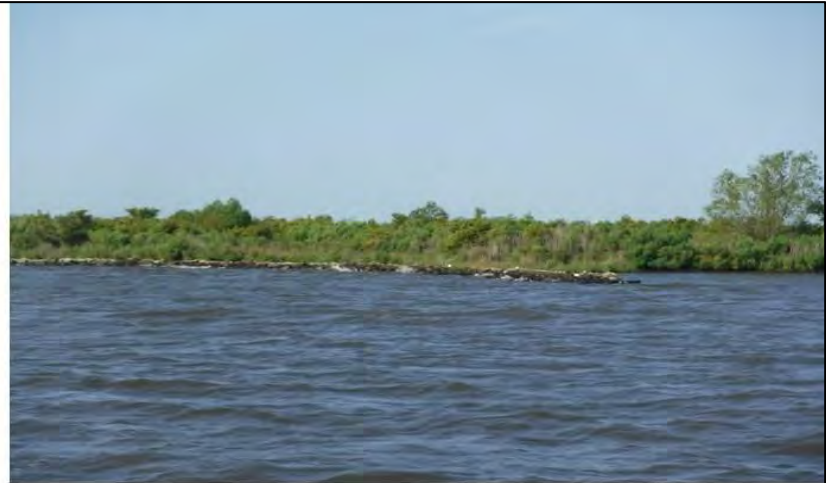
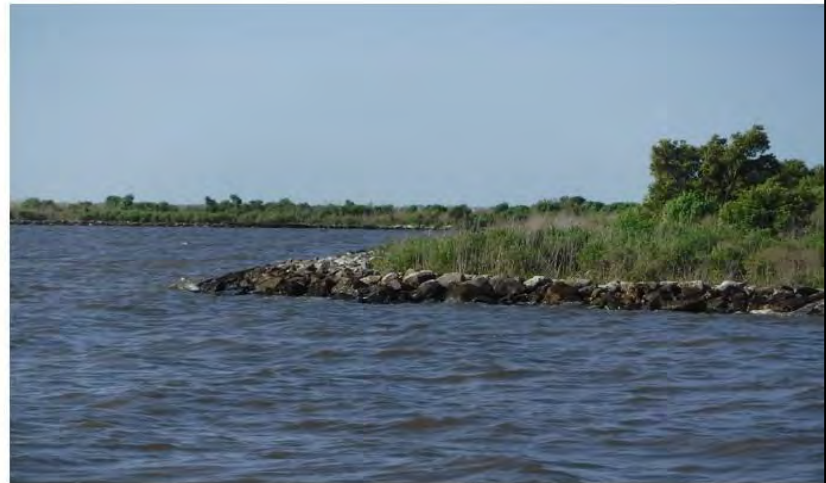
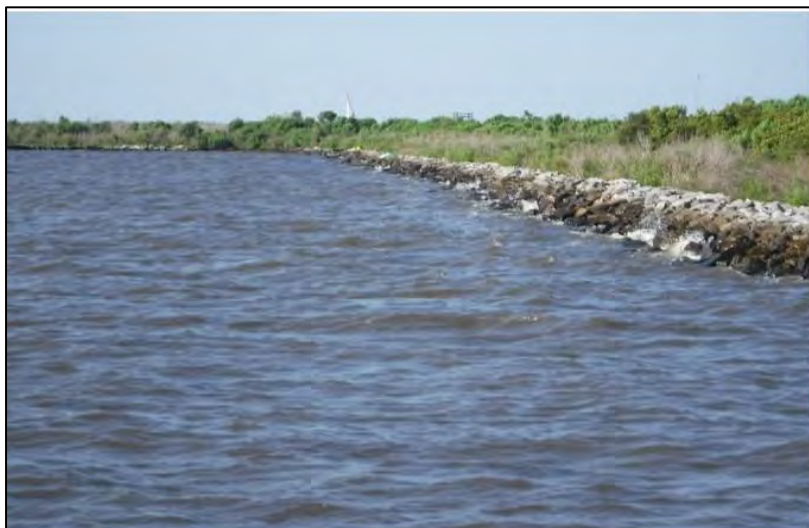
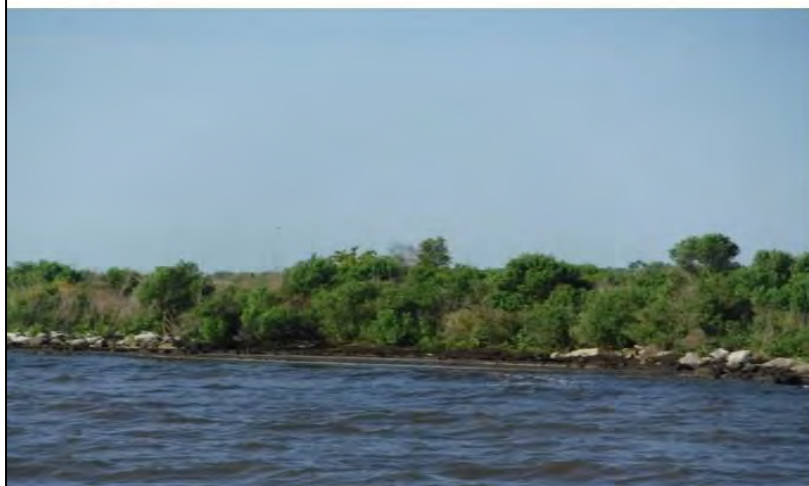
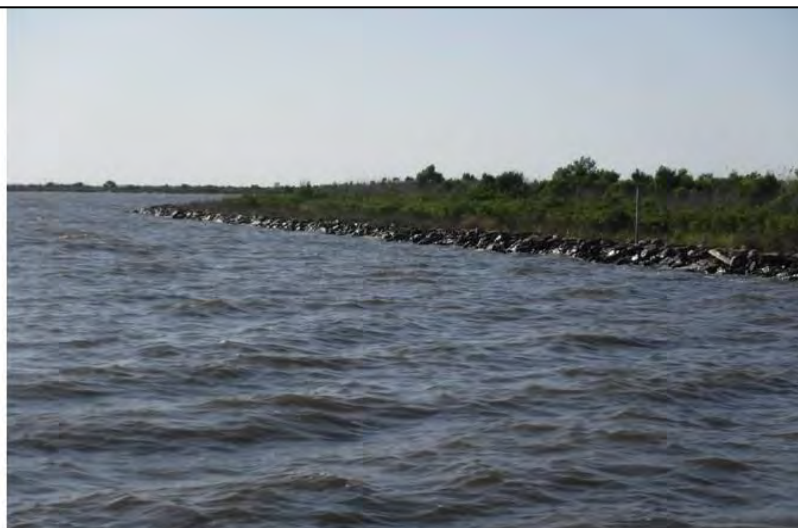
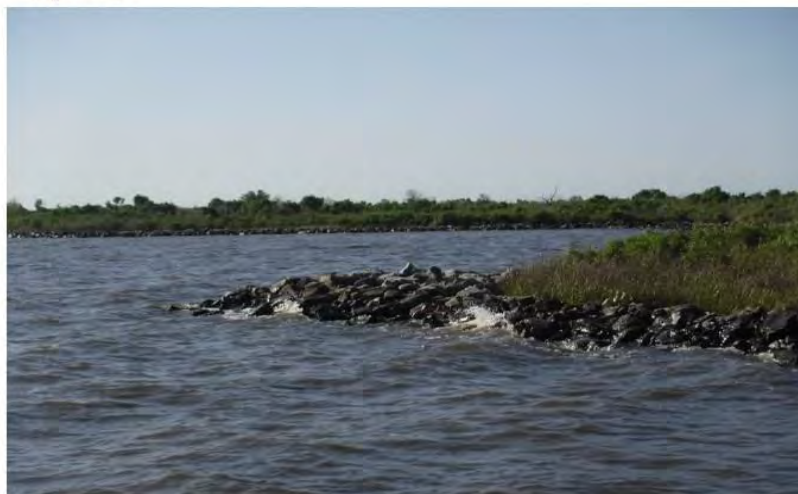
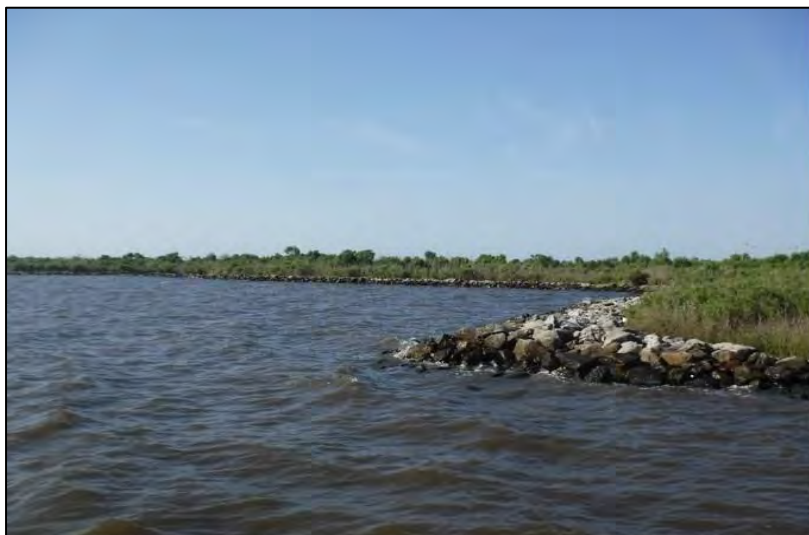
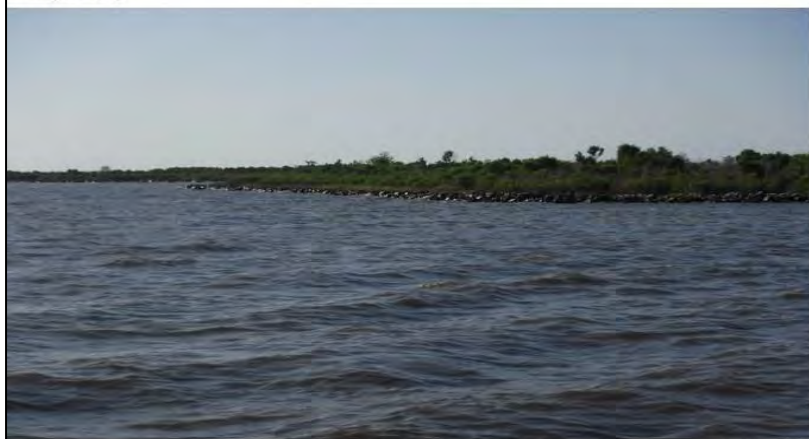
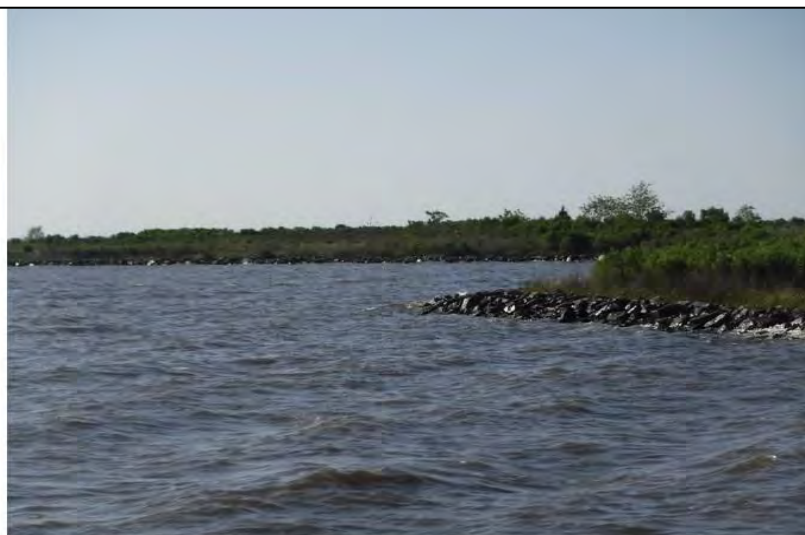
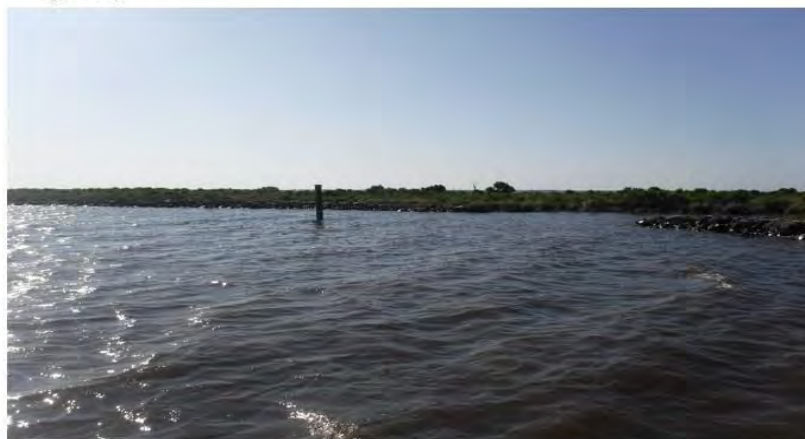
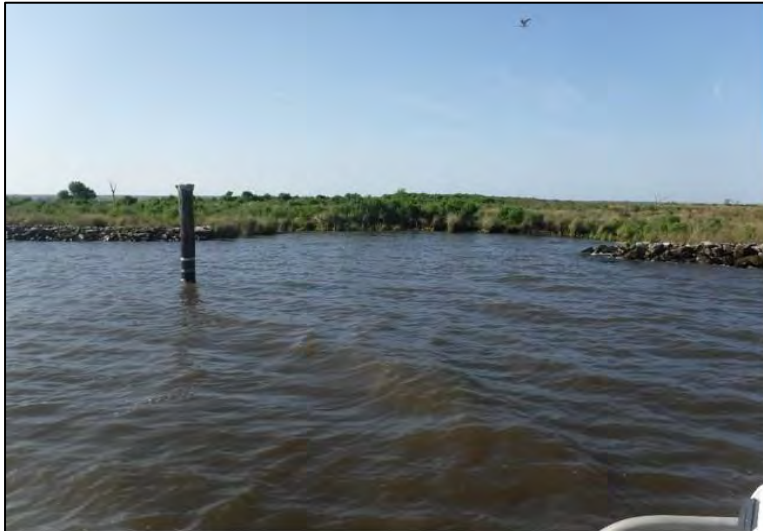
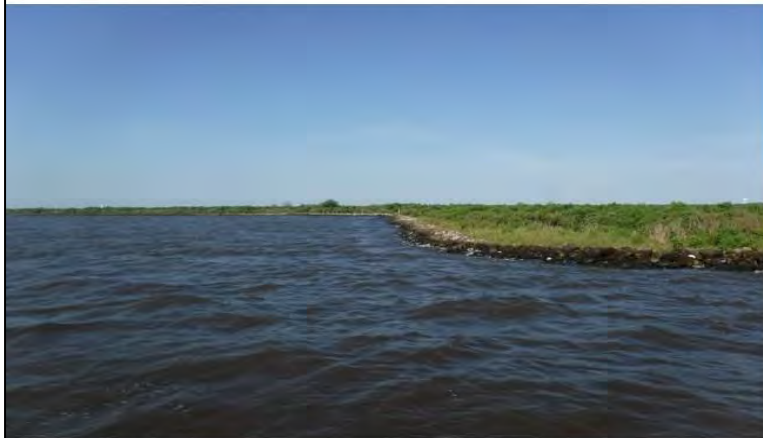
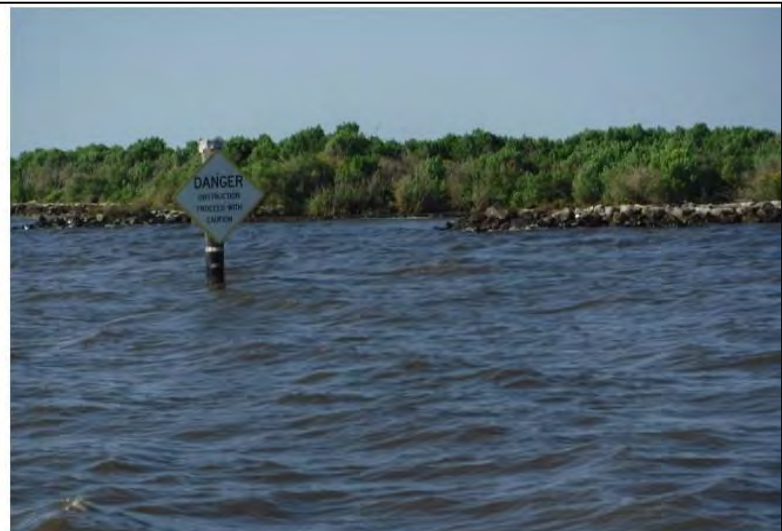
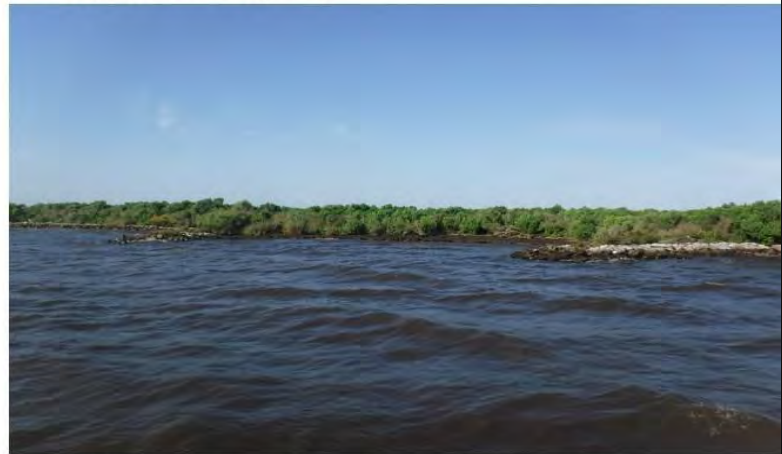
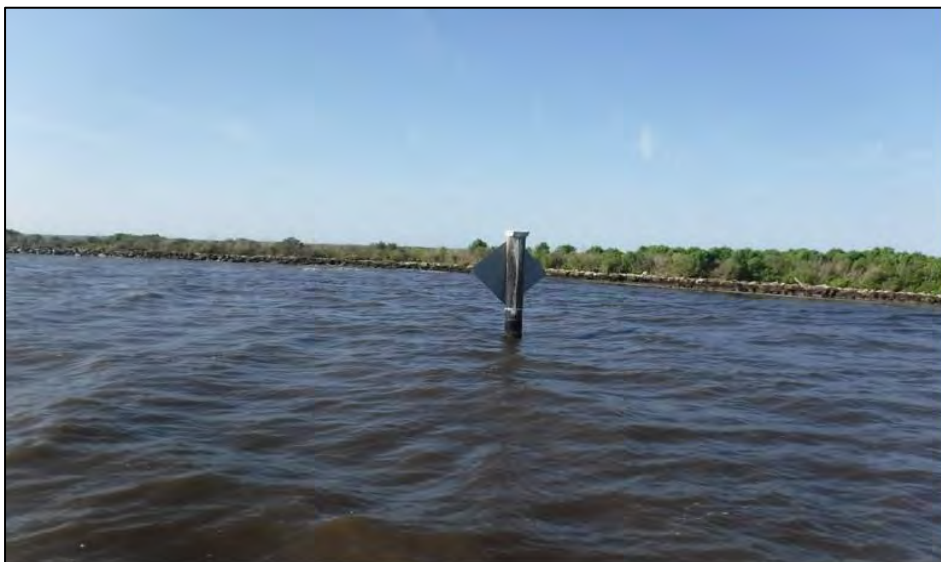
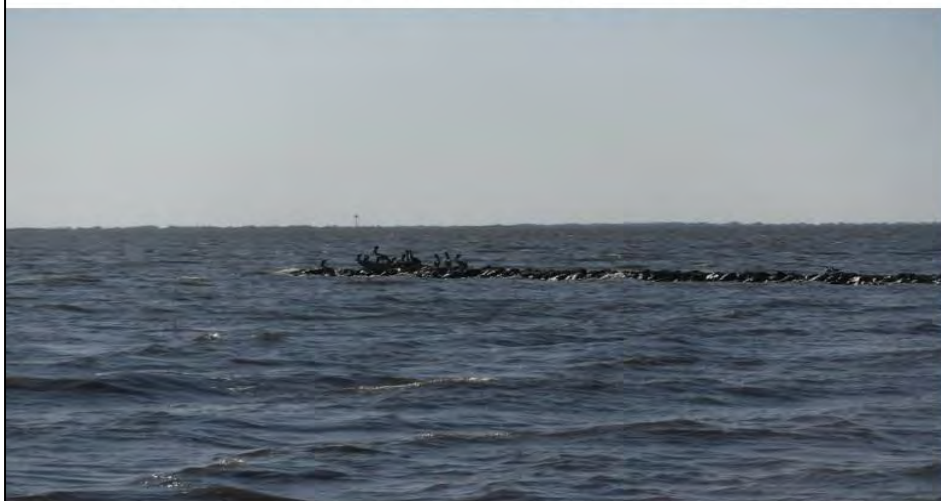
The southern segment of the rock dike from the choke down section to the southern termination point appear to be in fair to good condition with possible settlement in isolated areas. The rock section was in good condition with no noticeable rock displacement or change in the section. We did notice that the sign on the warning marker at the keyway location was missing. It was also evident that the marsh erosion at the very southern end of the structure has increased since the previous inspection. Approximately 275 feet of the structure was protruding into the lake compared to the estimated 150 feet documented in 2016. As a result of this inspection we recommended that a survey profile be conducted to determine if any corrective actions were needed. The survey was performed in June 2023. (See Appendix B, Photo 11 through 26)

Photo No.11 (8309) – near Sta. 400+00 – rock dike gap near pipeline channel (Southern Segment).

Photo No.12 (8311) – near Sta. 406+00 – rock dike shoreline (Southern Segment).

Photo 13 (8312) – near Sta. 412+00 – rock dike shoreline (Southern Segment).

Photo No. 15 (8315) – near Sta. 417+00 – rock dike shoreline (Southern Segment).

Photo 14 (8313) – near Sta. 415+00 – rock dike overgrown with vegetation with sediment buildup in front of structure (Southern Segment).

Photo No. 16 (8316) – near Sta. 423+00 – rock dike shoreline (Southern Segment).

Photo No. 17 (8317) – near Sta. 423+00 – rock dike shoreline (Southern Segment).

Photo No. 19 (8320) – near Sta. 432+00 – rock dike shoreline (Southern Segment).

Photo No. 18 (8318) – near Sta. 430+00 – rock dike shoreline (Southern Segment).

Photo No. 20 (8322) – near Sta. 438+00 – missing sign at marsh keyway (Southern Segment).

Photo No.21 (8324) – near 438+00 missing sign at rock dike opening/marsh keyway (Southern Segment).

Photo No.23 (8328) – near Sta. 447+00 – warning sign at rock dike gap (Southern Segment).

Photo No.22 (8326) – Rock Dike near Sta. 443+00 – rock dike shoreline (Southern Segment).

Photo No. 24 (8330) – near Sta. 447+00 – rock dike gap (Southern Segment).

Photo No.25 (8331) – near Sta. 447+00 – warning sign location (Southern Segment).

Photo No.26 (8335) – rock dike termination point near Sta. 453+00 (Southern Segment).

All segments (northern, central and southern) of the rock dike along the West Lake Boudreaux Shoreline Protection and Marsh Creation (TE-46) project appear to be in fair to good condition with visual settlement in isolated areas of the northern and southern segments. The rock dike consolidation and shape appear to be consistent along all segments with no noticeable rock displacement or distortion of the rock section. Overall, the rock dike structure has held up well since construction considering the number of tropical events that has occurred since construction of the project. The marsh, in the marsh creation area, behind the structure was plentiful and healthy with no measurable erosion other than the area at the termination point of the southern segment. Although we are not recommending any maintenance to the rock dike at this time, we will continue to monitor

the condition of the rock dike and other project features for the remainder of the 20 year life of the project which ends in November of 2029. We are also recommending that signs and warning markers that are missing or damaged be refurbished and/or replaced prior to project close-out.
