Installation of Sand Fence on
Timbalier Island (TE-40)

PROJECT COMPLETION REPORT

**Field Trip Report No. 2 (Final
Inspection)**

**INSTALLATION OF SAND FENCE
ON TIMBALIER ISLAND (TE-40)**

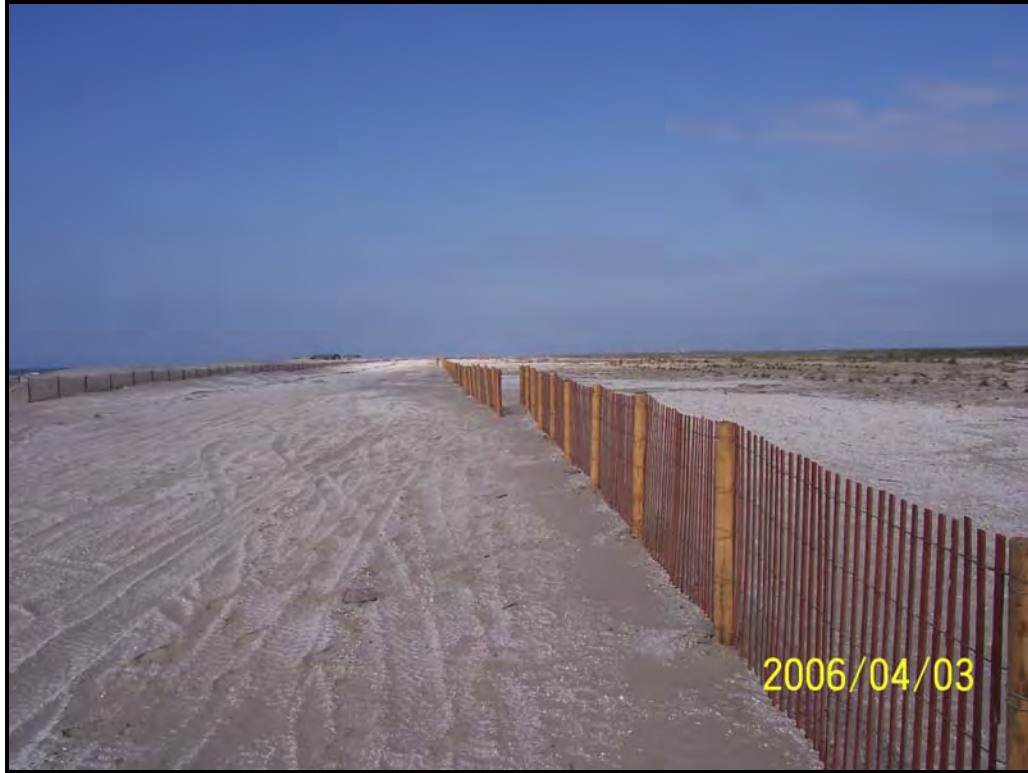
Photo 1. *View of new sand fence east of camp looking west. Existing north row of fence can be seen on left.*

- The main alignment runs parallel to and approximately 50' to the north of the existing north row of fence. It begins near the timber structure at the west end of the project and continues east approximately 9,500 linear feet to the eastern end of the dune platform. See Photos 1-4.

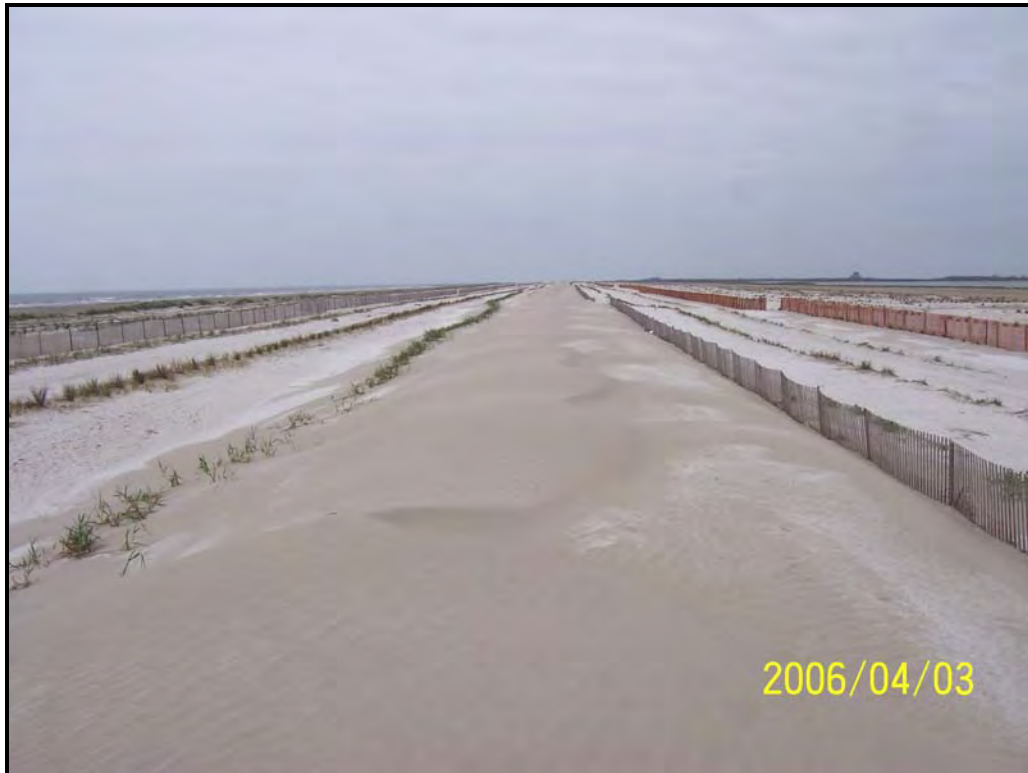
Photo 2. *View of new sand fence (right), existing north sand fence row and sand dune (middle), and existing south sand fence row (left) standing on north fence dune looking west near mid project.*

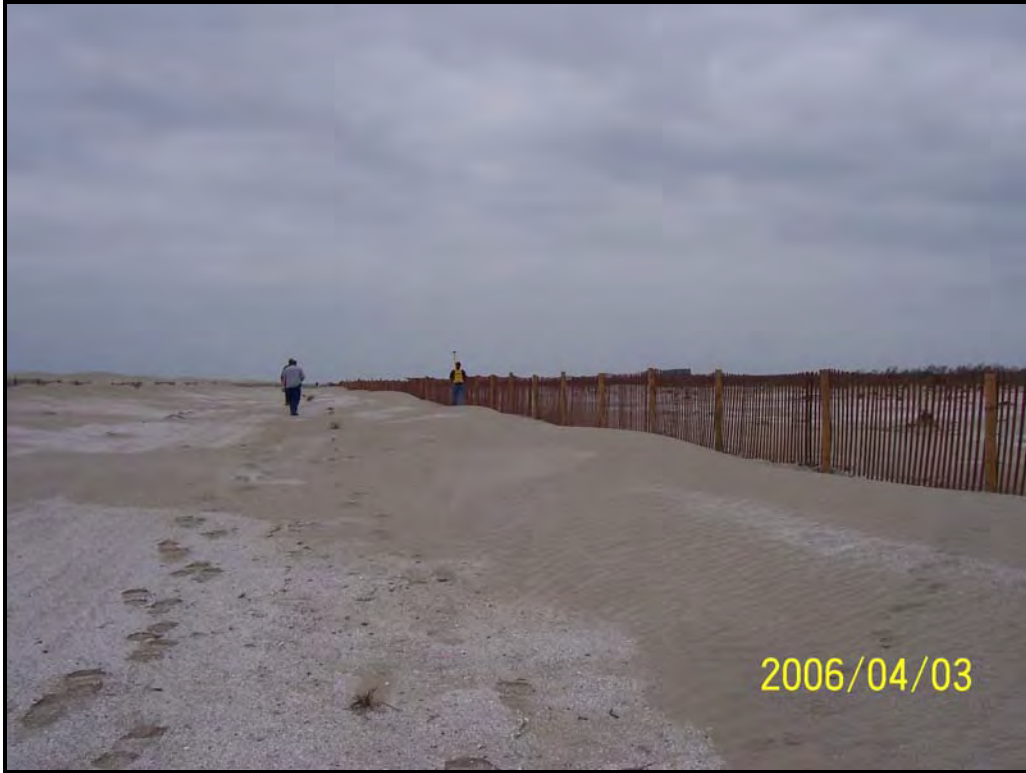
Photo 3. View of new fence near west end of project looking west. Wind-deposited sediments can be seen building up on the south side of the fence row.

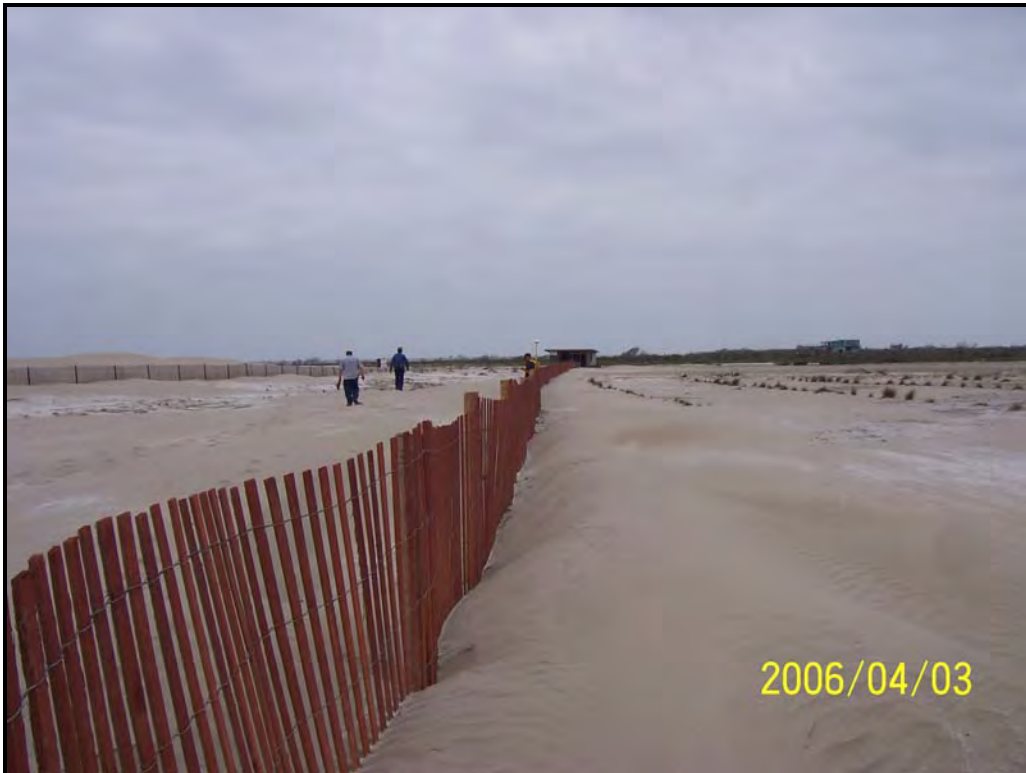
Photo 4. View of new fence near west end of project looking west. Wind-deposited sediments can be seen building up on the north side of the fence row also.

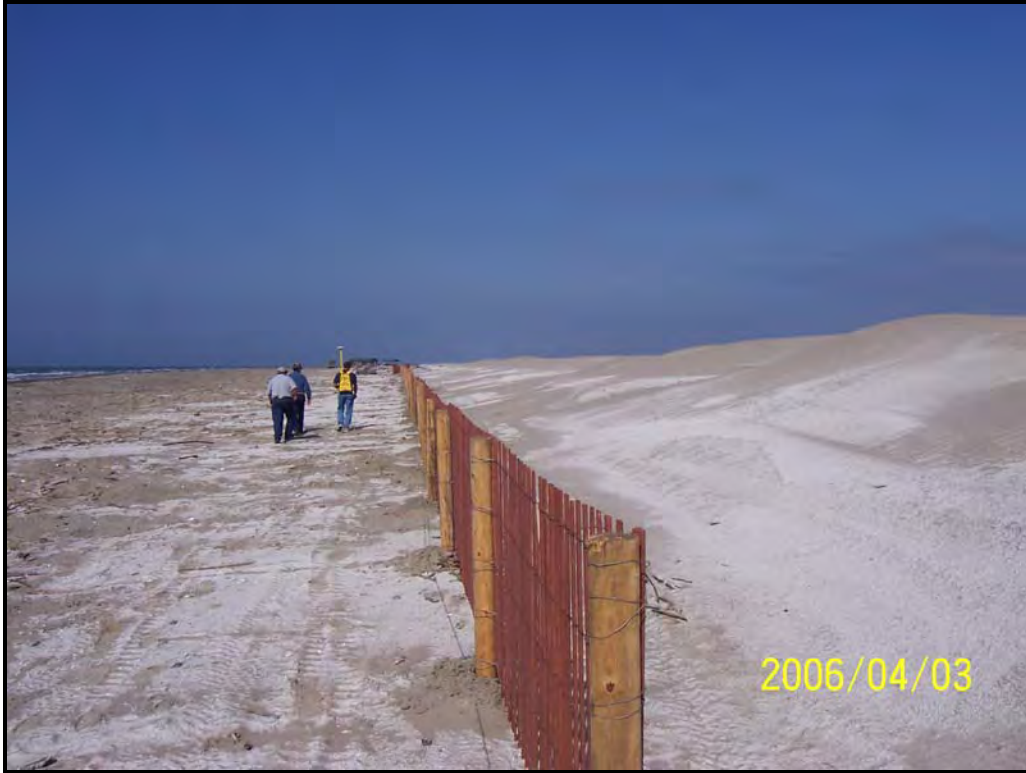
Photo 5. *View of new fence row south of existing north fence row looking west. This alignment is located east of the camp. The existing sand dune along the north fence row can be seen on the right.*

- East of the camp parallel to and south of the existing north row of fence. This row of sand fence is located approximately 50' to the south of the existing north row of fence and begins where the south row of existing fence had been removed by the storms and continues east for approximately 1,000 linear feet. See Photos 5-6.

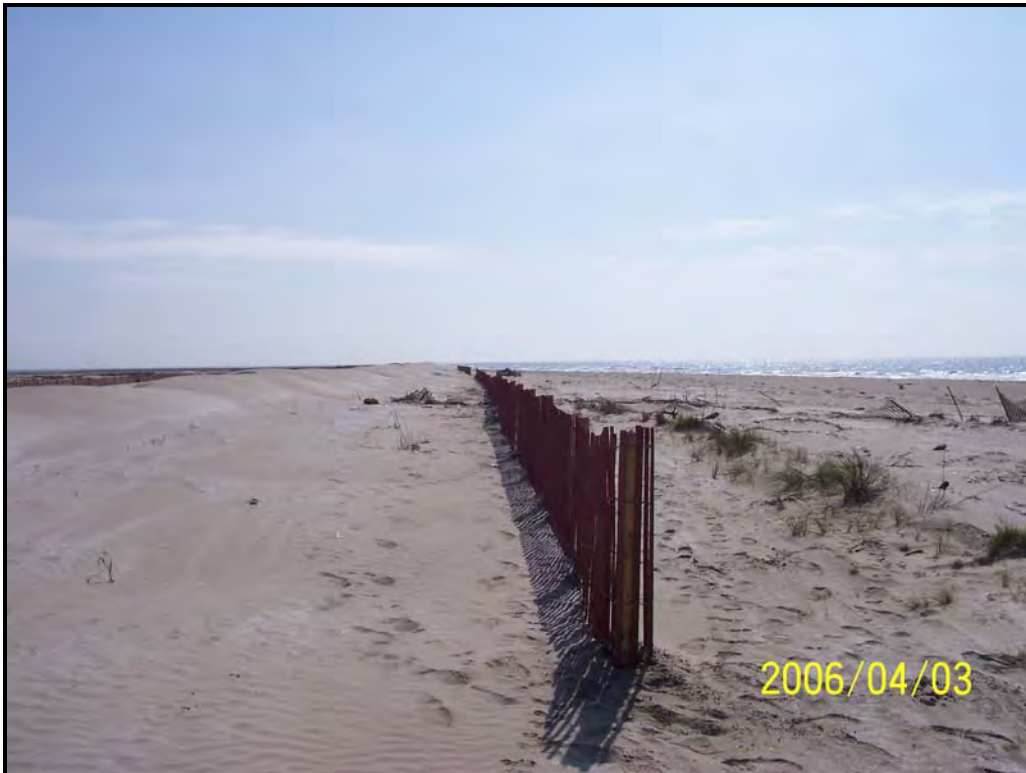
Photo 6. *View of new fence row south of existing north fence row looking east. This alignment is located east of the camp. The existing north fence row and dune can be seen on the left.*

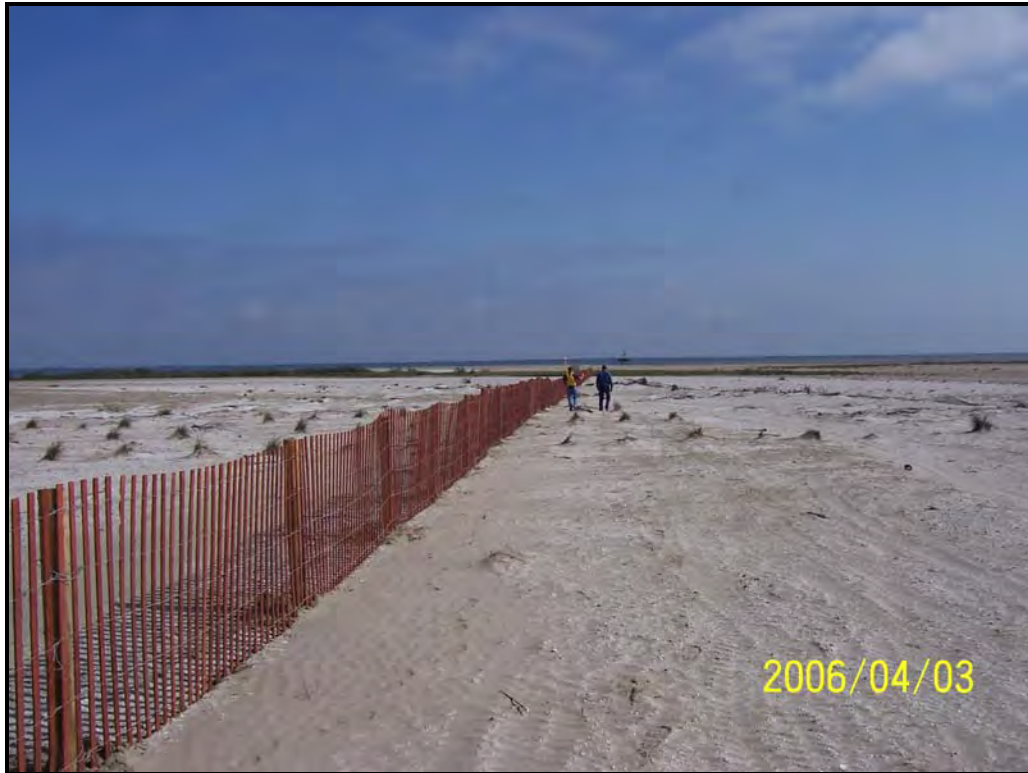
Photo 7. *View of new fence at east end of dune platform looking northeast.*

- Along the eastern edge of the remaining dune platform and back berm. This row of fence begins where the main alignment terminates at the eastern end of the existing dune platform. It extends in a northeasterly direction approximately 500 linear feet across dune platform and back berm sediments to the edge of the existing vegetation. See Photos 7-8.

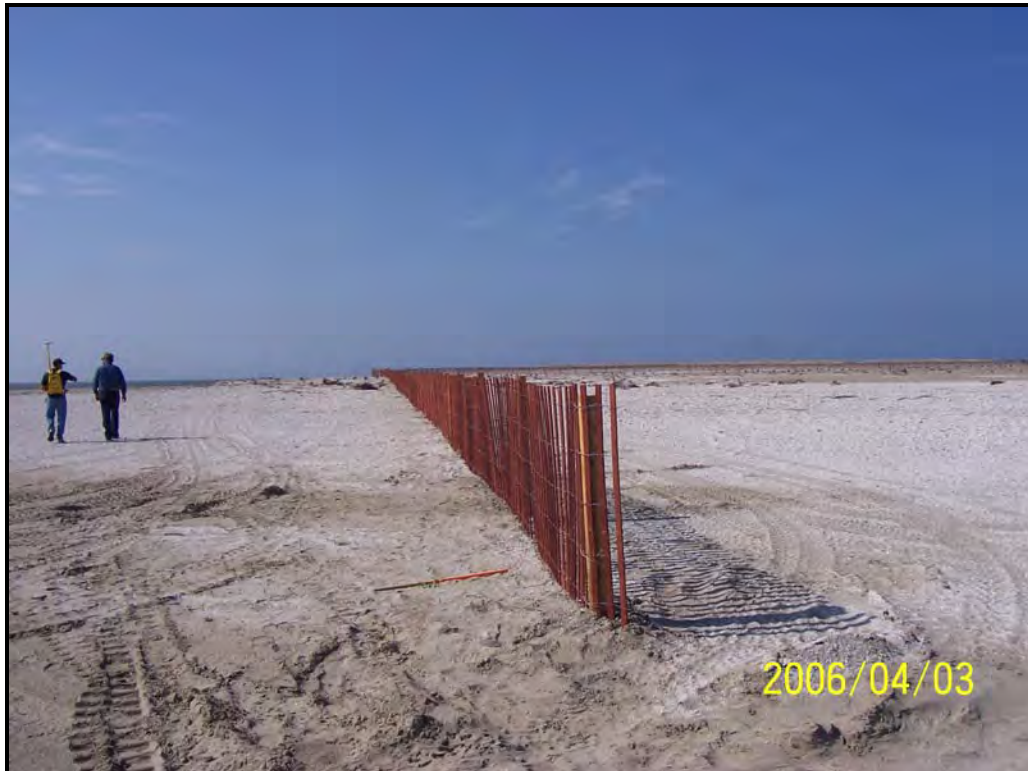
Photo 8. *View of new fence at east end of dune platform standing at the end point looking south towards Gulf.*

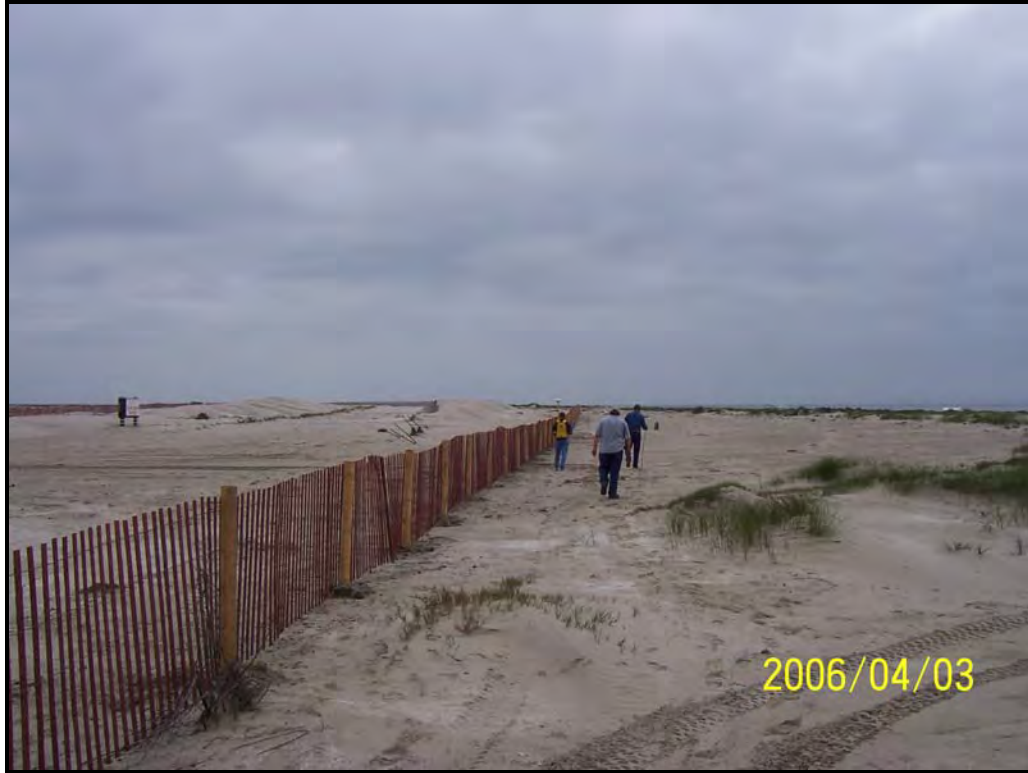
Photo 9. View of new fence alignment at west end of project standing at west end point looking east. To the left, the two existing sand fence rows/dunes and the new fence row can be seen.

- At the western end of the project area. This row of fence starts at the existing vegetation line at the western edge of the project area and continues east approximately 500 linear feet along the dune platform and terminates Gulf-side of the existing south row of fence. See Photo 9.

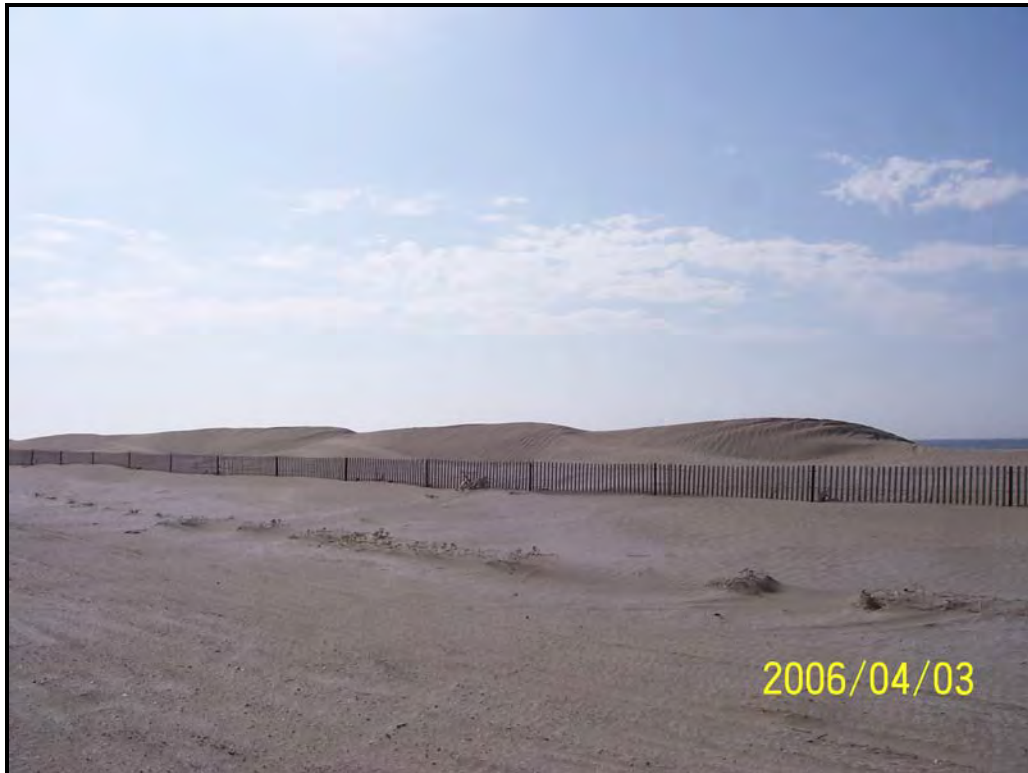
Photo 10. Photo of sand dune built up along the south side of the existing north fence row near east end of dune platform looking southeast. Material can also be seen on the north (near) side of fence.
