**Coastal Protection and Restoration Authority
of Louisiana (CPRA)**

2015 Operations, Maintenance, and Monitoring Report

Vermilion River Cutoff Bank Protection (TV-03)

State Project Number TV-03
Priority Project List 1

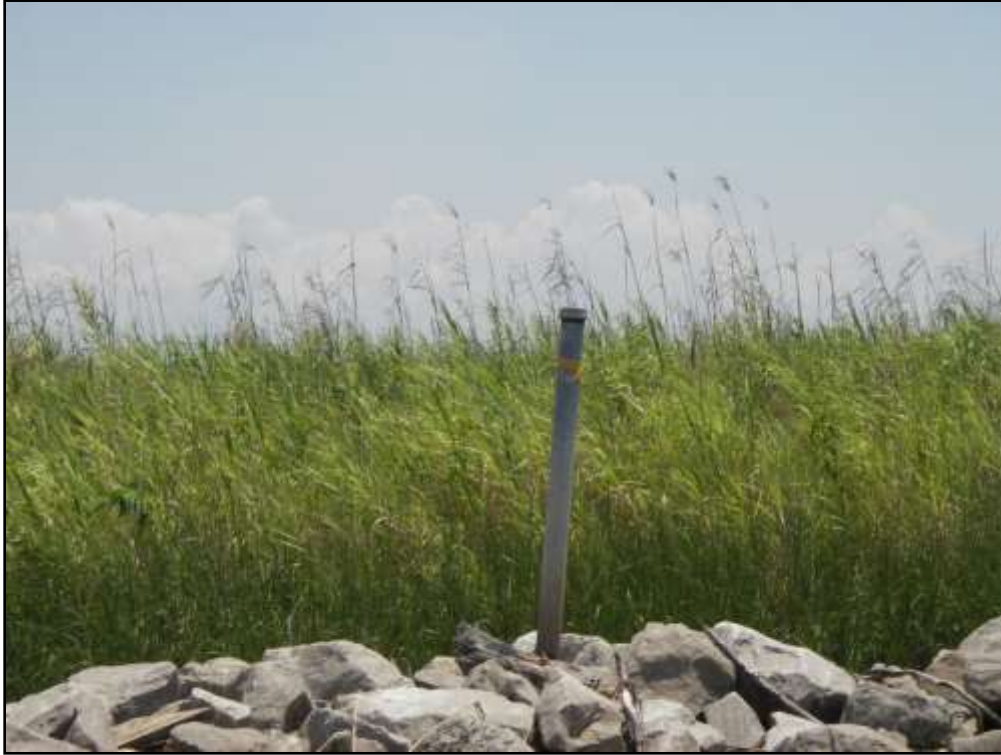
Direct shoreline measurements taken from each settlement plate (Figure 6) to the vegetated edge of the marsh behind the rock breakwater in the project area indicate an overall progradation of the shoreline. Shoreline change at settlement plates from 1998 to 2014 ranged from -0.04 m/yr to 0.95 m/yr and averaged 0.34 m/yr. Change rates between time intervals show a decrease in erosion over time at the settlement plates (Table 1).

Figure 6. Settlement plate 1007 in the Vermilion River Cutoff (TV03) project at the southern end of the rock breakwater.

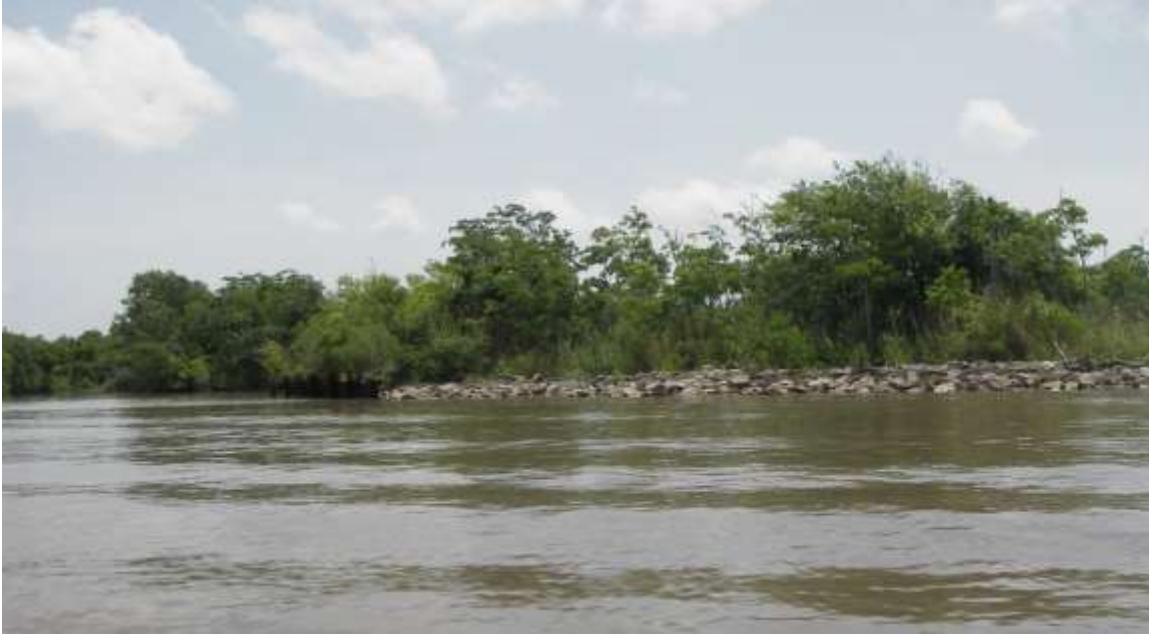
The foreshore dike is in excellent condition with no maintenance required or foreseen. Water level at the time of this inspection was approximately +1.0 NAVD. (Photos, Appendix A, Photos 1-2).

Photo No. 1—north end of dike

| Item | Condition | Physical Damage | Corrosion | Photo # | Observations and Remarks |
|---|---|---|---|---|--|
| Rip Rap (fill) (foreshore dike) | Good | | | 1,2 | The foreshore dike was in very good condition. |

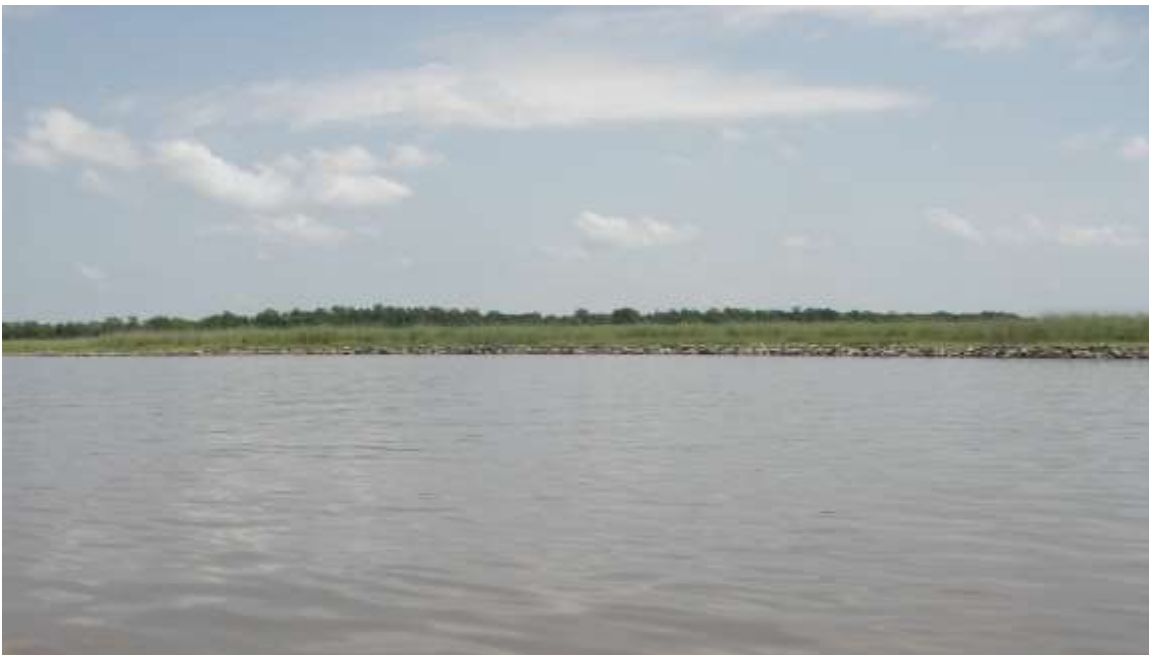
Photo No. 2—typical reach of dike
