**2015/2016 Annual Inspection  
Report**

**LAKE PORTAGE LAND  
BRIDGE PROJECT  
(TV-17)**

State Project Number TV-17  
Priority Project List 8

June 16, 2016  
Vermilion Parish

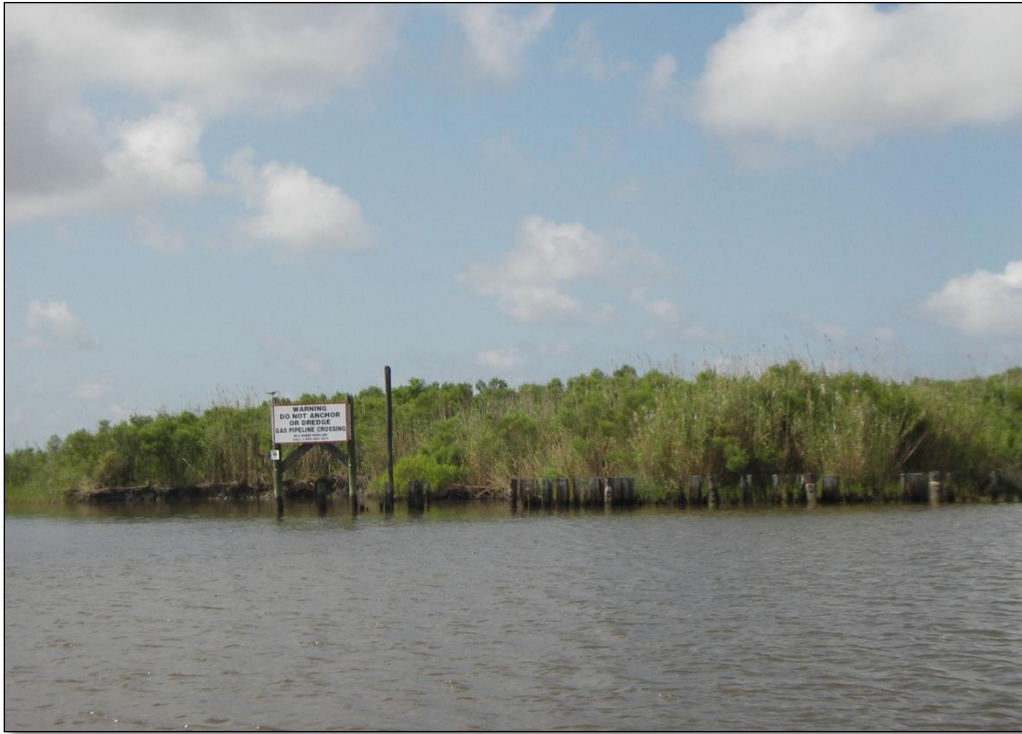
Area 1 is in good condition and vegetation has continued to expand from the containment banks moving towards the center of the channel and is 100 per cent vegetated. As a result of the inspection of Area 1, CPRA and NRCS agree that no corrective actions will be required this year. (Photos: Appendix B, Photo 1).

Photo 1, Area 1, Timber bulkhead.

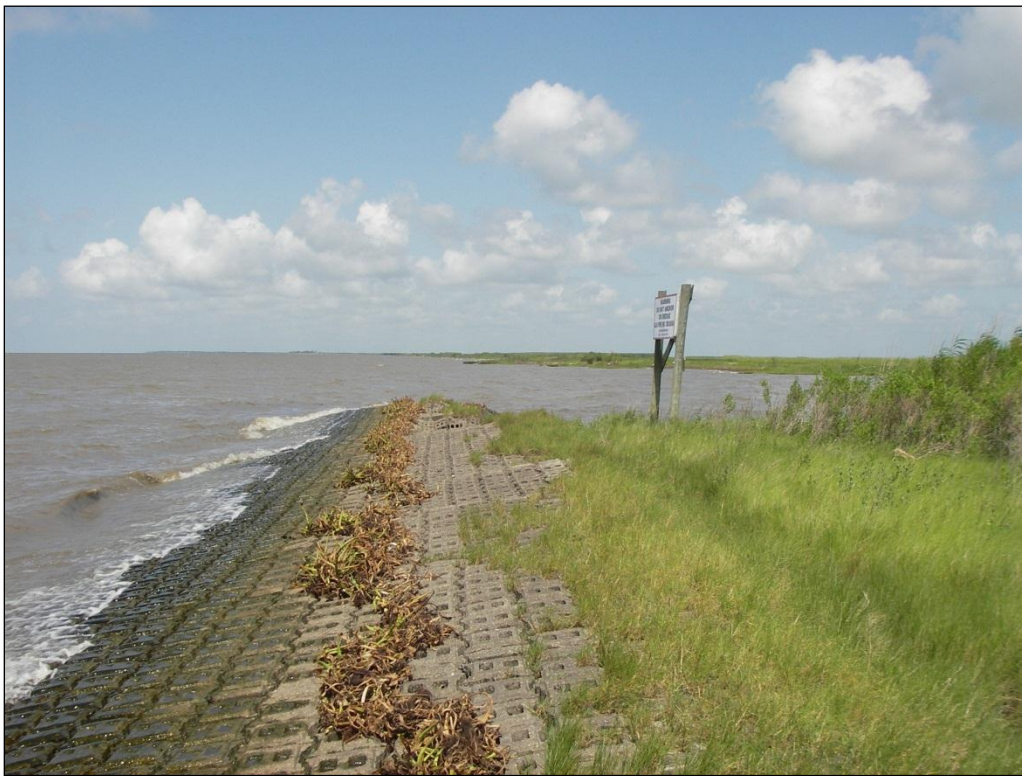
Area 2 is also in good condition and is fully vegetated, such that this reach was preexisting with additional dredge material added through this project to fill in any trenasses. Some erosion at the ends of the concrete mats along the Gulf shoreline has occurred over time and part of the mat system is showing signs of failure. Although the concrete mat system is not a feature to be maintained as part of this project, this area is experiencing erosion that may threaten the integrity of the overall project. Therefore, CPRA and NRCS agree that maintenance may be required at some time in the future. (Photos: Appendix B, Photos 2 & 3).

Photo 2, Area 2, West side of concrete mats.

Overall, the Lake Portage Land Bridge Project is in good condition and functioning as designed. However, the erosion problem occurring at the Gulf shoreline will need to be addressed. Preliminary survey work to develop an accurate estimate of costs was performed in 2008 and a subsequent request made to CWPPRA for additional funds. The Task Force decided that monitoring of the shoreline should continue and opted not to take any action at this time.

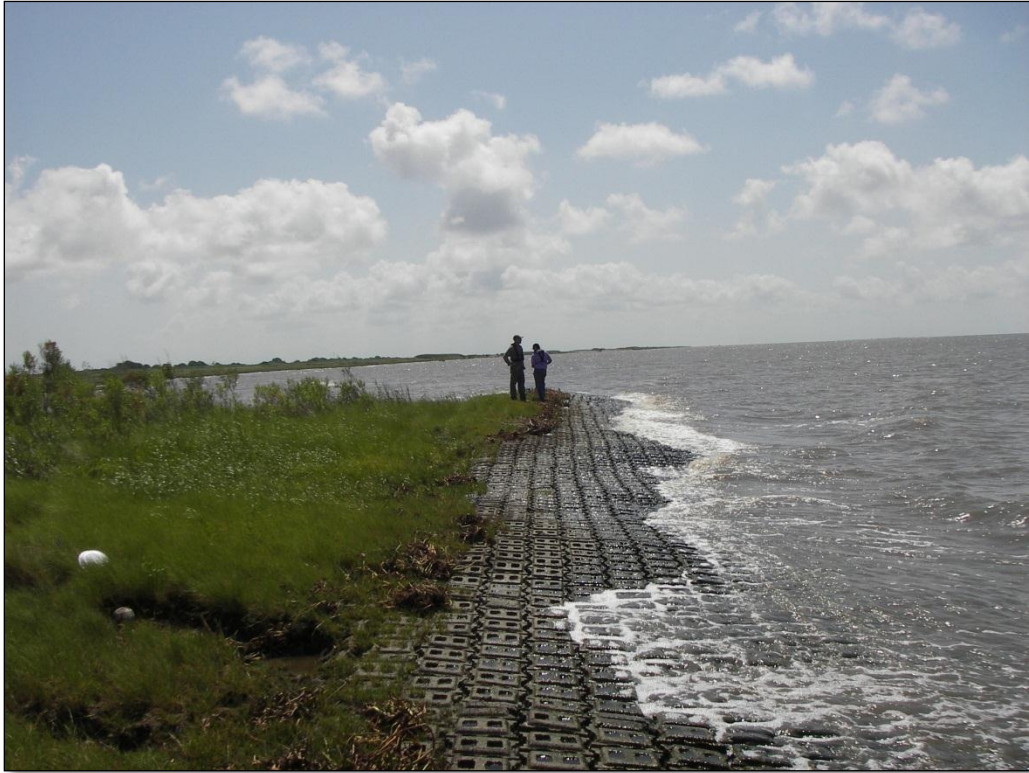
Photo 3, Area 2, East side of concrete mats.
