**State of Louisiana  
Coastal Protection and Restoration Authority  
(CPRA)**

**2025 Short Summary Report**

**East Marsh Island Marsh  
Creation**

State Project Number TV-21  
Priority Project List 14

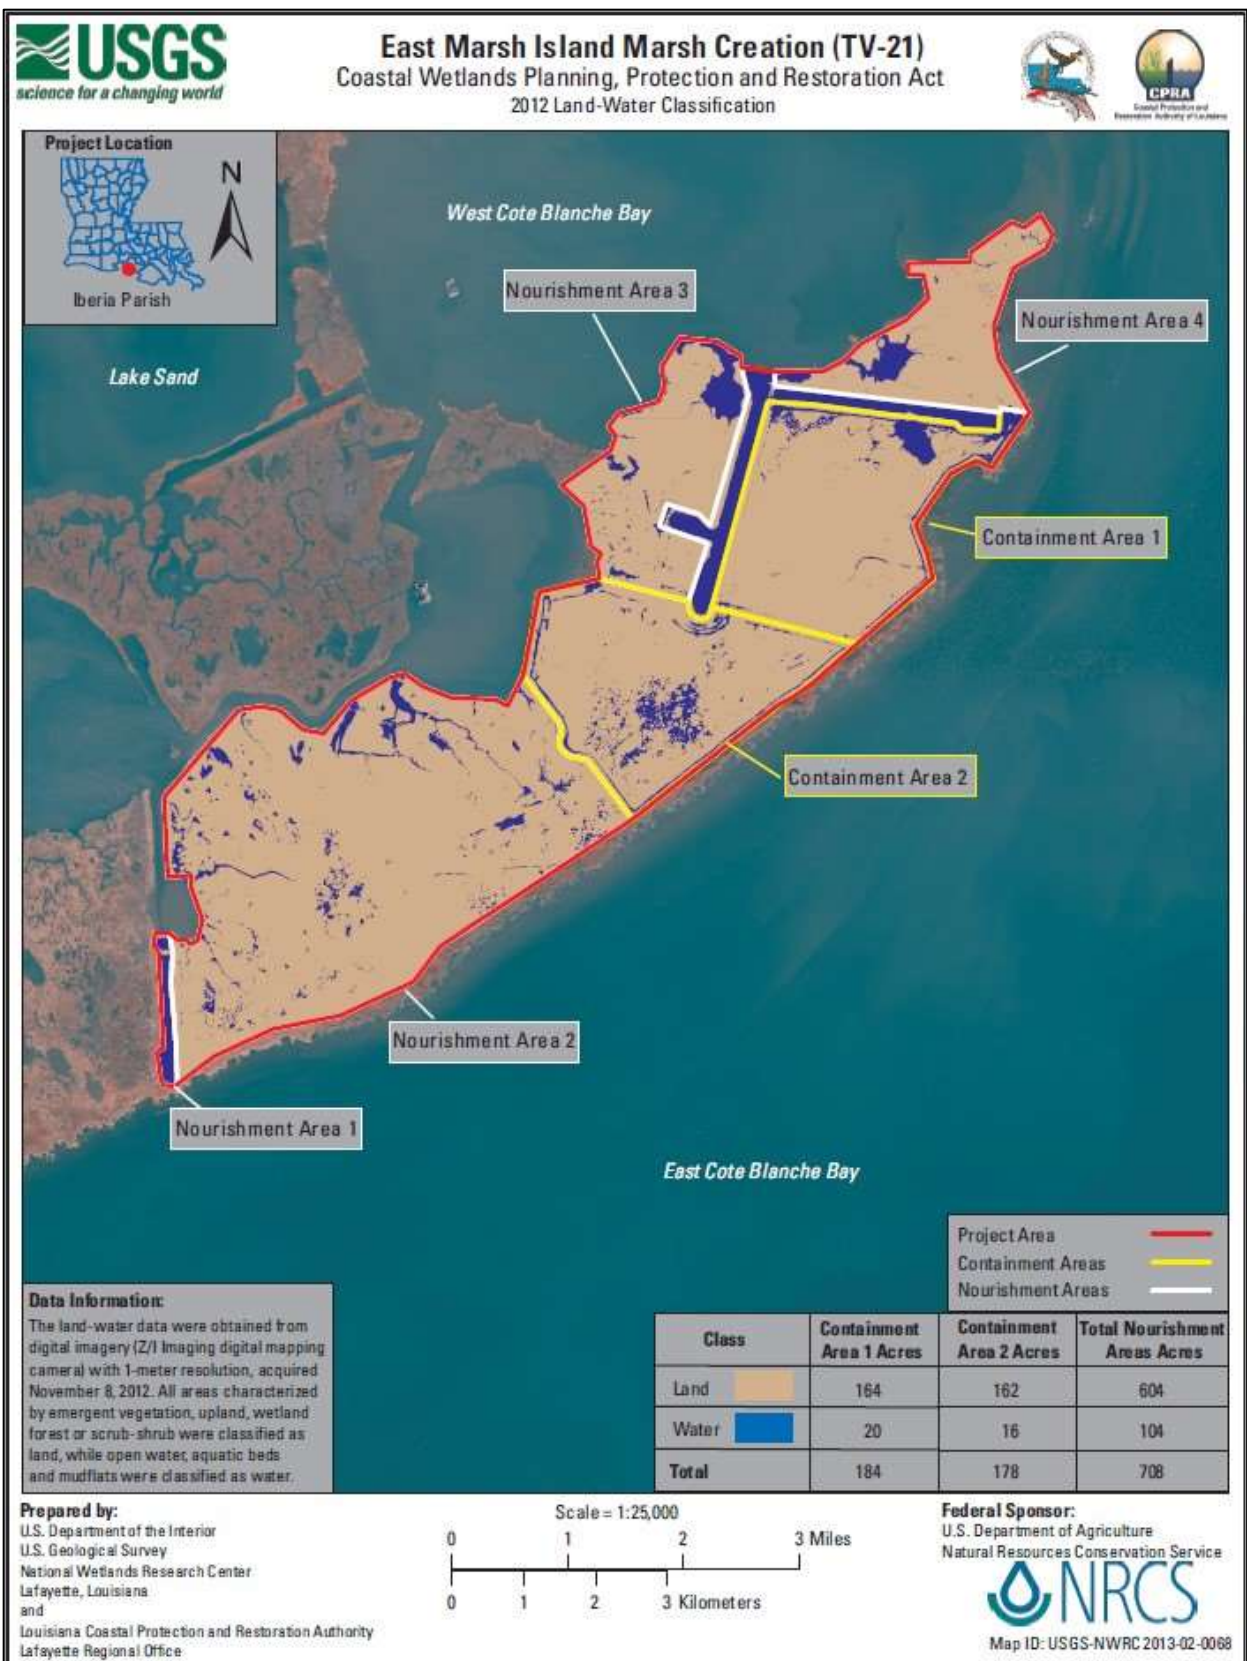
Figure 1. East Marsh Island Marsh Creation (TV-21) project 2012 Land:Water analysis.

For the two CRMS-like sites in the project area, land/water analysis was completed for the 2018 and 2021 digital imagery (Table 1). A slight loss of land occurred at both TV21-CR01 and TV21-CR02, due to small interior ponds opening up. There was a total loss of -4 acres between both sites. Since 2012, however, the entire TV-21 project area (containment plus nourishment areas) has gained approximately 42 acres of land, roughly 4% in both the two containment areas and the four nourishment areas. This appears mostly attributed to the infilling of interior ponds. Even though overall there has been an increase in land acreage it is important to note there is noticeable erosion occurring along the northern shoreline of nourishment areas 3 and 4 (Figures 1 and 2).

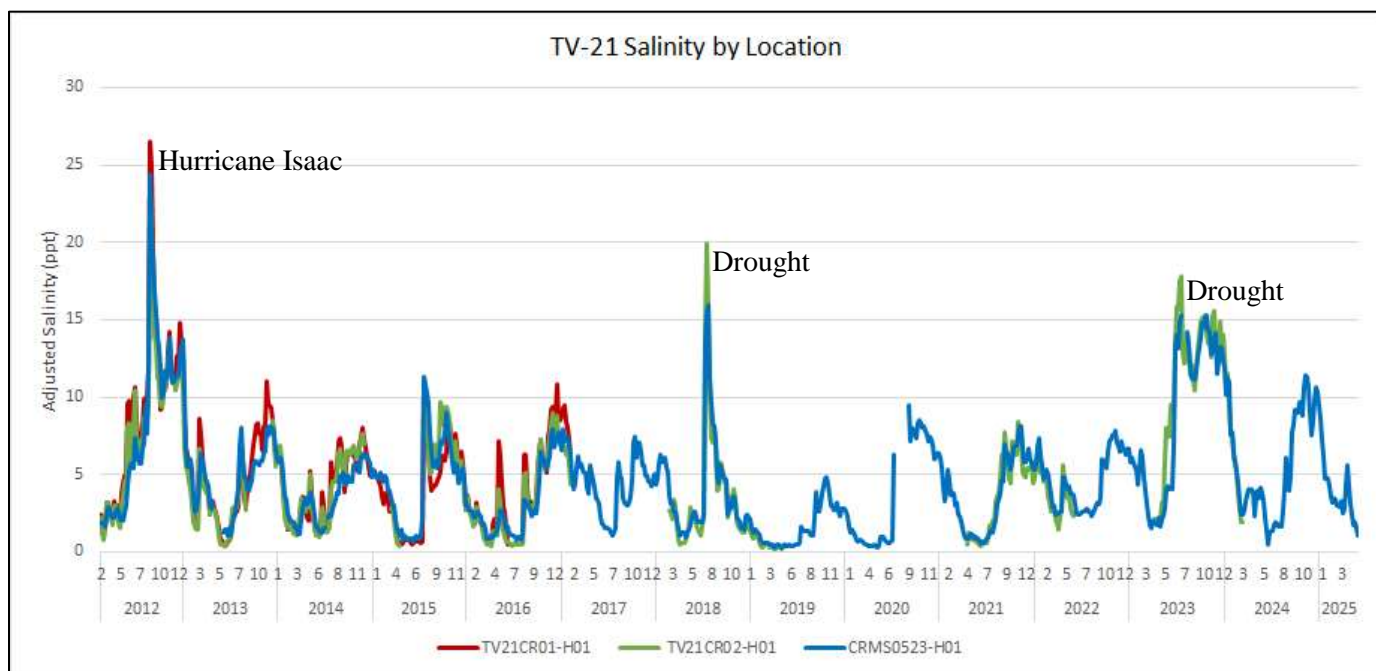
**Figure 3a.** Weekly means of salinity data collected at project and CRMS reference sites.

Salinities at both the project and reference areas averaged around 5 ppt from 2012-2025 (Figure 3a). Besides seasonal fluctuations with salinity increasing slightly in the late summer/fall months, spikes in salinity were due to Hurricane Isaac in 2012 and droughts in 2018 and 2023. Salinity spiked over 25 ppt, during Hurricane Isaac and ranged between 15 and 20 ppt during the droughts. The drought of 2023 caused the longest lasting increase in salinity lasting from mid-summer through the end of the year.

Average weekly salinities were compared between the project station and the reference station to determine if a difference in salinity occurred between the two. A non-parametric one-way median analysis showed that salinities were not statistically different across the period of record between TV21CR02 and the recorder at the reference site CRMS0523 ( $\chi^2=0.0000$ ,  $p=1.0000$ ).

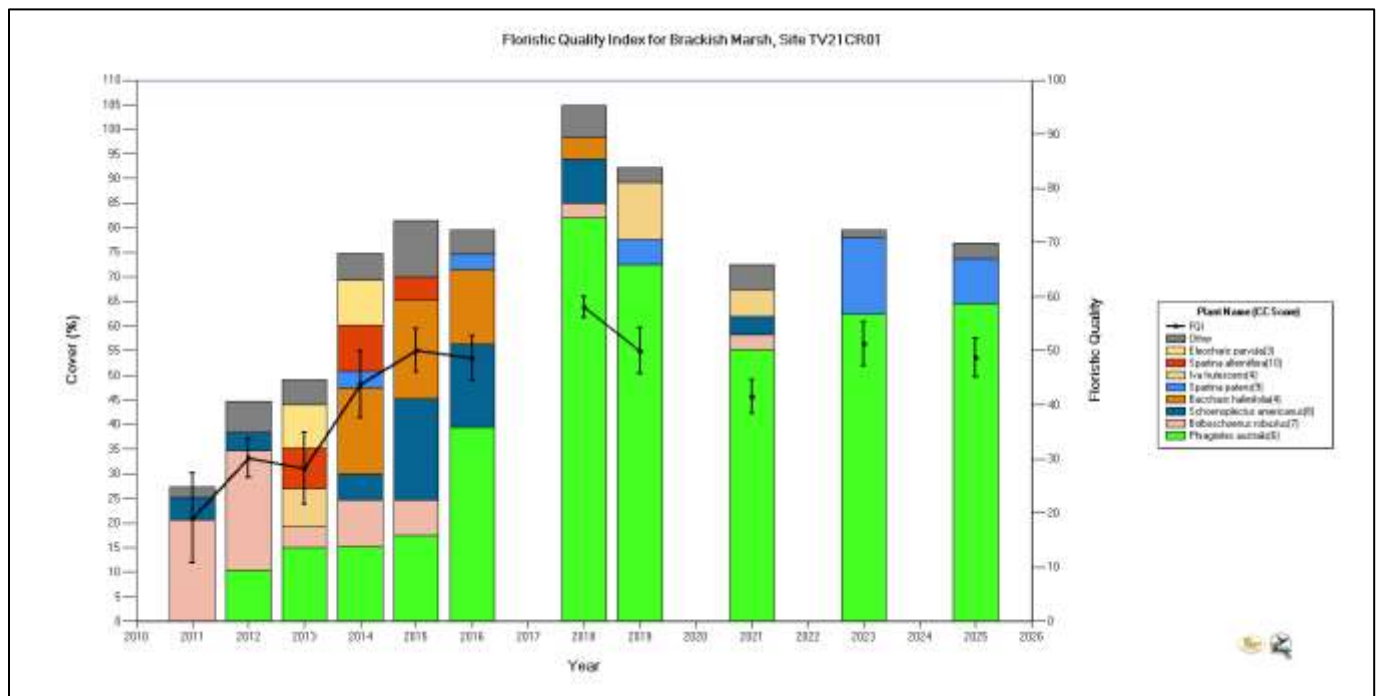
**Figure 5a.** Percent coverage and floristic quality index of species collected from station TV21-CR01 within the project area in years 2011-2024. The CC scores represent the quality of individual species from 1 to 10 where 1 represents disturbance species and 10 indicates stability.

Vegetation in the containment area, TV21CR01, has transitioned from a mix of *Schoenoplectus*, *Baccharis* and *Phragmites* into a monoculture of *Phragmites* with some *Spartina patens* (Figure 5a). Hurricane Barry seemingly had little effect on vegetative cover in this area, as it has remained over 70% prior to and after the storm. The nourishment area, TV21CR02, has been dominated by *Spartina patens* and *Schoenoplectus americanus*, along with some *Phragmites* since 2018 (Figure 3b). Vegetative cover in this area has been at least 80% except 2023 in which cover dropped to around 60%. This is likely attributed to the intense drought experienced that year with *Spartina patens* and *Schoenoplectus* being more sensitive to higher saline conditions rather than *Phragmites*, which is why the *Phragmites* dominated containment area showed no drought effects in 2023. Additionally, this area is prone to extensive herbivory damage by muskrats and nutria.

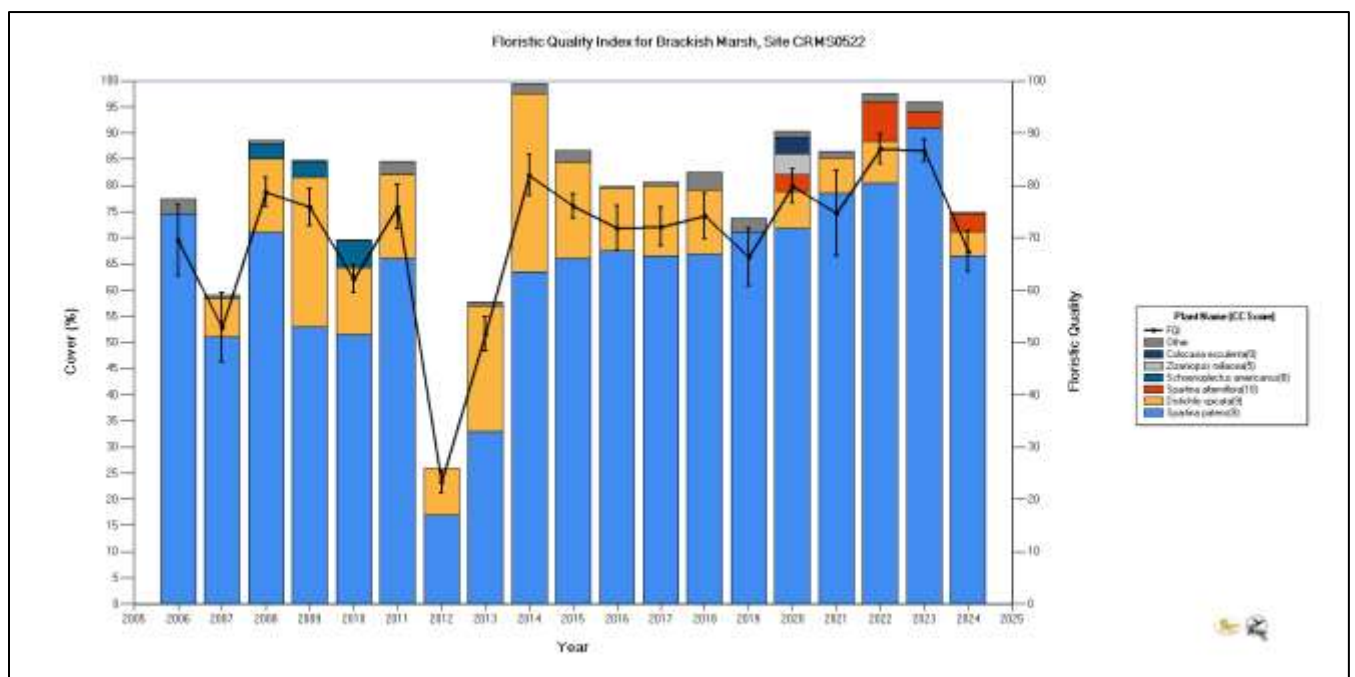
**Figure 5c.** Percent coverage and floristic quality index of species collected from reference site CRMS0522 in years 2006 - 2024. The CC scores represent the quality of individual species from 1 to 10 where 1 represents disturbance species and 10 indicates stability.

The nourishment (TV21CR02) most closely resembles the CRMS reference sites in regards to species assemblages. All three reference sites, CRMS0522, 523 and 524 are dominated mostly by *Spartina patens* along with some *Eleocharis parvula*, *Distichlis spicata* and *Spartina alterniflora* (Figures 5c – 5e). Overall, the CRMS sites maintained vegetative cover of at least 60%, which indicated little to no impacts from Hurricane Barry in 2019. CRMS0523 and CRMS0524 did see a slight dip in vegetative cover in 2023, likely due to drought conditions and some herbivory but increased in cover again in 2024.

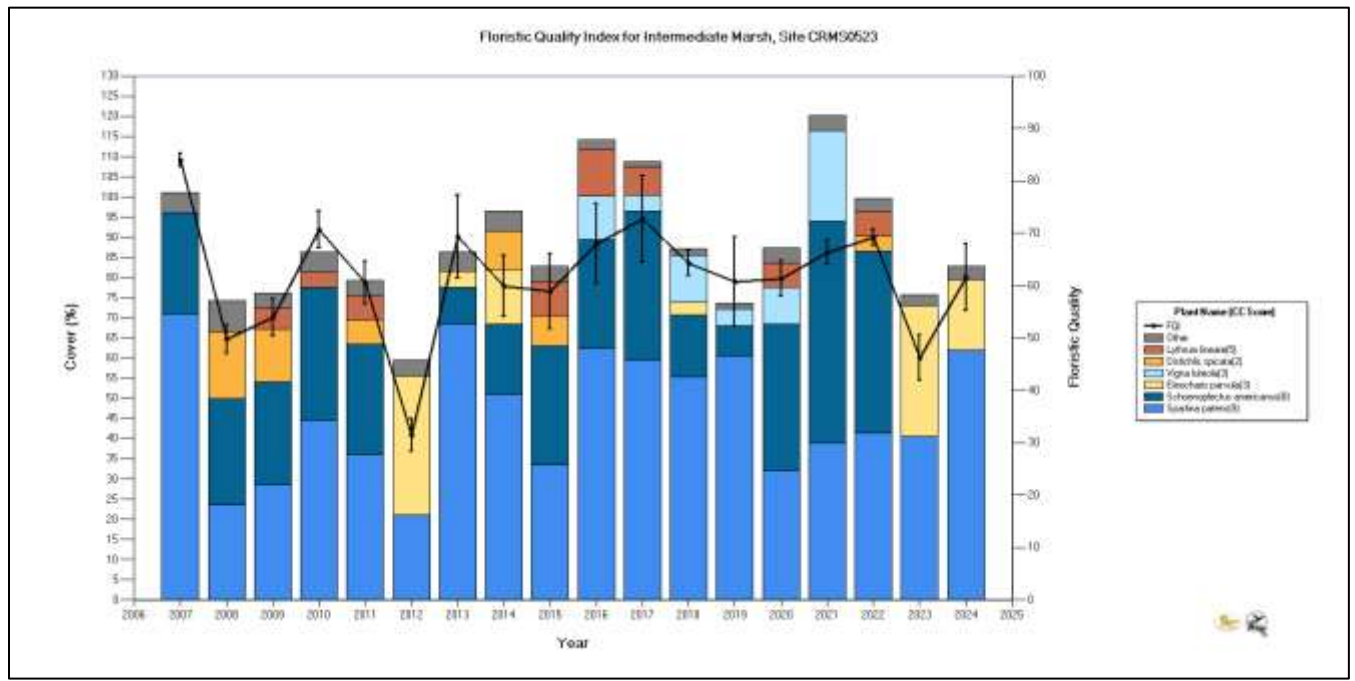
**Figure 5d.** Percent coverage and floristic quality index of species collected from reference site CRMS0523 in years 2007 - 2024. The CC scores represent the quality of individual species from 1 to 10 where 1 represents disturbance species and 10 indicates stability.
