Post Hurricane Monitoring Report Revision 1

Rockefeller Refuge Gulf Shoreline Stabilization Project

HDR Engineering, Inc.
State Project Number ME-0018
HDR Project Number 10270651

Cameron Parish, Louisiana
October 15, 2021

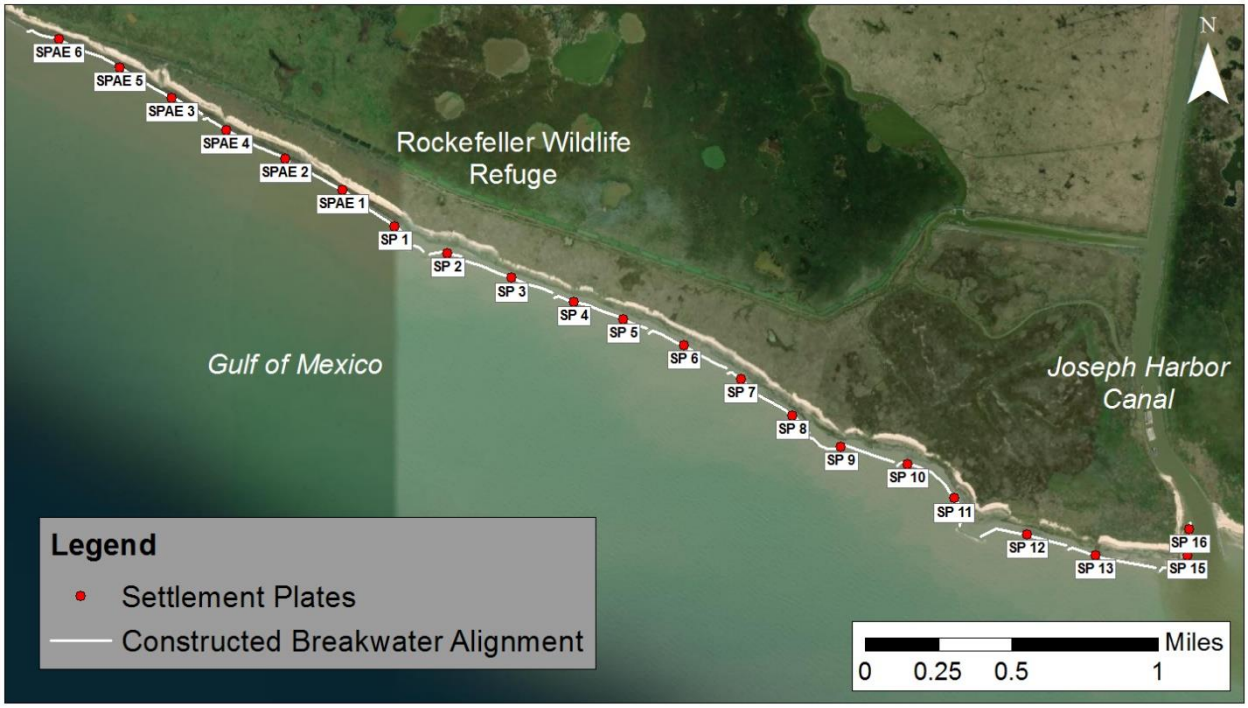
Figure 3-3. Settlement Plate Locations

Figure 3-4 shows the settlement between the As-Built and Monitoring surveys at each settlement plate and the corresponding breakwater elevation changes. One settlement plate showed no settlement, 18 settlement plates showed settlement between 0 and 1 ft, and two settlement plates showed settlement between 1 and 2 ft. The greatest amount of settlement experienced between the As-Built and Monitoring surveys was 1.09 ft at SP1.

Ninety-eight breakwater transects were surveyed. Of this total, 34 transects showed elevation change between 0 and -1 ft, 57 transects showed elevation change between -1 and -2 ft, and 6 transects showed elevation change exceeding -2 ft. One transect showed no elevation change. The maximum elevation change observed between the As-Built and Monitoring surveys was -2.64 ft at Station 415+01.The elevation change of the breakwater is generally higher than the settlement plate elevation change which indicates there may have been some

minimal movement of riprap. Since the majority of the structure appears to be intact, no corrective actions are recommended at this time. Future monitoring should continue to assess the structure integrity.

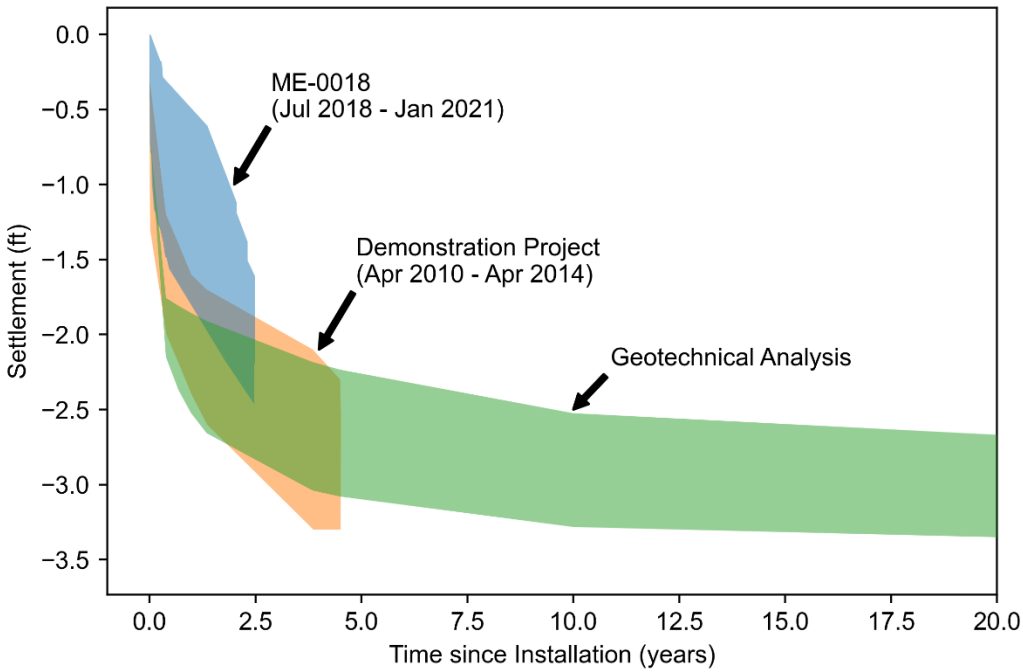
Figure 3-5. Settlement at ME-0018 compared to the LWAC demonstration project and geotechnical analysis.

A demonstration project which included a LWAC breakwater was constructed at the site in April 2010 before the full ME-0018 project was constructed. HDR performed geotechnical analyses on the demonstration project settlement plate data in October 2011 and April 2014. The results indicated an average settlement of 2.7 ft at the demonstration project over the 4 years from installation to the 2014 analysis. The full ME-0018 project was constructed between July 2018 and January 2020 with settlement plates installed throughout that timeframe as the breakwater was constructed. Each of the settlement plates from the full ME-0018 project were surveyed again in January 2021 as part of the current monitoring providing a range of settlement data from 12 to 30 months, depending on installation time. Figure 3-5 shows the maximum and minimum measured settlement values as shades for both the demonstration project and the full ME-0018 project relative to time since settlement plate installation. Also included is the predicted settlement curve used during design over the project's 20-yr design life. All settlement plates installed during the full ME-0018 construction project and all breakwater transects compared between the As-Built and Monitoring surveys show less settlement than what was estimated during design. This indicates that the breakwater is settling as anticipated, or better than anticipated.

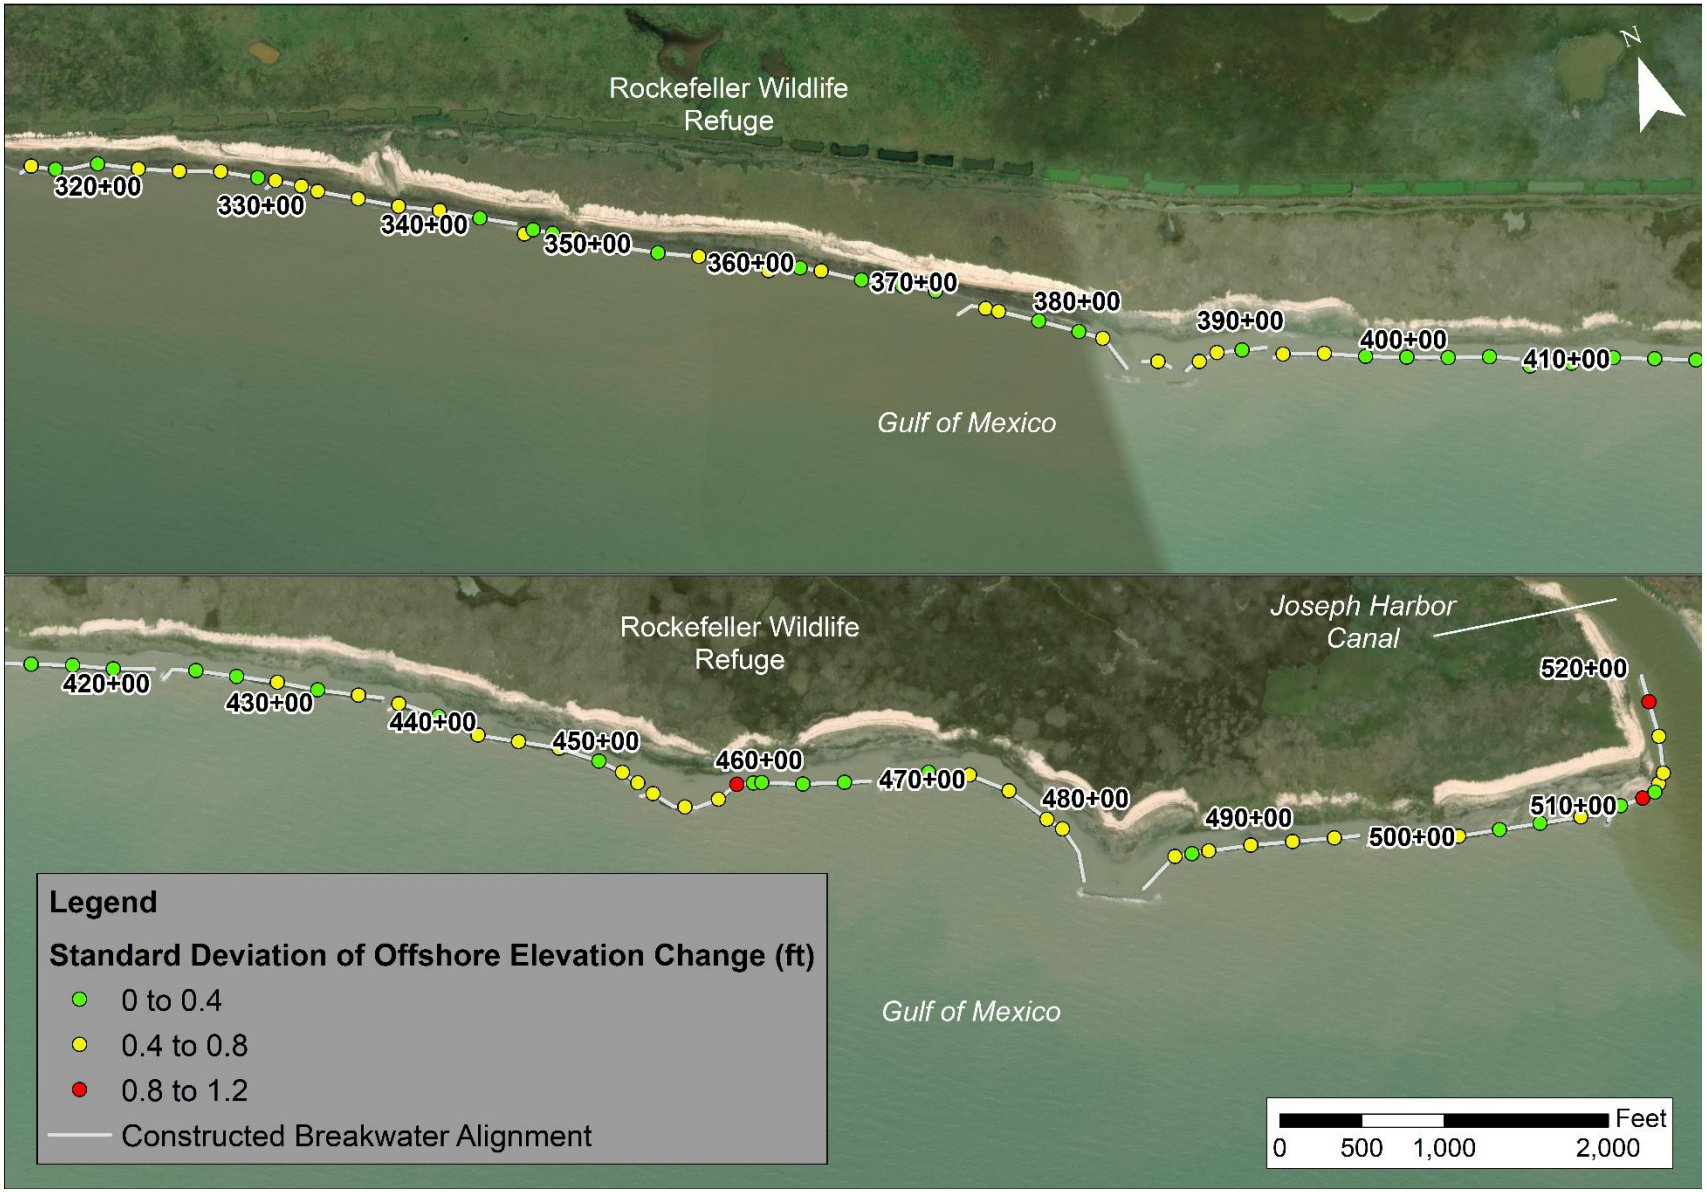
Figure 3-6. Standard Deviation of Offshore Scour (ft)

Figure 3-6 shows the standard deviation of each transect. The transects with the highest standard deviations (i.e., greater than 0.8 ft) mostly lie at the mouth of Joseph Harbor Canal where offshore erosion (away from breakwater toe within the canal) has been observed. Transects toward the center of the breakwater segments typically showed lower standard deviation values due to the greater protection from erosion with values ranging from 0 to 0.8 ft. Review of the transects did not indicate any significant toe scour near the breakwater. See Appendix C for As-Built and Monitoring Transect Plots.
