TIMBALIER ISLAND PLANTINGS (TE-18)
TE-18-MSPR-0696-2
PROGRESS REPORT NO. 2
for the period
August 01, 1995 to June 17, 1996

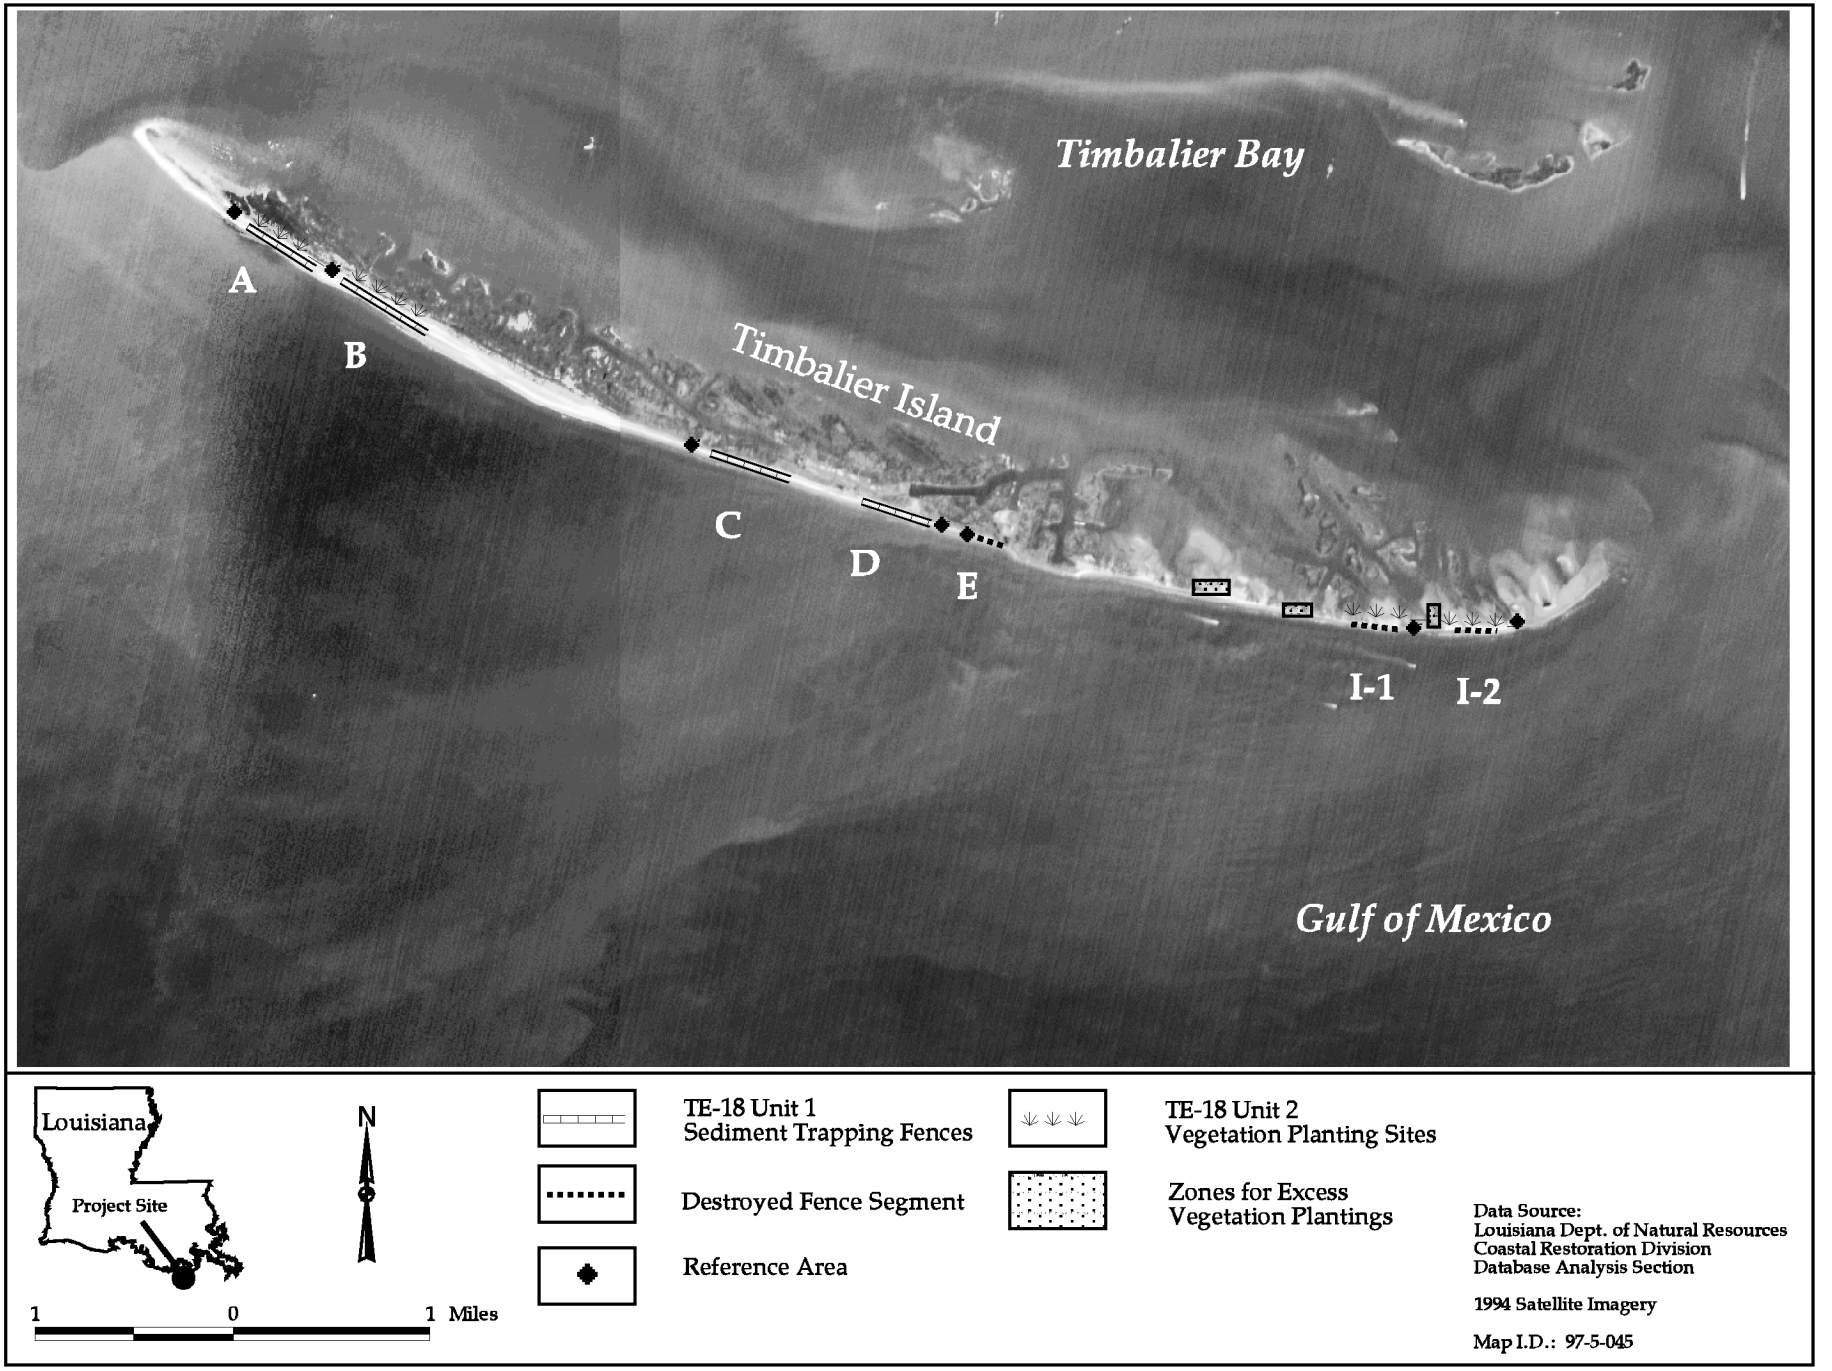
Tropical storms that passed near the Louisiana coast during the summer of 1995 caused extensive damage to the sediment-trapping fences. Three fencing segments were completely destroyed (figure 1) and the other four fences had damage that is being repaired by NRCS. Vegetation is naturally colonizing segments C and D. Vegetation will therefore only be planted at the fence segment locations that have not naturally vegetated (segments A and B), including some of the locations where the sediment-trapping fences were destroyed (segments I-1 and I-2). Any excess vegetation will be planted in designated plots established on bare beach or washover areas between the fence segments and the reference areas (figure 1).

Observations from recent field trips indicate the remaining fences are trapping sand. Accretion of sand as high as 2 ft in front of the fencing is common. The eastern end of Timbalier Island has suffered severe beach erosion. The beach has eroded beyond the original location of the sediment-trapping fences, completely destroying segments I-1 and I-2.

Figure 1. Timbalier Island Plantings (TE-18) project elements. Letters (A-I) represent fence segments.

The construction of the sediment-trapping fences was completed on May 11, 1995 but the vegetative plantings will not begin until June 1996. Three fence segments were destroyed and four fence segments were damaged by tropical storms that passed near the Louisiana coast in 1995. The damaged segments will be repaired by Natural Resources Conservation Service (NRCS) in June 1996.
